FINAL PRELIMINARY ASSESSMENT AND SITE INSPECTION OF PER- AND POLYFLUOROALKYL SUBSTANCES

Aliamanu Military Reservation, Hawaii

Prepared For:
U.S. Army Corps of Engineers, Baltimore District
2 Hopkins Plaza
Baltimore, Maryland 21201

July 2023

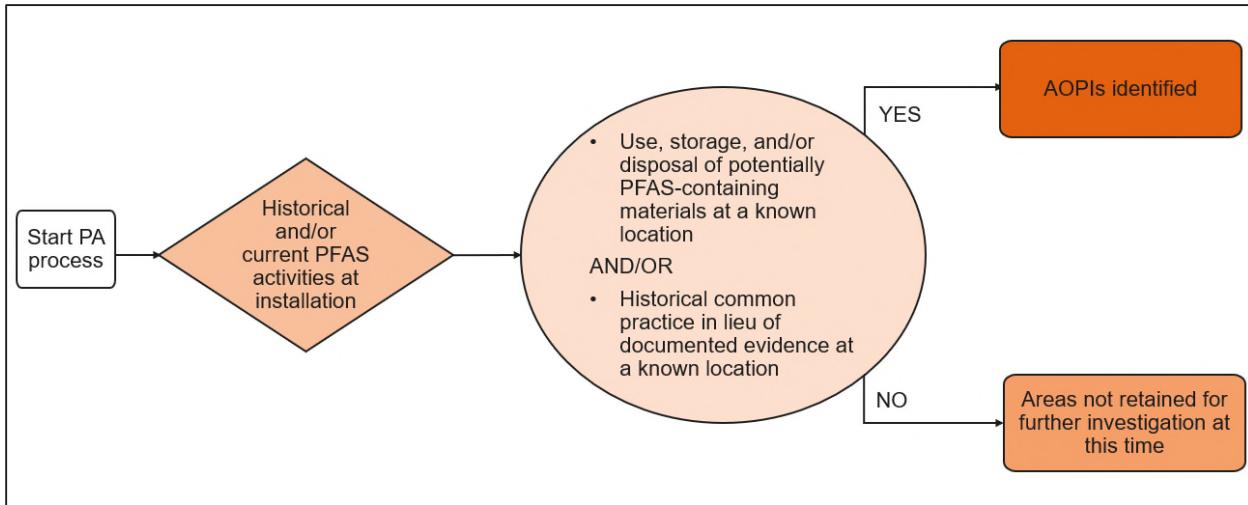
Figure 5-1: AOPI Decision Flowchart

The preliminary locations evaluated for potential use, storage, and/or disposal of PFAS-containing materials at AMR, were further refined during the PA process and identified either as an area not retained for further investigation or as an AOPI. In accordance with the established process for the PA/SI, two areas have been identified as AOPIs. The process used for refining these areas is presented on **Figure 5-1**.

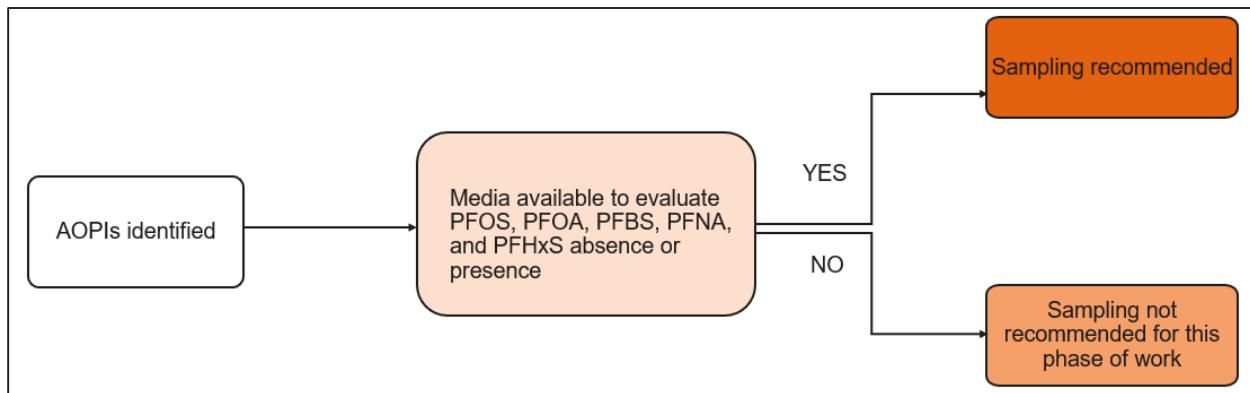
Figure 6-1: AOPI Sampling Decision Tree

The rationale for sampling at each AOPI is illustrated on **Figure 6-1** below.

The sampling design for SI sampling activities at AMR is detailed in Worksheet #17 of the QAPP Addendum (Arcadis 2022). For AOPIs Vehicle Fire Location 1 and Former Fire Station #6, samples were collected at locations of known or suspected former use and/or former storage of PFAS-containing materials, areas where surface runoff may have occurred, and downgradient locations if exact former use or former storage locations are unknown. Sample locations were selected based on site-specific historical evidence and/or ground surface conditions observed in the field. The targeted sampling areas were positioned in the center, downgradient, and/or cross-gradient of suspected PFAS (including PFOS, PFOA, PFBS, PFNA, and PFHxS) use, storage, and/or disposal areas. Sample media types (i.e., soil and groundwater) were based on media most likely to confirm the presence or absence of PFOS, PFOA, PFBS, PFNA, and PFHxS. Soil and groundwater samples were collected from each AOPI. Composite soil samples were collected from the upper 2 feet of native soil, as determined by the field geologist. Shallow (first encountered) single-interval groundwater samples were collected from temporary wells.

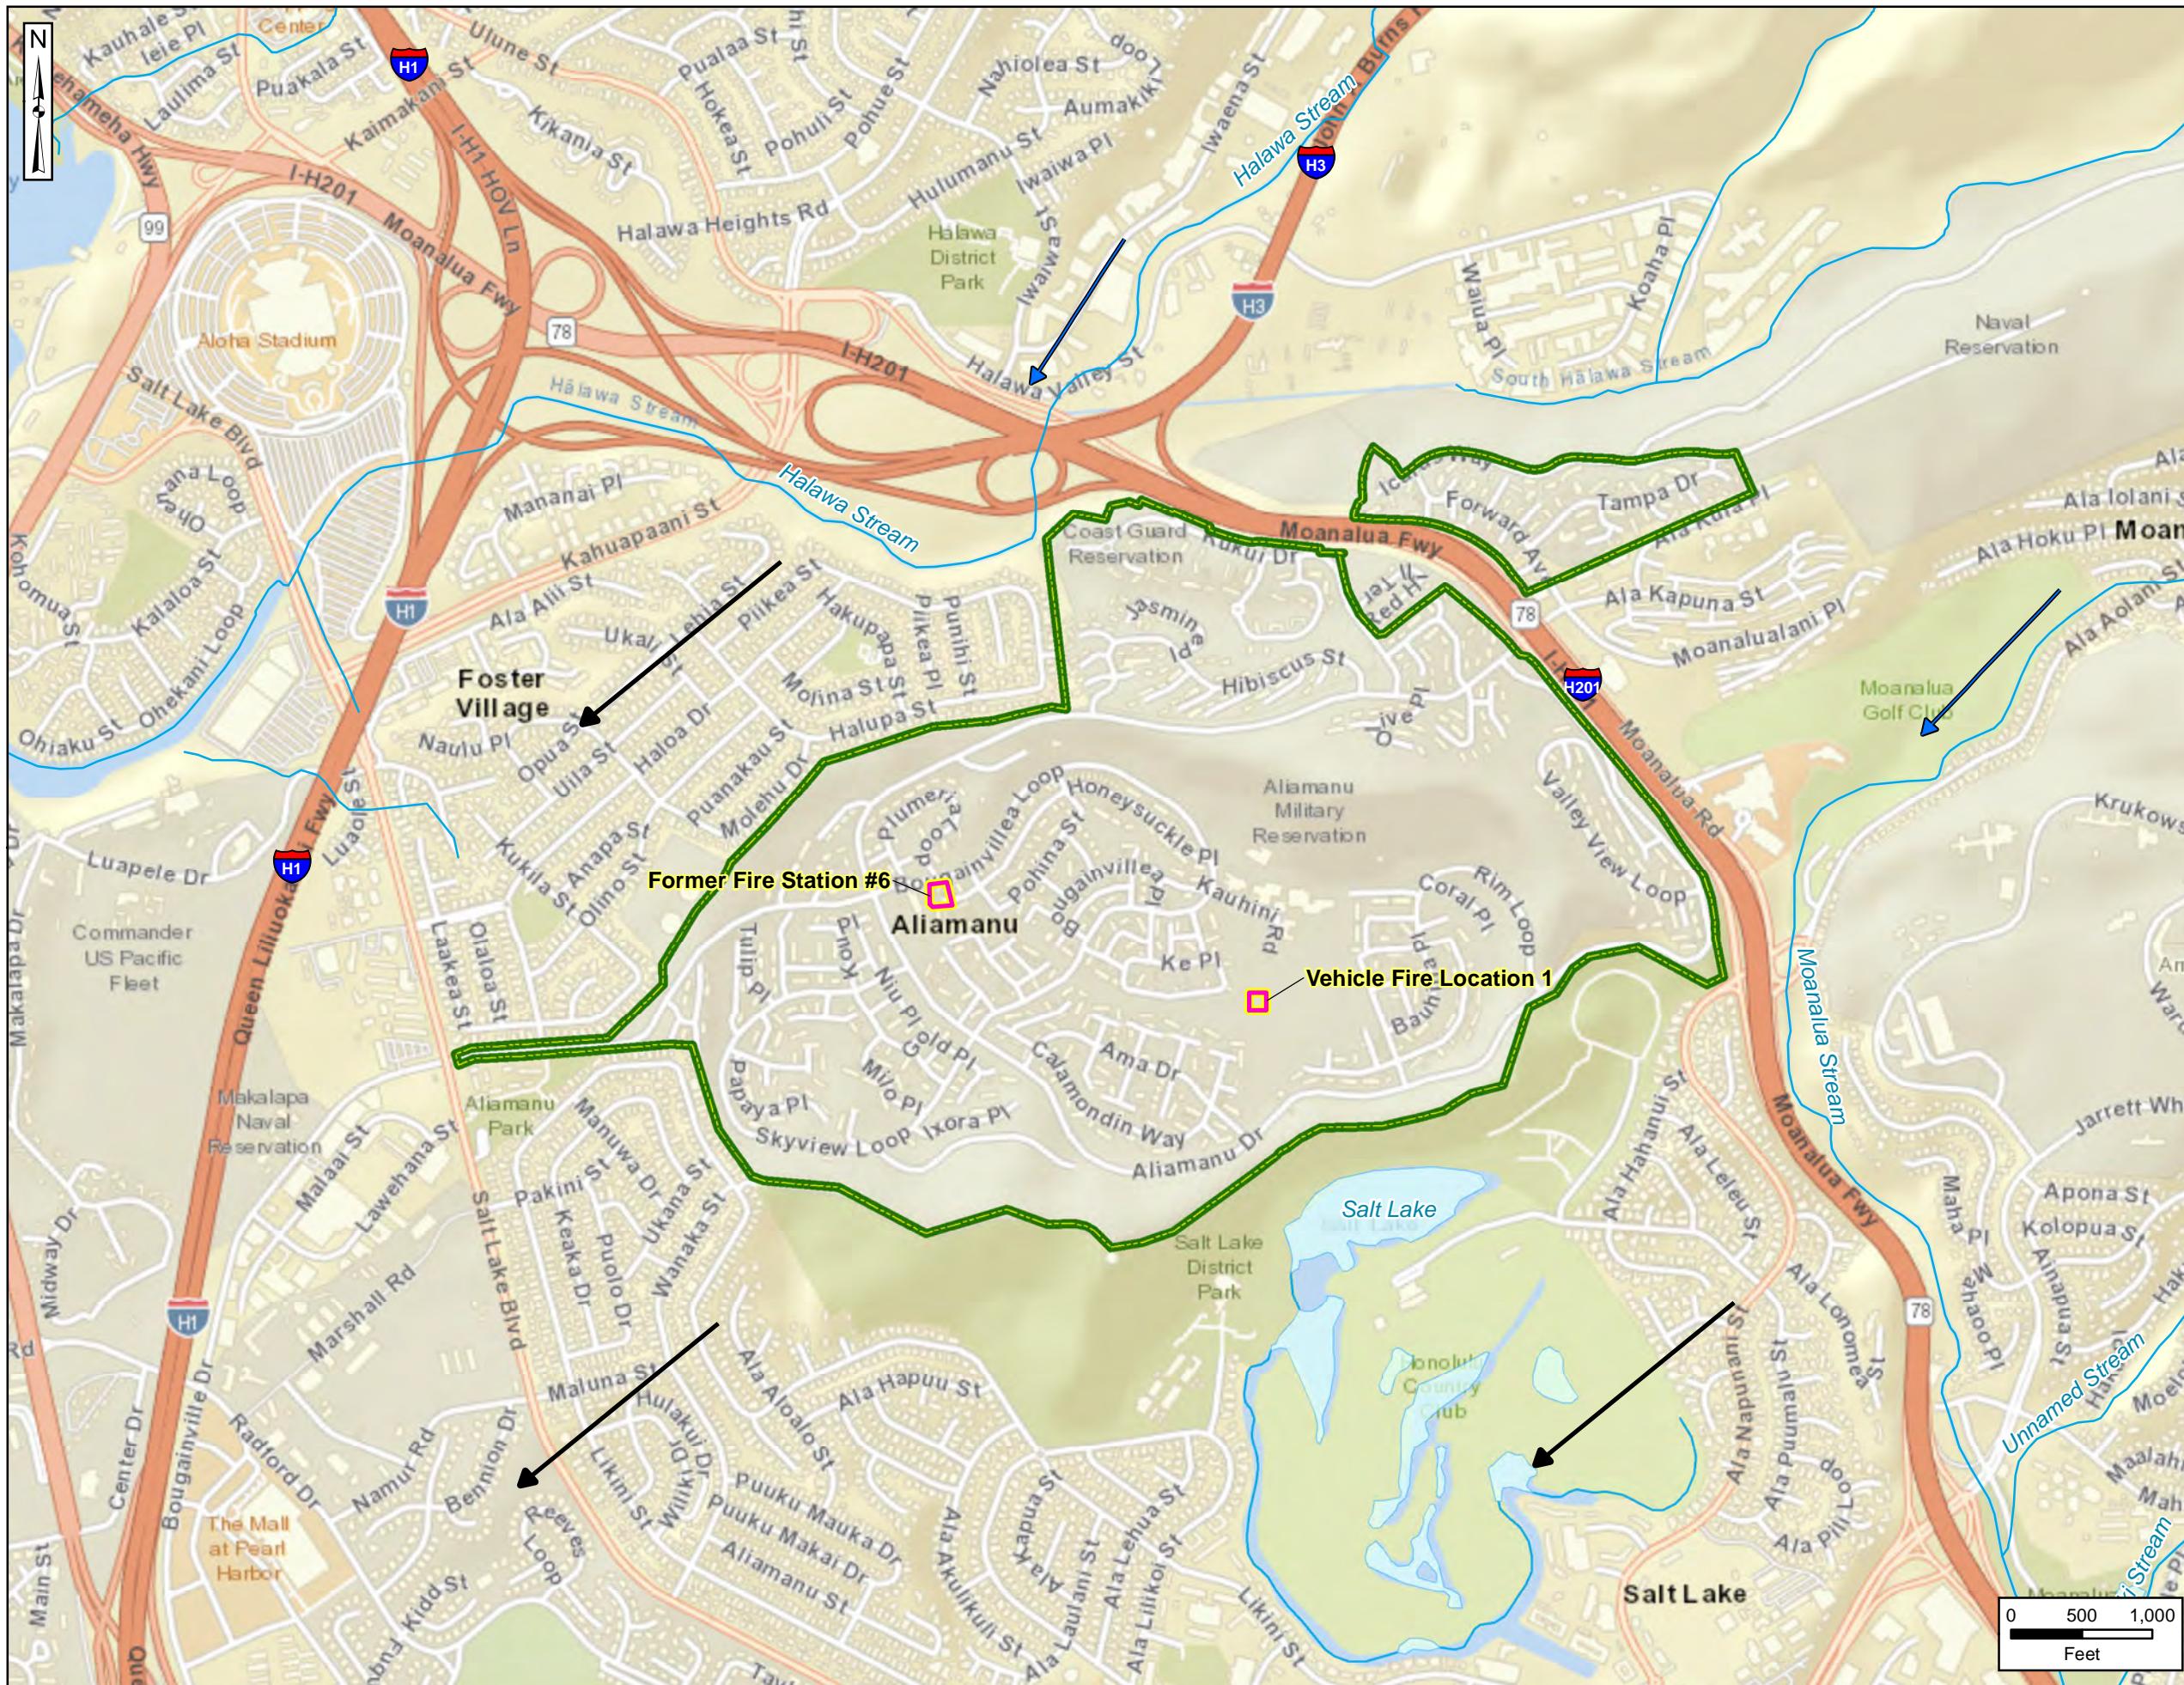
Figure 7-2
Vehicle Fire Location 1
PFOS, PFOA, PFBS, PFNA,
and PFHxS Analytical Results

PFOS was detected in the parent and field duplicate groundwater samples collected from AOPI Vehicle Fire Location 1 at concentrations of 4.9 ng/L and 4.1 ng/L, respectively, with J+ qualifiers (i.e., estimated quantities that may be biased high) due to EB contamination. Although those concentrations are biased high, further study of AOPI Vehicle Fire Location 1 in a remedial investigation is recommended because the groundwater results exceeded the OSD tap water risk screening level of 4 ng/L. Records gathered for the use, storage and/or disposal of PFAS-containing materials were reviewed during the PA process. Documentation specific to AFFF may have been limited (e.g., each AFFF use; procurement records, documentation of AFFF used during crash responses or fire training activities) due to lack of recordkeeping requirements for the full timeline of common AFFF practices. Anecdotal accounts of AFFF use (and therefore likely PFOS, PFOA, PFBS, PFNA, and PFHxS use) were limited to available USAG-HI and FFD personnel, whose knowledge of AFFF use may have been restricted by their time spent at the installation or previous roles held that limited their relevant knowledge of potential AFFF (or other PFAS-containing material) use.

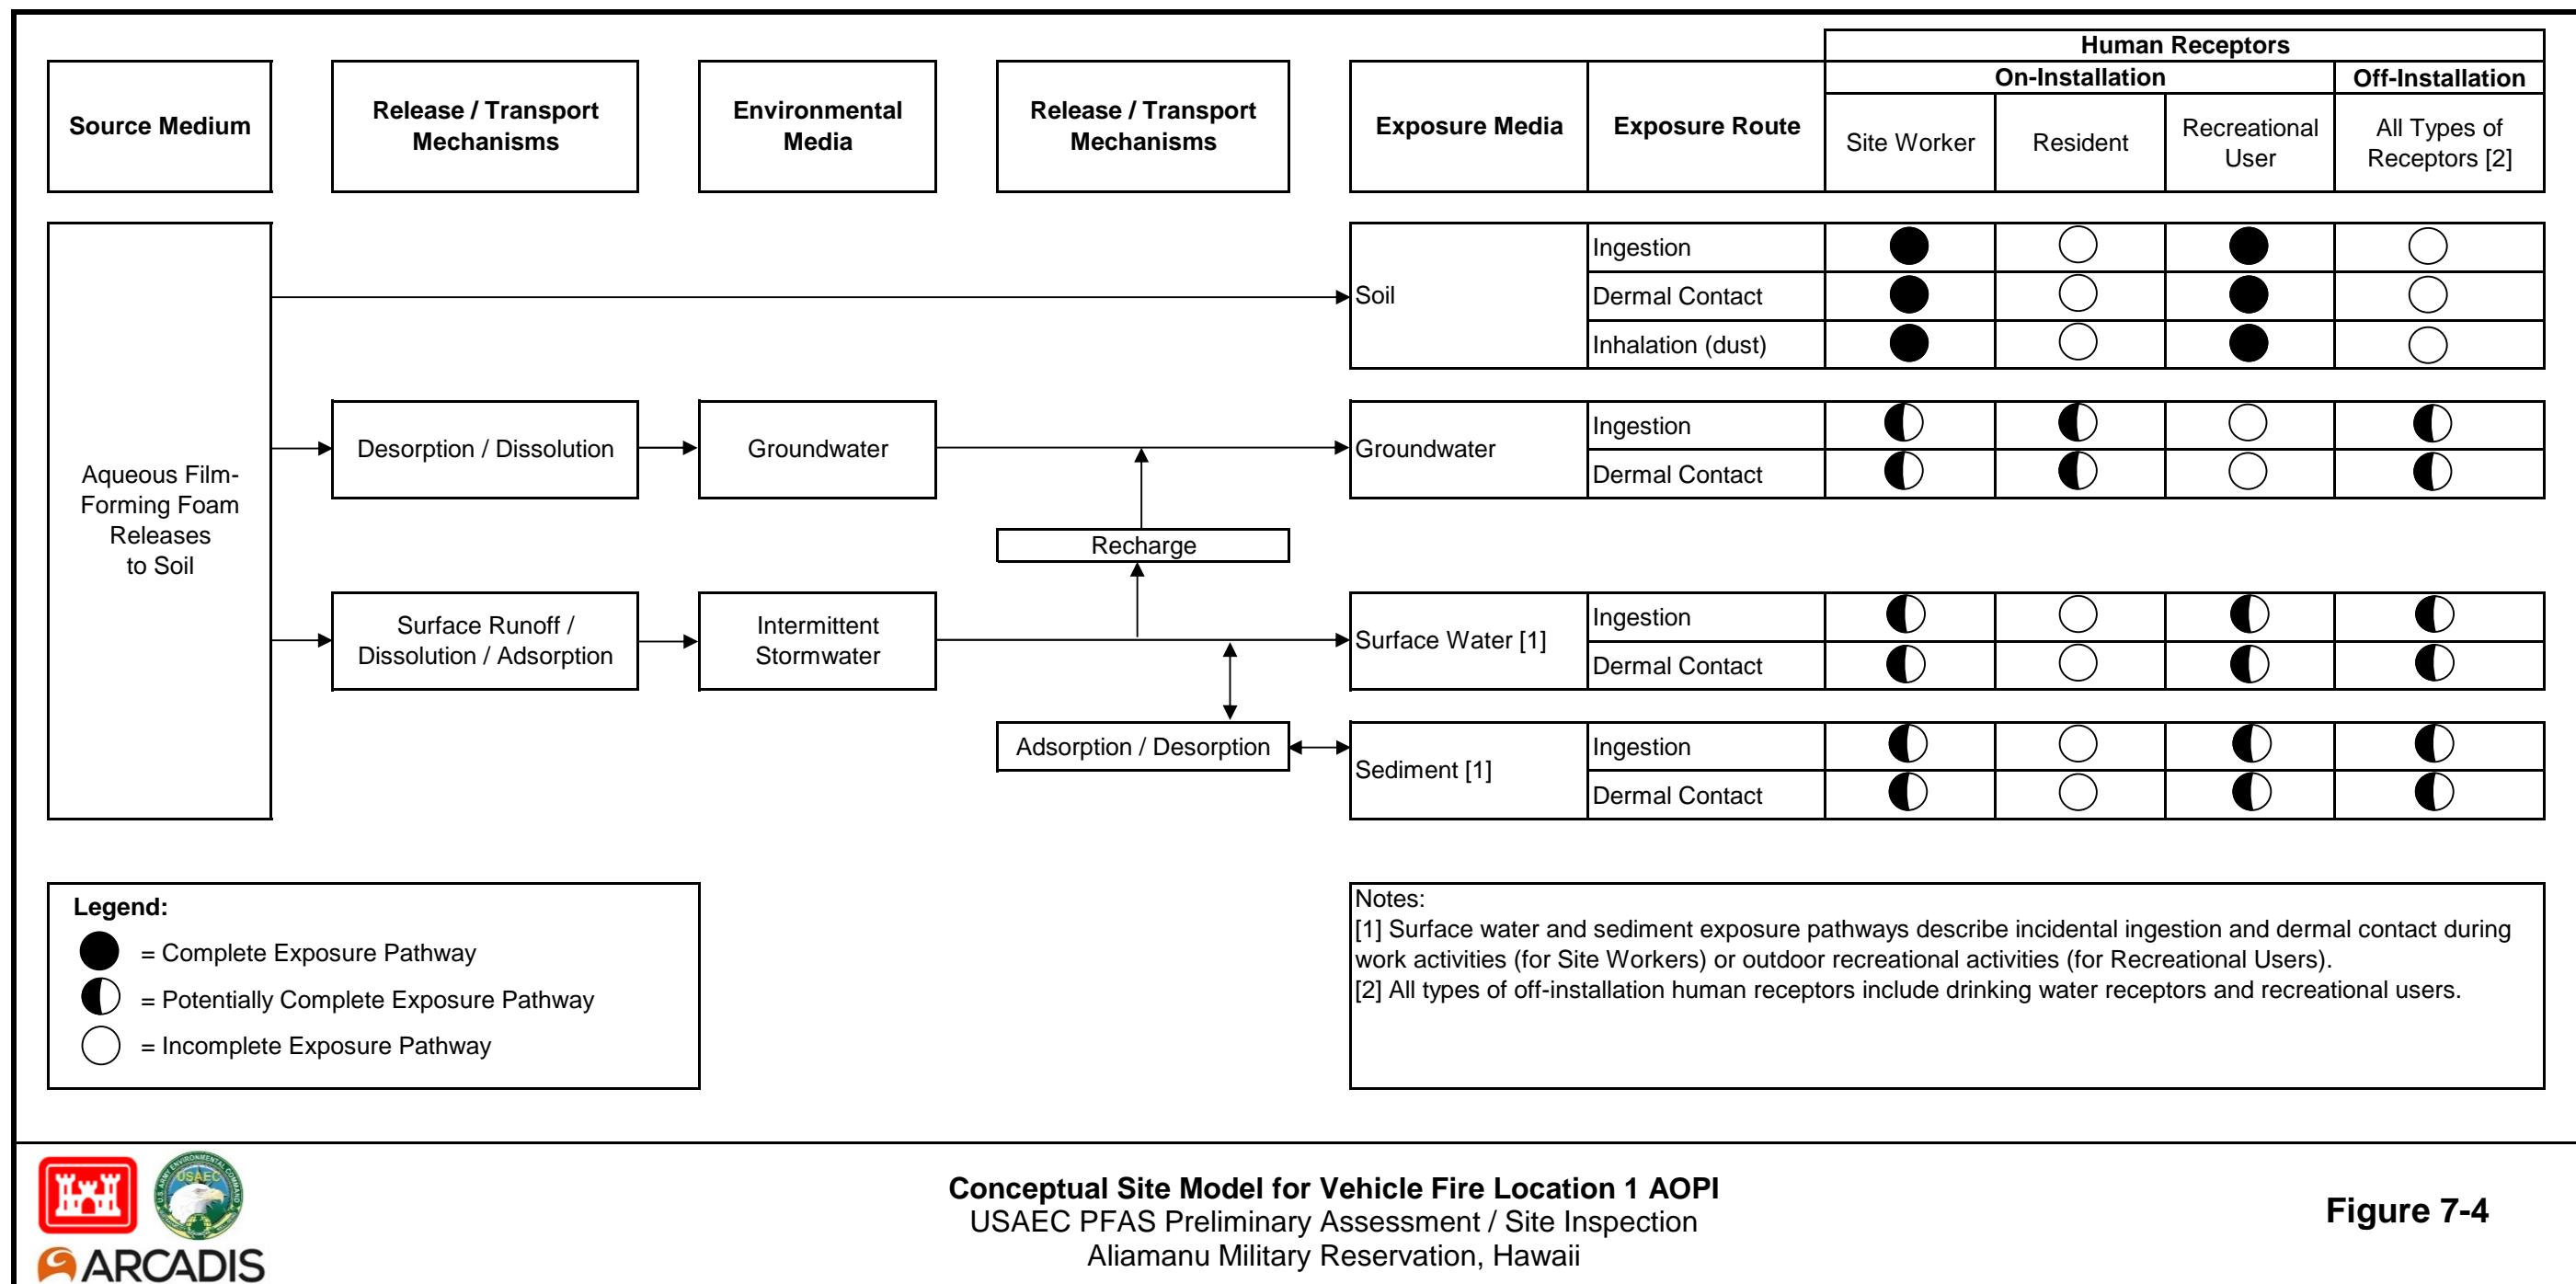
Figure 7-4

Human exposure pathways are shown as “complete”, “potentially complete”, or “incomplete” on the CSM figures. A complete exposure pathway consists of a constituent source and release mechanism, a transport or retention medium, an exposure point where human contact with the contaminated medium could occur, and an exposure route at the exposure point. If any of these elements is missing, the exposure pathway is incomplete. Pathways are “potentially complete” where data are insufficient to conclude the pathway is either “complete” or “incomplete”. Additionally, the CSMs do not include ecological receptors and exposure pathways. The potential for ecological exposures to PFOS, PFOA, PFBS, PFNA, and PFHxS may be evaluated at a future date if those pathways warrant further consideration.

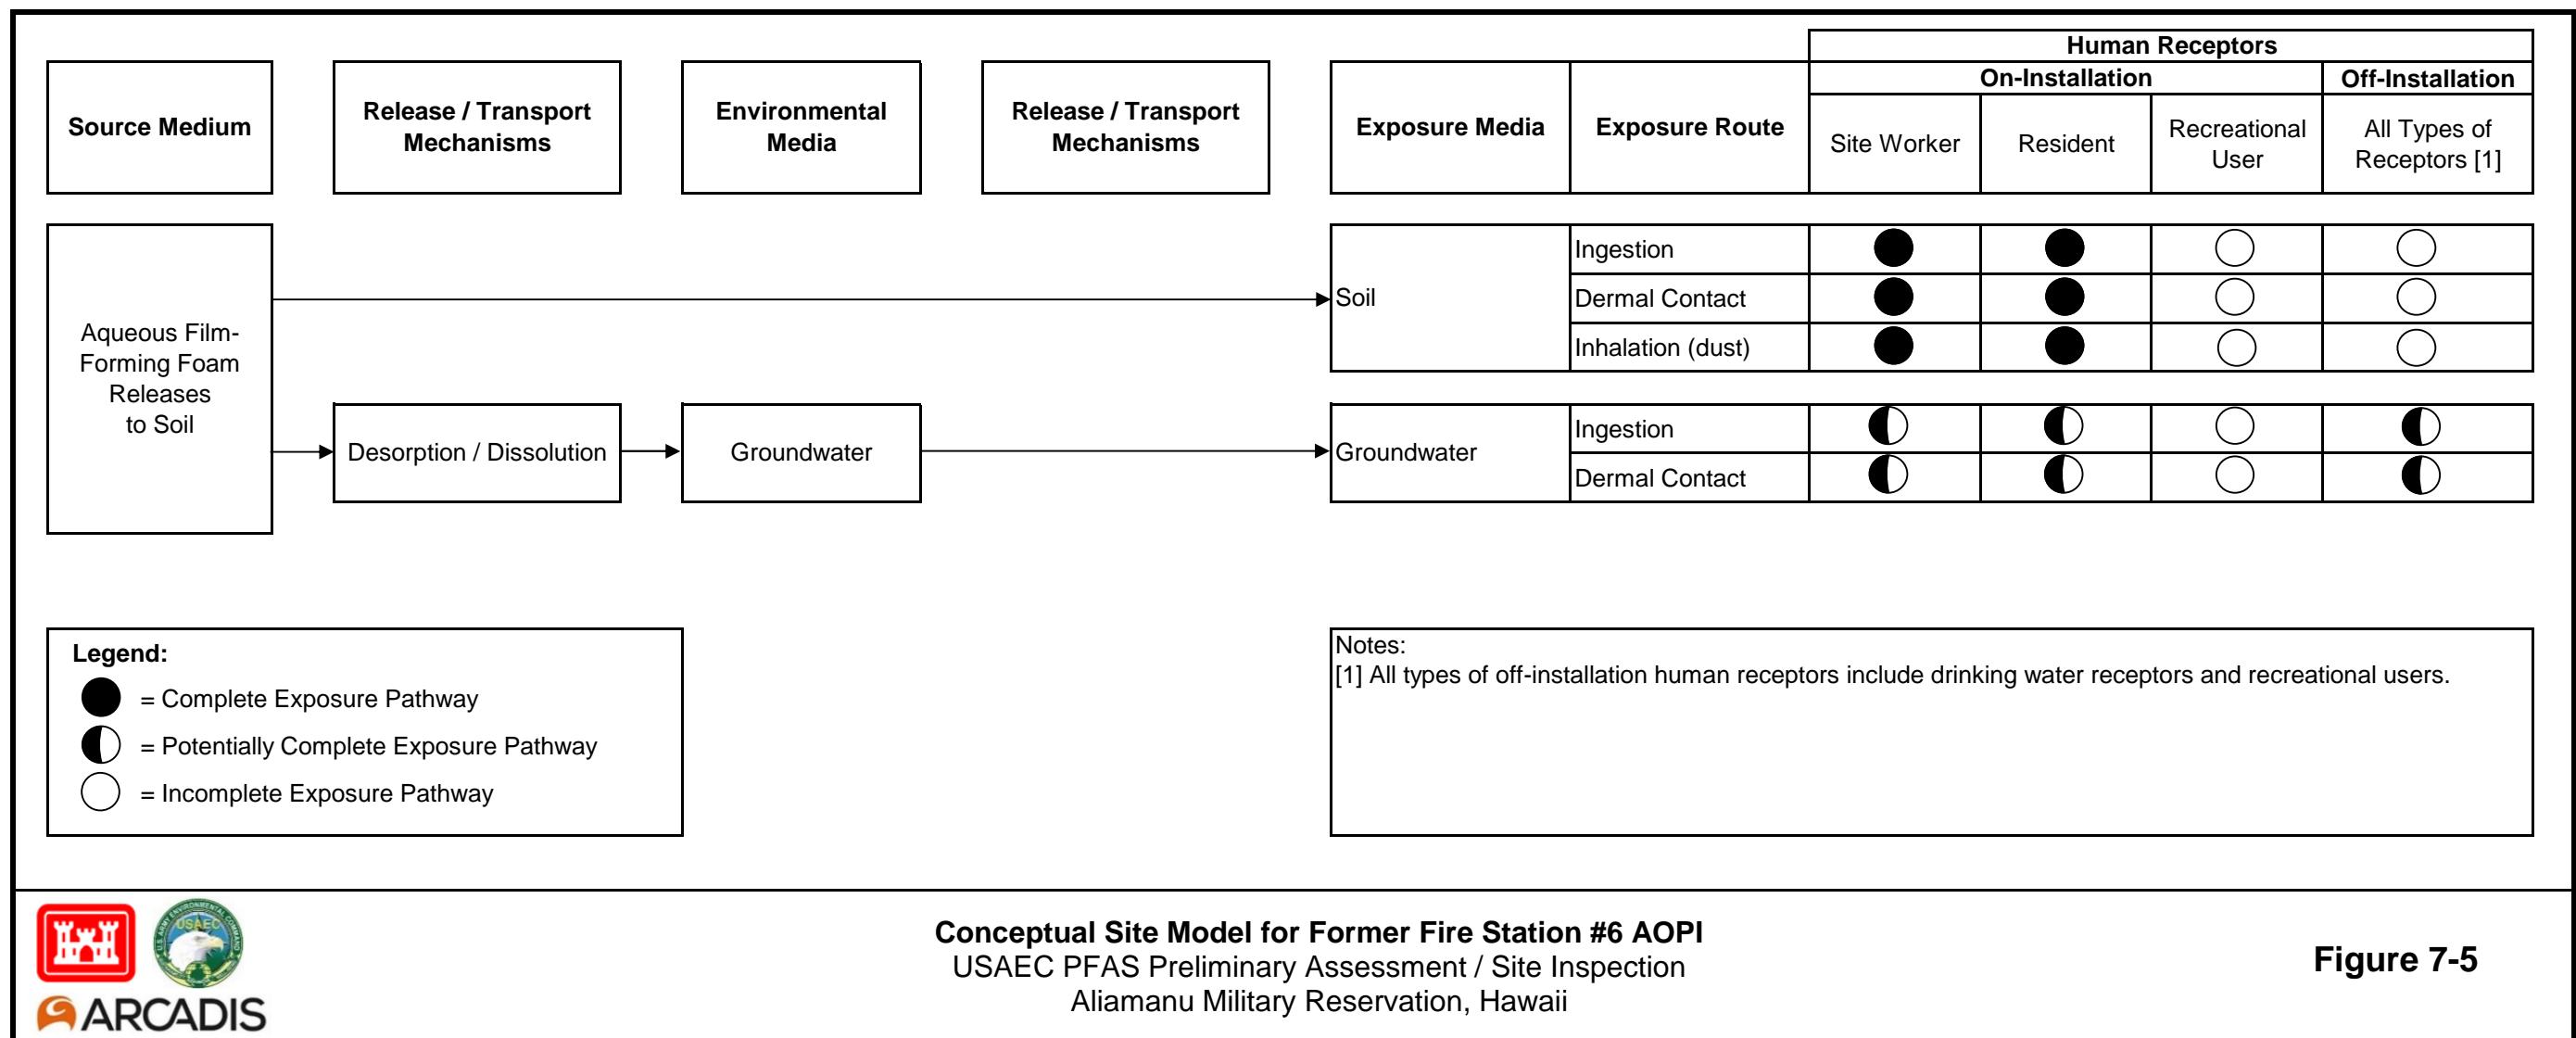
Figure 7-4 shows the CSM for Vehicle Fire Location 1. AFFF was historically released to soil during an incident response effort at the AOPI.

The preliminary CSMs presented in the QAPP Addendum (Arcadis 2022) were re-evaluated and updated based on the SI sampling results. The CSMs presented on **Figures 7-4** and **7-5** and in this section therefore represent the current understanding of the potential for human exposure.
