Subject:
Final Preliminary Assessment/Site Inspection Report for Aberdeen Proving Ground,
MD
Contract No: W912DR-13-D-0019
Delivery Order No: W912DR17F0396

FINAL PRELIMINARY ASSESSMENT AND SITE INSPECTION OF PER- AND POLYFLUOROALKYL SUBSTANCES

Aberdeen Proving Ground, Maryland

PRELIMINARY ASSESSMENT/SITE INSPECTION OF PFAS AT ABERDEEN PROVING GROUND,
MARYLAND

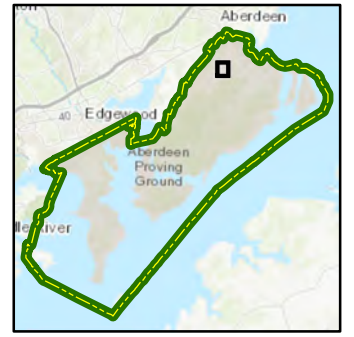
Figure 5-32
Biosolid Application Fields: C-1, C-2, C-3, F and G AOPIs

The Biosolid Application Field G is displayed on **Figure 5-32** and is identified as an AOPI following records research and personnel interviews due to the approval of this land parcel by the MDE in 1993 and 2001 as an application area for biosolids suspected to have contained waste AFFF that were generated at the Aberdeen and Edgewood Area WWTPs. The AOPI parcel is a predominantly featureless, grassed area located directly east of the PAAF runway. Based on review of aerial photography, topographic contours, and stormwater maps, there are no man-made drainage features originating from the AOPI parcel. Surface water runoff from this AOPI is presumed to infiltrate to groundwater or migrate eastwards across topography into an unnamed stream that eventually feeds into

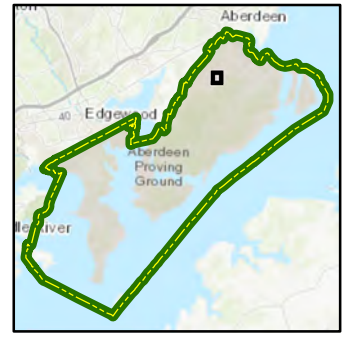
Figure 5-33
Biosolid Application Fields: H and I AOPIs

The Biosolid Application Field H is displayed on **Figure 5-33** and is identified as an AOPI following records research and personnel interviews due to the approval of this land parcel by the MDE in 1993 as an application area for biosolids suspected to have contained waste AFFF that were generated at the Aberdeen and Edgewood Area WWTPs. The AOPI parcel is a predominantly featureless, grassed area located directly east of the PAAF runway. The parcel is bordered to the east by Biosolid Application Field I. Based on review of aerial photography, topographic contours, and stormwater maps, there are no man-made drainage features originating from the AOPI parcel. Surface water runoff from this AOPI is presumed to infiltrate to groundwater or migrate eastwards across topography into an unnamed stream that eventually feeds into Romney Creek. Due to a lack of data confirming the historical application of biosolids at this land parcel and its proximity to neighboring AOPIs with exceedances of PFOS, PFOA, PFBS, PFHxS, and PFNA, Biosolid Application Field H was not sampled as part of this SI.

The Biosolid Application Field I is displayed on **Figure 5-33** and is identified as an AOPI following personnel interviews and site reconnaissance due to the approval of this land parcel by the MDE in 1993 as an application area for biosolids suspected to have contained waste AFFF that were generated at the Aberdeen and Edgewood Area WWTPs. The AOPI consists of two featureless, grassed land parcels located directly east of the PAAF runway. The parcel is bordered to the west by Biosolid Application Field H. Based on review of aerial photography, topographic contours, and stormwater maps, there are no man-made drainage features within or surrounding the AOPI parcel. Surface water runoff from this AOPI is presumed to infiltrate to groundwater or migrate eastwards across topography into an unnamed stream that eventually feeds into Romney Creek. Due to a lack of data confirming the historical application of biosolids at this land parcel and its proximity to neighboring AOPIs with exceedances of PFOS, PFOA, PFBS, PFHxS, and PFNA, Biosolid Application Field I was not sampled as part of this SI.

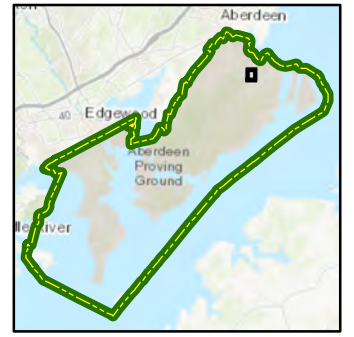
Figure 5-34
Biosolid Application Field: ATC-1 AOPI

The Biosolid Application Field ATC-1 is displayed on **Figure 5-34** and is identified as an AOPI following records research and personnel interviews due to the approval of this land parcel by the MDE in 1993 and 2001 as an application area for biosolids suspected to have contained waste AFFF that were generated at the Aberdeen and Edgewood Area WWTPs. The AOPI parcel is located approximately 0.6 mile southwest of the Building 300 Former Fire Station AOPI and the Building 250 Supply Wells. Based on review of aerial photography, topographic contours, and stormwater maps, there are no man-made drainage features within or surrounding the AOPI parcel. The AOPI parcel is bordered to the east and west by two unnamed streams that feed into Romney Creek. Surface runoff is presumed to flow radially across topography into these two streams. At the time of this PA/SI report, there are no installation IRP identifiers or HQAES numbers associated with this site.

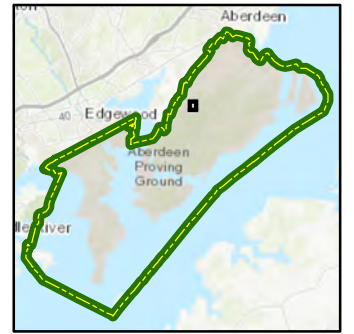
Figure 5-35
Biosolid Application Field: ATC-2 AOPI

The Biosolid Application Field ATC-2 is displayed on **Figure 5-35** and is identified as an AOPI following records research and personnel interviews due to the approval of this land parcel by the MDE in 1993 and 2001 as an application area for biosolids suspected to have contained waste AFFF that were generated at the Aberdeen and Edgewood Area WWTPs. The AOPI parcel is predominantly covered with grassed areas, with trees and vegetation surrounding most of the parcel boundary. Two buildings (892 and 893) in addition to tarmac road infrastructure also reside atop the parcel. Based on review of aerial photography, topographic contours, and stormwater maps, there are no man-made drainage features within or surrounding the AOPI parcel. Surface water runoff from this AOPI is presumed to infiltrate to groundwater or flow east across topography into Romney Creek. While the application of biosolids to this land parcel could not be confirmed, Biosolid Application Field ATC-2 was sampled as part of this SI to assess the presence or absence of PFOS, PFOA, PFBS, PFHxS, and PFNA due to the potential application of biosolids at APG. This Biosolid Application Field was selected for sampling due to its location hydraulically upgradient or geographically away from other AOPIs.

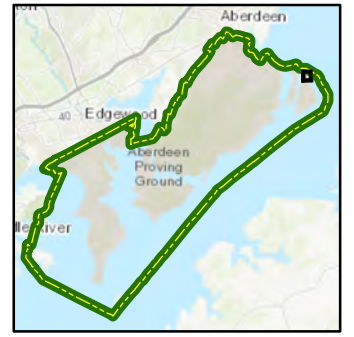
Figure 5-36
Biosolid Application Field: S-1A AOPI

The Biosolid Application Field S-1A is displayed on **Figure 5-36** and is identified as an AOPI following records research and personnel interviews due to the approval of these seven land parcels by the MDE in 1993 as an application area for biosolids suspected to have contained waste AFFF that were generated at the Aberdeen and Edgewood Area WWTPs. The AOPI parcels are defined by featureless grass lawns

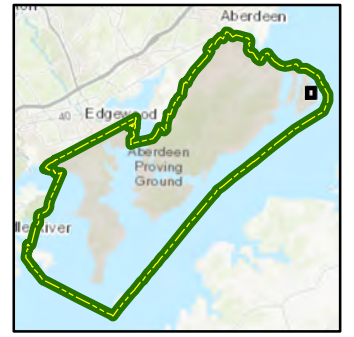
Figure 5-37
Biosolid Application Field: S-2 AOPI

The Biosolid Application Field S-2 is displayed on **Figure 5-37** and is identified as an AOPI following records research and personnel interviews due to the approval of this land parcel by the MDE in 1993 as an application area for biosolids suspected to have contained waste AFFF that were generated at the Aberdeen and Edgewood Area WWTPs. The AOPI parcel resides within a wetland area dense in trees and vegetation. Two ranges, EF-7 and EF-7A, as well as two surface water bodies, border the parcel to the north and west respectively. Based on review of aerial photography, topographic contours, and stormwater maps, there are no man-made drainage features managing stormwater runoff at this AOPI. Surface water runoff from this AOPI would flow directly north and west into the two unidentified surface water bodies that eventually feed into the Chesapeake Bay. At the time of this PA/SI report, there are no installation IRP identifiers or HQAES numbers associated with this site.

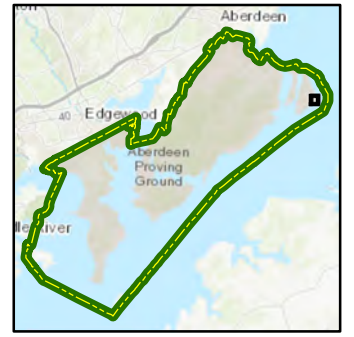
Figure 5-38
Biosolid Application Field: S-3 AOPI

The Biosolid Application Field S-3 is displayed on **Figure 5-38** and is identified as an AOPI following records research and personnel interviews due to the approval of this land parcel by the MDE in 1993 as an application area for biosolids suspected to have contained waste AFFF that were generated at the Aberdeen and Edgewood Area WWTPs. The AOPI parcel resides within a grassy wetland area surrounded by heavy vegetation and trees. Two range areas (designated as EF-20) built on tarmac border the AOPI. Based on review of aerial photography, topographic contours, and stormwater maps, there are no man-made drainage features managing stormwater runoff at this AOPI. Surface water runoff from this AOPI would flow radially across topography, westward toward an unnamed stream feeding into the Chesapeake Bay, and eastward directly into the Chesapeake Bay. At the time of this PA/SI report, there are no installation IRP identifiers or HQAES numbers associated with this site.

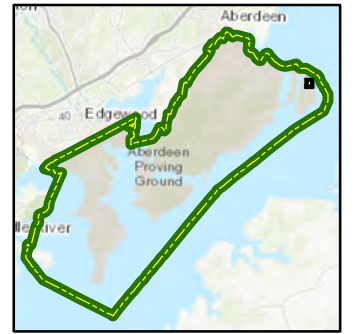
Figure 5-39
Biosolid Application Fields: S-5 and S-6 AOPIs

The Biosolid Application Field S-5 is displayed on **Figure 5-39** and is identified as an AOPI following records research and personnel interviews due to the approval of the two land parcels by the MDE in 1993 as application areas for biosolids suspected to have contained waste AFFF that were generated at the Aberdeen and Edgewood Area WWTPs. The AOPI parcels reside within a grass and tree dominated wetland area located directly along the western Spesutie Island coastline and north of the Sonic Range. Building 1118A overlaps the southeastern portion of the east S-5 parcel. Based on review of aerial photography, topographic contours, and stormwater maps, there are no man-made drainage features managing stormwater runoff at this AOPI. Surface water runoff from these two biosolid application parcels would flow through naturally occurring wetland features directly east into the Chesapeake Bay. At the time of this PA/SI report, there are no installation IRP identifiers or HQAES numbers associated with this site.

The Biosolid Application Field S-6 is displayed on **Figure 5-39** and is identified as an AOPI following records research and personnel interviews due to the confirmed application of biosolids generated at the Aberdeen and Edgewood Area WWTPs sometime between 1986 and 2003/2004. These biosolids are suspected to have contained waste AFFF that were generated at the Aberdeen and Edgewood Area WWTPs. The AOPI parcel resides within a grass and tree dominated wetland area located directly south of the Biosolid Application Field S-5 and along the western Spesutie Island coastline. Based on review of aerial photography, topographic contours, and stormwater maps, there are no buildings or man-made drainage features managing stormwater runoff at this AOPI. Surface water runoff from these two biosolid

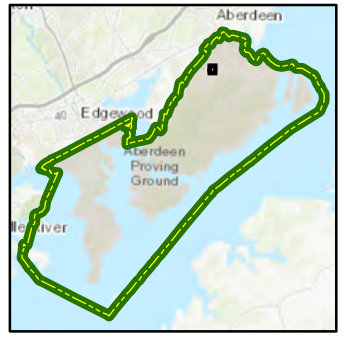
Figure 7-29
Biosolid Application Fields: B, D and E
PFOS, PFOA, PFBS, PFNA, and PFHxS Analytical Results

One grab groundwater sample was collected from one boring via DPT at first-encountered groundwater at the Biosolid Application Field D AOPI (APG-BAF-D-1-GW; **Figure 7-29**). A summary of PFOS, PFOA, PFBS, PFHxS, and PFNA groundwater analytical results is provided in **Table 7-1**.

One surface soil sample was collected from one location at the Biosolid Application Field D AOPI (APG-BAF-D-1-SO; **Figure 7-29**). A summary of PFOS, PFOA, PFBS, PFHxS, and PFNA soil analytical results is provided in **Table 7-2**.

The subsections below summarize the groundwater and soil PFOS, PFOA, PFBS, PFHxS, and PFNA analytical results associated with Biosolid Application Field E AOPI shown on **Figure 7-29** and **Tables 7-1** and **7-2**.

One grab groundwater sample was collected from one boring via DPT at first-encountered groundwater at the Biosolid Application Field E AOPI (APG-BAF-E-1-GW; **Figure 7-29**). A summary of PFOS, PFOA, PFBS, PFHxS, and PFNA groundwater analytical results is provided in **Table 7-1**.

One surface soil sample was collected from one location at the Biosolid Application Field E AOPI (APG-BAF-E-1-SO; **Figure 7-29**). A summary of PFOS, PFOA, PFBS, PFHxS, and PFNA soil analytical results is provided in **Table 7-2**.

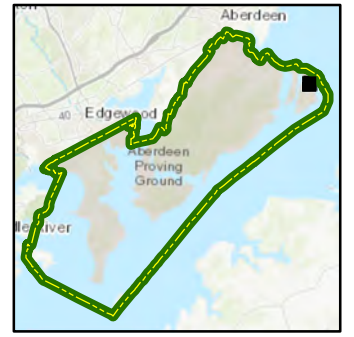
Figure 7-30
Biosolid Application Field: S-6
PFOS, PFOA, PFBS, PFNA, and PFHxS Analytical Results

The subsections below summarize the groundwater and soil PFOS, PFOA, PFBS, PFHxS, and PFNA analytical results associated with Biosolid Application Field S-6 AOPI shown on **Figure 7-30** and **Tables 7-1** and **7-2**.

One grab groundwater sample was collected from one boring via DPT at first-encountered groundwater at the Biosolid Application Field S-6 AOPI (APG-BAF-S6-1-GW; **Figure 7-30**). A summary of PFOS, PFOA, PFBS, PFHxS, and PFNA groundwater analytical results is provided in **Table 7-1**.

One surface soil sample was collected from one location at the Biosolid Application Field S-6 AOPI (APG-BAF-S6-1-SO; **Figure 7-30**). A summary of PFOS, PFOA, PFBS, PFHxS, and PFNA soil analytical results is provided in **Table 7-2**.

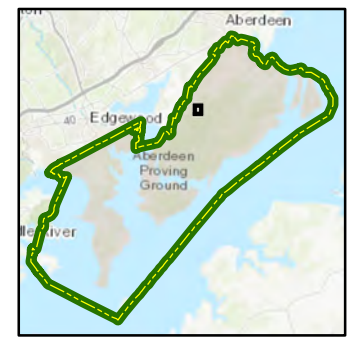
Figure 7-32
Biosolid Application Field: ATC-2
PFOS, PFOA, PFBS, PFNA, and PFHxS Analytical Results

The subsections below summarize the groundwater and soil PFOS, PFOA, PFBS, PFHxS, and PFNA analytical results associated with Biosolid Application Field ATC-2 AOPI shown on **Figure 7-32** and **Tables 7-1** and **7-2**.

One grab groundwater sample was collected from one boring via DPT at first-encountered groundwater at the Biosolid Application Field ATC-2 AOPI (APG-ATC2-1-GW [duplicate sample collected at APG-ATC2-1-GW]; **Figure 7-32**). A summary of PFOS, PFOA, PFBS, PFHxS, and PFNA groundwater analytical results is provided in **Table 7-1**.

One surface soil sample was collected from one location at the Biosolid Application Field ATC-2 AOPI (APG-ATC2-1-SO; **Figure 7-32**). A summary of PFOS, PFOA, PFBS, PFHxS, and PFNA soil analytical results is provided in **Table 7-2**.

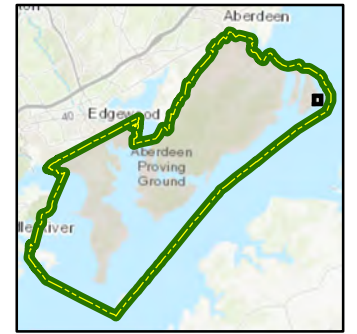
Figure 7-34
Biosolid Application Field: S-3
PFOS, PFOA, PFBS, PFNA, and PFHxS Analytical Results

The subsections below the groundwater and soil PFOS, PFOA, PFBS, PFHxS, and PFNA analytical results associated with Biosolid Application Field S-3 AOPI shown on **Figure 7-34** and **Tables 7-1** and **7-2**.

One grab groundwater sample was collected from one boring via DPT at first-encountered groundwater at the Biosolid Application Field S-3 AOPI (APG-S3-1-GW; **Figure 7-34**). A summary of PFOS, PFOA, PFBS, PFHxS, and PFNA groundwater analytical results is provided in **Table 7-1**.

One surface soil sample was collected from one location at the Biosolid Application Field S-3 AOPI (APG-S3-1-SO; **Figure 7-34**). A summary of PFOS, PFOA, PFBS, PFHxS, and PFNA soil analytical results is provided in **Table 7-2**.

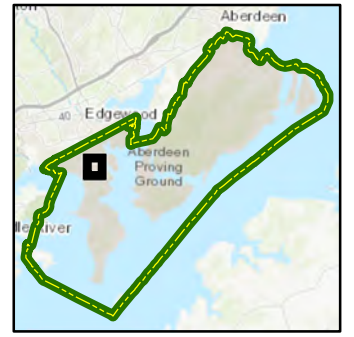
Figure 7-37
Canal Creek Groundwater Treatment System
PFOS, PFOA, PFBS, PFNA, and PFHxS Analytical Results

The subsections below summarize the groundwater PFOS, PFOA, PFBS, PFHxS, and PFNA analytical results associated with Canal Creek GWTP System shown on **Figure 7-37** and **Tables 7-1**.

One effluent groundwater sample was collected from the Canal Creek GWTP System (APG-GWTP-1-GW; **Figure 7-37**). A summary of PFOS, PFOA, PFBS, PFHxS, and PFNA groundwater analytical results is provided in **Table 7-1**.
