# FINAL PRELIMINARY ASSESSMENT AND SITE INSPECTION OF PER- AND POLYFLUOROALKYL SUBSTANCES

## Blue Grass Army Depot, Kentucky

Prepared For:  
U.S. Army Corps of Engineers, Baltimore District  
2 Hopkins Plaza  
Baltimore, Maryland 21201

April 2022

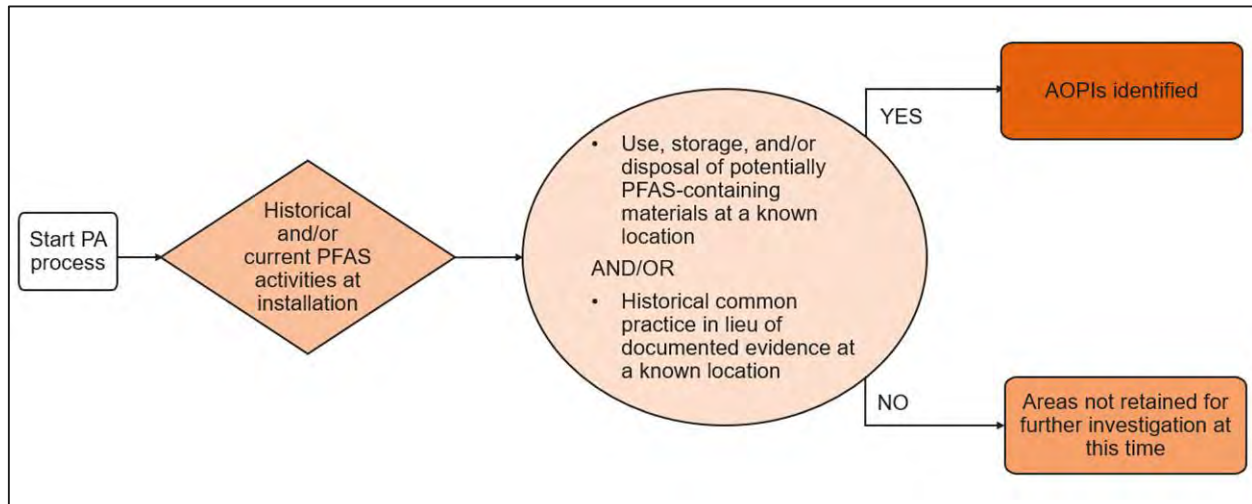
Figure 5-1: AOPI Decision Flowchart

The preliminary locations evaluated for potential use, storage and/or disposal of PFAS-containing materials at BGAD were further refined during the PA process and identified either as an area not retained for further investigation or as an AOPI. In accordance with the established process for the PA/SI, nine areas have been identified as AOPIs. The process used for refining these areas is presented on **Figure 5-1**, below.

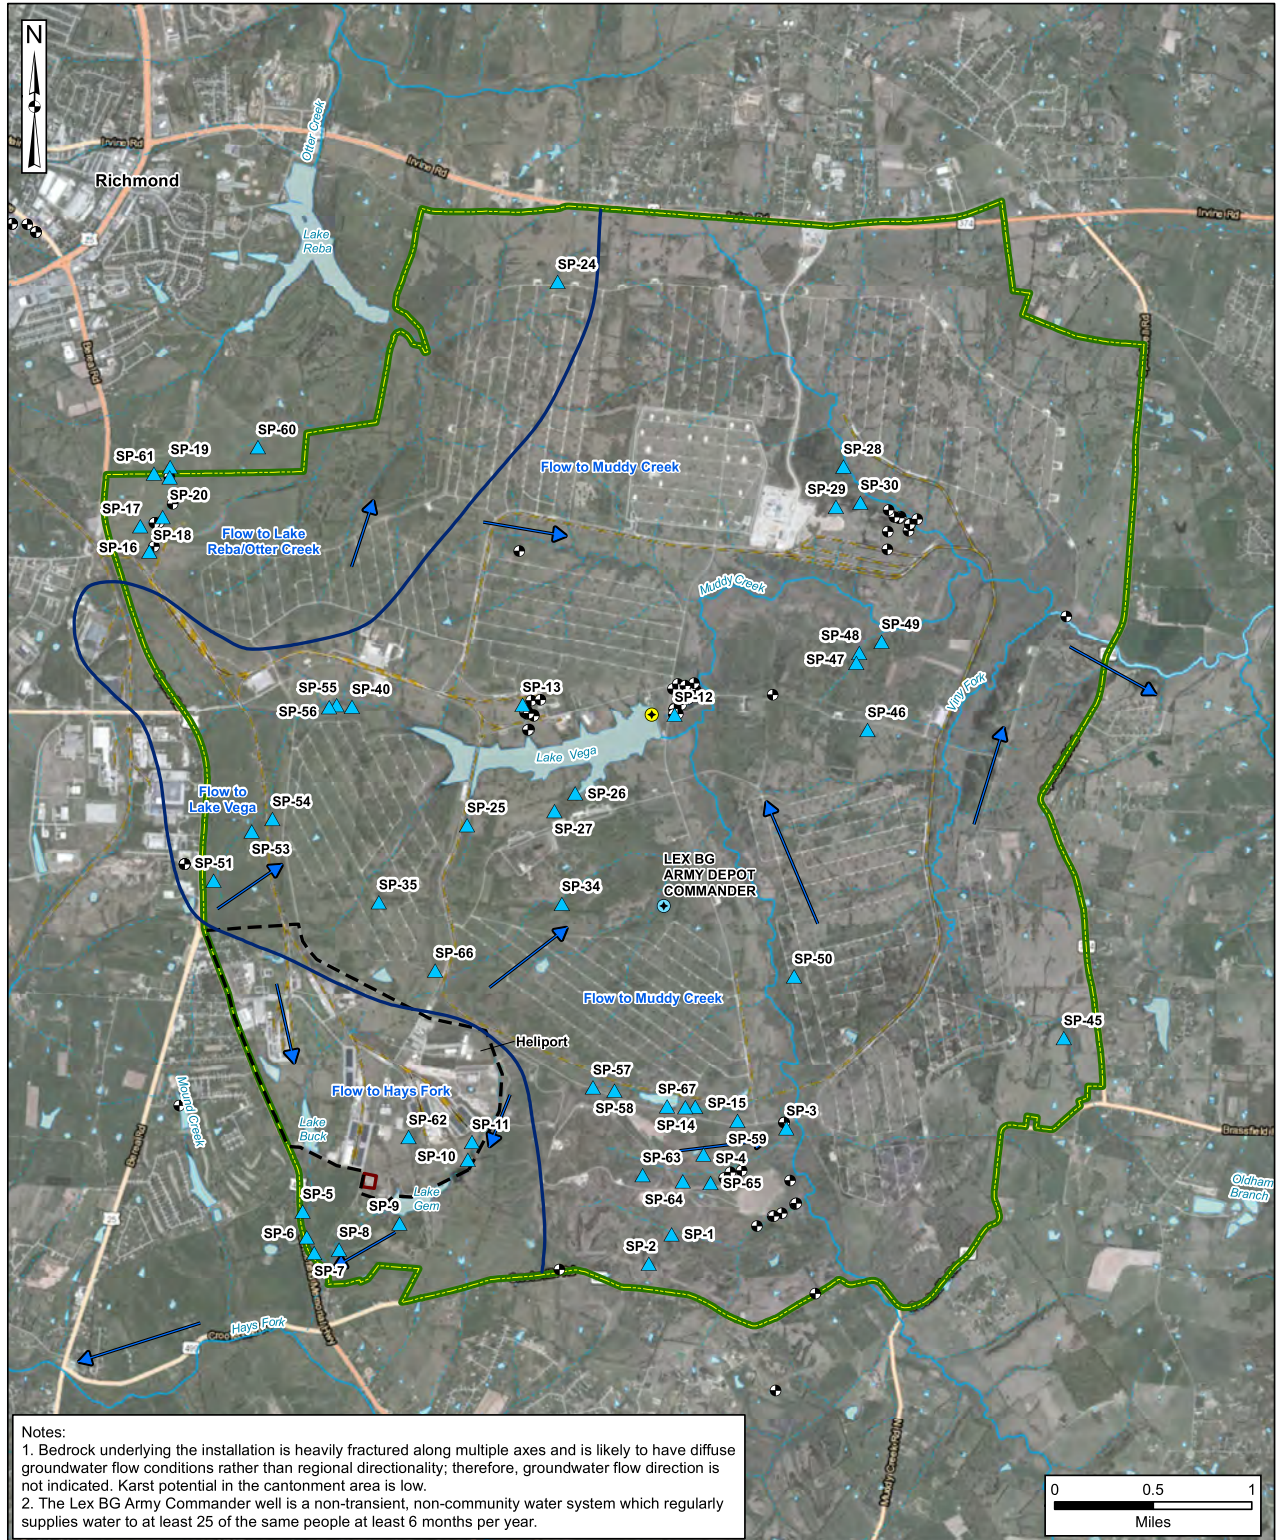
Figure 2-2  
Site Layout

Notes:  
 1. Bedrock underlying the installation is heavily fractured along multiple axes and is likely to have diffuse groundwater flow conditions rather than regional directionality; therefore, groundwater flow direction is not indicated. Karst potential in the cantonment area is low.  
 2. The Lex BG Army Commander well is a non-transient, non-community water system which regularly supplies water to at least 25 of the same people at least 6 months per year.

BGAD covers approximately 14,500 acres in Madison County, Kentucky, with approximately 1,000 personnel working onsite. BGAD can house up to 330 military personnel in barracks (BGAD 2017). The nearest municipality is Richmond, Kentucky (approximately 6 miles northwest) with a population of approximately 33,000. Other key municipalities in the region include Berea (approximately 8 miles south) with a population of approximately 8,200, and Lexington (about 35 miles north) with a population of 350,000 (BGAD 2016). **Figure 2-1** shows the location of the installation. Most of the installation land is covered by ammunition storage points in open fields and wooded areas with a small cantonment area to the southwest (**Figure 2-2**).

The stormwater management system consists mainly of unlined ditches which follow natural topographic surface drainage. The cantonment area largely drains to Hays Fork Creek, and most of the remainder of the installation drains to Muddy Creek. **Figure 2-2** shows the approximate surface water and stormwater drainage divide. Stormwater is not captured for treatment except for in a limited area around the burn pans in the open burn/open detonation (OB/OD) area located east of the cantonment area. Though the stormwater management and sewer systems are not connected, some stormwater occasionally infiltrates and inflows into compromised sewer system piping during high-precipitation events, as indicated by the installation water engineers.

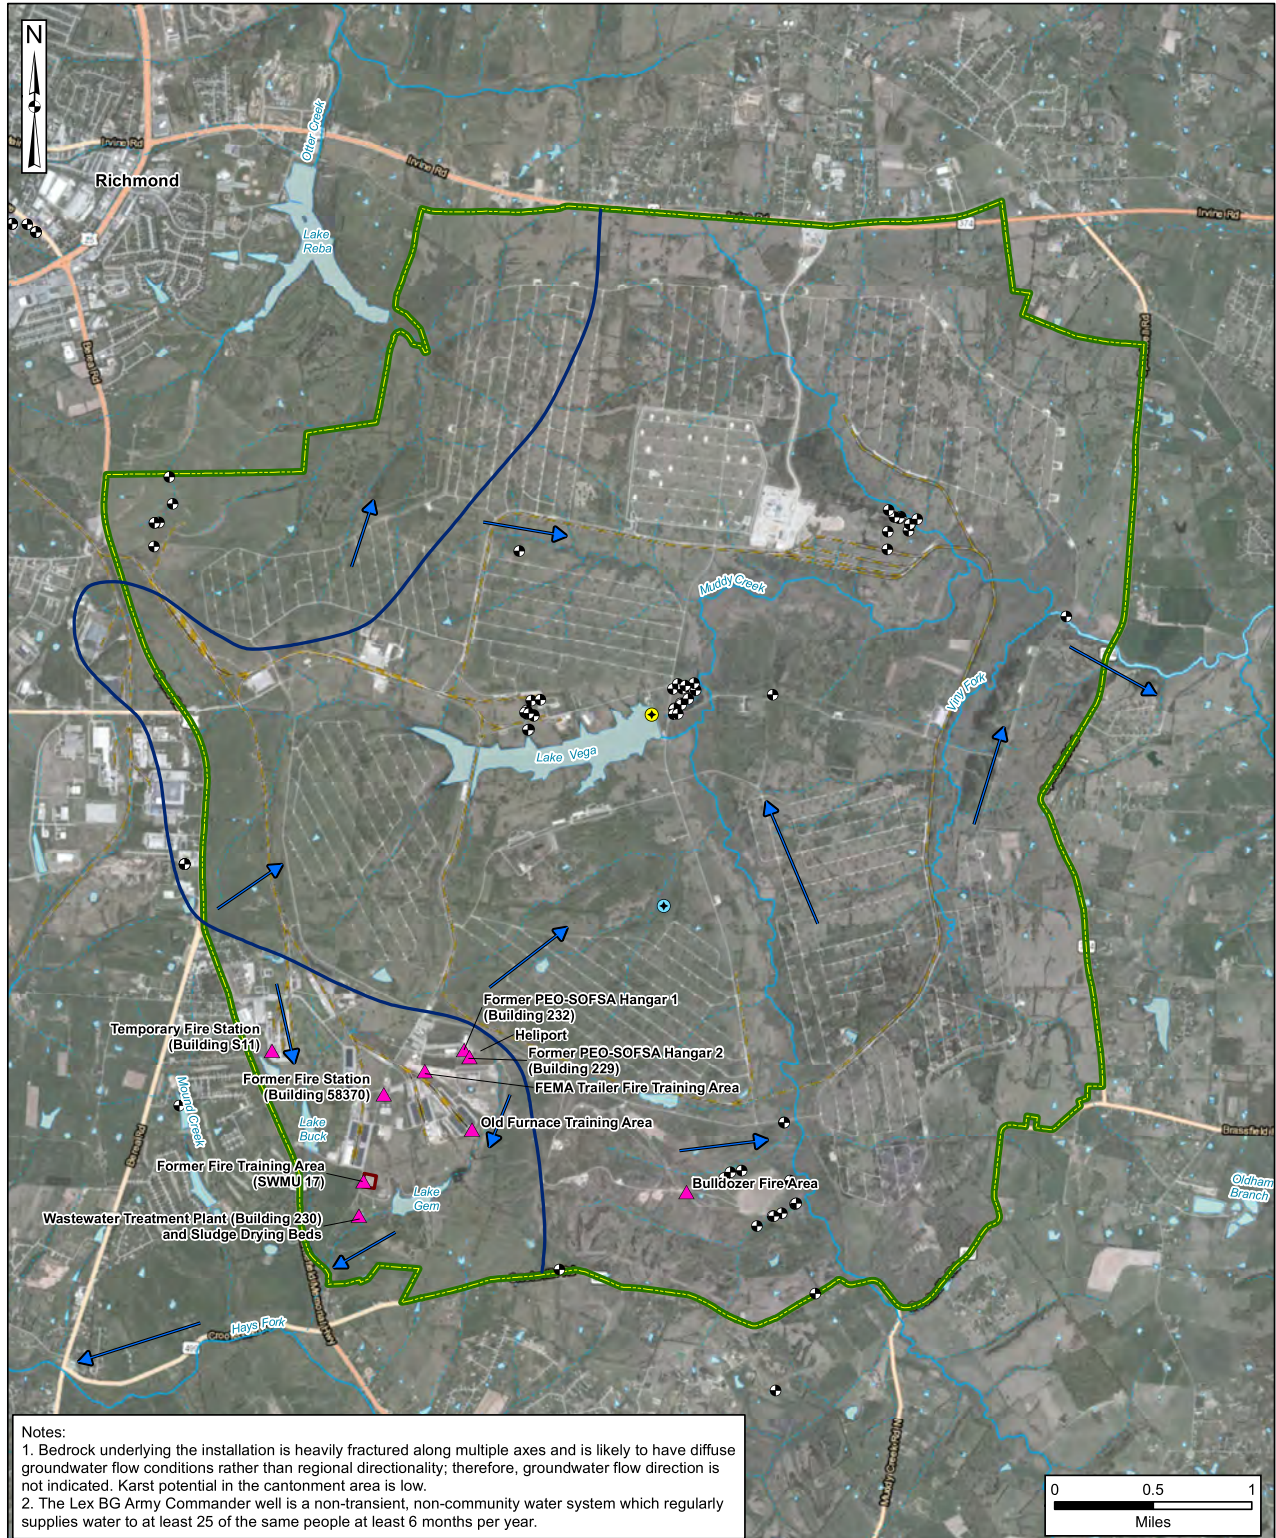
Figure 5-2  
AOPI Locations

Notes:  
 1. Bedrock underlying the installation is heavily fractured along multiple axes and is likely to have diffuse groundwater flow conditions rather than regional directionality; therefore, groundwater flow direction is not indicated. Karst potential in the cantonment area is low.  
 2. The Lex BG Army Commander well is a non-transient, non-community water system which regularly supplies water to at least 25 of the same people at least 6 months per year.
