FINAL PRELIMINARY ASSESSMENT AND SITE INSPECTION OF PER- AND POLYFLUOROALKYL SUBSTANCES

Fort Benning, Georgia

March 2022

PRELIMINARY ASSESSMENT/SITE INSPECTION OF PFAS AT FORT BENNING, GEORGIA

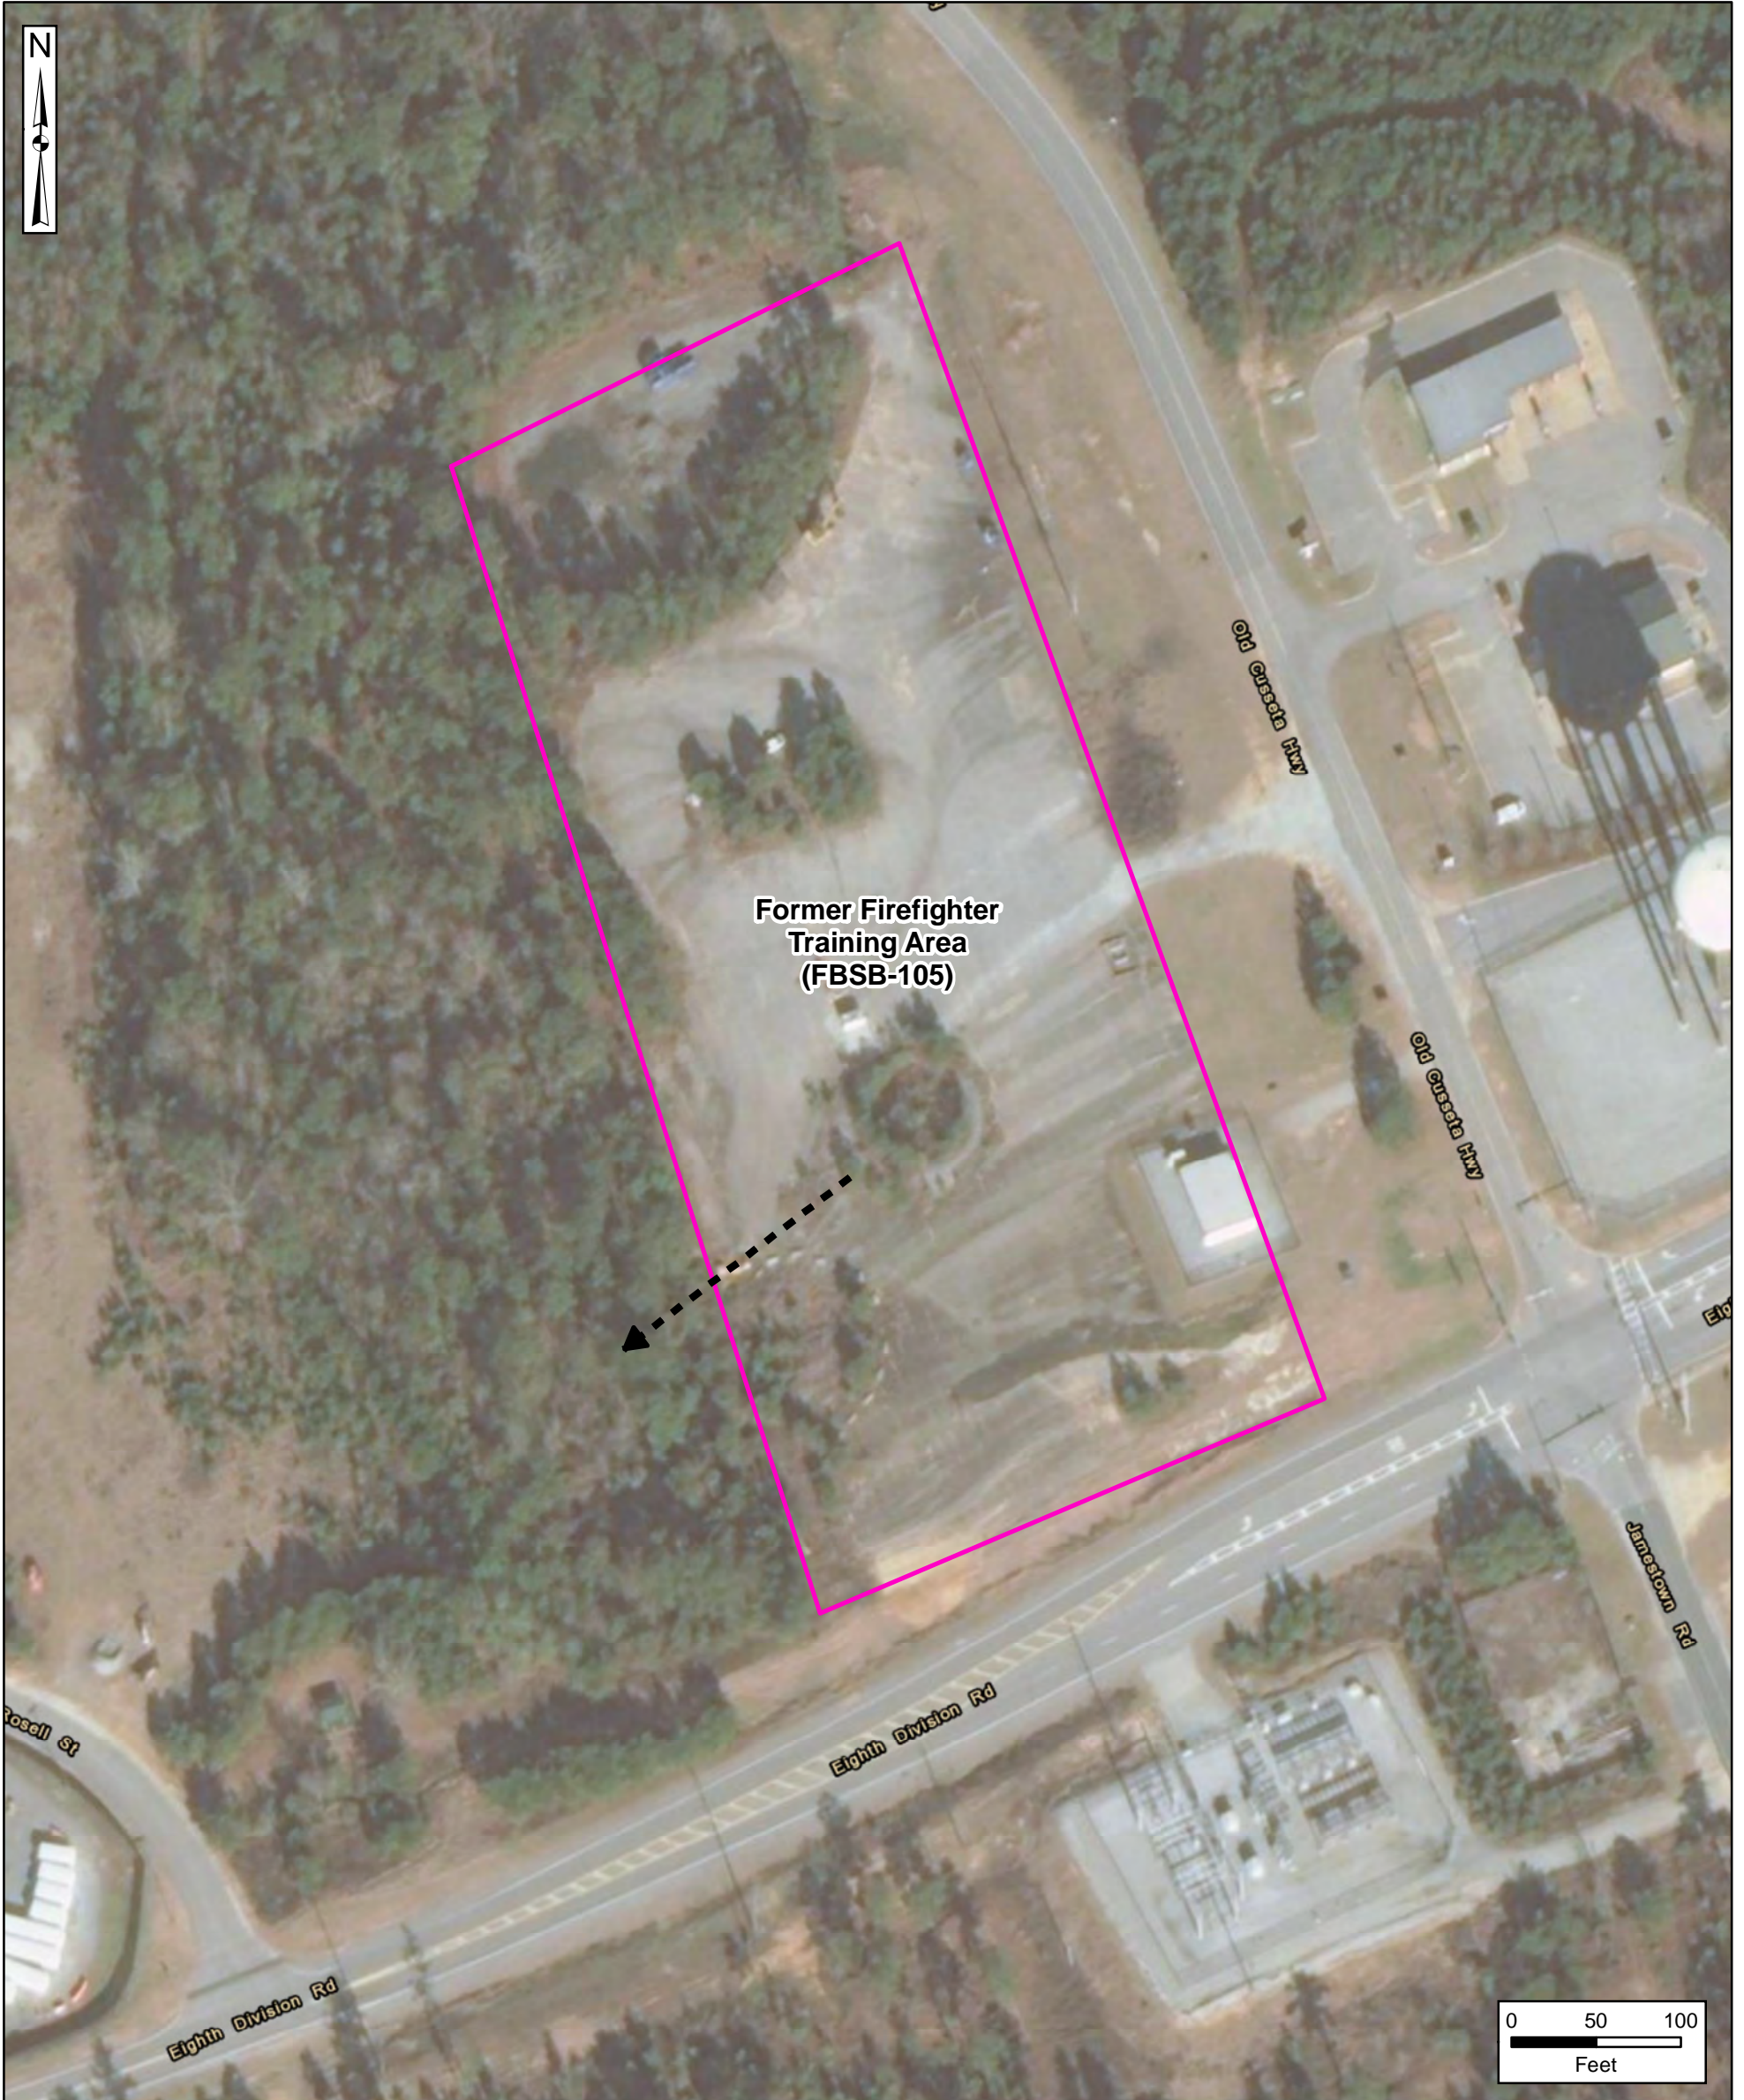
Figure 5-4
Aerial Photo of
AOPI Former Firefighter Training Area (FBSB-105)

FFTA FBSB-105 was identified as an AOPI following document research, personnel interviews, and site reconnaissance trips due to its designation as an FFTA. It is a concrete lined pit, filled with gravel that had been used for training activities until approximately the late 1900s to the early 2000s. The FFTA is located in the Harmony Church section of Fort Benning and was closed in 2008. Fire Department personnel confirmed AFFF use associated with firefighting training. Liquid waste material remaining in the pit after training events discharged into an OWS and then to a WWTP via the sanitary sewer, however the concrete liner is in poor condition and therefore may have resulted in discharges to Harps Creek. FFTA FBSB-105 is shown on **Figure 5-4**.

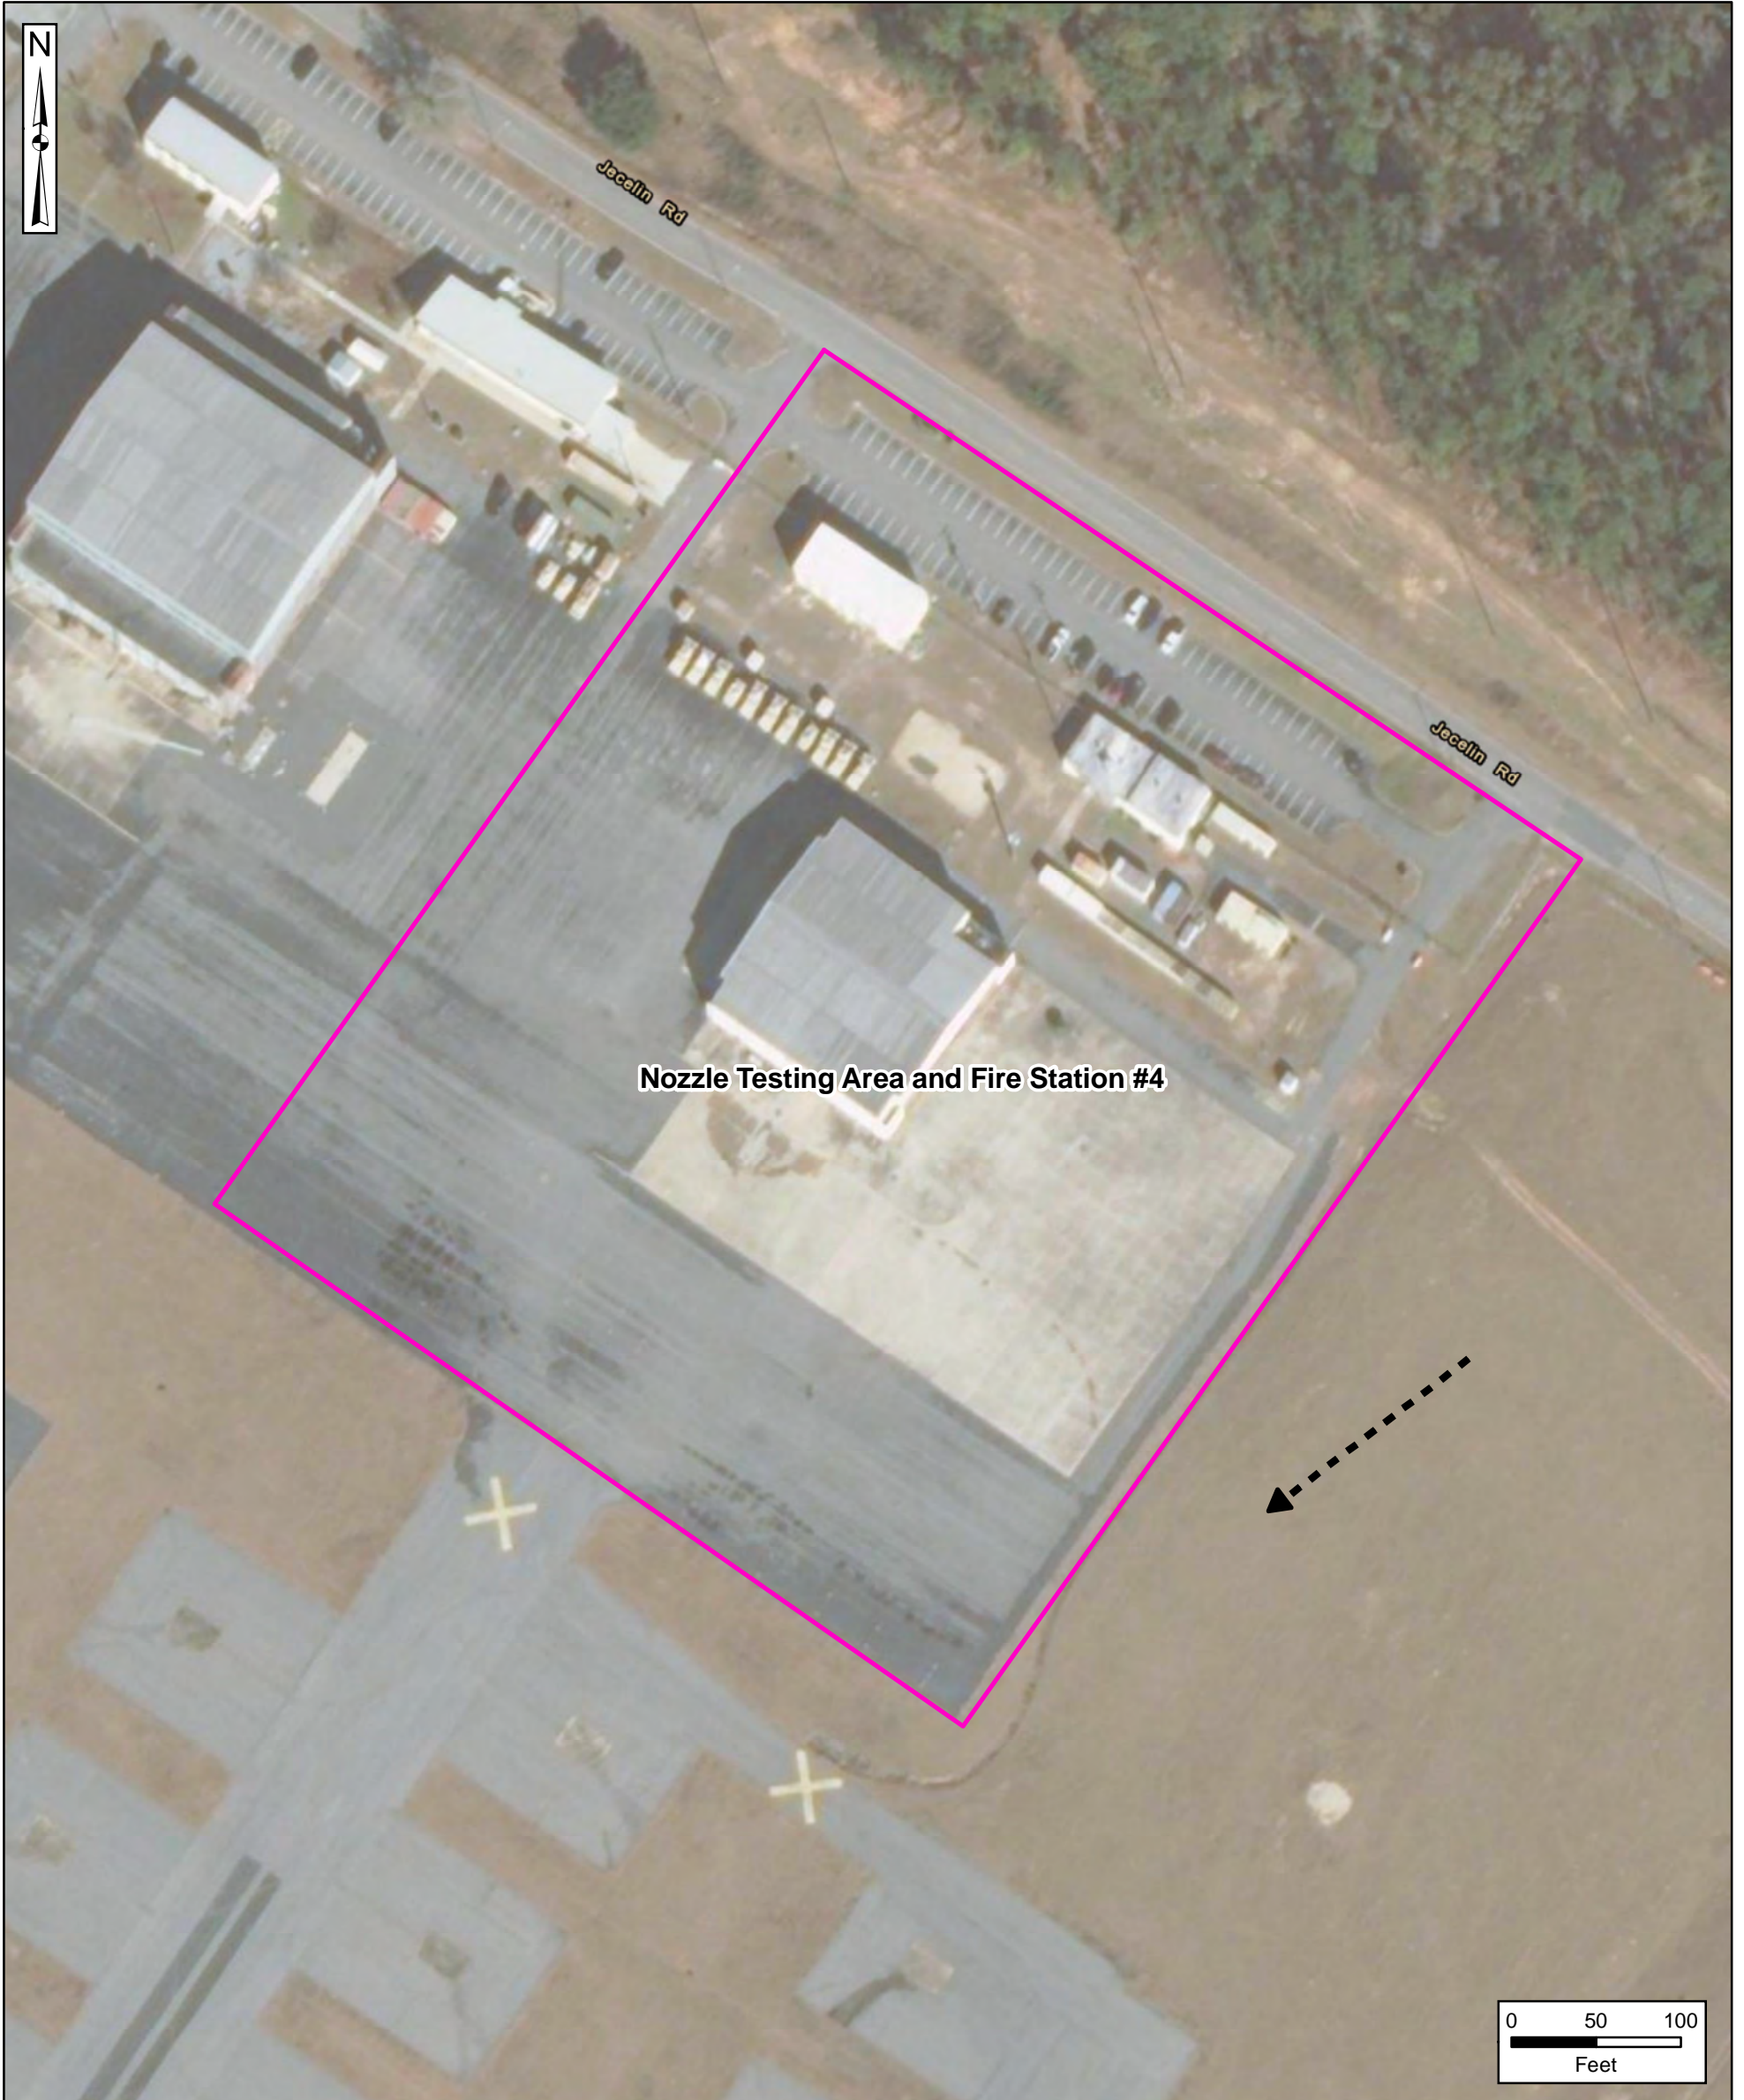
Figure 5-6
Aerial Photo of
AOPI Nozzle Testing Area and Fire Station #4

The Nozzle Testing Area and Fire Station #4 was identified as an AOPI following document research, personnel interviews, and site reconnaissance trips due to its designation as an area with documented AFFF use, storage, and release. The fire station is still active and is also the former Hangar 2492 which was converted to a fire station. AFFF has historically been, and is currently, stored at this location. AFFF storage currently occurs in three Fort Benning Fire Department vehicles and inside the station in 5-gallon buckets and 55-gallon drums. A concrete pad located just outside of Fire Station #4 was used to test the nozzles on the fire trucks which use AFFF. The last occurrence of AFFF usage was reportedly in 2016. Nozzle testing usage with AFFF was conducted on an annual basis for two years (2014 to 2016), with an estimated 50 gallons of AFFF concentrate used per event. The Nozzle Testing Area and Fire Station #4 are shown on **Figure 5-6**.

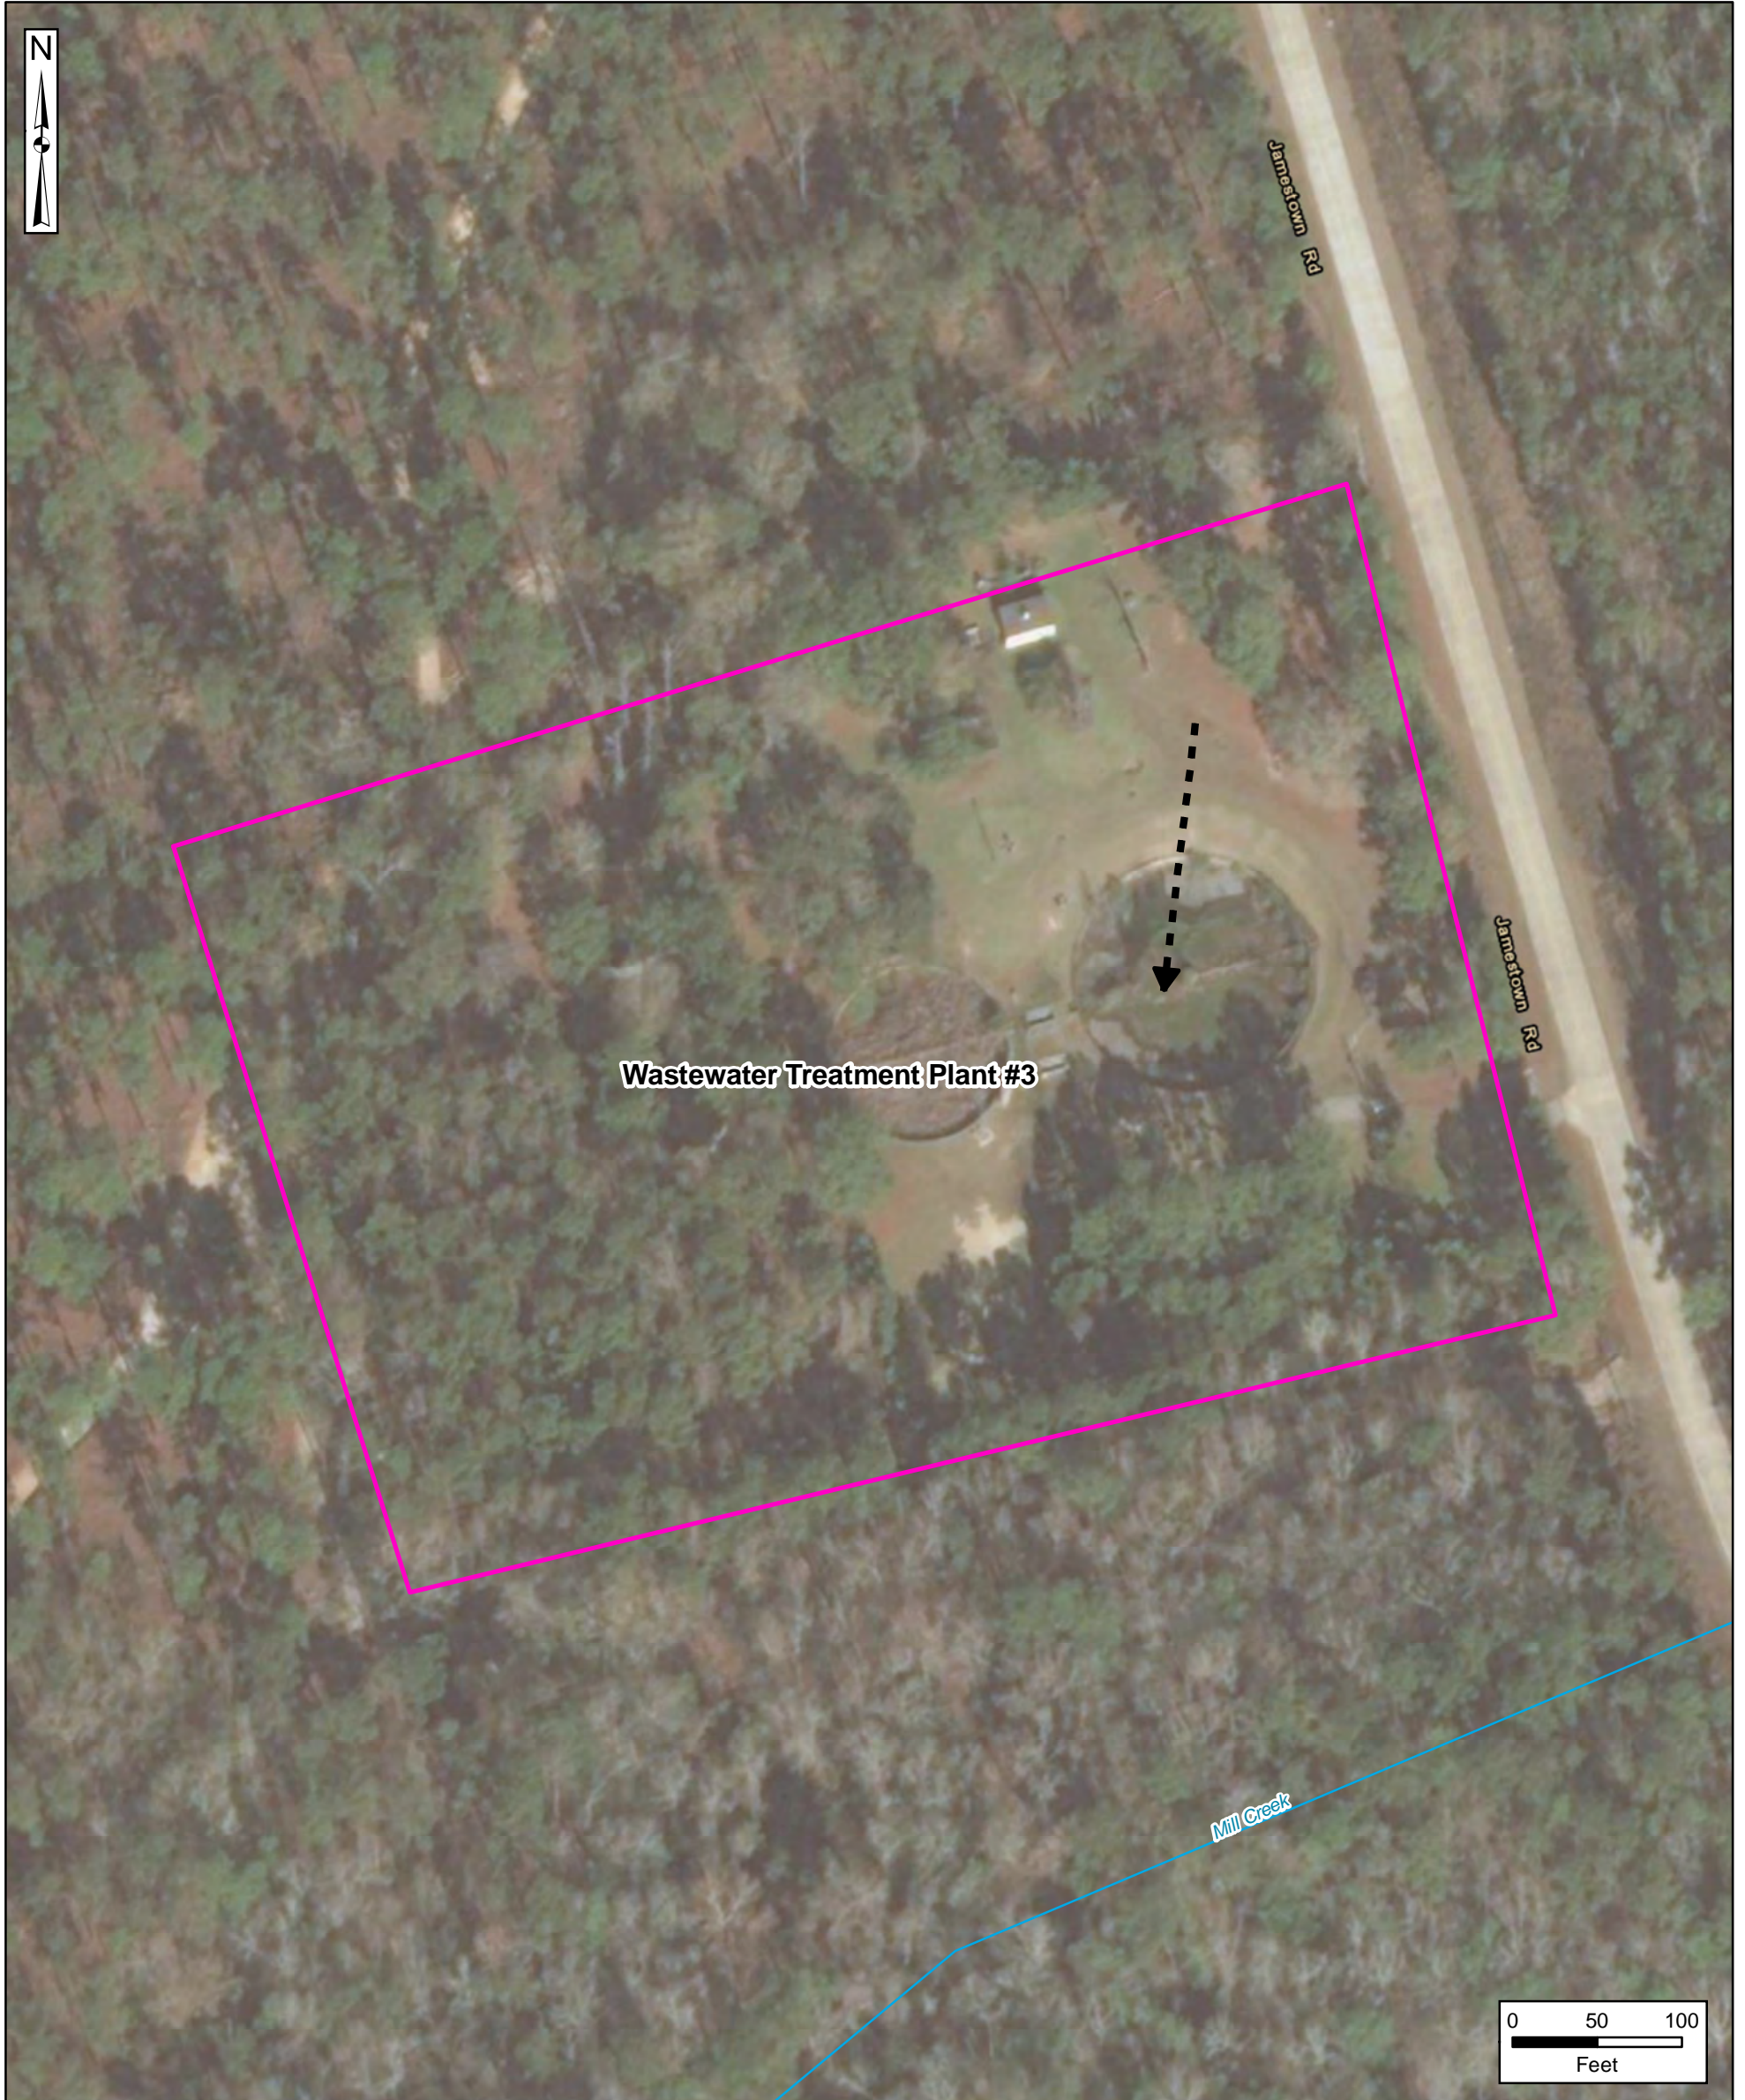
Figure 5-8
Aerial Photo of
AOPI Wastewater Treatment Plant #3

WWTP #1 and WWTP #3 were identified as AOPIs following document research, personnel interviews, and site reconnaissance trips due to discharge of AFFF to the sanitary sewer. When the FBSB-105 fire training area was active (confirmed AFFF use), liquids from the training pit discharged into an OWS and then to WWTP #3, via the sanitary sewer. WWTP #3 drained its effluent into WWTP #1 and the outfall discharges to the Chattahoochee River. WWTP #1 is shown on **Figure 5-7** and WWTP #3 is shown on **Figure 5-8**.

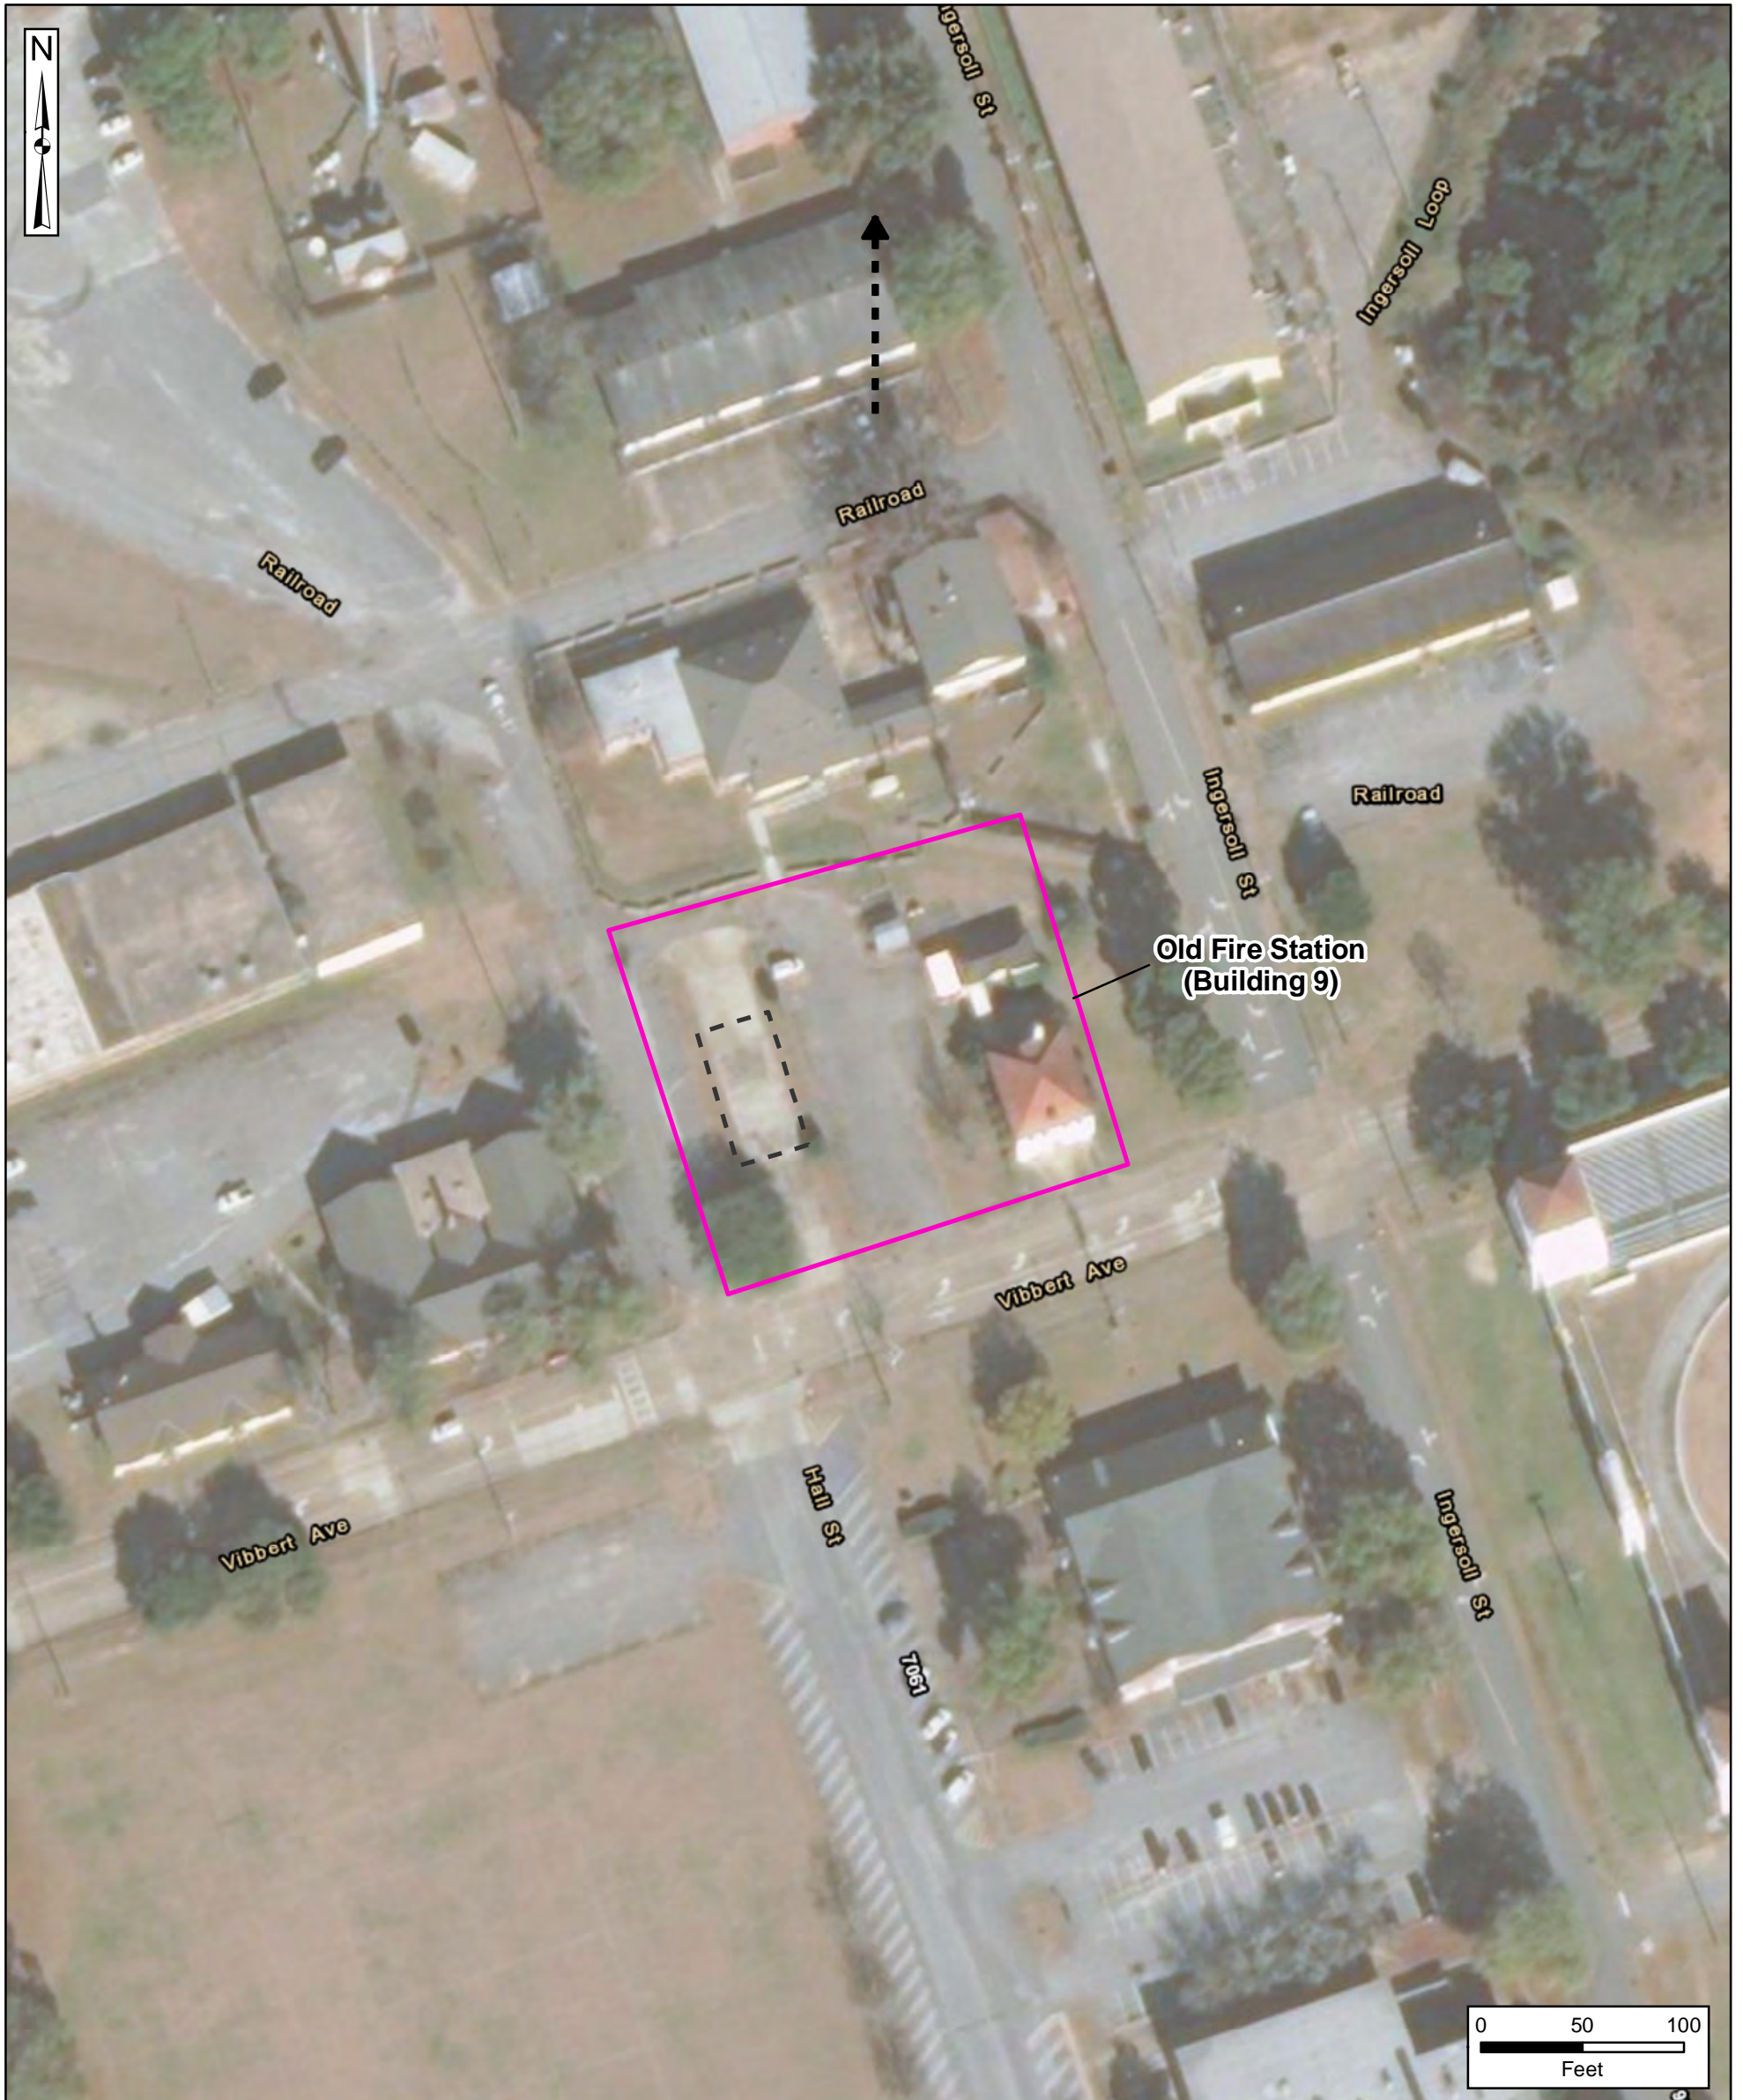
Figure 5-10
Aerial Photo of
AOPI Old Fire Station (Building 9)

Old Fire Station Building 9 was identified as an AOPI following document research, personnel interviews, and site reconnaissance due to its use as a fire station. The fire station was an original fire station at Fort Benning and was demolished in 2006. A temporary building was located next to the fire station to store fire trucks and was also demolished. Class A foam was carried on the trucks. There are data gaps for AFFF storage and usage prior to 2005. The Old Fire Station Building 9 is shown on **Figure 5-10**.
