**PRELIMINARY ASSESSMENT OF PER- AND  
POLYFLUOROALKYL SUBSTANCES AT  
CAMP BONNEVILLE,  
VANCOUVER, WASHINGTON**

**U.S. ARMY**

**Final  
November 2023**

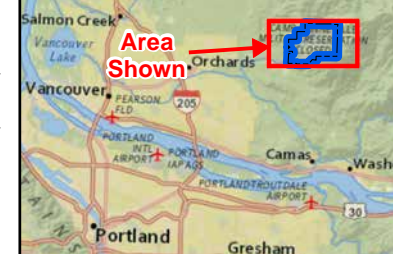
<b>SITE FEATURES</b> CAMP BONNEVILLE VANCOUVER, WASHINGTON	
FIGURE: 2-1	DATE: 9/12/2023

1. Data Sources: USGS National Elevation Dataset (NED), USGS National Hydrography Dataset (NHD).
2. Inferred Groundwater Flow Direction is from the 2010 PA (Ecology and Environment).
3. Background Source: ESRI World Imagery (Vivid/Maxar, 4/2020).

Camp Bonneville is located on the western slope of the Cascade Mountains in the Lamas Creek Valley, where the terrain is generally covered with undergrowth and large stands of coniferous timber (Woodward-Clyde 1997). The western portion of Camp Bonneville consists of low hills and low plains of the Lamas Creek valley. Elevations range from about 300 feet above mean sea level (amsl) in Lamas Creek at the southwestern corner of the site to 1,000 and 1,700 feet amsl along the moderately steep ridges within the installation boundary to the northwest and southeast, respectively (U.S. Geological Survey National Elevation Dataset, as depicted in Figure 2-1).

Camp Bonneville currently has two non-potable supply wells: a 385-foot well at the Bonneville cantonment and a 193-foot well at the Killpack cantonment (ESE 1983). Use of these supply wells is subject to a deed restriction that limits the use of groundwater from the existing water systems at the Bonneville cantonment, the Killpack cantonment, and the Caretaker's building to providing only non-potable water to these facilities (BCRRT 2011). An additional well with a depth of 516 feet also may have been present historically at the Killpack cantonment (Mundorff 1964). Well water is pumped, chlorinated, and stored in reservoirs for distribution at the cantonments to provide non-potable water only. An additional non-potable well was reportedly drilled at the FBI range in 1998, extending to a depth of 105 feet (BCRRT 2007). The on-post water systems drawn from four deep wells are restricted from potable use due to potential hexahydro-1,3,5-trinitro-1,3,5-triazine (RDX), 2,4-dinitrotoluene (DNT), perchlorate, dichlorofluoromethane, 1,1,1-trichloroethane (TCA), 1,1-dichloroethylene (DCE), and tetrachloroethylene (PCE) contamination in groundwater potentially underlying Demolition Area/Landfill 1 (U.S. Army 2006). Deed restrictions also are in place that prohibit groundwater use at Landfill 4/Demolition Area 1 (BCRRT 2011). The locations of non-potable wells are shown in Figure 2-1. According to personnel interviews, potable water for the installation is carried in as needed.

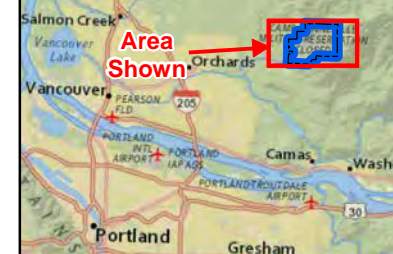
<b>PARCEL TRANSFER MAP</b> CAMP BONNEVILLE VANCOUVER, WASHINGTON	
FIGURE: 2-2	DATE: 10/19/2022

September 2006  
Property Transfer  
of Early Transfer Parcel  
to Clark County
