**SITE INSPECTION REPORT FOR PER- AND
POLYFLUOROALKYL SUBSTANCES AT
CAMP BONNEVILLE,
VANCOUVER, WASHINGTON**

CAMP BONNEVILLE

**Final
December 2023**

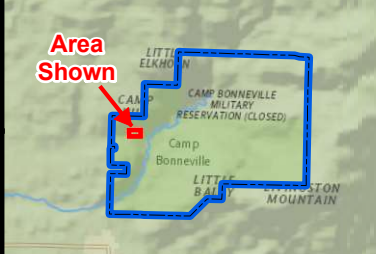
FIGURE: ES-2 DATE: 9/27/2023

BUILDING 483 FIRE STATION AOPI AND WASH RACKS 1 AND 2 AOPI SAMPLE RESULTS CAMP BONNEVILLE VANCOUVER, WASHINGTON

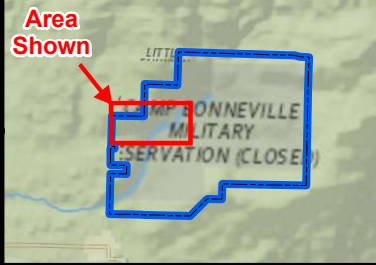
AOPI LOCATIONS	
CAMP BONNEVILLE VANCOUVER, WASHINGTON	
FIGURE: 1-2	DATE: 9/14/2023

During the PA records reviews, interviews, aerial photographic analysis, and site reconnaissance, Leidos investigated available documentation and physical evidence for areas having a potential historical PFAS release. The sites evaluated include an airstrip, fire stations, landfills, hazardous waste disposal areas, wastewater treatment plants (WWTPs), pesticide facilities, maintenance shops, open burning/open detonation areas, wash racks, and historical building fires. The Camp Bonneville PFAS PA recommended three AOPIs for further investigation in an SI due to known or potential historical PFAS use, storage, and/or release due to Army activities. The AOPIs, as well as the dates of operation and sizes of each area, are presented in Table 1-1 and illustrated in Figure 1-2.

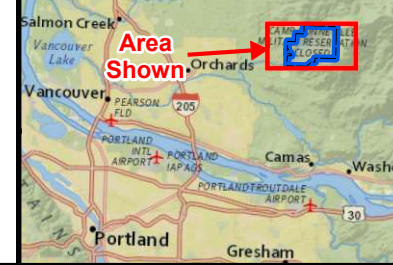
<p>SITE FEATURES</p> <p>CAMP BONNEVILLE VANCOUVER, WASHINGTON</p>	
<p>FIGURE: 2-1</p>	<p>DATE: 8/24/2023</p>

Camp Bonneville is a former Army facility in Clark County, Washington, approximately 12 miles east of Vancouver, Washington (Figure 1-1). While in operation, Camp Bonneville occupied the 3,840 acres. Camp Bonneville was originally composed of 3,020 acres and leased 820 acres from WDNR. It is on the western slope of the Cascade Mountains in the Lacamas Creek Valley. The installation is mostly forested, except for the approximately 30 acres that comprise the Bonneville and Killpack cantonment areas near the installation's former main entrance. The property surrounding Camp Bonneville is zoned for agriculture, rural residential, and forestry uses (LRA 2005). Camp Bonneville is bounded to the northeast by the WDNR-managed Yacolt Burn State Forest, and the Livingston Quarry gravel mining operation is located along the southern boundary of the site. Figure 2-1 depicts the Camp Bonneville site features.

Camp Bonneville is on the western slope of the Cascade Mountains in the Lacamas Creek Valley, where the terrain is generally covered with undergrowth and large stands of coniferous timber (Woodward-Clyde 1997). The western portion of Camp Bonneville consists of low hills and low plains of the Lacamas Creek valley. Elevations range from approximately 300 feet above mean sea level (amsl) in Lacamas Creek at the southwestern corner of the site to 1,000 and 1,400 feet amsl along the moderately steep ridges within the installation boundary to the northwest and southeast, respectively (U.S. Geological Survey National Elevation Dataset, as depicted in Figure 2-1).

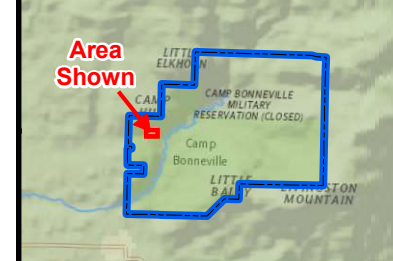
FIGURE: 6-4 DATE: 9/27/2023

Soil and sediment samples were collected from the Building 4483 Fire Station AOPI at the following locations (Figure 6-4):

Soil, groundwater, surface water, and sediment samples were collected from the Wash Racks 1 and 2 AOPI at the following locations (Figures 6-4):
