FINAL PRELIMINARY ASSESSMENT AND SITE INSPECTION OF PER- AND POLYFLUOROALKYL SUBSTANCES

Fort Campbell, Kentucky

Prepared For:
U.S. Army Corps of Engineers, Baltimore District
2 Hopkins Plaza
Baltimore, Maryland 21201

May 2022

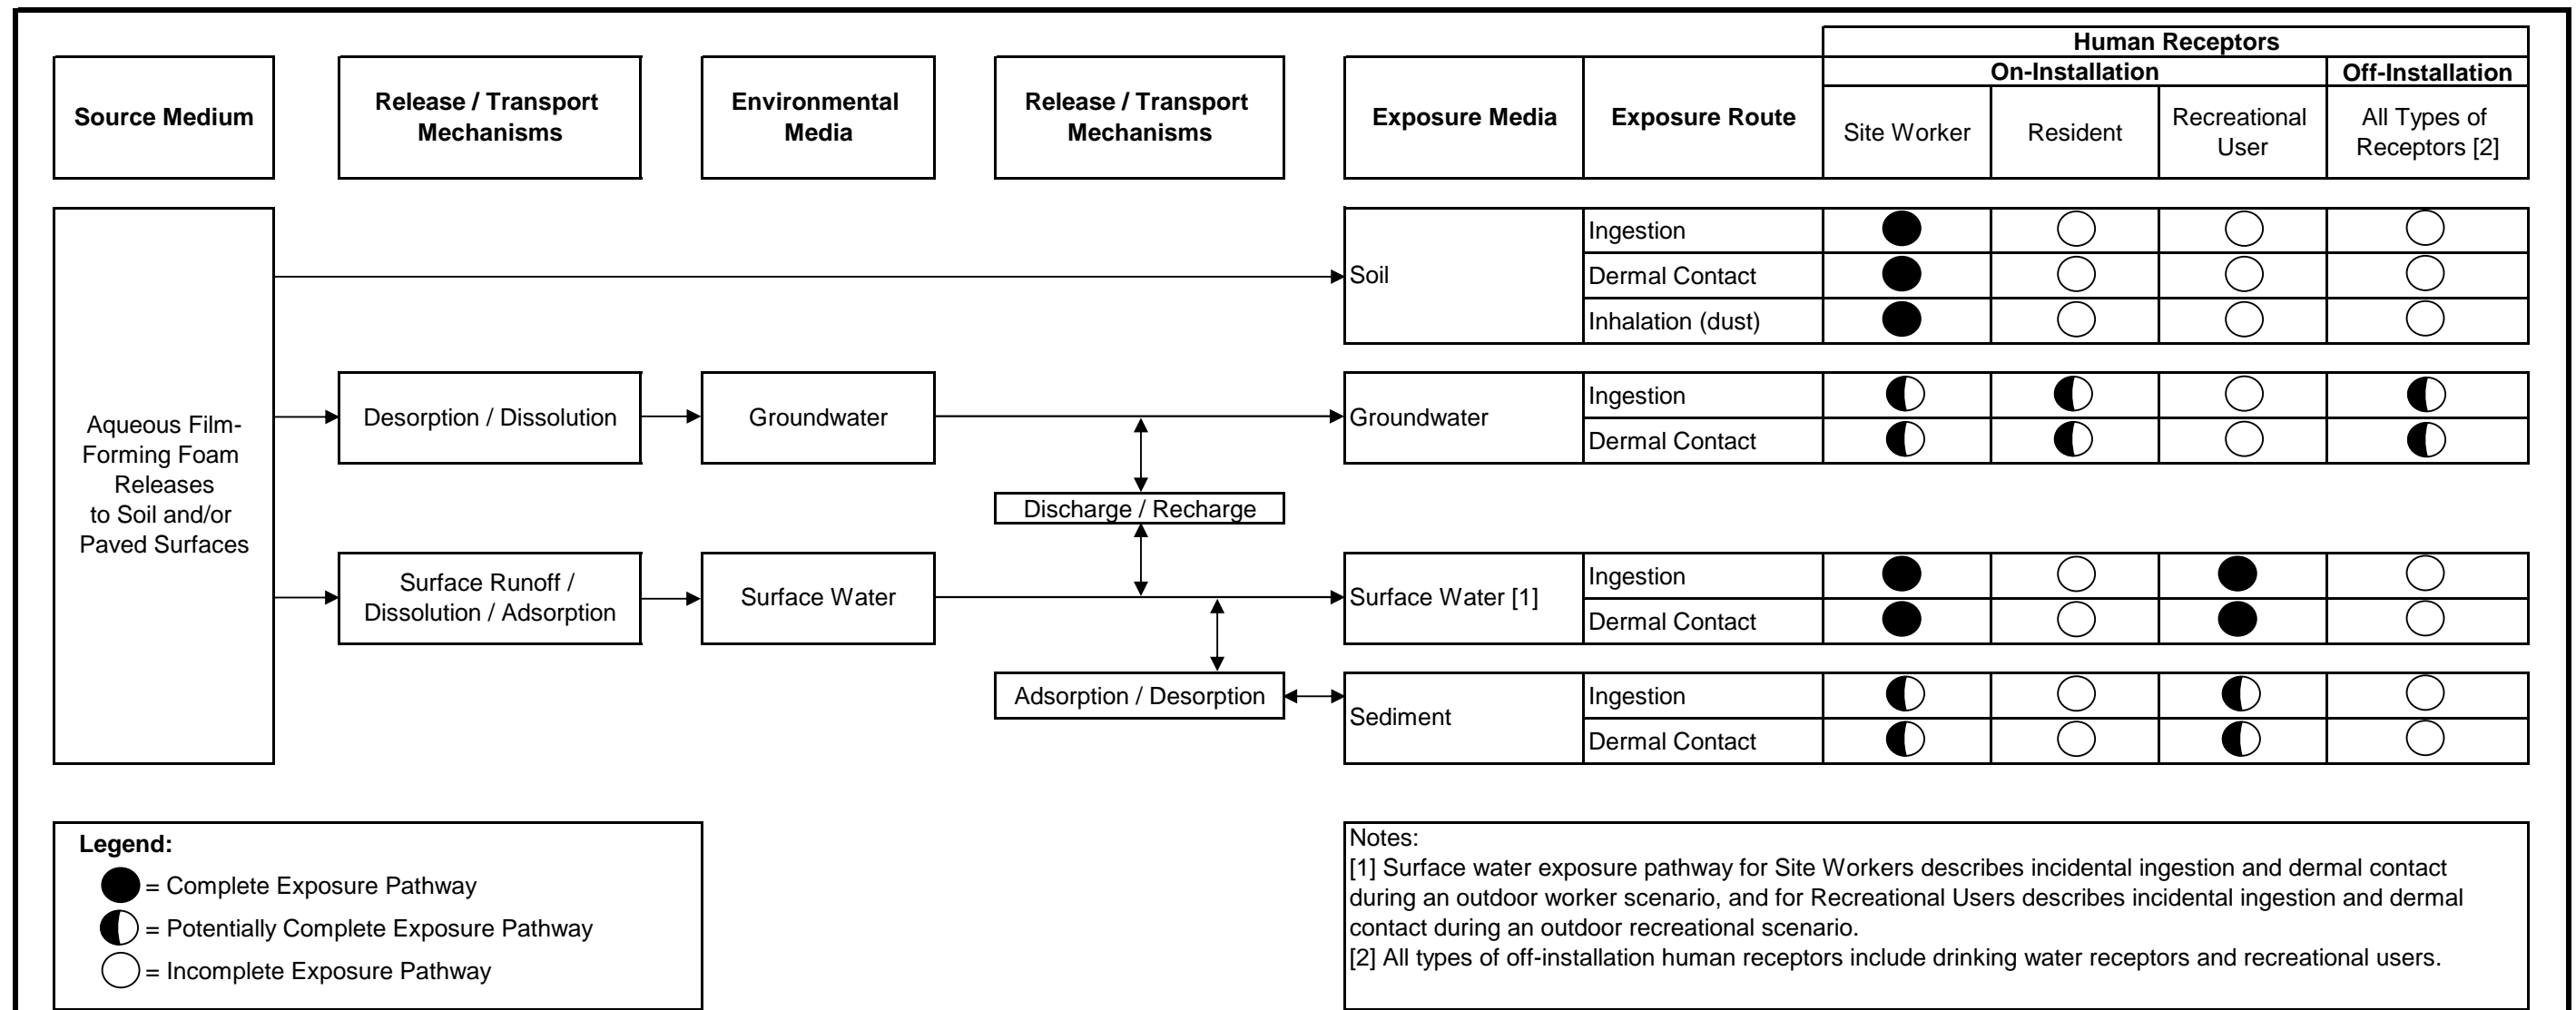
Figure 7-10

Conceptual Site Model - Campbell Army Airfield Former Fire Training Area, Aqueous Film-Forming Foam Rinse-Out Building 6310, and Training Area 03 Crash Site
 USAEC PFAS Preliminary Assessment / Site Inspection
 Fort Campbell, Kentucky
