FINAL PRELIMINARY ASSESSMENT AND SITE INSPECTION OF PER- AND POLYFLUOROALKYL SUBSTANCES

Carlisle Barracks, Pennsylvania

Prepared For:
U.S. Army Corps of Engineers, Baltimore District
2 Hopkins Plaza
Baltimore, Maryland 21201

December 2022

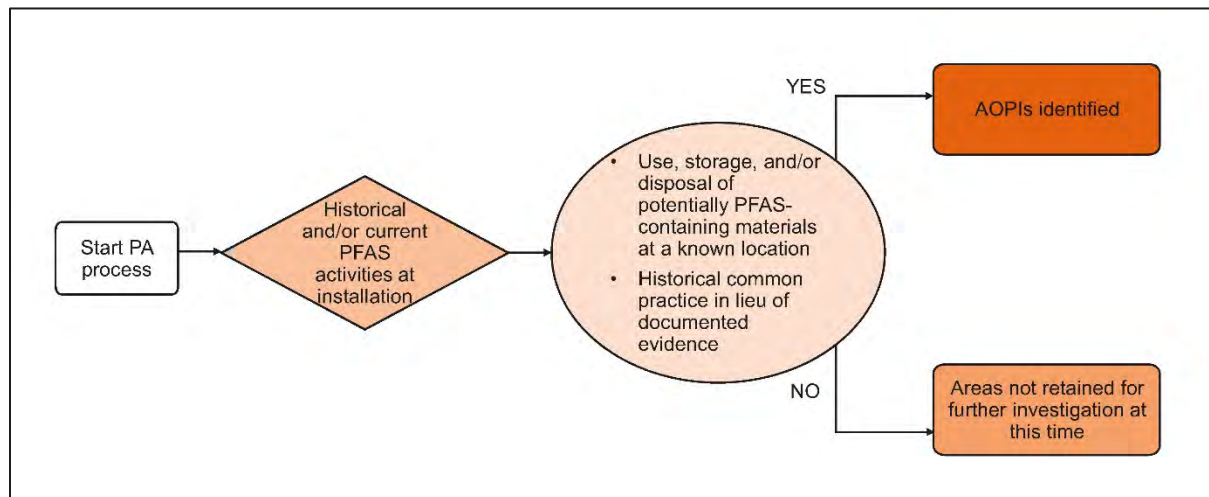
Figure 5-1: AOPI Decision Flowchart

The preliminary locations evaluated for use, storage, and/or disposal of PFAS-containing materials at Carlisle Barracks were further refined during the PA process and identified either as an area not retained for further investigation or as an AOPI. In accordance with the established process for the PA/SI, five areas have been identified as AOPIs. The process used for refining these areas is presented on **Figure 5-1**, below.

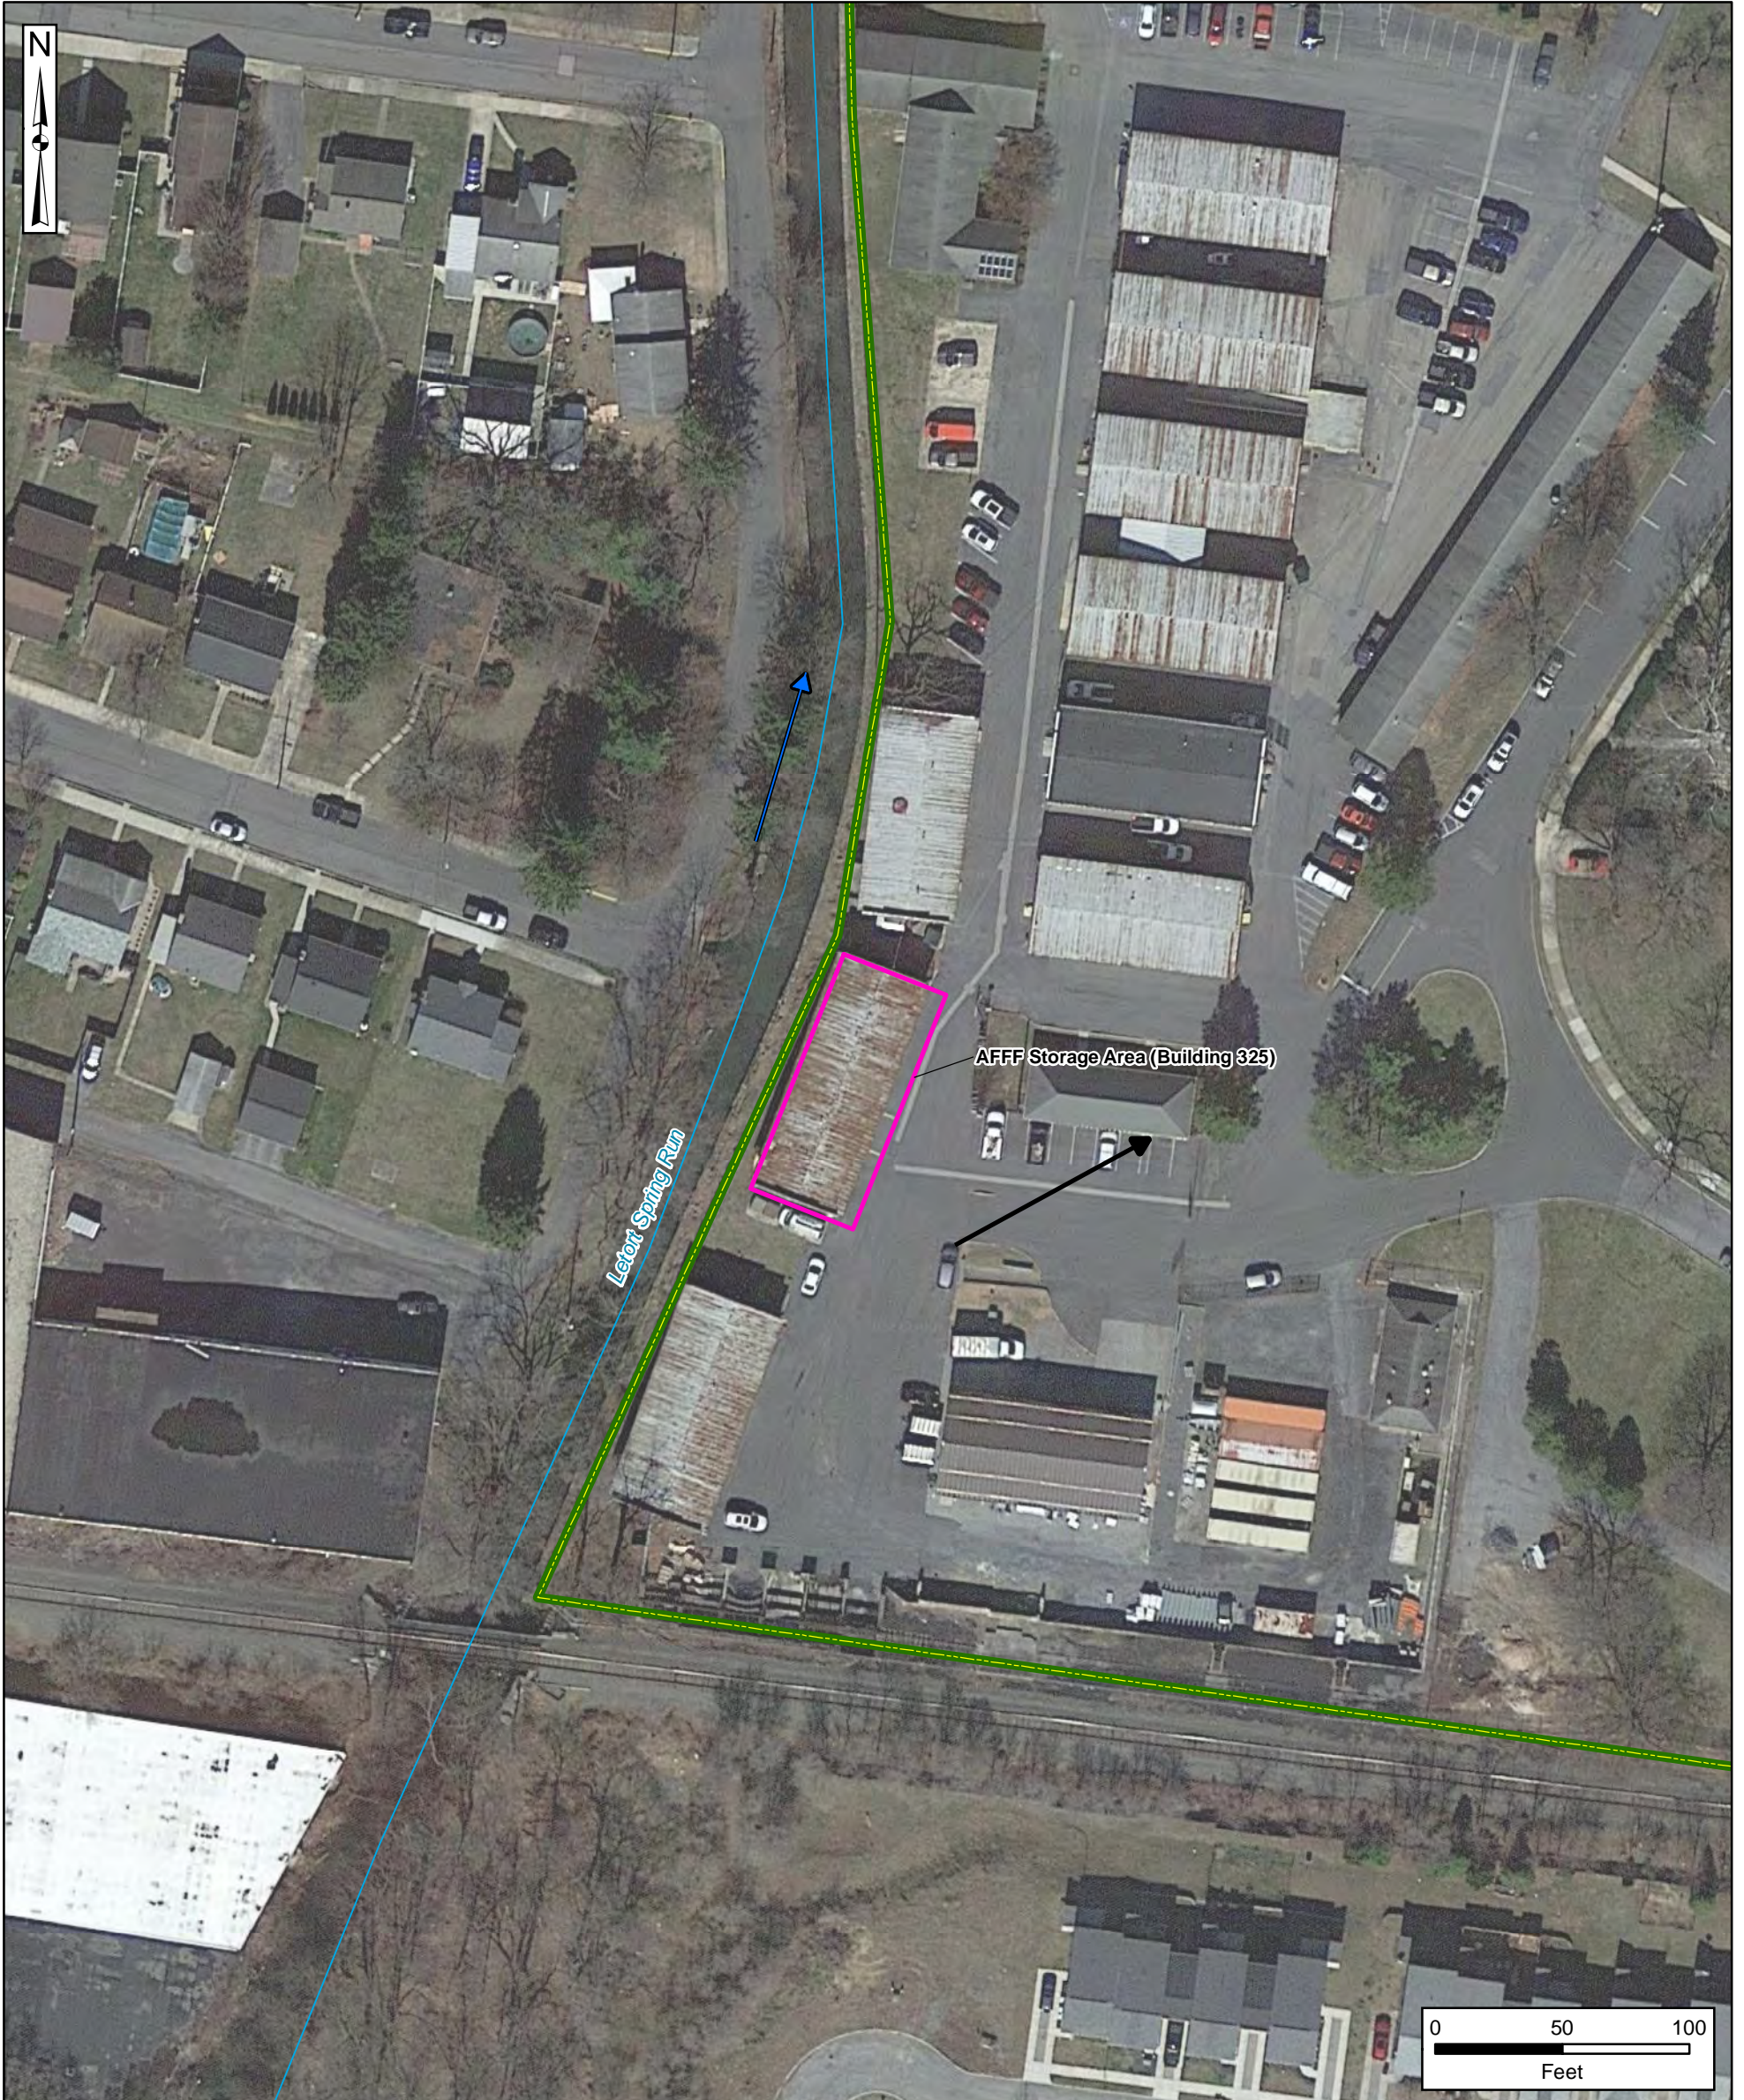
Figure 5-6
Aerial Photo of
AFFF Storage Area (Building 325)

The AOPI is a brick building with a concrete floor used for storage for various departments, including the Carlisle Barracks Fire Department. Building 325 is surrounded by paved surfaces and storage buildings to the north, east, and south, and the LeTort Spring Run to the west. Drainage from the pavement and garage bay area of Building 325 flows north along the pavement and potentially to the northwest into a grassy area (**Figure 5-6**).

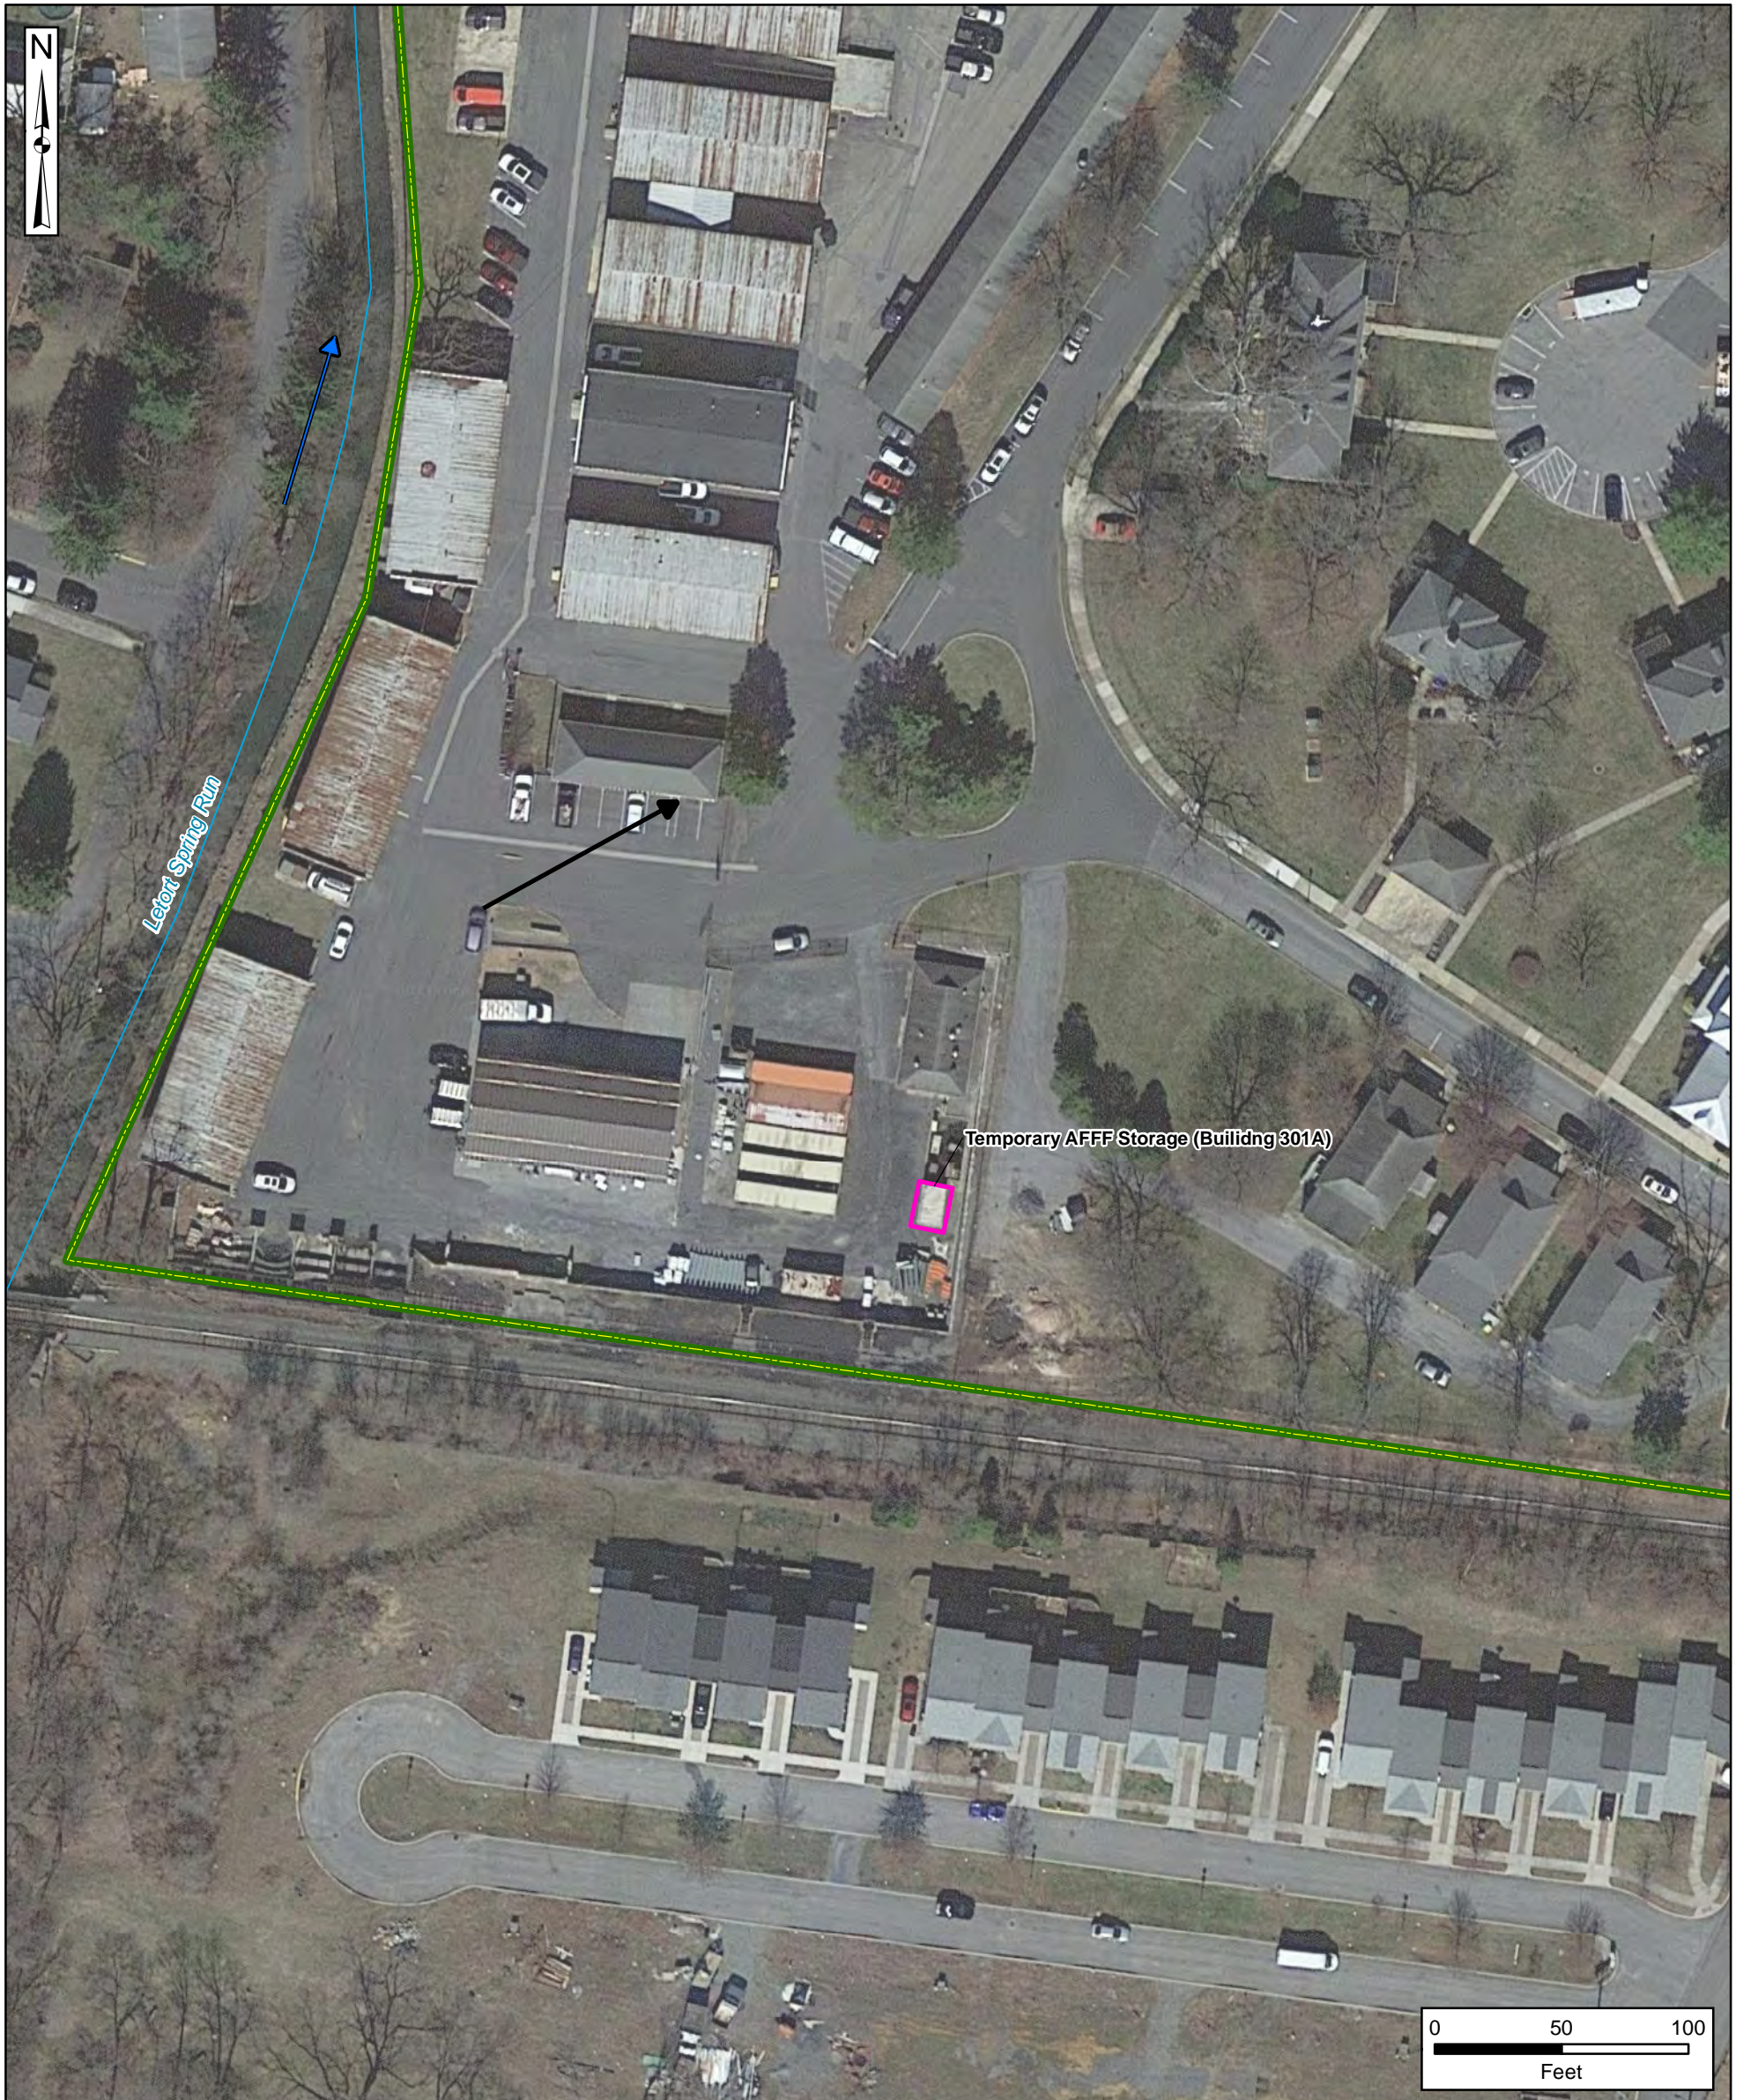
Figure 5-7
Aerial Photo of
Temporary AFFF Storage (Building 301A)

The AOPI is a small metal building that is used for hazardous waste storage. Stored AFFF drums were placed on a suspended grate flooring. Secondary containment infrastructure (a collection basin) is located underneath the grate. It is not connected to any other infrastructure and is emptied by a waste contractor as needed (**Appendix H**). Temporary AFFF Storage (Building 301A) is surrounded by a concrete wall and fence to the east, gravel surfaces to the north and south, and other industrial use buildings to the west (**Figure 5-7**).

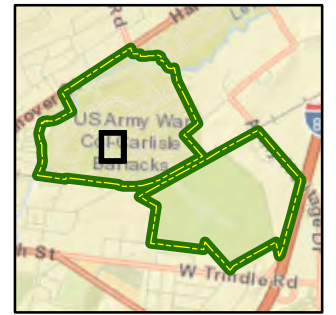
Figure 7-2
Current Fire Station (Building 400)
PFOS, PFOA, and PFBS Analytical Results

Soil sampling at the Current Fire Station (Building 400) occurred on 30 June 2020. Three surface soil samples (CBKS-B400-1-SO, CBKS-B400-2-SO, and CBKS-B400-3-SO) were collected from the 0.5-2 feet bgs interval using a hand auger and were located within the low-lying drainage area where AFFF potentially migrated following fire truck washing activities (**Figure 7-2**).

Groundwater sampling at the Current Fire Station (Building 400) occurred on 25 August 2022. One groundwater sample, CBKS-B400-1-GW, was collected following the installation of a temporary well. The groundwater sample/temporary well boring was located within the grassy area on the southwest side of the Current Fire Station (Building 400), where runoff from AFFF use, storage, and/or disposal on the driveway possibly drained (**Figure 7-2**).

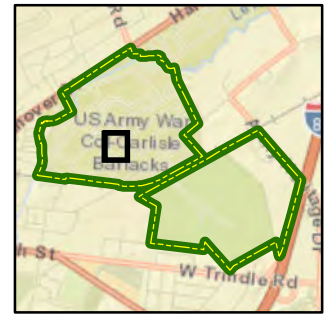
Figure 7-3
Fire Station Support Storage Facility (Building 400B)
PFOS, PFOA, and PFBS Analytical Results

Soil sampling at the Fire Station Support Storage Facility (Building 400B) occurred on 30 June 2020. Two surface soil samples (CBKS-B400B-1-SO and CBKS-B400B-2-SO) were collected from the 0.5-2 feet bgs interval using a hand auger and were located within the low-lying drainage area where AFFF potentially migrated following fire truck washing activities (**Figure 7-3**).

Groundwater sampling at the Fire Station Support Storage Facility (Building 400B) occurred on 26 August 2022. One groundwater sample, CBKS-B400B-GW-01, was collected following the installation of a temporary well. The groundwater sample/temporary well boring was located within a grassy area on the assumed downgradient edge of the paved driveway. The boring was located on the southeast side of the Fire Station Support Storage Facility (Building 400B), where runoff from AFFF use, storage, and/or disposal on the driveway possibly drained (**Figure 7-3**).

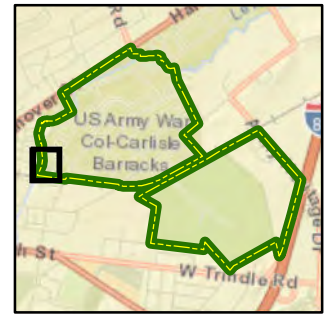
Figure 7-5
AFFF Storage Area (Building 325)
PFOS, PFOA, and PFBS Analytical Results

Soil sampling at AFFF Storage Area (Building 325) occurred on 29 June 2020. One surface soil sample (CBKS-B325-1-SO) was collected from the 4.5-5 feet bgs interval (i.e., where native soil was encountered) behind Building 325 to account for any potential releases from the compromised AFFF drums that were stored at the back of Building 325. One surface soil sample was collected from the 0.5-2 feet bgs interval (CBKS-B325-2-SO) immediately downslope of the drainage path from the pavement outside of the Building 325 bay door to account for potential historical AFFF spills during AFFF transport (**Figure 7-5**). Both soil samples were collected using a hand auger.

Groundwater sampling at the AFFF Storage Area (Building 325) occurred on 29 August 2022. One groundwater sample, CBKS-B325-GW-01, was collected following the installation of a temporary well. The groundwater sample/temporary well boring was located within the grassy area immediately outside of Building 325 (**Figure 7-5**).

Surface water sampling at the AFFF Storage Area (Building 325) occurred on 30 August 2022. One surface water sample, CBKS-B325-SW-01, was collected from LeTort Spring Run, where the stream first enters the installation (**Figure 7-5**).

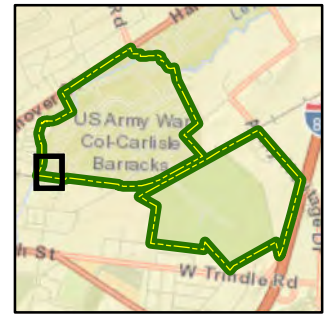
Figure 7-6
Temporary AFFF Storage (Building 301A)
PFOS, PFOA, and PFBS Analytical Results

Soil sampling at Temporary AFFF Storage (Building 301A) occurred on 29 June 2020. Two surface soil samples (CBKS-B301A-1-SO and CBKS-B301A-2-SO) were collected from the 0-0.5 foot bgs interval (as described in **Section 6.3.4**) immediately in front of the doors to Building 301A, where AFFF spills may have occurred while transporting the drums in and out of the building (**Figure 7-6**). Both soil samples were collected using a hand auger.

Groundwater sampling at the Temporary AFFF Storage (Building 301A) occurred on 29 August 2022. One groundwater sample, CBKS-B301A-GW-01, was collected following the installation of a temporary well. The groundwater sample/temporary well boring was located immediately outside of Building 301A (**Figure 7-6**).
