**PRELIMINARY ASSESSMENT REPORT**

**OF PFAS**

**FORT CHAFFEE, ARKANSAS**

September 7, 2023

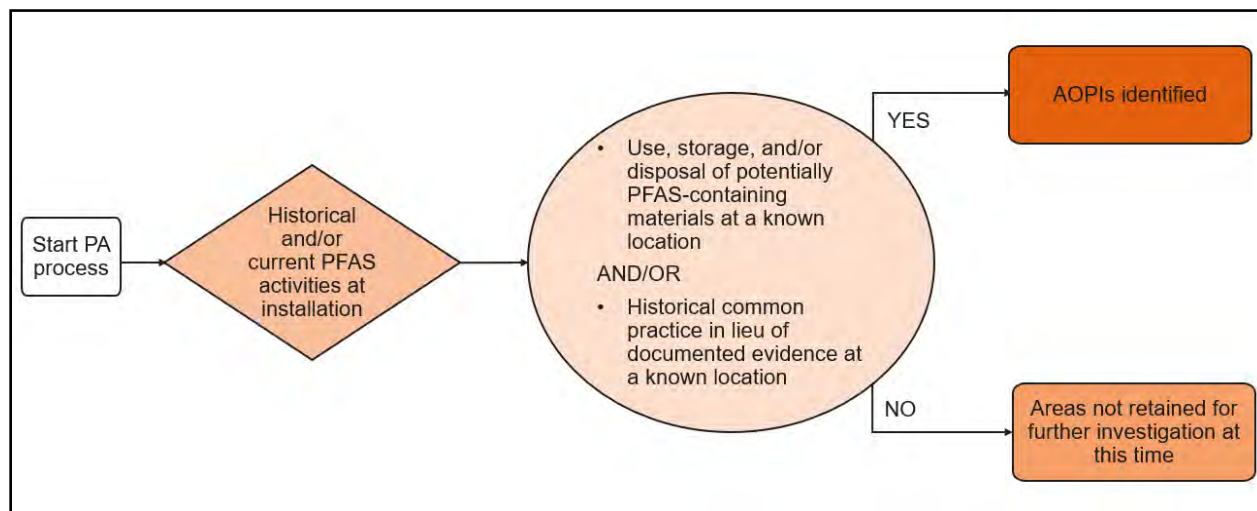
**Figure 5-1: AOPI Decision Flowchart**

The preliminary locations evaluated for potential use, storage, and/or disposal of PFAS-containing materials at Fort Chaffee, were further refined during the PA process and identified either as an area not retained for further investigation or as an AOPI. In accordance with the established process for the PA, 21 areas have been identified as AOPIs on *Figure 5-1*, below.

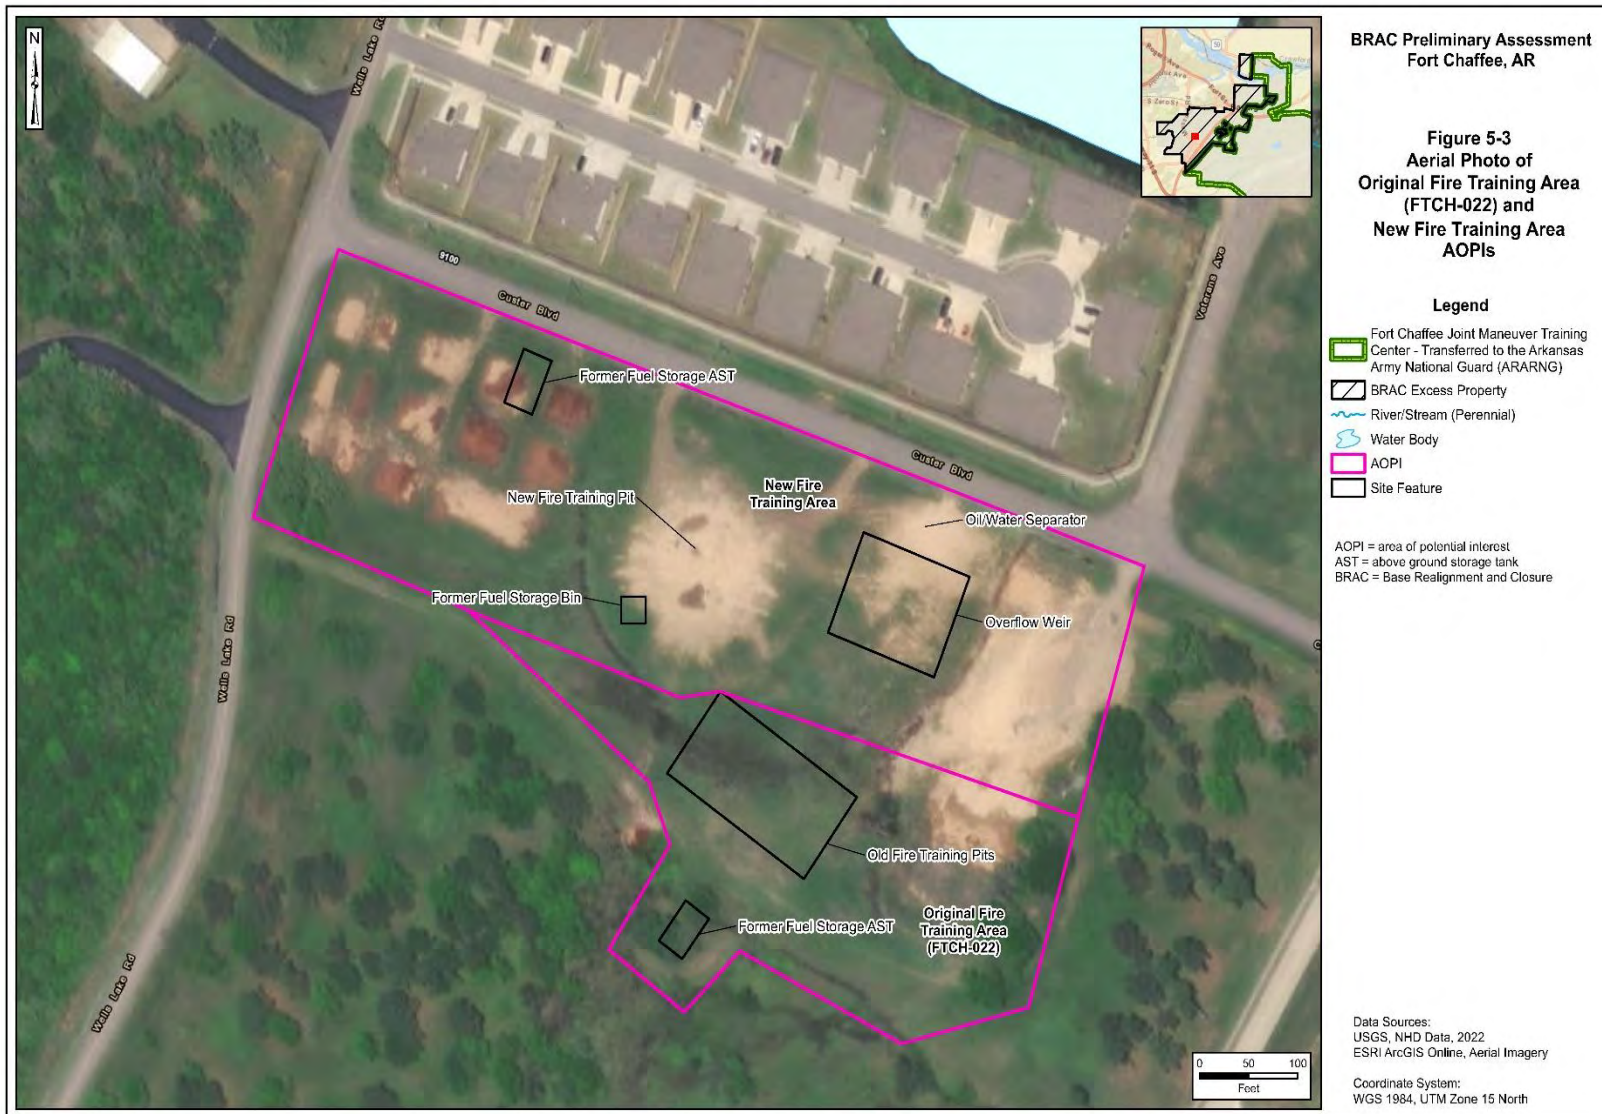
**Figure 5-3: Aerial Photo of Original Fire Training Area (FTCH-022) & New Fire Training Area AOPIs**

The New Fire Training Area was constructed to replace the Original Fire Training Area (FTCH-022). Together, they represent two generations of fire training areas as shown on **Figure 5-3**. The Fort Chaffee Fire Department would train here in addition to neighboring fire departments (e.g., 188<sup>th</sup> Tactical Fighter Group based in Fort Smith, Arkansas) according to an interview. Flammable liquids were routed from a fuel storage tank to the pits, ignited, and extinguished with “fire suppression chemicals”. Used oil from across the installation was also burned here; stored in a fuel storage bin kept to the west of the pit. The new fire training area was completed in the early 1990s; considered to be a more “environmentally friendly” setup. An aircraft hull and lined containment area would be filled with flammable materials and used for fuel-based firefighter training. Piping from the aircraft hull containment area conveyed overflow fuel and extinguishing media to a lined overflow weir and then to an oil/water separator. It is unclear whether this oil/water separator was connected to the sanitary sewer system.

Location Name	Identifier	AOPI	Recommendation	Rationale	Land Ownership
Original Fire Training Area	FTCH-022	Yes	Further study in SI	Interview statements indicate that AFFF was used in the area. During its time of operation, it was also historical common practice to use AFFF as an extinguishing material for fuel-based fires.	Transferred outside of Federal Government
New Fire Training Area	--	Yes	Further study in SI	Evidence of AFFF being utilized in this area includes interview statements and historical common practice of extinguishing materials for fuel-based fires to be AFFF during the period of use.	Transferred outside of Federal Government
Airfield Firefight and Rescue Station	Building 5850	Yes	Further study in SI	Historical common practice of nozzle testing or AFFF storage at fire stations.	Transferred outside of Federal Government
Primary Fire Station	Building 2100	Yes	Further study in SI	Historical common practice of nozzle testing or AFFF storage at fire stations.	BRAC Surplus to ARARNG

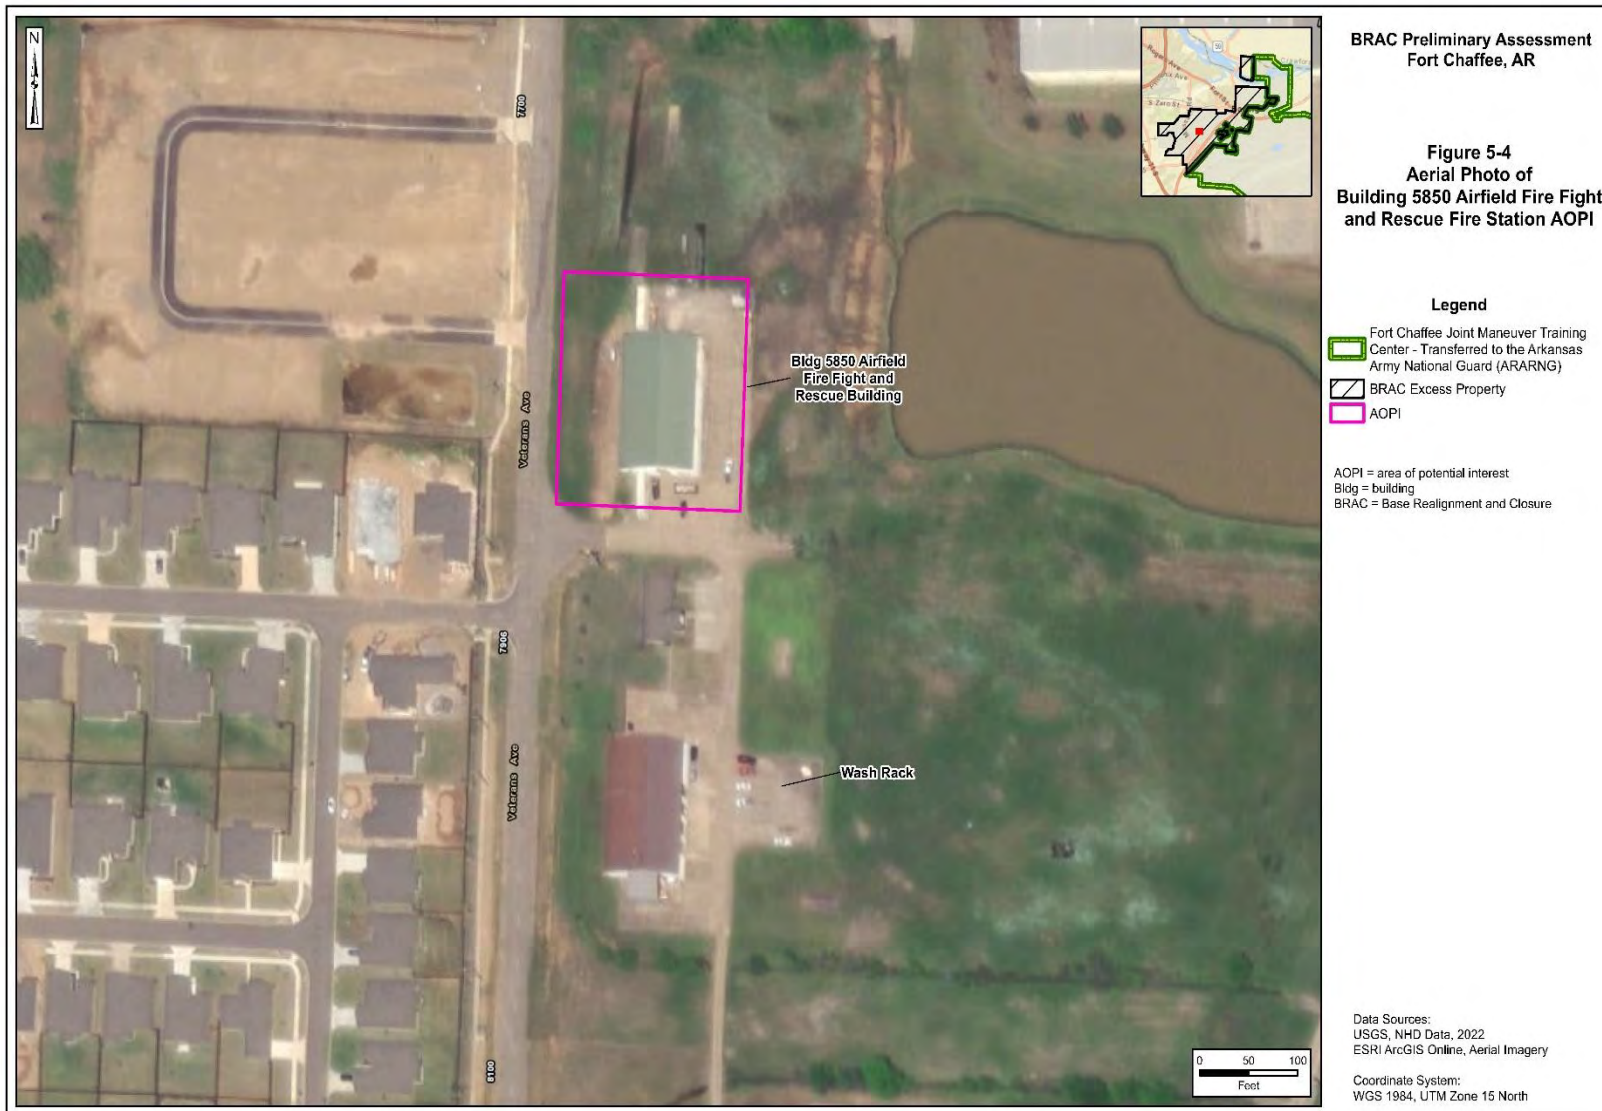
**Figure 5-4: Aerial Photo of Bldg. 5850 Airfield Fire Fighter & Rescue Fire Station AOPI**

The Airfield Fire and Rescue Station (Building 5850) has been used as recently as 1990, but the building was reported to be in substandard conditions (USACE Little Rock District 1990). The Airfield Fire and Rescue Station is located in the BRAC Surplus Property area, in the former western cantonment area, adjacent to the firefighter training area. There was one chemical additive pumper listed in a site inventory and described as having been housed primarily here until closure and transfer. This chemical additive pumper may have utilized AFFF.

The Airfield Fire and Rescue Station (Building 5850) is identified as an AOPI following records review due to possible nozzle testing, vehicle maintenance and washing, and AFFF storage being conducted here. Building 5850 was constructed in 1943 and is located in the Western Cantonment Area. This building was utilized as a fire station until the 1997 BRAC event at Fort Chaffee and was described as being in very poor condition. At the time of this PA the building still stands. Various records also describe it as a vehicle maintenance building.

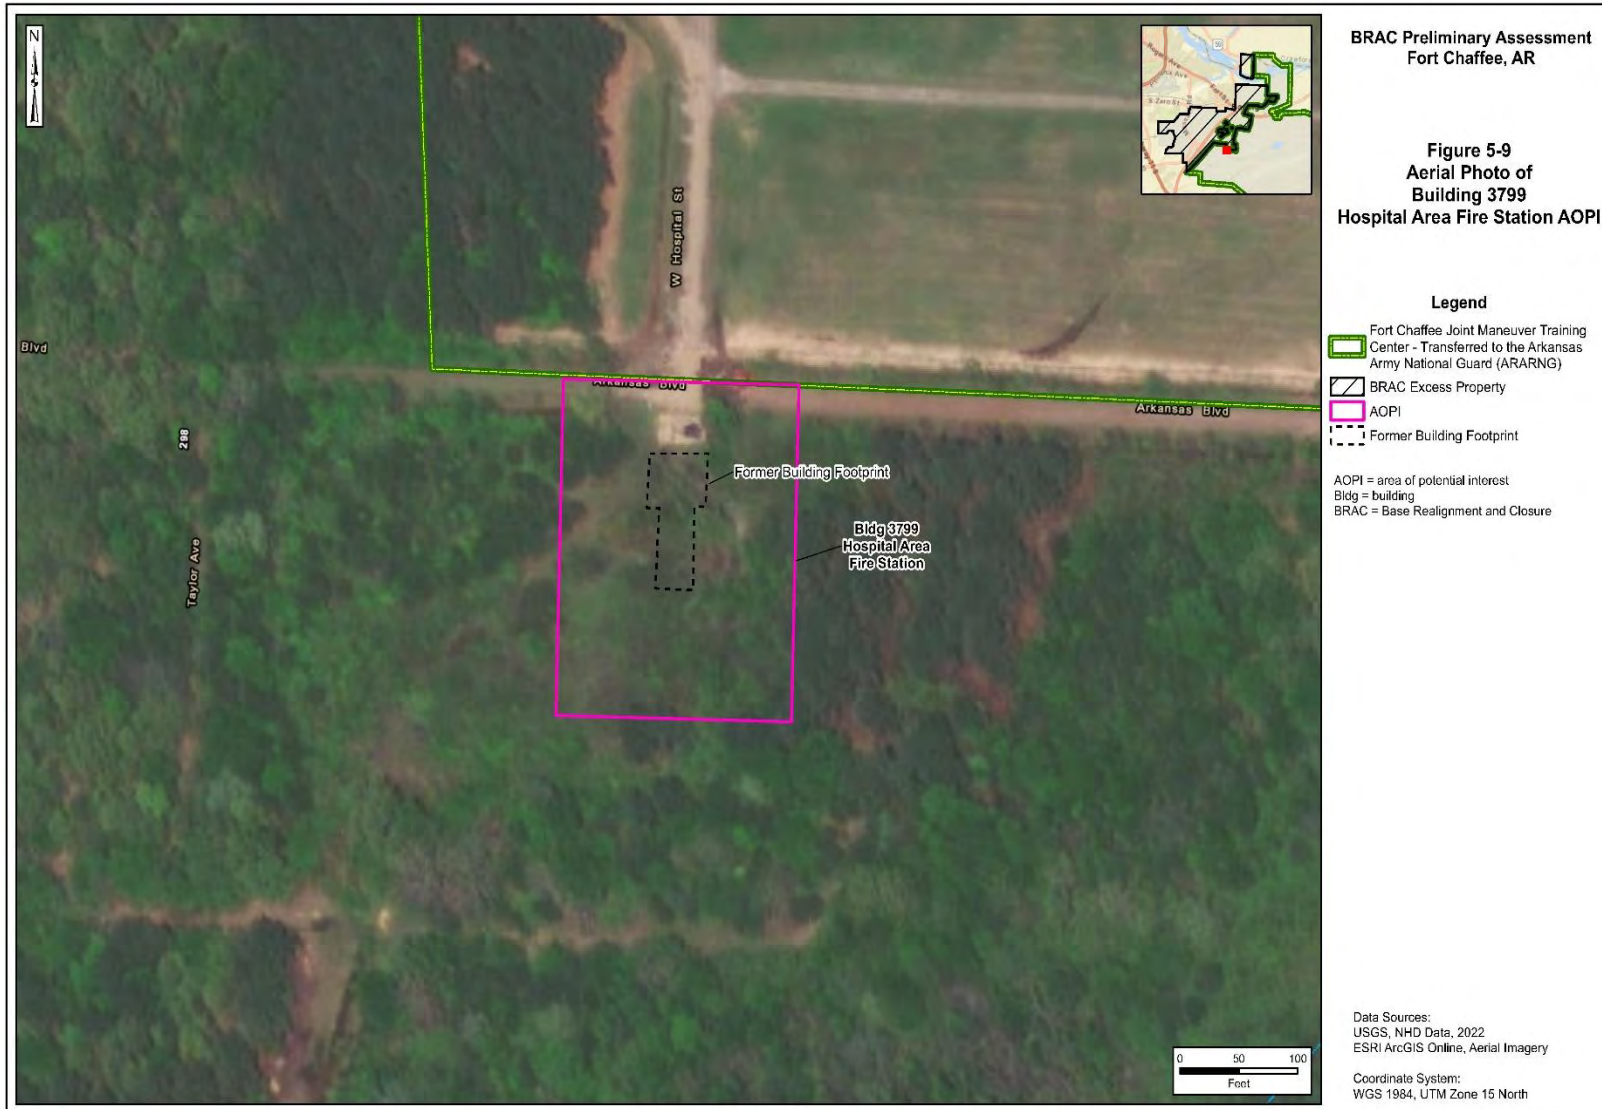
**Figure 5-9: Aerial Photo of Bldg. 3799 Hospital Area Fire Station AOP1**

Hospital Area Fire Station (Building 3799) was constructed in 1942. Very little information could be gathered about this building. The Hospital Area, which was located in the cantonment area, comprised of 122 buildings, and covering 75 acres, was generally in disrepair as late as the early 1990s (USACE Little Rock District 1990). A 1998 survey of the area stated that these buildings, including the Hospital Area Fire Station, were in such poor and unsafe conditions, that demolition of these buildings was recommended (Fort Chaffee Public Trust 1998).

Location Name	Identifier	AOPI	Recommendation	Rationale	Land Ownership
Hospital Area Fire Station	Building 3799	Yes	Further study in SI	Historical common practice of nozzle testing or AFFF storage at fire stations.	BRAC Surplus to ARARNG
Oil/Water Separator Sludge Disposal Area	FTCH-033	Yes	Further study in SI	Sediments and sludge collected from vehicle wash rack troughs and related OWSs were spread evenly on the ground surface at the site.	Transferred outside of Federal Government
Sewage Treatment Lagoons	FTCH-011	Yes	Further study in SI	Wastewater from the silver recovery unit and vehicle washout near fire training areas was routed here for treatment.	Transferred outside of Federal Government
East Land Application Site	FTCH-043	Yes	Further study in SI	Impacted soil from the Fire Training Area being brought here for disposal.	BRAC Surplus to ARARNG
West Land Application Site	FTCH-044	Yes	Further study in SI	Impacted soil from the Fire Training Area being brought here for disposal.	Transferred outside of Federal Government

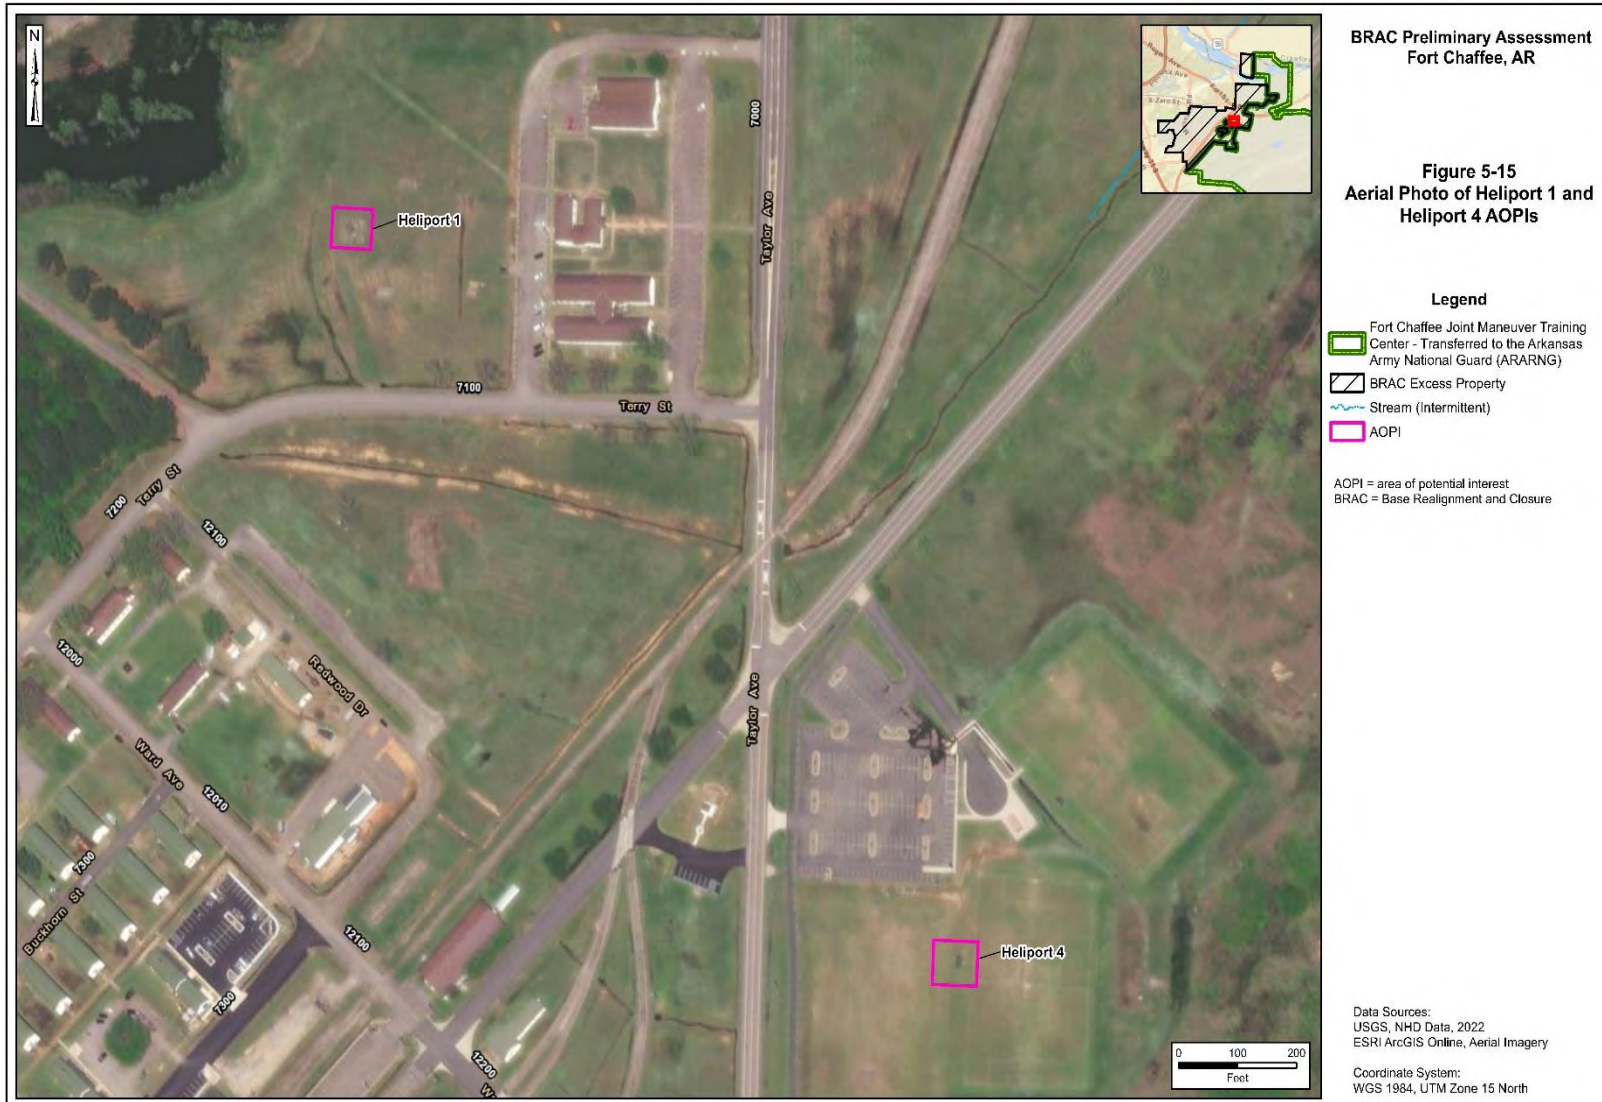
**Figure 5-15: Aerial Photo of Heliport 1 & Heliport 4 AOPs**

The four Cantonment Area Heliports are identified as an AOPI following records review due to the possibility of AFFF being used in response to helicopter failures here. Four heliports are indicated to exist within the Cantonment Area (**Figures 5-15** and **5-16**). The area around the Fort Chaffee Airfield was also used as a drop zone for parachute JRTC training. They first appear in 1980 historical aerials. Two of these helicopter pads are located in close proximity to the Central Cantonment Area Fire Station and Primary Fire Station. An aerial photograph of the Cantonment Area Heliports is provided on **Figures 5-15** and **5-16**.

Location Name	Identifier	AOPI	Recommendation	Rationale	Land Ownership
Cantonment Area Heliports <i>4 Total</i>			Further study in SI	These heliports are not currently utilized. There are no reported incidents of AFFF being utilized in response to a crash or fire. However, it is likely that AFFF was also made available for use during takeoff and landing procedures historically and it was historical common practice to conduct AFFF nozzle testing to prepare for potential fuel-based fire response at the area of staging.	Transferred outside of Federal Government
Fort Chaffee Airfield	--	Yes	Further study in SI	Current fire department procedure requires that AFFF be available for use during takeoff and landing procedures at the landing strips. This airfield no longer exists. There are no reported incidents of AFFF being utilized in response to a crash or fire. However, it is likely that AFFF was also made available for use during takeoff and landing procedures historically and it was historical common practice to conduct AFFF nozzle testing to prepare for potential fuel-based fire response at the area of staging.	Transferred outside of Federal Government
