# **Final Supplemental Site Inspection Report for Per- and Polyfluoroalkyl Substances (PFAS)**

**Former Sudbury Training Annex,  
Areas of Contamination A9 and P13  
Former Fort Devens Army Installation  
Sudbury, Massachusetts**

July 2023

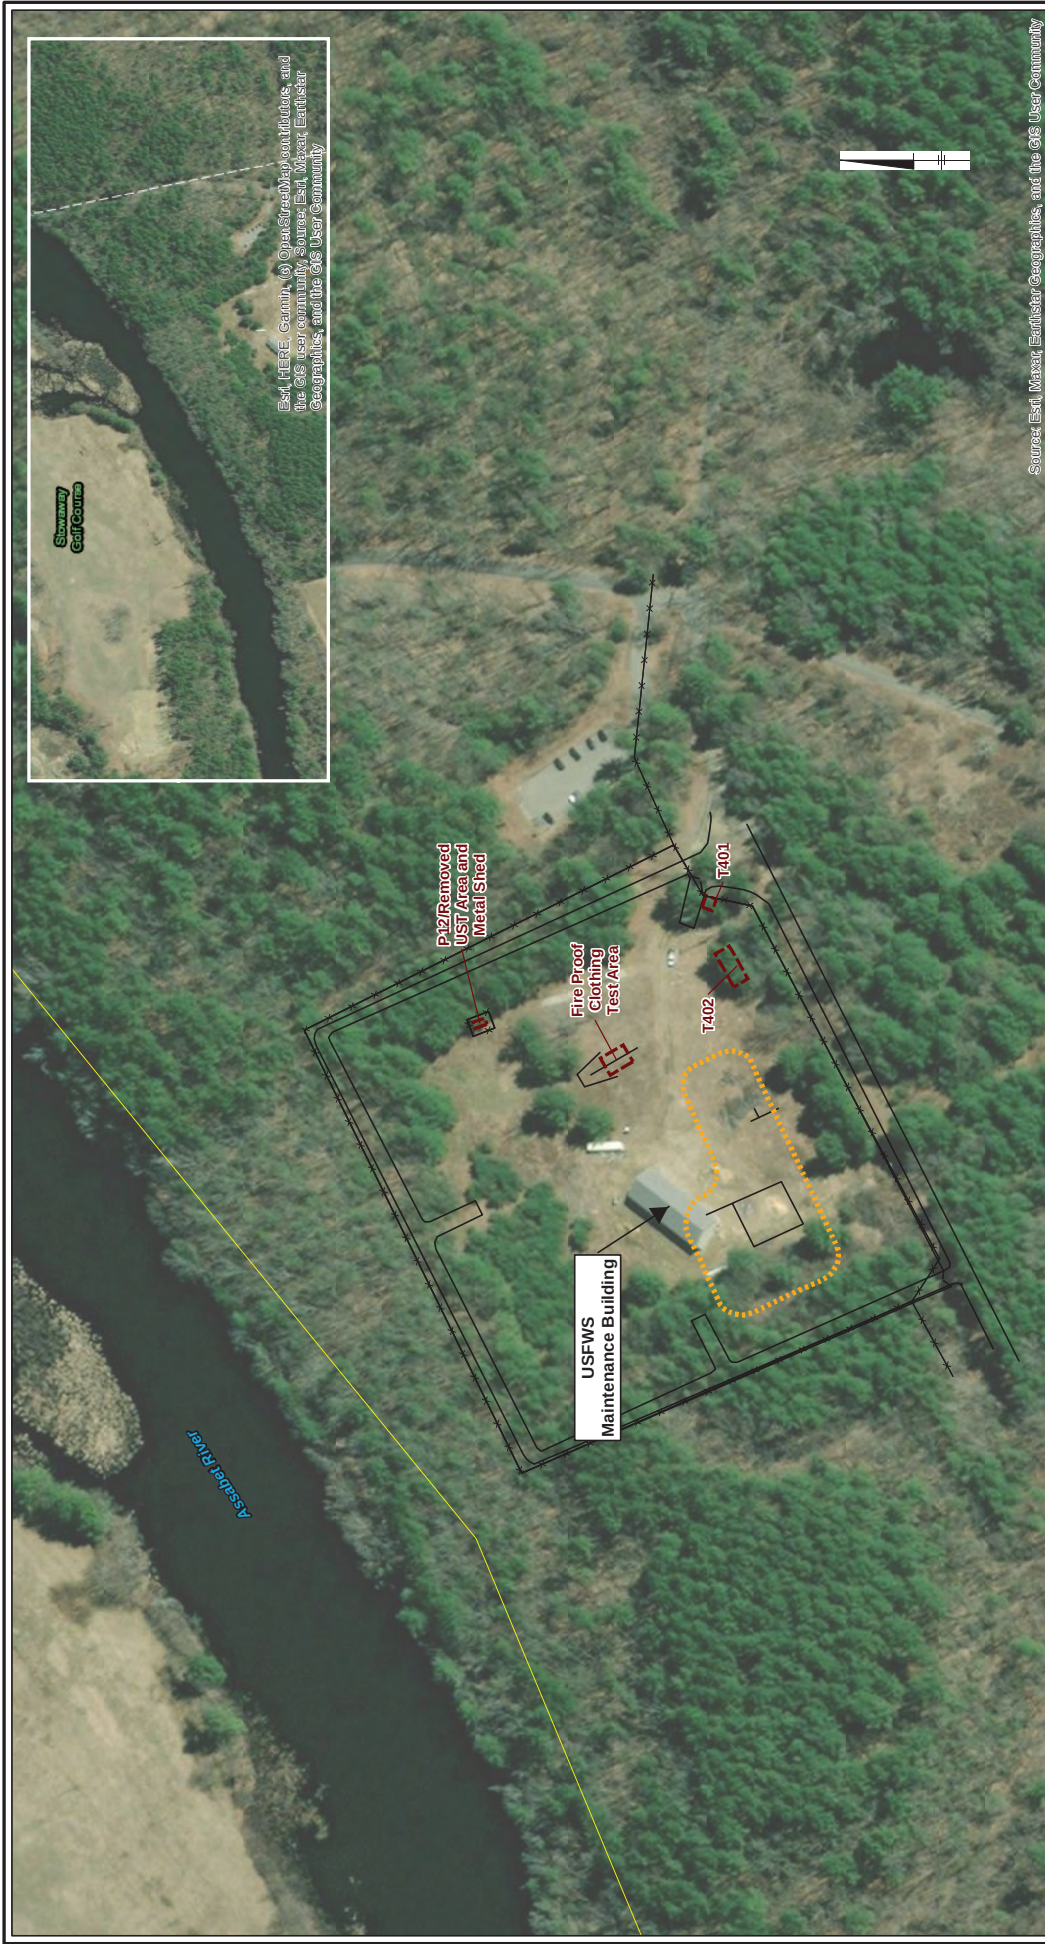
**FIGURE 2-1**

MFA activities included the construction and use of two fire pits and several trenches (referred to as the "Fire Pit Area" or POL Burn area for firefighting training (**Figure 2-1**). Supporting facilities included at least one above-ground storage tank (AST) and storage drums. One fire pit was approximately 20 feet long by 20 feet wide and no more than 2 feet deep, with a 1- to 1.5-foot-high berm composed of soil and cinder blocks that surrounded it. The bottom of the pit was unlined. During firefighting training exercises, this pit was filled with approximately six inches of water topped off with virgin fuel oil and ignited (OHM 1995a). When fuel oil costs began to rise, MFA utilized watered-down JP-4 jet fuel with MassDEP permission. The second pit used for training consisted of two 10- to 15-foot long trenches in the shape of a "T". These trenches were 18 to 24-inches wide, approximately 24-inches deep, unlined, and were used for fire suppression/flashback training. Later, the "T" was backfilled and replaced with a "Z" configuration in the same area. The usual practice was for the flammable fluid provider to deliver material one to two days ahead of the training exercise. Fuel was placed in a tank and into the waterfilled pits. The water was obtained from a hydrant near AOC A9 (OHM 1995a).

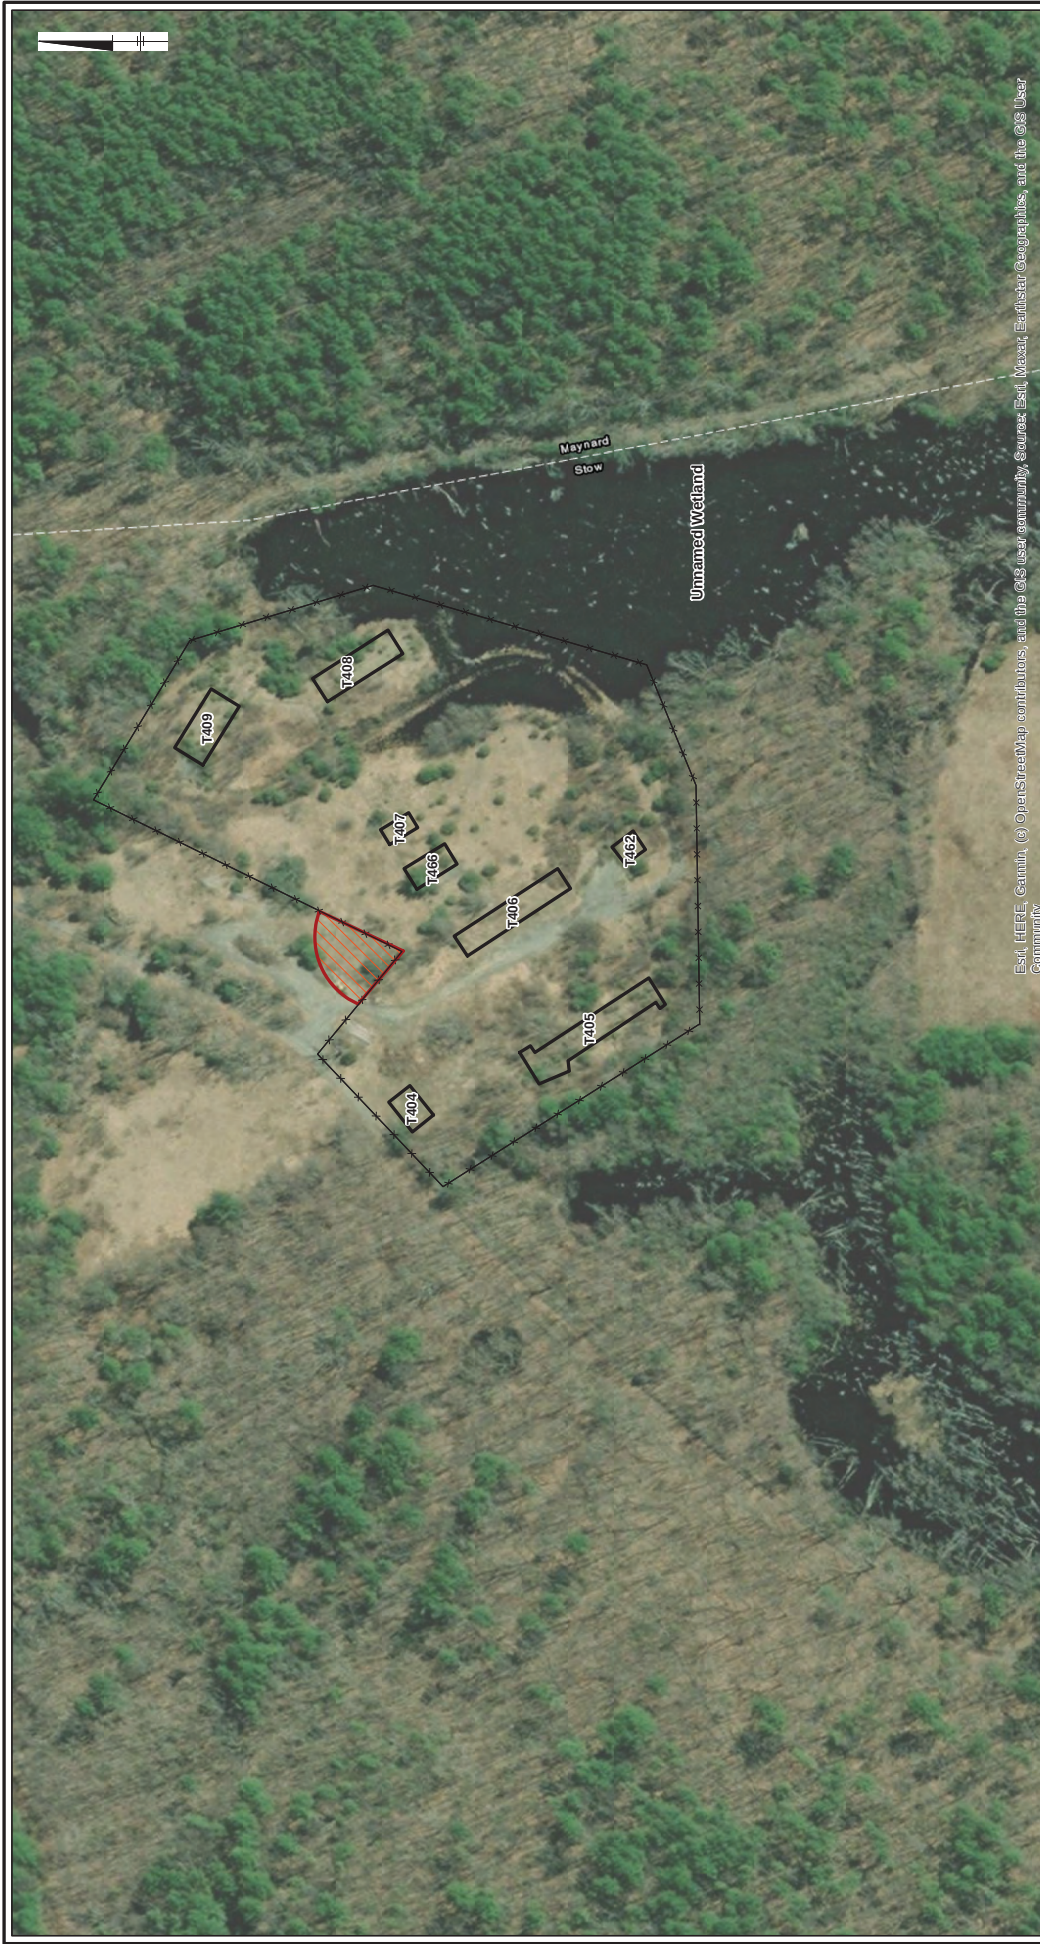
AOC P13 reportedly was not used by MFA for chemical fire training or storage (OHM 1994). Car fire and flammable liquid fire training were conducted in the parking area (Former Burn Pad) at the entrance of AOC P13 (**Figure 2-2**).

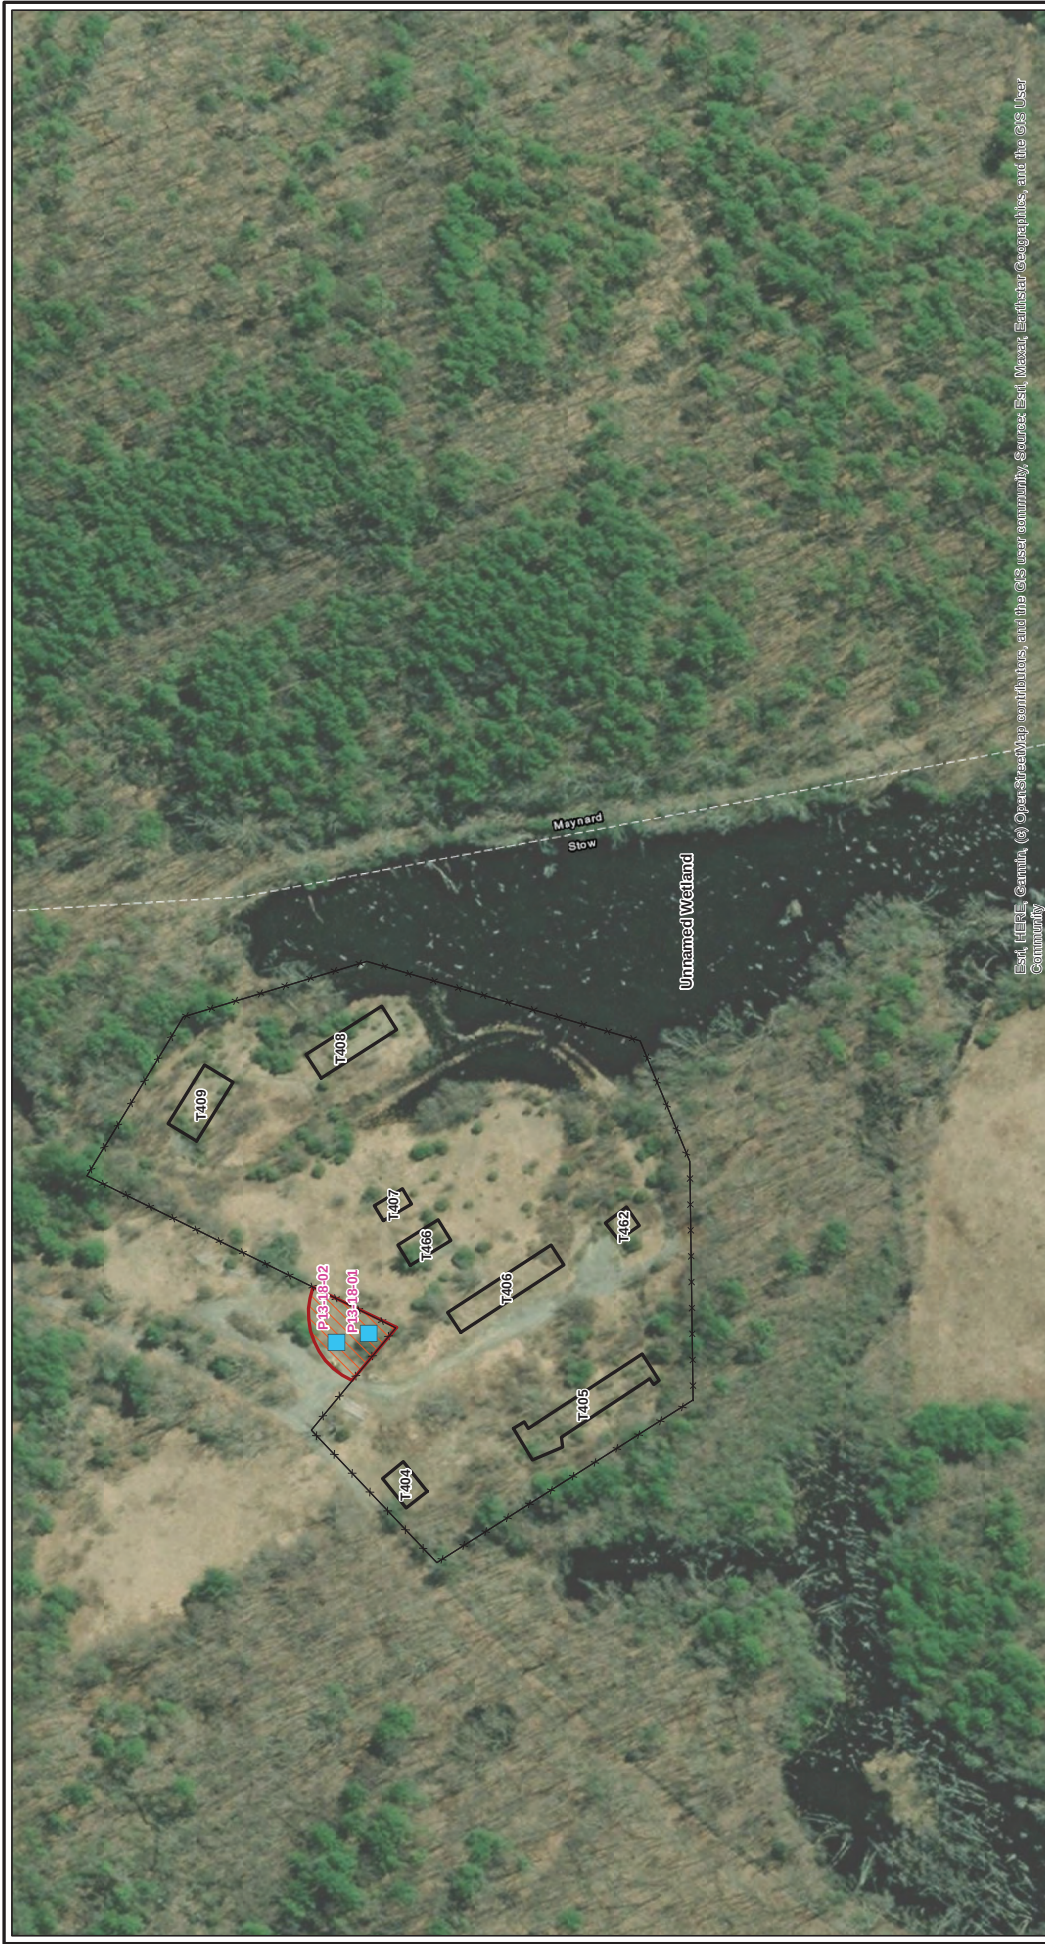
| 8SERIES<br>ARCADIS | FIGURE<br><b>5-2</b> |

| <b>AOC P13 Soil Sample Results</b> | |
