**SITE INSPECTION REPORT FOR PER- AND
POLYFLUOROALKYL SUBSTANCES AT
FORT BENJAMIN HARRISON,
LAWRENCE TOWNSHIP, INDIANA**

Final
October 2023

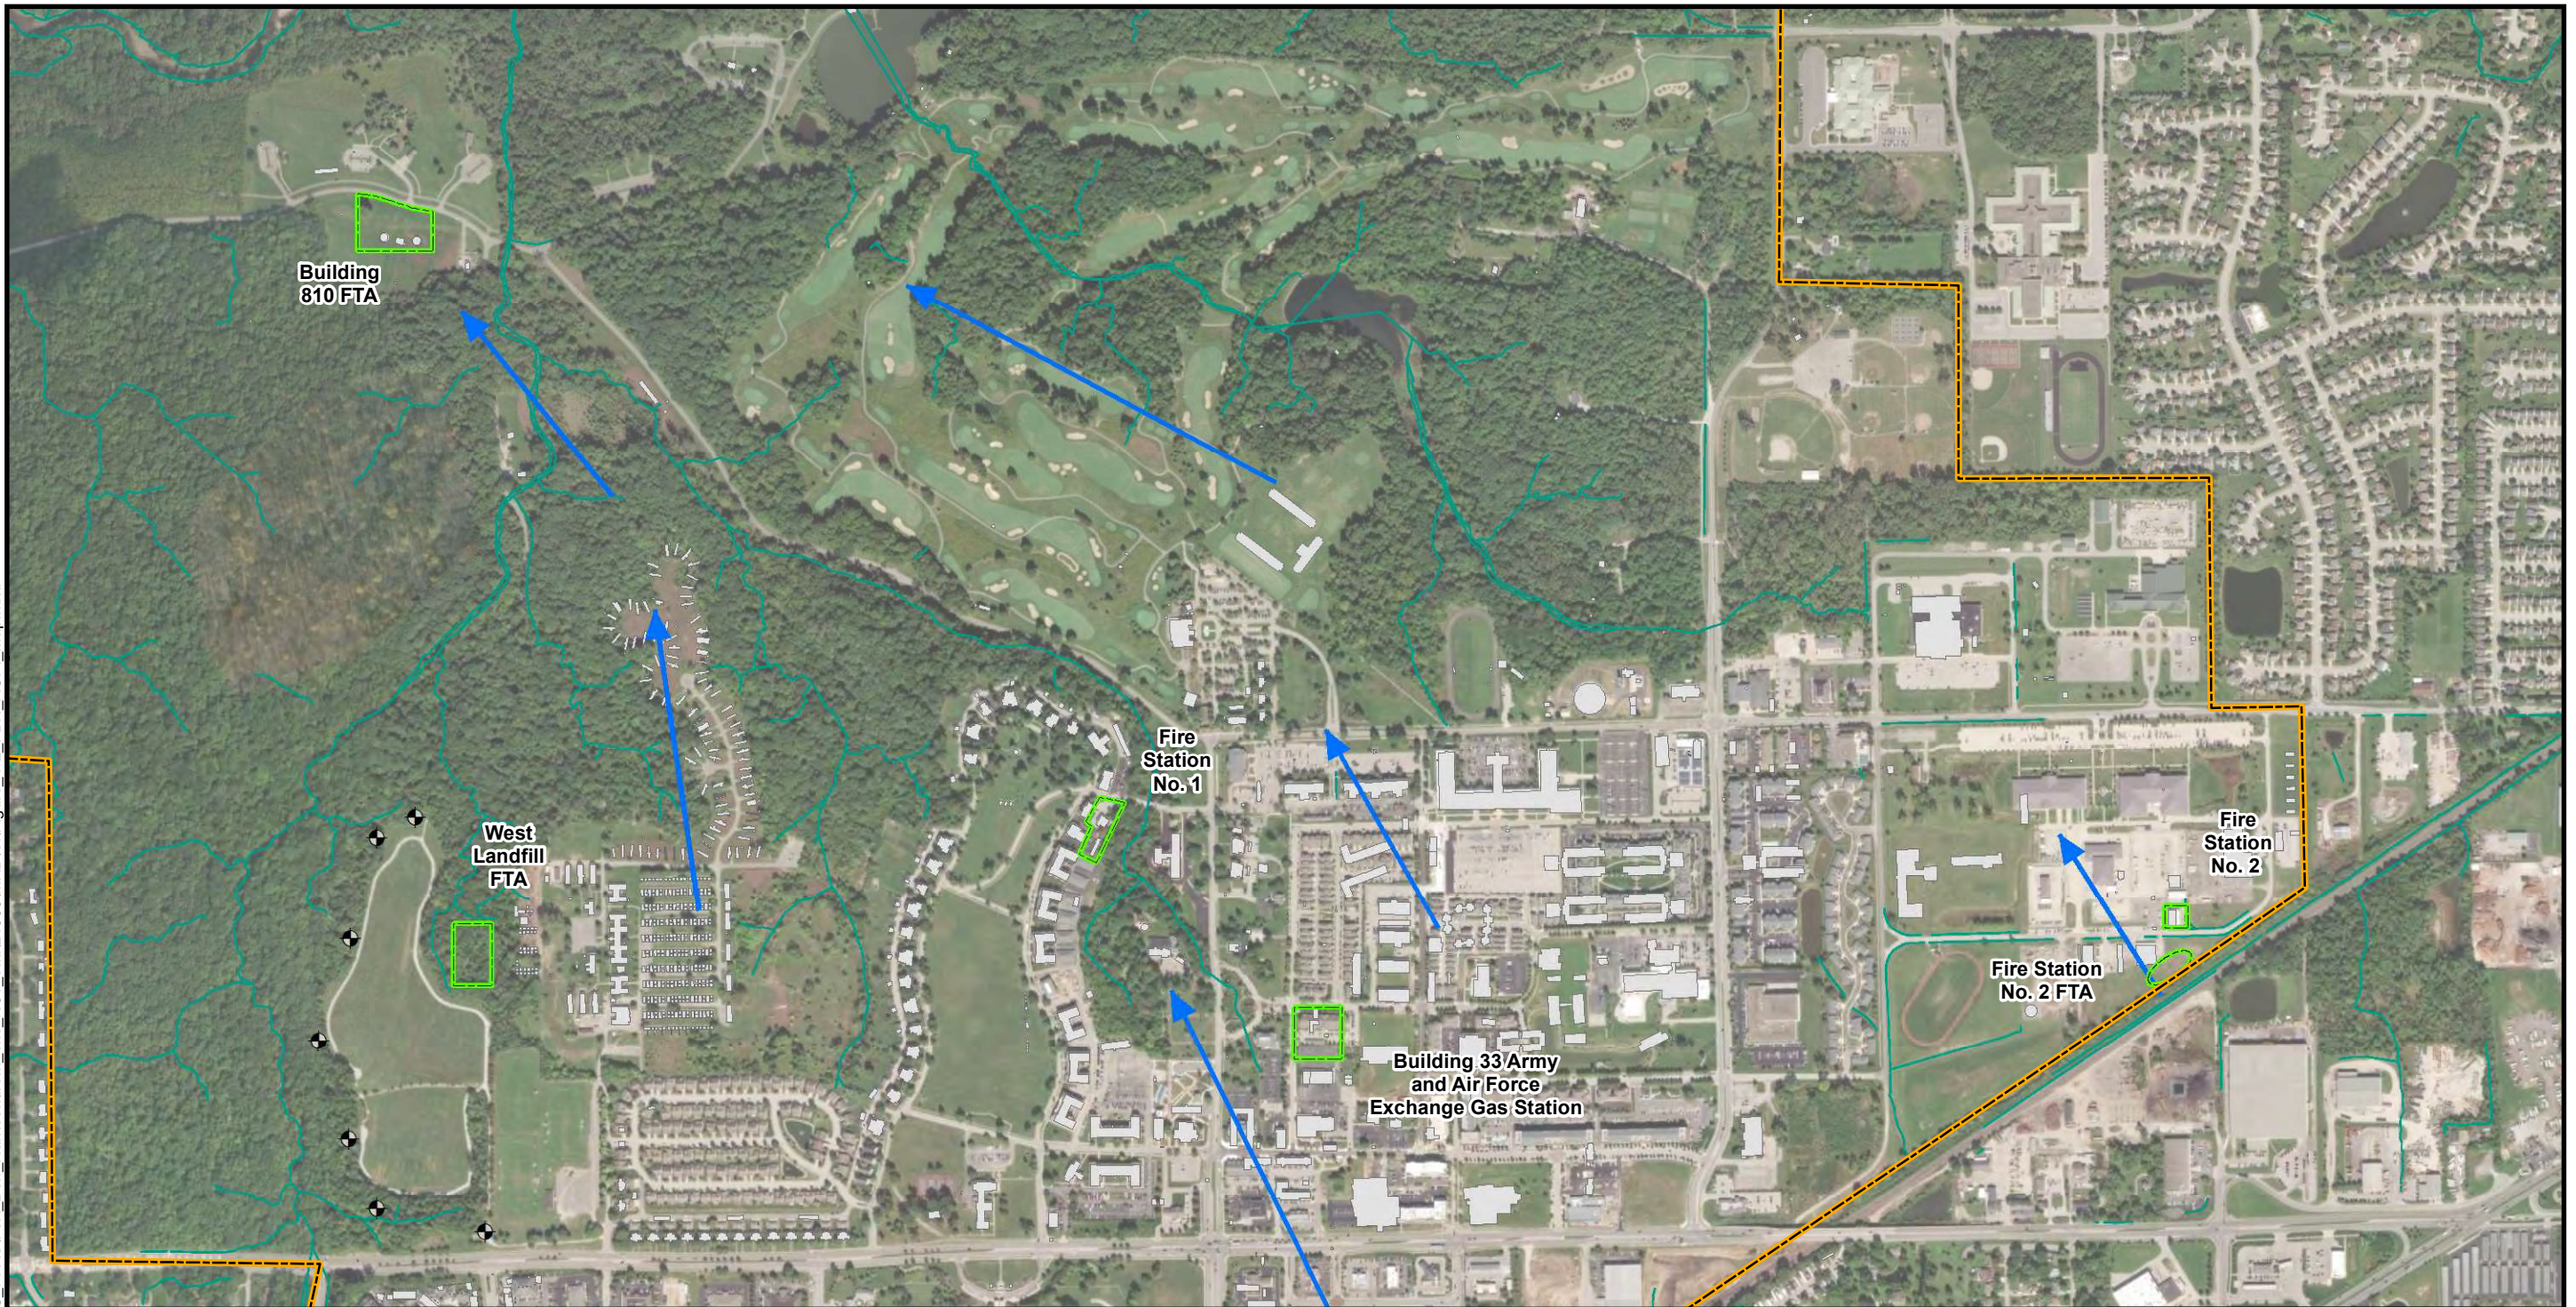
PFAS-containing materials may have previously been stored, used, or disposed of (40 CFR §300.420(b)). The evaluated areas include fire stations, fire training areas (FTAs), landfills, plating operations, wastewater treatment plants (WWTPs), pesticide facilities, vehicle maintenance shops, paint shops, and photographic processing facilities. The FBH PFAS PA recommended six AOPIs for further investigation in an SI due to known or potential historical PFAS-containing material use, storage, or disposal. The AOPIs, as well as the dates of operation and sizes of each area, are presented in Table 1-1 and illustrated in Figure 1-2.

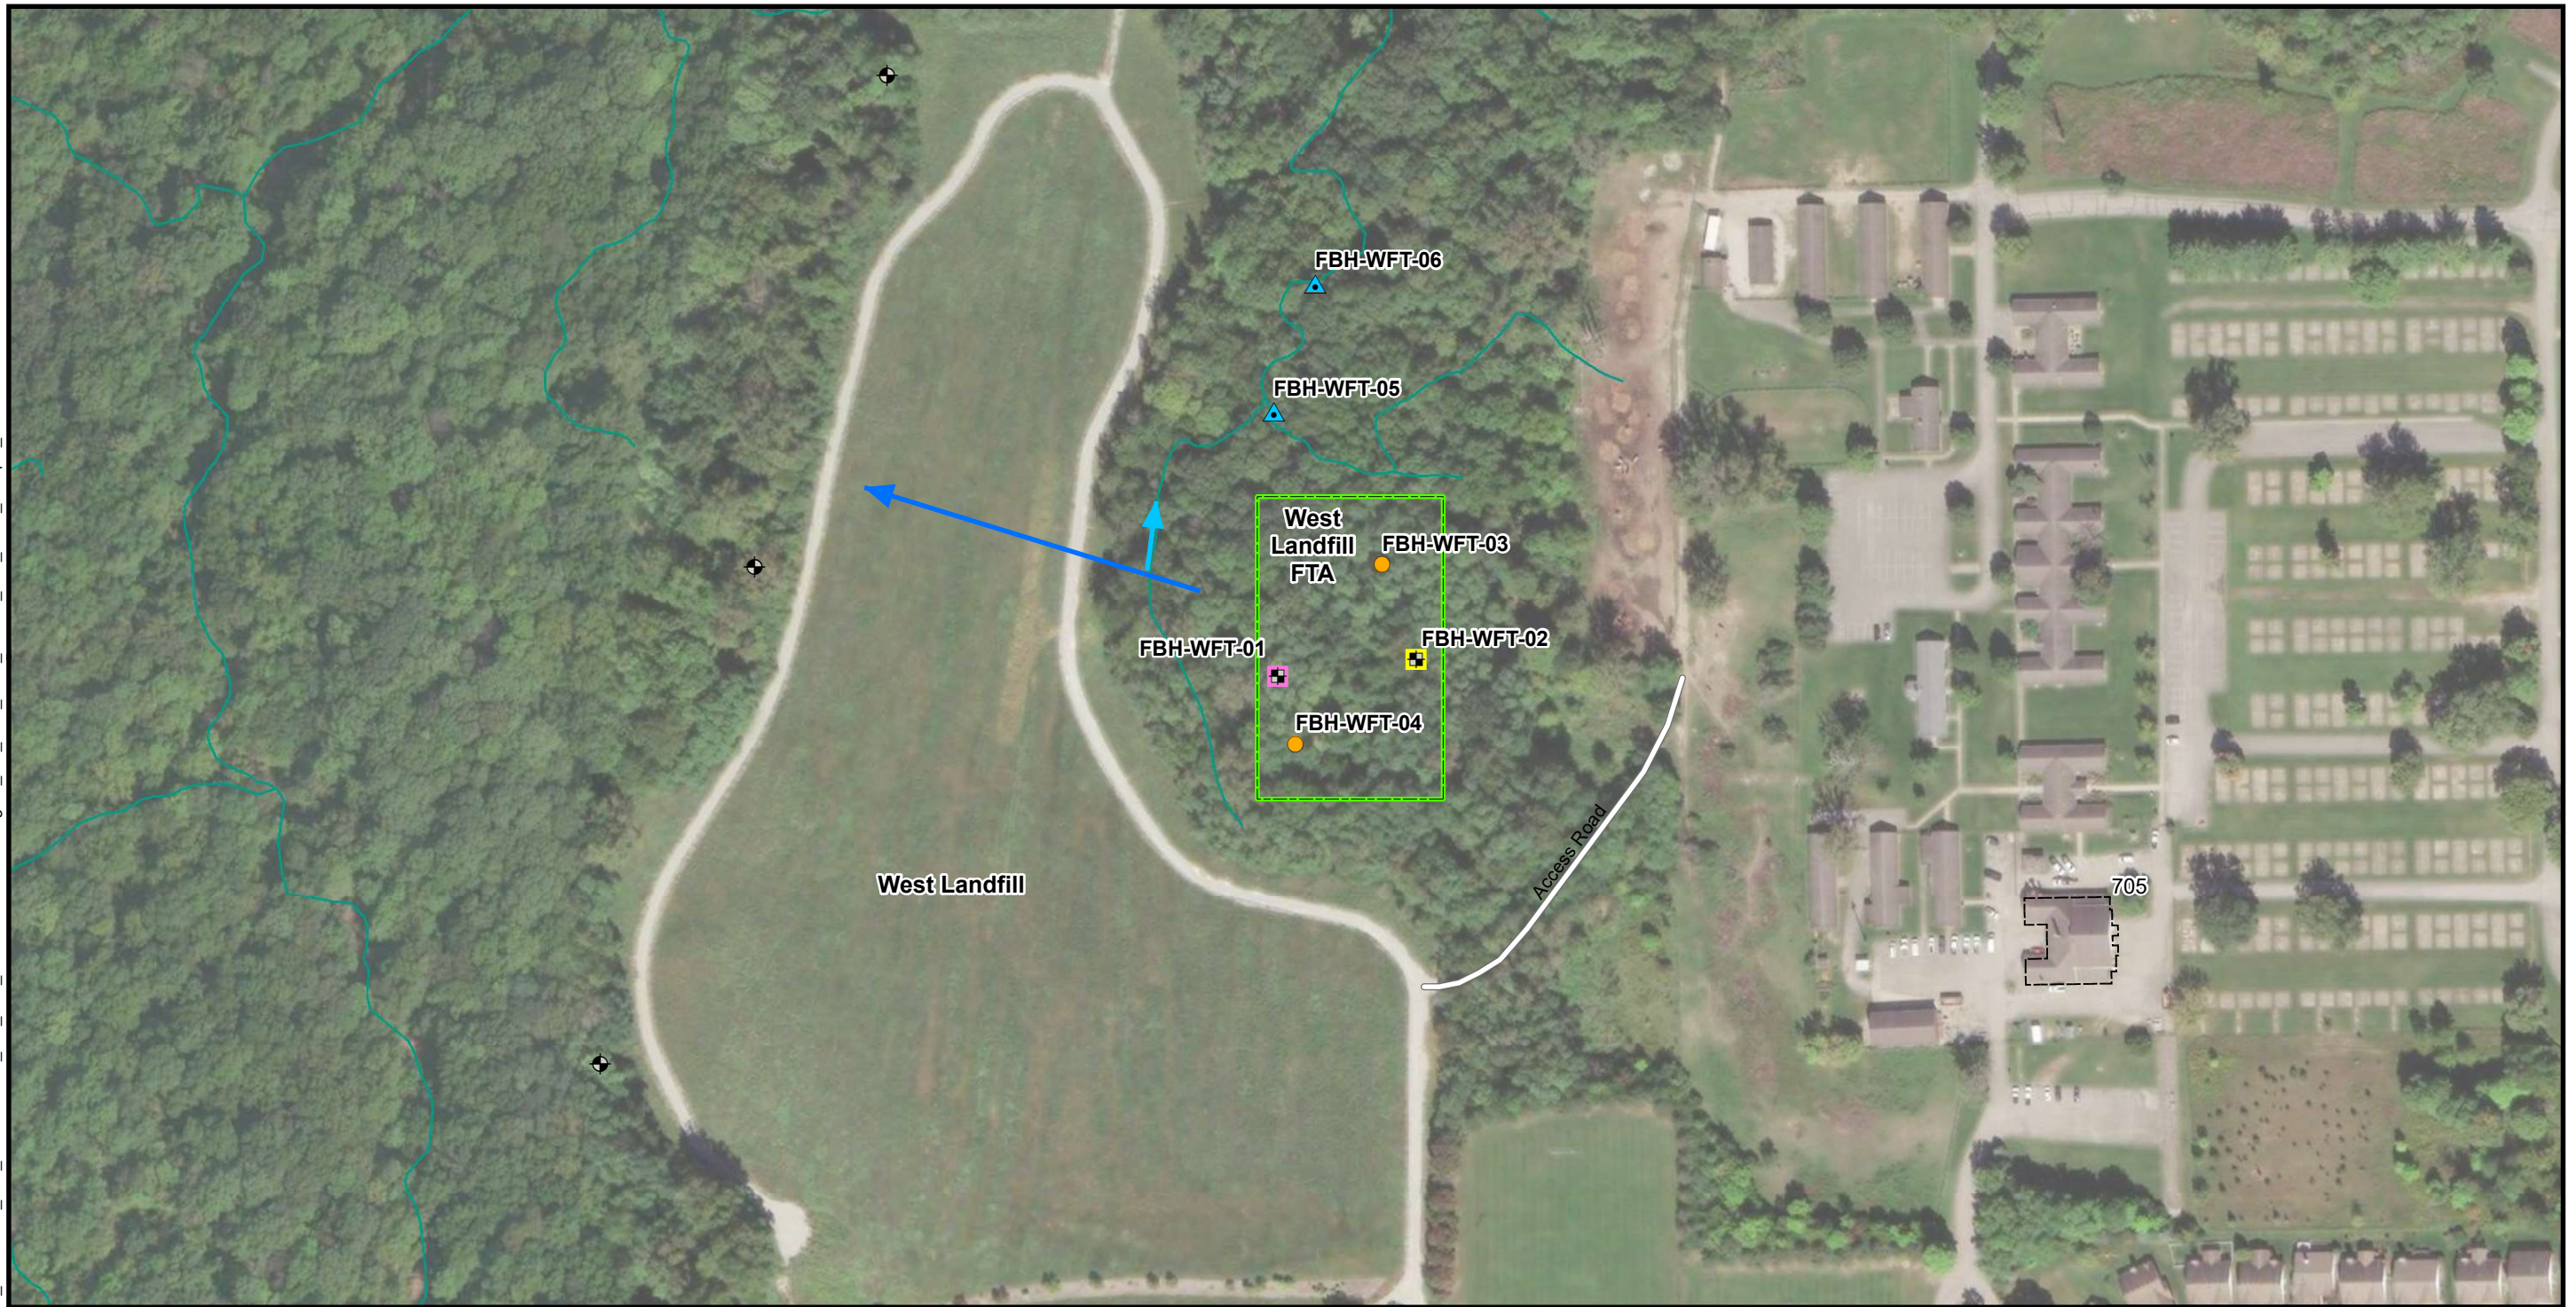
The area of the West Landfill FTA is currently heavily shrubby and wooded. During operation of the West Landfill FTA, the site was a maintained grass and dirt field. Activities consisted of burning 10 to 20 gallons of fuel oil ignited in a large metal trough two or three times per training period with three periods annually. The remaining fuel was recorded to have been allowed to burn off (Weston 1992). It is unknown how the fuel was extinguished; water and/or foam may have been used for fire training activities.

Documented dates of operation are unknown. However, based on the aerial photographic analysis, the area shown in the 1992 U.S. Army Toxic and Hazardous Materials Agency (USATHAMA) Enhanced PA (Weston 1992) correlates with an area on the eastern side of the West Landfill that appears to be cleared of brush and trees from 1941 until the mid-1970s.

Detected concentrations of Target PFAS in soil and groundwater at the West Landfill FTA AOPI were less than the SLs; therefore, further investigation is not recommended at the AOPI. Estimated concentrations of PFOS, PFOA, and PFHxS in surface water exceeded the SLs at one location downstream from the AOPI. Since a PFAS source was not identified at the AOPI, further investigation of a potential upstream source may be warranted.

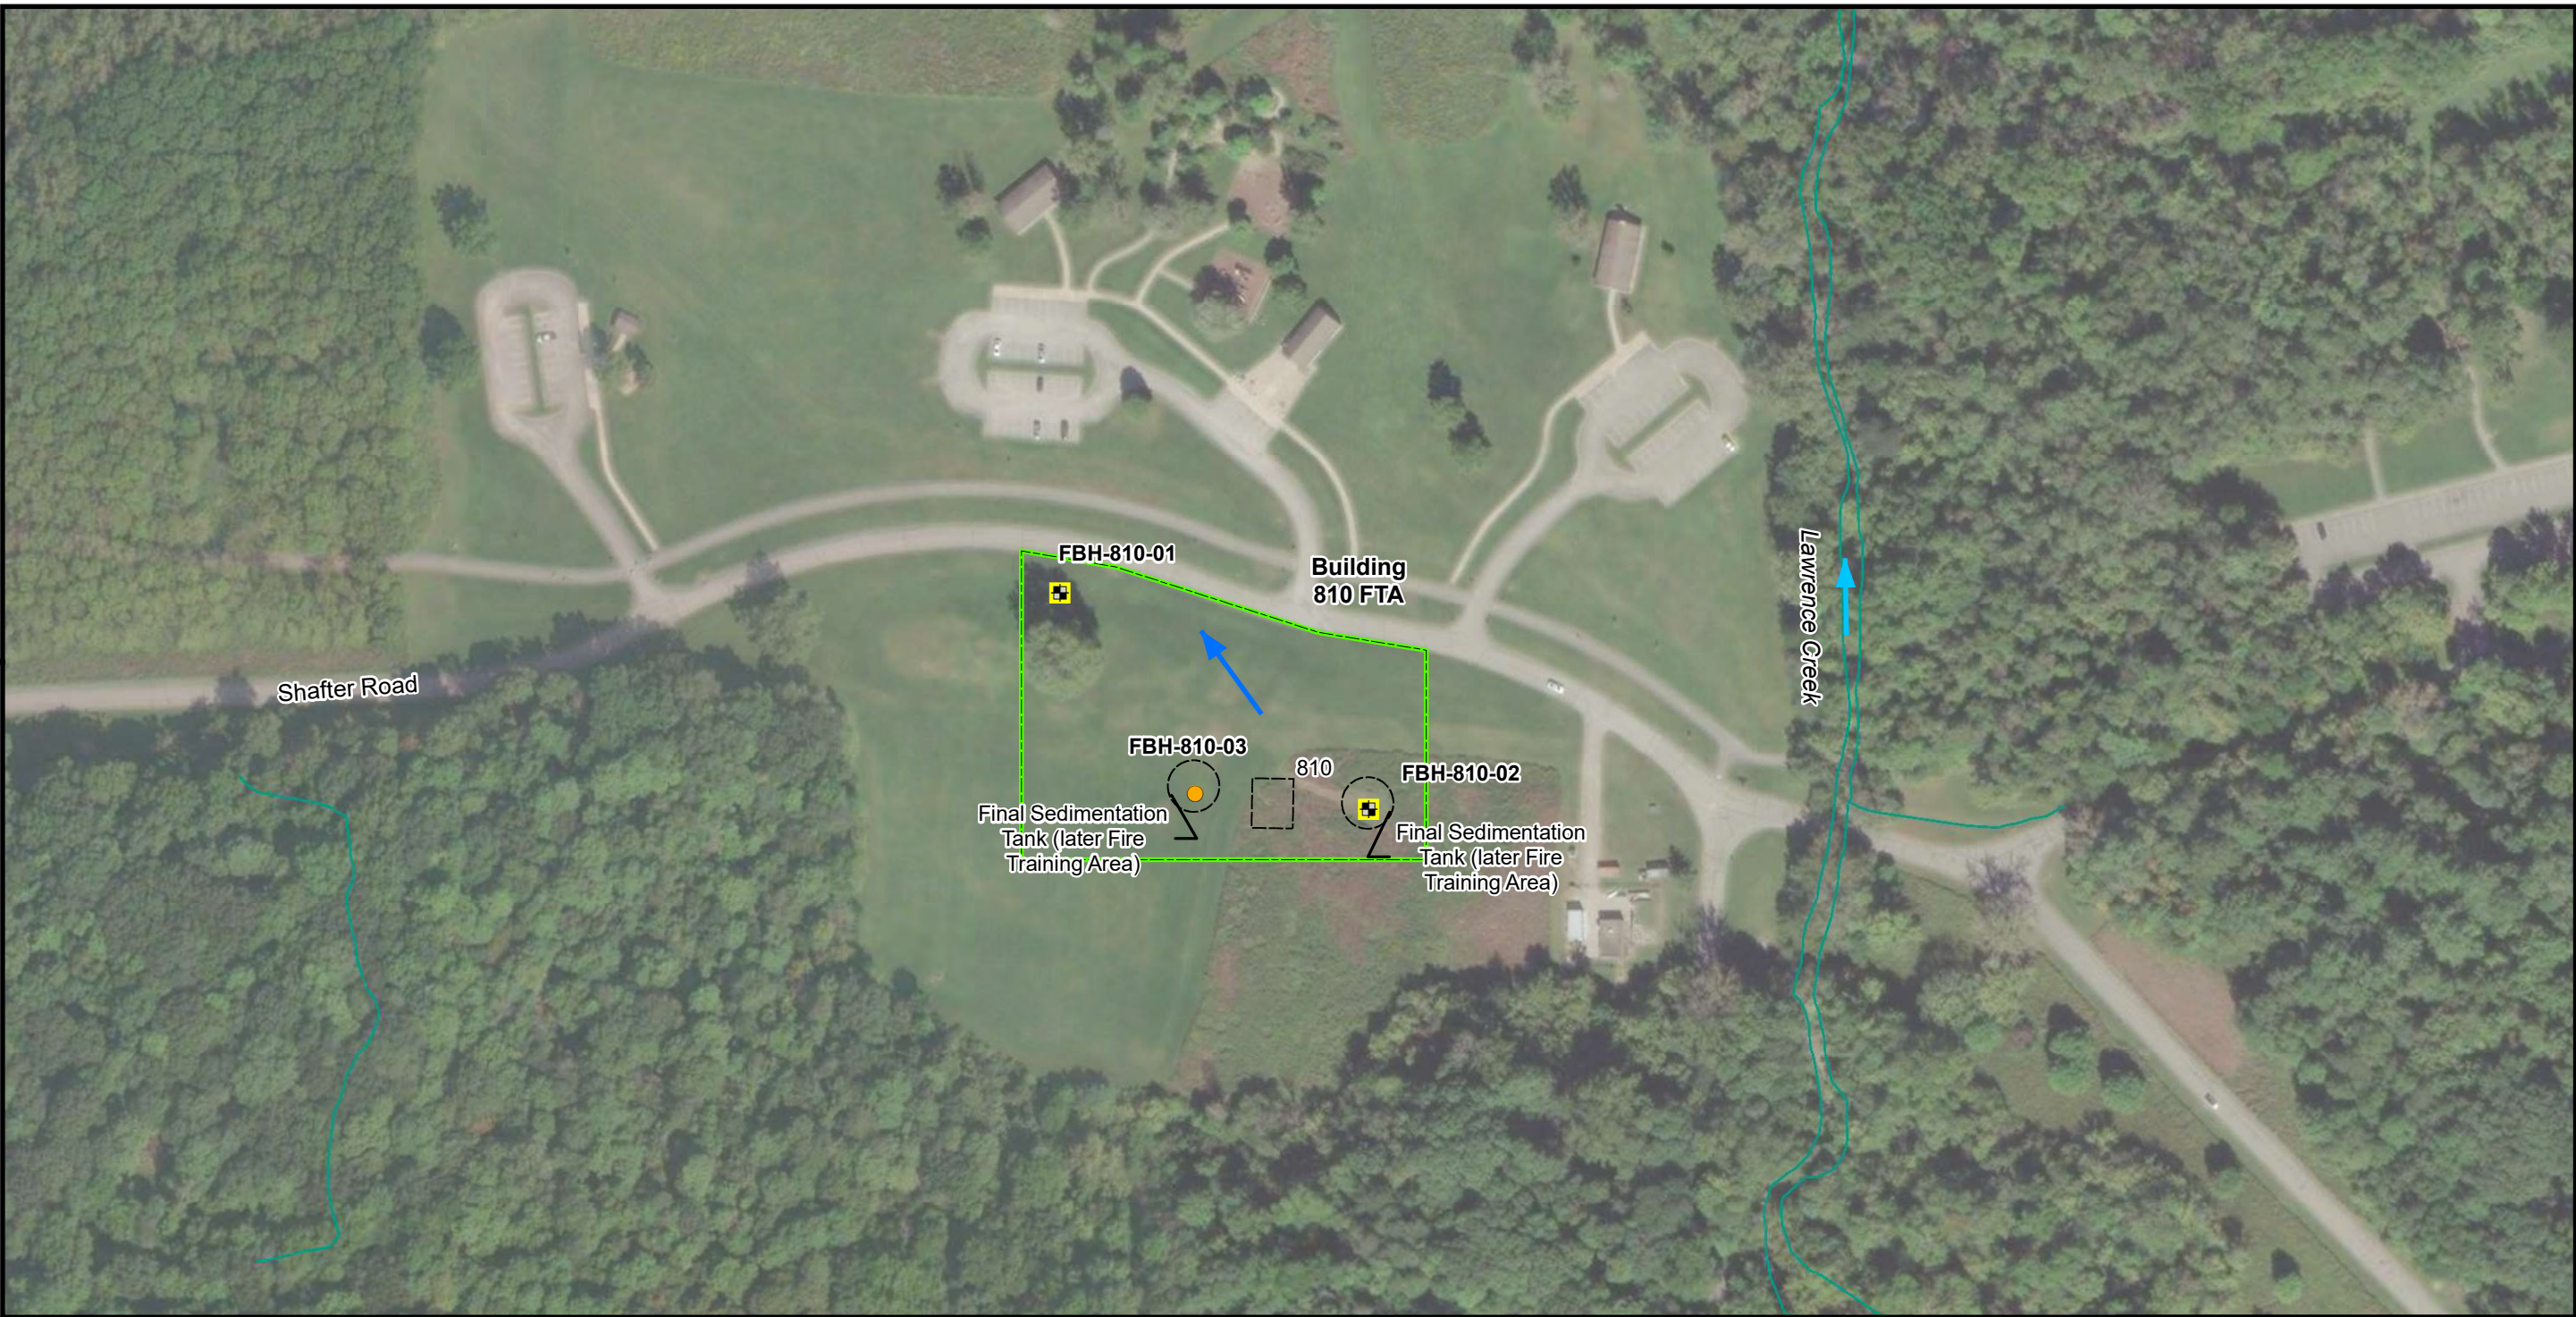
| | | FIGURE 6-4 | DATE: 5/4/2023 |

Fire training exercises were conducted by igniting fuel on old car bodies or in 55-gallon drum halves partially filled with water, which were placed on top of the old treatment tanks. According to site personnel interviews conducted during the 1992 USATHAMA Enhanced PA (Weston 1992), the fuel was consumed during burning and little to no drainage of fuel from the area occurred. It is unknown how the fuel was extinguished, and water and/or foam may have been used for fire training activities.

Detected (estimated) concentrations of Target PFAS in subsurface soil and groundwater samples at the Building 810 FTA AOPI exceed the SLs; therefore, further investigation is recommended.

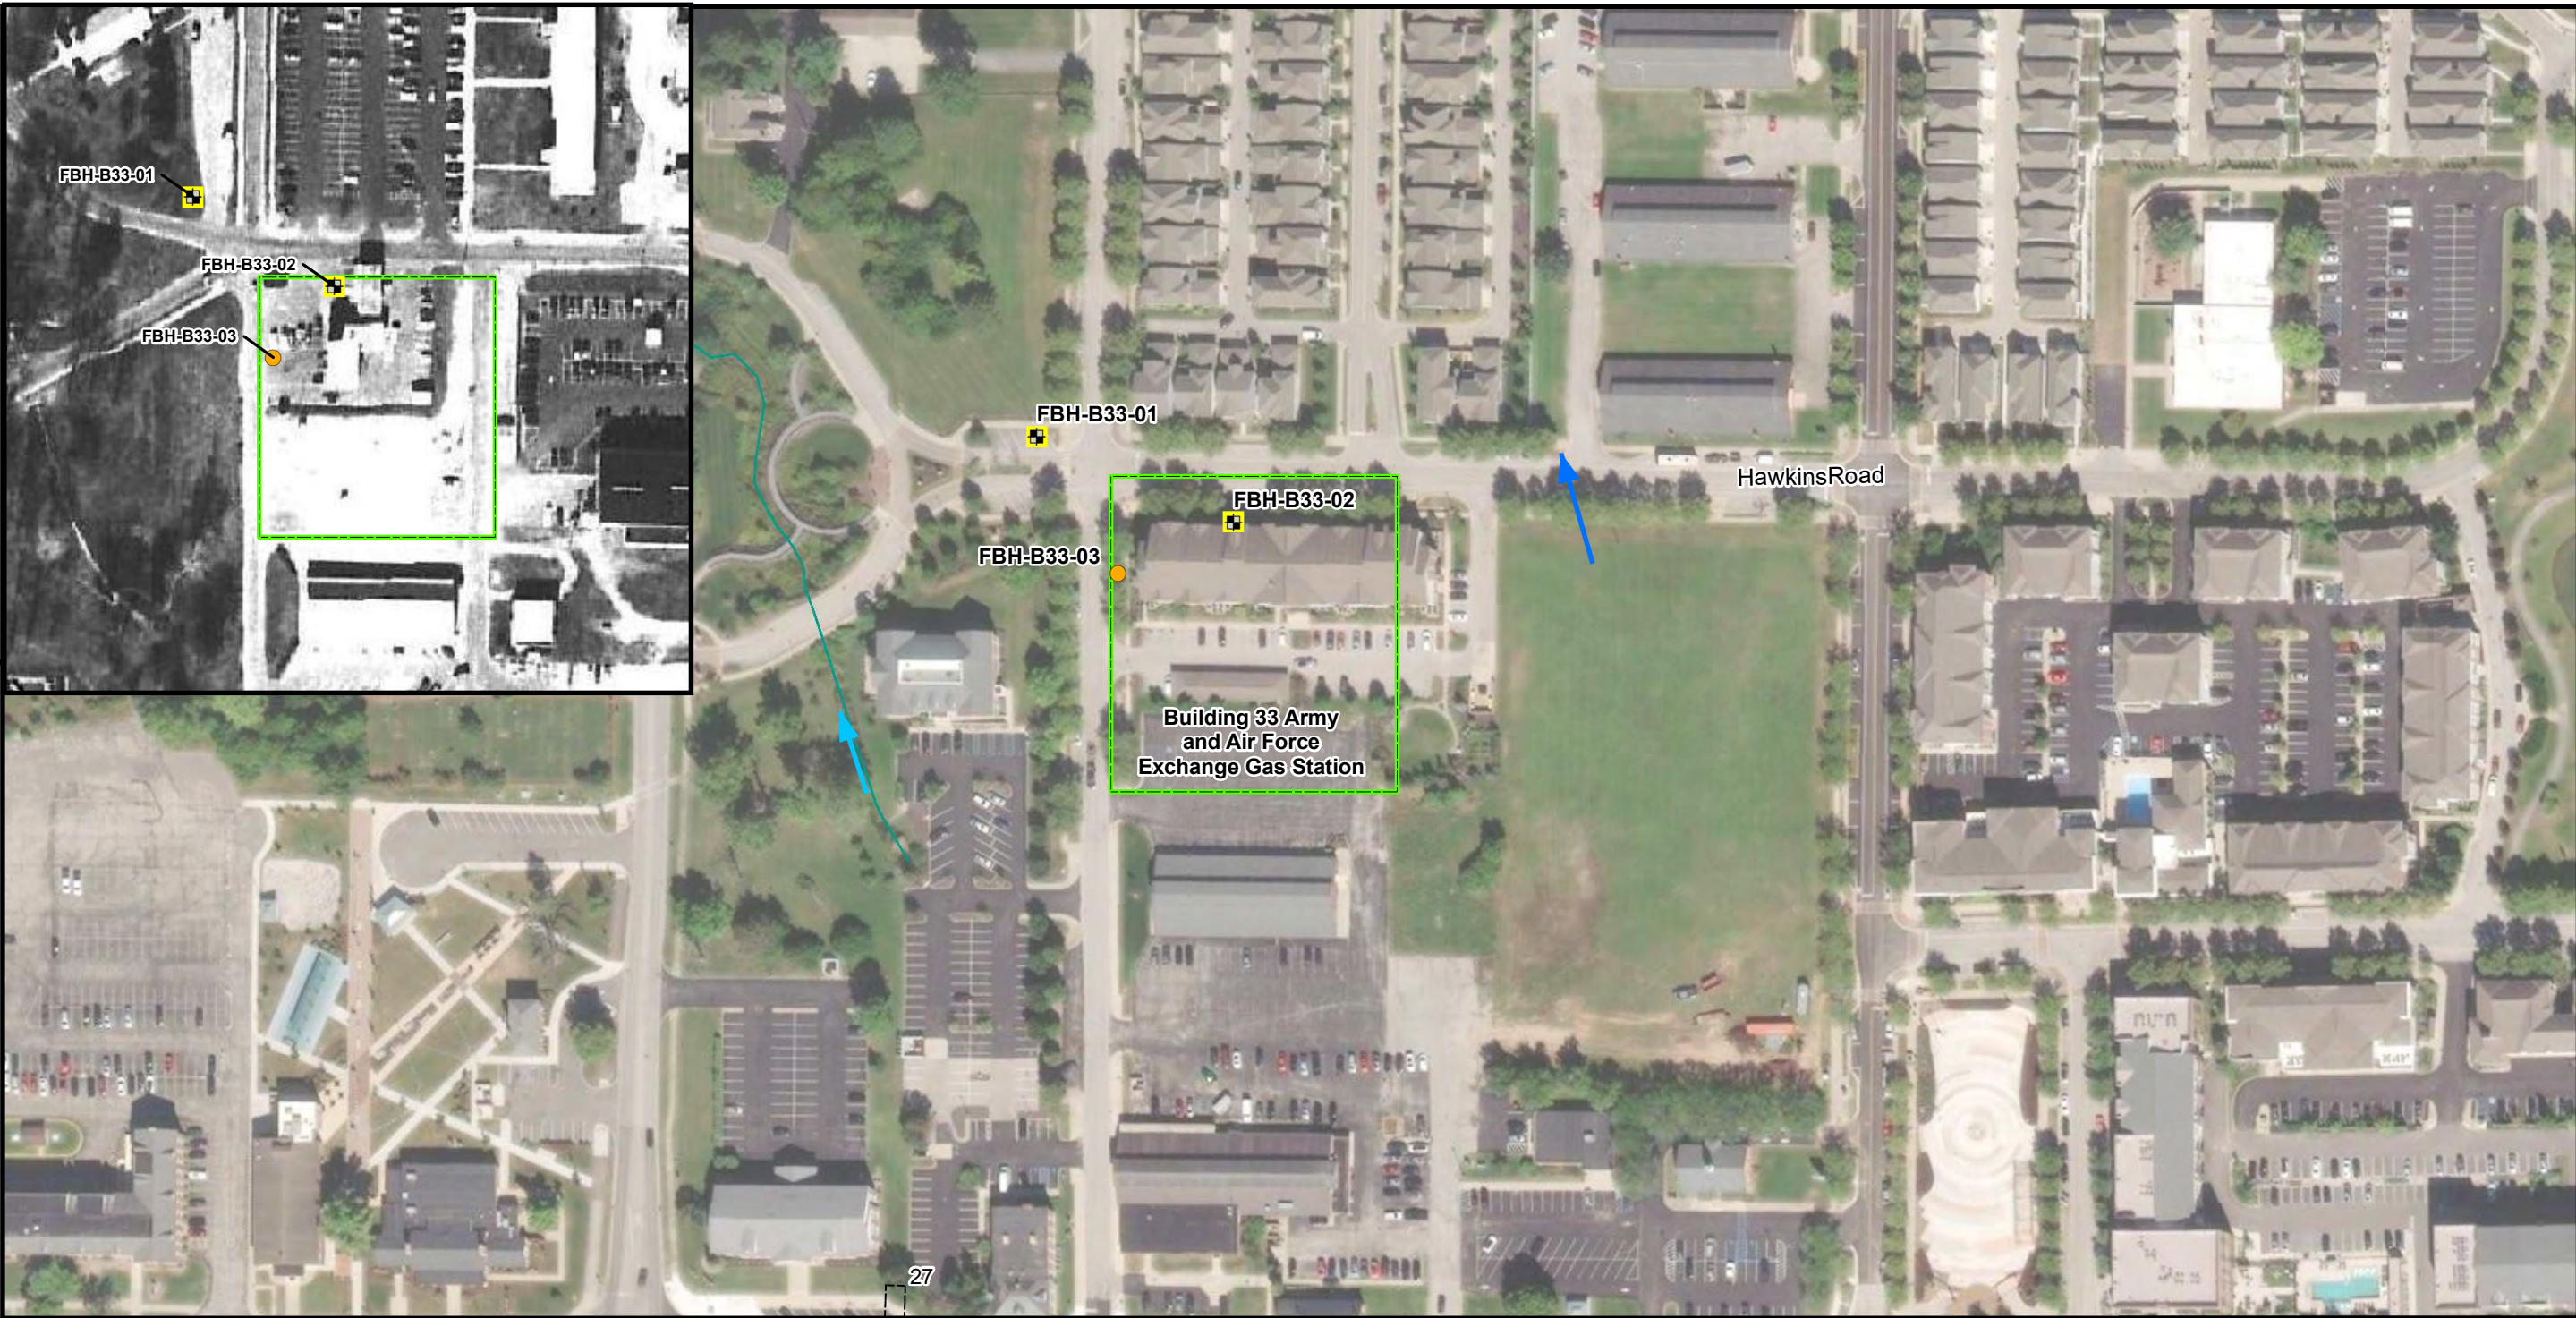
FIGURE 6-7
DATE: 5/5/2023

During use as a gas station, several spills were documented at the facility. Two gasoline spills, one on August 5, 1979, and the second on October 25, 1979, released 15 and 10 gallons of gasoline, respectively, due to a failure of the float vent valve on the vapor recovery system. At the direction of the FBH Fire Department, the areas of the spills were flushed. On November 5, 1988, foam was applied to a gasoline spill at the Building 33 Gas Station and runoff from the road was diked with sand. Spill Recovery of Indiana conducted the cleanup, and an estimated 100 gallons were recovered (Weston 1992, Sverdrup 1997). On December 6, 1988, a fuel line was broken during digging operations, releasing 20 to 50 gallons of gasoline. Sand was dumped for diking purposes, the FBH Fire Department applied foam as a precaution, and all material was recovered with a vacuum truck (Sverdrup 1997). It is unknown whether the foam used at the site contained PFAS. The USTs were removed in 1995 as part of installation closure activities, and removal and environmental sampling activities were documented in the Building 33 Closure Report (Sverdrup 1997).

Detected concentrations of Target PFAS in both groundwater samples at the Building 33 Gas Station AOPI exceed the SLs; therefore, further investigation is recommended.

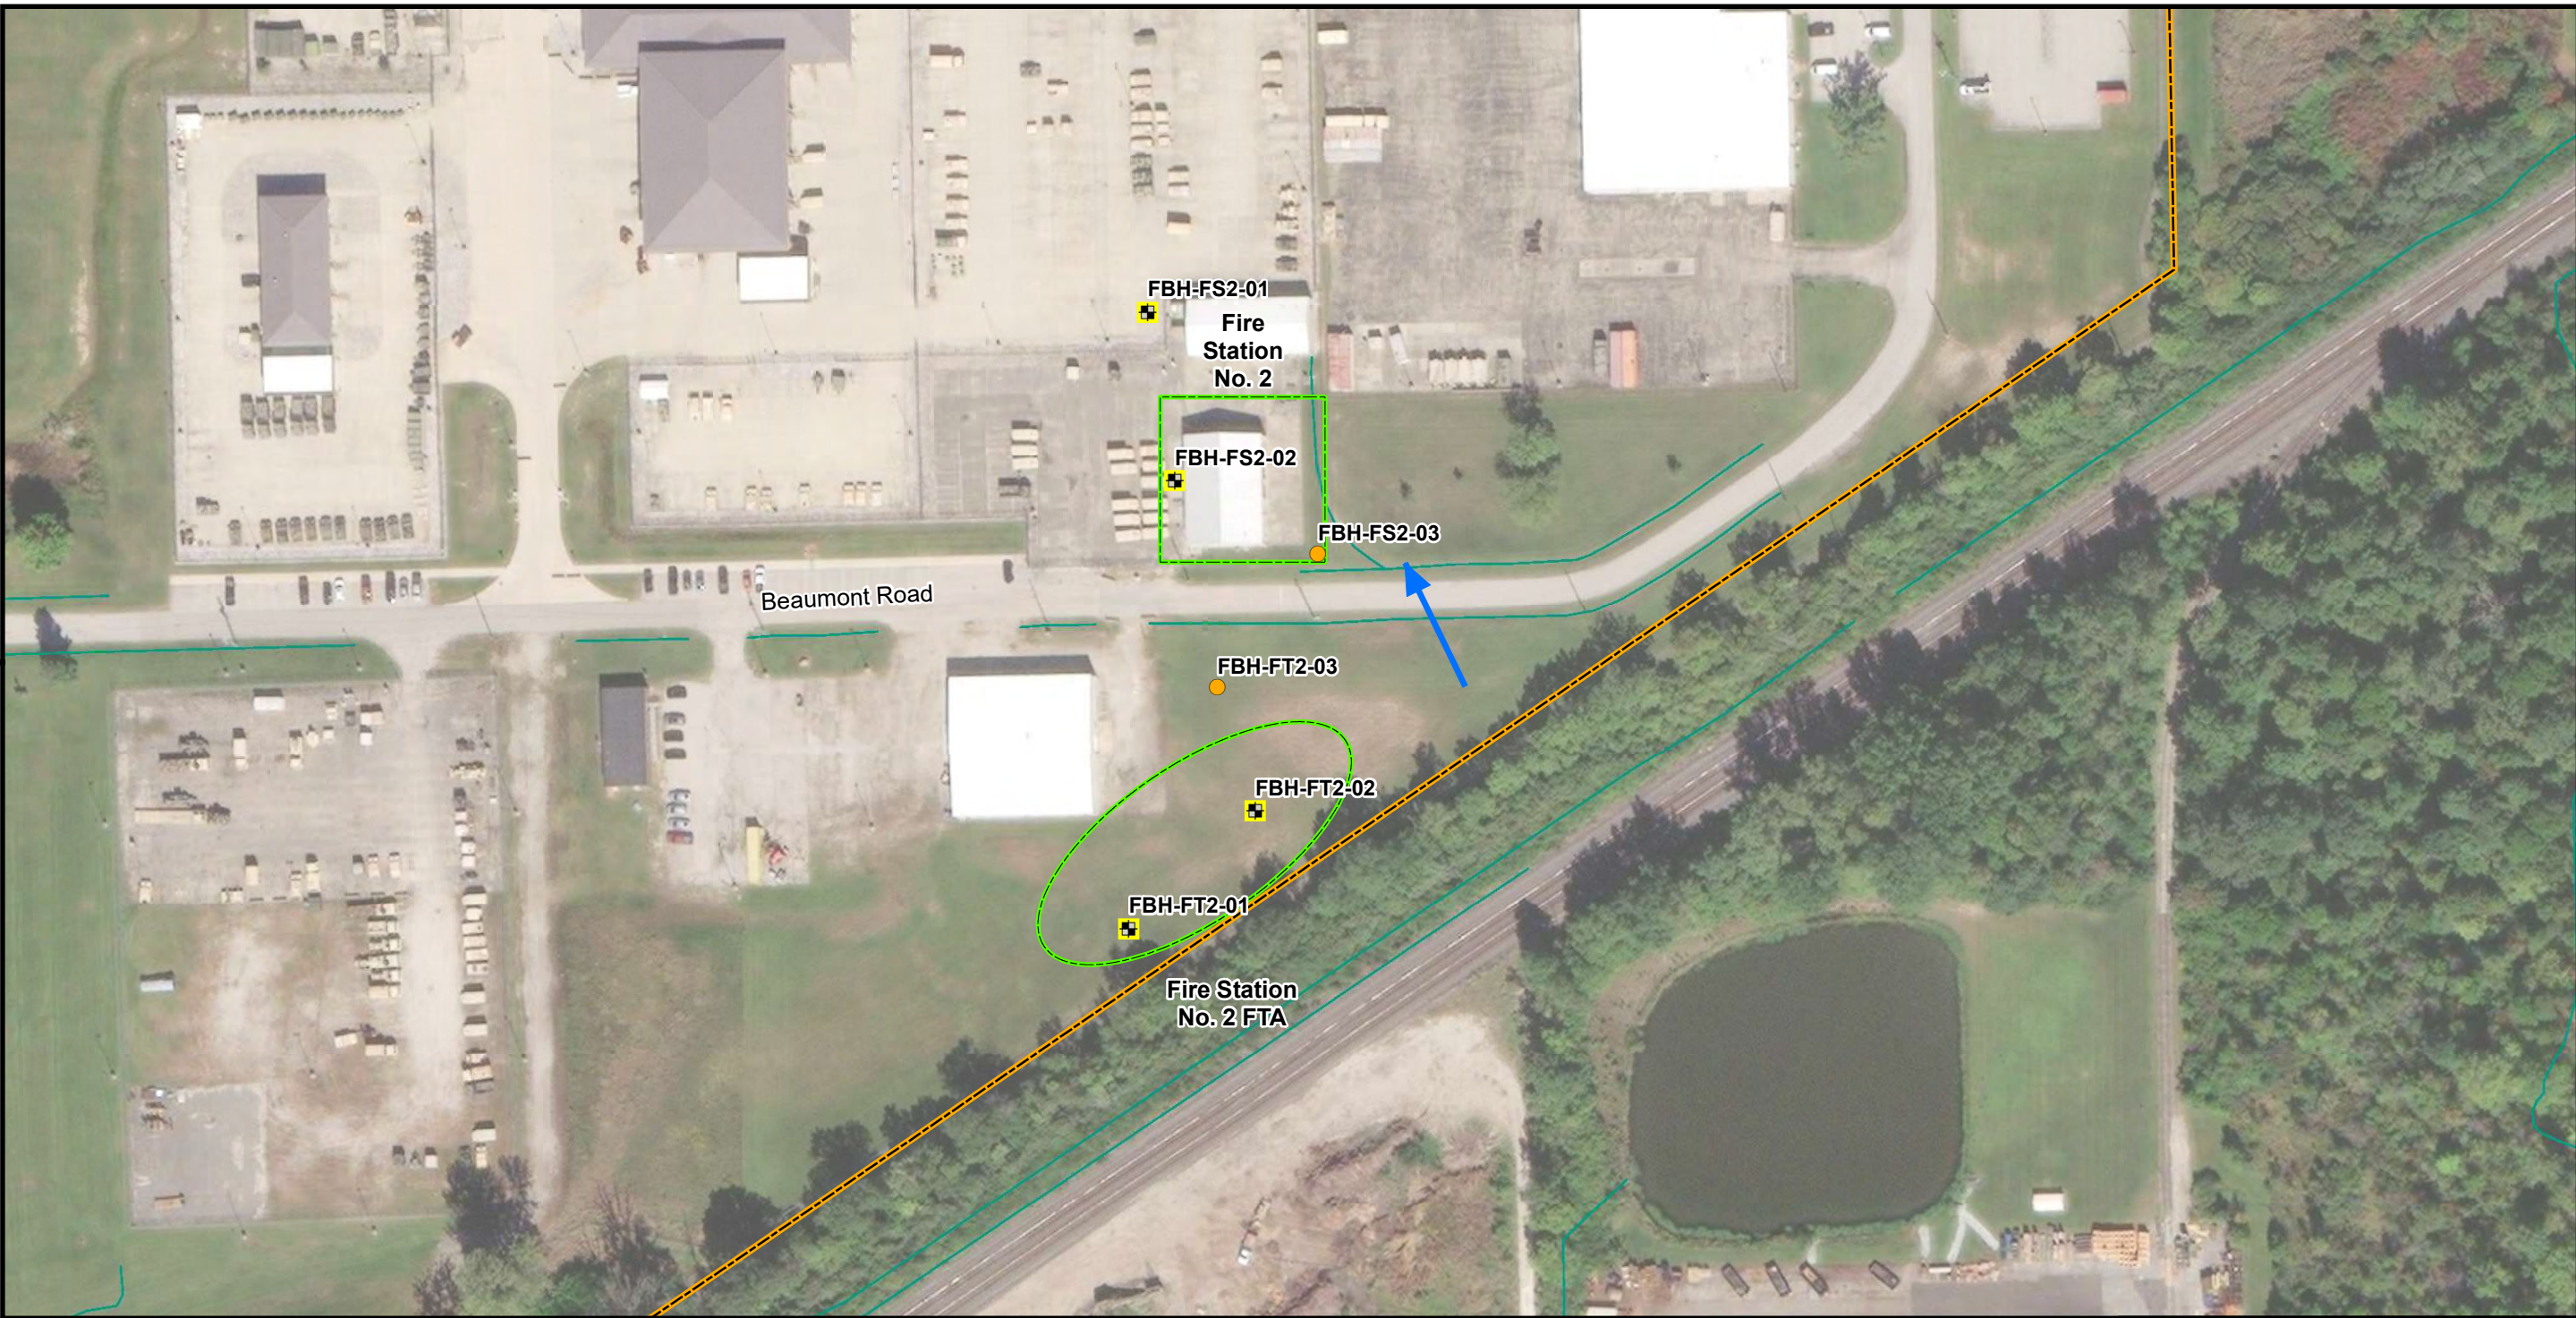
- Legend**
- Streams
 - Localized groundwater flow direction
 - Areas of Potential Interest (AOPI)
 - Installation Boundary
 - DPT Groundwater Sample/Soil Boring (4)
 - Soil Boring (2)

Detected concentrations of Target PFAS in groundwater at the Fire Station No. 2 FTA AOPI exceed the SLs; therefore, further investigation is recommended.
