SUBJECT: Fourth Five-Year Review Final Report for Tipton Airfield Parcel

Please find enclosed the electronic copy of the *Fourth Five-Year Review Final Report for the Tipton Airfield Parcel; Fort George G. Meade; Anne Arundel County, Maryland for your document repository files.*

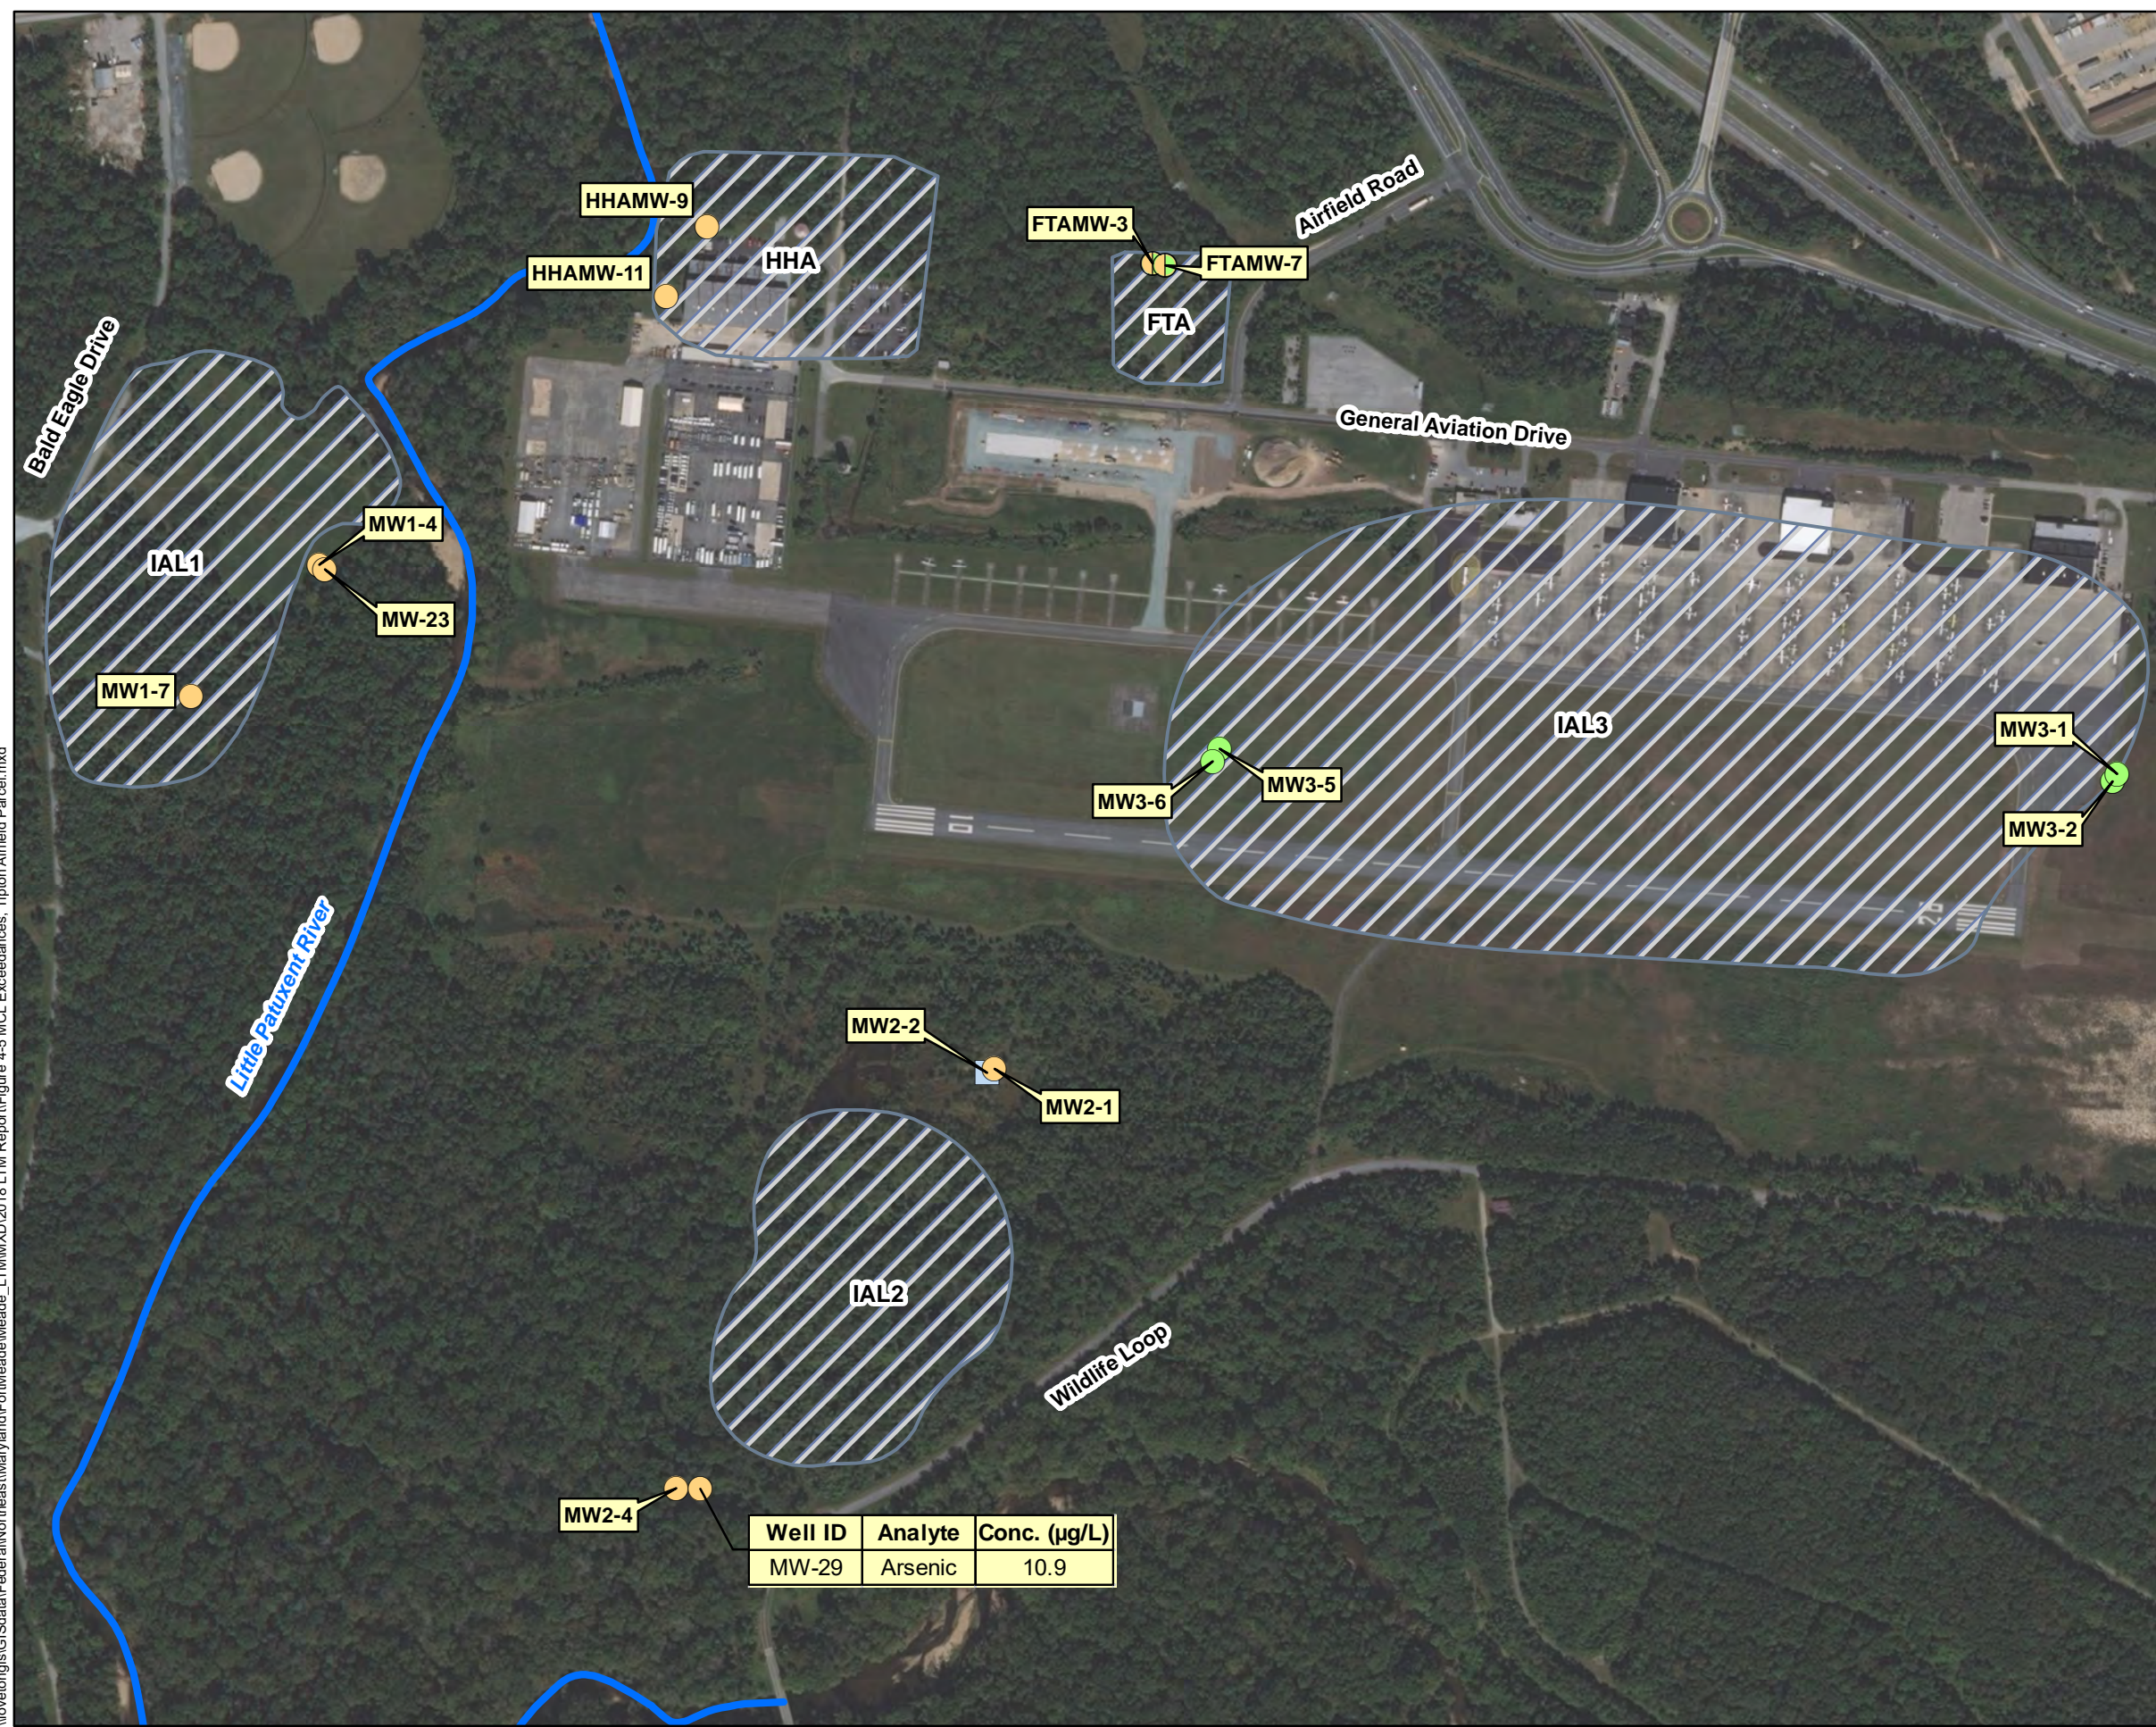
**FIGURE 6-1**  
**2018 MCL EXCEEDANCES,**  
**TIPTON AIRFIELD PARCEL**  
 Anne Arundel County, Maryland

Note:  
 Groundwater sampling conducted on 6/19/18  
 HHA = Helicopter Hangar Area  
 FTA = Fire Training Area  
 IAL = Inactive Landfill

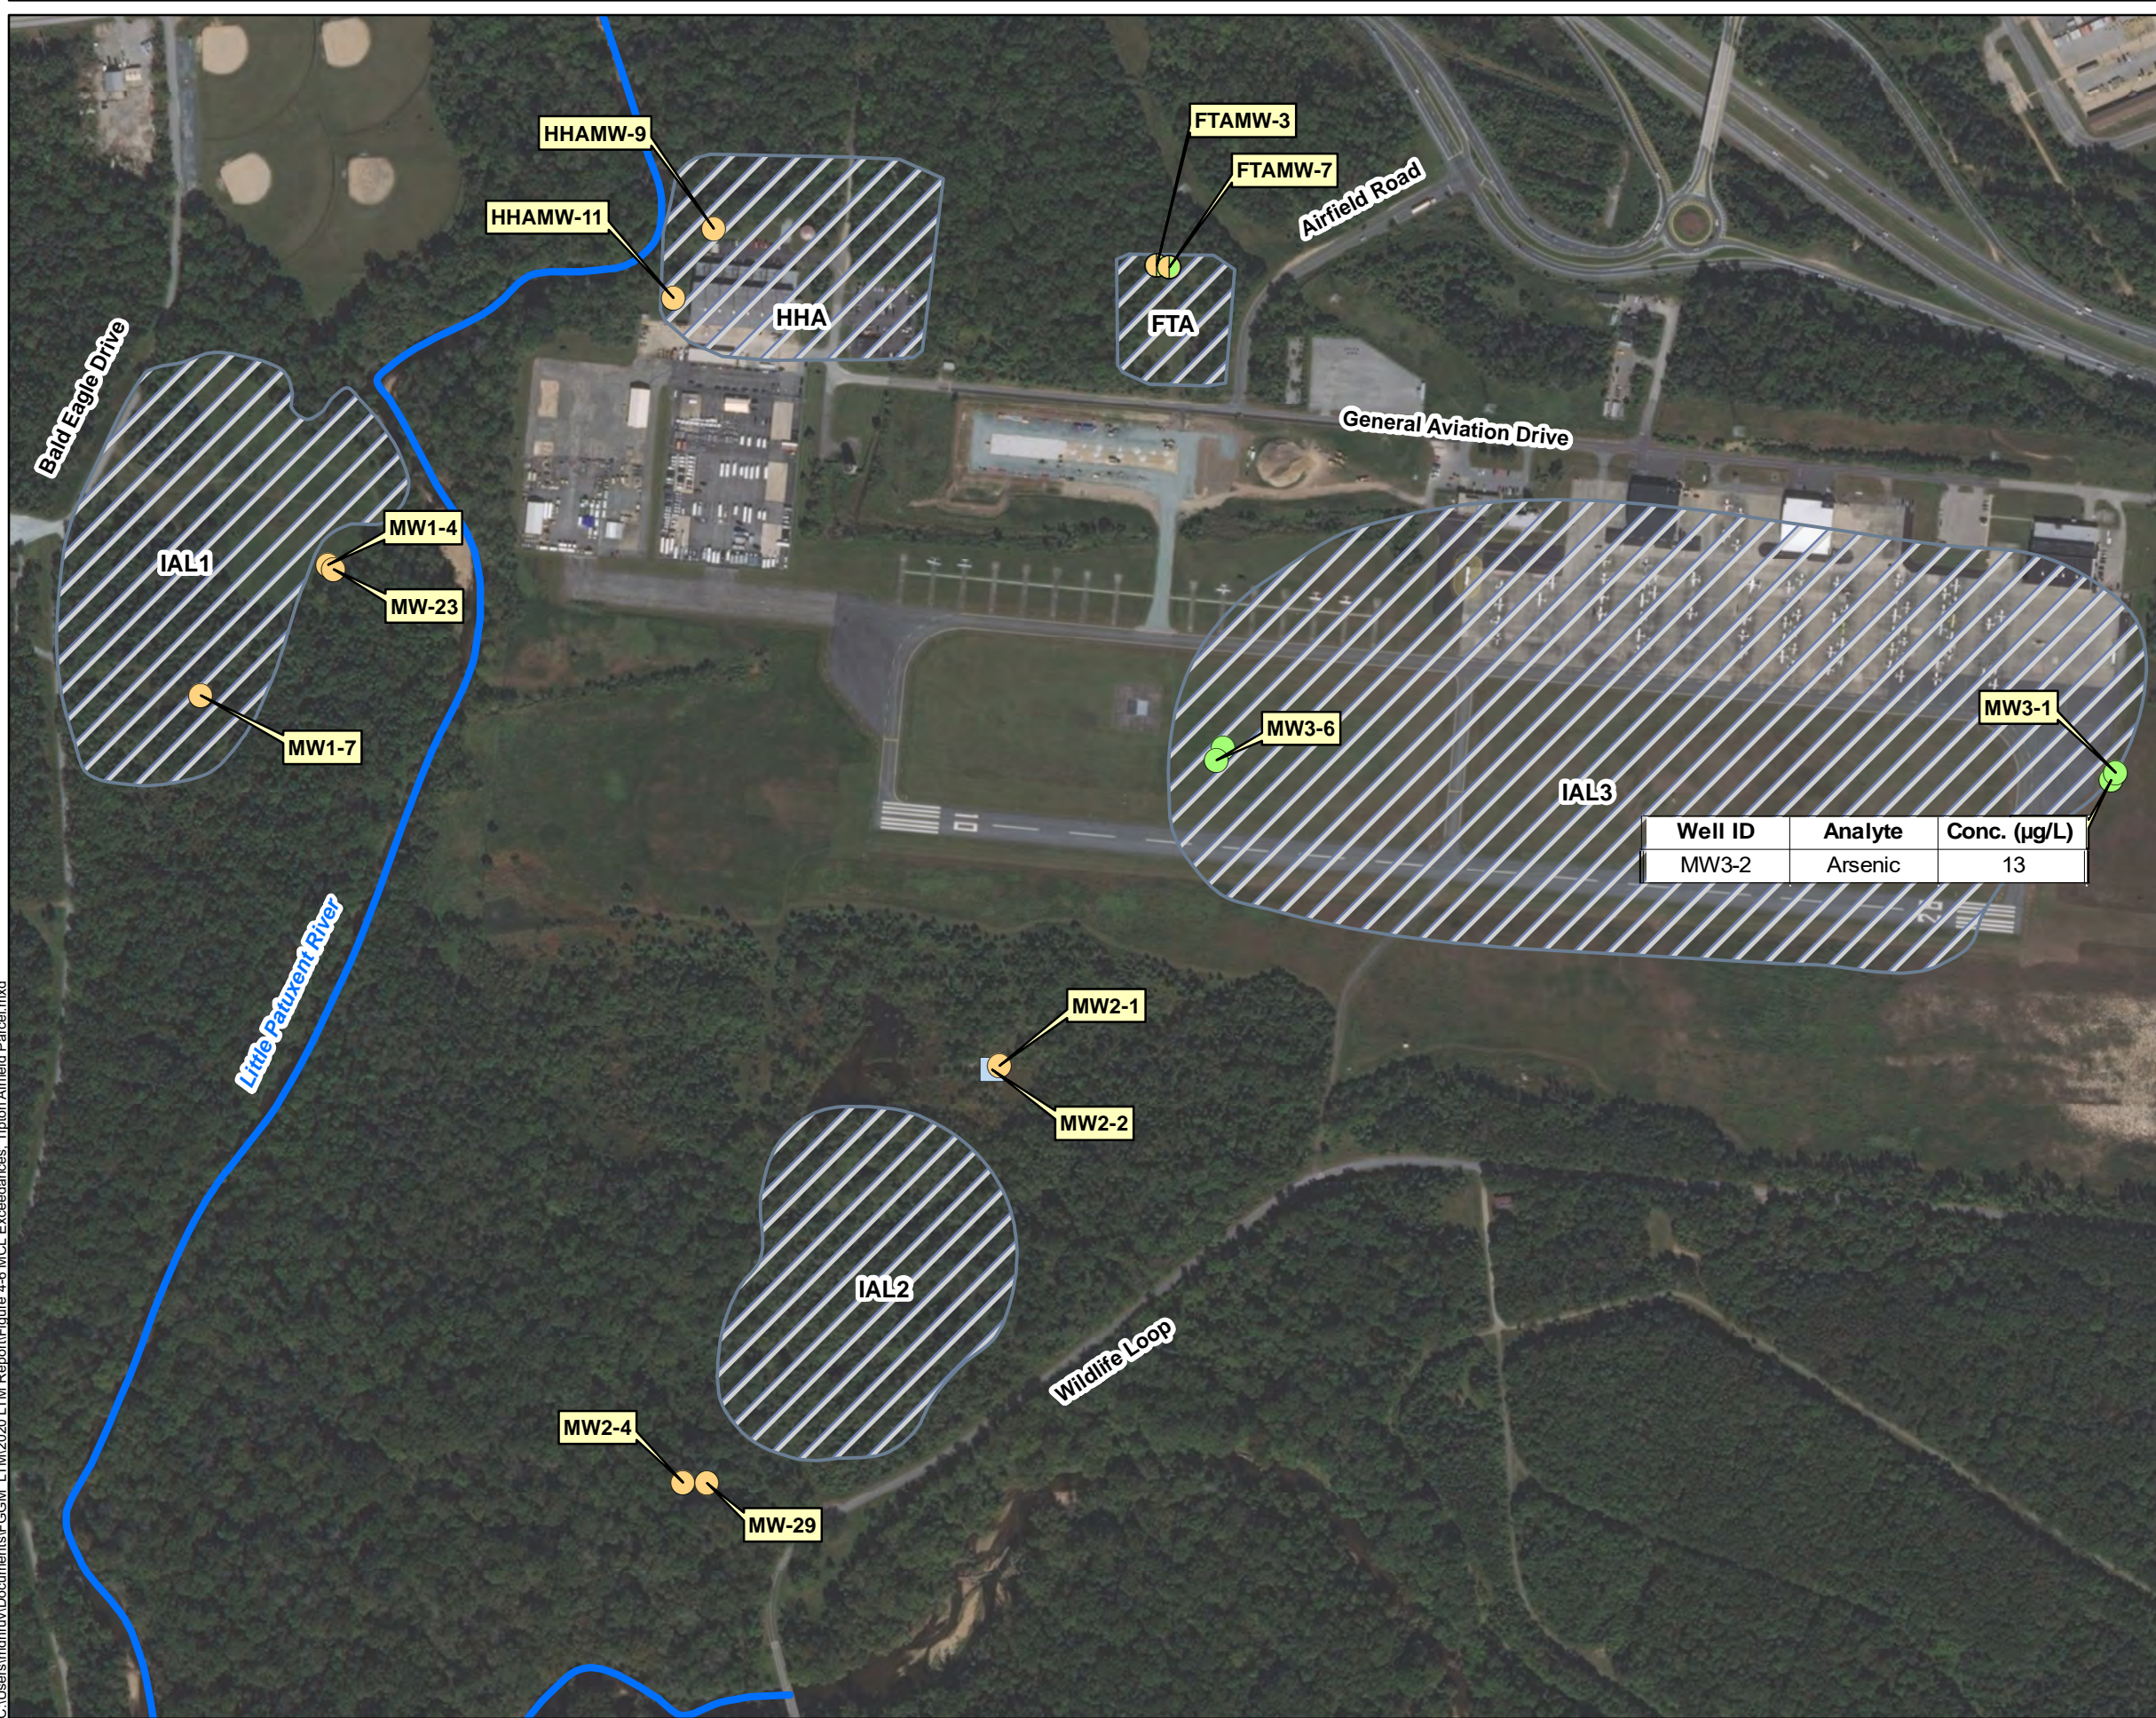
**FIGURE 6-2**  
**2020 MCL EXCEEDANCES,**  
**TIPTON AIRFIELD PARCEL**  
 Anne Arundel County, Maryland

Note:  
 Groundwater sampling conducted in September 2020  
 HHA = Helicopter Hangar Area  
 FTA = Fire Training Area  
 IAL = Inactive Landfill

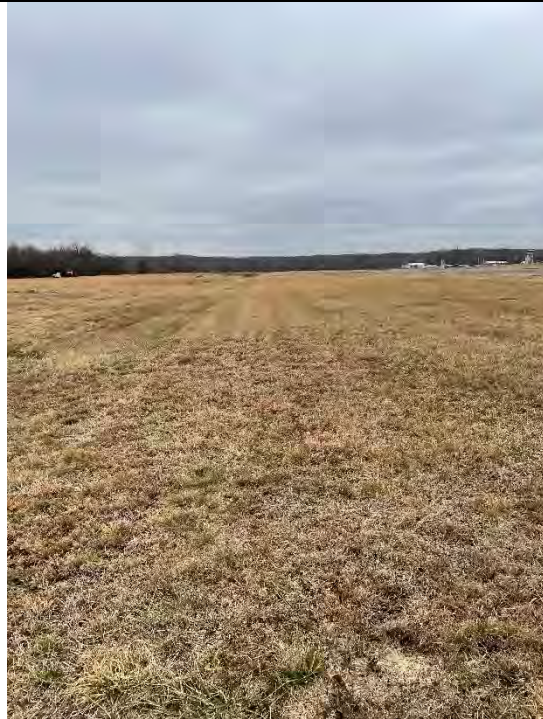
<b>Photo No.</b> 1	<b>Date:</b> 1/25/21
<b>Direction Photo Taken:</b> West	
<b>Description:</b> Overview of IAL3

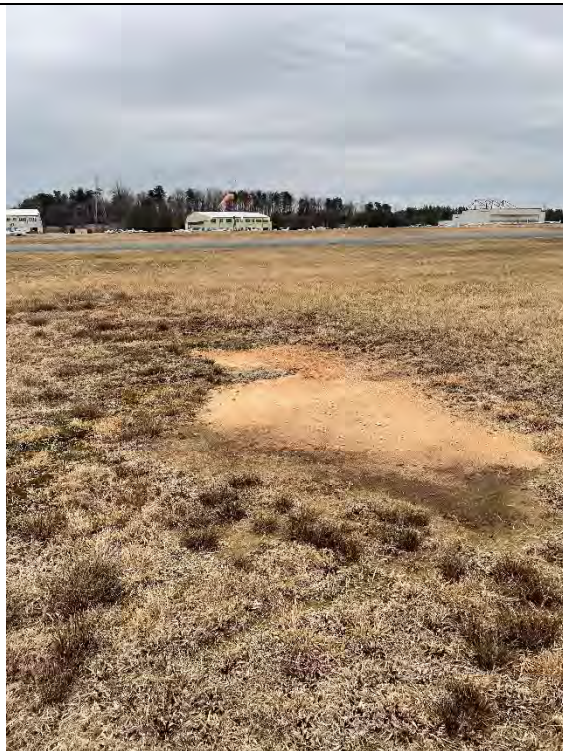
<b>Photo No.</b> 2	<b>Date:</b> 1/25/21
<b>Direction Photo Taken:</b> North	
<b>Description:</b> Depression identified on the south side of IAL3.

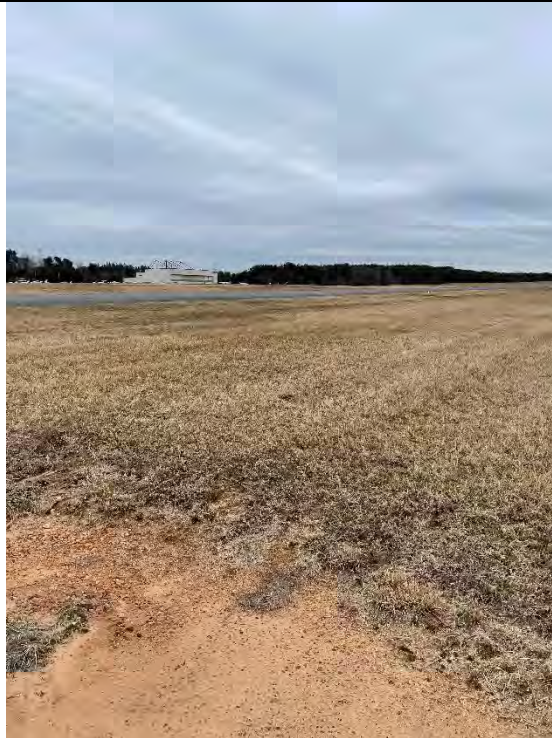
<b>Photo No.</b> 3	<b>Date:</b> 1/25/21
<b>Direction Photo Taken:</b> Northeast	
<b>Description:</b> Depression identified on the south side of IAL3.

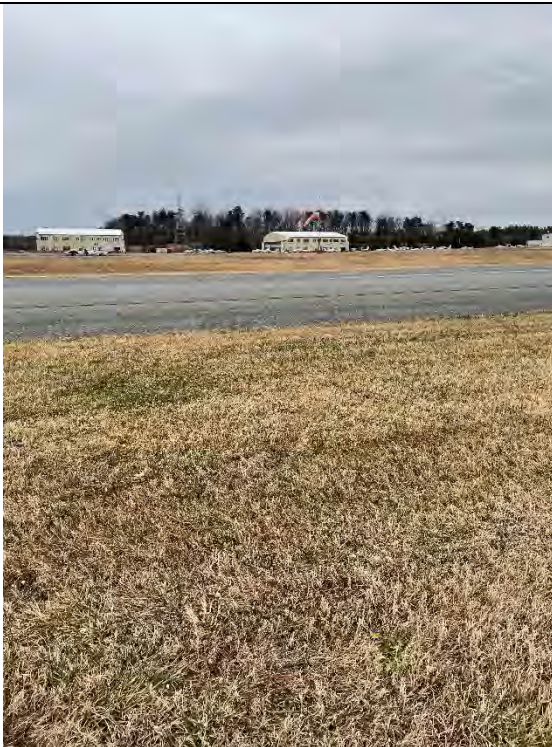
<b>Photo No.</b> 4	<b>Date:</b> 1/25/21
<b>Direction Photo Taken:</b> North	
<b>Description:</b> General overview of IAL3

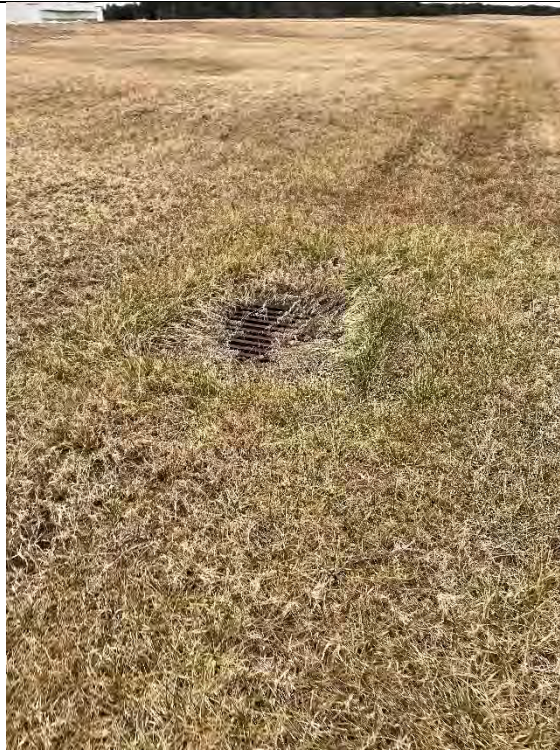
<b>Photo No.</b> 5	<b>Date:</b> 1/25/21
<b>Direction Photo Taken:</b> Northeast	
<b>Description:</b> Drainage identified on IAL3.

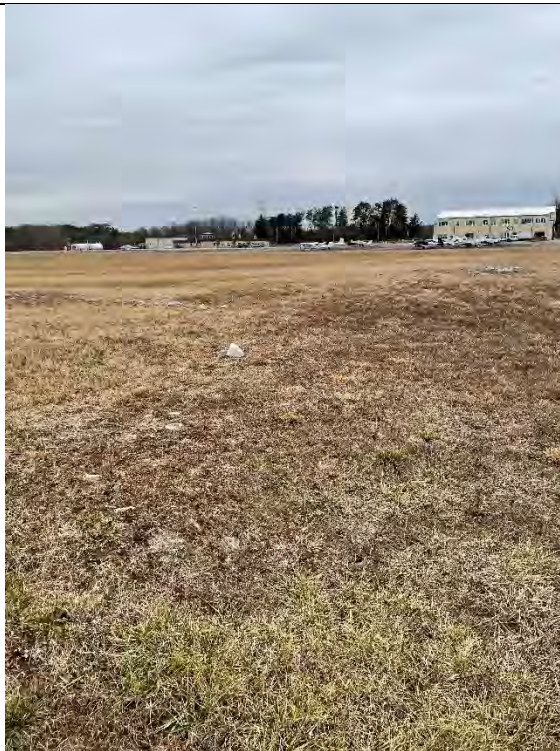
<b>Photo No.</b> 6	<b>Date:</b> 1/25/21
<b>Direction Photo Taken:</b> Northeast	
<b>Description:</b> Riprap around the windsock on IAL3 where ponding periodically occurs.

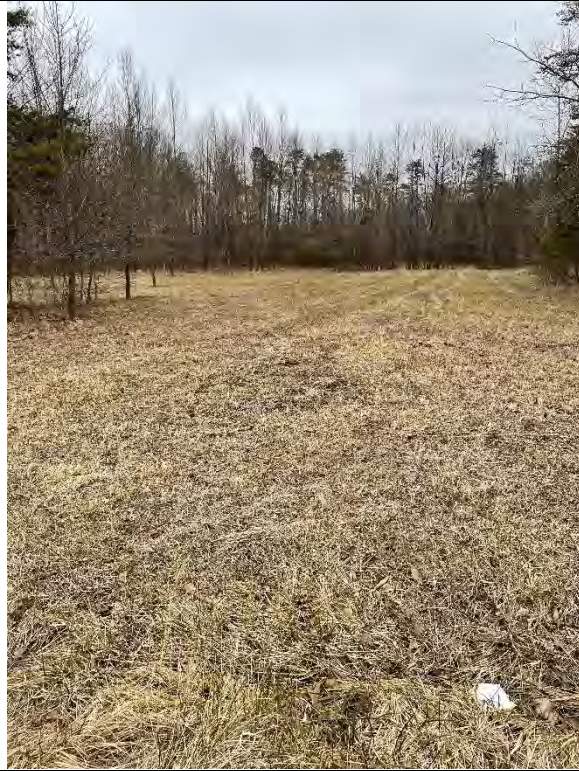
**Description:**  
General overview of IAL1.

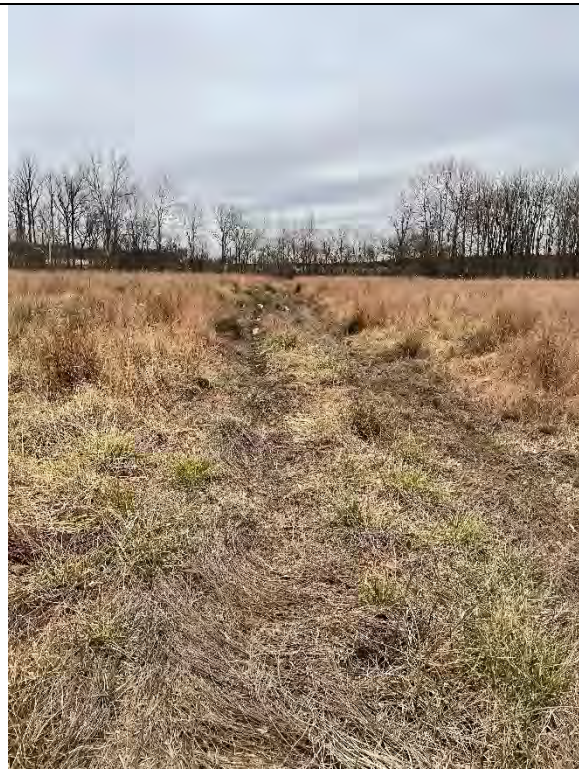
<b>Photo No.</b> 8	<b>Date:</b> 1/25/21
-----------------------	-------------------------

**Description:**  
Tire ruts identified on IAL1.

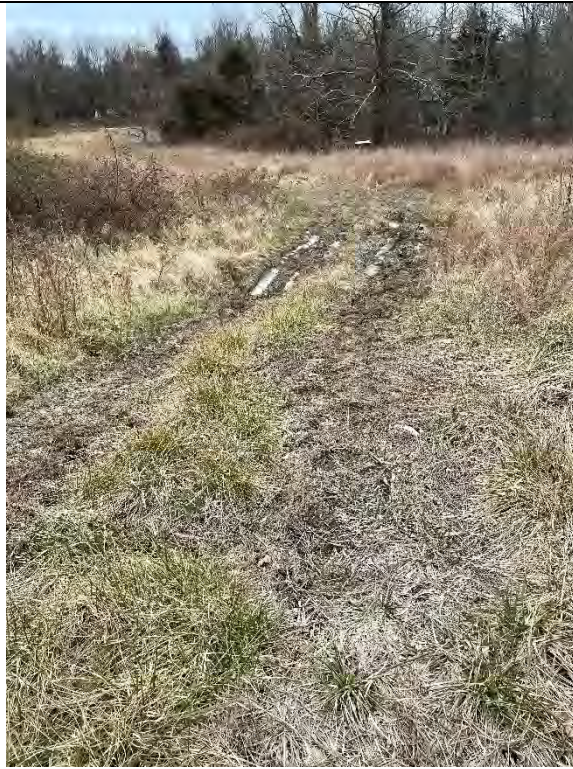
**Description:**  
Tire ruts at the entrance to IAL1  
off Bald Eagle Drive.

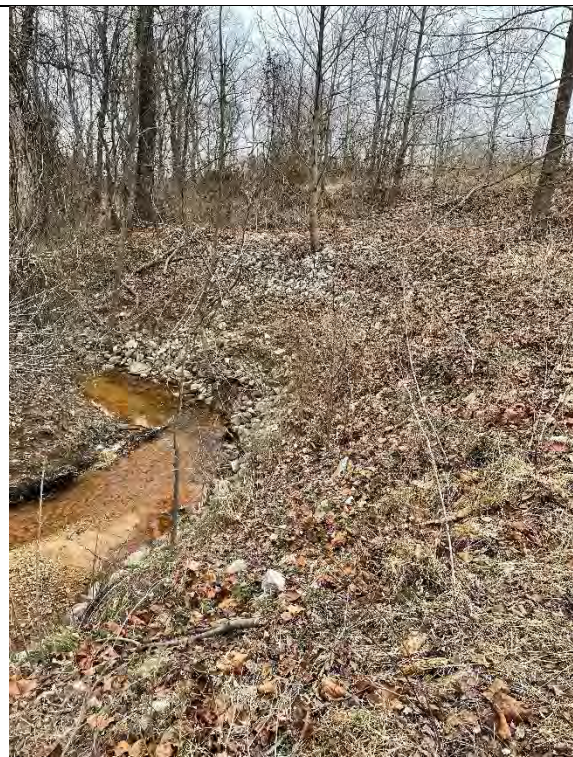
<b>Photo No.</b> 10	<b>Date:</b> 1/25/21
------------------------	-------------------------

**Description:**  
Stabilized erosion area on a  
tributary of the Little Patuxent  
River.

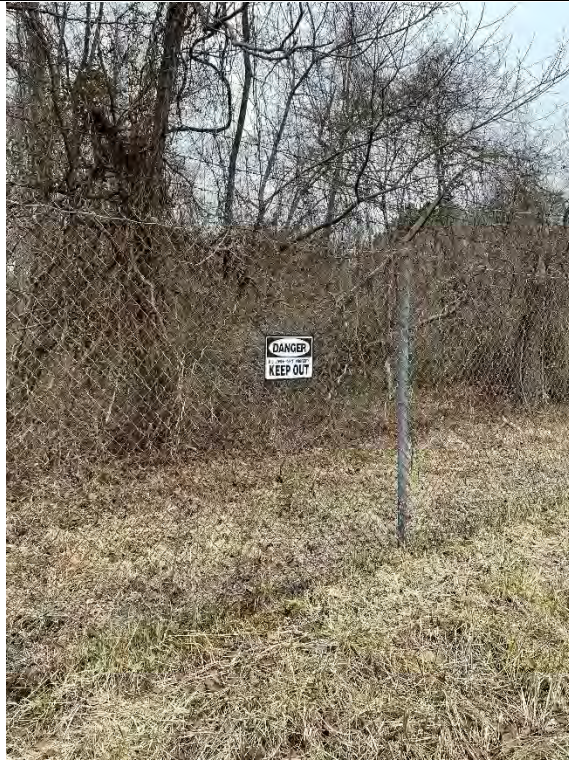
**Description:**  
Southern fence line of IAL2 with warning sign.

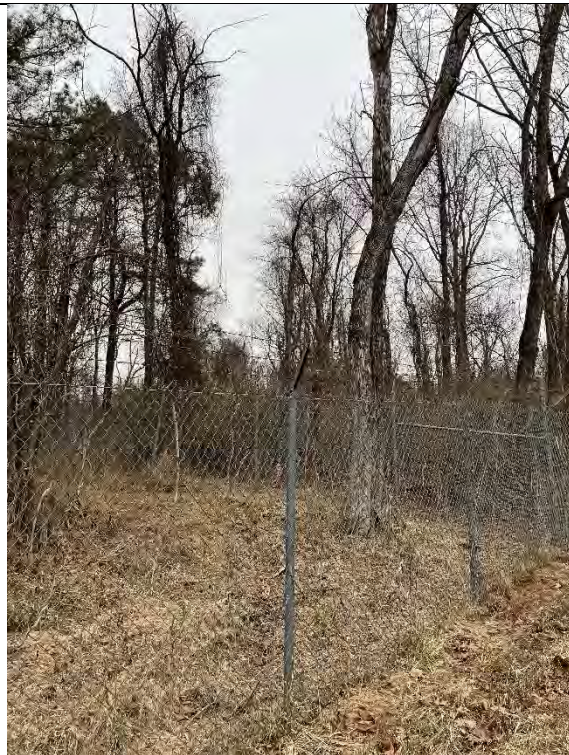
<b>Photo No.</b> 12	<b>Date:</b> 1/25/21
------------------------	-------------------------

**Description:**  
Southern fence line of IAL2 showing cleared buffer areas on either side of the fence.
