FINAL PRELIMINARY ASSESSMENT AND SITE INSPECTION OF PER- AND POLYFLUOROALKYL SUBSTANCES

Fort Leonard Wood, Missouri

Prepared For:
U.S. Army Corps of Engineers, Baltimore District
2 Hopkins Plaza
Baltimore, Maryland 21201

September 2022

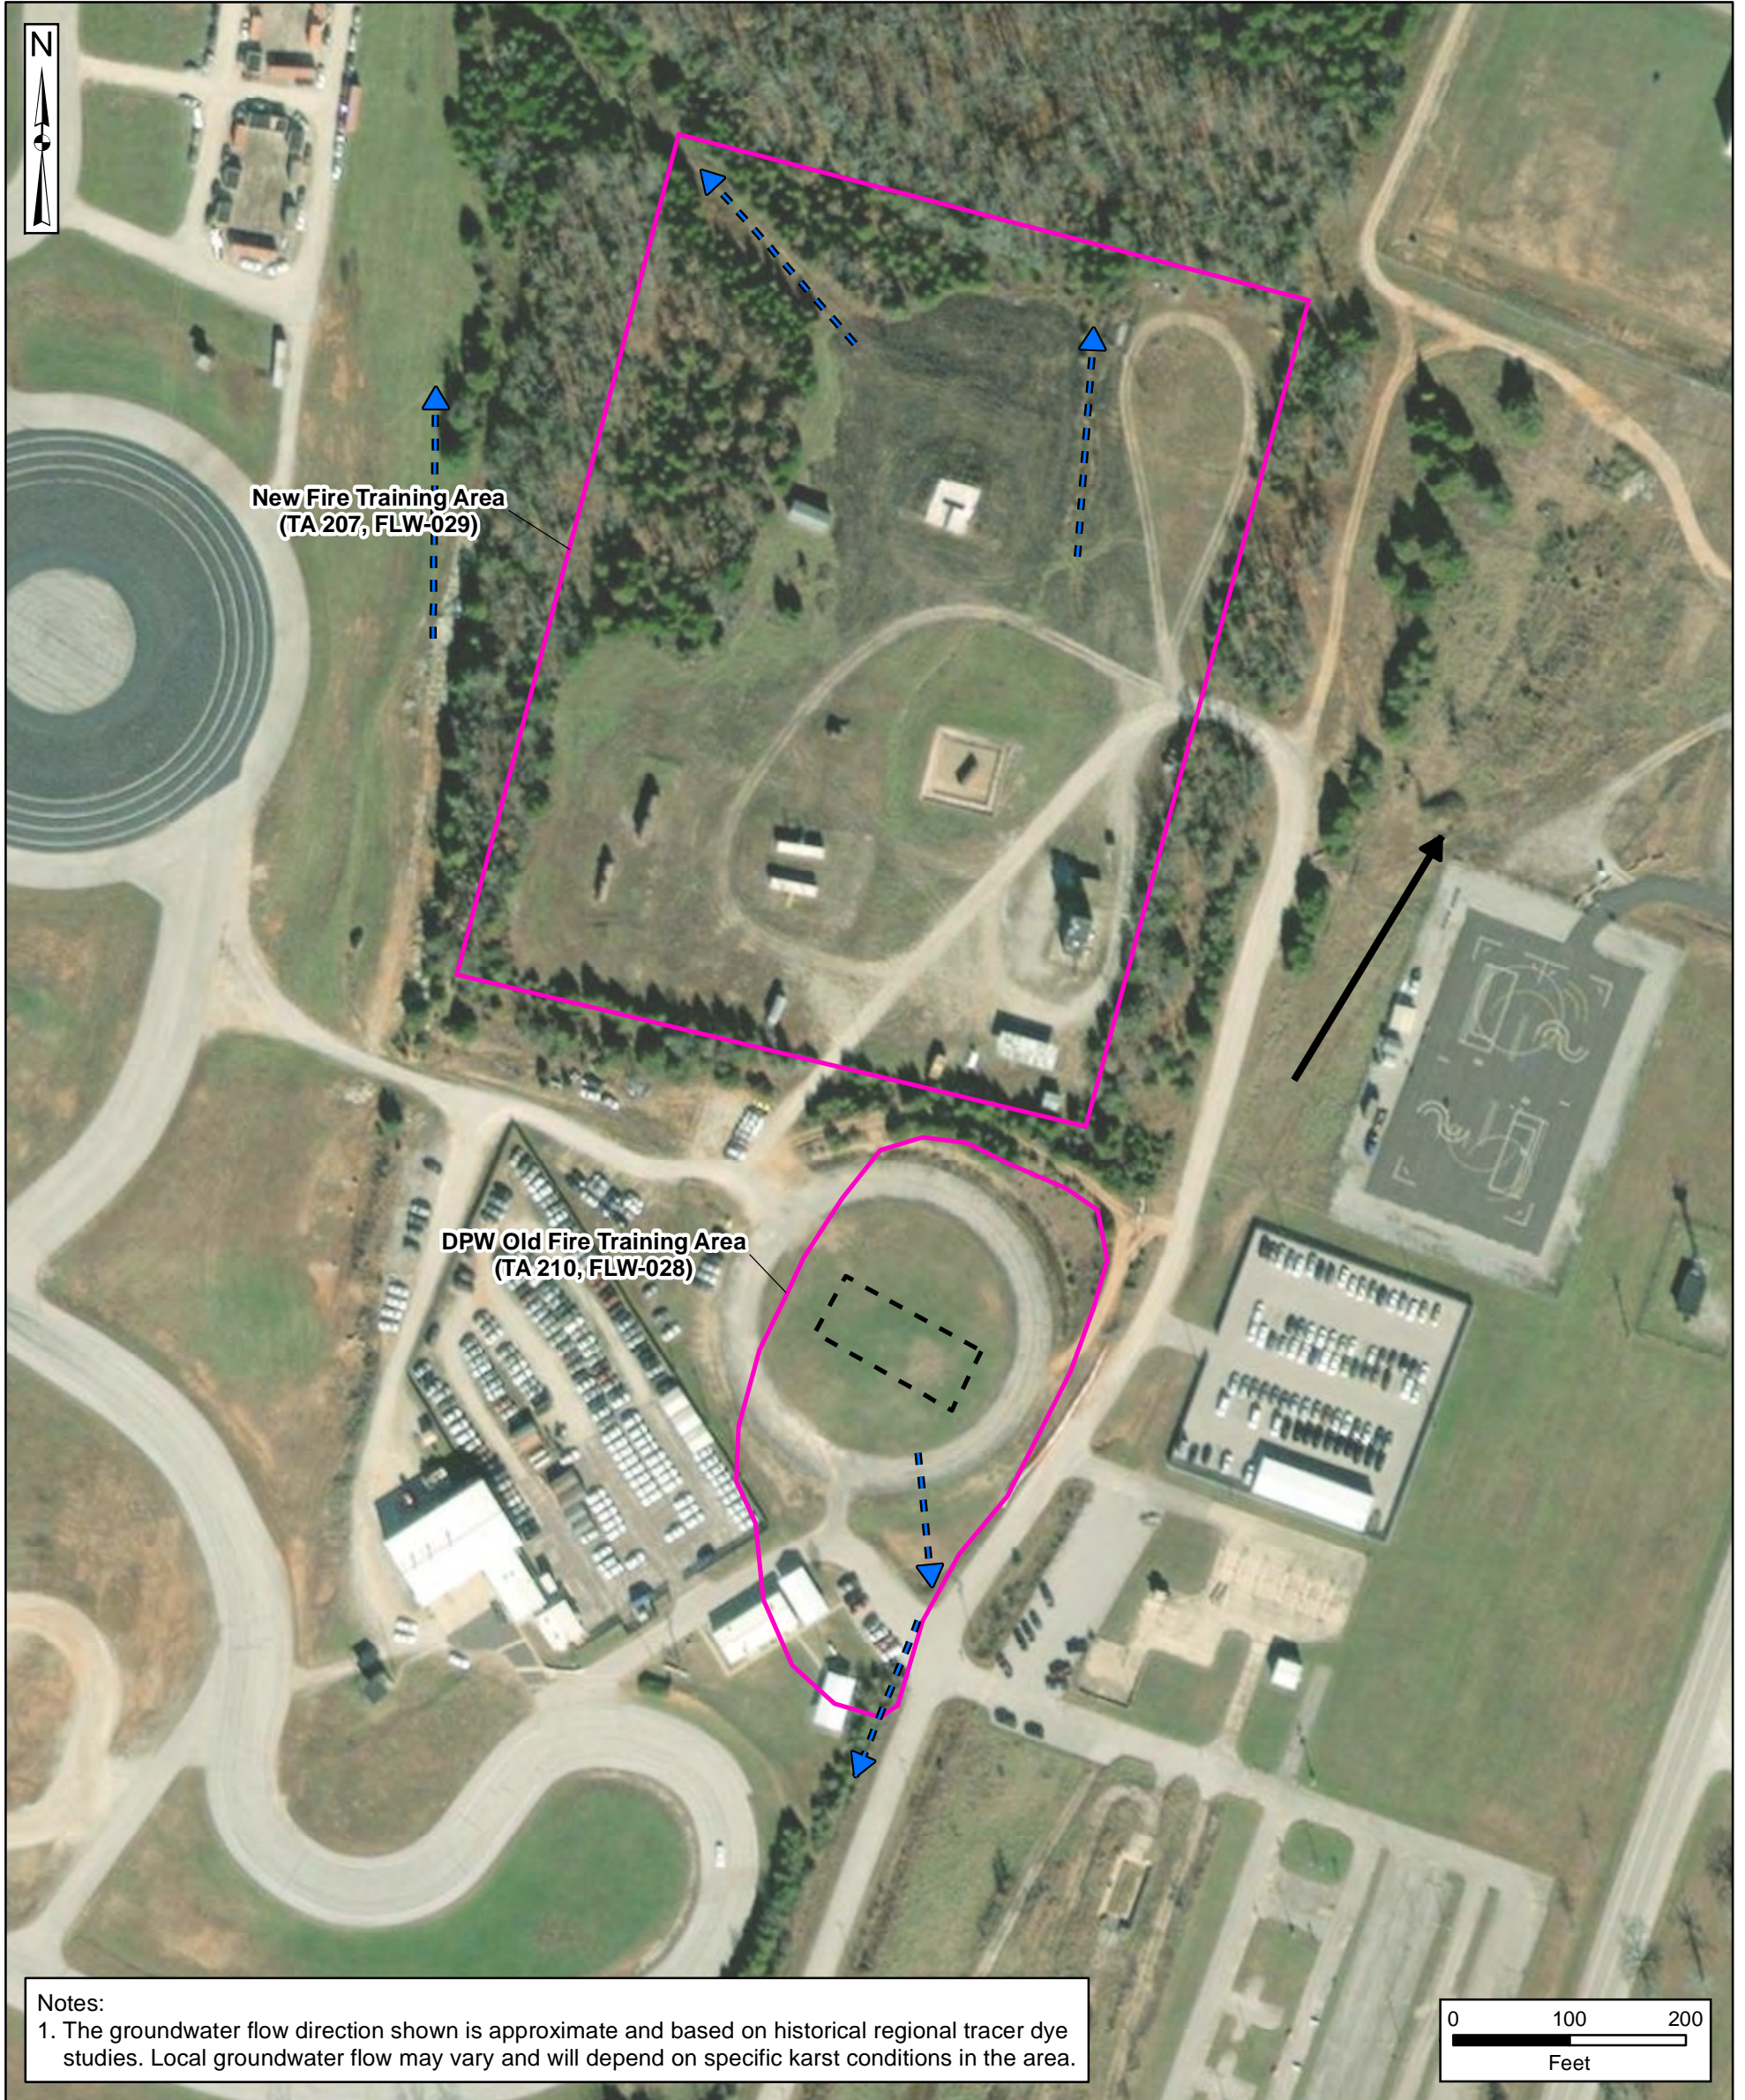
Figure 5-4
Aerial Photo of
DPW Old Fire Training Area (TA 210, FLW-028) and
New Fire Training Area (TA 207, FLW-029)

Notes:
1. The groundwater flow direction shown is approximate and based on historical regional tracer dye studies. Local groundwater flow may vary and will depend on specific karst conditions in the area.

| AOPI Name | PFOS, PFOA, and/or PFBS detected greater than OSD Risk Screening Levels? (Yes/No/NA/ND/NS) | | | | Recommendation |
|--|--|---|---|---|--|
| DPW Old Fire Training Area (TA 210, FLW-028) | NS | No | NS | NS | Supplemental groundwater sampling is recommended |

- The New Fire Training Area (TA 207, FLW-029, 29995.1029) was used for annual fire training exercises and nozzle testing of the ARFF truck from 1988 until 2016, both of which are suspected to have used AFFF. In 2016, two TRI-MAX 30 compressed air foam fire extinguishers from the airfield were emptied into this area. An in-ground concrete pad approximately 65 feet by 65 feet, observed during the PA site visit on 10 to 12 December 2018, was used for fire training and nozzle testing activities.

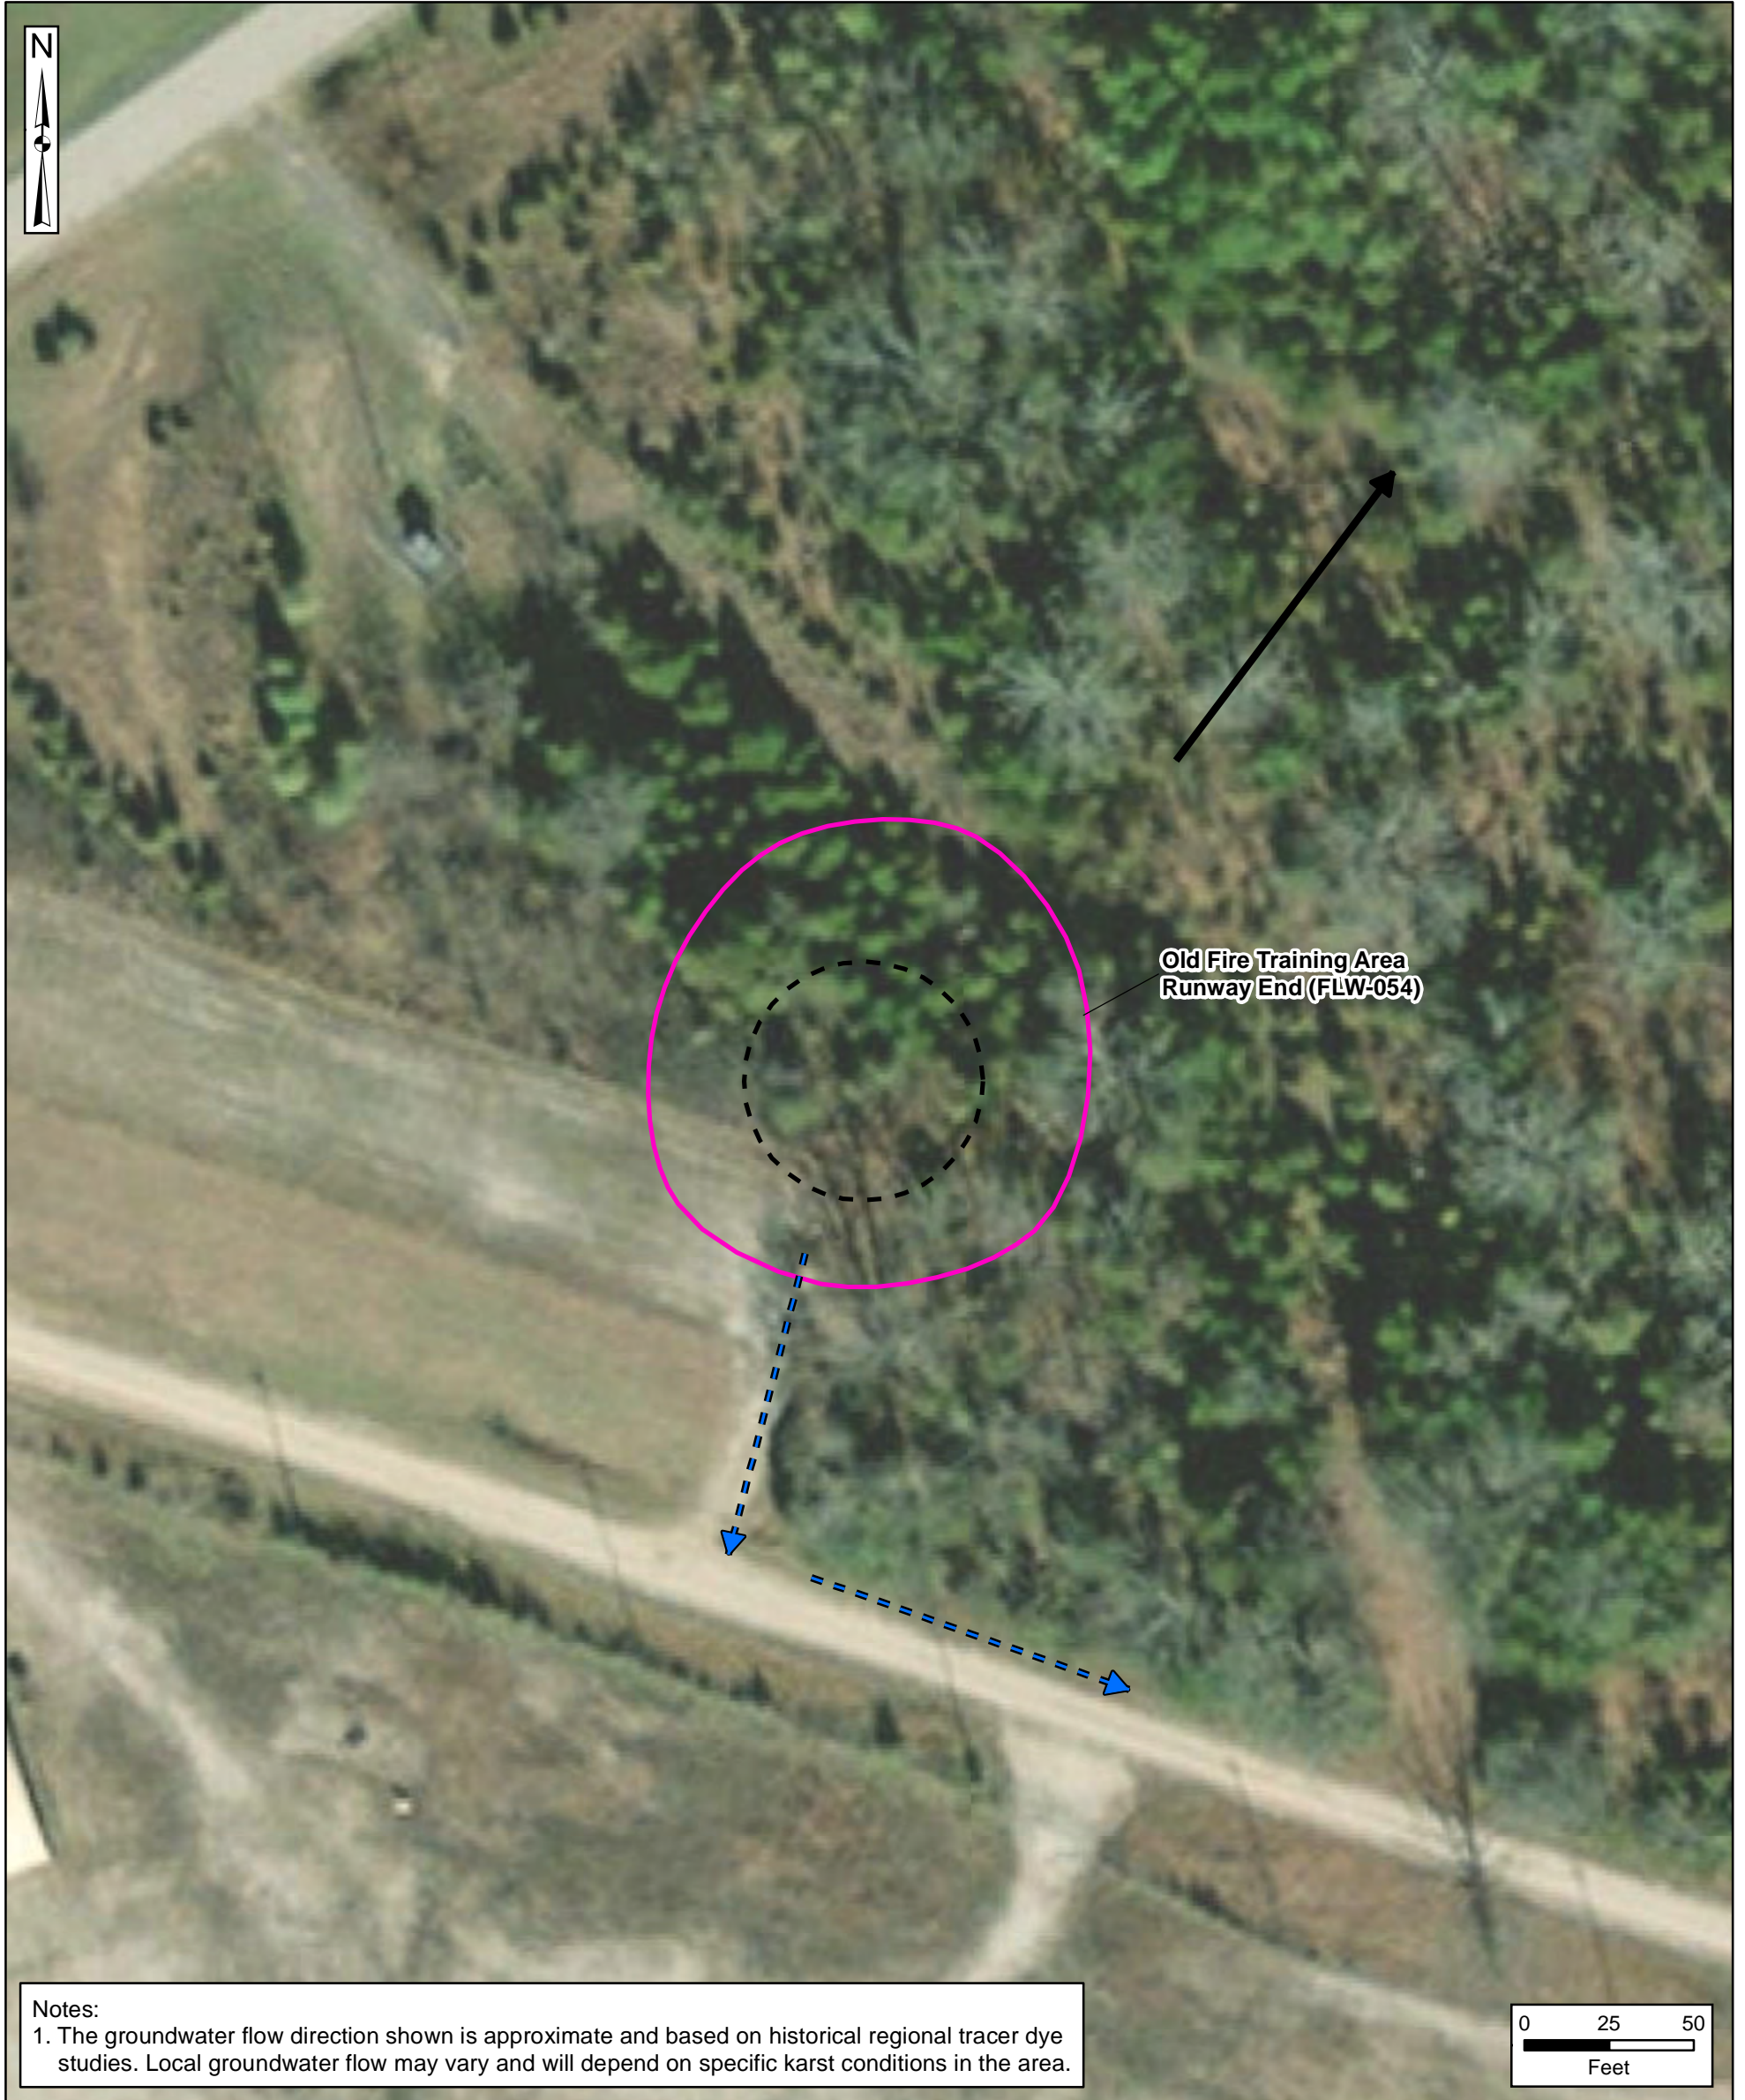
Figure 5-6
Aerial Photo of
Old Fire Training Area Runway End (FLW-054)

Notes:
1. The groundwater flow direction shown is approximate and based on historical regional tracer dye studies. Local groundwater flow may vary and will depend on specific karst conditions in the area.

| AOPI Name | PFOS, PFOA, and/or PFBS detected greater than OSD Risk Screening Levels? (Yes/No/NA/ND/NS) | | | | Recommendation |
|--|--|---|---|---|--|
| Old Fire Training Area Runway End (FLW-054) | NS | No | NS | NS | Supplemental groundwater sampling is recommended |

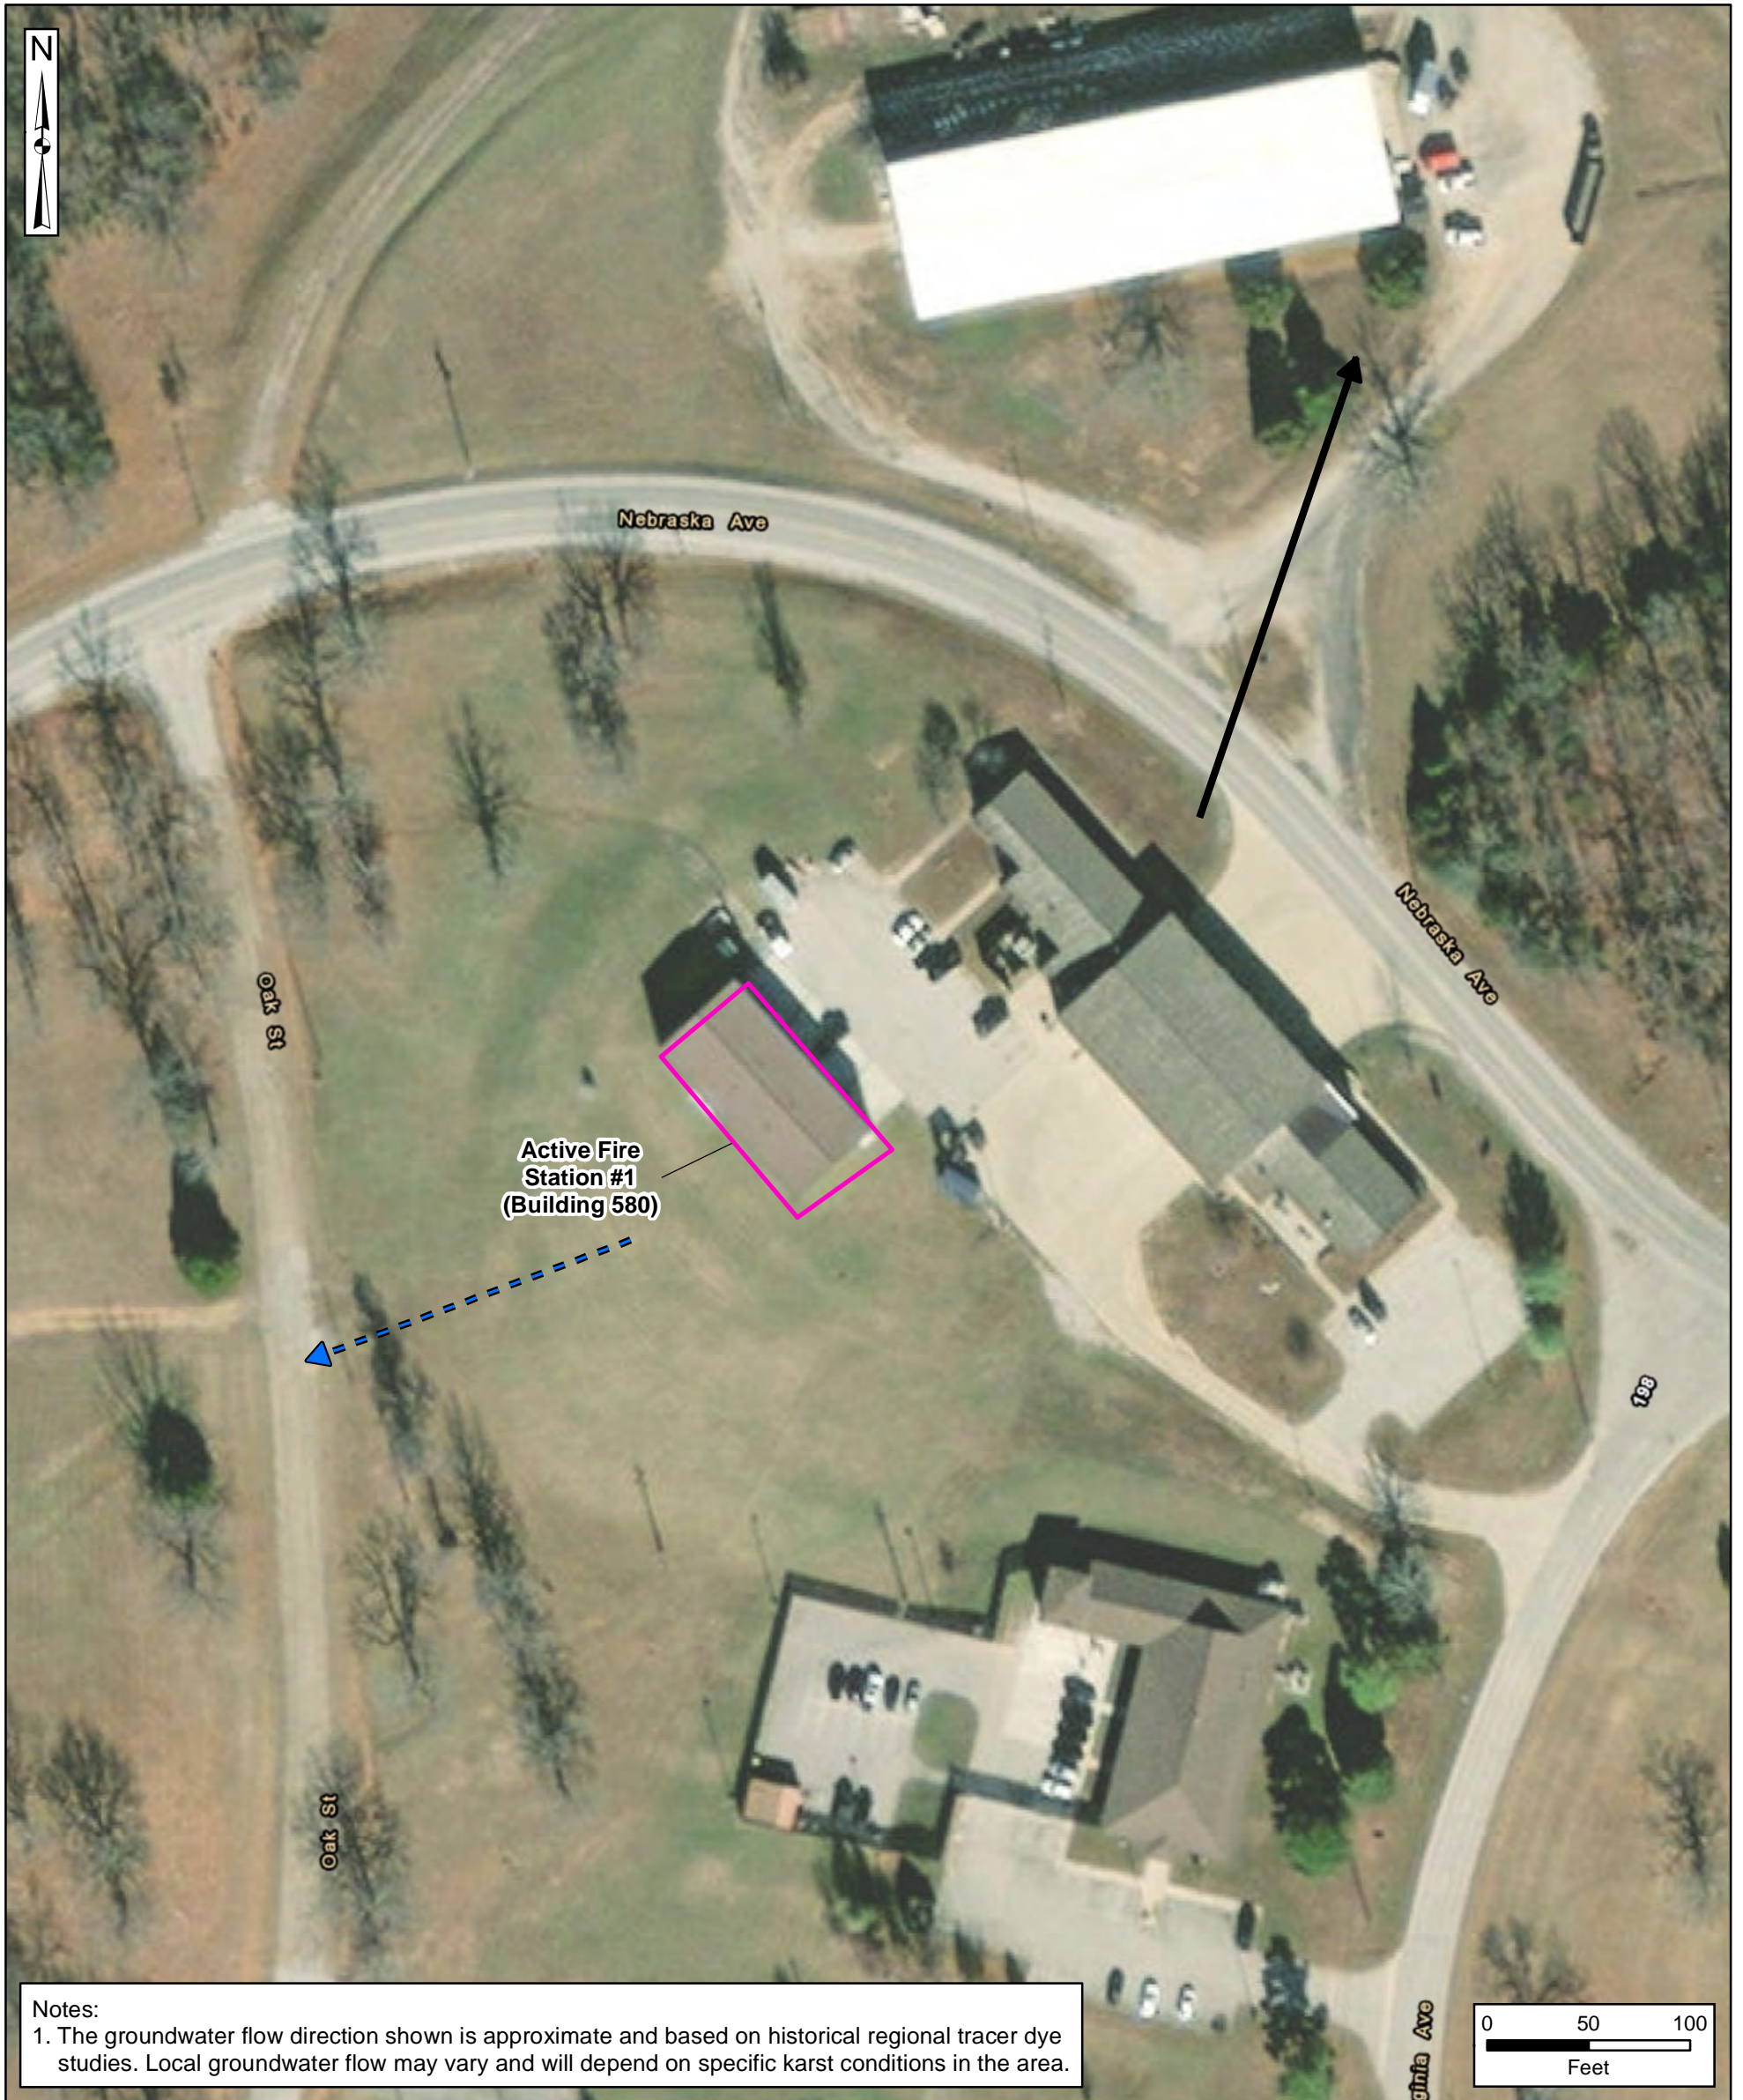
Figure 5-7
Aerial Photo of
Active Fire Station #1 (Building 580)

Notes:
1. The groundwater flow direction shown is approximate and based on historical regional tracer dye studies. Local groundwater flow may vary and will depend on specific karst conditions in the area.

- Active Fire Station #1 (Building 580) has been in operation since approximately 2011. Nine 55-gallon drums of Chemguard 3%-6% AR-AFFF concentrate, and an approximately 20-gallon container of Class A foam were stored in the garage bay adjacent to the garage door without secondary containment. Fire trucks housed here, some of which have minor leaks according to interviews, include structural trucks with 30 gallons of AFFF each and a ladder truck with 15 gallons of AFFF. All foams in the trucks and storage are currently military specification compliant.

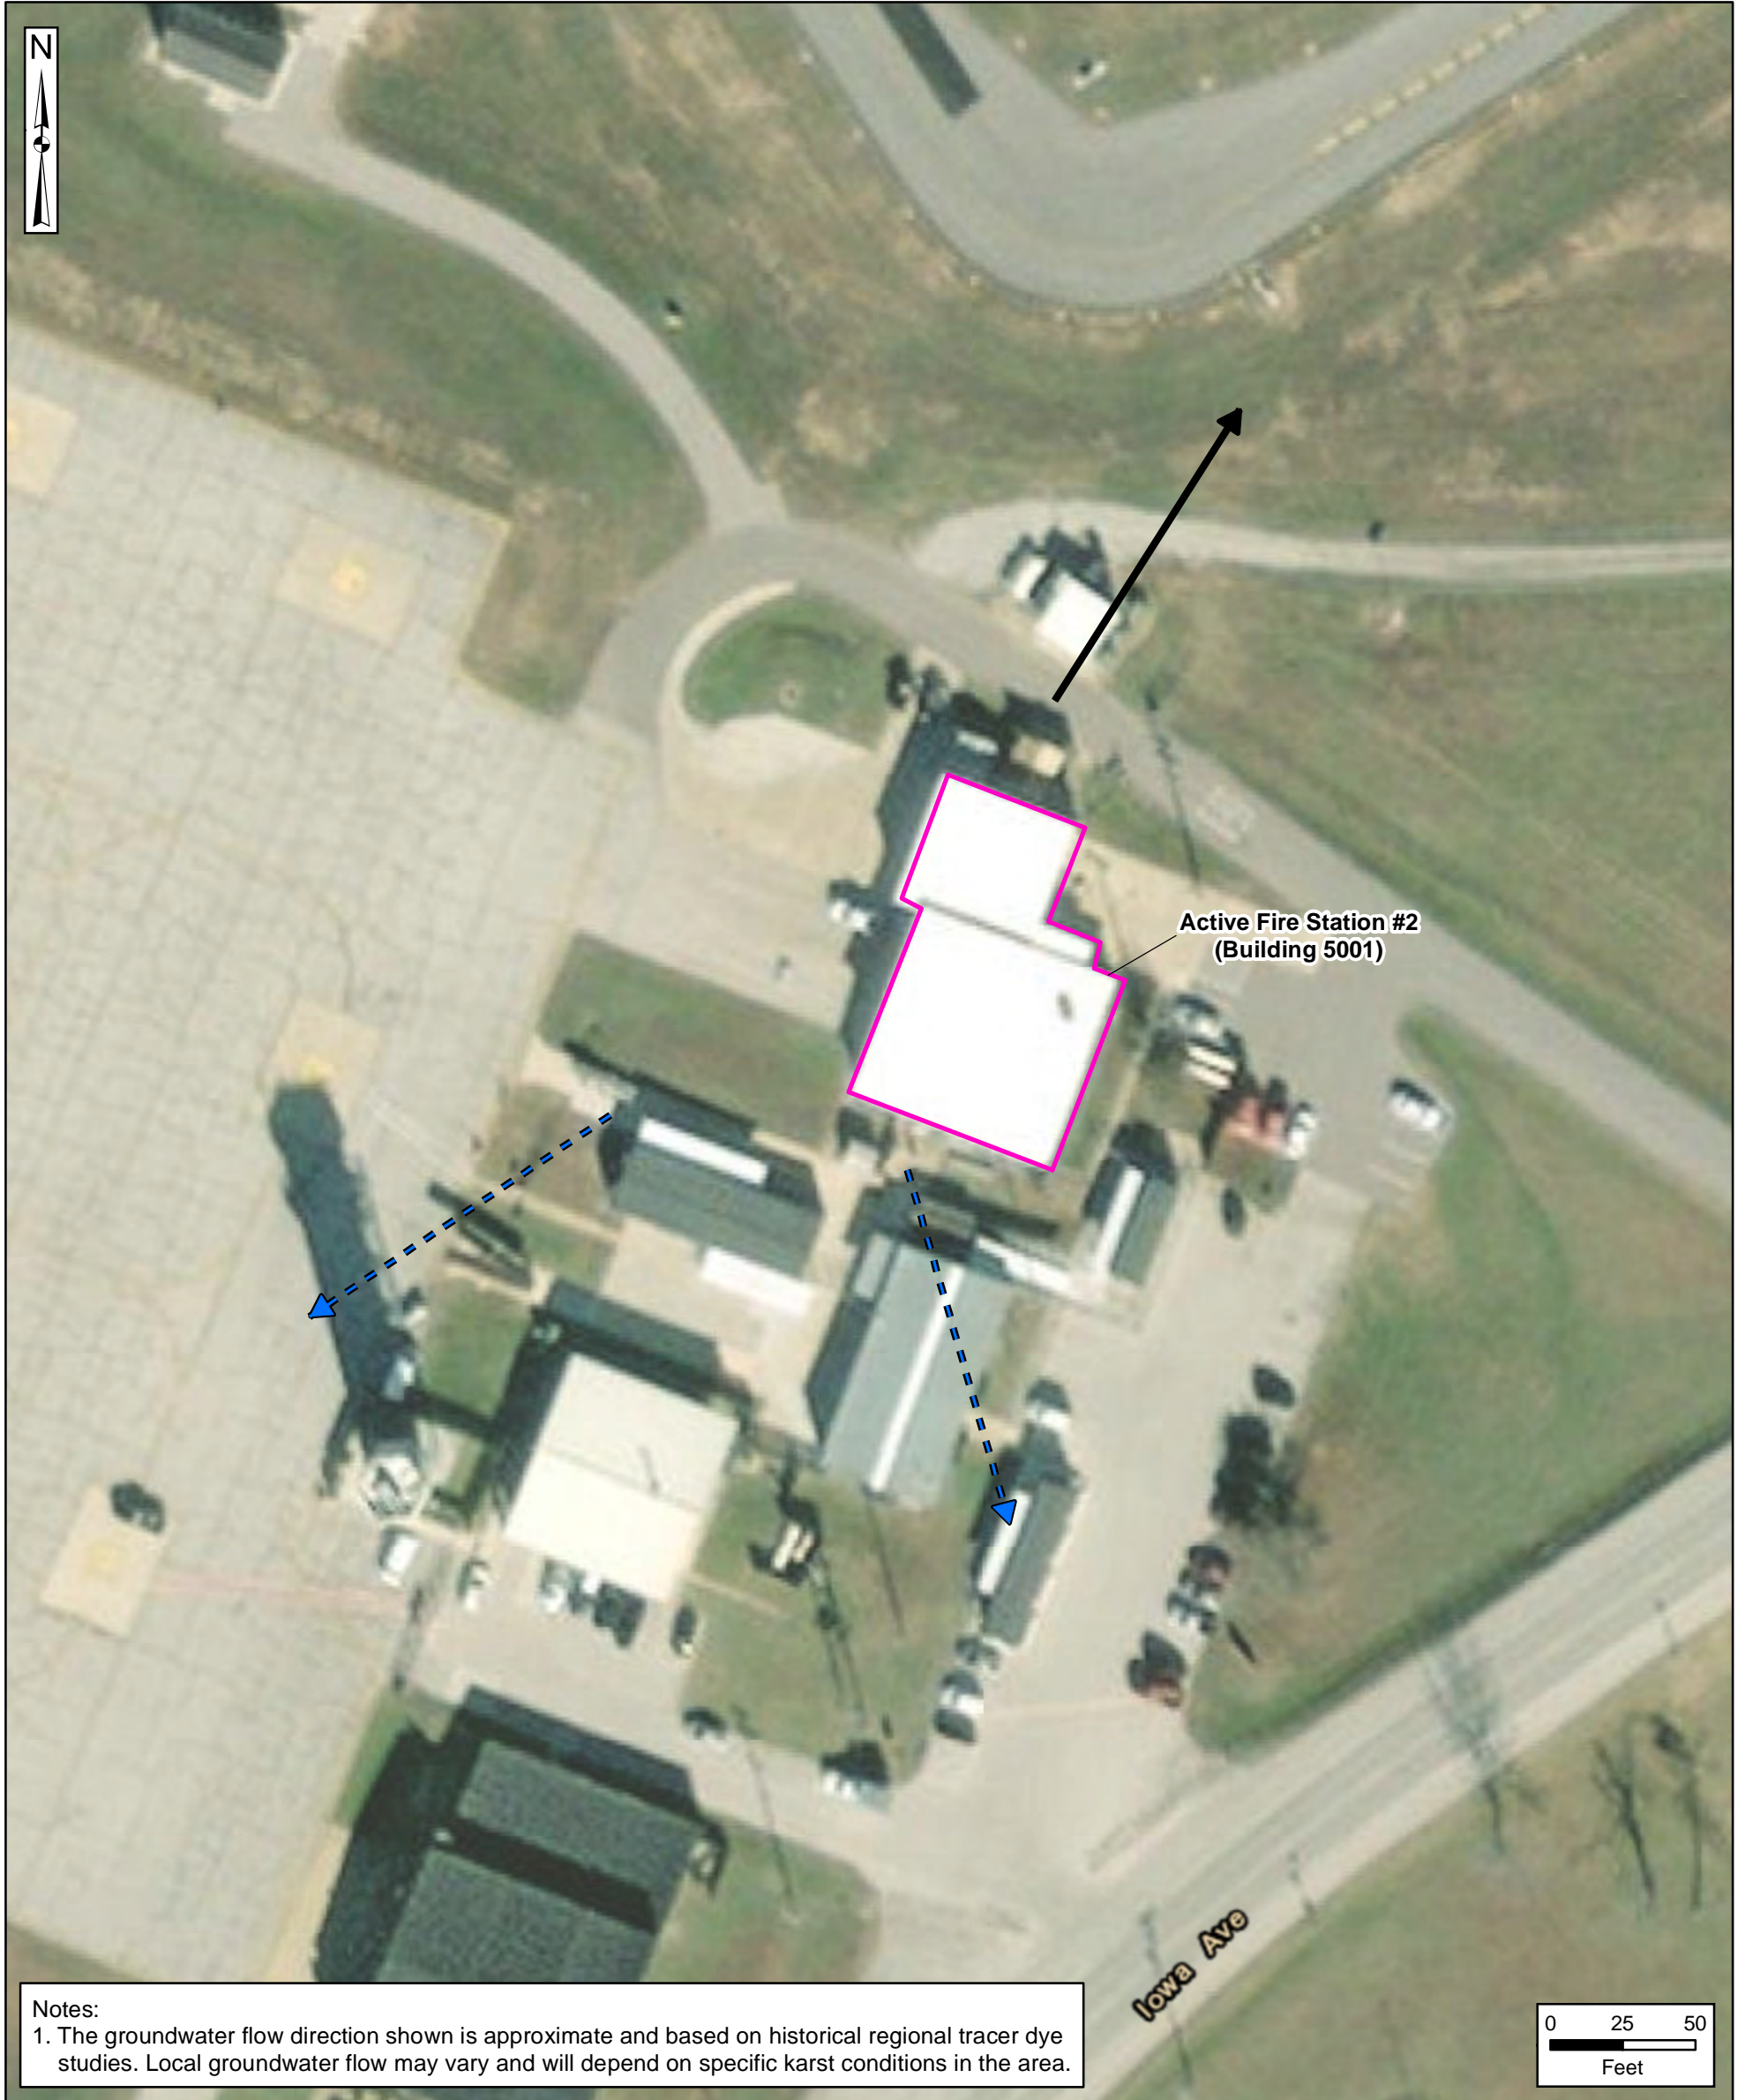
Figure 5-8
Aerial Photo of
Active Fire Station #2 (Building 5001)

Notes:
1. The groundwater flow direction shown is approximate and based on historical regional tracer dye studies. Local groundwater flow may vary and will depend on specific karst conditions in the area.

- Active Fire Station #2 (Building 5001) fire trucks, most of which have minor leaks, include a structural truck containing 30 gallons of AFFF, ARFF truck containing 210 gallons of AFFF and 450 pounds Purple-K foams. All the foams stored in the trucks are currently military specification compliant.

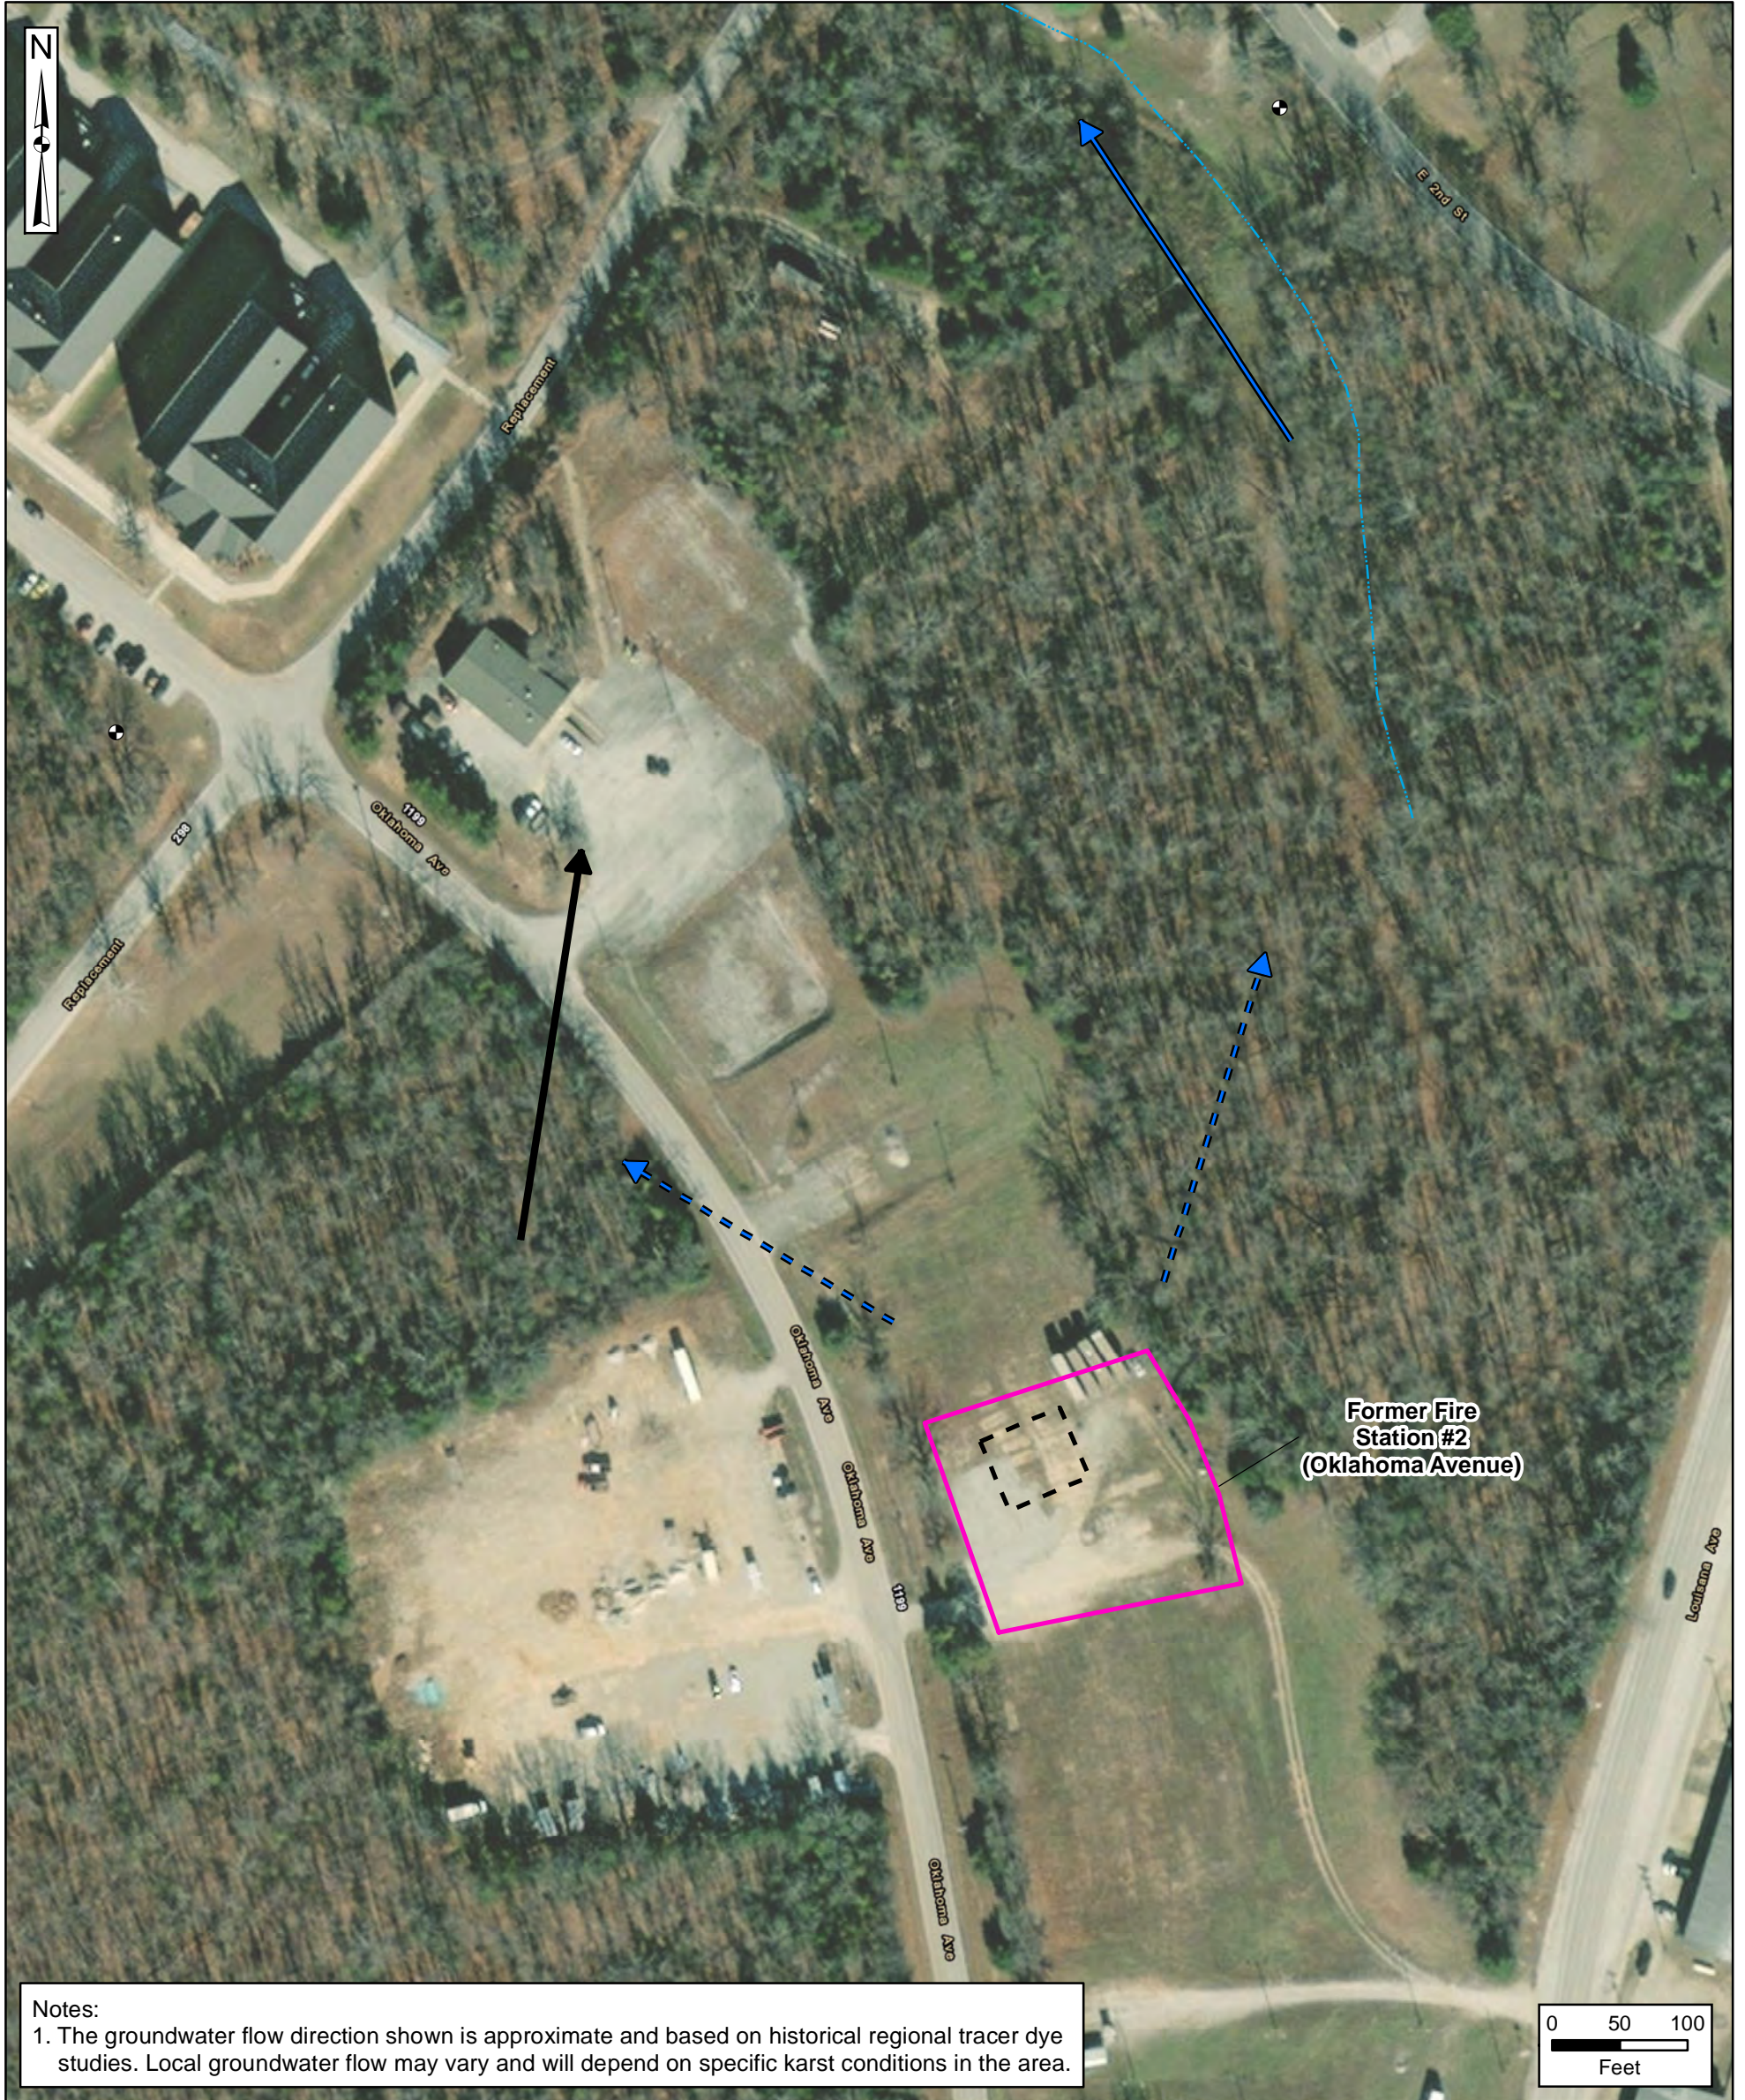
Figure 5-10
Aerial Photo of
Former Fire Station #2 (Oklahoma Avenue)

The Former Fire Station #2 (Oklahoma Avenue) is identified as an AOPI following records research, personnel interviews, and site reconnaissance due to storage of fire trucks containing AFFF (**Figure 5-10**). This former fire station was located near the intersection of Oklahoma Avenue and Replacement Avenue and the details of the construction are unknown. The former fire station was used to house fire trucks until 2012, when it was demolished. Use and storage of AFFF at this fire TA is unknown; however, the period of operation overlaps with the time during which AFFF was historically used at fire TAs at FLW. Currently, a gravel pad is present, with some short grass and trees on the perimeter. There are several old mobile homes and trailers stored at the location. The area drains to a dry creek which flows northeast to the Big Piney River. The Former Fire Station #2 (Oklahoma Avenue) CSM information is presented in **Section 5.3**. The current and future land use is industrial. This AOPI does not overlap with any open or closed IRP sites.
