FINAL PRELIMINARY ASSESSMENT AND SITE INSPECTION OF PER- AND POLYFLUOROALKYL SUBSTANCES

Fort Leonard Wood, Missouri

Prepared For:
U.S. Army Corps of Engineers, Baltimore District
2 Hopkins Plaza
Baltimore, Maryland 21201

September 2022

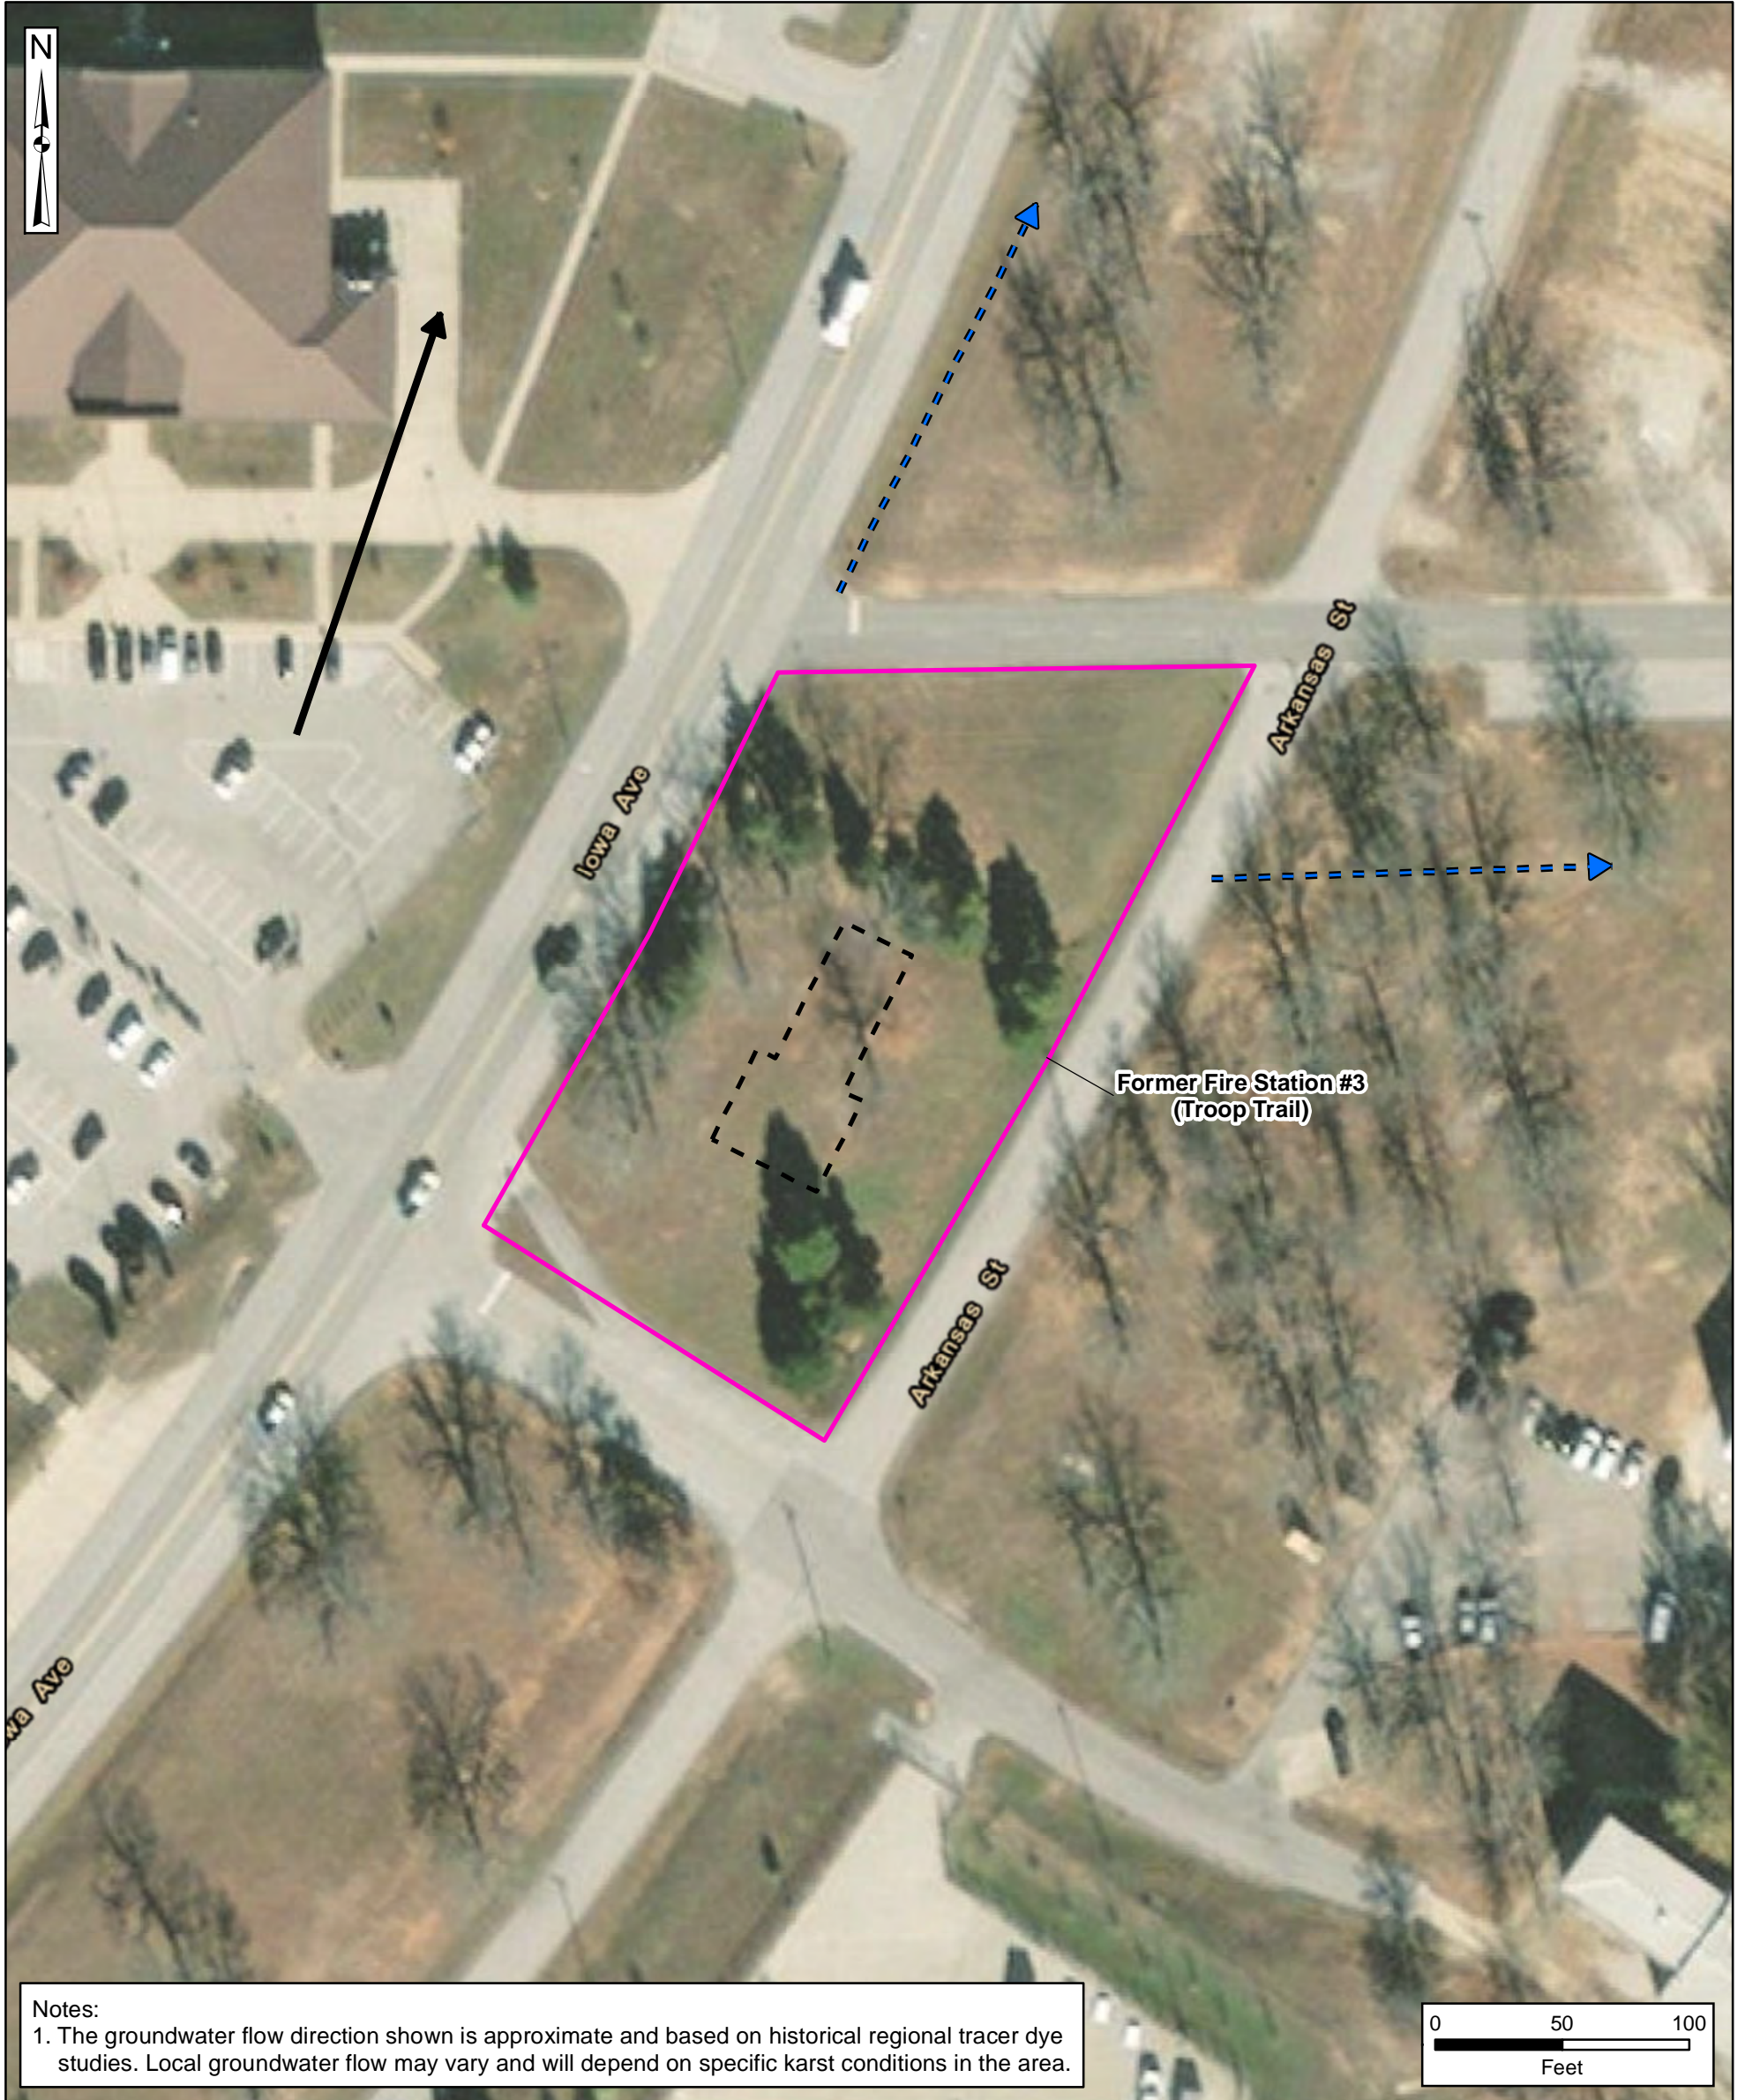
Figure 5-11
Aerial Photo of
Former Fire Station #3 (Troop Trail)

The Former Fire Station #3 (Troop Trail) is identified as an AOPI following records research, personnel interviews, and site reconnaissance due to the possible storage of fire trucks containing AFFF (**Figure 5-11**). Former Fire Station #3 (Troop Trail) is currently a frequently mowed grass area with trees throughout. The AOPI is located on Iowa Avenue near Troop Trail across from the Starship Barracks, where Building 1028 and 1029 are currently located. The former fire station was reported to be present in 1991; however, the exact dates of operation and historical use and storage of AFFF is unknown. In addition, construction and demolition activities of the former fire station are unknown. The area currently lies relatively flat with surface runoff likely flowing northeast to ephemeral tributaries of Dry Creek. The site is within the Shanghai Spring Recharge Basin and groundwater generally flows northeast towards the Big Piney River. The Former Fire Station #3 (Troop Trail) CSM information is presented in **Section 5.3**. The current and future land use is industrial. This AOPI does not overlap with any open or closed IRP sites.

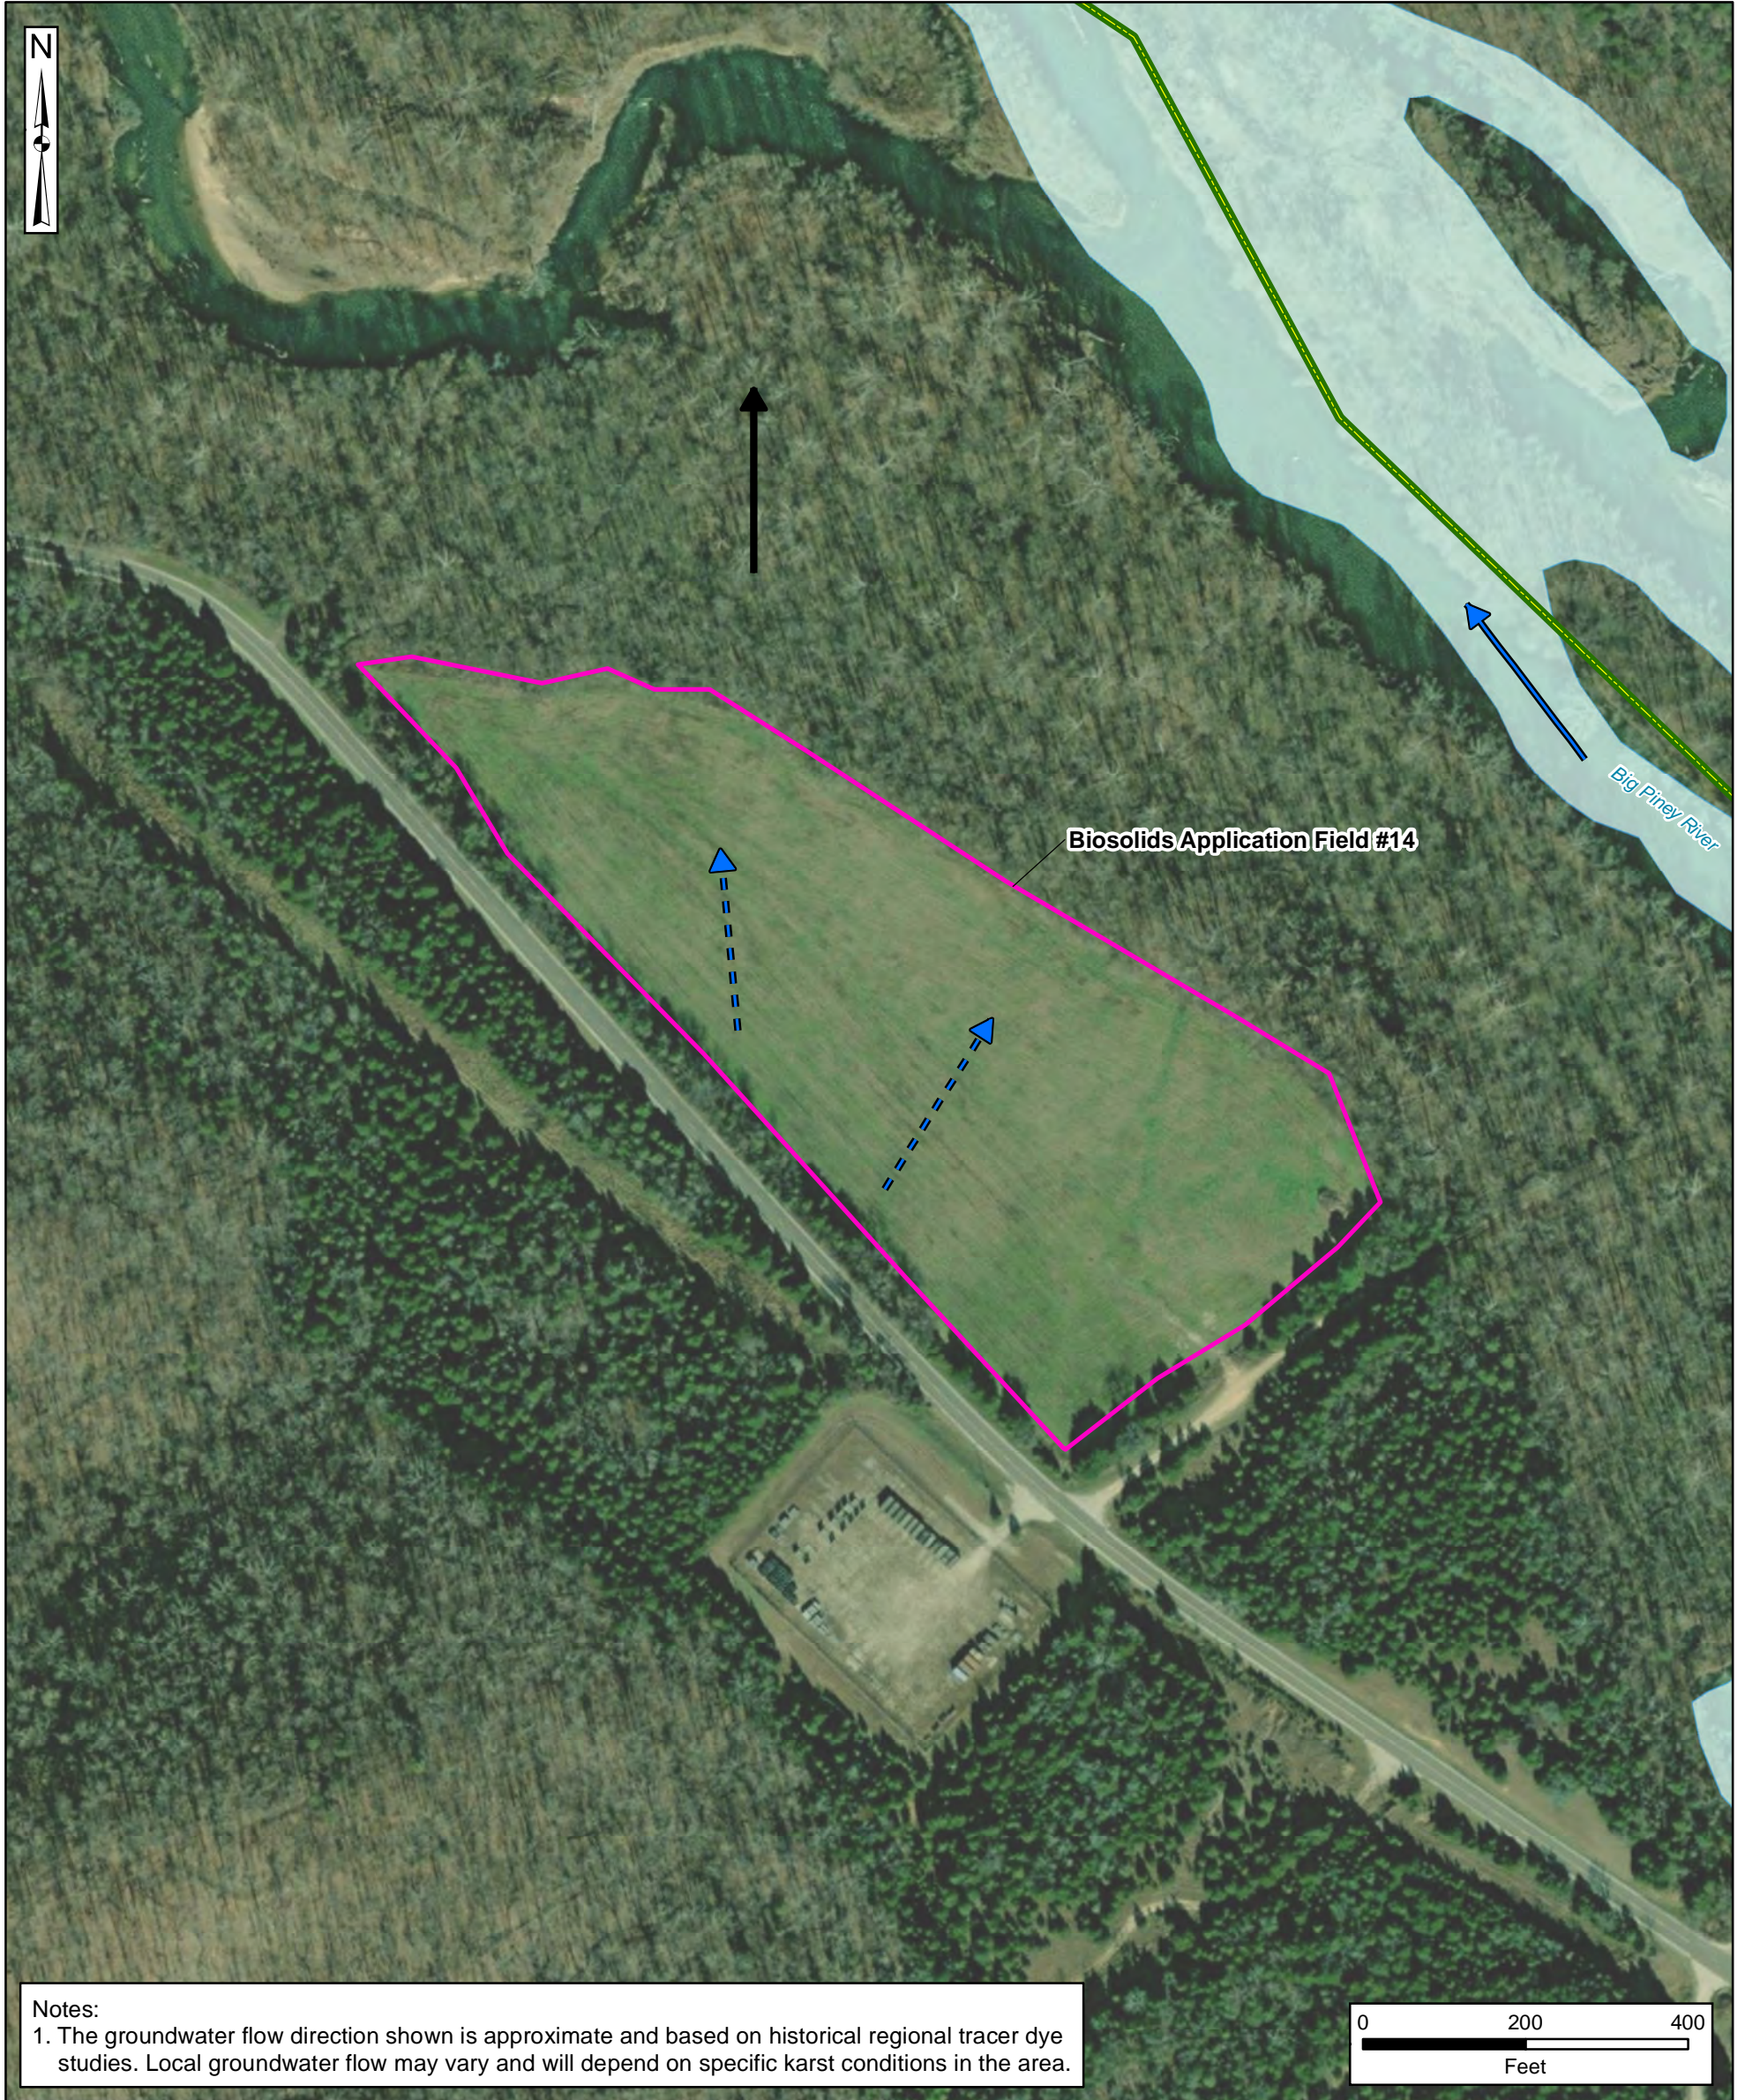
Figure 5-22
Aerial Photo of
Biosolids Application Field #14

The Biosolids Application Field #14 is identified as an AOPI following records research, personnel interviews, and site reconnaissance due to historical and/or recent application of STP sludge (i.e., biosolids) to the land surface to encourage vegetation growth (**Figure 5-22**). The STP received wastewater potentially containing PFOS, PFOA, and/or PFBS from historical and recent AFFF leaks at the ARNG hangars, former FTAs, and fire stations; therefore, biosolids applied at this AOPI potentially

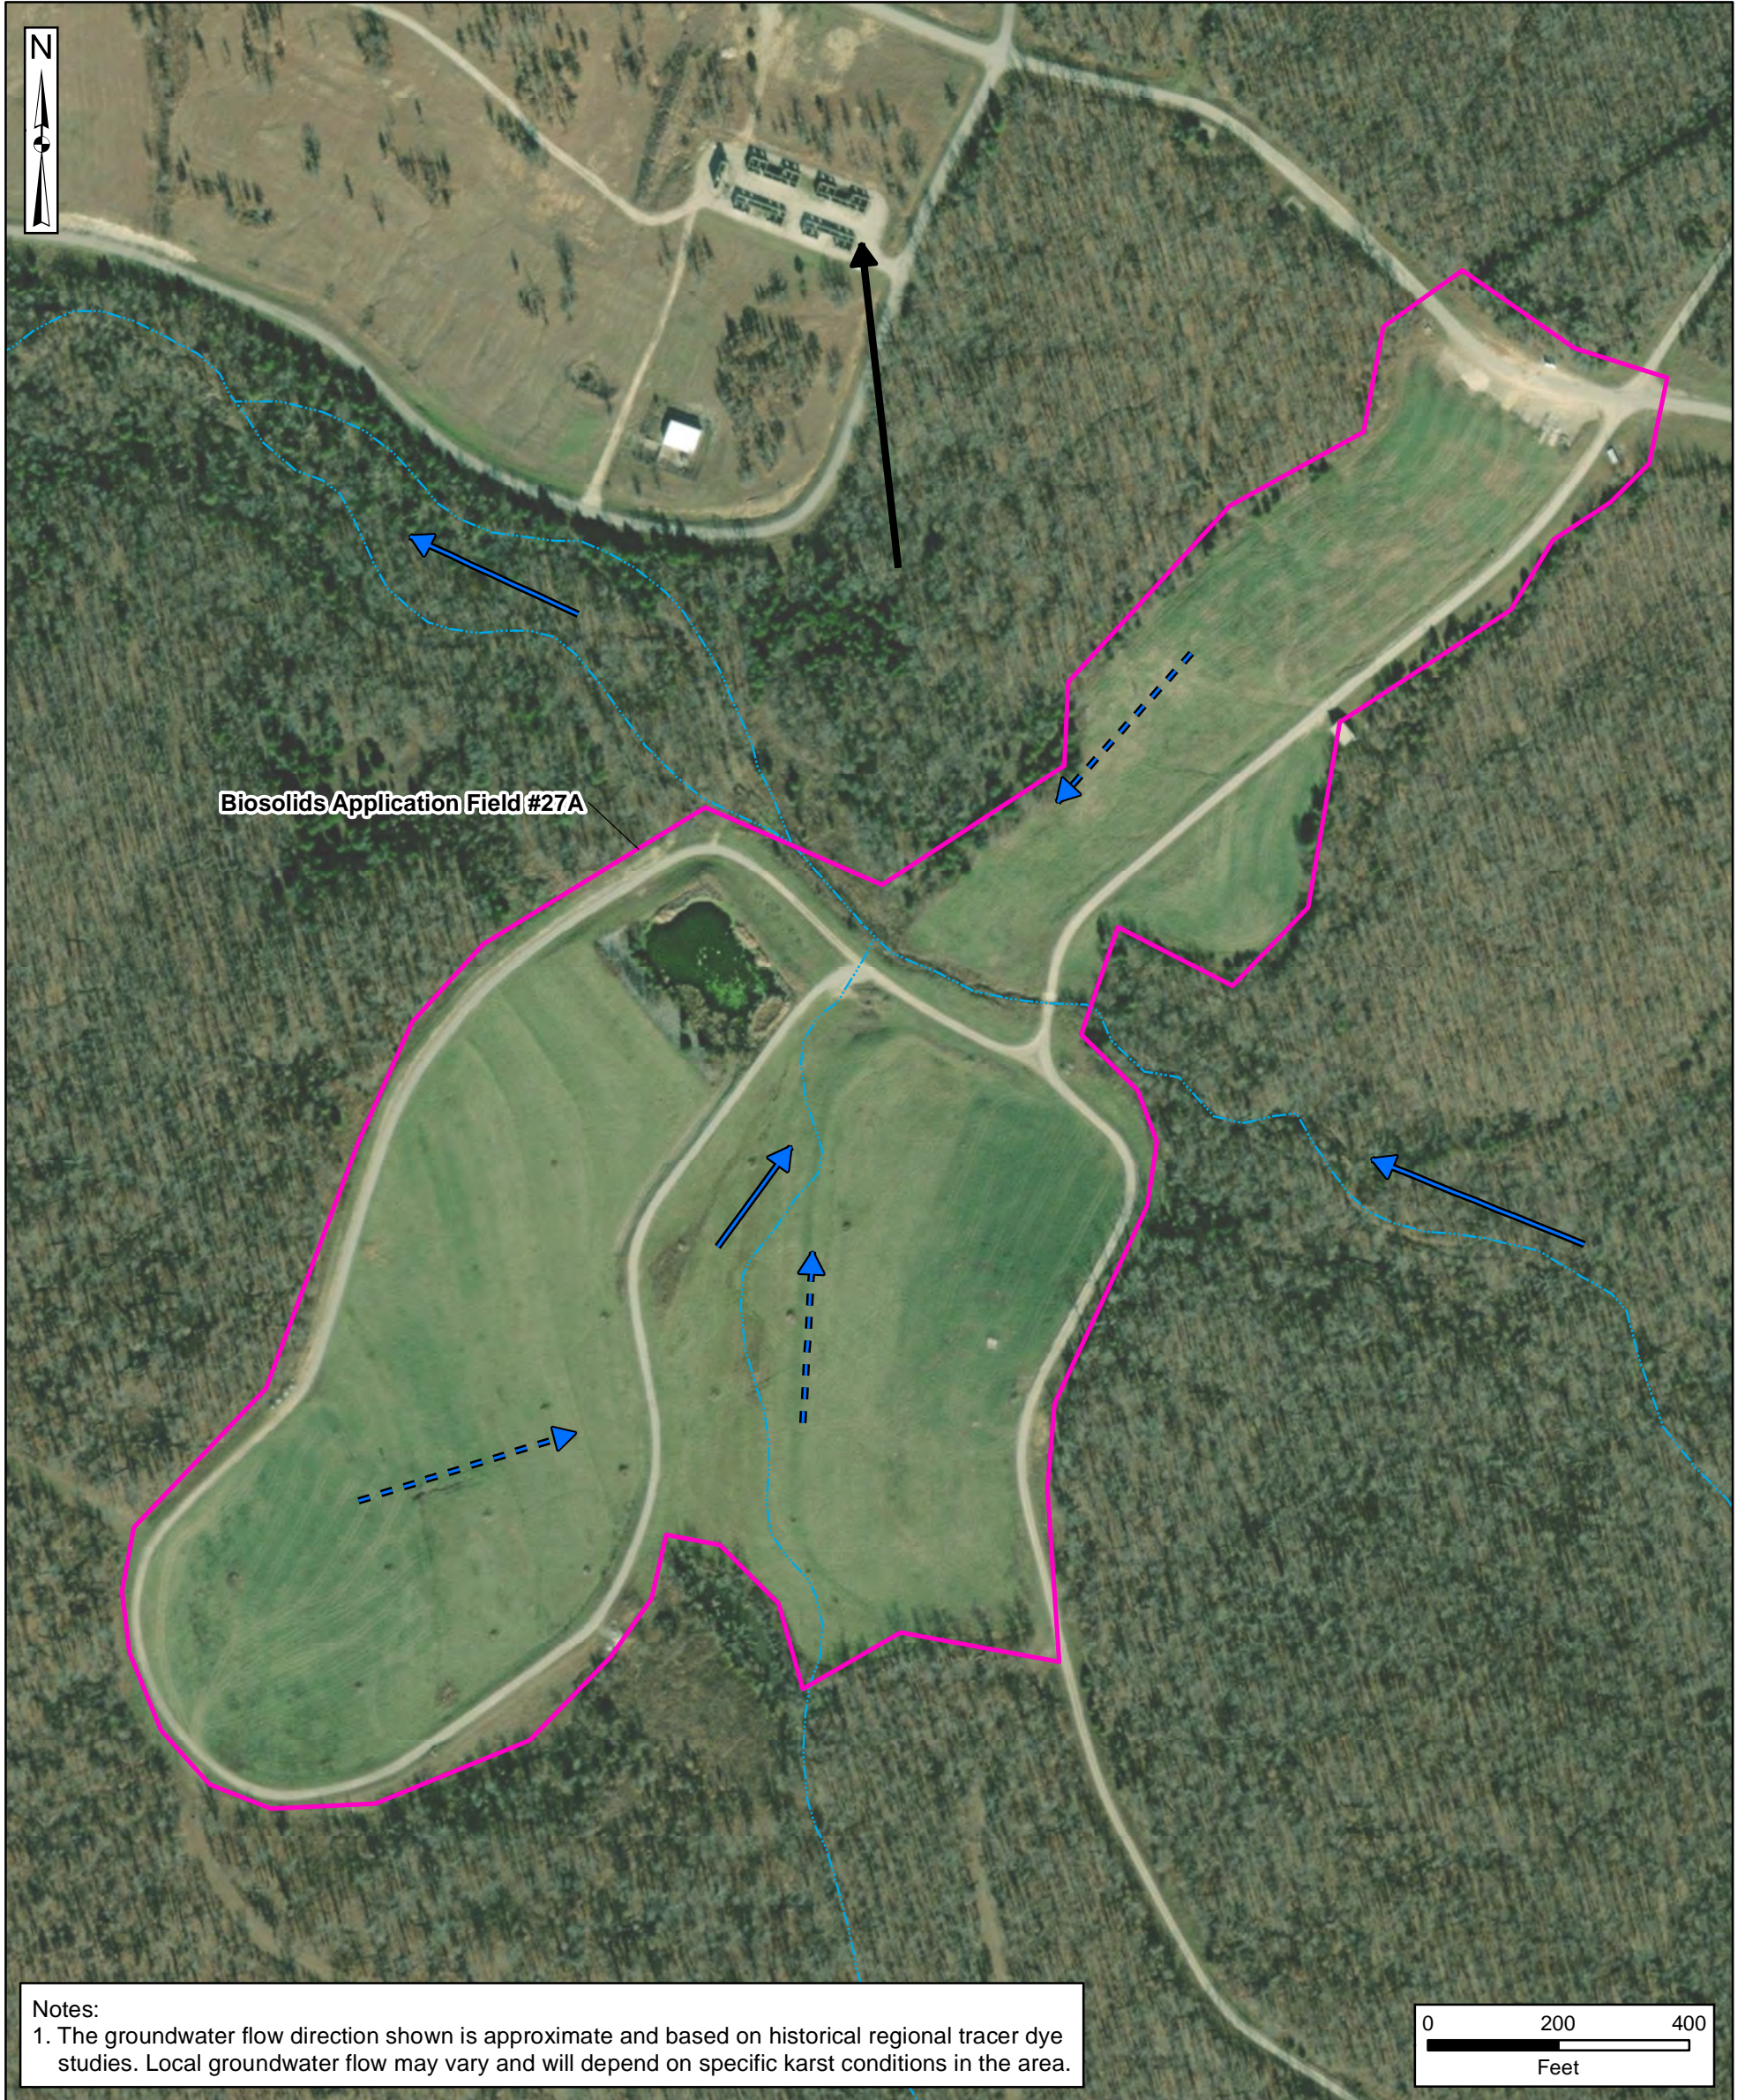
Figure 5-26
Aerial Photo of
Biosolids Application Field #27A

The Biosolids Application Field #27A is identified as an AOPI following records research, personnel interviews, and site reconnaissance due to historical and/or recent application of STP sludge (i.e., biosolids) to the land surface to encourage vegetation growth (**Figure 5-26**). The STP received wastewater potentially containing PFOS, PFOA, and/or PFBS from historical and recent AFFF leaks at the ARNG hangars, former FTAs, and fire stations; therefore, biosolids applied at this AOPI potentially contain PFOS, PFOA, and/or PFBS. The site is an active biosolids management area 35 acres in size. The field is periodically mowed and surrounded by trees. Surface runoff flows to the center of the site, then the northwest to an adjacent ephemeral tributary of Roubidoux Creek. Groundwater from this area generally flows north. The Biosolids Application Fields #27A CSM information is presented in **Section 5.3**. The current and future land use is industrial. This AOPI does not overlap with any open or closed IRP sites.
