Preliminary Assessment/Site Inspection Report

August 2020

Joint Base Lewis-McChord

Pierce County, Washington

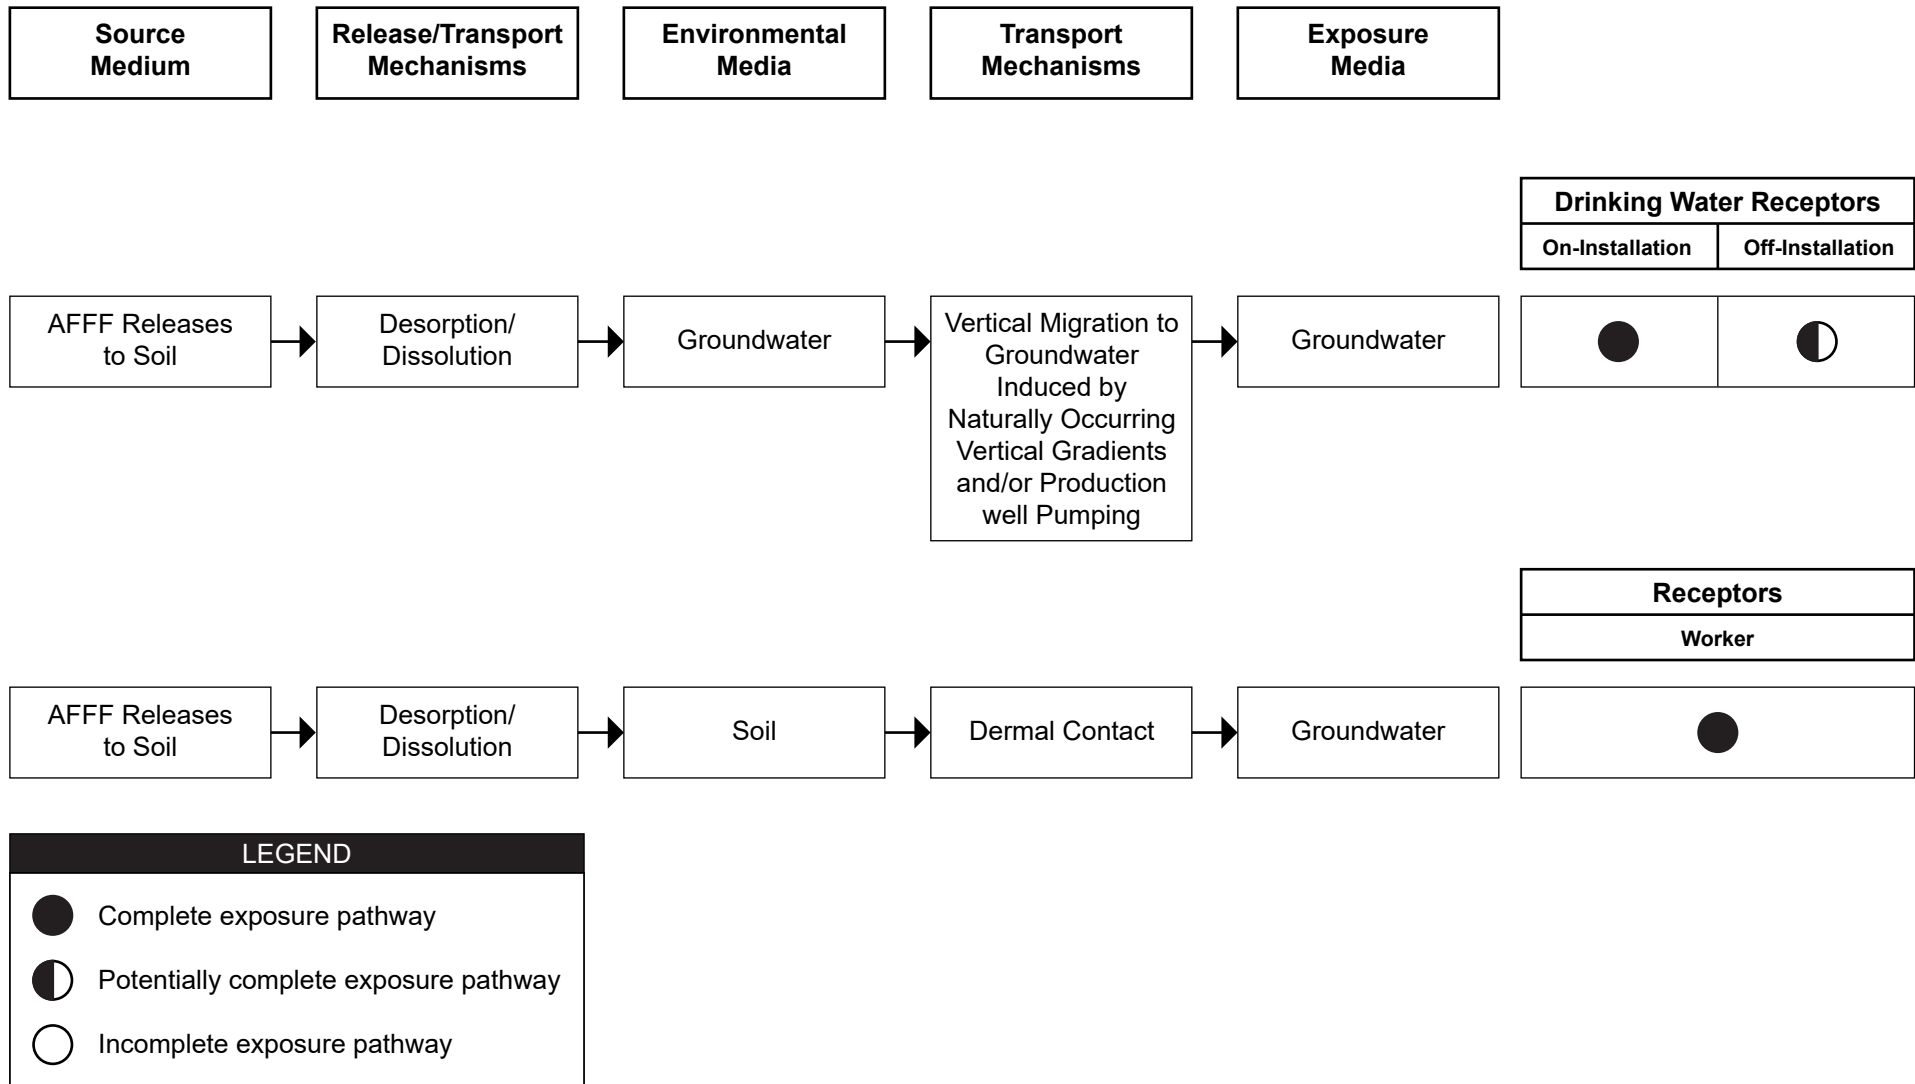
Figure 6-3
Conceptual Exposure Model for
Drinking Water and Soil Pathways,
JBLM Fire Training Areas

- 8 PFAS compounds are not volatile and do not pose a vapor intrusion risk or airborne exposure potential.
- 9 There is some potential for airborne exposure to fire fighters and AFFF-handling personnel only during
- 10 training exercises, emergency actions, and material handling. However, the exposure is terminated at
- 11 the conclusion of the exposing activity.
