FINAL PRELIMINARY ASSESSMENT AND SITE INSPECTION OF PER- AND POLYFLUOROALKYL SUBSTANCES

Fort Drum, New York

Prepared For:
U.S. Army Corps of Engineers, Baltimore District
2 Hopkins Plaza
Baltimore, Maryland 21201

November 2022

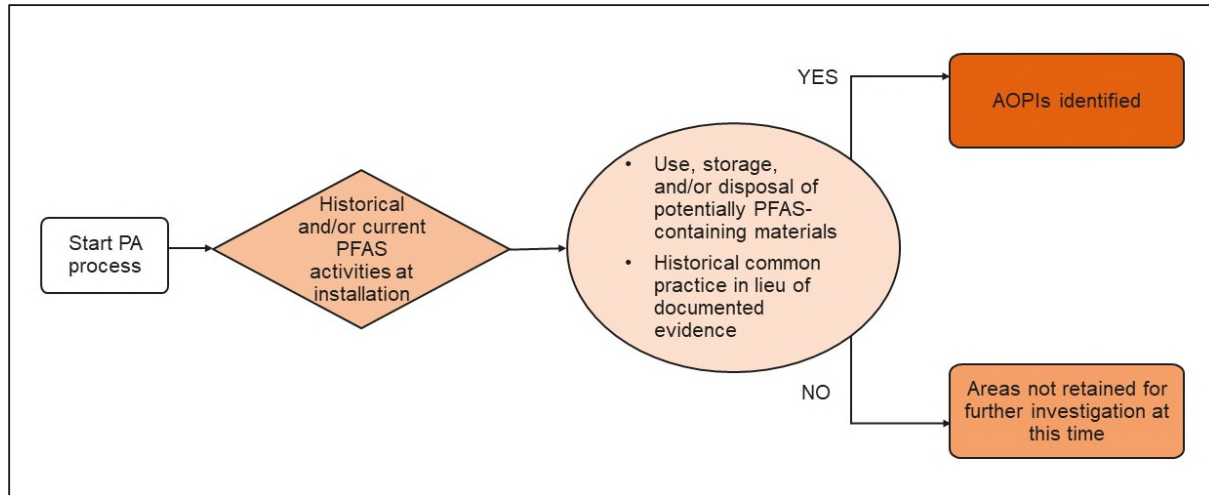
Figure 5-1: AOPI Decision Flowchart

The preliminary locations evaluated for potential use, storage and/or disposal of PFAS-containing materials at Fort Drum were further refined during the PA process and identified either as an area not retained for further investigation or as an AOPI. In accordance with the established process for the PA/SI, 36 areas have been identified as AOPIs. The process used for refining these areas is presented on **Figure 5-1**, below.

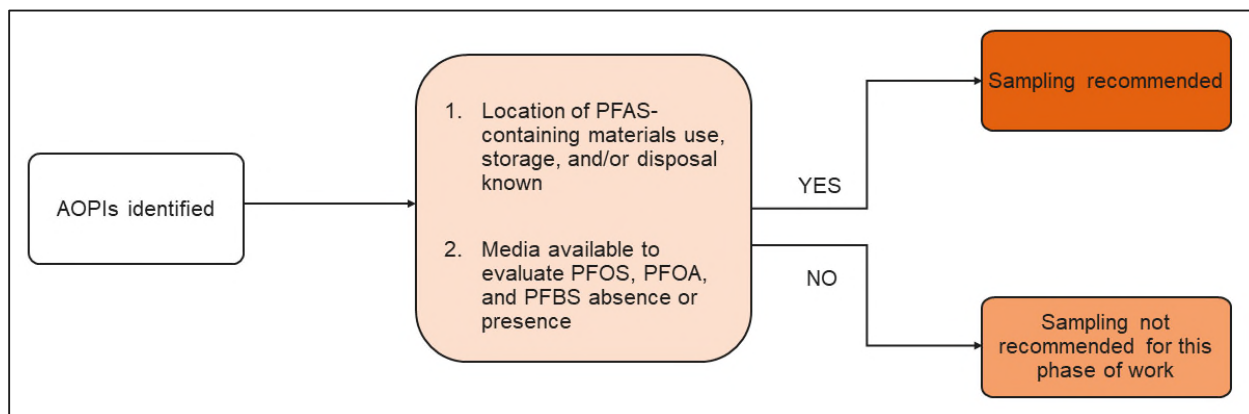
Figure 6-1: AOPI Sampling Decision Tree

The rationale for sampling at each AOPI is illustrated on **Figure 6-1** below.

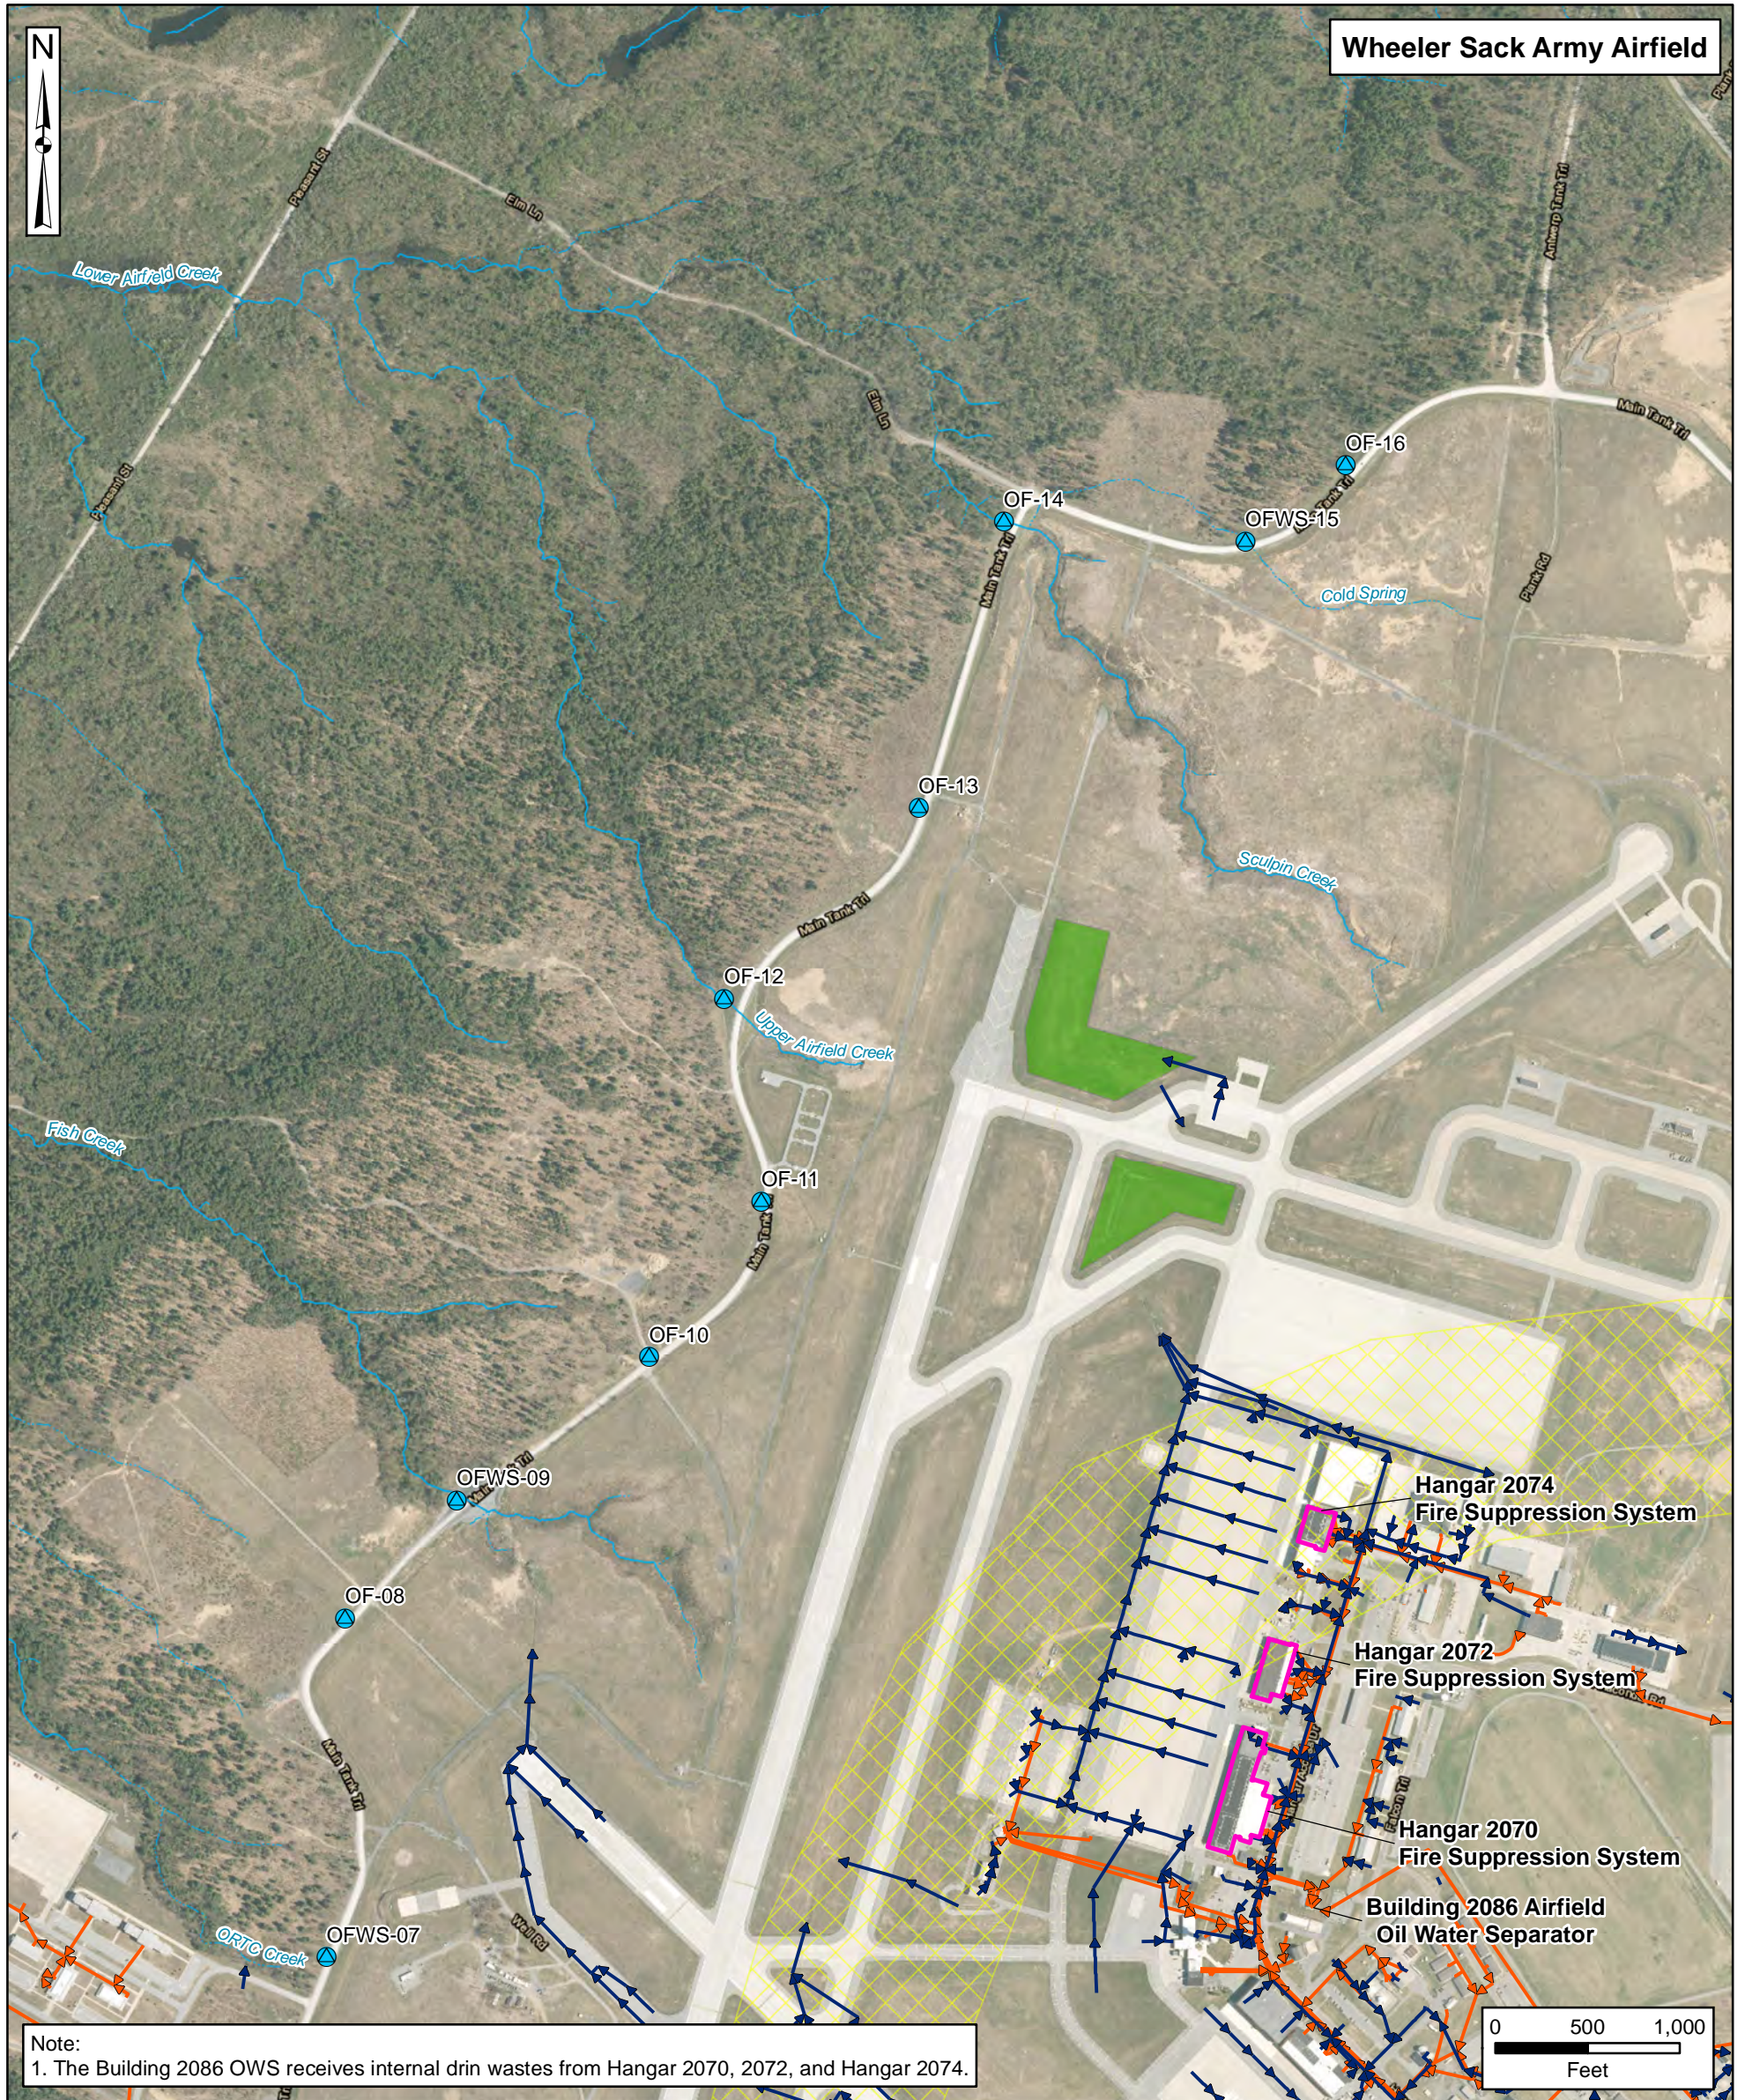
Figure 5-5
Aerial Photo of
Hangars 2070, 2072, and 2074 and
Secondary Source Building 2086 Airfield OWS

Note:
1. The Building 2086 OWS receives internal drain wastes from Hangar 2070, 2072, and Hangar 2074.

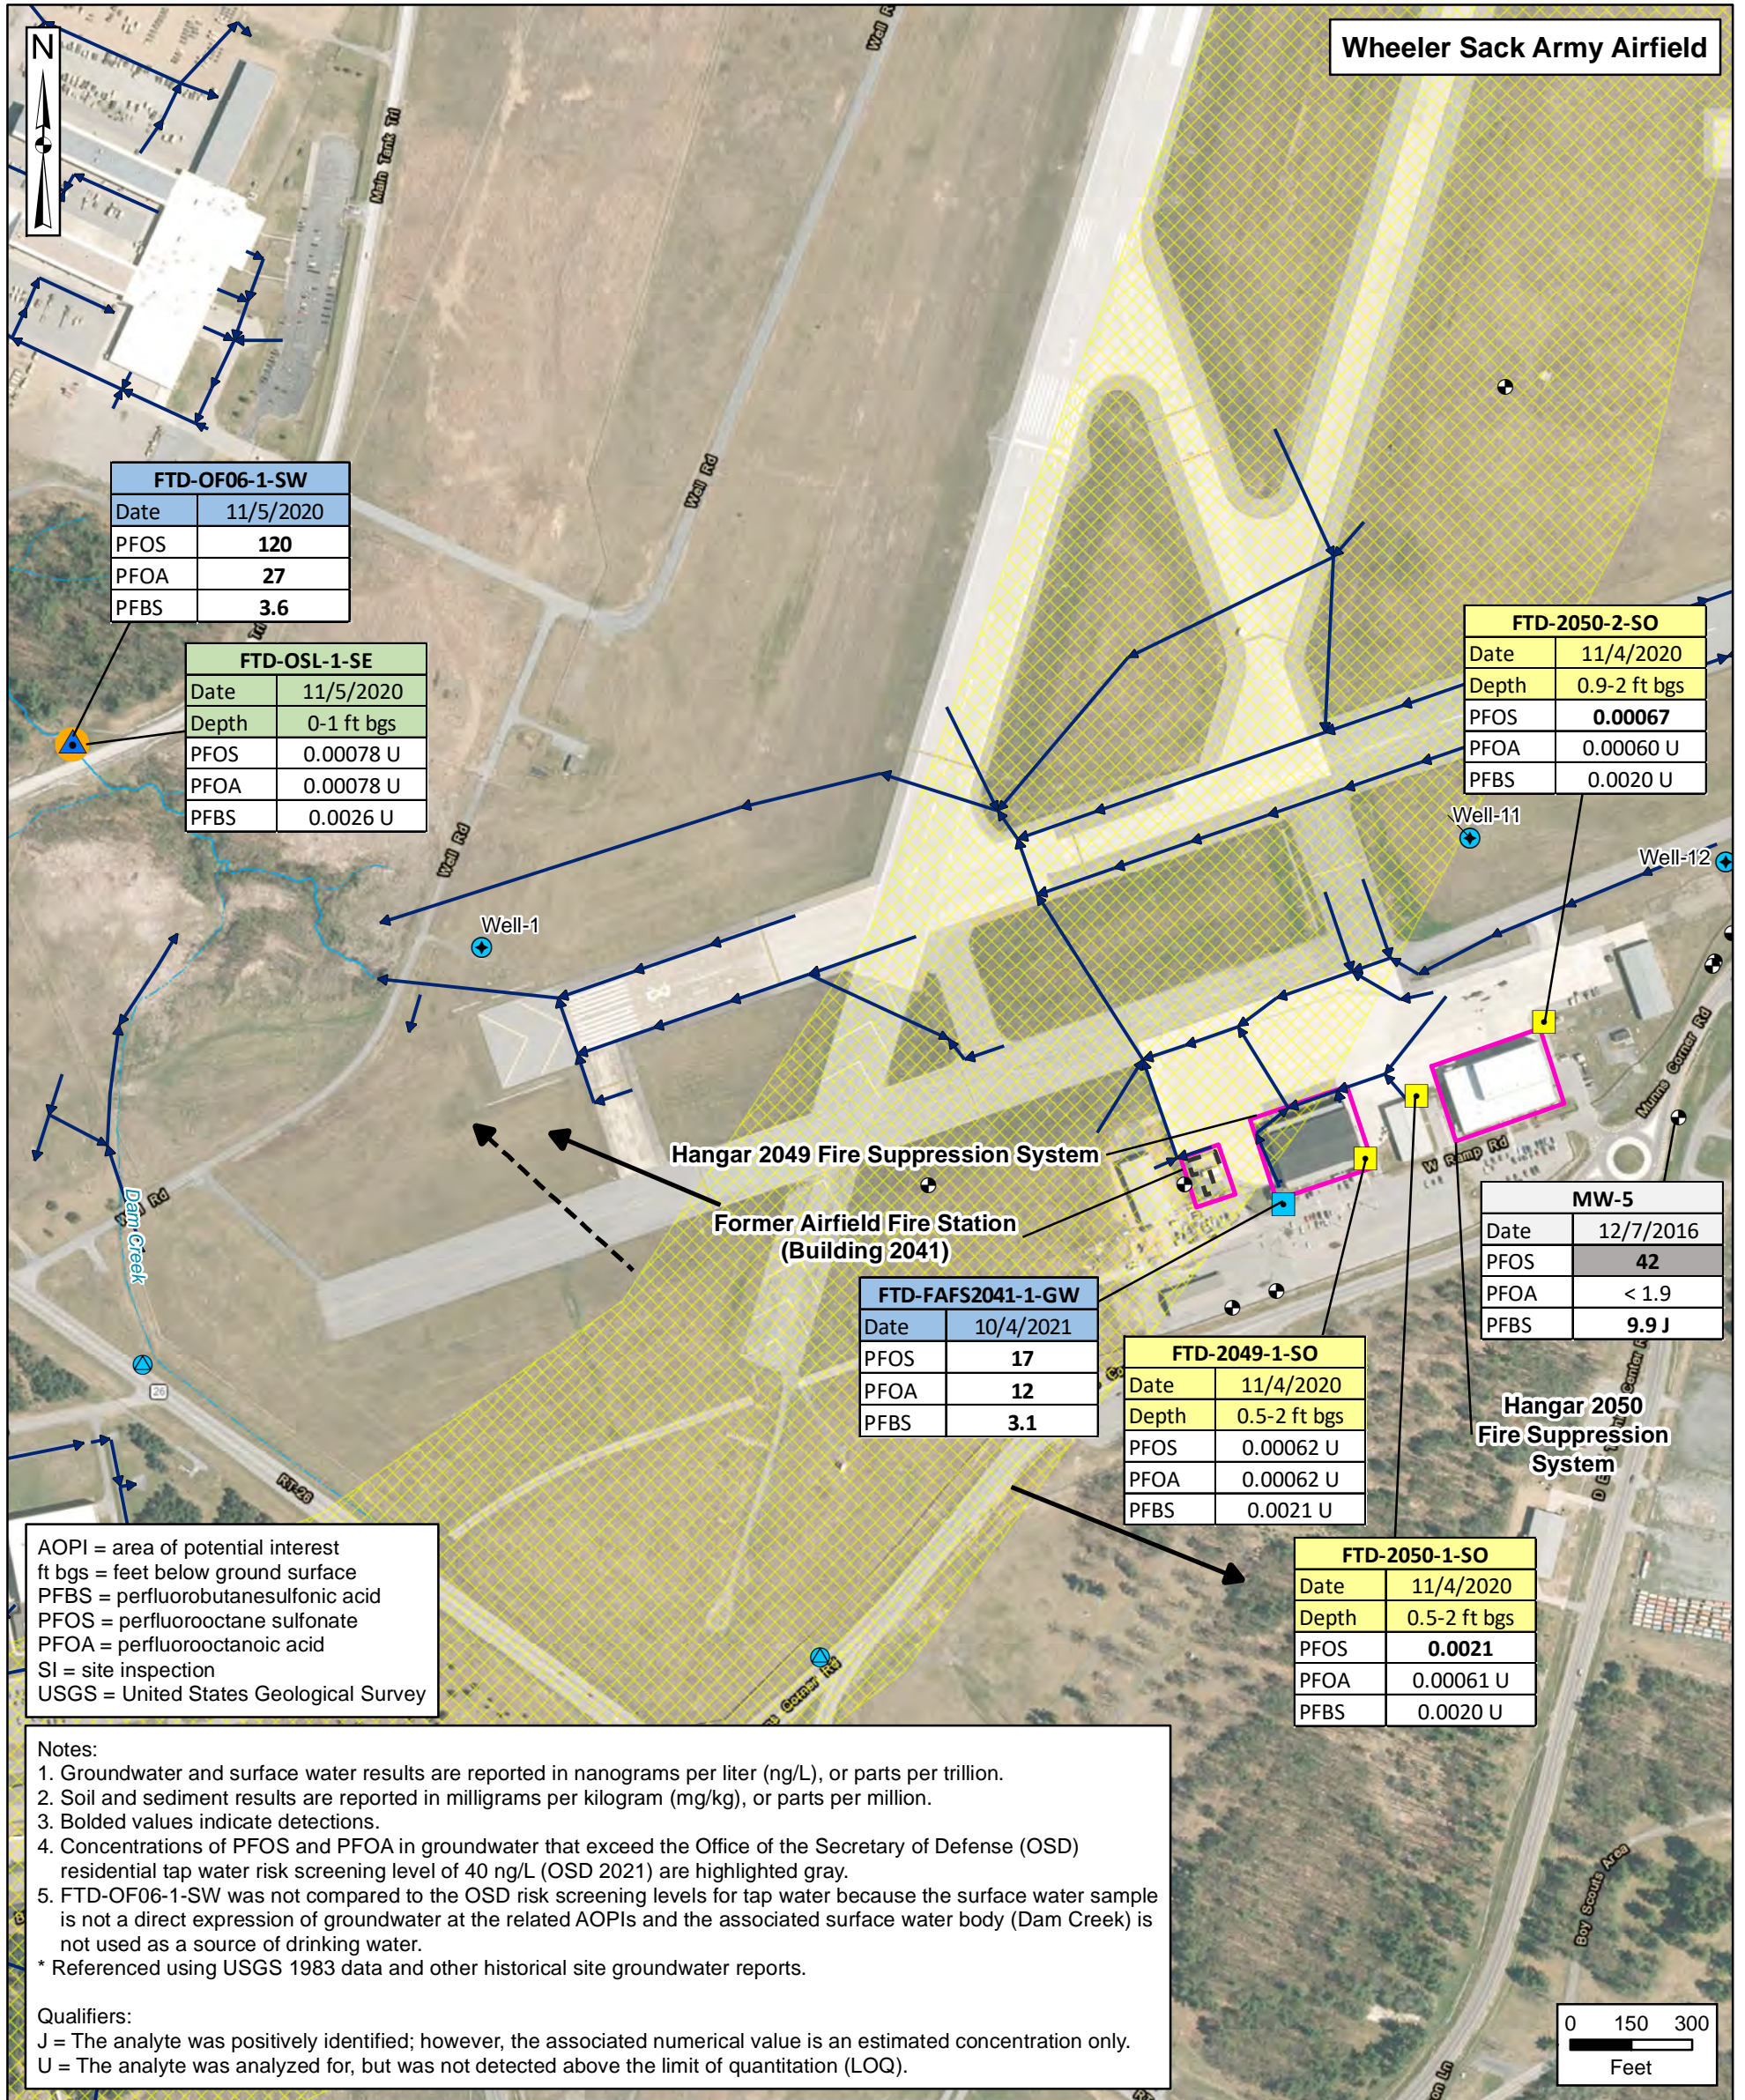
Figure 7-9
Hangar 2049 Fire Suppression System, Hangar 2050 Fire Suppression System, and Former Airfield Fire Station (Building 2041) PFOS, PFOA, and PFBS Analytical Results

FTD-OF06-1-SW	
Date	11/5/2020
PFOS	120
PFOA	27
PFBS	3.6

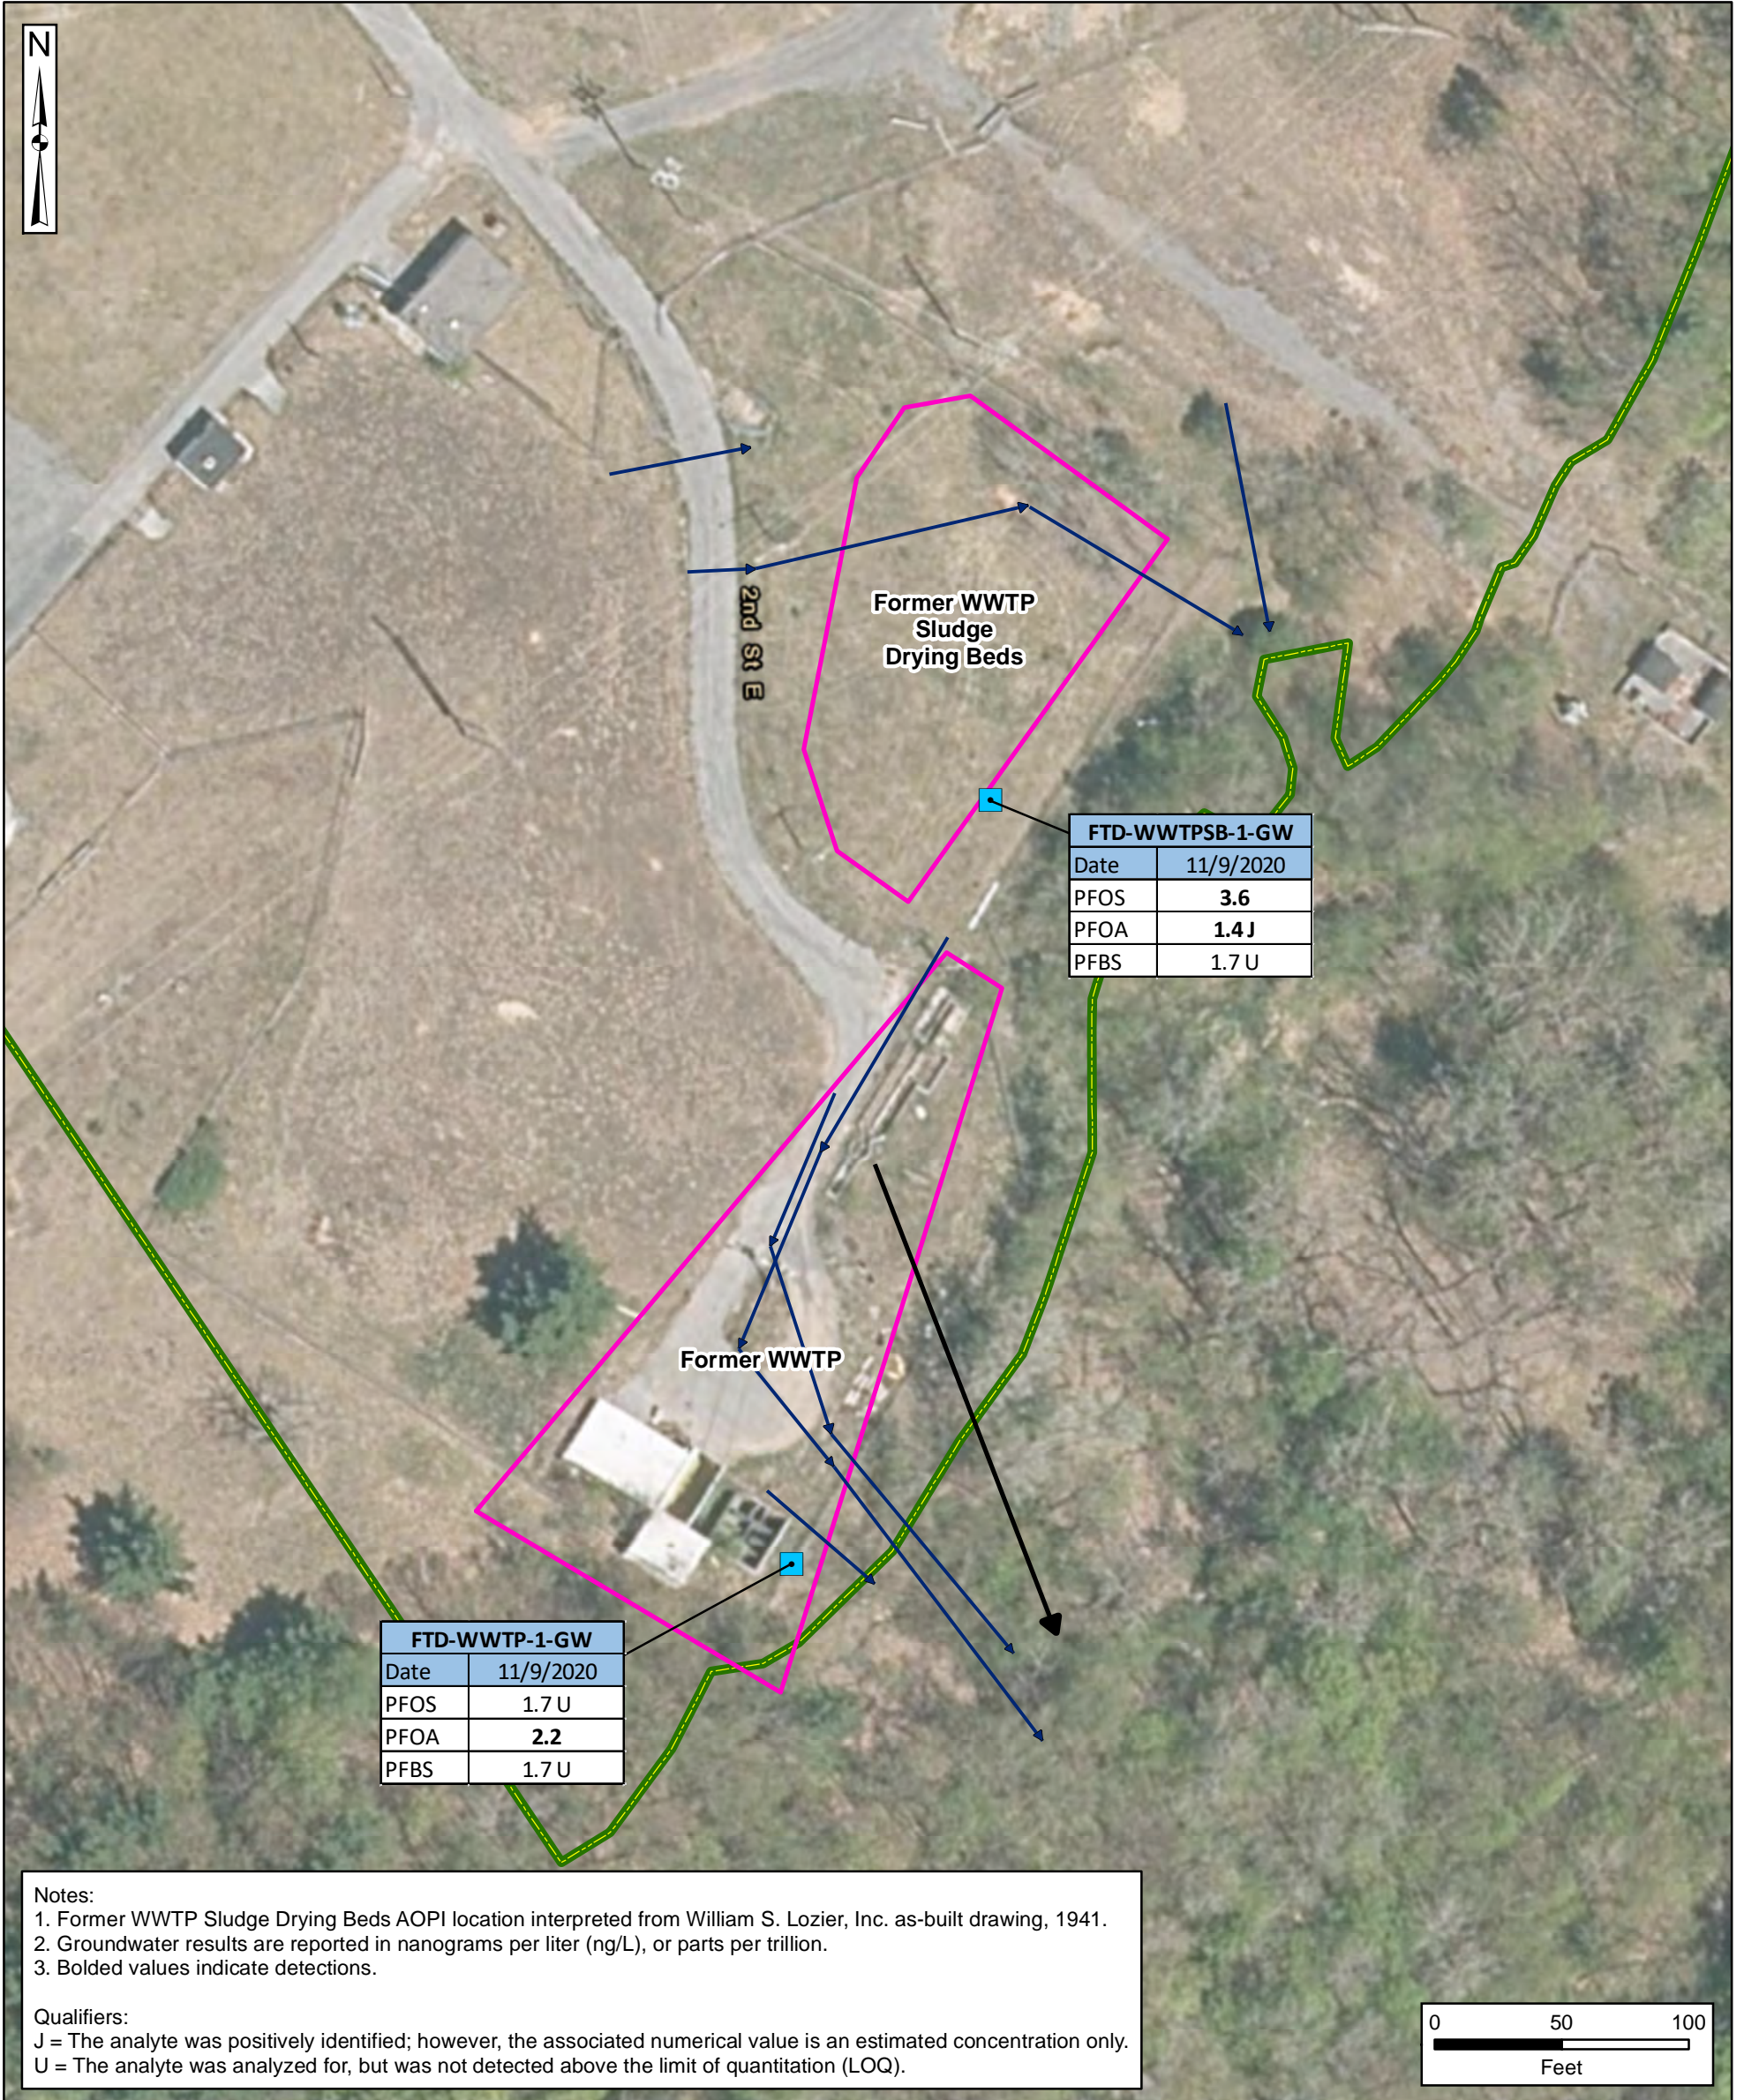
Figure 7-10
Former WWTP and Former WWTP
Sludge Drying Beds AOPIs
PFOS, PFOA, and PFBS Analytical Results

groundwater sample was collected immediately downgradient of the Former WWTP to capture AFFF that might have been released via leaks in the Former WWTP infrastructure (**Figure 7-10**).

One grab groundwater sample (FTD-WWTPSB-1-GW) was collected following DPT drilling. The groundwater sample was collected immediately downgradient of the Former WWTP Sludge Drying Beds to capture PFOS, PFOA, and PFBS releases from sludges before they were excavated (**Figure 7-10**).

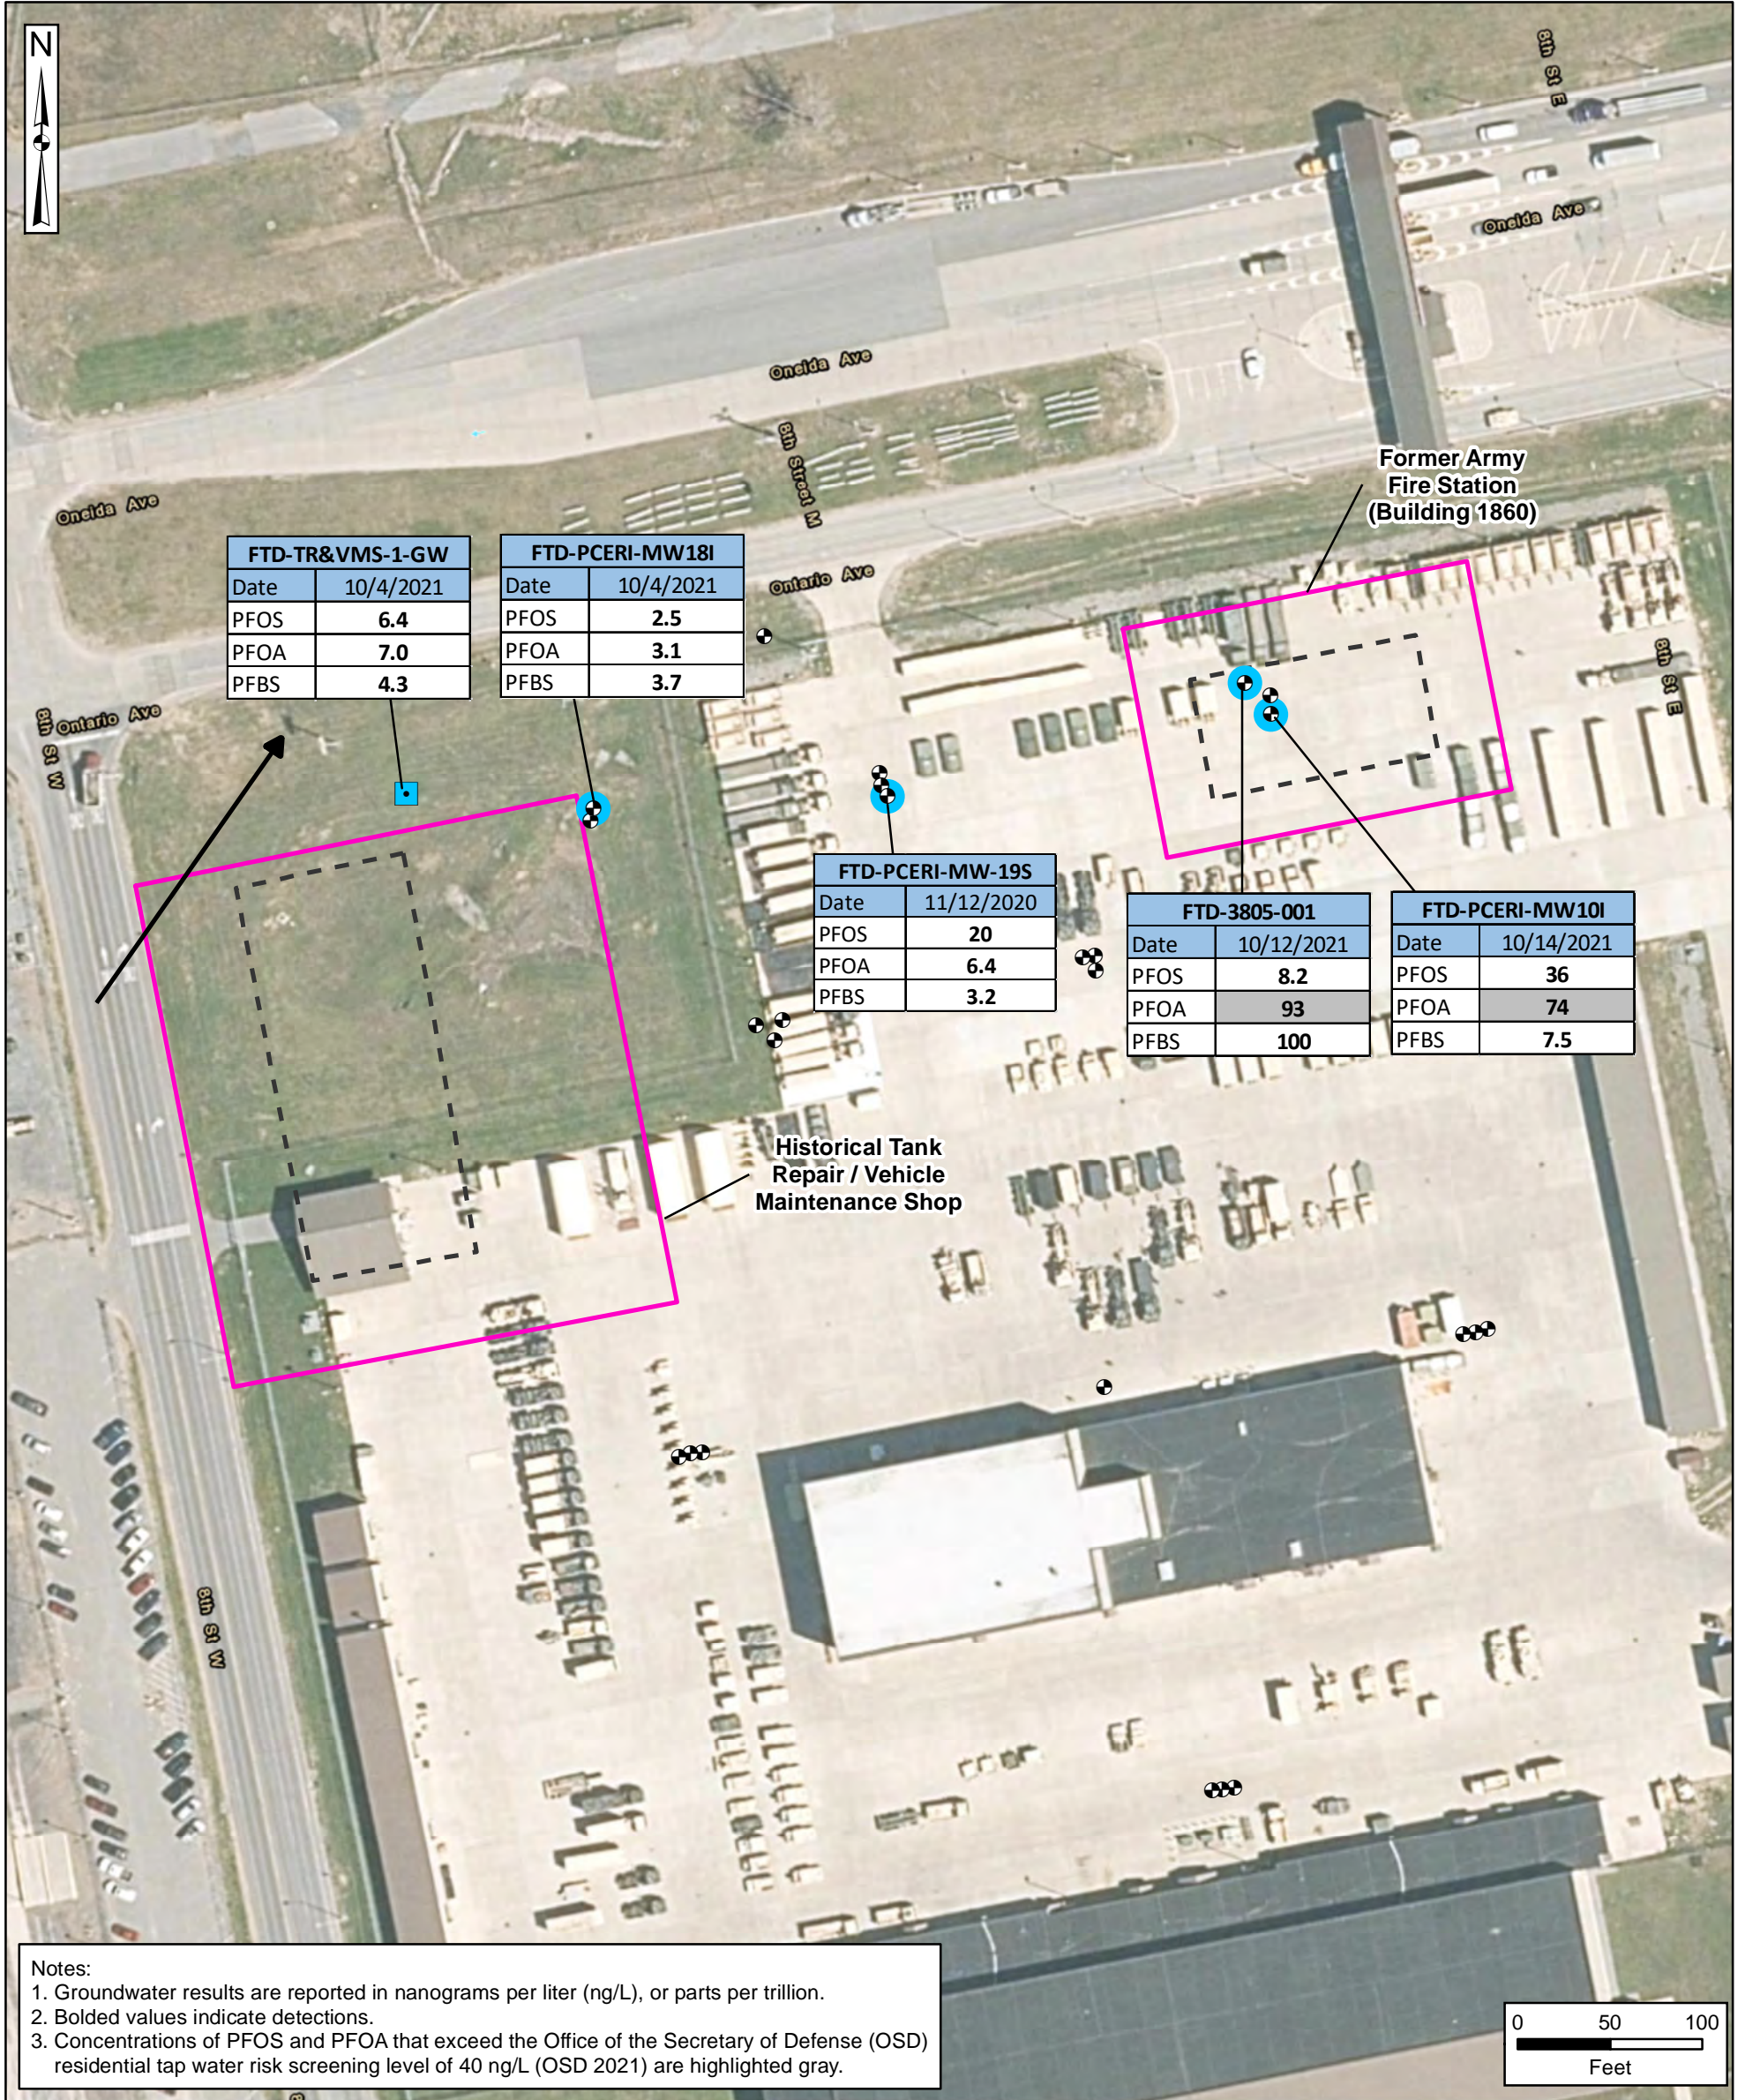
Figure 7-11
Former Army Fire Station (Building 1860) and
Historical Tank Repair/Vehicle Maintenance Shop AOPIs
PFOS, PFOA, and PFBS Analytical Results

Notes:
1. Groundwater results are reported in nanograms per liter (ng/L), or parts per trillion.
2. Bolded values indicate detections.
3. Concentrations of PFOS and PFOA that exceed the Office of the Secretary of Defense (OSD) residential tap water risk screening level of 40 ng/L (OSD 2021) are highlighted gray.

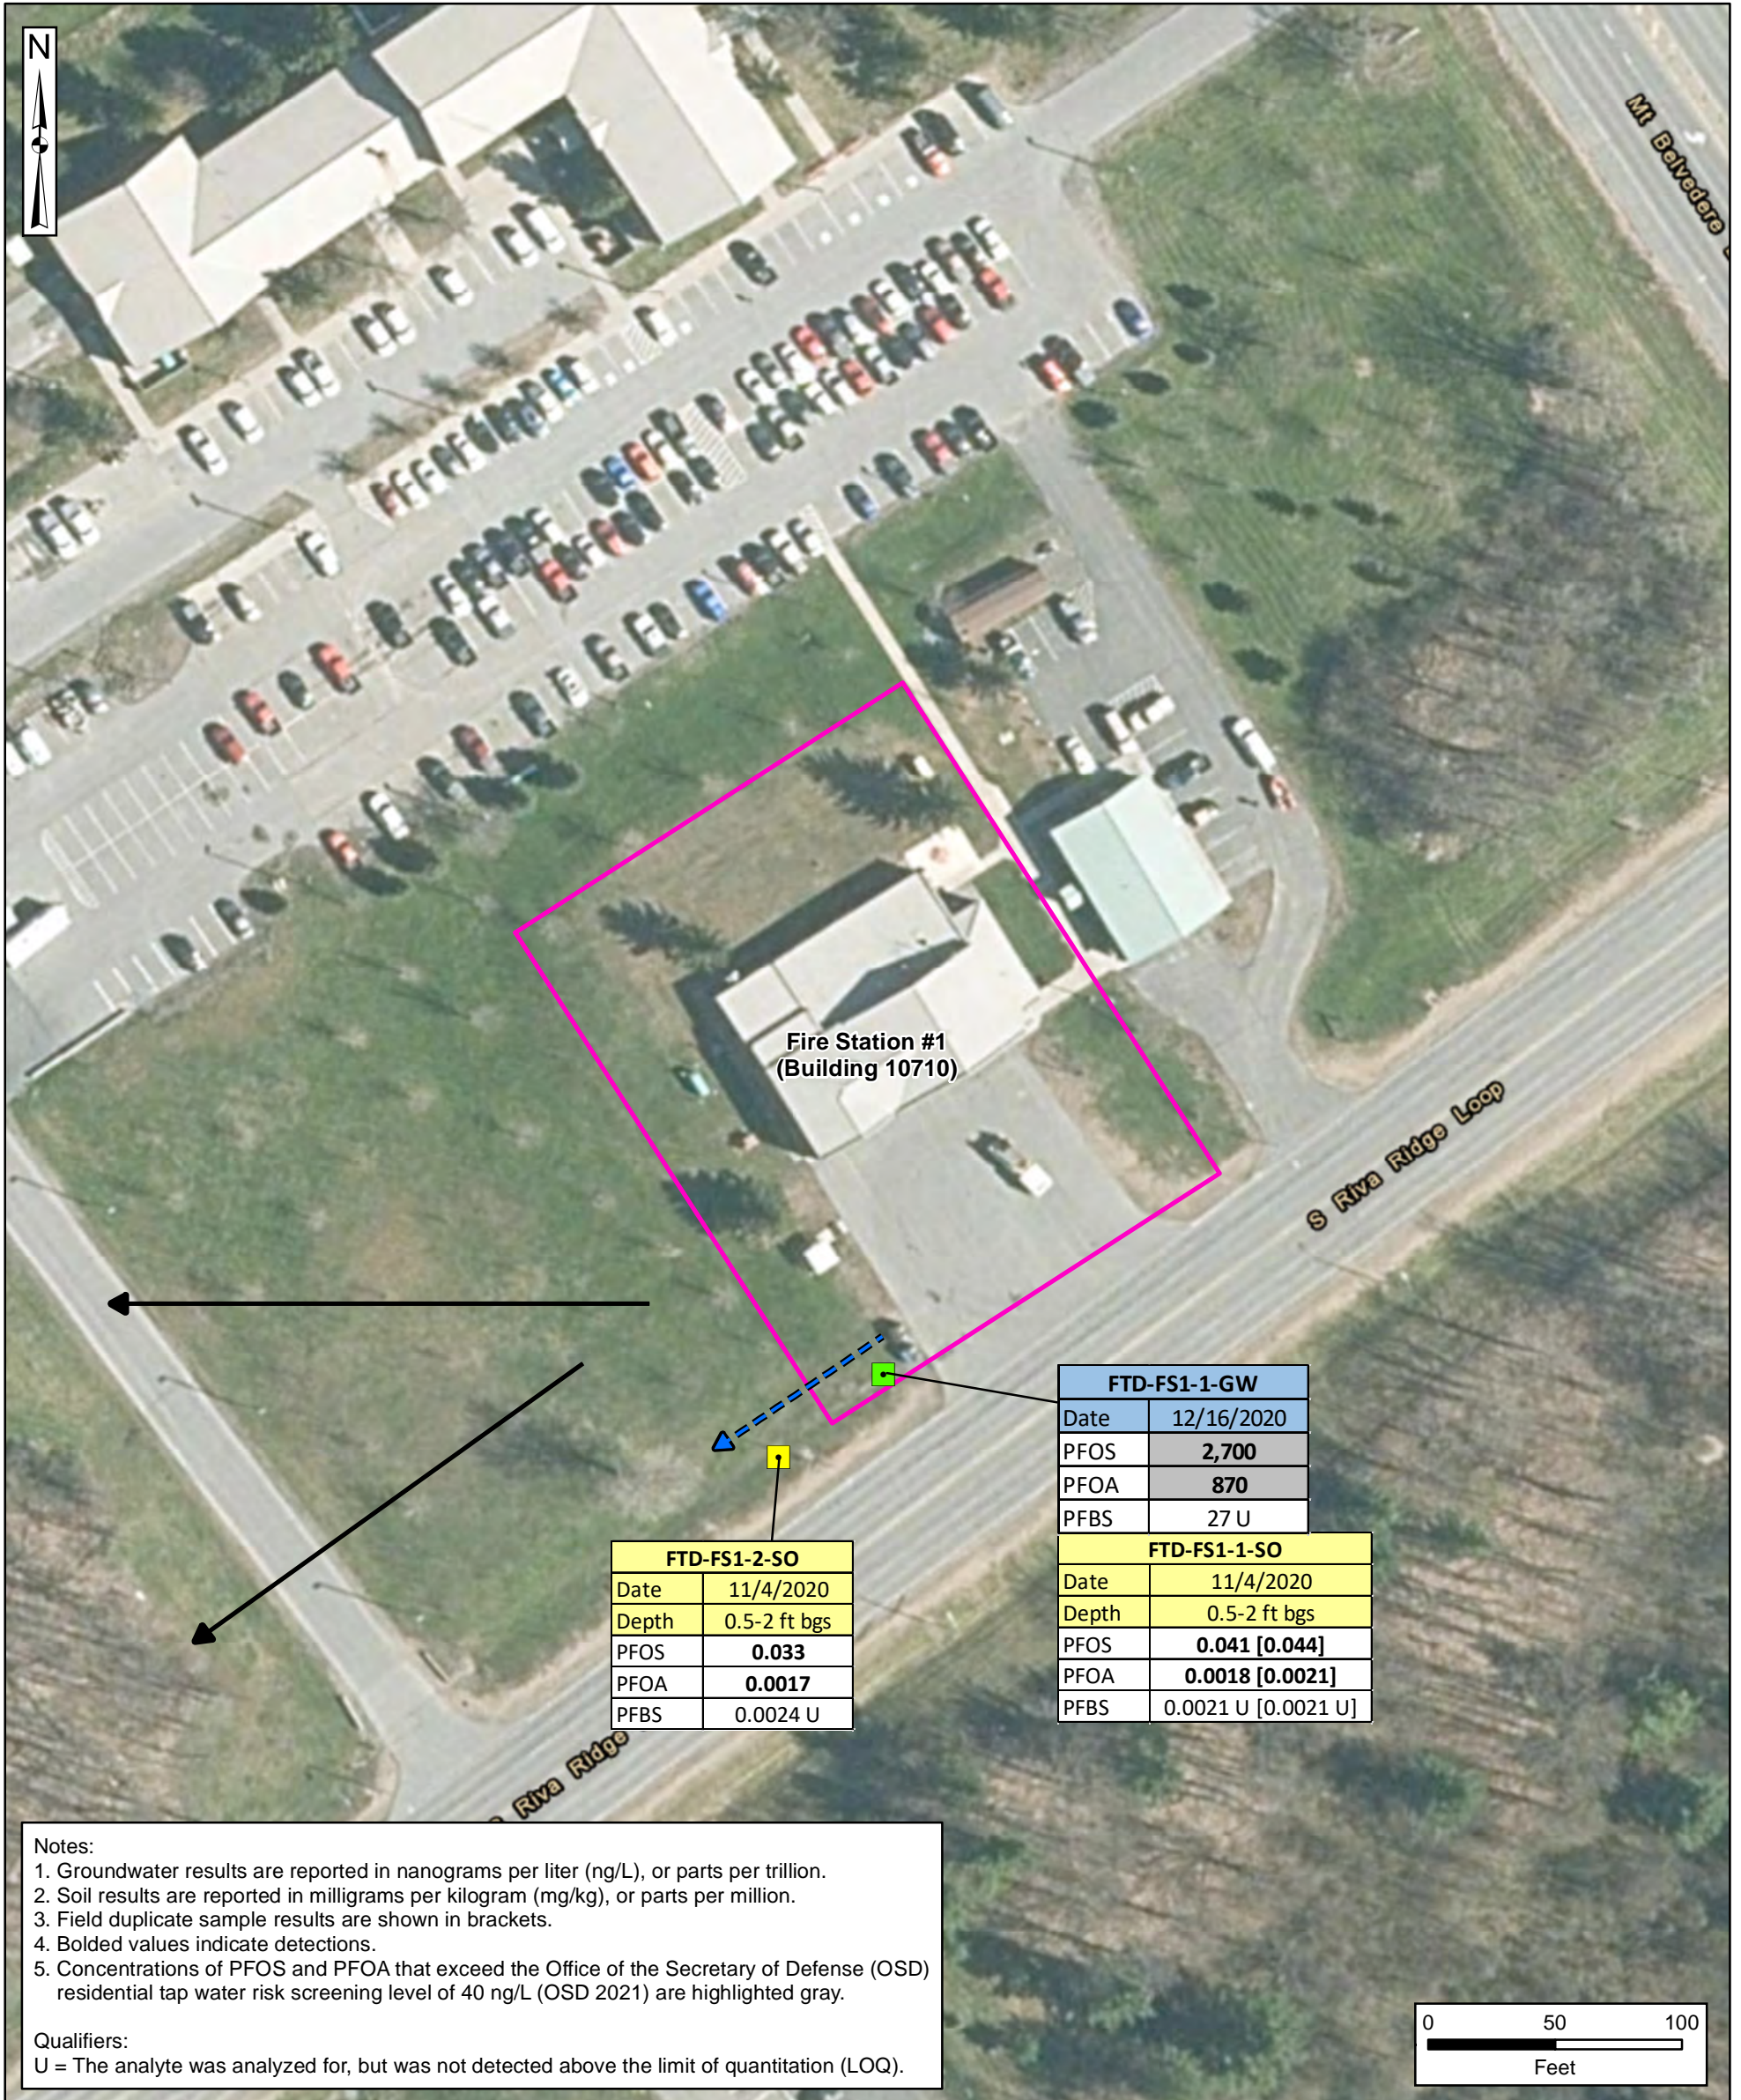
Figure 7-12
Fire Station #1 (Building 10710) AOP
PFOS, PFOA, and PFBS Analytical Results

One grab groundwater sample (FTD-FS1-1-GW) was collected following HSA drilling. The exact area of potential AFFF release is unknown, therefore the groundwater sample was collected from a stormwater drainage swale downgradient from the station driveway to assess AFFF releases from fire truck washing/storage, and transfers into fire truck tanks (**Figure 7-12**).

Two surface soil samples (FTD-FS1-1-SO and FTD-FS1-2-SO) were collected via hand auger within the stormwater drainage swale that potentially received runoff from AFFF releases from the fire station and parking lot/driveway during the operational period. Surface soil sample FTD-FS1-1-SO was co-located with groundwater sample FTD-FS1-1-GW (**Figure 7-12**).
