FINAL PRELIMINARY ASSESSMENT AND SITE INSPECTION OF PER- AND POLYFLUOROALKYL SUBSTANCES

Fort Drum, New York

Prepared For:
U.S. Army Corps of Engineers, Baltimore District
2 Hopkins Plaza
Baltimore, Maryland 21201

November 2022

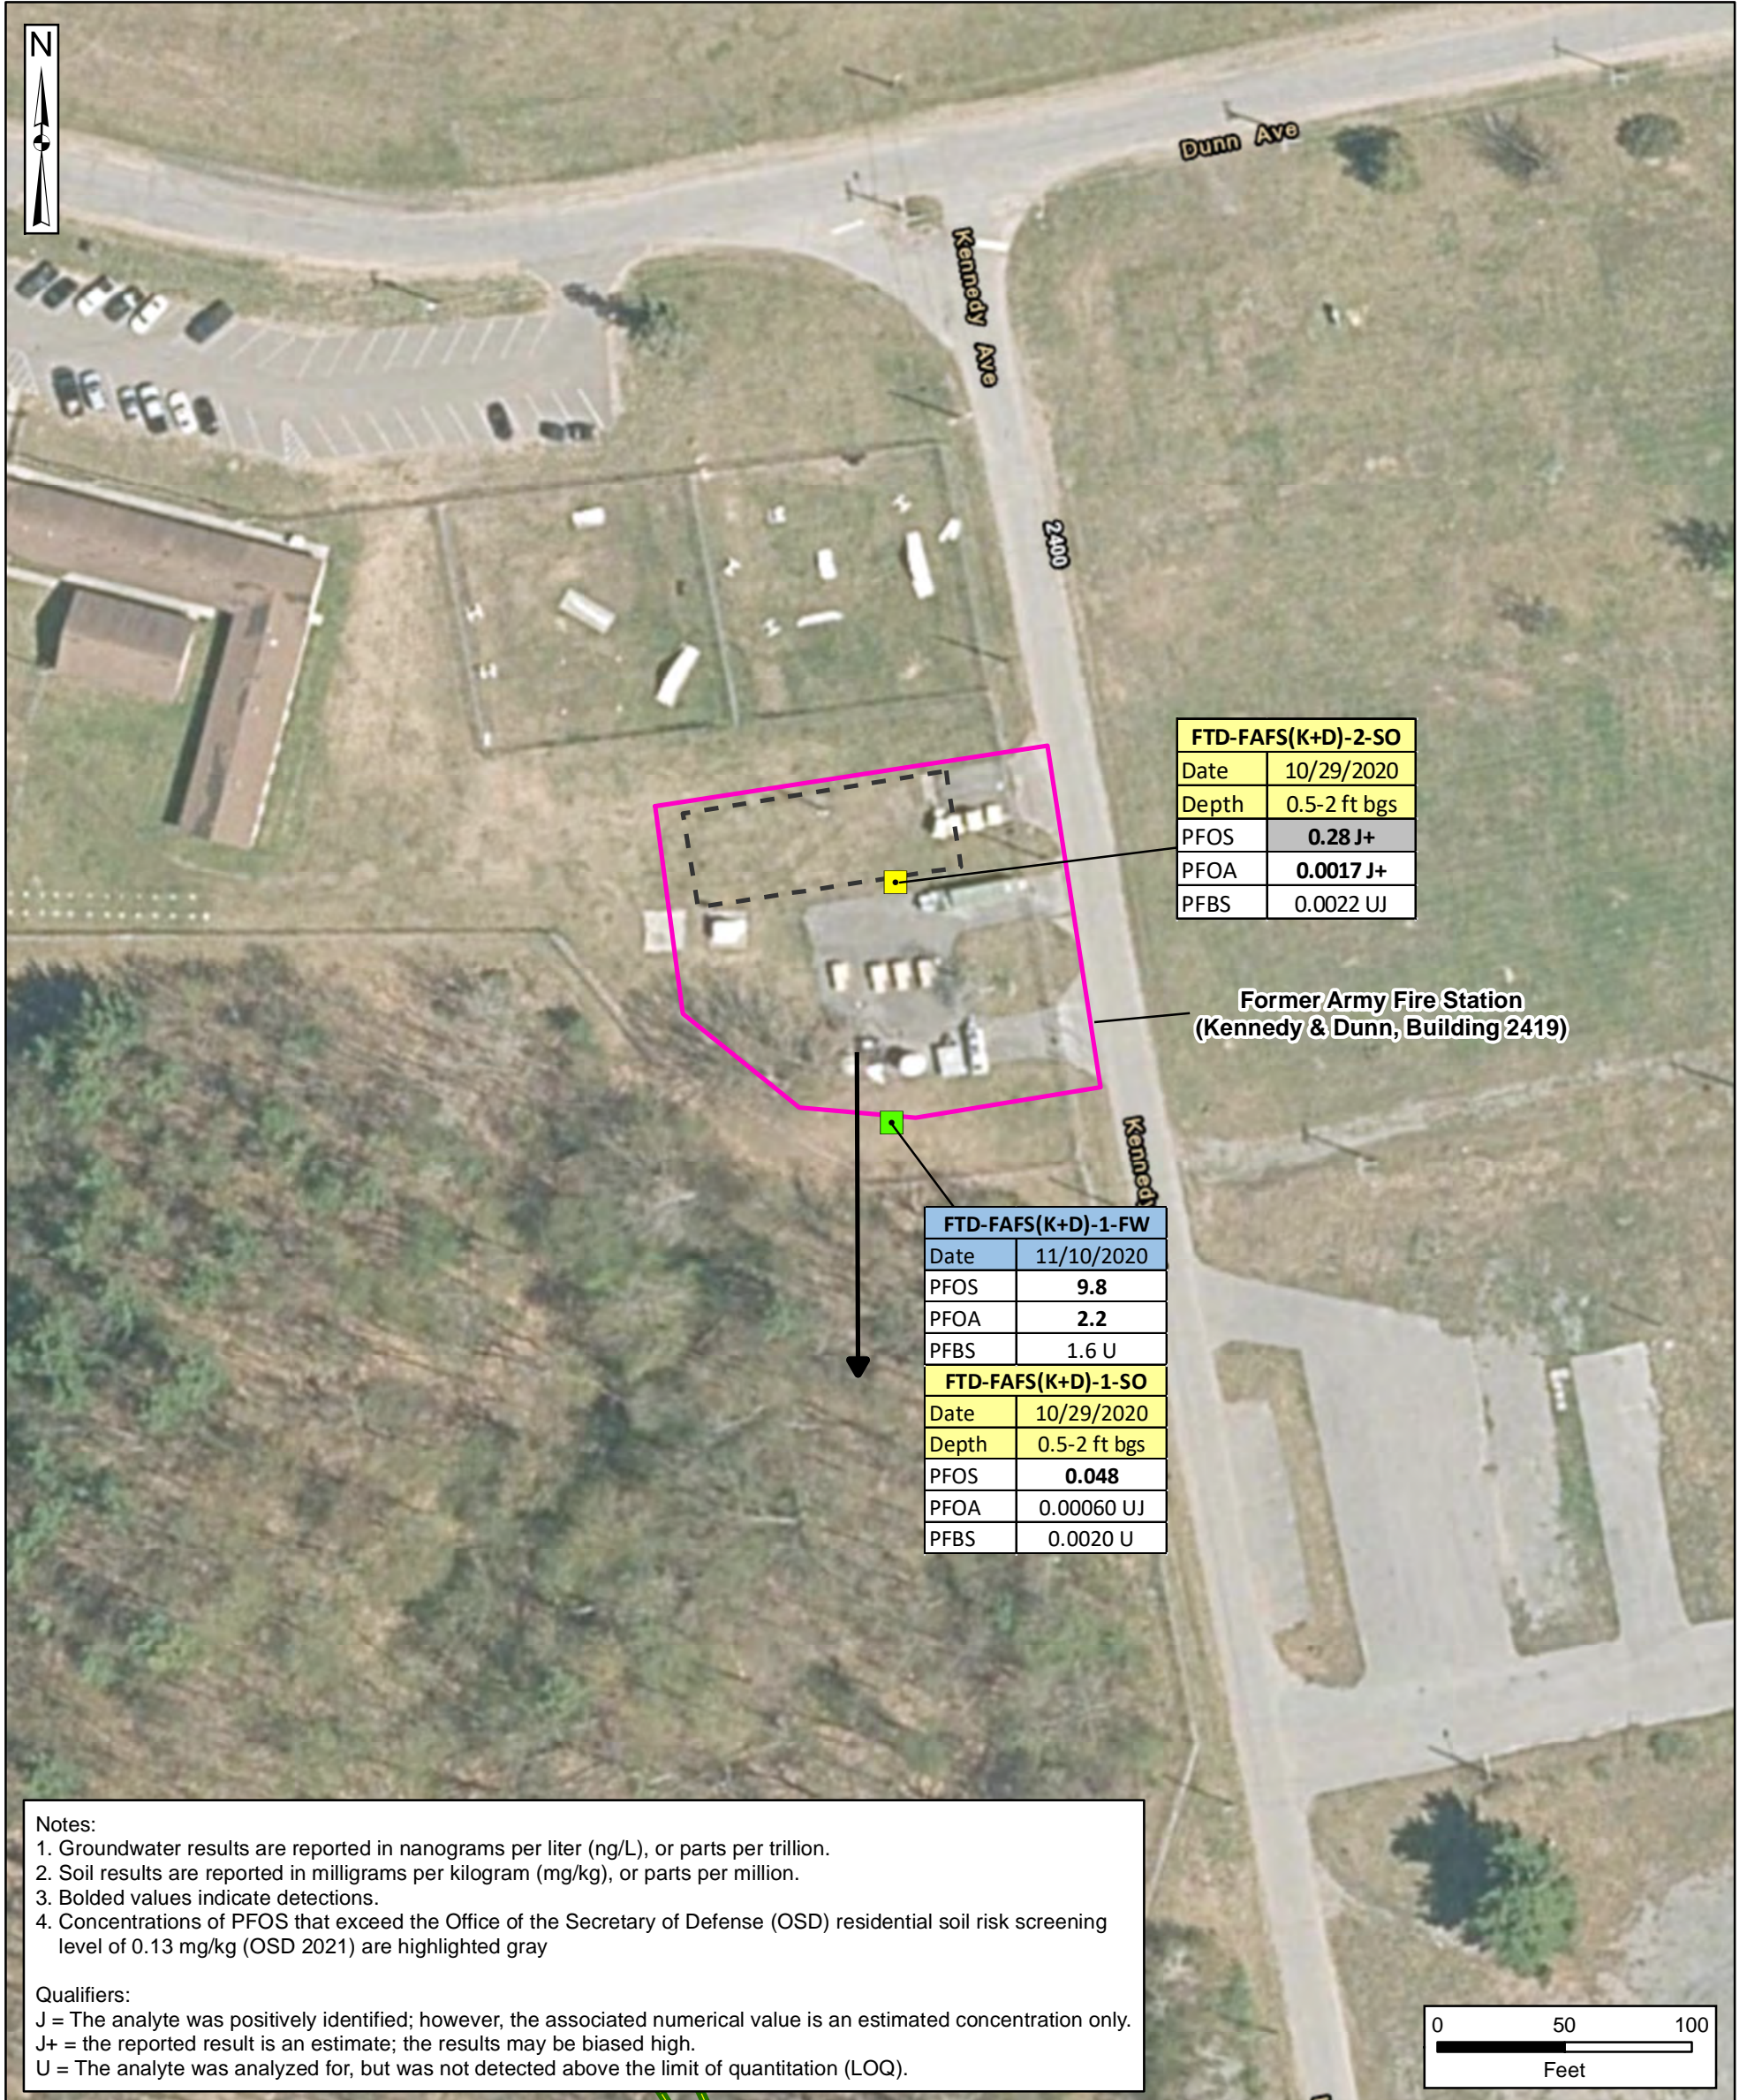
Figure 7-13
Former Army Fire Station
(Kennedy & Dunn, Building 2419) AOP
PFOS, PFOA, and PFBS Analytical Results

One grab groundwater sample (FTD-FAFS[K+D]-1-GW) was collected following DPT drilling. The potential AFFF release area at the AOPI is unknown. Therefore, the groundwater sample was located downgradient of the historical building footprint to capture historical AFFF releases during the operational period of the fire station (**Figure 7-13**).

Two surface soil samples (FTD-FAFS[K+D]-1-SO and FTD-FAFS[K+D]-2-SO) were collected via hand auger. The potential AFFF release area at the AOPI is unknown. Therefore, surface soil sample FTD-FAFS[K+D]-2-SO was collected adjacent to former building where the vehicle bays were located and surface soil sample FTD-FAFS[K+D]-1-SO was collected at the edge of the paved driveway to assess potential AFFF runoff from the fire station driveway. Surface soil sample FTD-FAFS[K+D]-1-SO was co-located with groundwater sample FTD-FAFS[K+D]-1-GW (**Figure 7-13**).

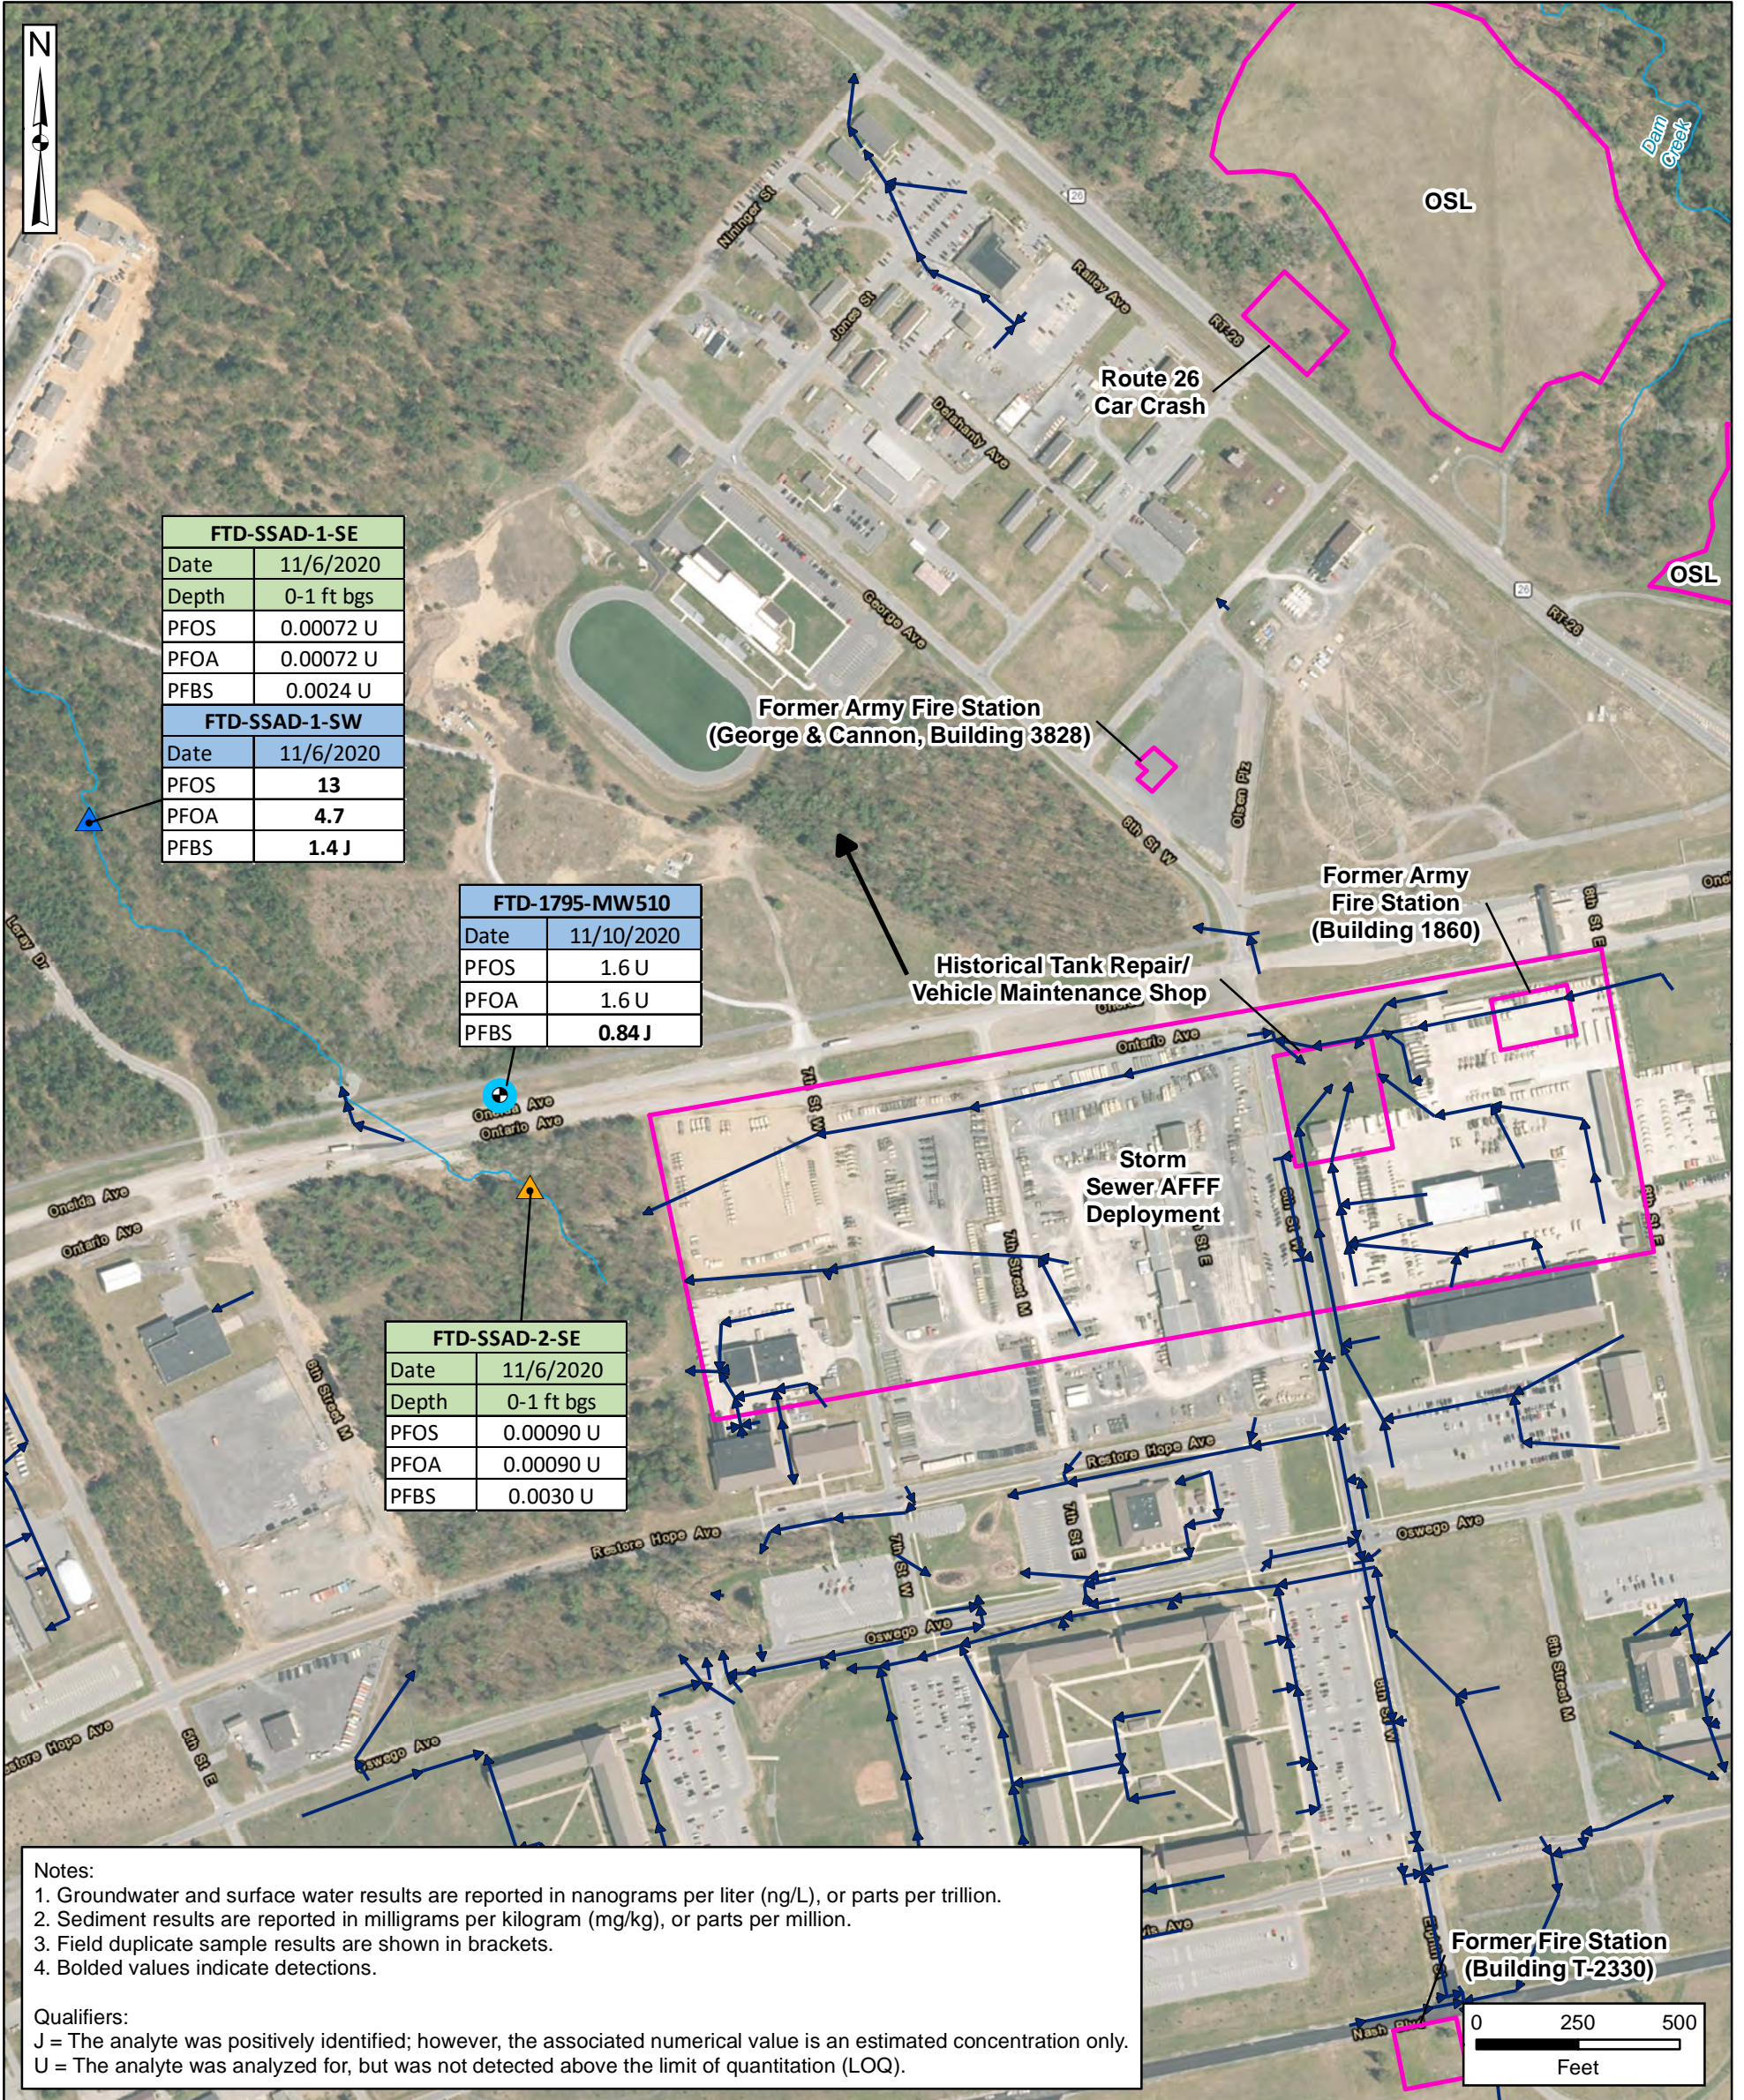
Figure 7-17
Storm Sewer AFFF Deployment AOP
PFOS, PFOA, and PFBS Analytical Results

One surface water sample (FTD-SSAD-1-SW) was collected from a tributary to Upper Pleasant Creek, where stormwater from the AFFF release area likely entered the tributary (**Figure 7-17**). Sample results for surface water sample FTD-SSAD-1-SW were not compared to the OSD risk screening levels for tap water because the surface water sample is not a direct expression of groundwater at the related AOPIs, and the associated surface water body (tributary to Upper Pleasant Creek) is not used as a source of drinking water.

have likely entered the tributary. Sediment sample FTD-SSAD-2-SE was collected upstream of Oneida Avenue. Sediment sample FTD-SSAD-1-SE was collected downstream of Oneida Avenue and was co-located with surface water sample FTD-SSAD-1-SW (**Figure 7-17**).

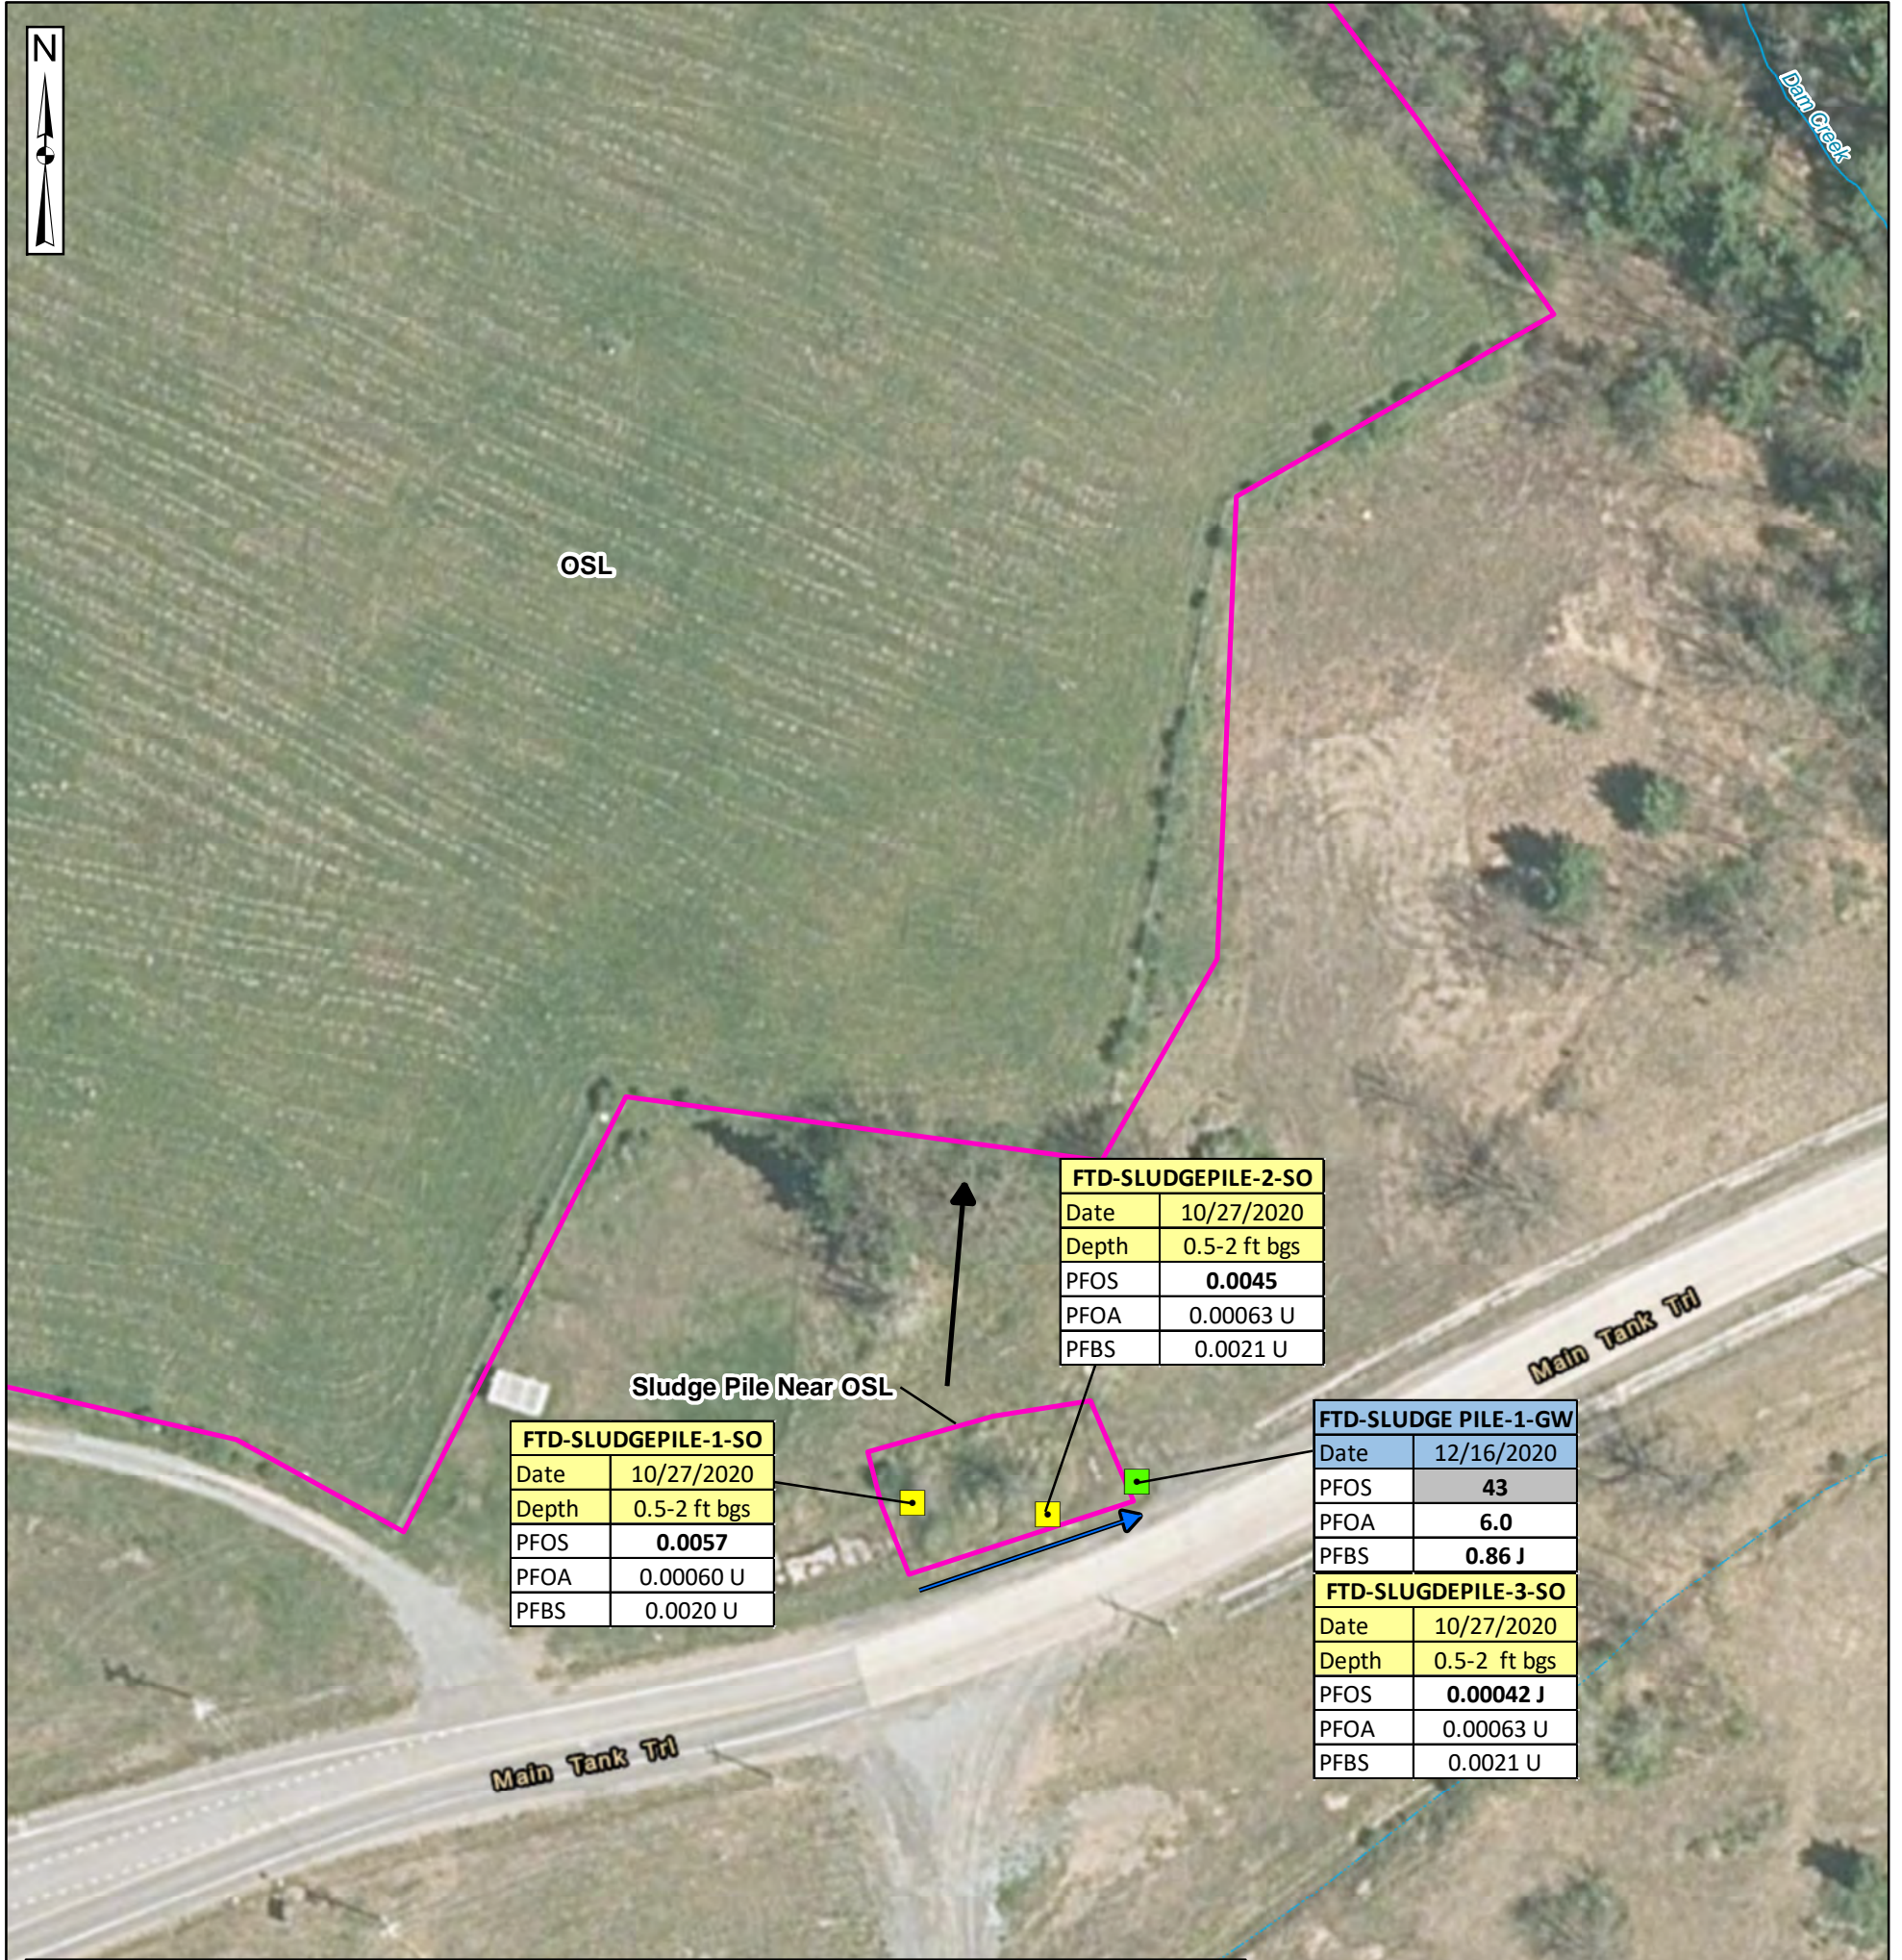
Figure 7-18
Sludge Pile Near OSL AOP
PFOS, PFOA, and PFBS Analytical Results

One grab groundwater sample (FTD-SludgePile-1GW) was collected following HSA drilling. The groundwater sample was collected on the southeastern edge of the Sludge Pile, where surface runoff is directed (**Figure 7-18**).

Three surface soil samples (FTD-SludgePile-1-SO, FTD-SludgePile-2-SO, and FTD-SludgePile-3-SO) were collected via hand auger. Surface soil samples FTD-SludgePile-1-SO and FTD-SludgePile-2-SO were collected within the AOPI. FTD-SludgePile-3-SO was collected at the edge of the AOPI, where runoff from the pile would have collected during precipitation events (**Figure 7-18**).

FTD-SLUDGEPILE-2-SO	
Date	10/27/2020
Depth	0.5-2 ft bgs
PFOS	0.0045
PFOA	0.00063 U
PFBS	0.0021 U

FTD-SLUDGEPILE-1-SO	
Date	10/27/2020
Depth	0.5-2 ft bgs
PFOS	0.0057
PFOA	0.00060 U
PFBS	0.0020 U

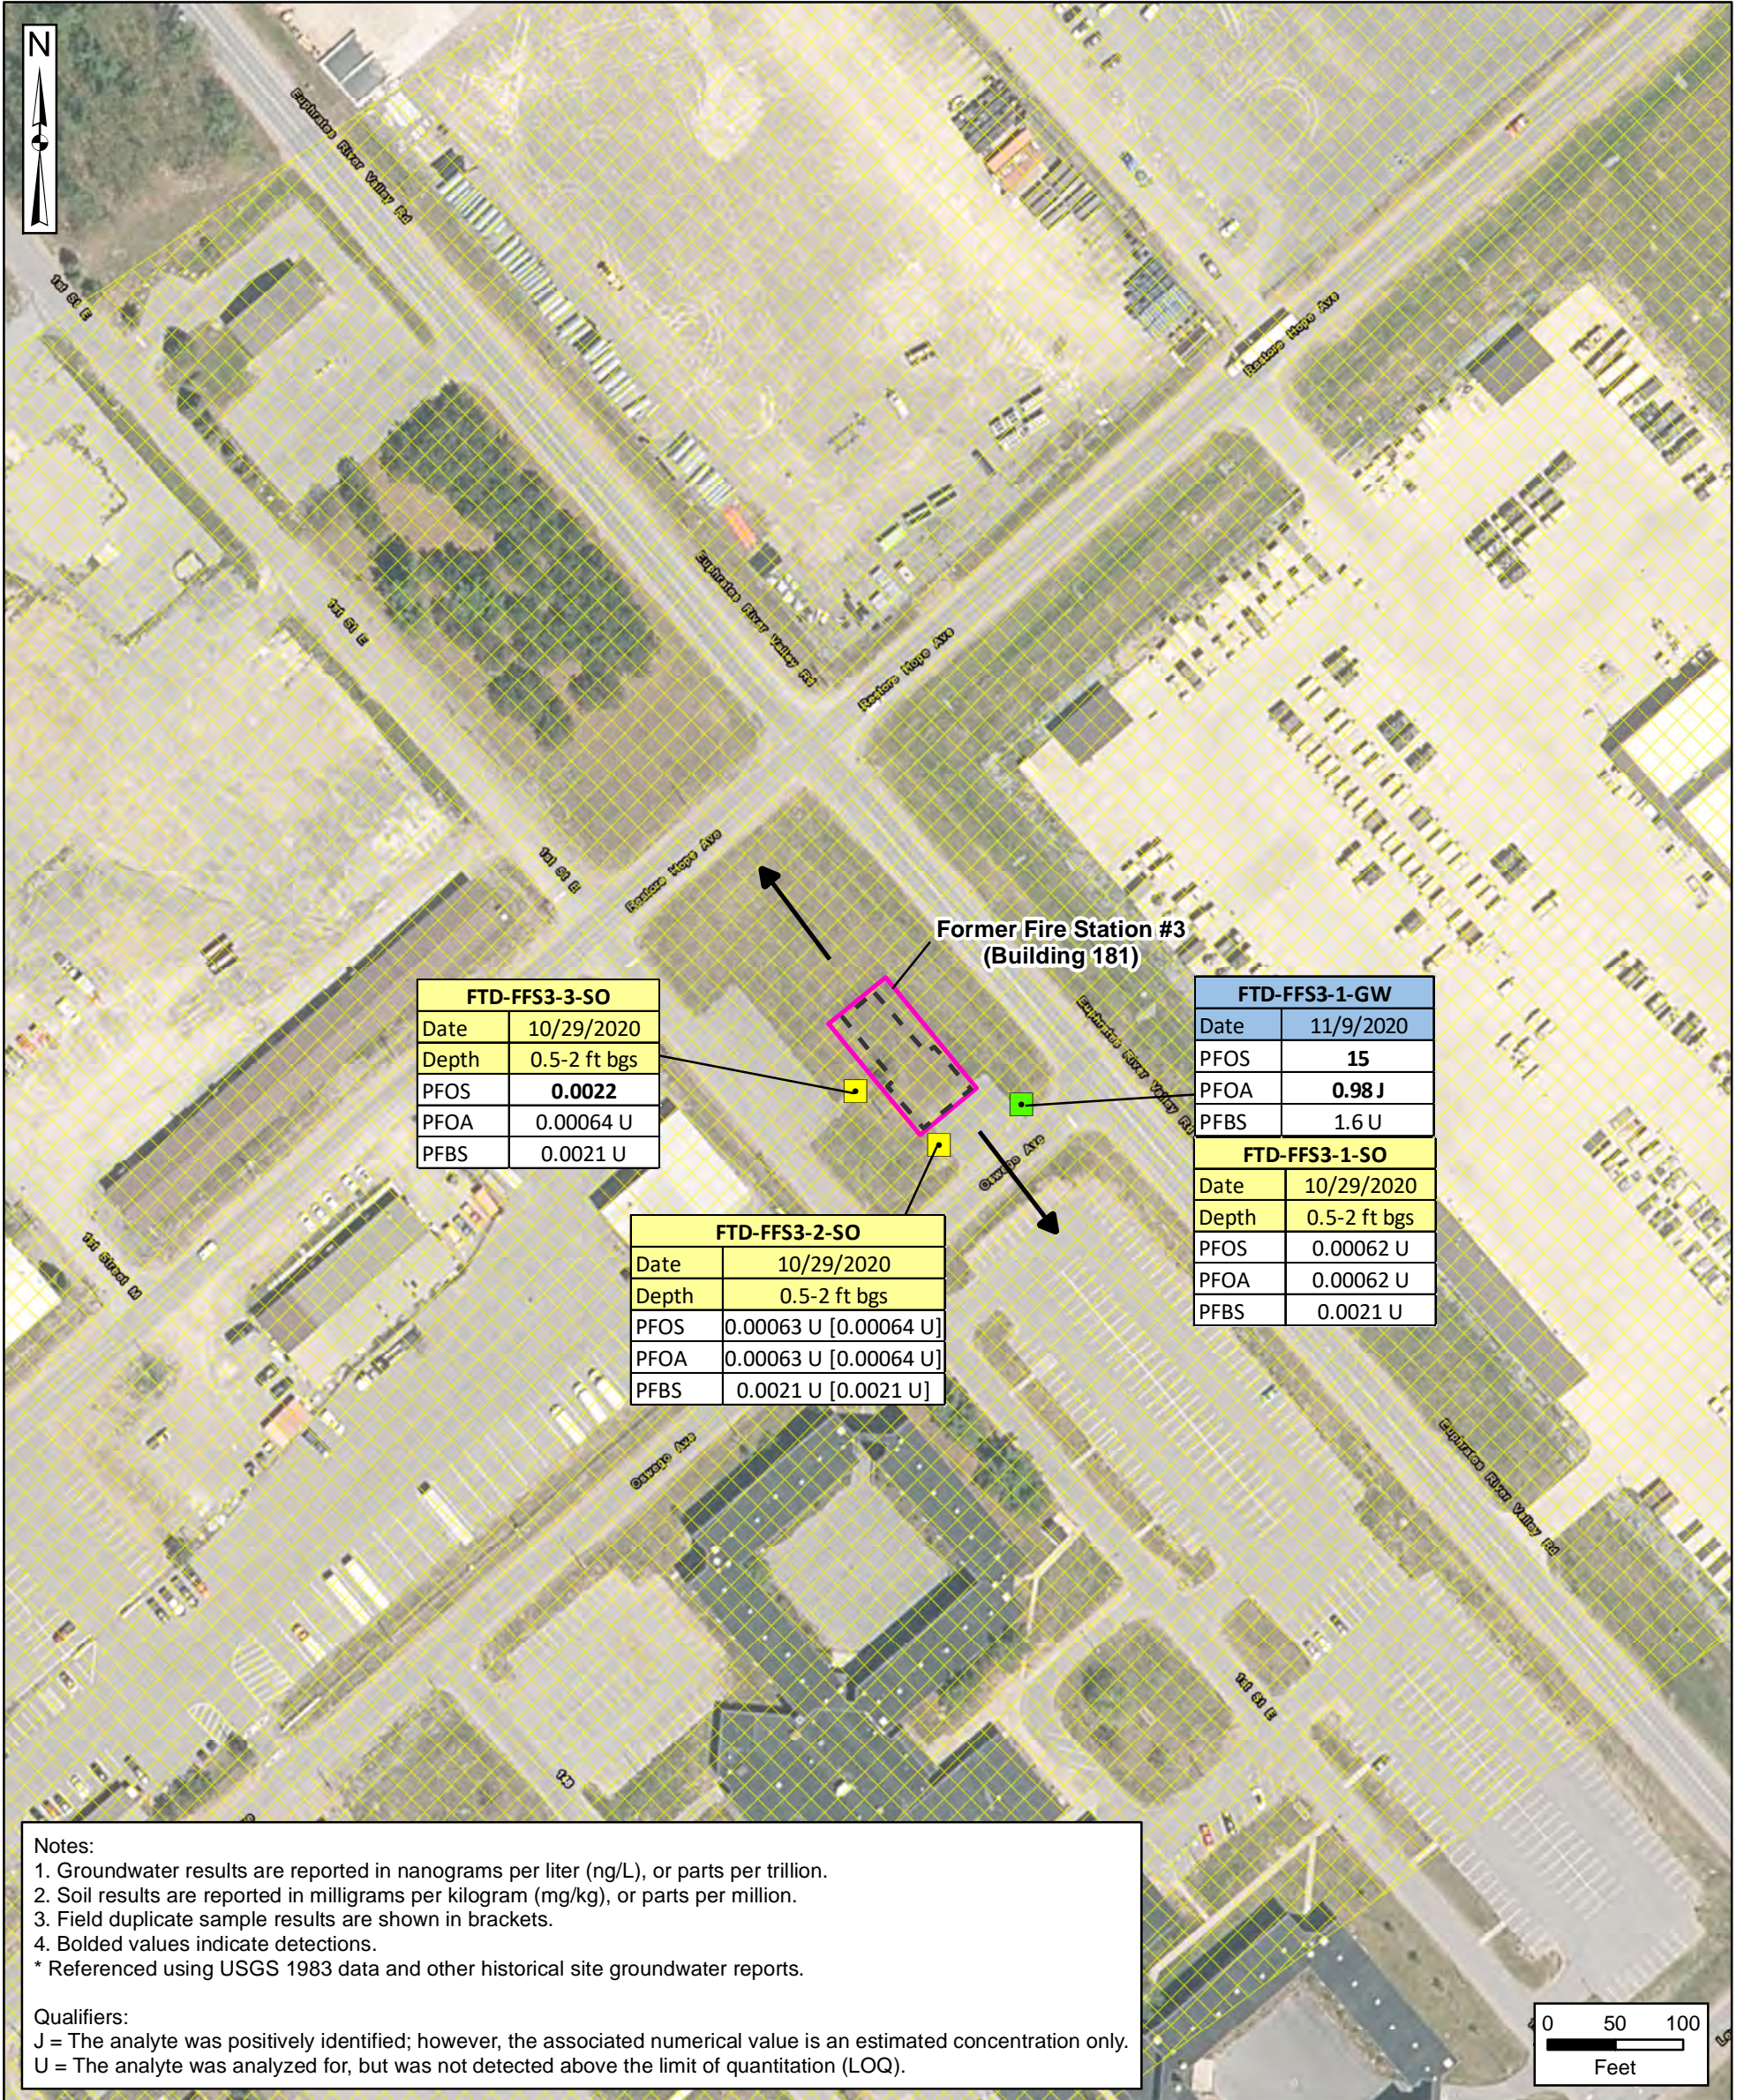
Figure 7-19
Former Fire Station #3 (Building 181)
PFOS, PFOA, and PFBS Analytical Results

One grab groundwater sample (FTD-FFS3-1-GW) was collected following DPT drilling. The exact area of AFFF release is unknown. Therefore, the groundwater sample was located at the edge of driveway pavement, where AFFF potentially released from the building would likely have flowed via runoff (**Figure 7-19**).

Three surface soil samples (FTD-FFS3-1-SO, FTD-FFS3-2-SO, and FTD-FFS3-3-SO) were collected via hand auger. The exact area of AFFF release is unknown. Therefore, the surface soil samples were collected along the edges of pavement, where historical AFFF releases may have occurred from fire truck washing or parking. Surface soil sample FTD-FFS3-1-SO was co-located with groundwater sample FTD-FFS3-1-GW (**Figure 7-19**).

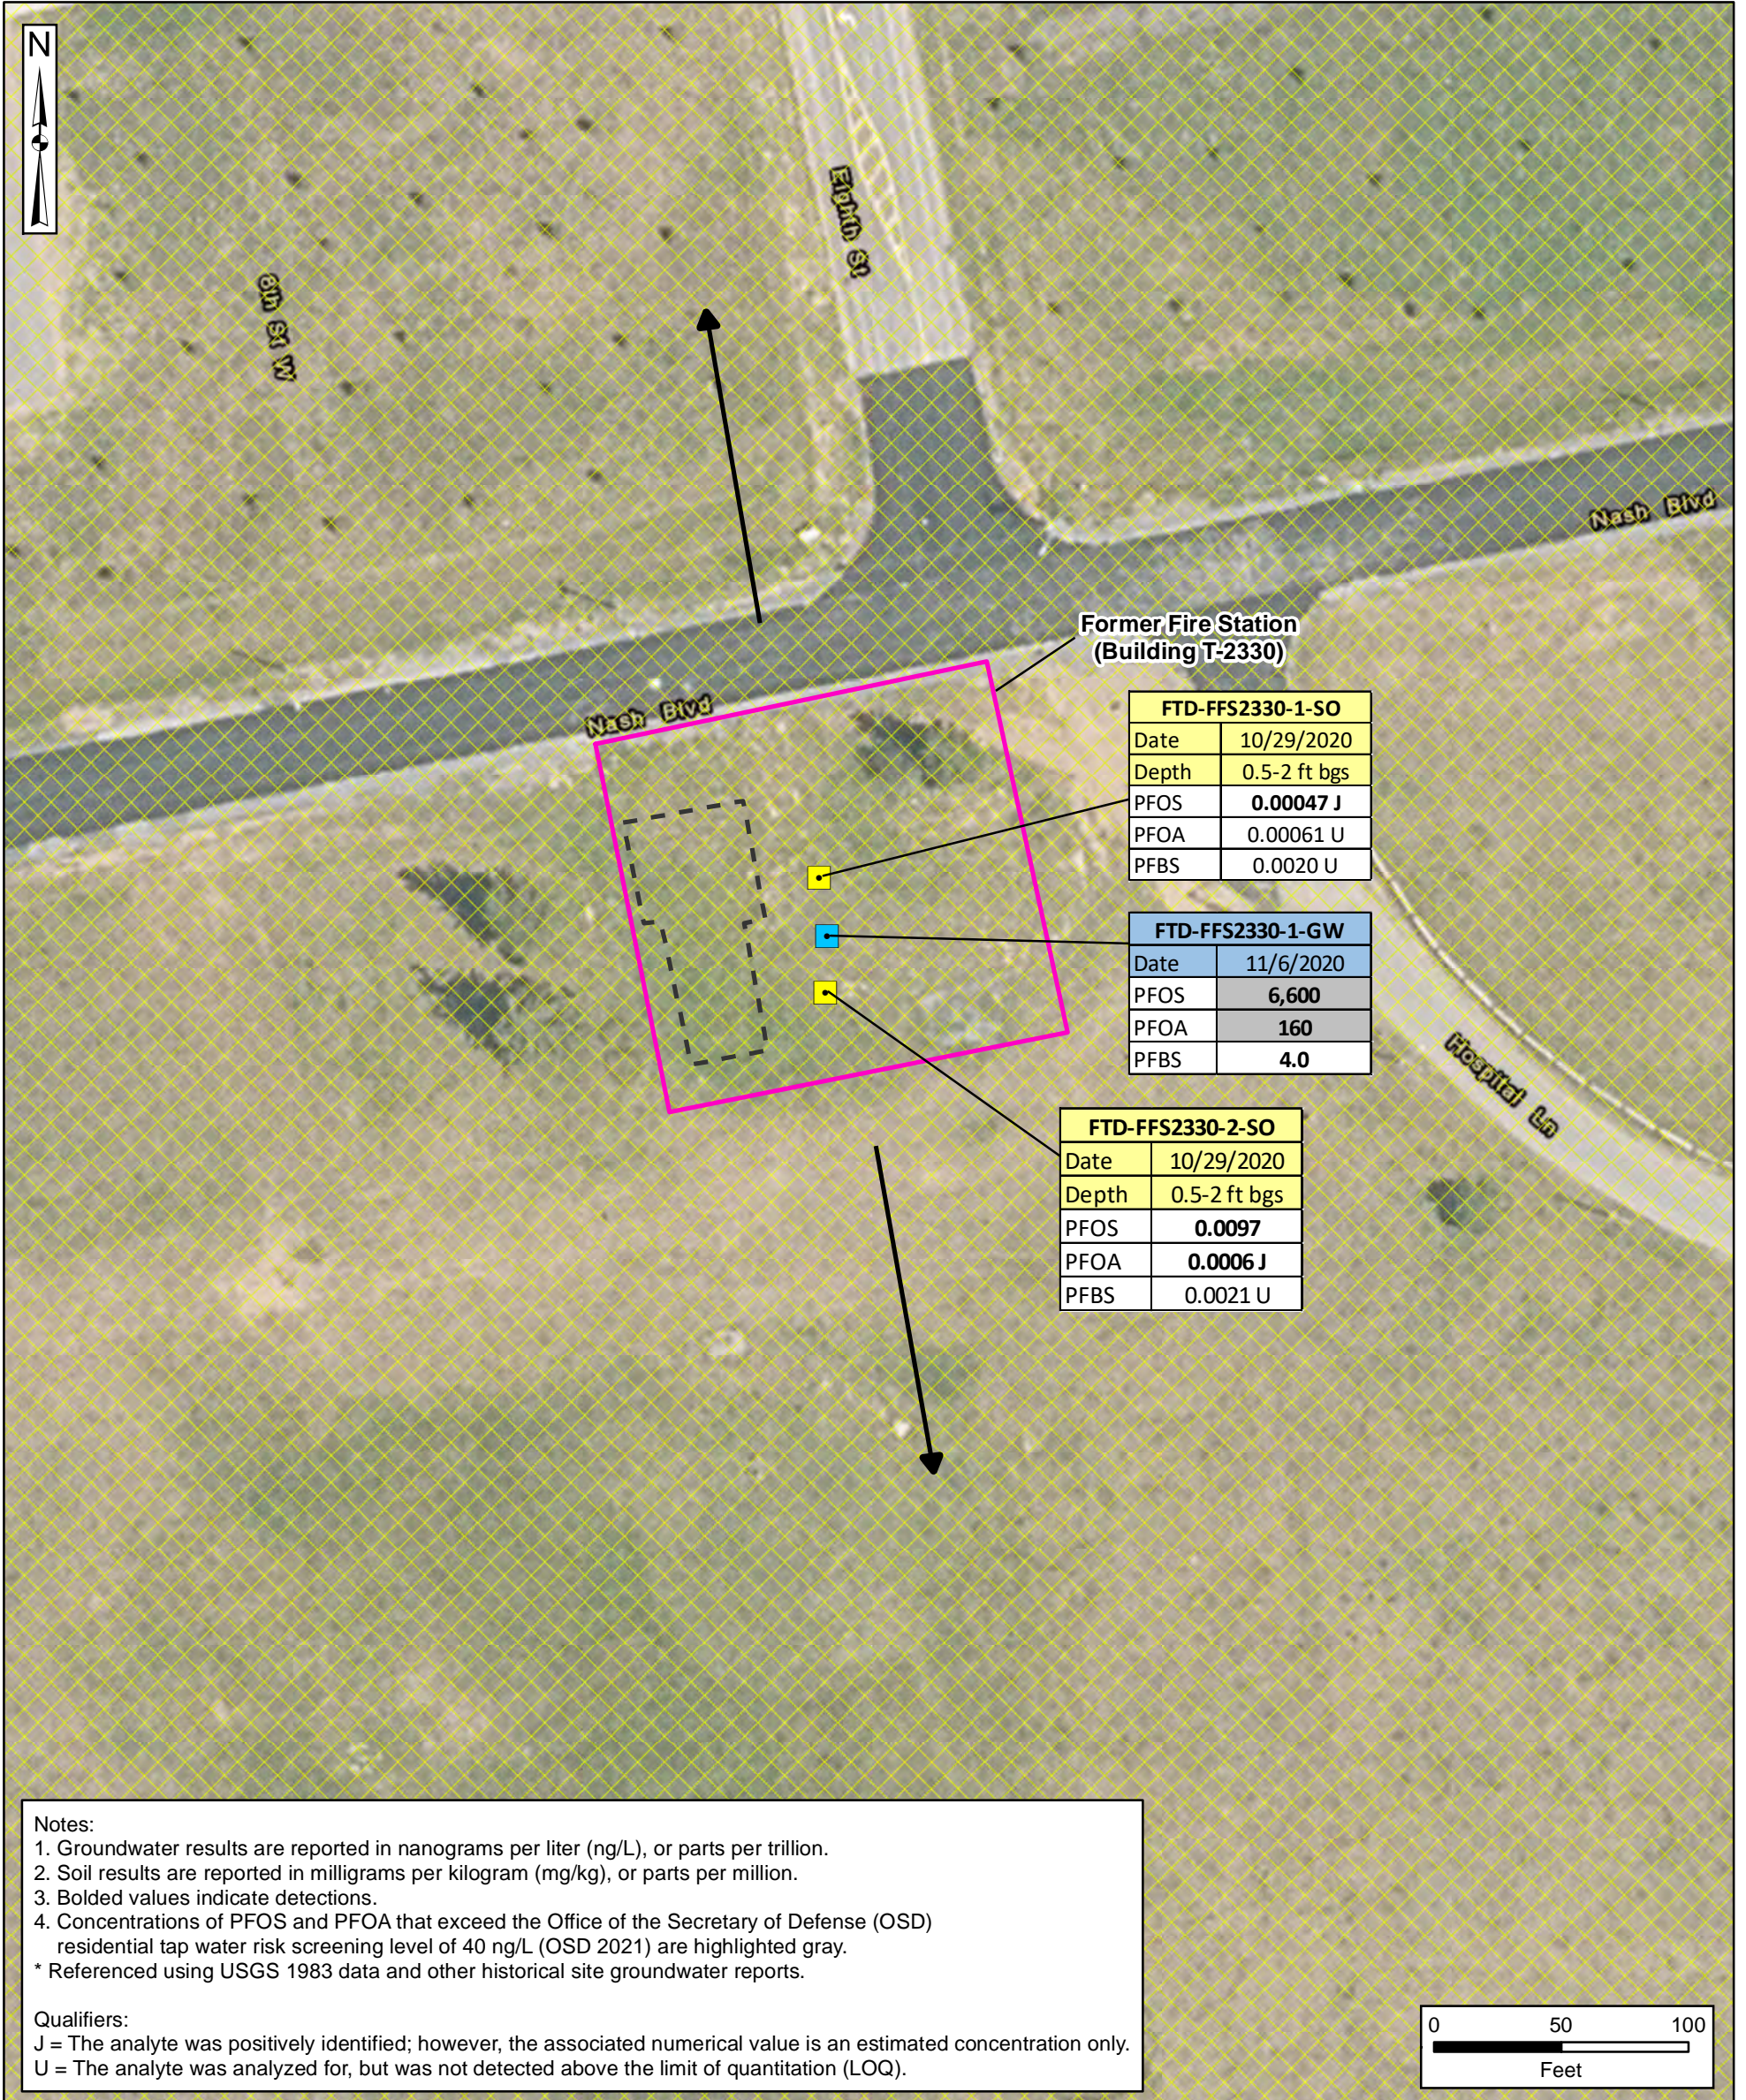
Figure 7-20
Former Fire Station (Building T-2330) AOPI
PFOS, PFOA, and PFBS Analytical Results

One grab groundwater sample (FTD-FFS2330-1-GW) was collected following DPT drilling. The exact area of AFFF release is unknown. Therefore, the groundwater sample was located where the historical building bay doors were located to capture historical AFFF releases during the operational period of the fire station (**Figure 7-20**).

Two surface soil samples (FTD-FFS2330-1-SO and FTD-FFS2330-2-SO) were collected via hand auger on the edge of the former station driveway pavement, where AFFF releases may have occurred during fire truck washing or parking (**Figure 7-20**).
