FINAL PRELIMINARY ASSESSMENT AND SITE INSPECTION OF PER- AND POLYFLUOROALKYL SUBSTANCES

Fort Drum, New York

Prepared For:
U.S. Army Corps of Engineers, Baltimore District
2 Hopkins Plaza
Baltimore, Maryland 21201

November 2022

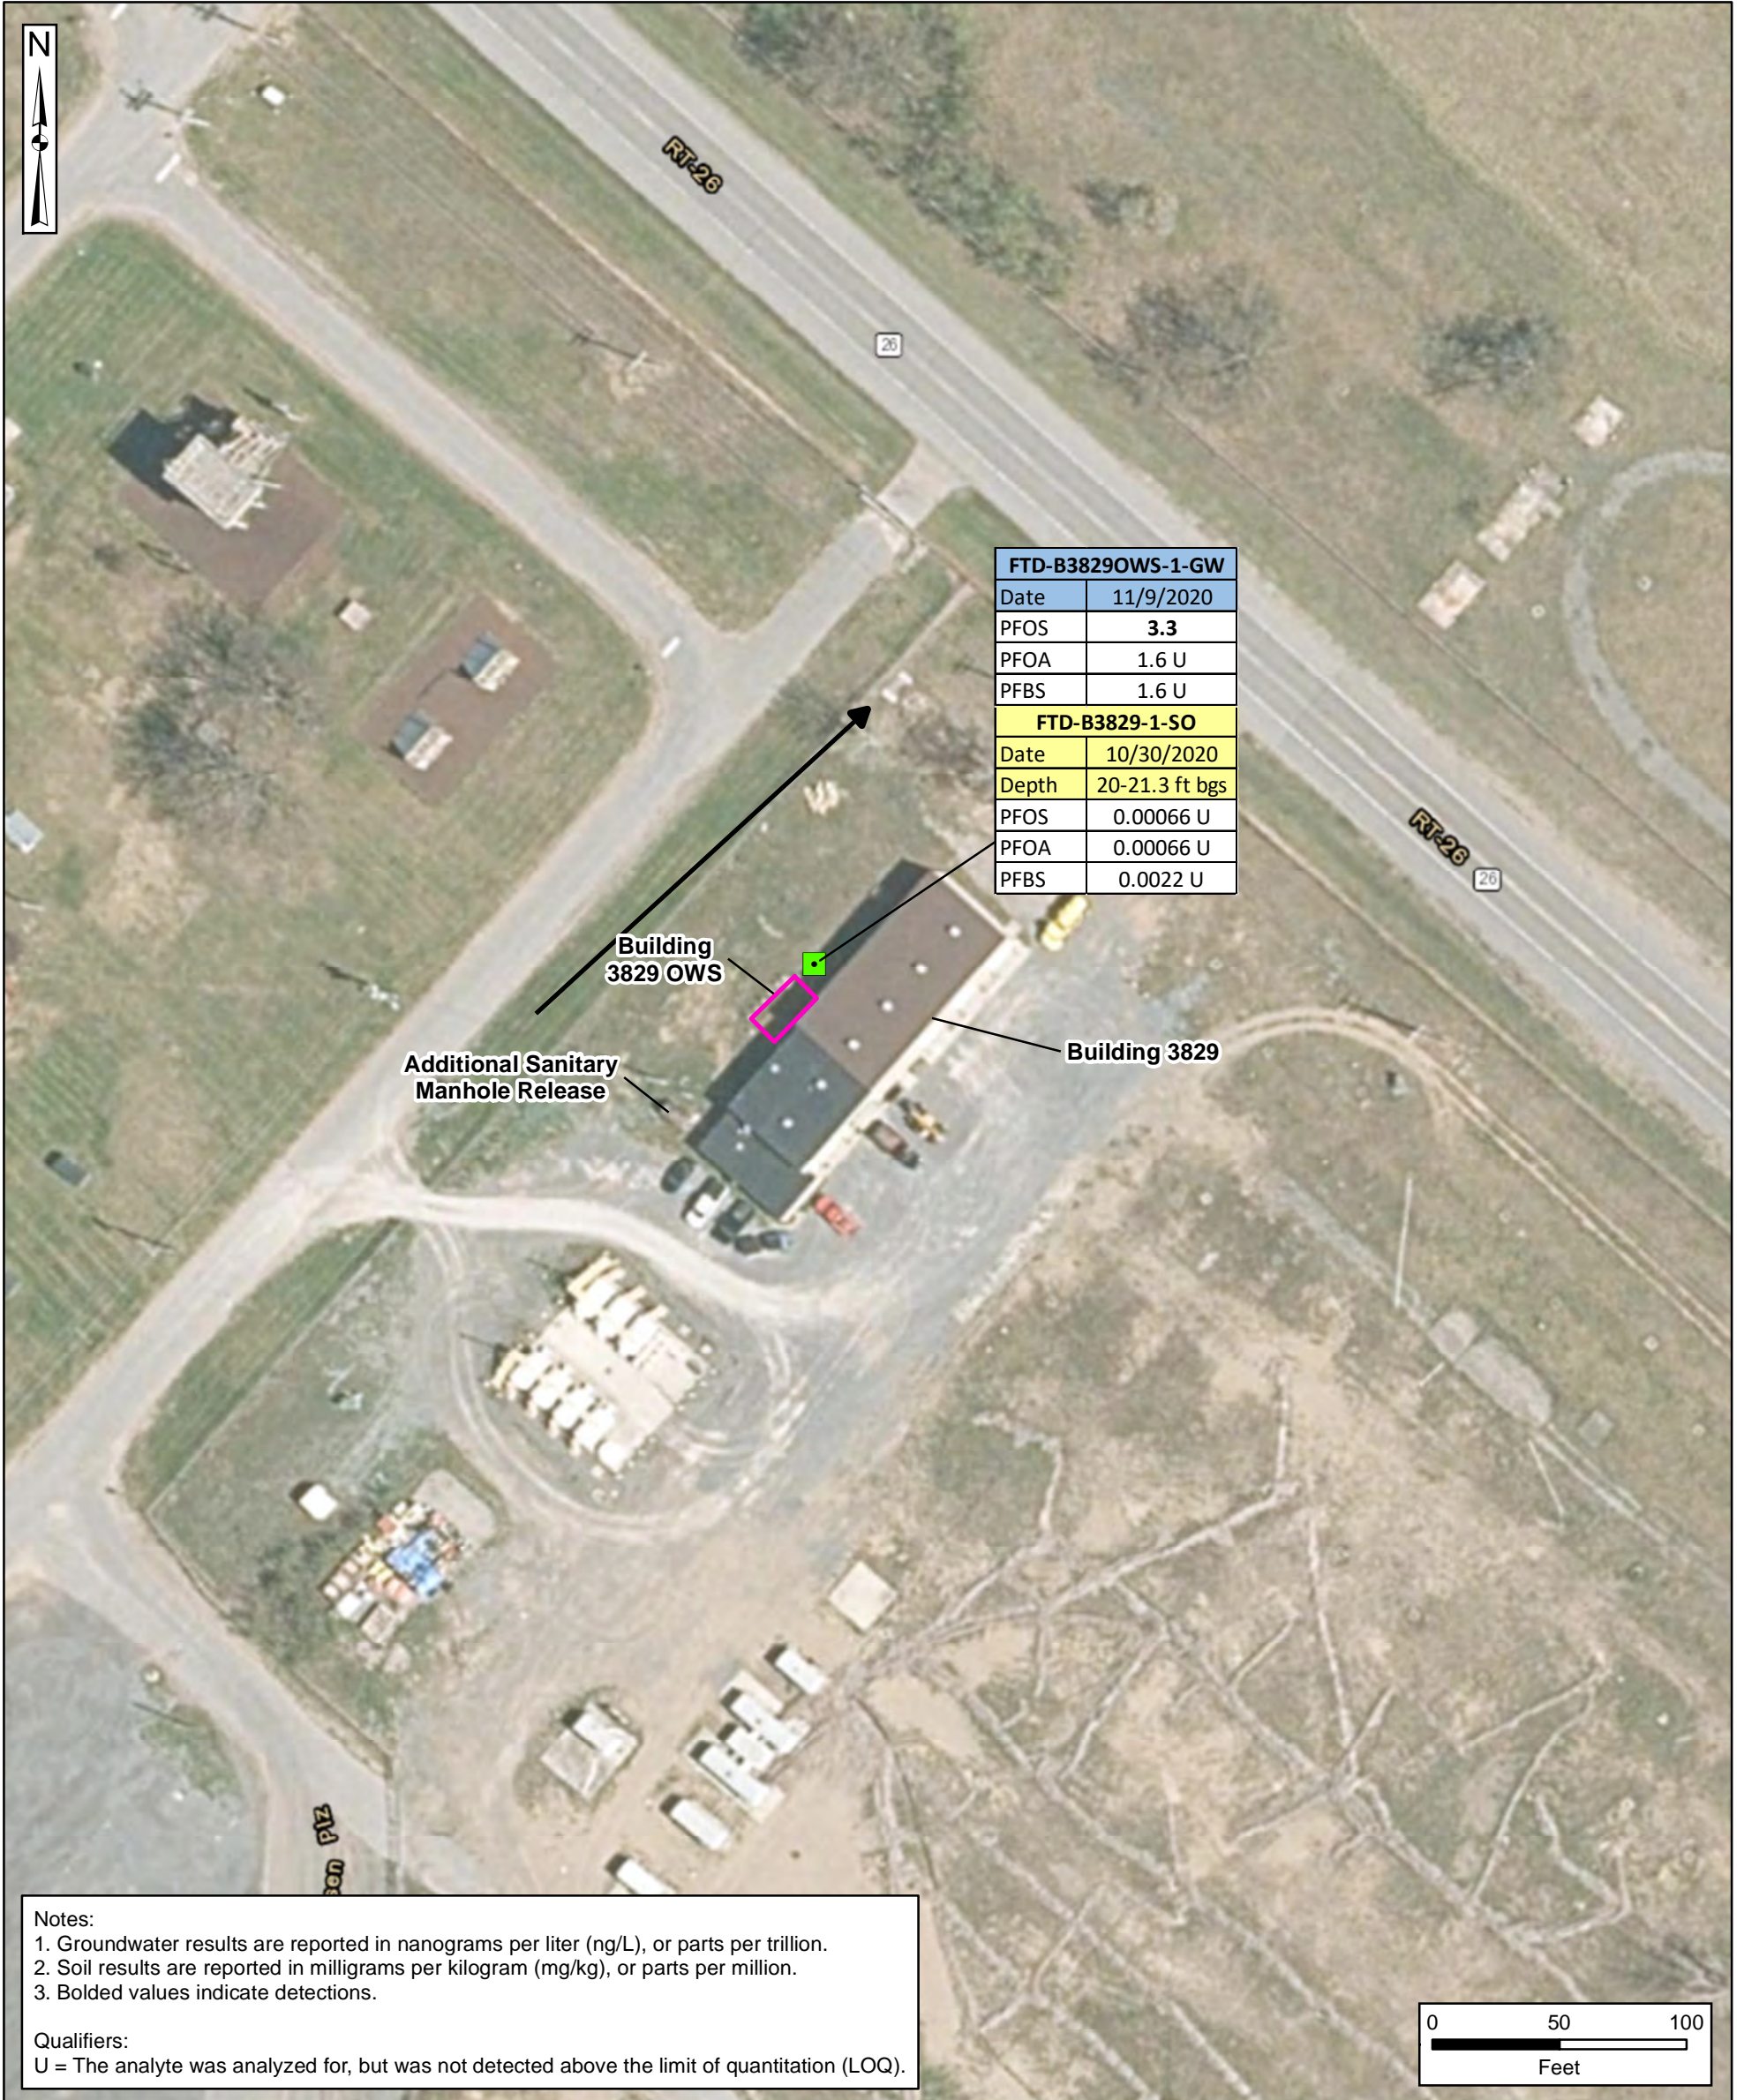
Figure 7-21
Building 3829 OWS AOP
PFOS, PFOA, and PFBS Analytical Results

One grab groundwater sample (FTD-3829OWS-1-GW) was collected following DPT drilling. The groundwater sample was located immediately adjacent to the Building 3829 OWS to capture potential releases from the OWS infrastructure following AFFF transfers (**Figure 7-21**).

A subsurface soil sample (FTD-B3829-1-SO) was collected via DPT drilling at the equivalent approximate depth of the bottom of the OWS (~20 ft bgs) to capture potential releases of AFFF from spills that may have occurred during discharges of water from the holding tank at the FTA to the OWS, or from leaks in the OWS or connected piping. Subsurface soil sample FTD-B3829-1-SO was co-located with groundwater sample FTD-3829OWS-1-GW (**Figure 7-21**).

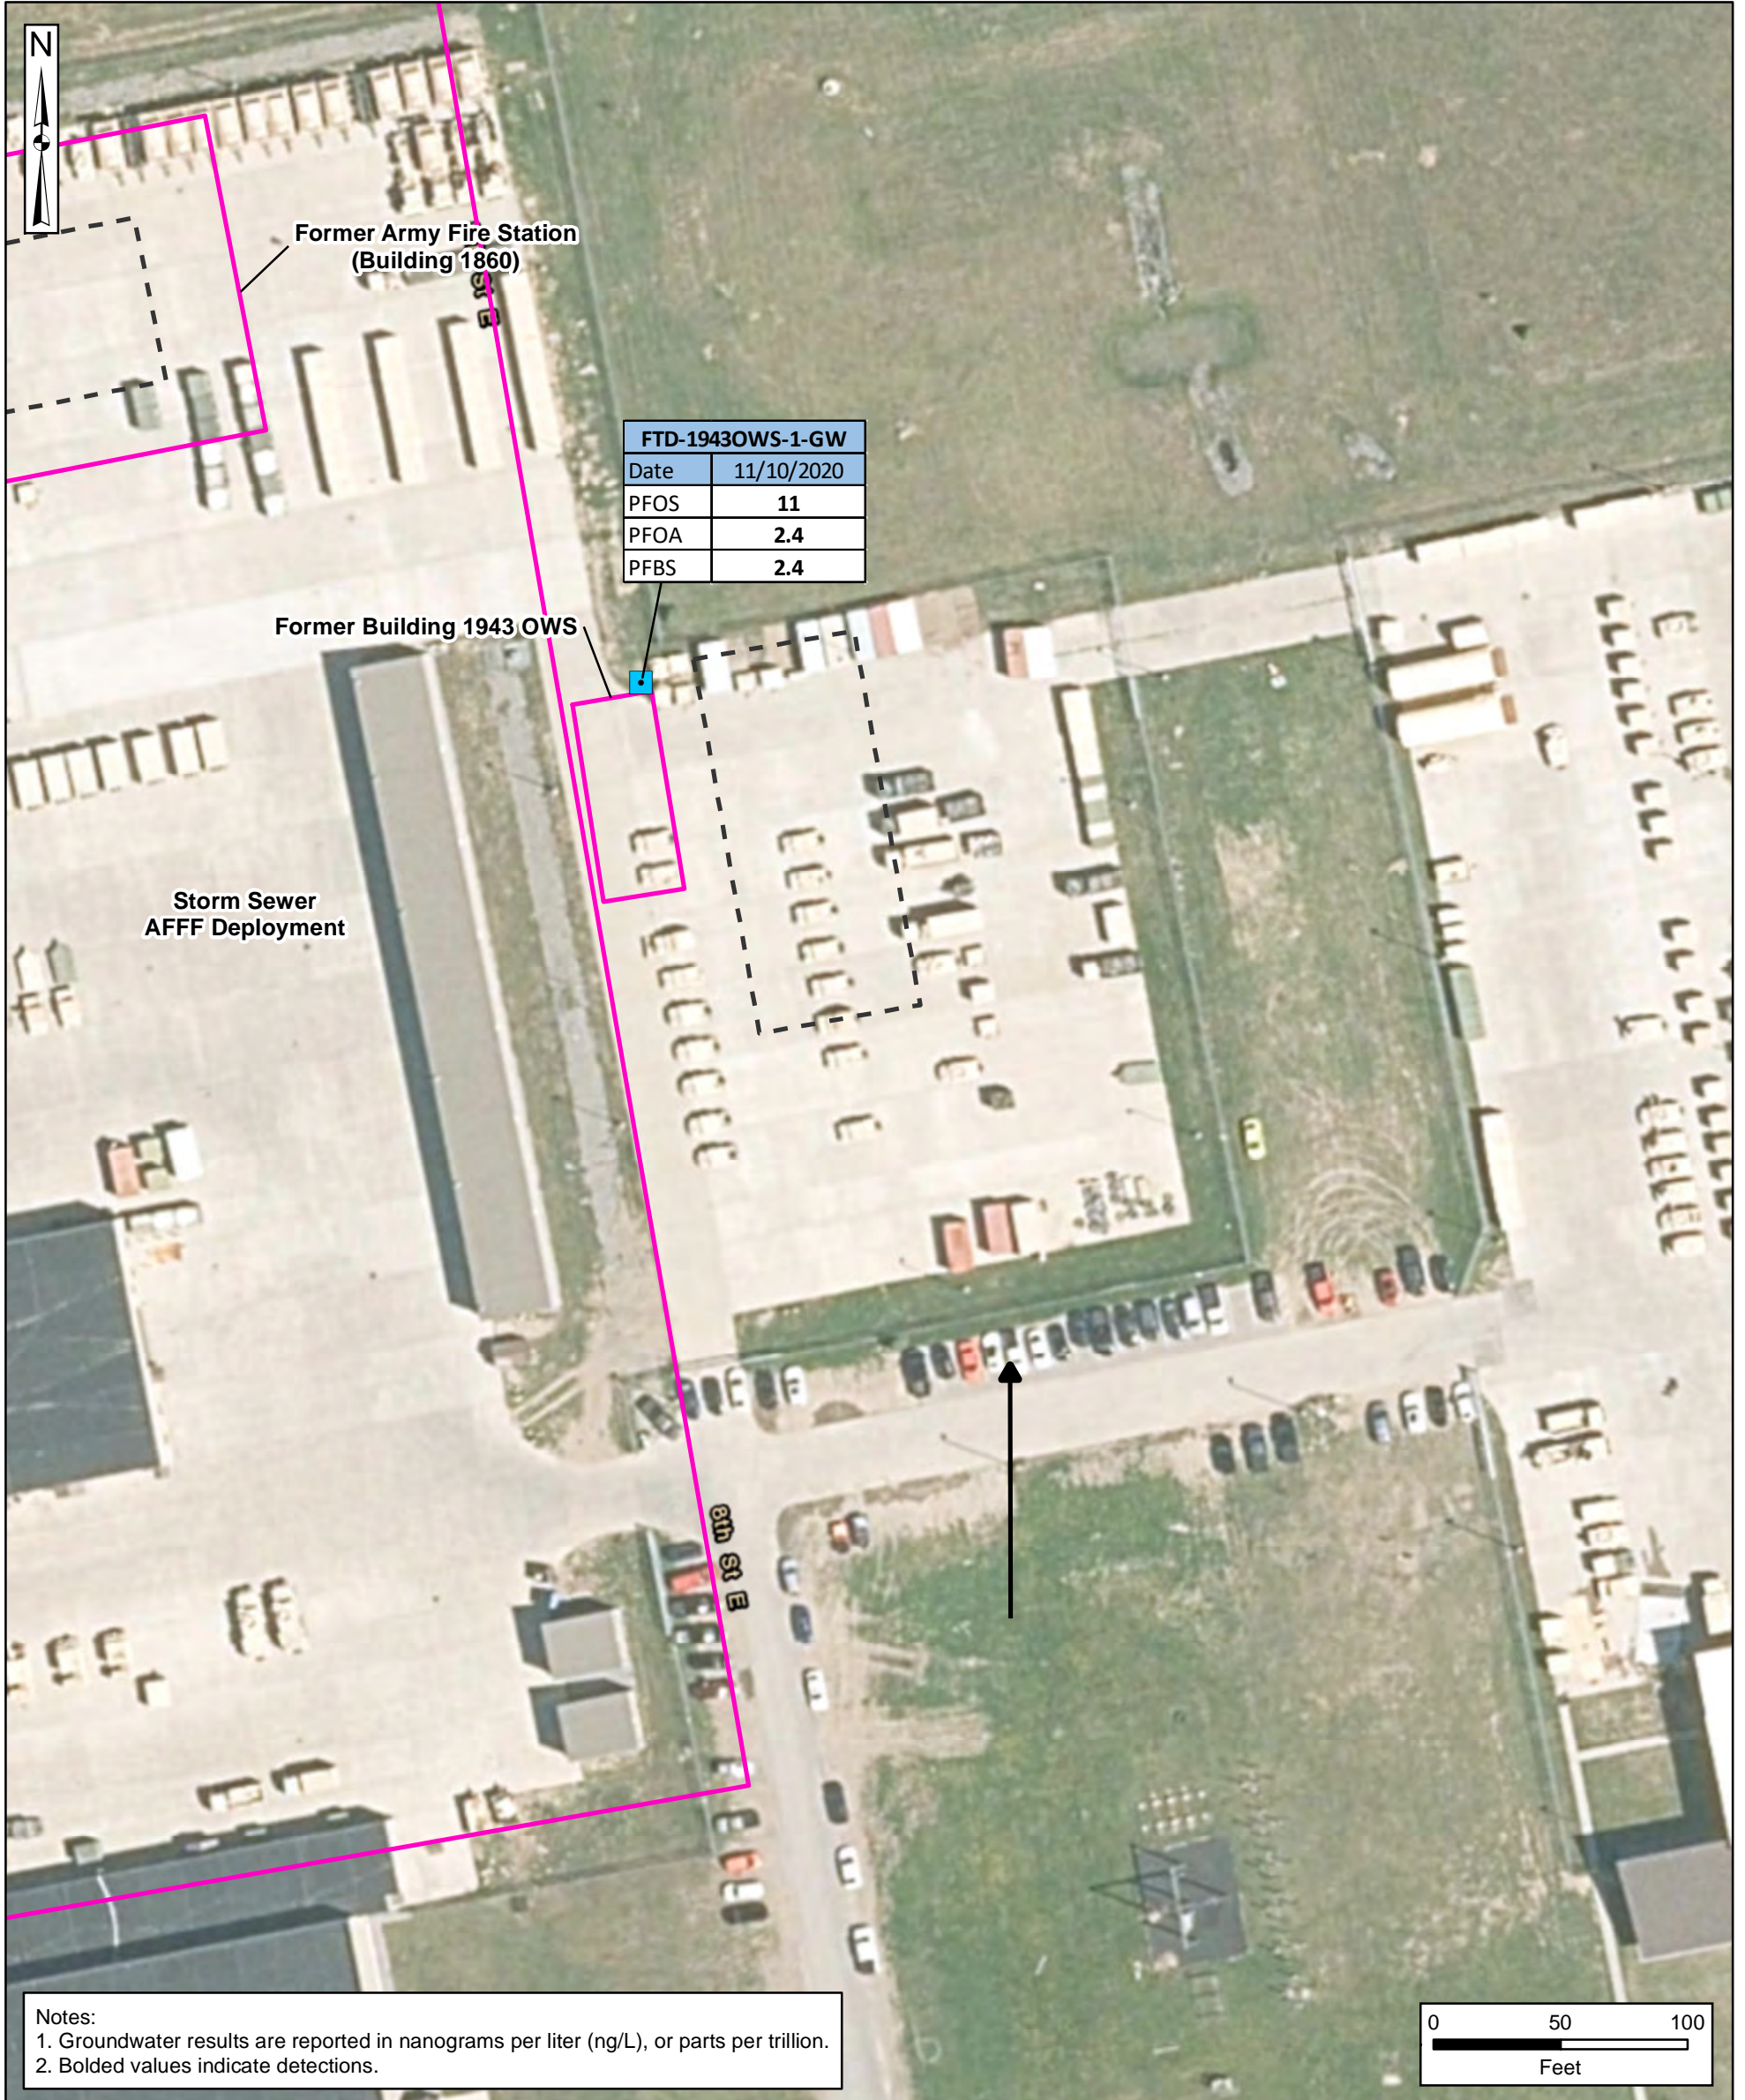
Figure 7-22
Former Building 1943 OWS AOPI
PFOS, PFOA, and PFBS Analytical Results

One grab groundwater sample (FTD-1943OWS-1-GW) was collected following DPT drilling. The groundwater sample was located immediately downgradient of the Former Building 1943 OWS to capture potential releases of AFFF from spills that may have occurred during discharges of water from the holding tank at the FTA to the OWS, or from leaks in the OWS or connected piping (**Figure 7-22**).

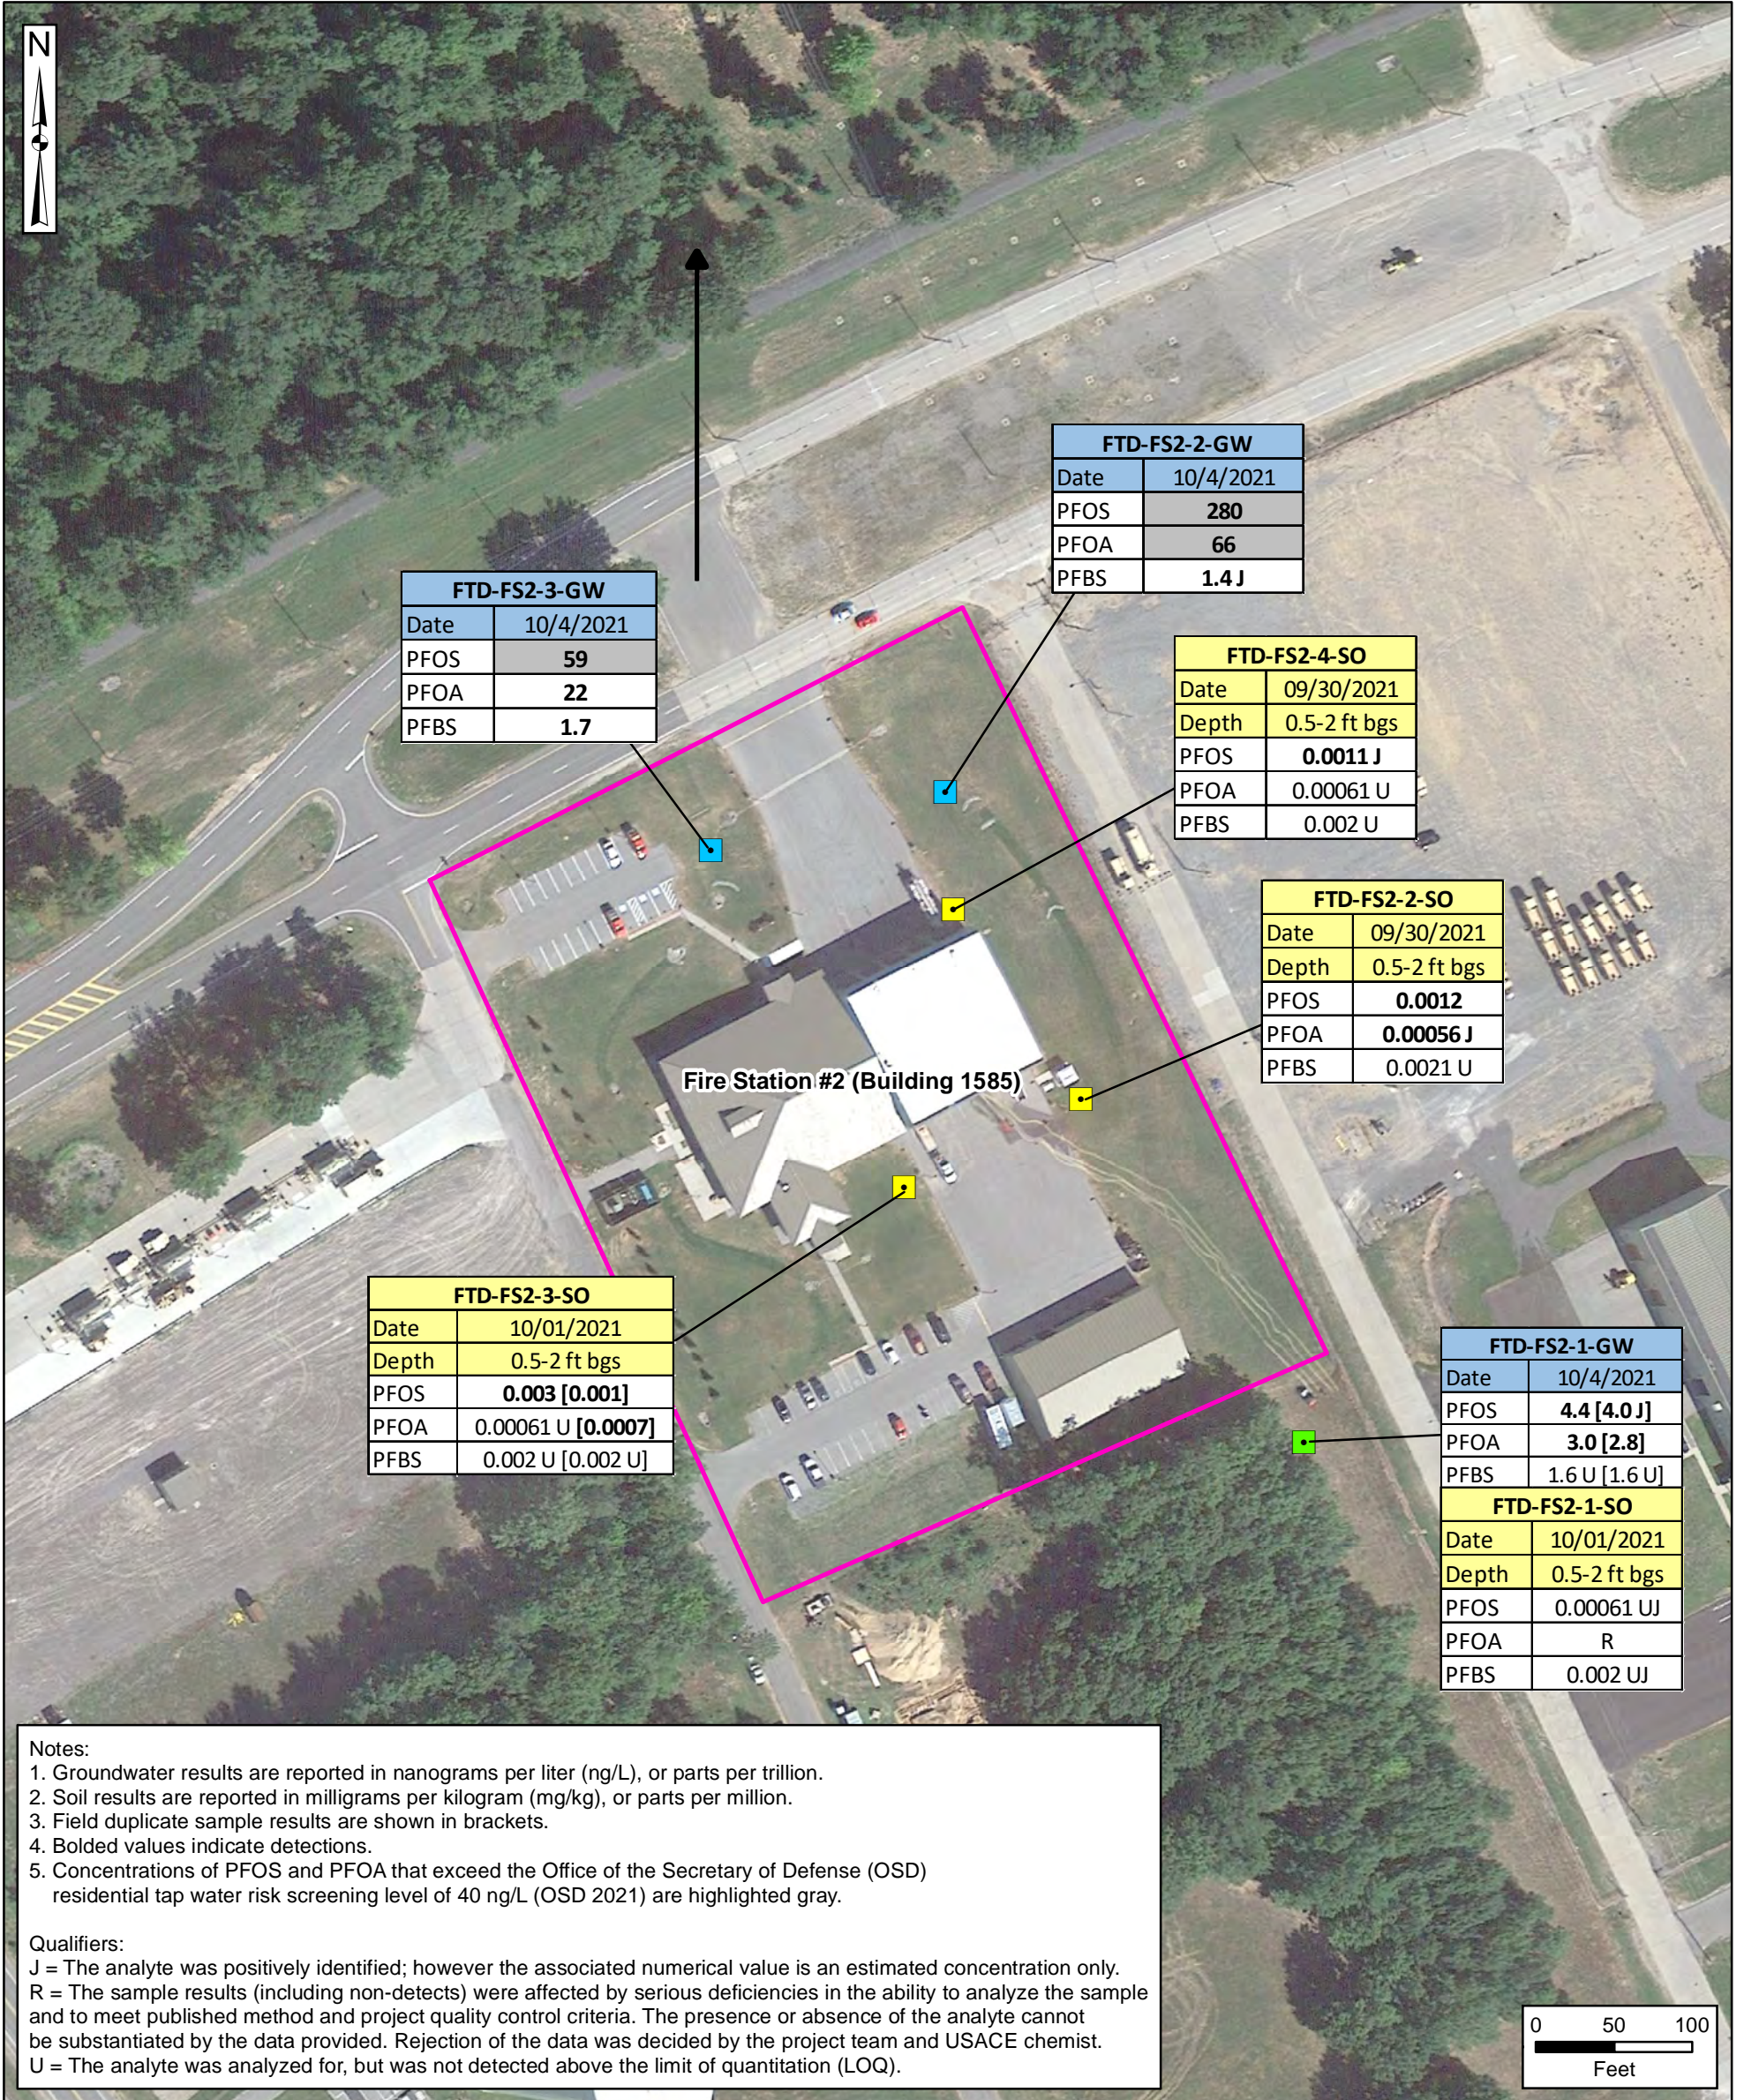
Figure 7-23
Fire Station #2 (Building 1585) AOPI
PFOS, PFOA, and PFBS Analytical Results

A total of three grab groundwater samples (FTD-FS2-1-GW, FTD-FS2-2-GW, and FTD-FS2-3-GW) were collected via DPT drilling methods in the central portion of the AOPI near the pavement edges as well as the downgradient edges of the AOPI since the points of potential use, storage, and disposal of PFAS-containing materials are unknown (**Figure 7-23**).

A total of four surface soil samples (FTD-FS2-1-SO, FTD-FS2-2-SO, FTD-FS2-3-SO, and FTD-FS2-4 SO) were collected via hand auger from areas where surface runoff potentially drained and/or where Fort Drum Fire Department nozzles were rinsed at the AOPI (**Figure 7-23**).
