# FINAL PRELIMINARY ASSESSMENT AND SITE INSPECTION OF PER- AND POLYFLUOROALKYL SUBSTANCES

## Fort Sill, Oklahoma

Prepared For:  
U.S. Army Corps of Engineers, Baltimore District  
2 Hopkins Plaza  
Baltimore, Maryland 21201

March 2022

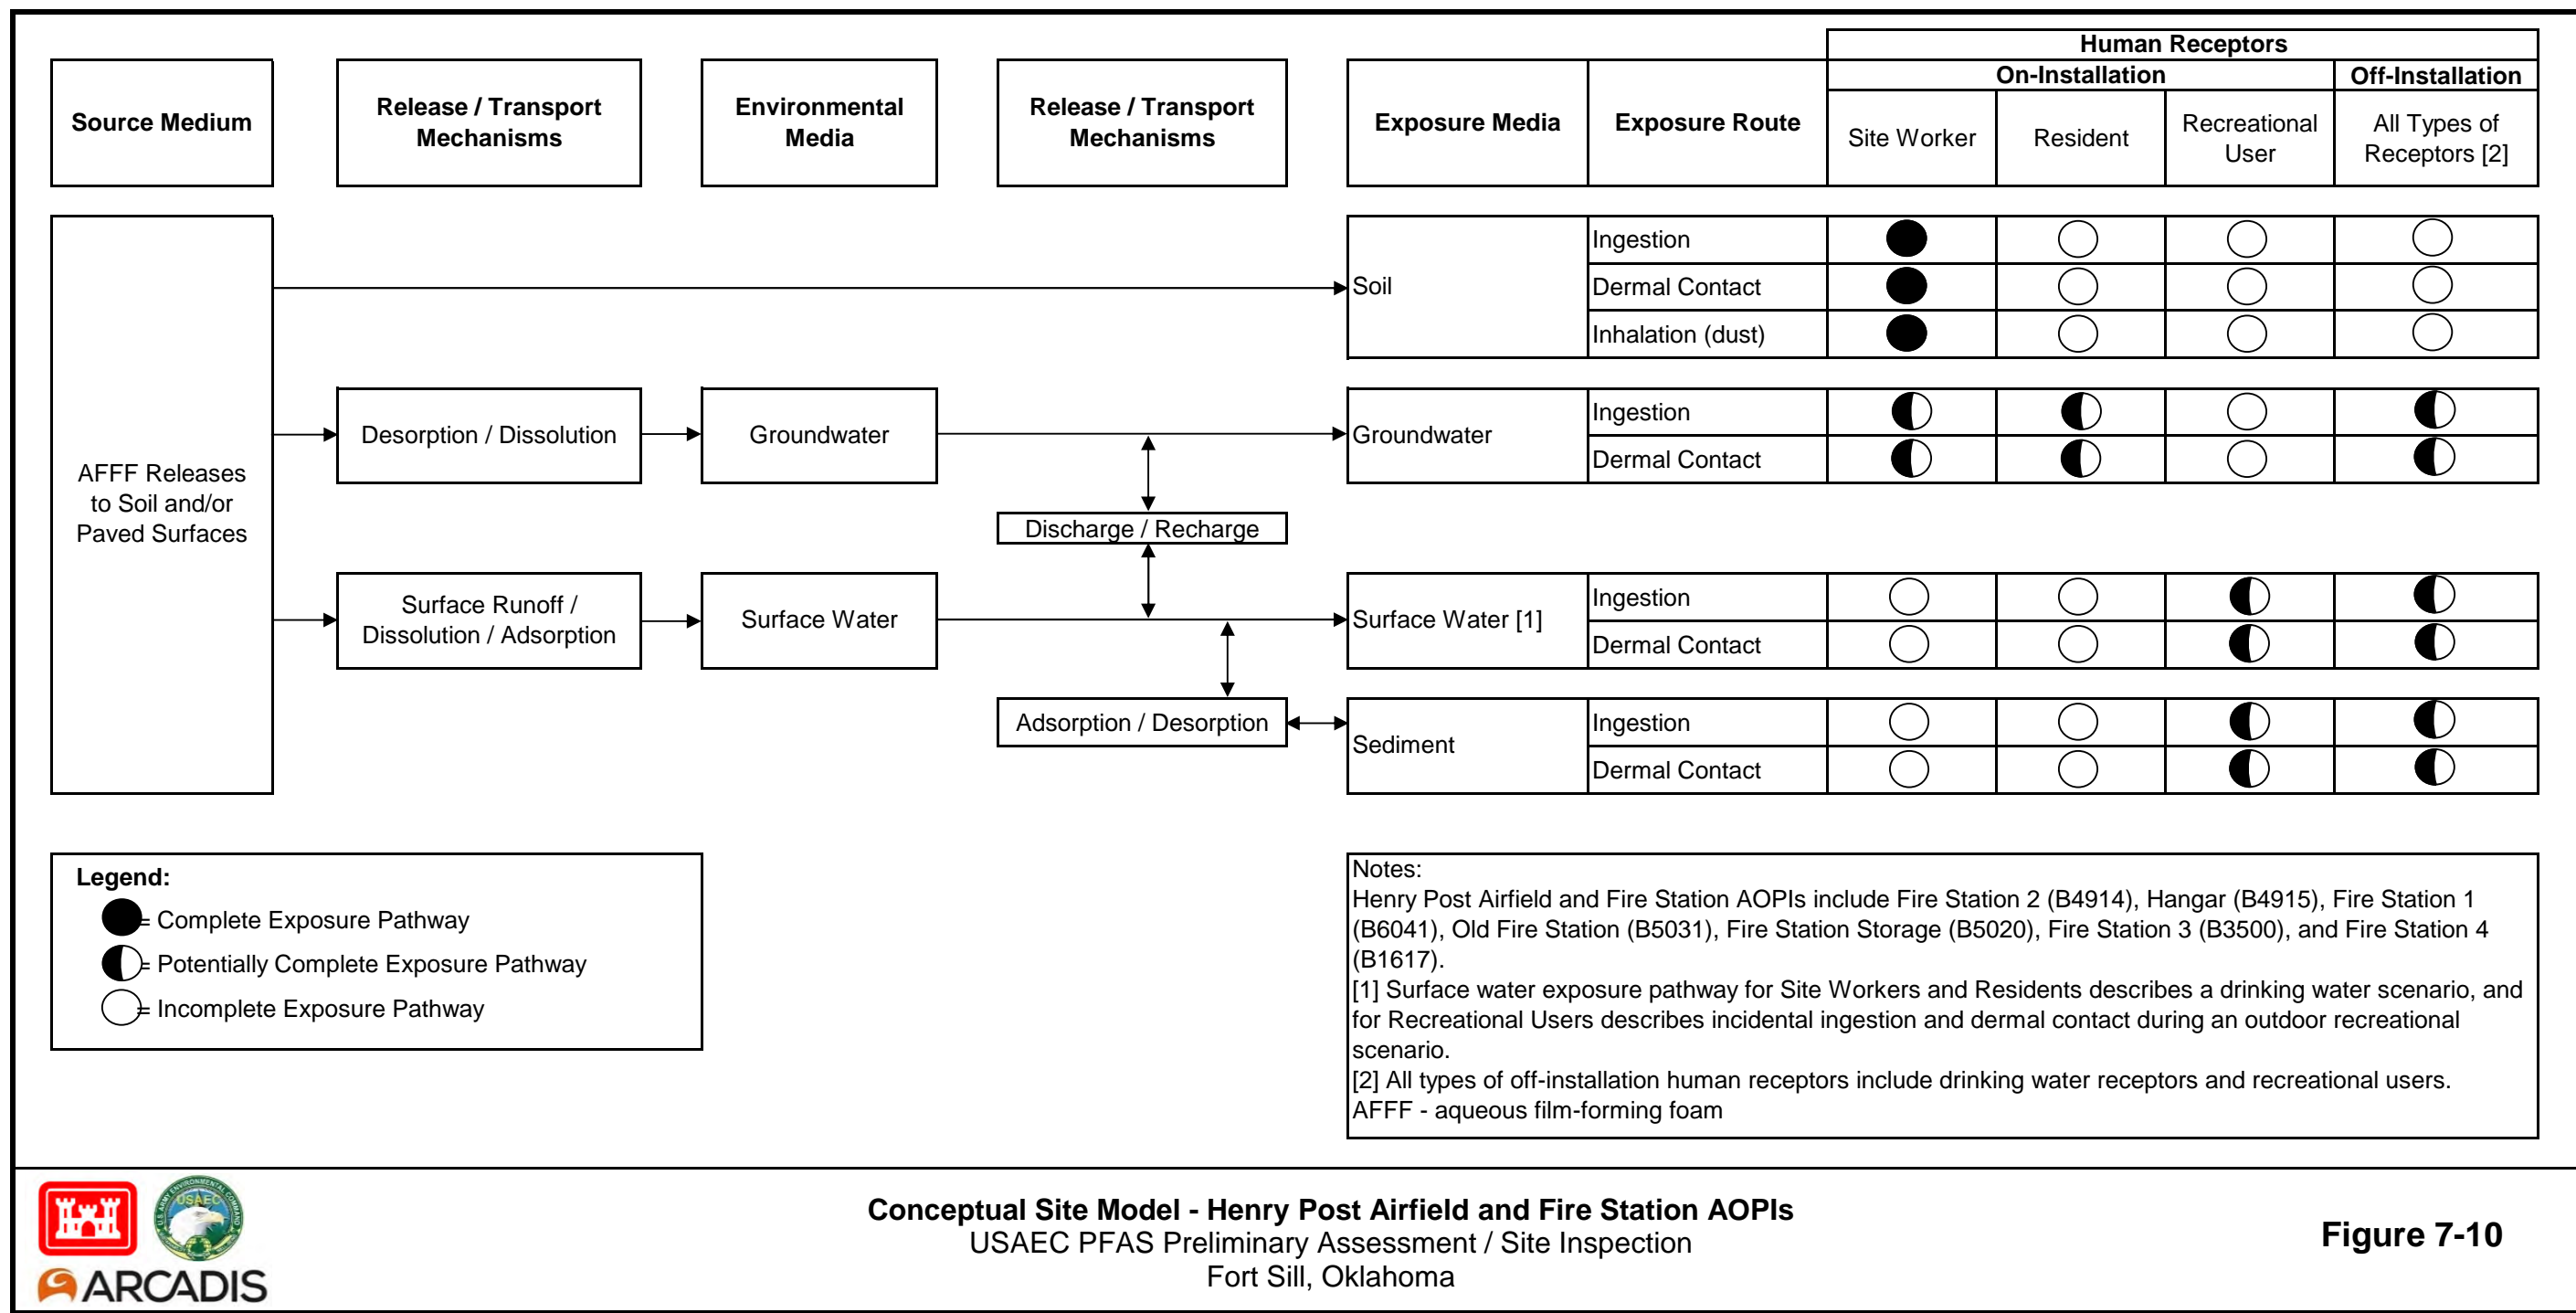
**Figure 7-10**

**Conceptual Site Model - Henry Post Airfield and Fire Station AOPIs**  
 USAEC PFAS Preliminary Assessment / Site Inspection  
 Fort Sill, Oklahoma
