FINAL PRELIMINARY ASSESSMENT AND SITE INSPECTION OF PER- AND POLYFLUOROALKYL SUBSTANCES

Fort Greely, Alaska

June 2022

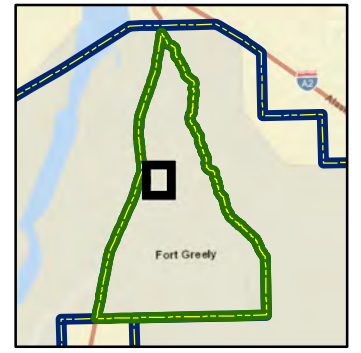
Figure 7-5
PFOS, PFOA, and PFBS Analytical Results -
Old Post Forest Fire Area and Bldg 347 AFFF Storage

FGA-32-MW-A	
Date	09/15/2020
PFBS	3.6 U
PFOA	3.6 U
PFOS	3.6 U

FGA-OPFF-2-SO	
Date	09/22/2020
PFBS	0.0012 U
PFOA	0.0012 U
PFOS	0.0012 U

One existing groundwater supply well (W-5) was sampled cross- or downgradient of the Building 347 AFFF Storage AOPI. This well is also located downgradient of the Main Gate Fire AOPI. PFOS, PFOA, and PFBS were not detected in the sample (**Figure 7-5; Table 7-1**). Additionally, as noted later in **Section 7.22**, off-post well MW-36 may intercept groundwater originating at the Building 347 AFFF Storage AOPI. PFOS detected in well MW-36 (18 ng/L) may be attributed to multiple AOPIs including the Building 347 AFFF Storage AOPI.

As noted in **Section 7.10**, existing groundwater monitoring wells sampled in association with other AOPIs (i.e., W-5) may intercept groundwater originating at the Main Gate Fire AOPI. PFOS, PFOA, and PFBS were not detected in well W-5 (**Figure 7-5, Table 7-1**).
