FINAL PRELIMINARY ASSESSMENT AND SITE INSPECTION OF PER- AND POLYFLUOROALKYL SUBSTANCES

Hunter Army Airfield, Georgia

July 2022

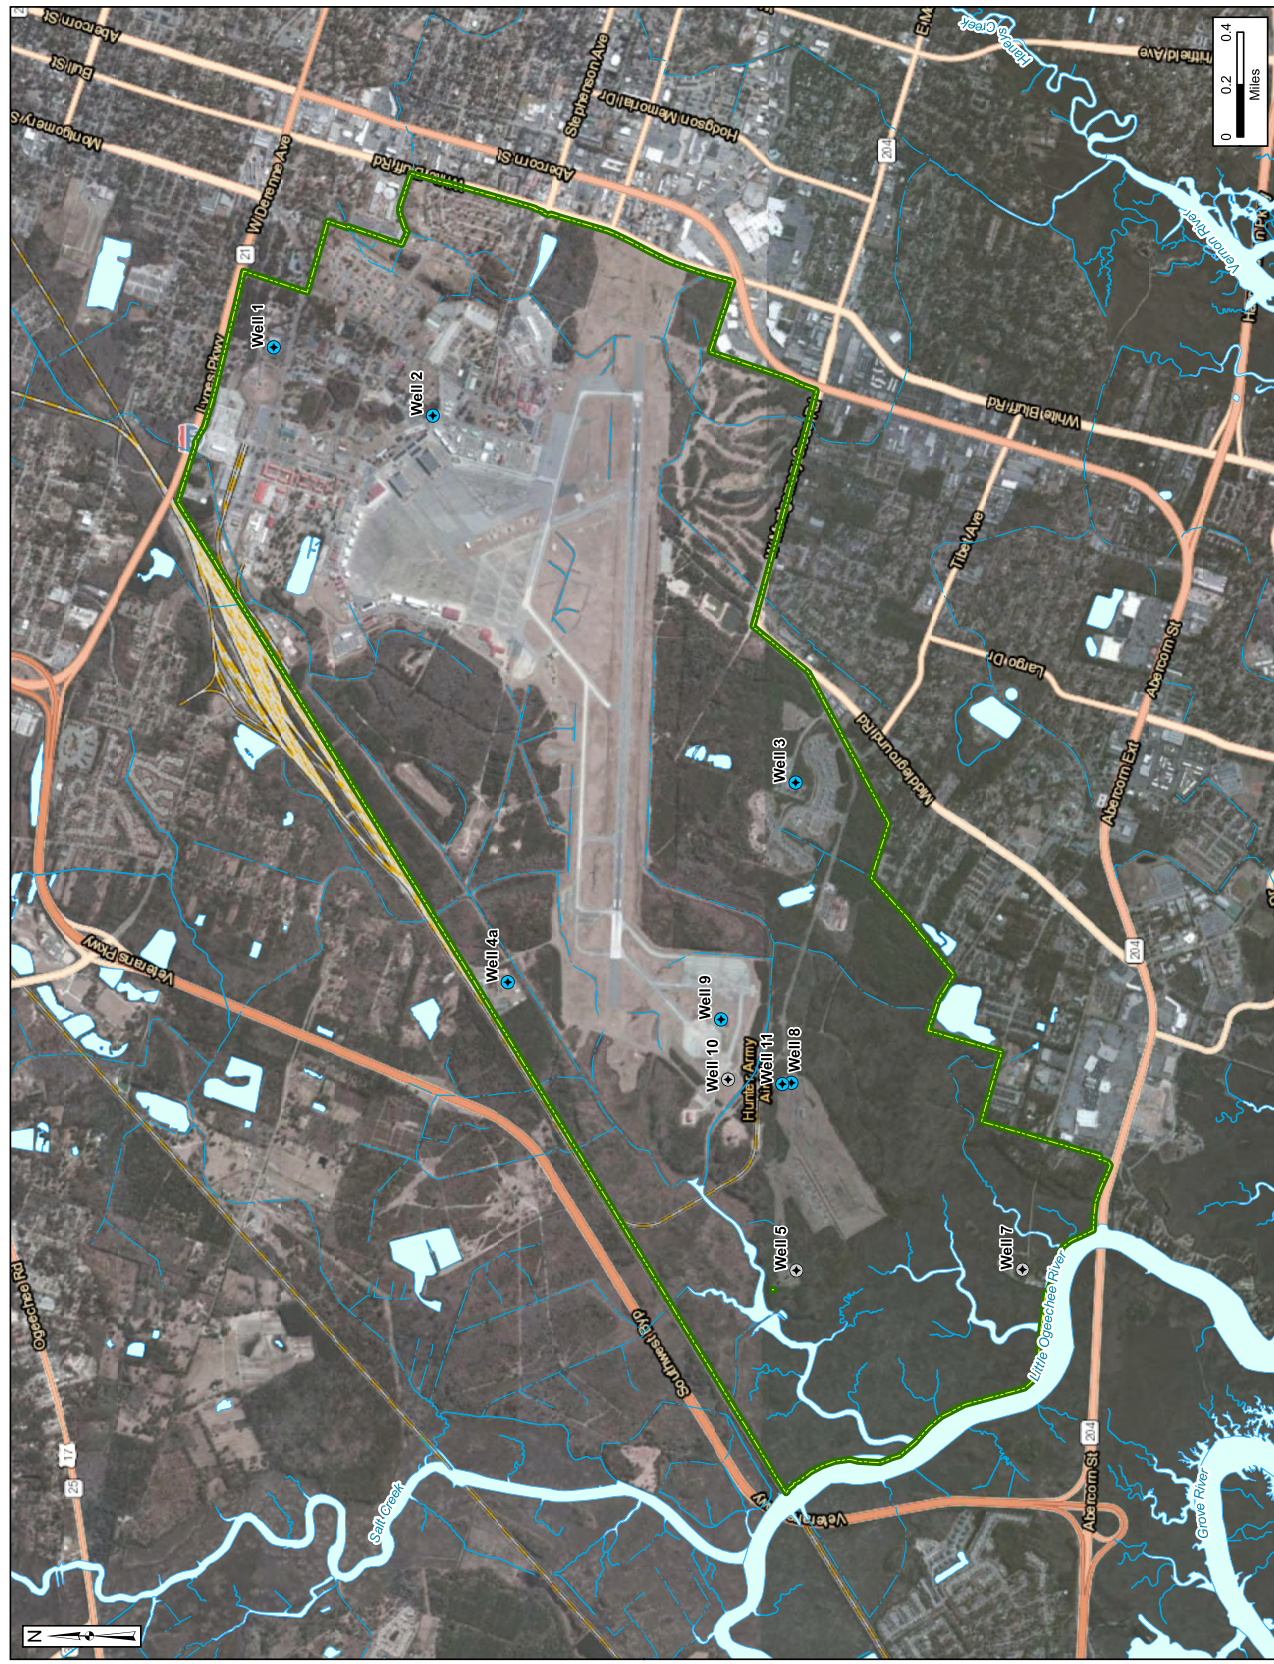
Figure 2-2
 Site Layout

Groundwater is the principal source of potable water in coastal Georgia. HAAF operates four separate groundwater systems for supplying safe drinking water to residents and employees and for providing water for fire protection. A total of eight potable wells are included in these systems, two of which have been capped. All the wells in the eight groundwater systems pump from the Floridan aquifer. The main post system is a community water system and consists of two deep potable wells located in the cantonment area. Water treatment for the main post system consists of chlorination and fluoridation. On-post potable wells are shown on **Figure 2-2**. Available on-post potable well depths can be found in **Table 2-1**.

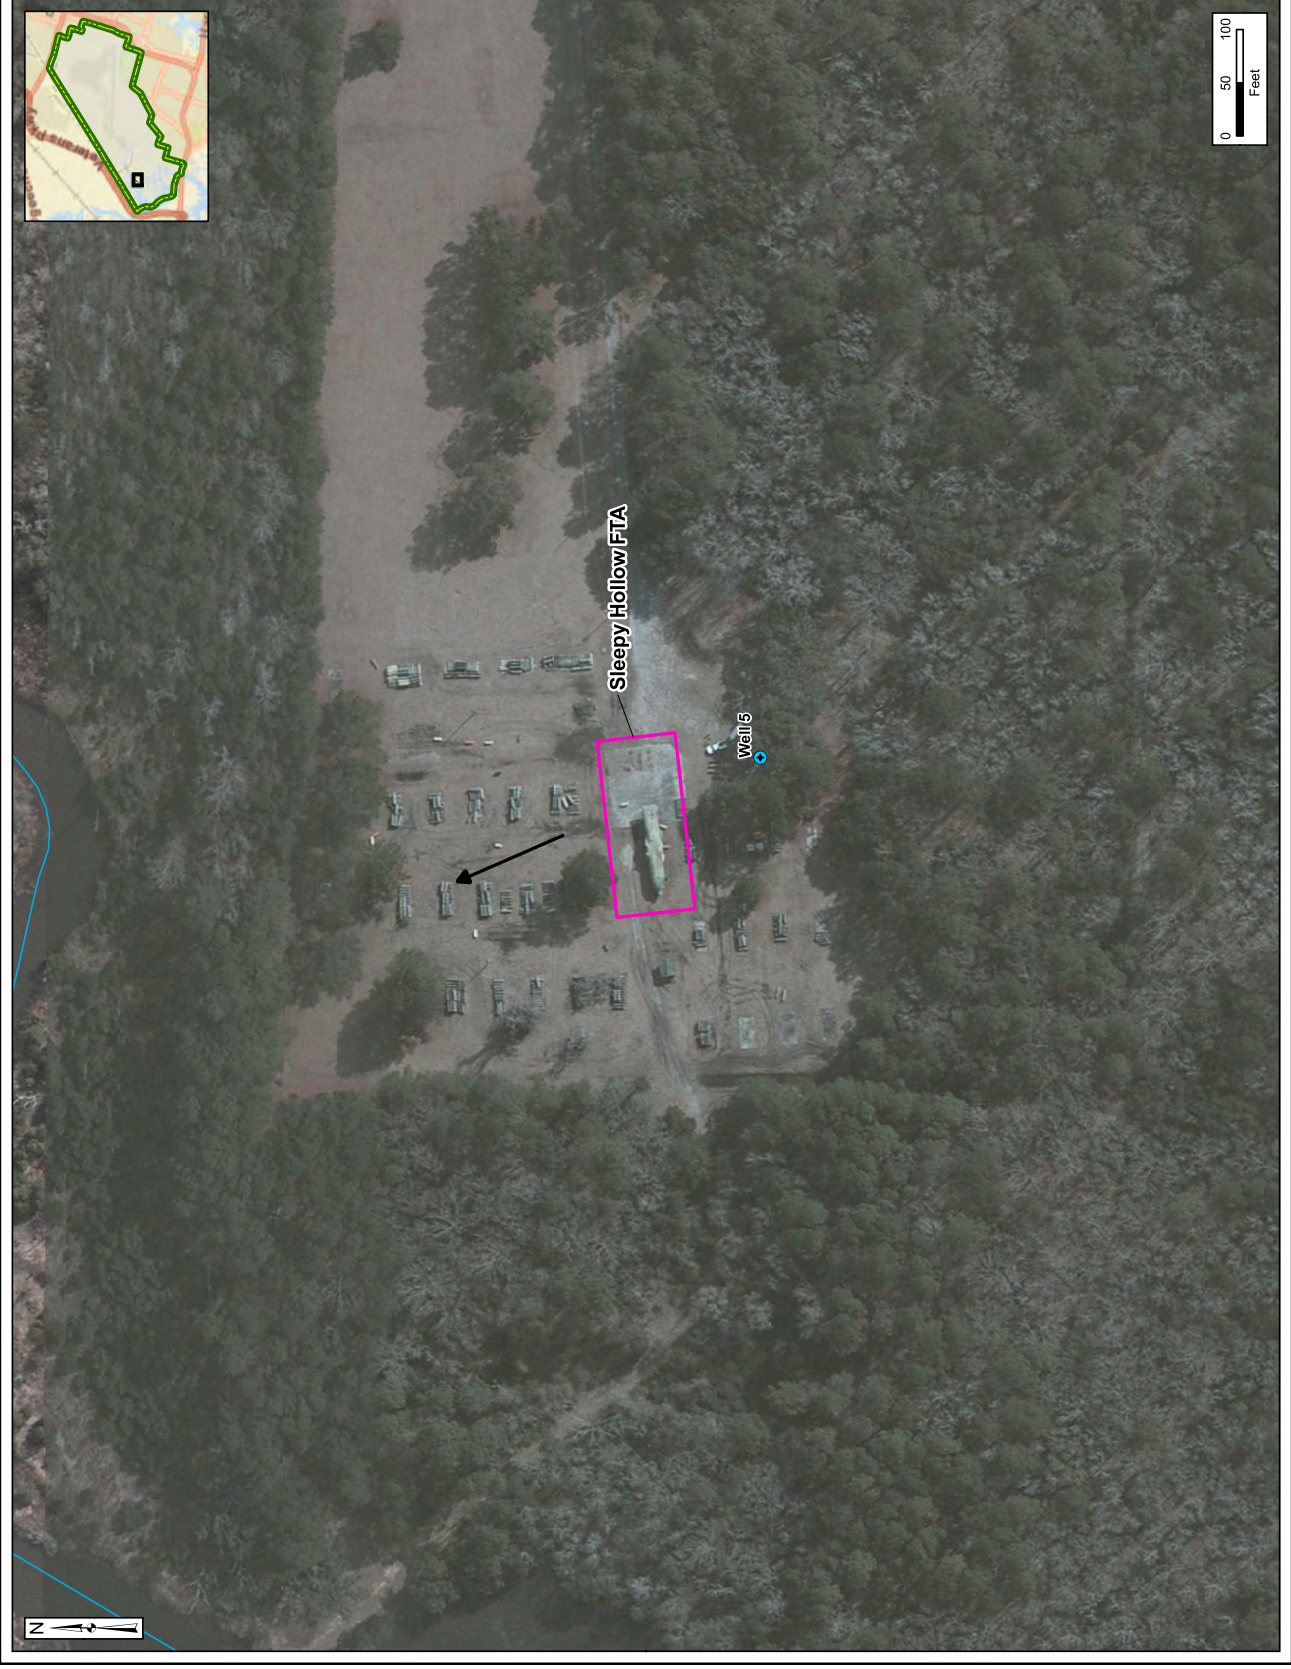
Figure 5-5
Aerial Photo of
Fire Station 02, Vehicle Fire 03,
and Nozzle Testing Area

Fire Station 02 is identified as an AOPI following document research, personnel interviews, and site reconnaissance trips due to a historical AFFF leak that occurred from Crash Truck 02 while on site. This fire station houses Crash Truck 02, which had a slow AFFF leak (less than 0.1 liter per day) at an unknown frequency from approximately 2005 to 2016. Installation drinking water well 2 is approximately 0.5 miles upgradient of Fire Station 02. The interior of Fire Station 02 contains floor drains that discharge to the sanitary sewer system which then discharges to the HAAF WWTP (**Figure 5-5**).

Note: The location of Vehicle Fire 03 is estimated.

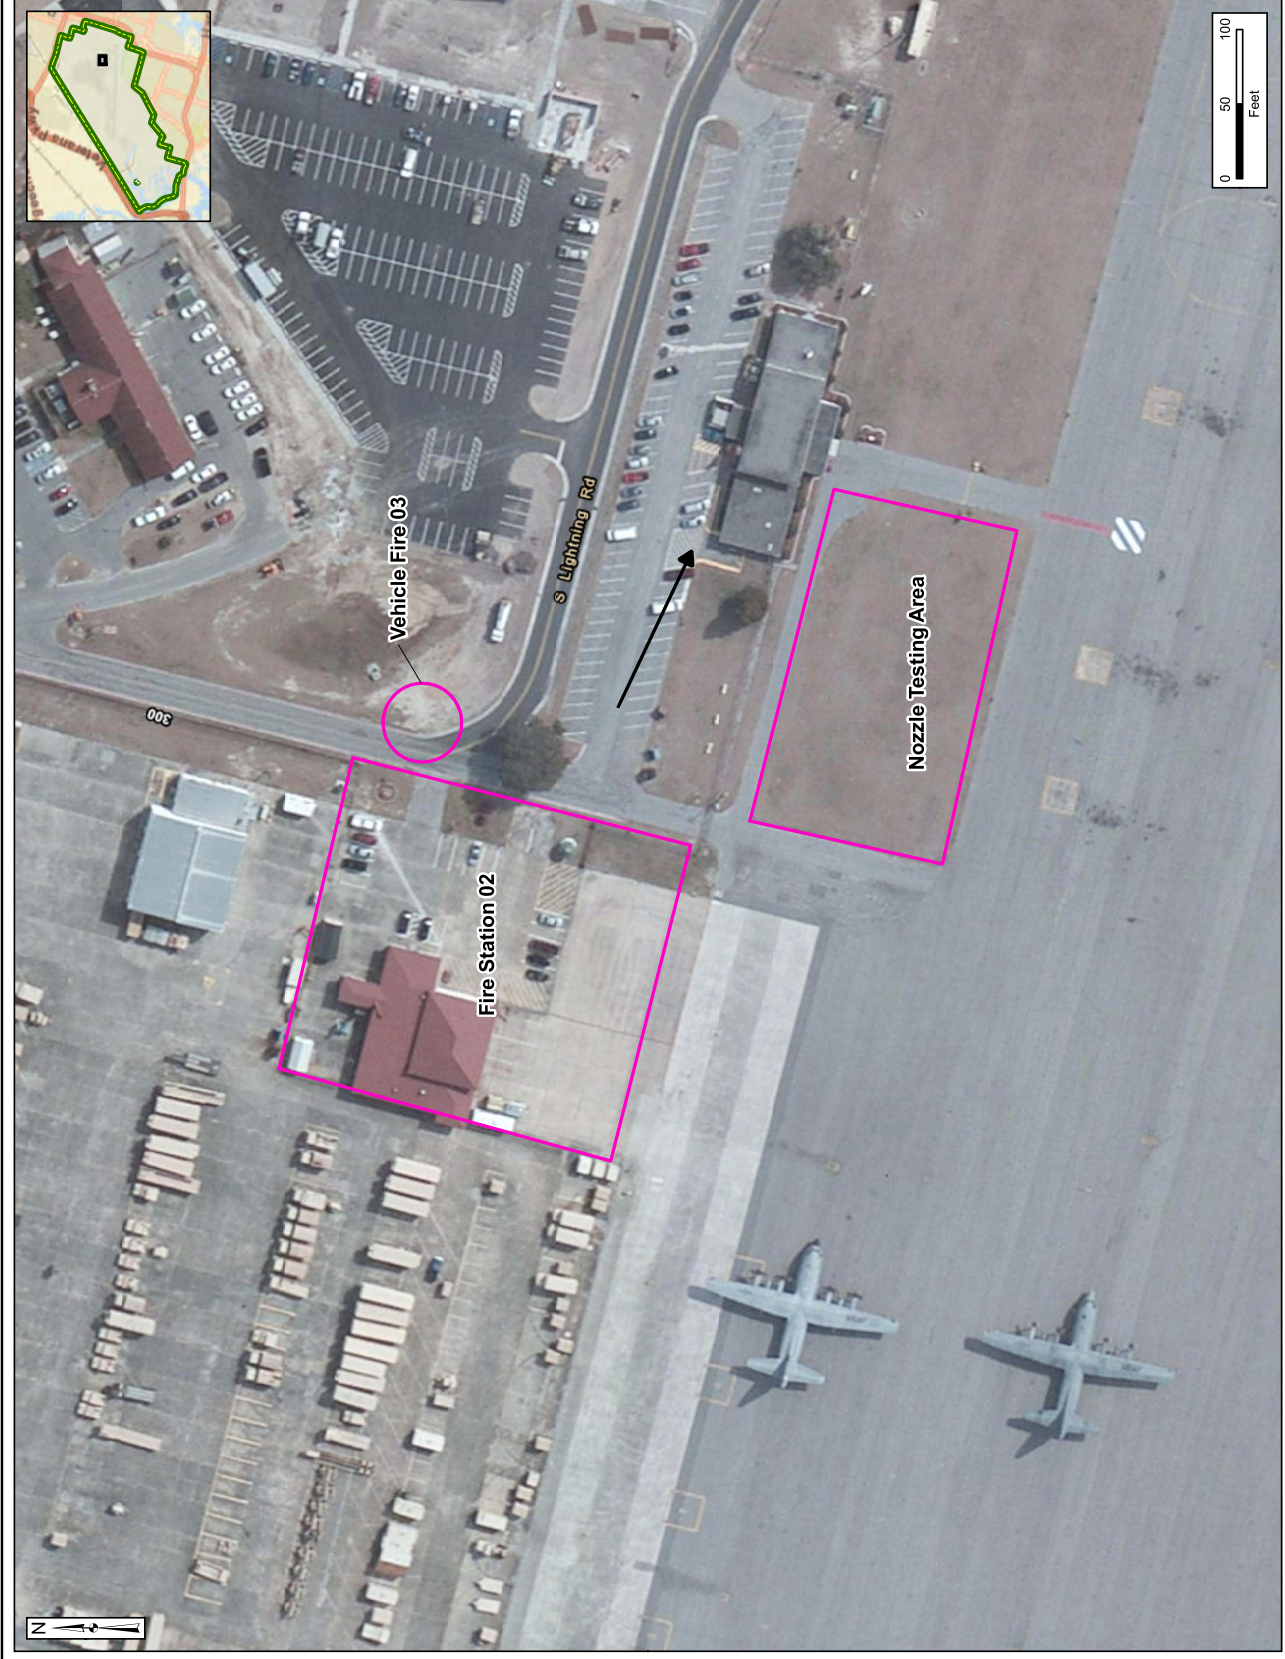
Figure 5-6
Aerial Photo of
Hangar 830

Hangar 830 is identified as an AOPI following document research, personnel interviews, and site reconnaissance trips due to a leaking AFFF fire suppression system. This hangar contains an AFFF suppression system. An unknown amount of foam leaked in 2015. Drainage from the interior of the hangar flows through floor drains to a large underground storage tank (UST) behind the hangar. The UST has reportedly never been emptied. (**Figure 5-6**)

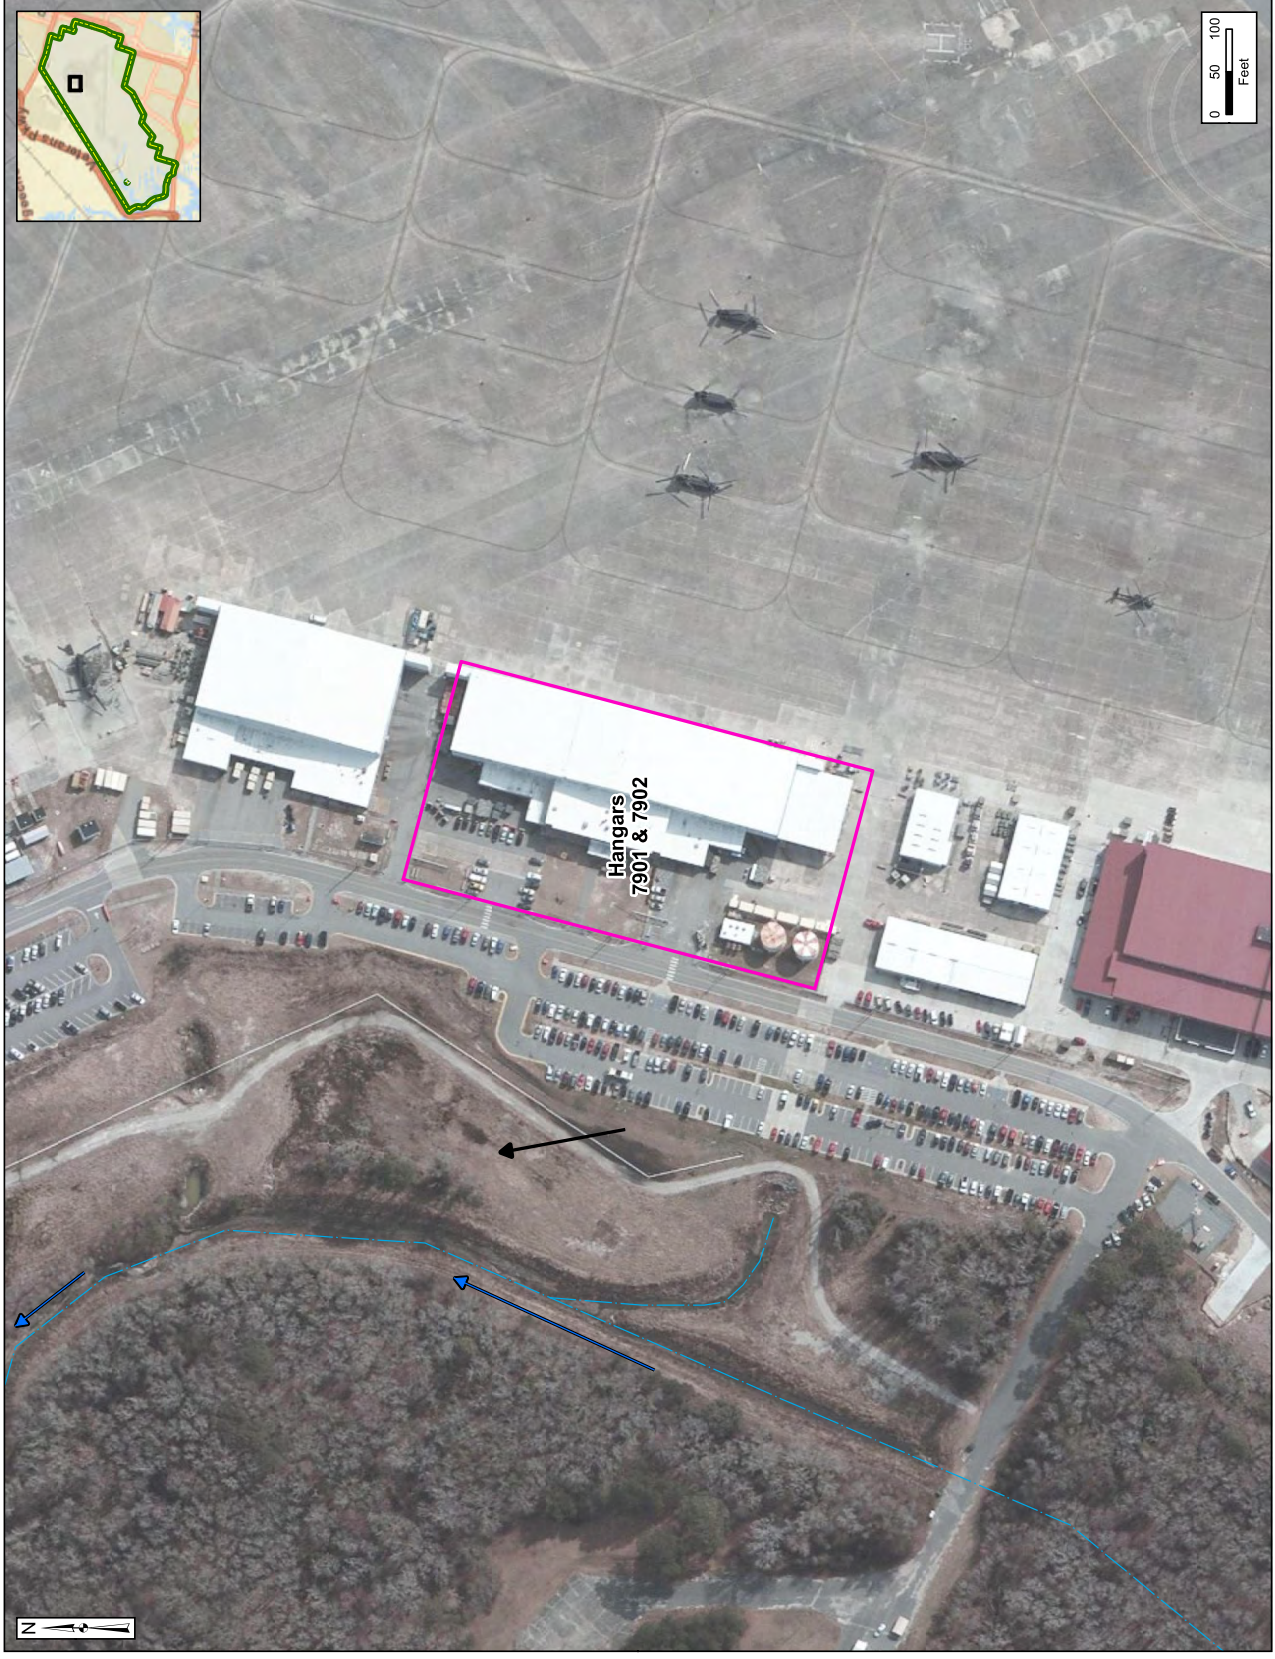
Figure 5-7
Aerial Photo of
Hangars 7901 & 7902

location. Drainage from the trench drains flows to the sanitary sewer. Drainage from some areas of the hangar exterior flows into the stormwater system, which eventually discharges to tributaries of the Little Ogeechee River (**Figure 5-7**).

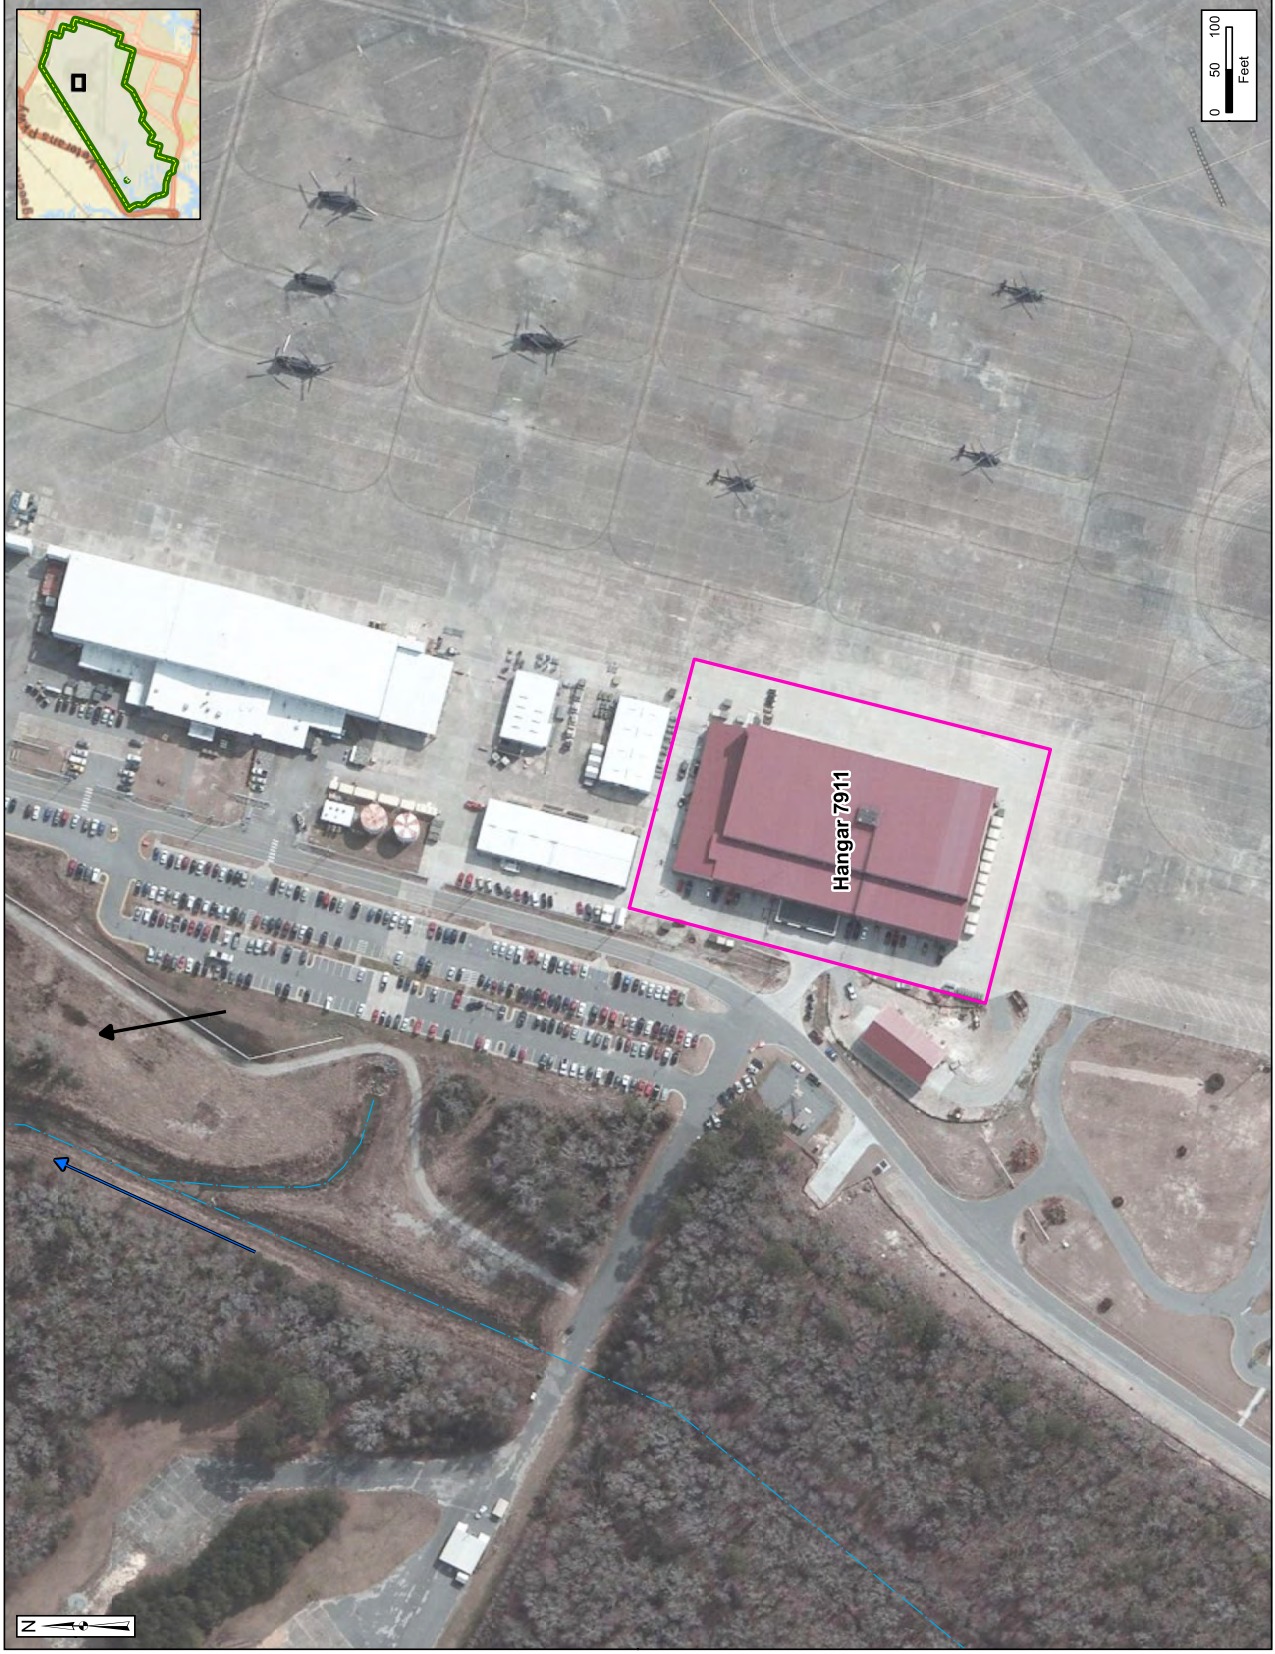
Figure 5-8
Aerial Photo of
Hangar 7911

Hangar 7911 is identified as an AOPI following document research, personnel interviews, and site reconnaissance trips due to an AFFF release from the building's fire suppression systems. An unknown amount of high expansion foam release occurred in 2018. A defoaming agent was used to reduce the foam, which was then vacuumed and containerized. PFAS-related compounds were detected in IDW samples. Some foam extruded outside of the building doors and foam was detected in a stormwater outfall (**Figure 5-8**).

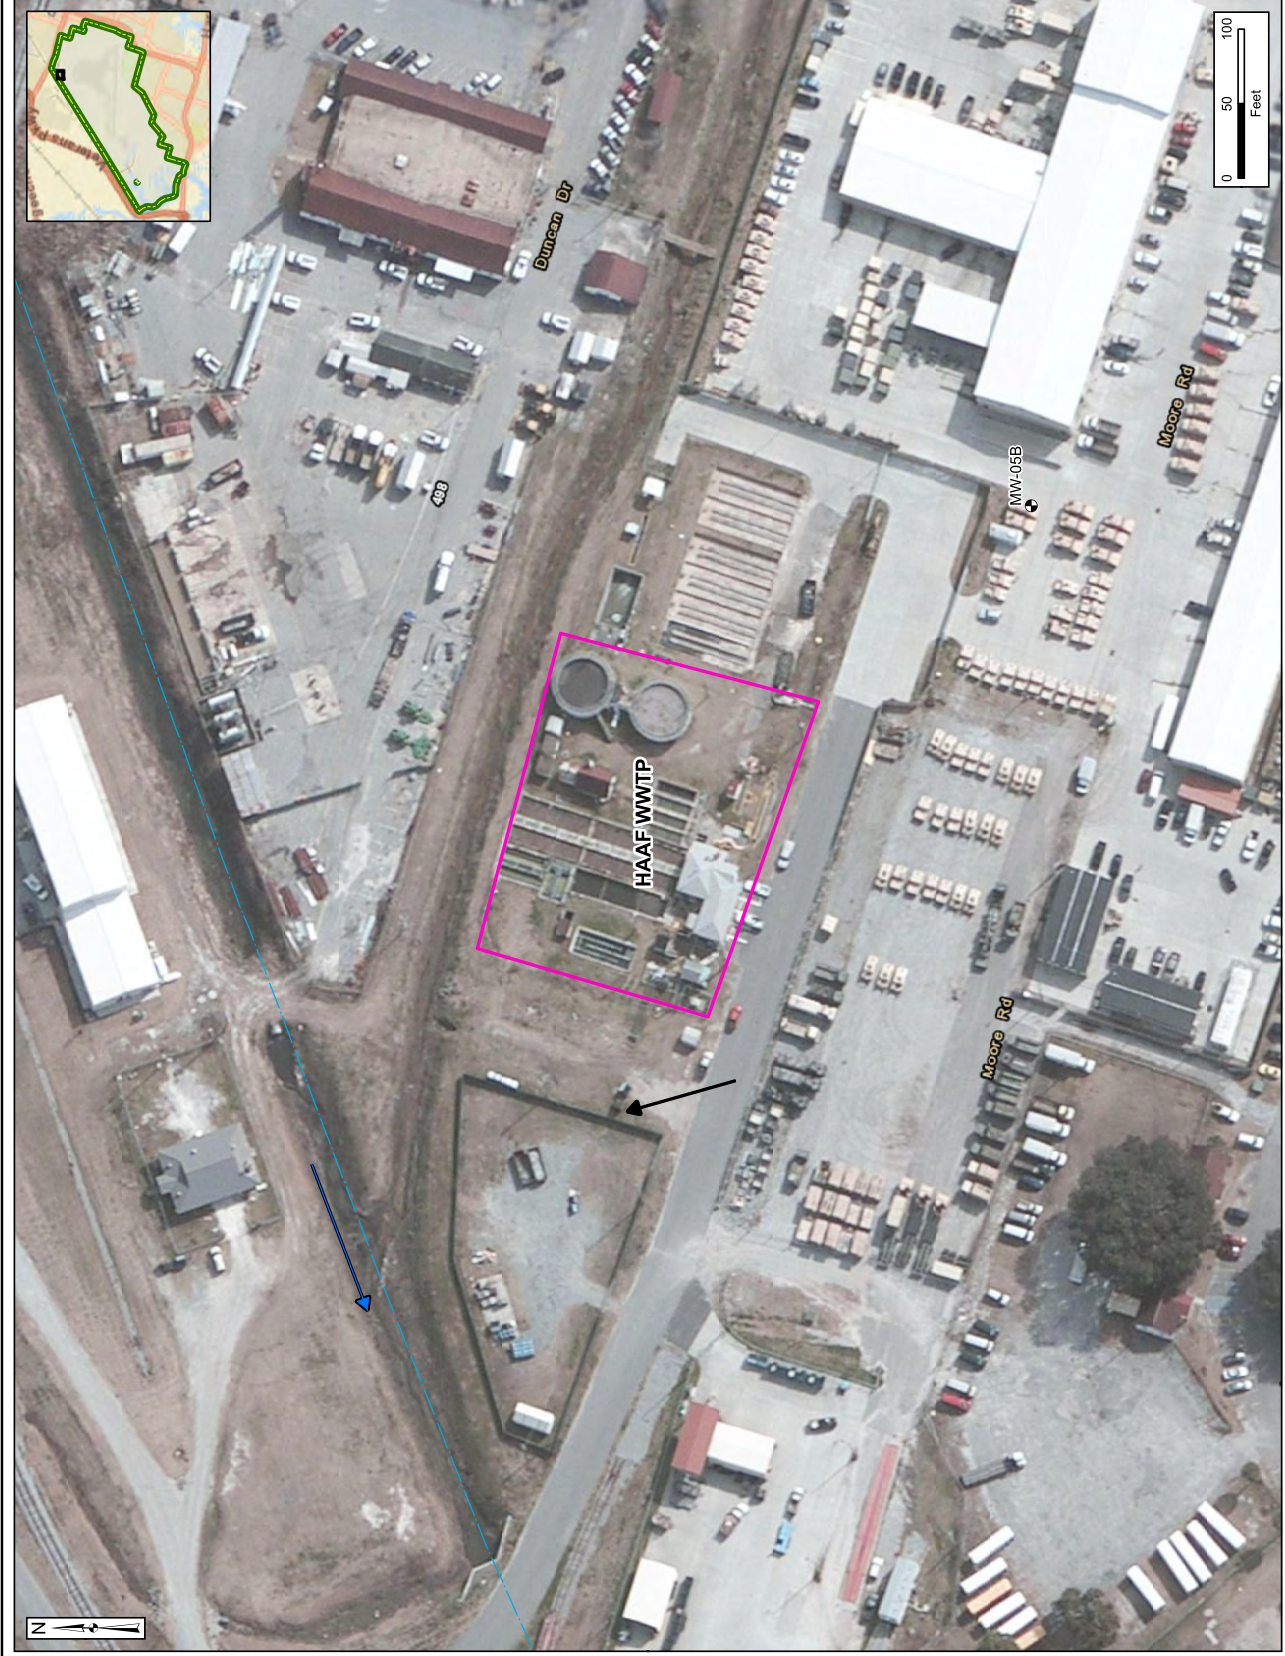
Figure 5-9
 Aerial Photo of
 HAAF WWTP

The HAAF WWTP is identified as an AOPI following document research, personnel interviews, and site reconnaissance trips due to history of accepting drainage from Fire Station 02 that may have contained PFAS impacted liquid. Waste drainage from Fire Station 02 has historically and continues to be treated at the HAAF WWTP. Historically, biosolids were applied to drying beds, then bed drainage was sent back through the HAAF WWTP. A belt-press is now used to dry solids instead of the drying beds. HAAF WWTP effluent eventually discharges to the Savannah River. Pre-1991, biosolids were disposed at Post South Central Landfill (FST-001), located within the footprint of Fort Stewart. Post-1991, biosolids were disposed off-site at Waste Management's Superior Landfill (**Figure 5-9**).

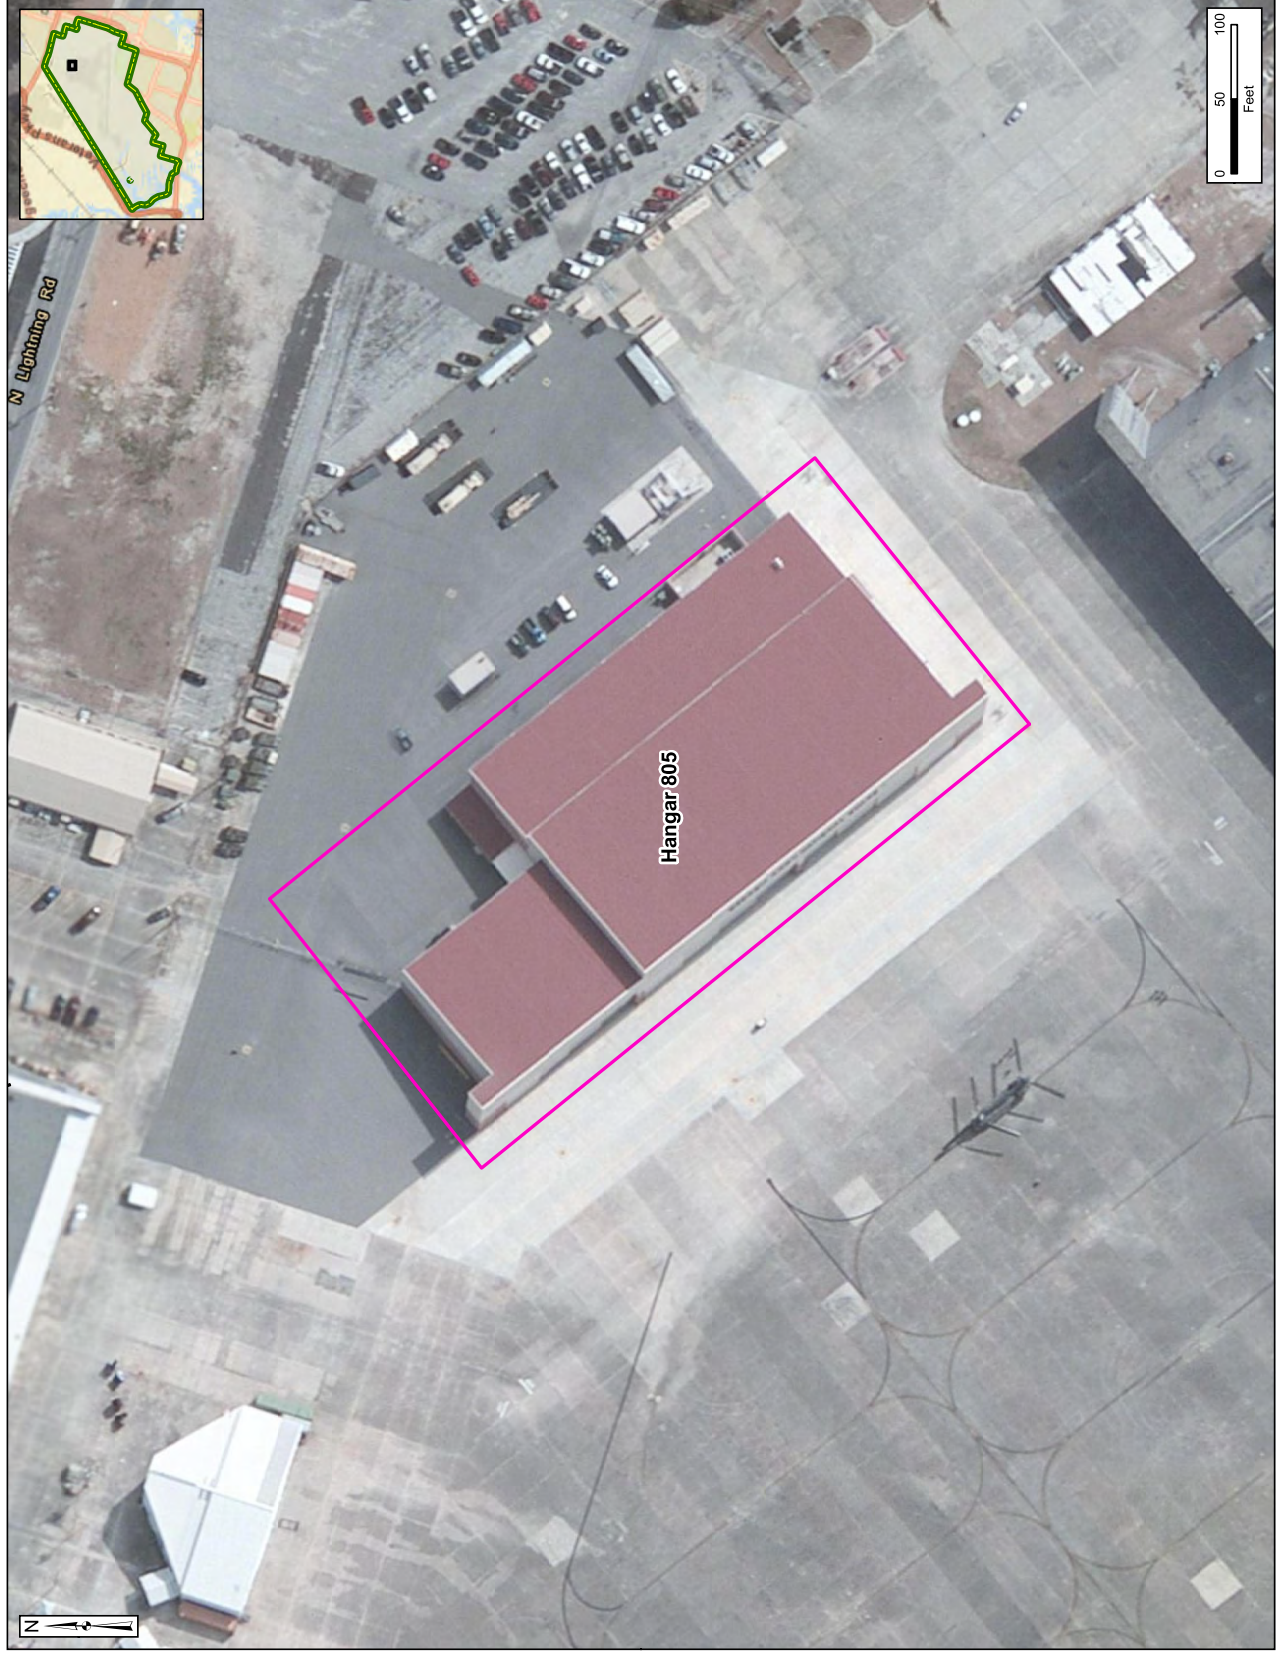
**Figure 7-1
AOPI Locations and
OSD Risk Screening Level
Exceedances**

AOPI = area of potential interest
FTA = Fire Training Area
HAA/HAAF = Hunter Army Airfield
OSD = Office of the Secretary of Defense
WWTP = Wastewater Treatment Plant
* Exceedance for Hangar 805 is based on HAAF WWTP results.

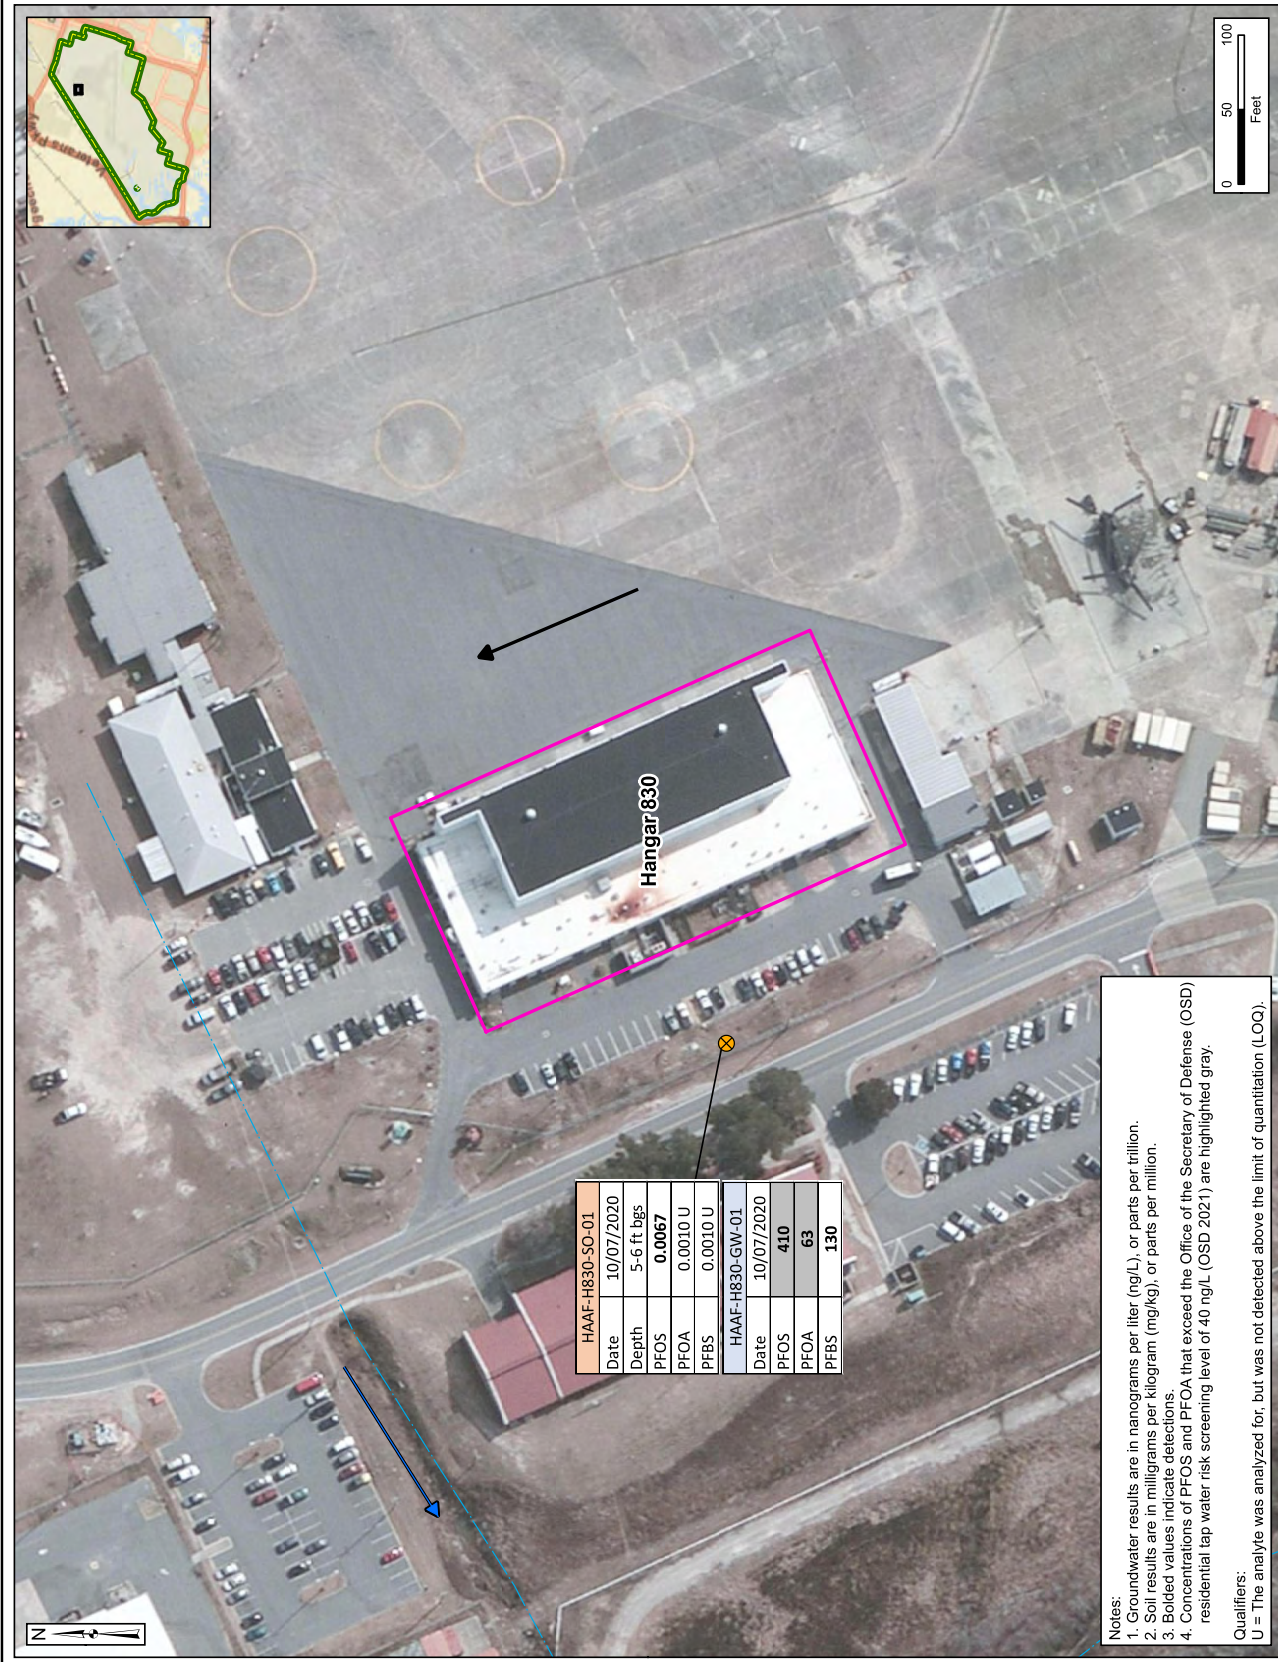
HAAF-H830-SO-01	
Date	10/07/2020
Depth	5-6 ft bgs
PFOS	0.0067
PFOA	0.0010 U
PFBS	0.0010 U
HAAF-H830-GW-01	
Date	10/07/2020
PFOS	410
PFOA	63
PFBS	130

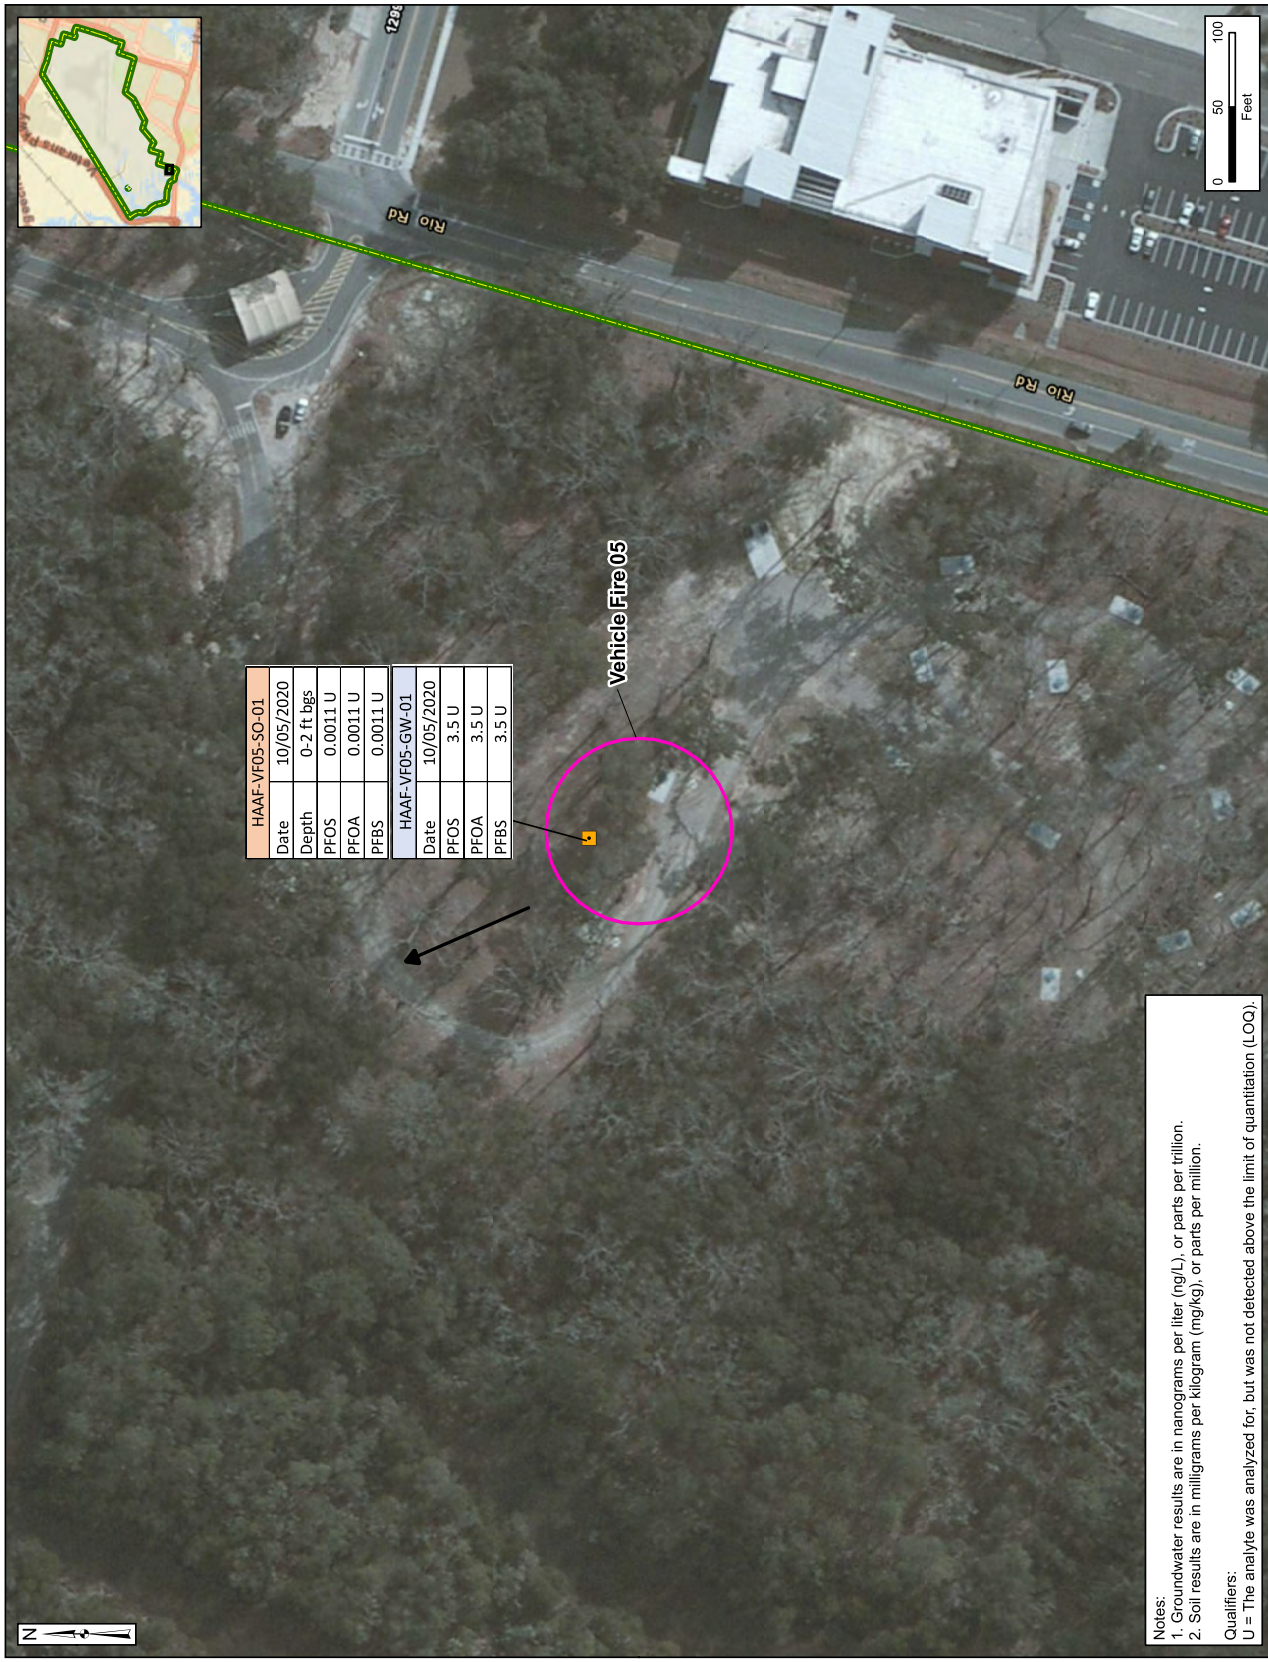
HAAF-VF05-SO-01	
Date	10/05/2020
Depth	0-2 ft bgs
PFOS	0.0011 U
PFOA	0.0011 U
PFBS	0.0011 U

HAAF-VF05-GW-01	
Date	10/05/2020
PFOS	3.5 U
PFOA	3.5 U
PFBS	3.5 U
