**PRELIMINARY ASSESSMENT OF PER- AND
POLYFLUOROALKYL SUBSTANCES AT
HAMILTON ARMY AIRFIELD,
NOVATO, CALIFORNIA**

**Final
October 2023**

Leidos
**1750 Presidents Street
Reston, Virginia 20190**

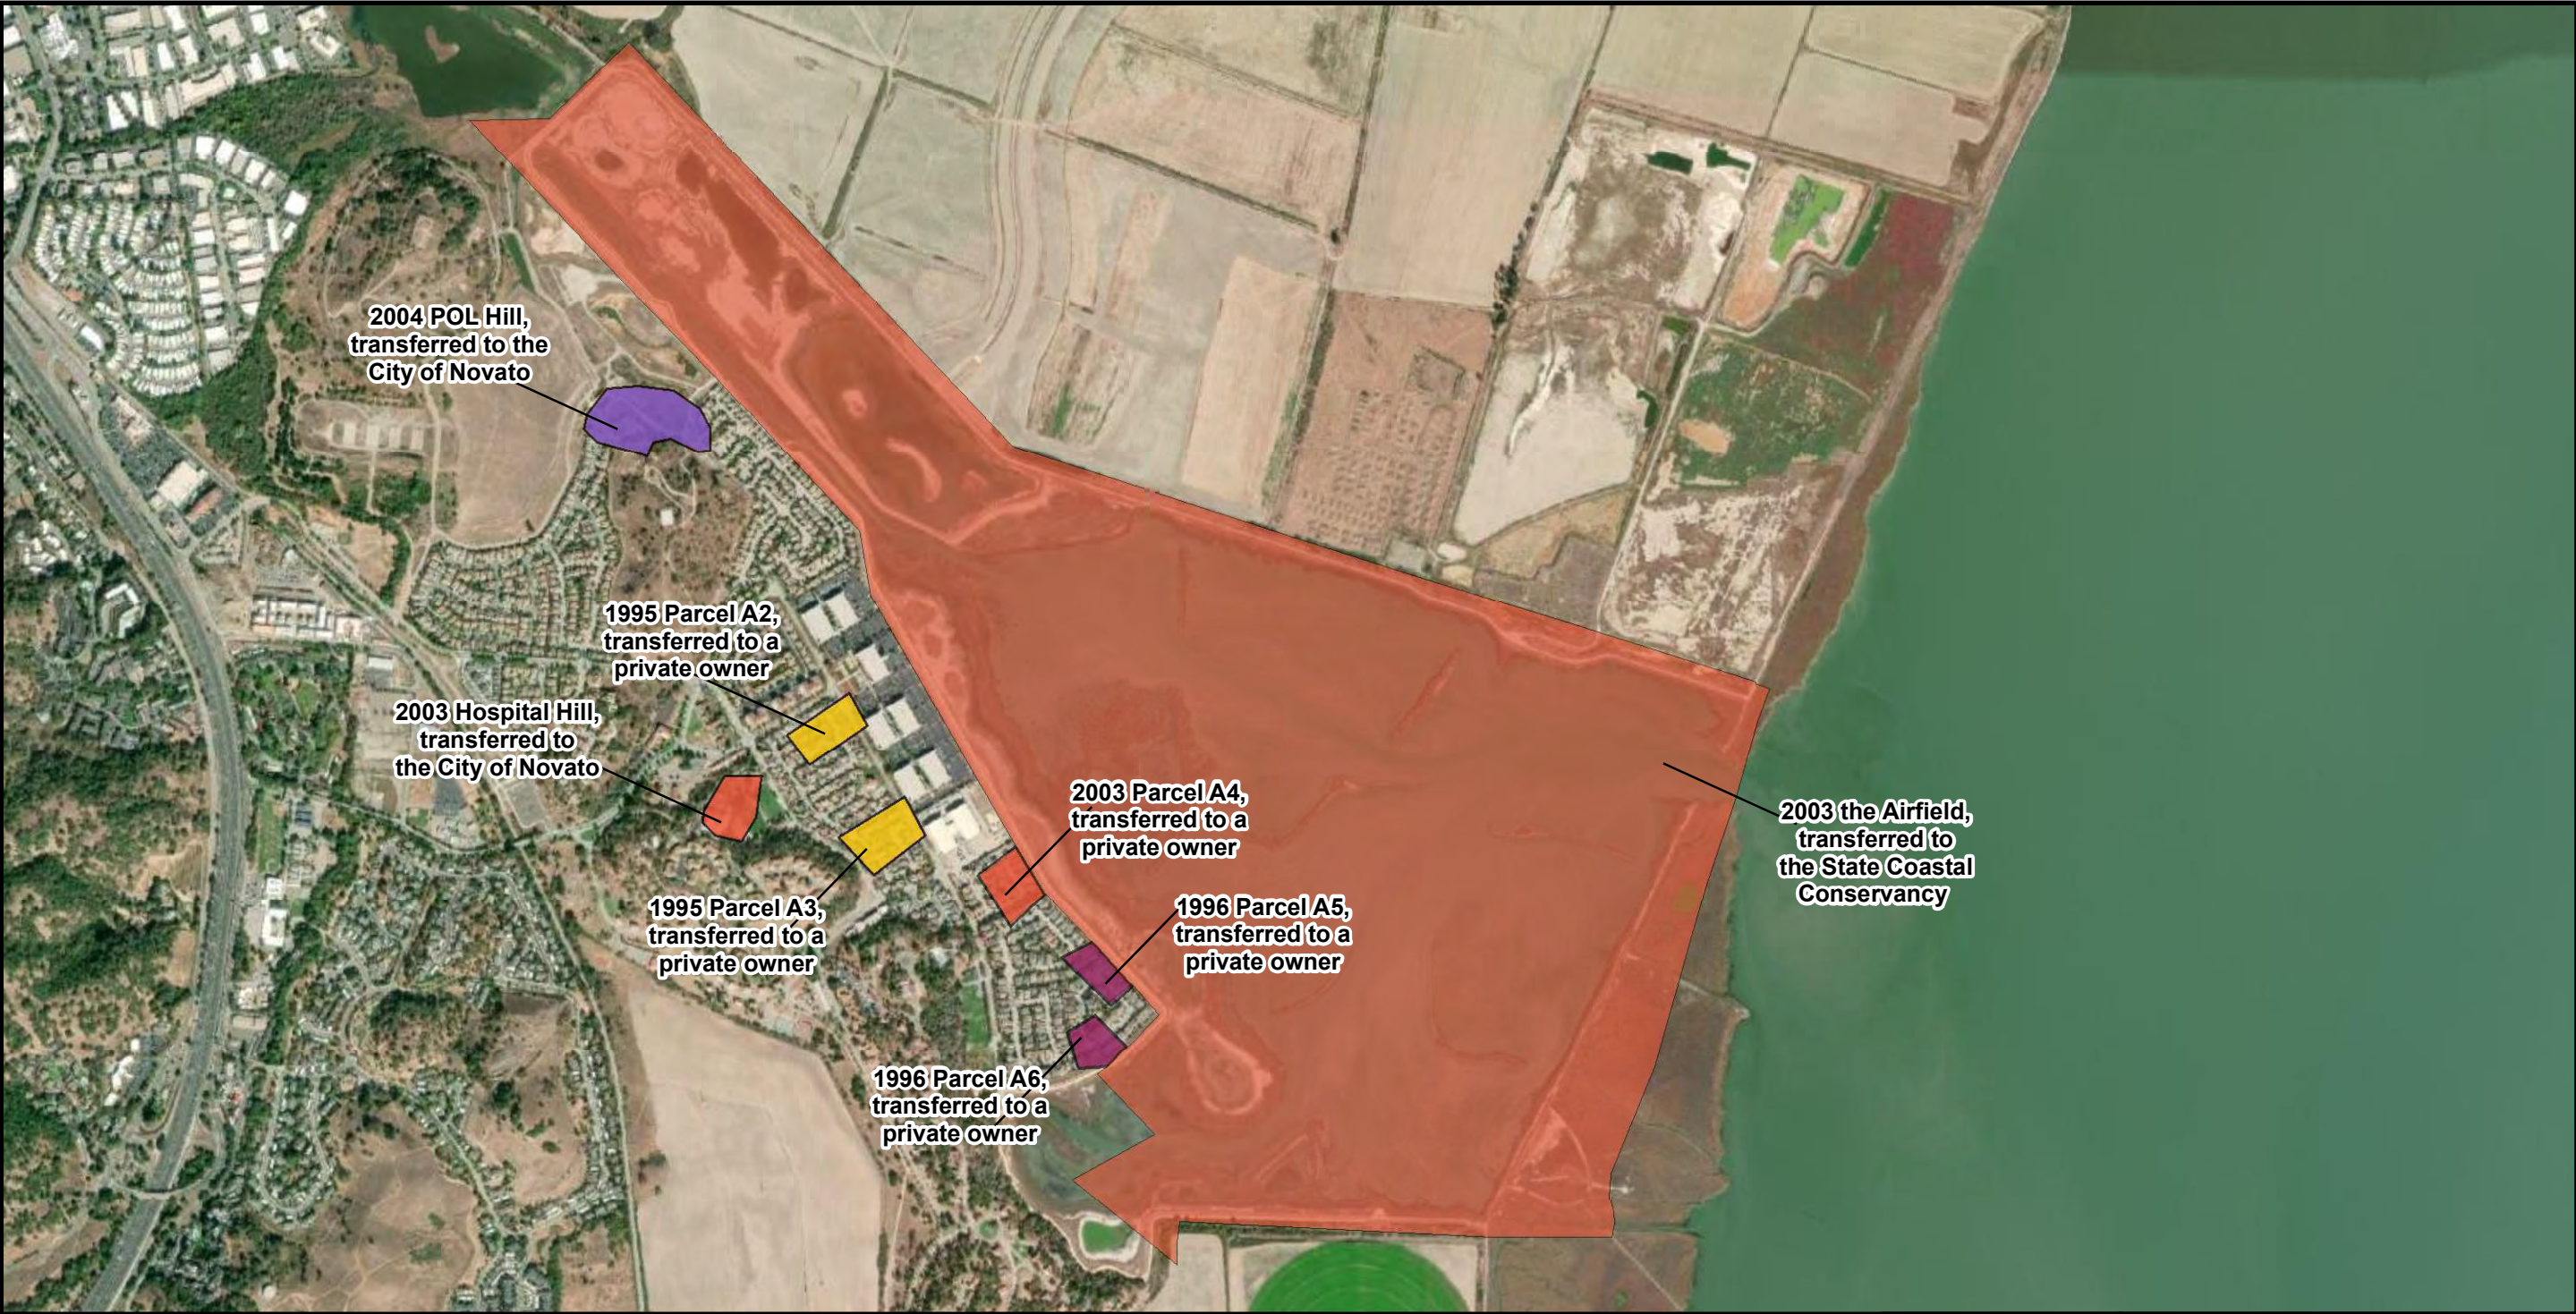
PARCEL TRANSFER MAP HAMILTON ARMY AIRFIELD NOVATO, CALIFORNIA	
FIGURE 2-2	DATE: 5/17/2023

and training). The former airfield itself (approximately 631 acres) was transferred to the California State Coastal Conservancy (CA SCC) by public benefit conveyance in 2003 and has been restored to wetlands (Earth Tech 1994). Parcel A4 (4 acres) consisted of former Buildings 138 and 140, which were previously used for administration, training, and minor electronic repair, and were sold to a private owner in 2003. Parcels A5 and A6 (3.9 acres) were transferred to private ownership in 1996. Parcel A5 was formerly an aircraft wash rack, and Parcel A6 was formerly part of the airfield (Earth Tech 1994). Parcels A2, A3, A4, A5, and A6 are currently residential housing. The HAAF transferred property and the property recipients are shown in Figure 2-2.
