FINAL PRELIMINARY ASSESSMENT AND SITE INSPECTION OF PER- AND POLYFLUOROALKYL SUBSTANCES

Hawthorne Army Depot, Nevada

Prepared For:
U.S. Army Corps of Engineers, Baltimore District
2 Hopkins Plaza
Baltimore, Maryland 21201

April 2022

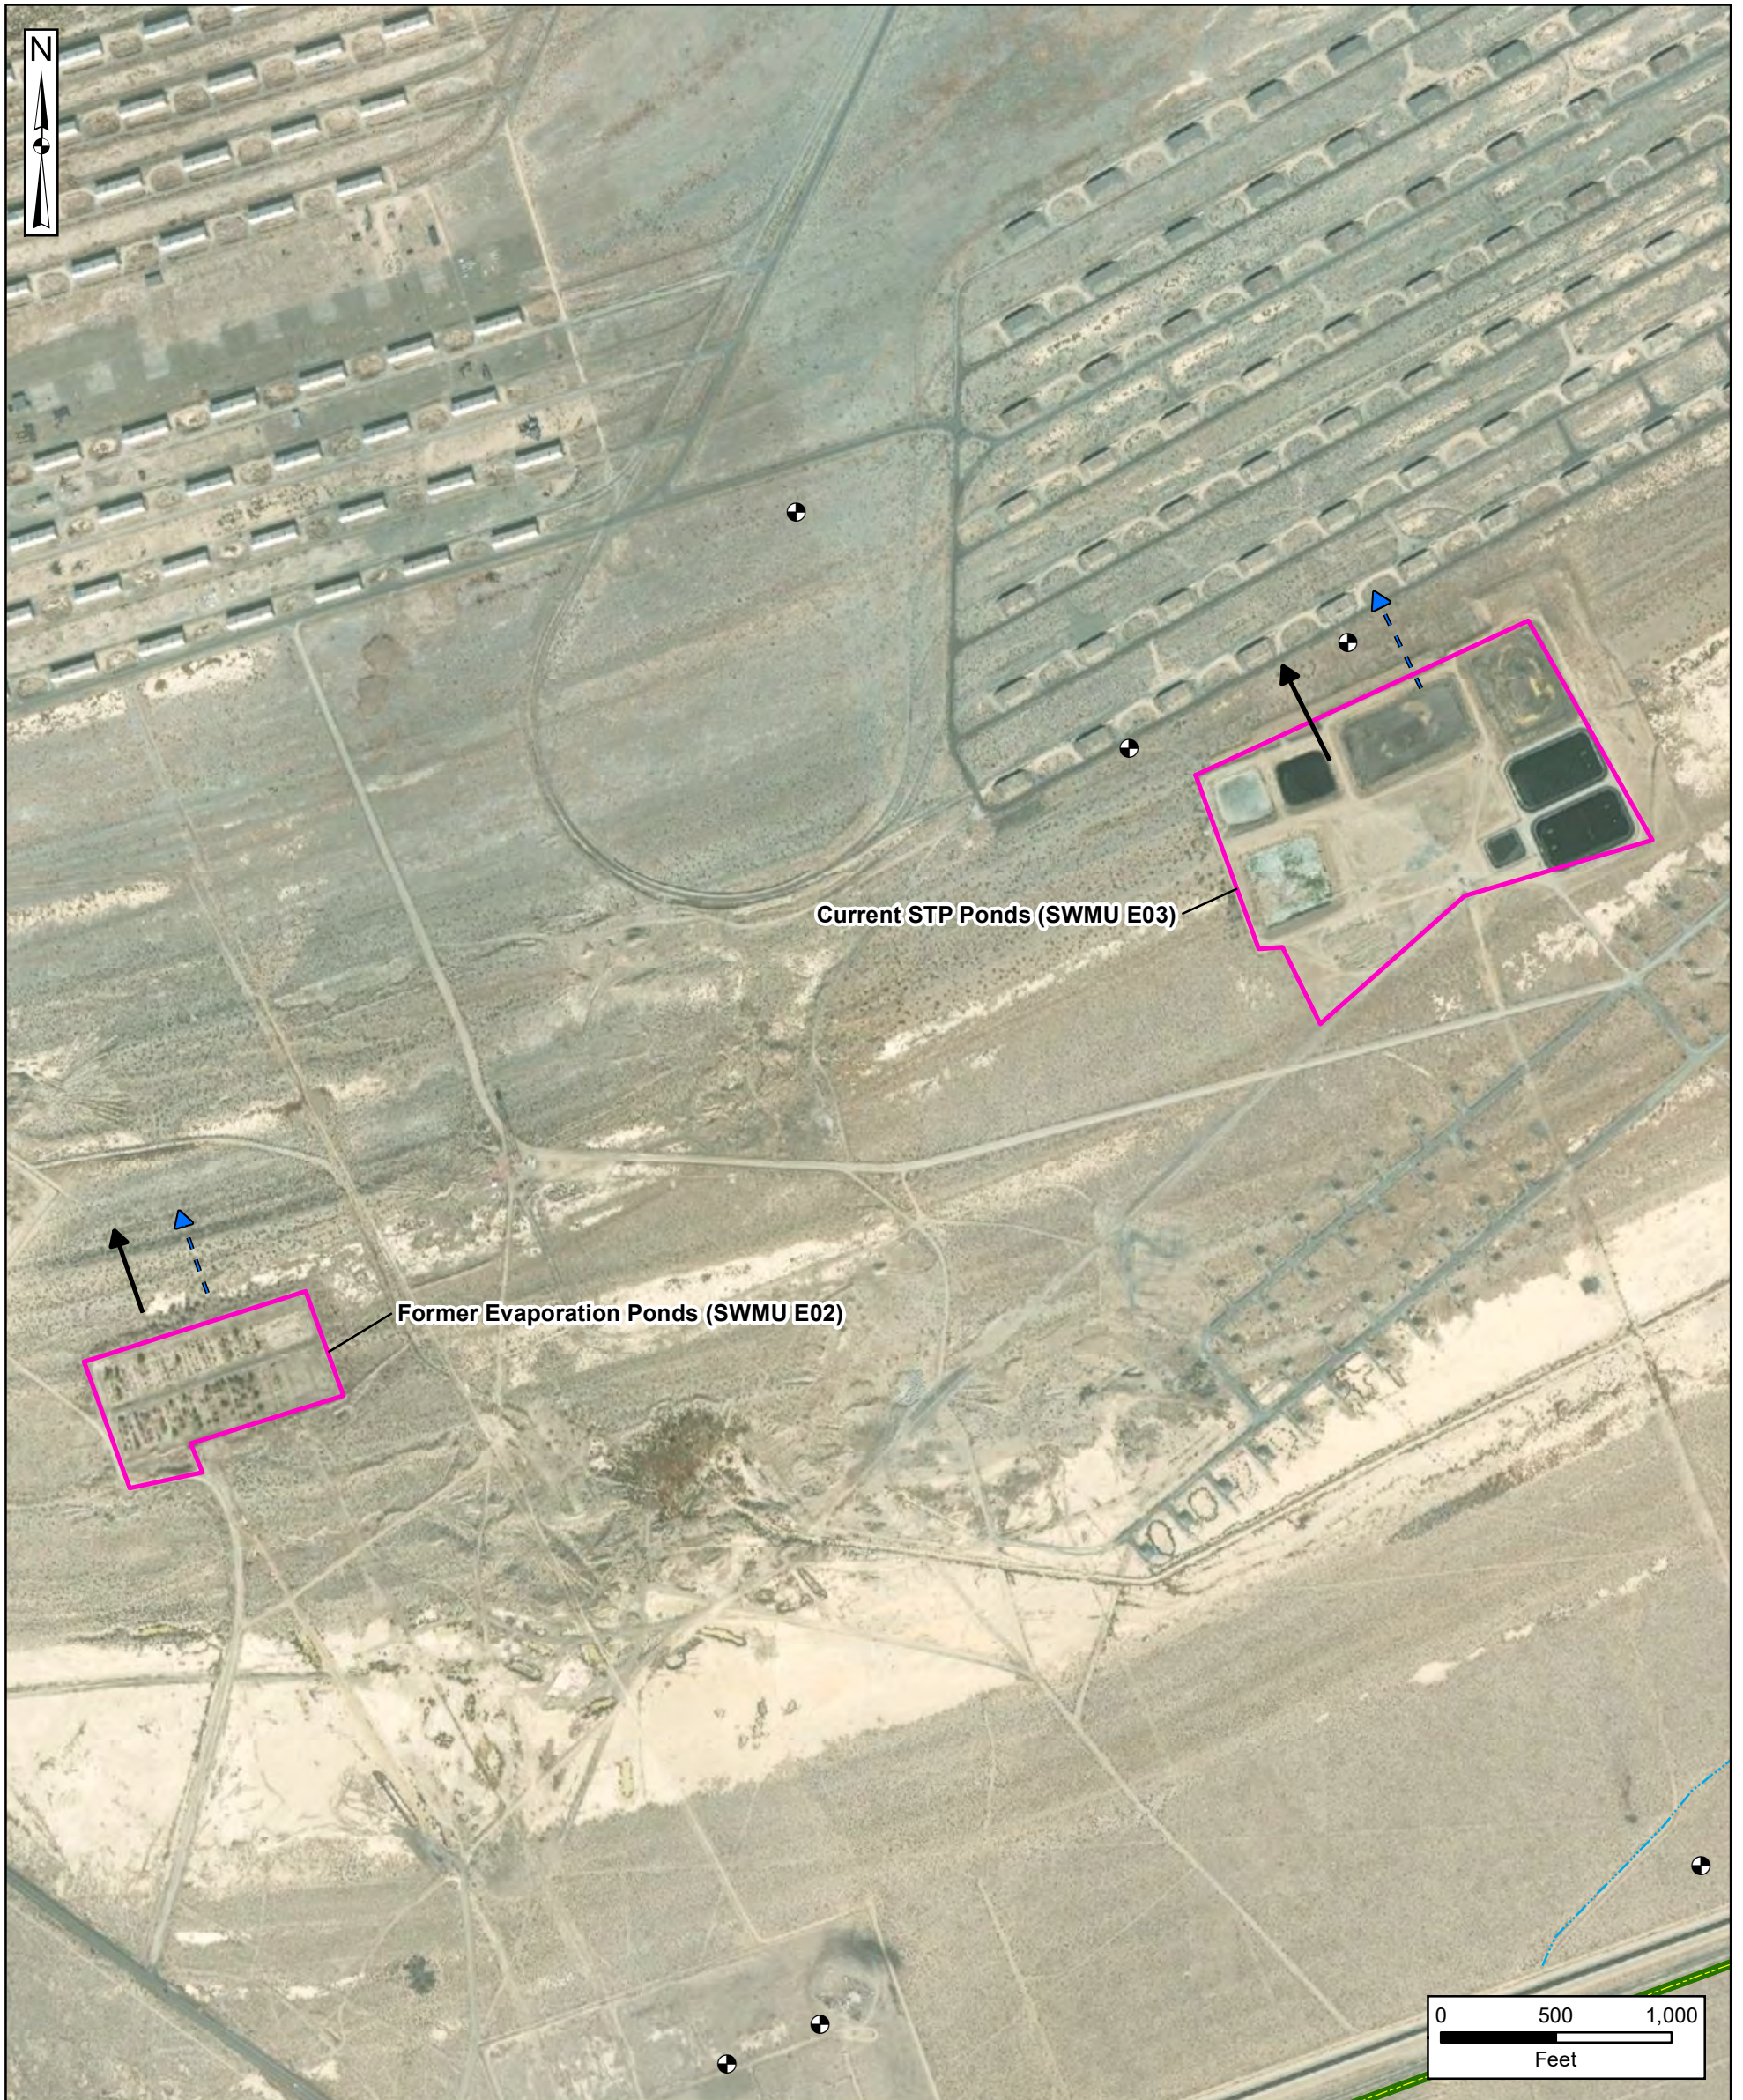
Figure 5-8
Aerial Photo of
Former Evaporation Ponds (SWMU E02) and
Current STP Ponds (SWMU E03)

Former evaporation ponds (**Figure 5-8**), associated with the former STP, are identified as an AOPI following records review, personnel interviews, and site reconnaissance due to its use for the disposal of PFAS-containing wastewater. The former evaporation ponds overlap with SWMU E02 (IRP No. HWAAP-E02, HQAES 32225.1065).

The current STP ponds (SWMU E03, IRP No. HWAAP-E03, HQAES 32225.1066) (**Figure 5-8**), associated with the current STP, is identified as an AOPI following records review, personnel interviews, and site reconnaissance due to its use for the disposal of PFAS-containing wastewater.

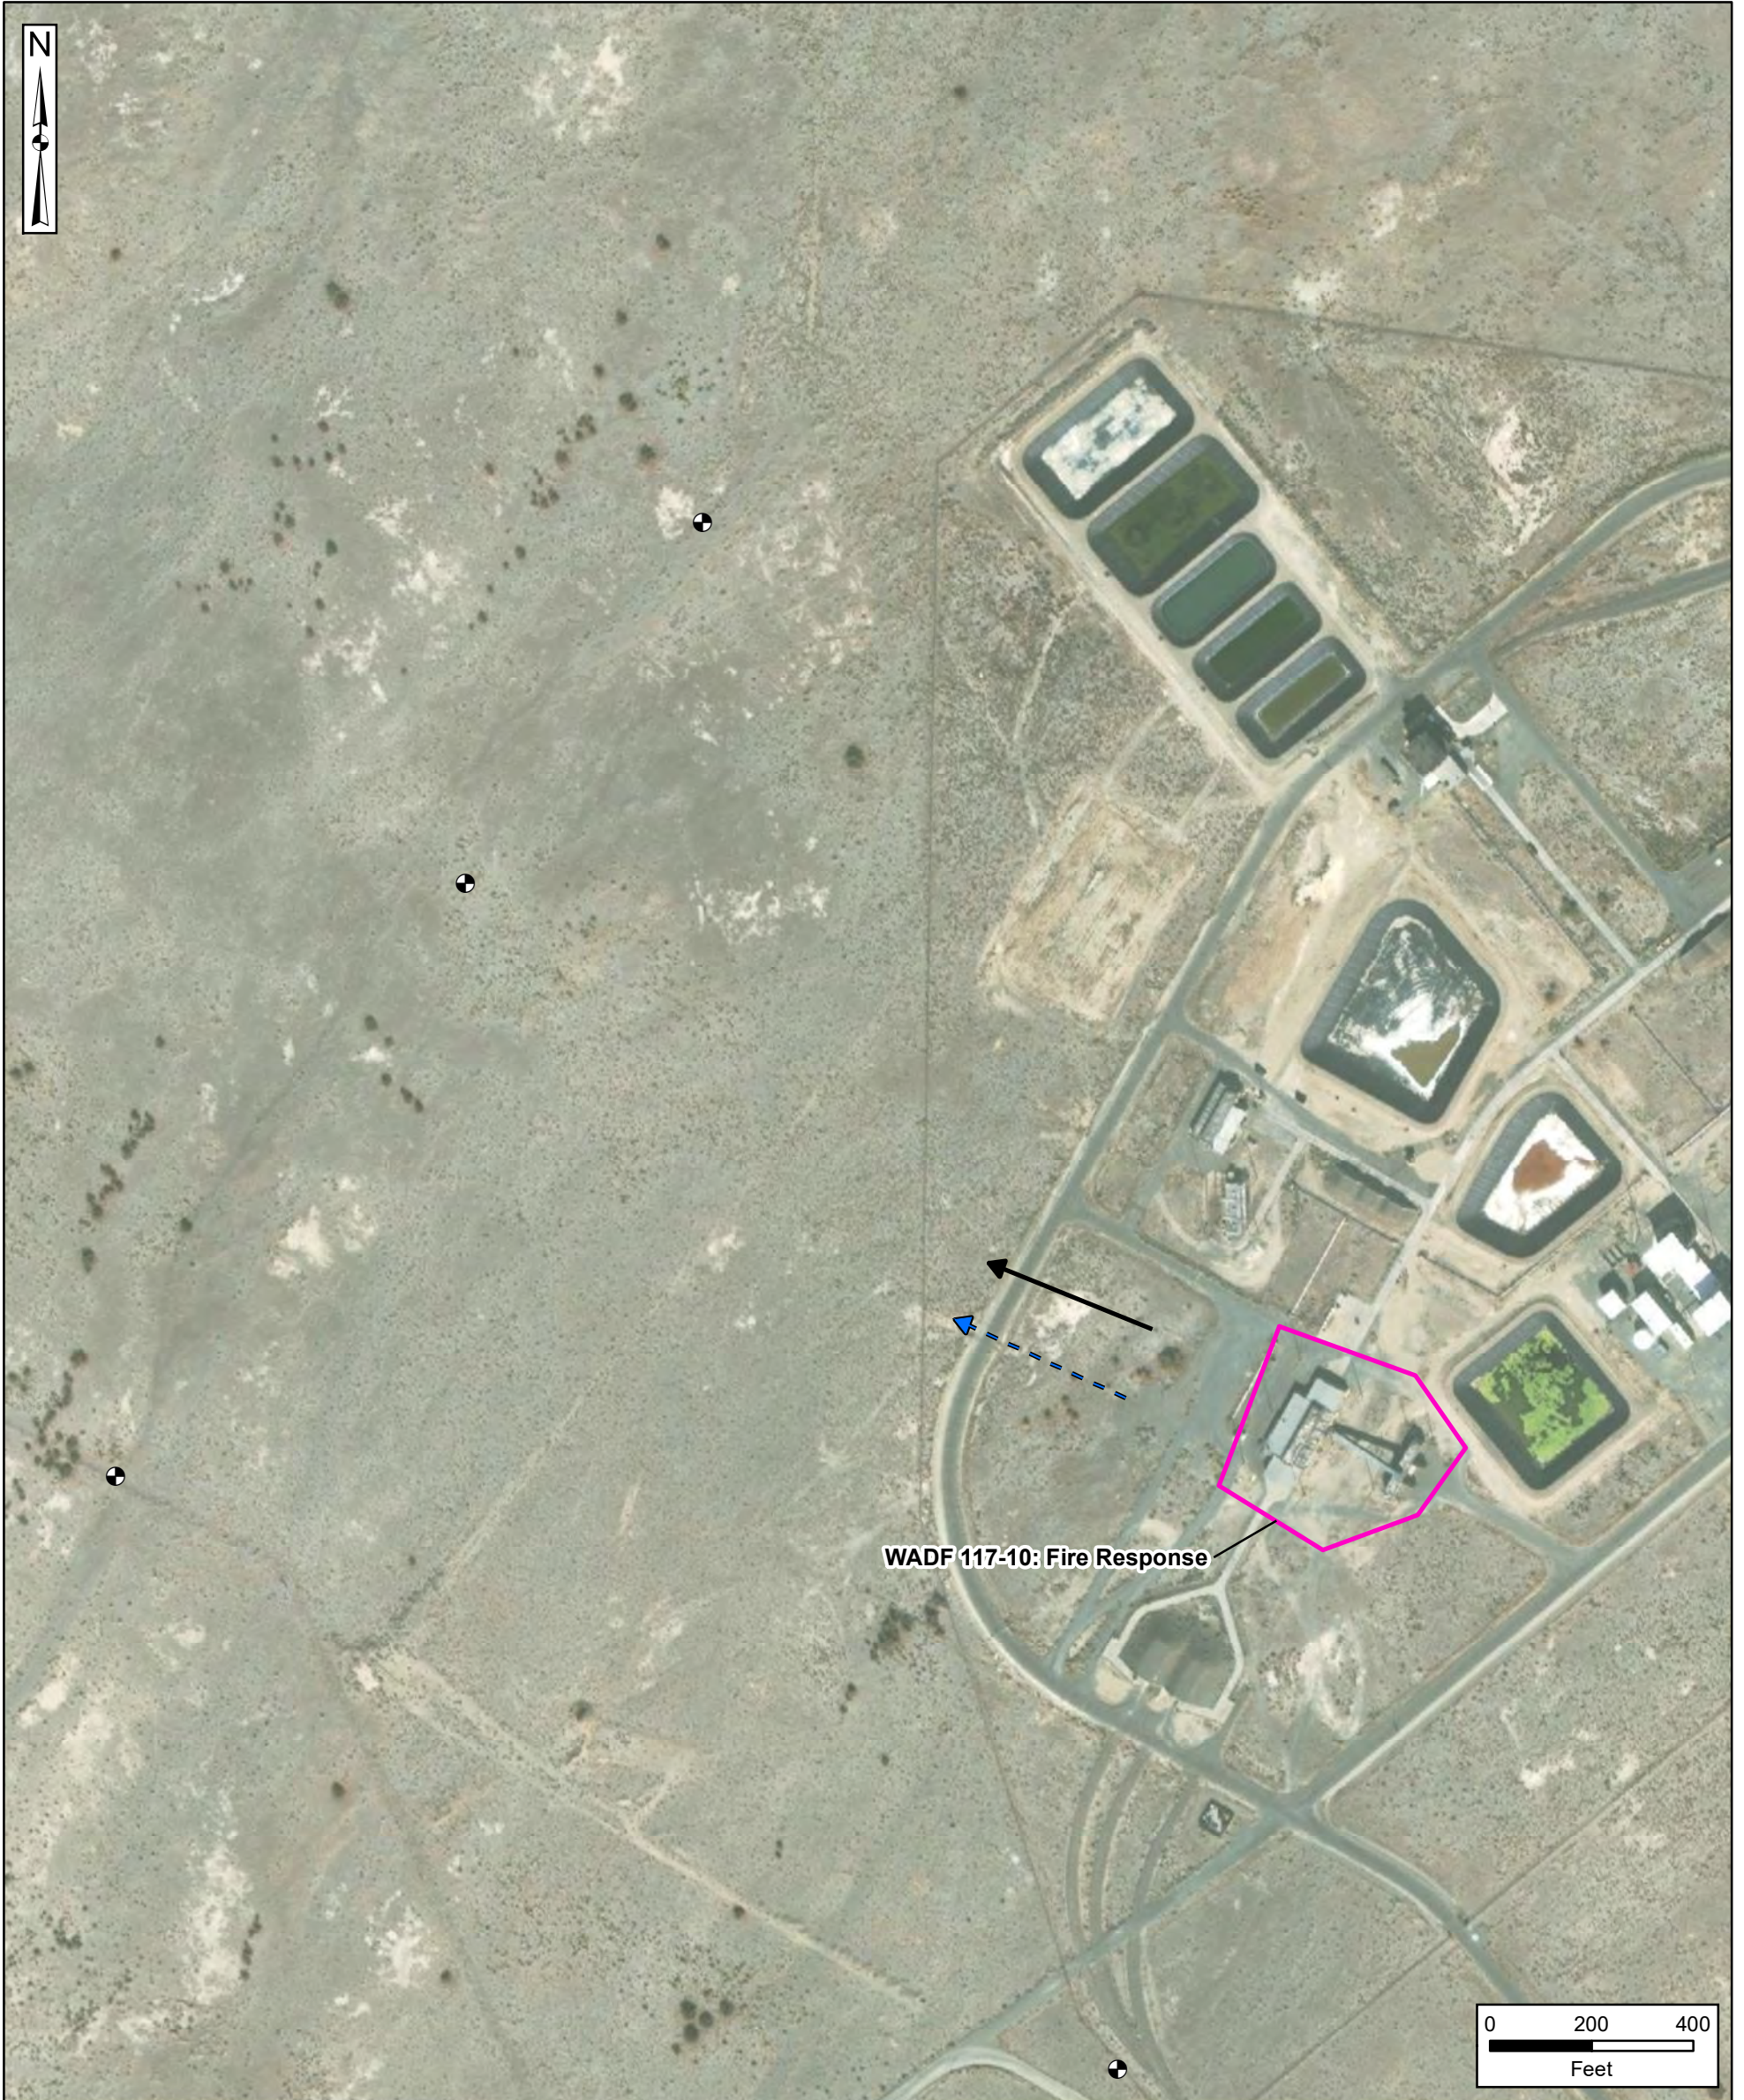
Figure 5-9
Aerial Photo of
WADF 117-10: Fire Response

The WADF 117-10: Fire Response is identified as an AOPI following records review, personnel interviews, and site reconnaissance due to AFFF being used to extinguish a fire in Building 117-10. The WADF (**Figure 5-9**), located south of Walker Lake and just north of the North Magazine Area, includes a collection of buildings used for demilitarization and disposal of munitions.

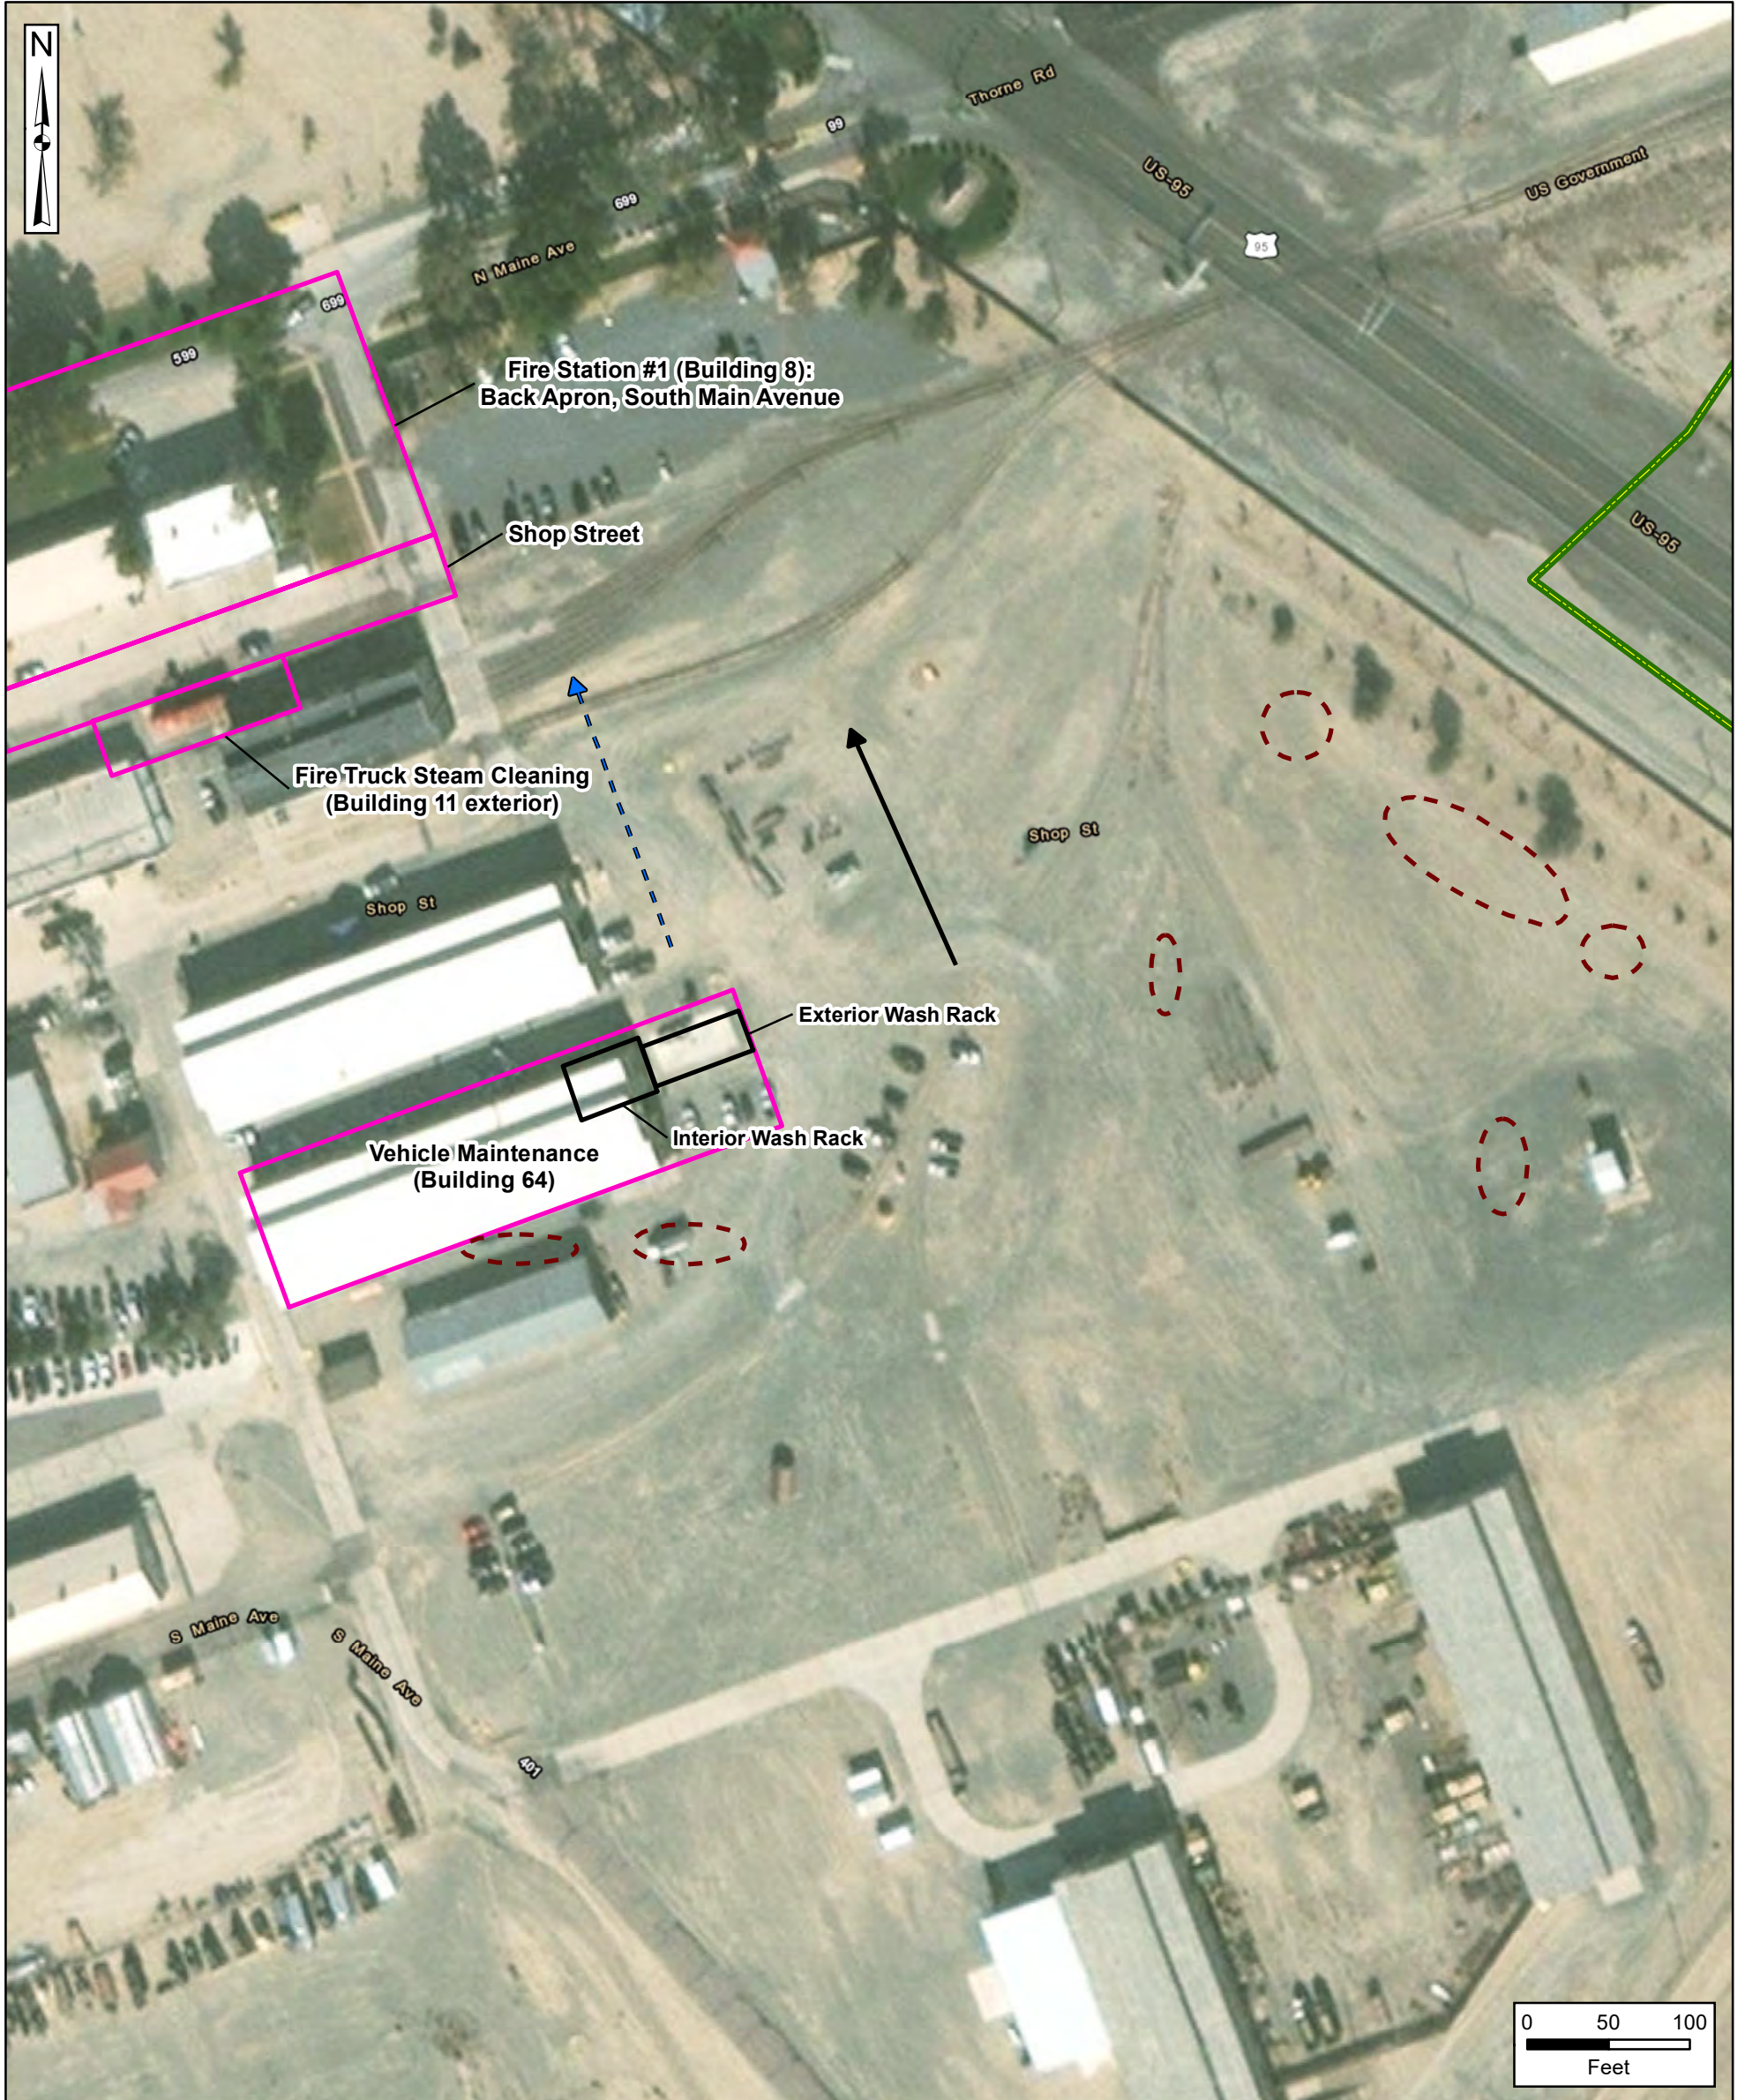
Figure 5-10
Aerial Photo of
Vehicle Maintenance (Building 64)

Building 64 is identified as an AOPI following records review, personnel interviews, and site reconnaissance due to the use of AFFF. Building 64 (**Figure 5-10**) is in the Cantonment Area and is used for maintenance activities on smaller vehicles (e.g., fire department brush trucks and Hummers). There is a roll-up door at each end of Building 64 and a floor drain connected to the sanitary sewer. Historically, including when HWAD was a Navy installation, all fire trucks (including those carrying AFFF) were repaired/maintained in Building 64. However, as fire trucks have gotten bigger over time, maintenance activities on fire trucks carrying AFFF transitioned from Building 64 to Building 102-52. The HWAD Fire Chief indicated that they were not aware of fire trucks containing AFFF being worked on in Building 64 since 2015. No AFFF was historically stored in Building 64.

Prior to installation of the closed-loop recirculating system in the interior wash rack, the wash rack utilized a sand trap under the drain grate to filter out debris before liquid flowed to the sanitary sewer. Periodically the drain would become blocked, and vehicle maintenance staff had to shovel the sludge out of the sand trap. The removed sludge and residual sand were dried on top of newspaper outside of the building (often the newspaper was placed on top of drums that used to be located outside the building's east door). After drying, the removed sludge material and residual sand was dumped at various locations south and east of Building 64 (i.e., near the gun barrels that used to be located east of Building 64 and other nearby locations where there may have been a small depression in the ground) (**Figure 5-10**). This sludge-disposal practice continued for an uncertain period of time after the closed-loop recirculating system was installed in the interior wash rack (sludge and residual sand from the sand trap).

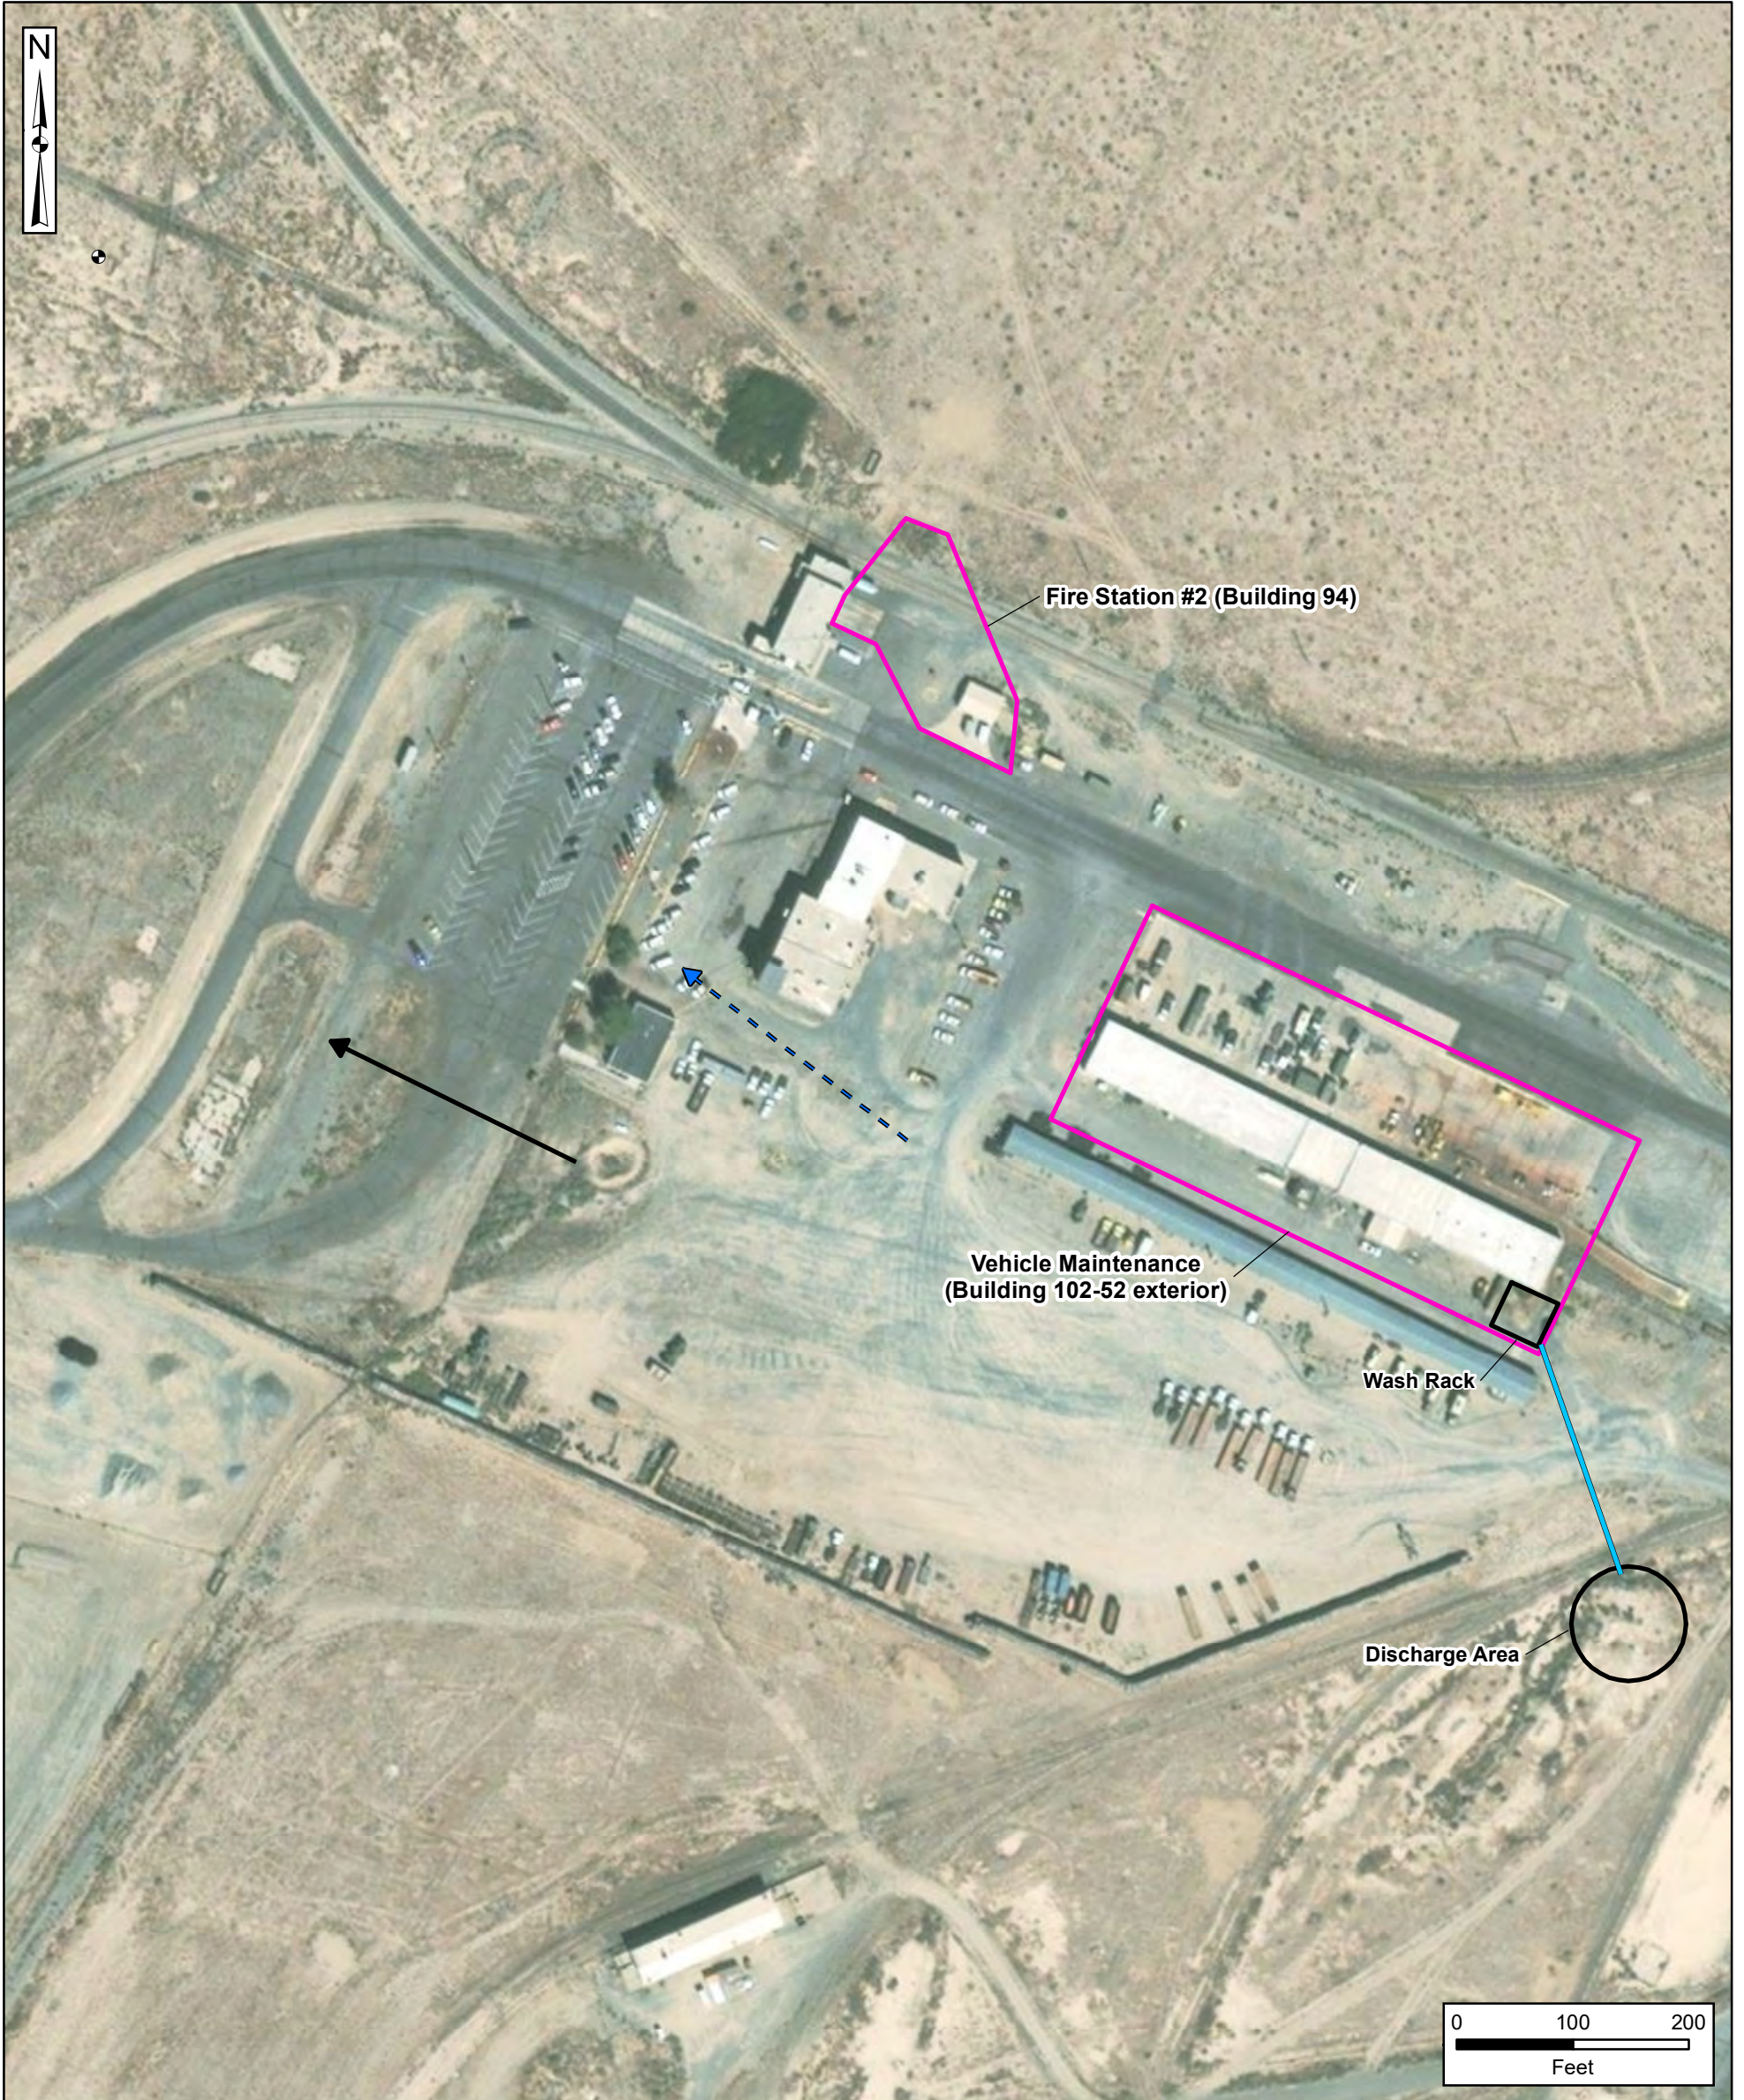
Figure 5-11
Aerial Photo of
Vehicle Maintenance (Building 102-52 exterior)

The exterior of Building 102-52 is identified as an AOPI following records review, personnel interviews, and site reconnaissance due to the potential use of AFFF. The individual garages in Building 102-52 (**Figure 5-11**) have roll-up doors. Building 102-52 is used for maintenance activities on larger vehicles and heavy equipment (e.g., ladder trucks, forklifts, and semi-truck trailers). The building also has a tire shop, battery washing station for forklifts, and a battery shop. The building has a closed-loop recirculating wash rack located behind the building at the southeast corner. According to the HWAD Facilities
