FINAL PRELIMINARY ASSESSMENT AND SITE INSPECTION OF PER- AND POLYFLUOROALKYL SUBSTANCES

Helemano Military Reservation, Hawaii

September 2023

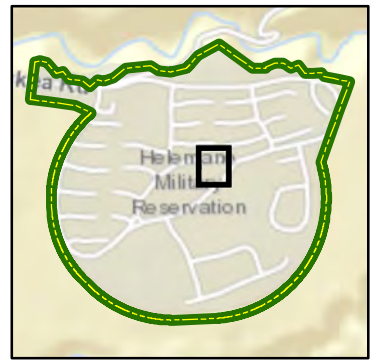
Figure 5-3
Building 22: Fire Station #10

The Building 22: Fire Station #10 is identified as an AOPI following records research, personnel interviews, and site reconnaissance due to storage of known PFAS containing materials at this location (**Figure 5-3**).

AOPI Name	PFOS, PFOA, PFBS, PFNA, and/or PFHxS detected greater than OSD Risk Screening Levels? (Yes/No/ND/NS)		Recommendation
	GW ¹	SO	
Building 22: Fire Station #10	NS	No	No action at this time ¹
Car Fire	NS	No	No action at this time ¹
Retention Basin	NS	No	No action at this time ¹

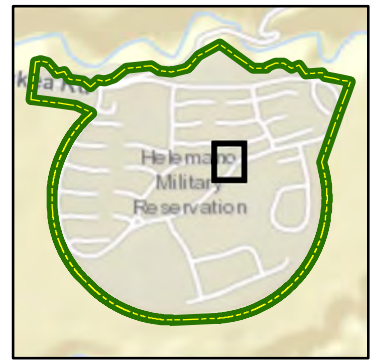
Figure 5-4
Car Fire

The Car Fire is identified as an AOPI following records research, personnel interviews, and site reconnaissance due to use of known PFAS containing materials at this location (**Figure 5-4**).

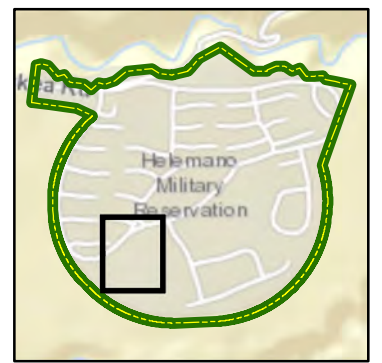
Figure 5-5
Retention Basin

The Retention Basin is identified as an AOPI following records research, personnel interviews, and site reconnaissance due to disposal of known PFAS containing materials at this location (**Figure 5-5**).

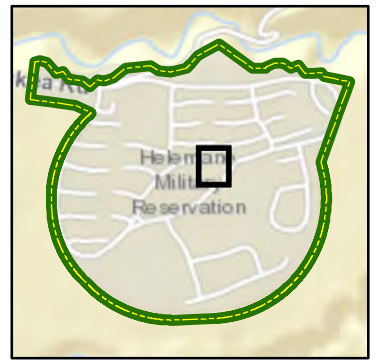
Figure 7-1
Building 22: Fire Station #10
PFOS, PFOA, PFBS, PFNA, and PFHxS Analytical Results

The subsection below summarizes the soil PFOS, PFOA, PFBS, PFNA, and PFHxS analytical results associated with the Building 22: Fire Station #10 AOPI. The sampling locations and analytical results are presented on **Figure 7-1**. The soil analytical results are presented in **Table 7-1**.

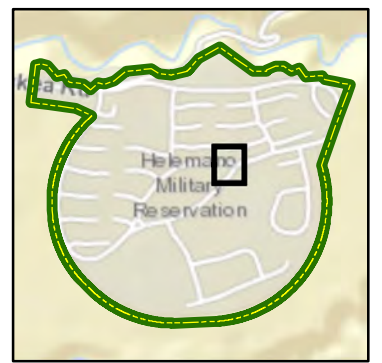
Figure 7-2
Car Fire

The subsection below summarizes the soil PFOS, PFOA, PFBS, PFNA, and PFHxS analytical results associated with the Car Fire AOPI. The sampling locations and analytical results are presented on **Figure 7-2**. The soil analytical results are presented in **Table 7-1**.

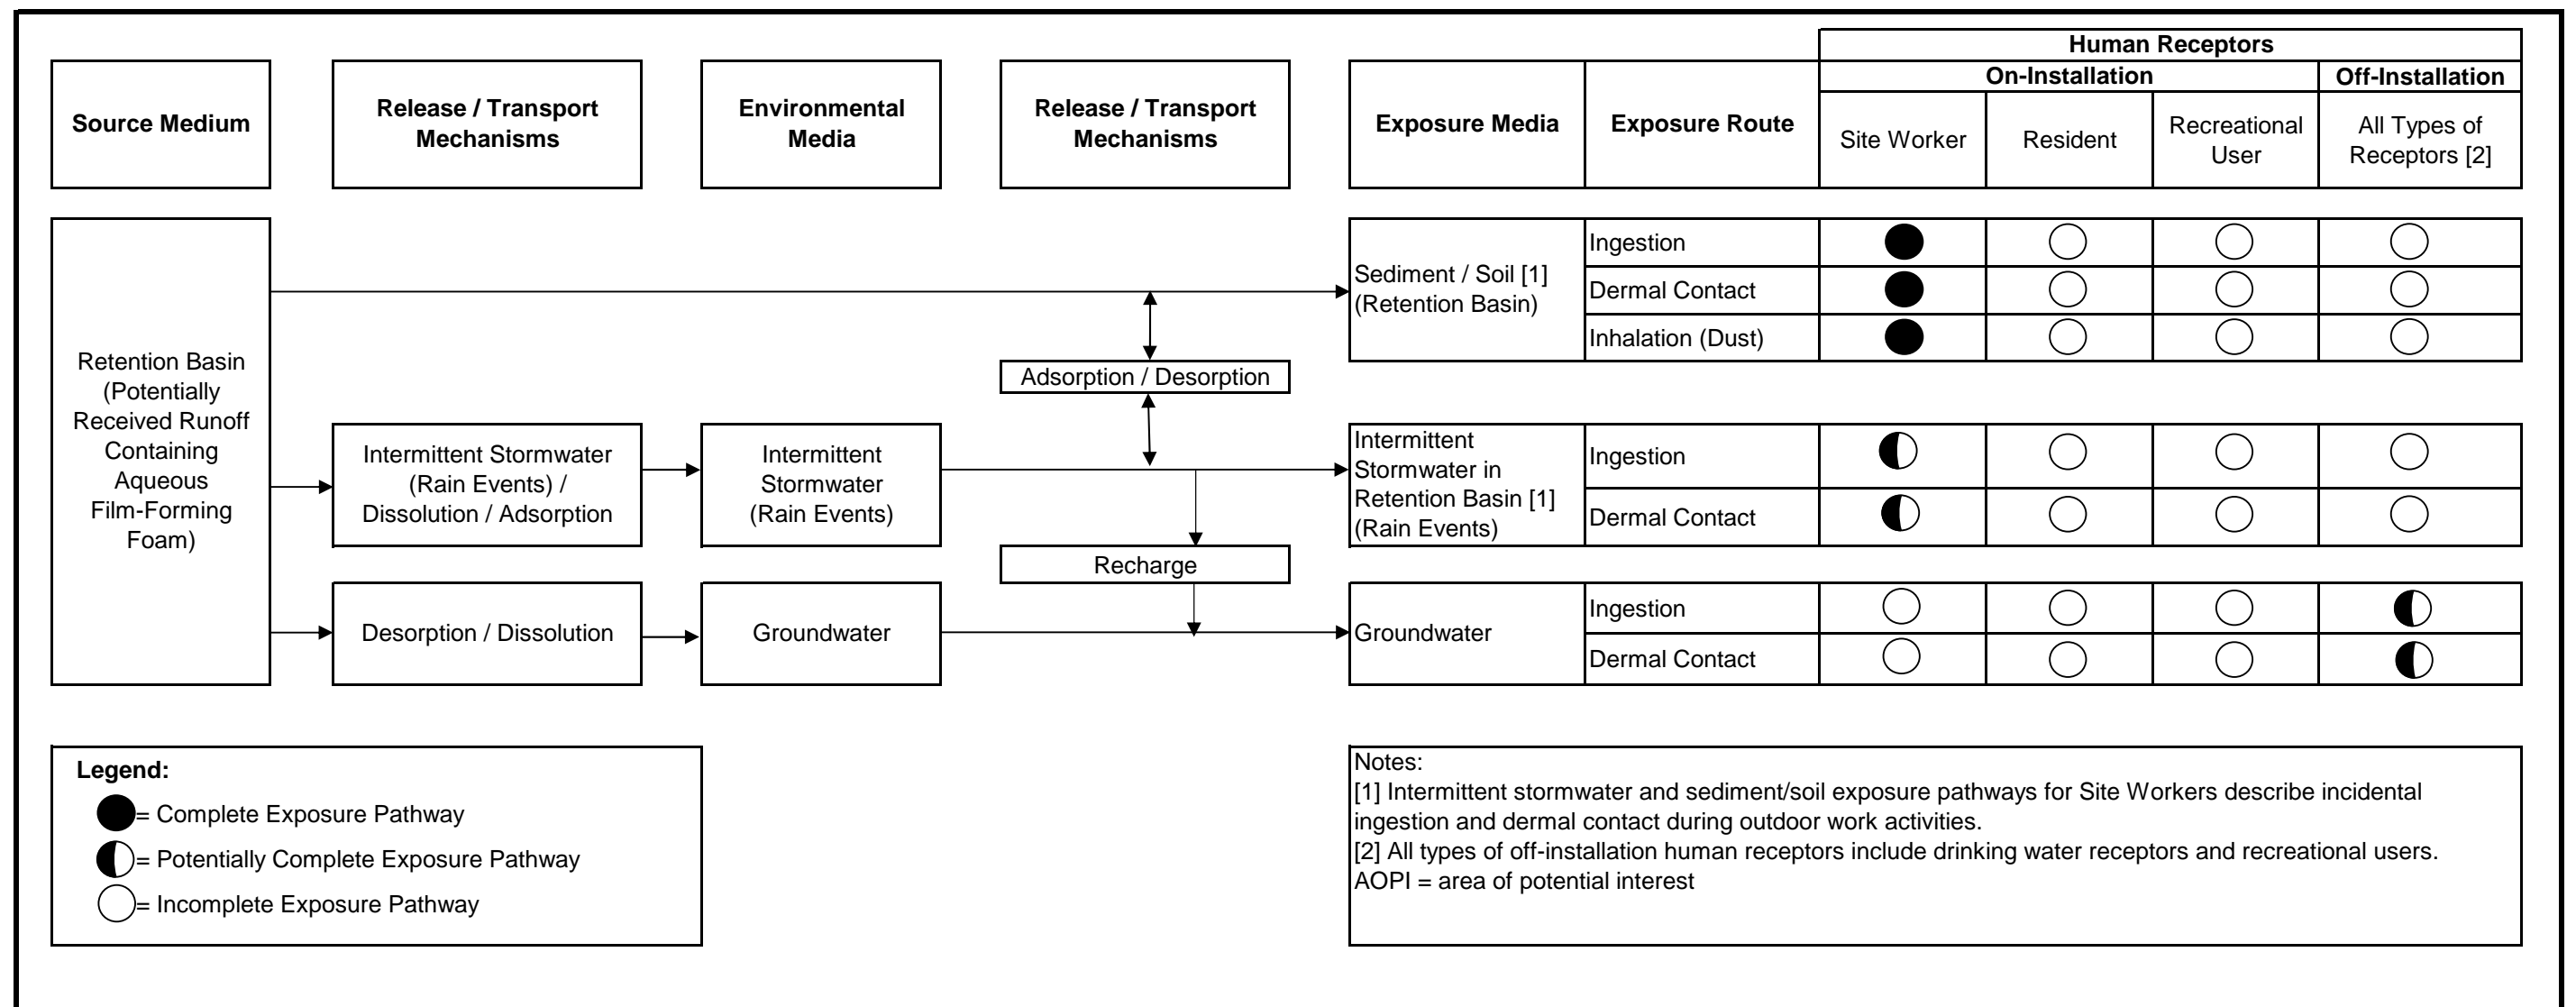
Figure 7-5

- The Retention Basin AOPI is not likely to be regularly accessed by on-installation residents or recreational users; therefore, the intermittent stormwater and sediment/soil exposure pathways at the Retention Basin for those receptors are incomplete. Additionally, given that stormwater infiltrates and evaporates in the Retention Basin (i.e., does not enter off-installation surface water bodies), stormwater and sediment/soil exposure pathways for off-installation receptors are also considered to be incomplete.

Conceptual Site Model for Retention Basin AOP
 USAEC PFAS Preliminary Assessment / Site Inspection
 Helemano Military Reservation, Hawaii

Following the SI sampling, all three AOPIs were considered to have complete or potentially complete exposure pathways. Although the CSMs indicate complete or potentially complete exposure pathways may exist, the recommendation for remedial investigation is based on the comparison of analytical results for PFOS, PFOA, PFBS, PFNA, and PFHxS to the OSD risk screening levels (**Table 7-2**).
