FINAL PRELIMINARY ASSESSMENT AND SITE INSPECTION OF PER- AND POLYFLUOROALKYL SUBSTANCES

Fort Huachuca, Arizona

Prepared For:
U.S. Army Corps of Engineers, Baltimore District
2 Hopkins Plaza
Baltimore, Maryland 21201

February 2023

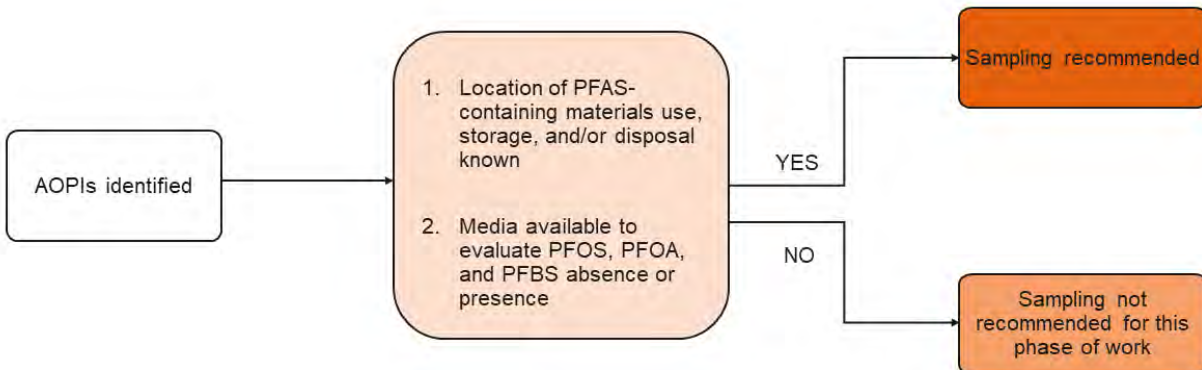
Figure 6-1: AOPI Sampling Decision Tree

The rationale for sampling at each AOPI is illustrated on **Figure 6-1** below.

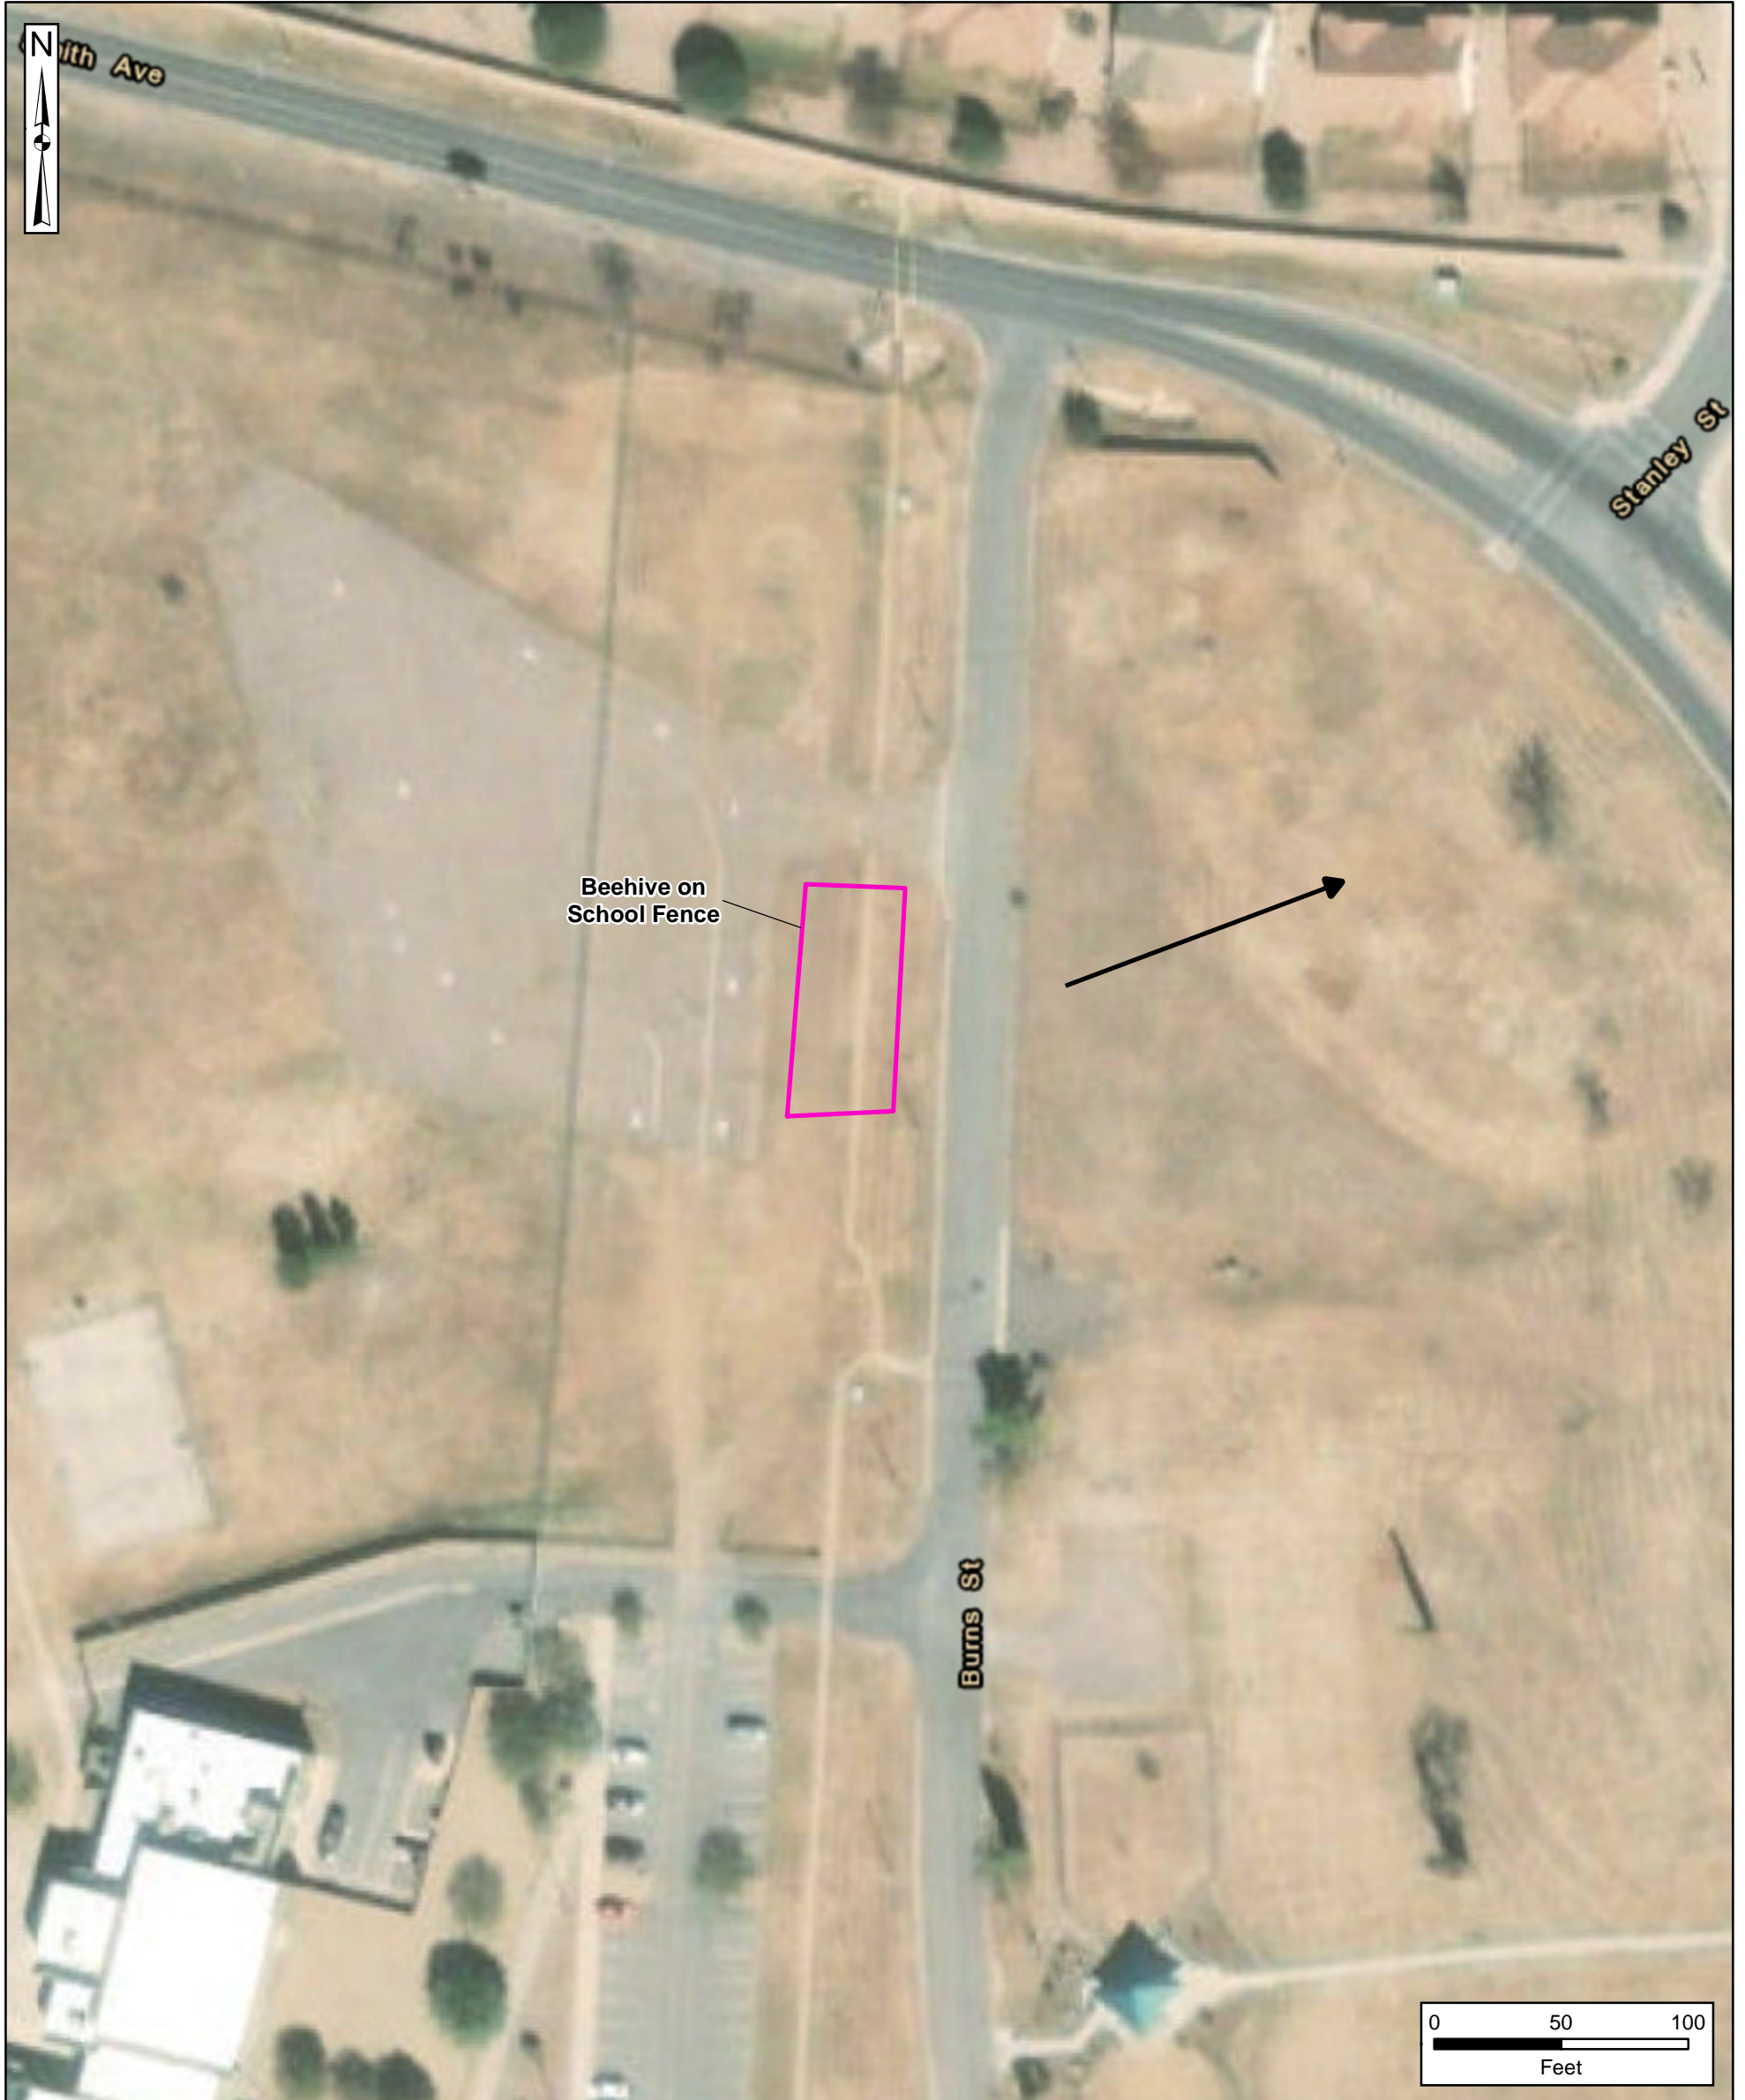
Figure 5-4
Aerial Photo of
Beehive on School Fence AOPI

The Beehive on School Fence AOPI does not overlap with IRP sites and consists of the portion of fence that the beehive was located on, and a strip of soil on either side of the fence. **Figure 5-4** shows the aerial extent of this AOPI.

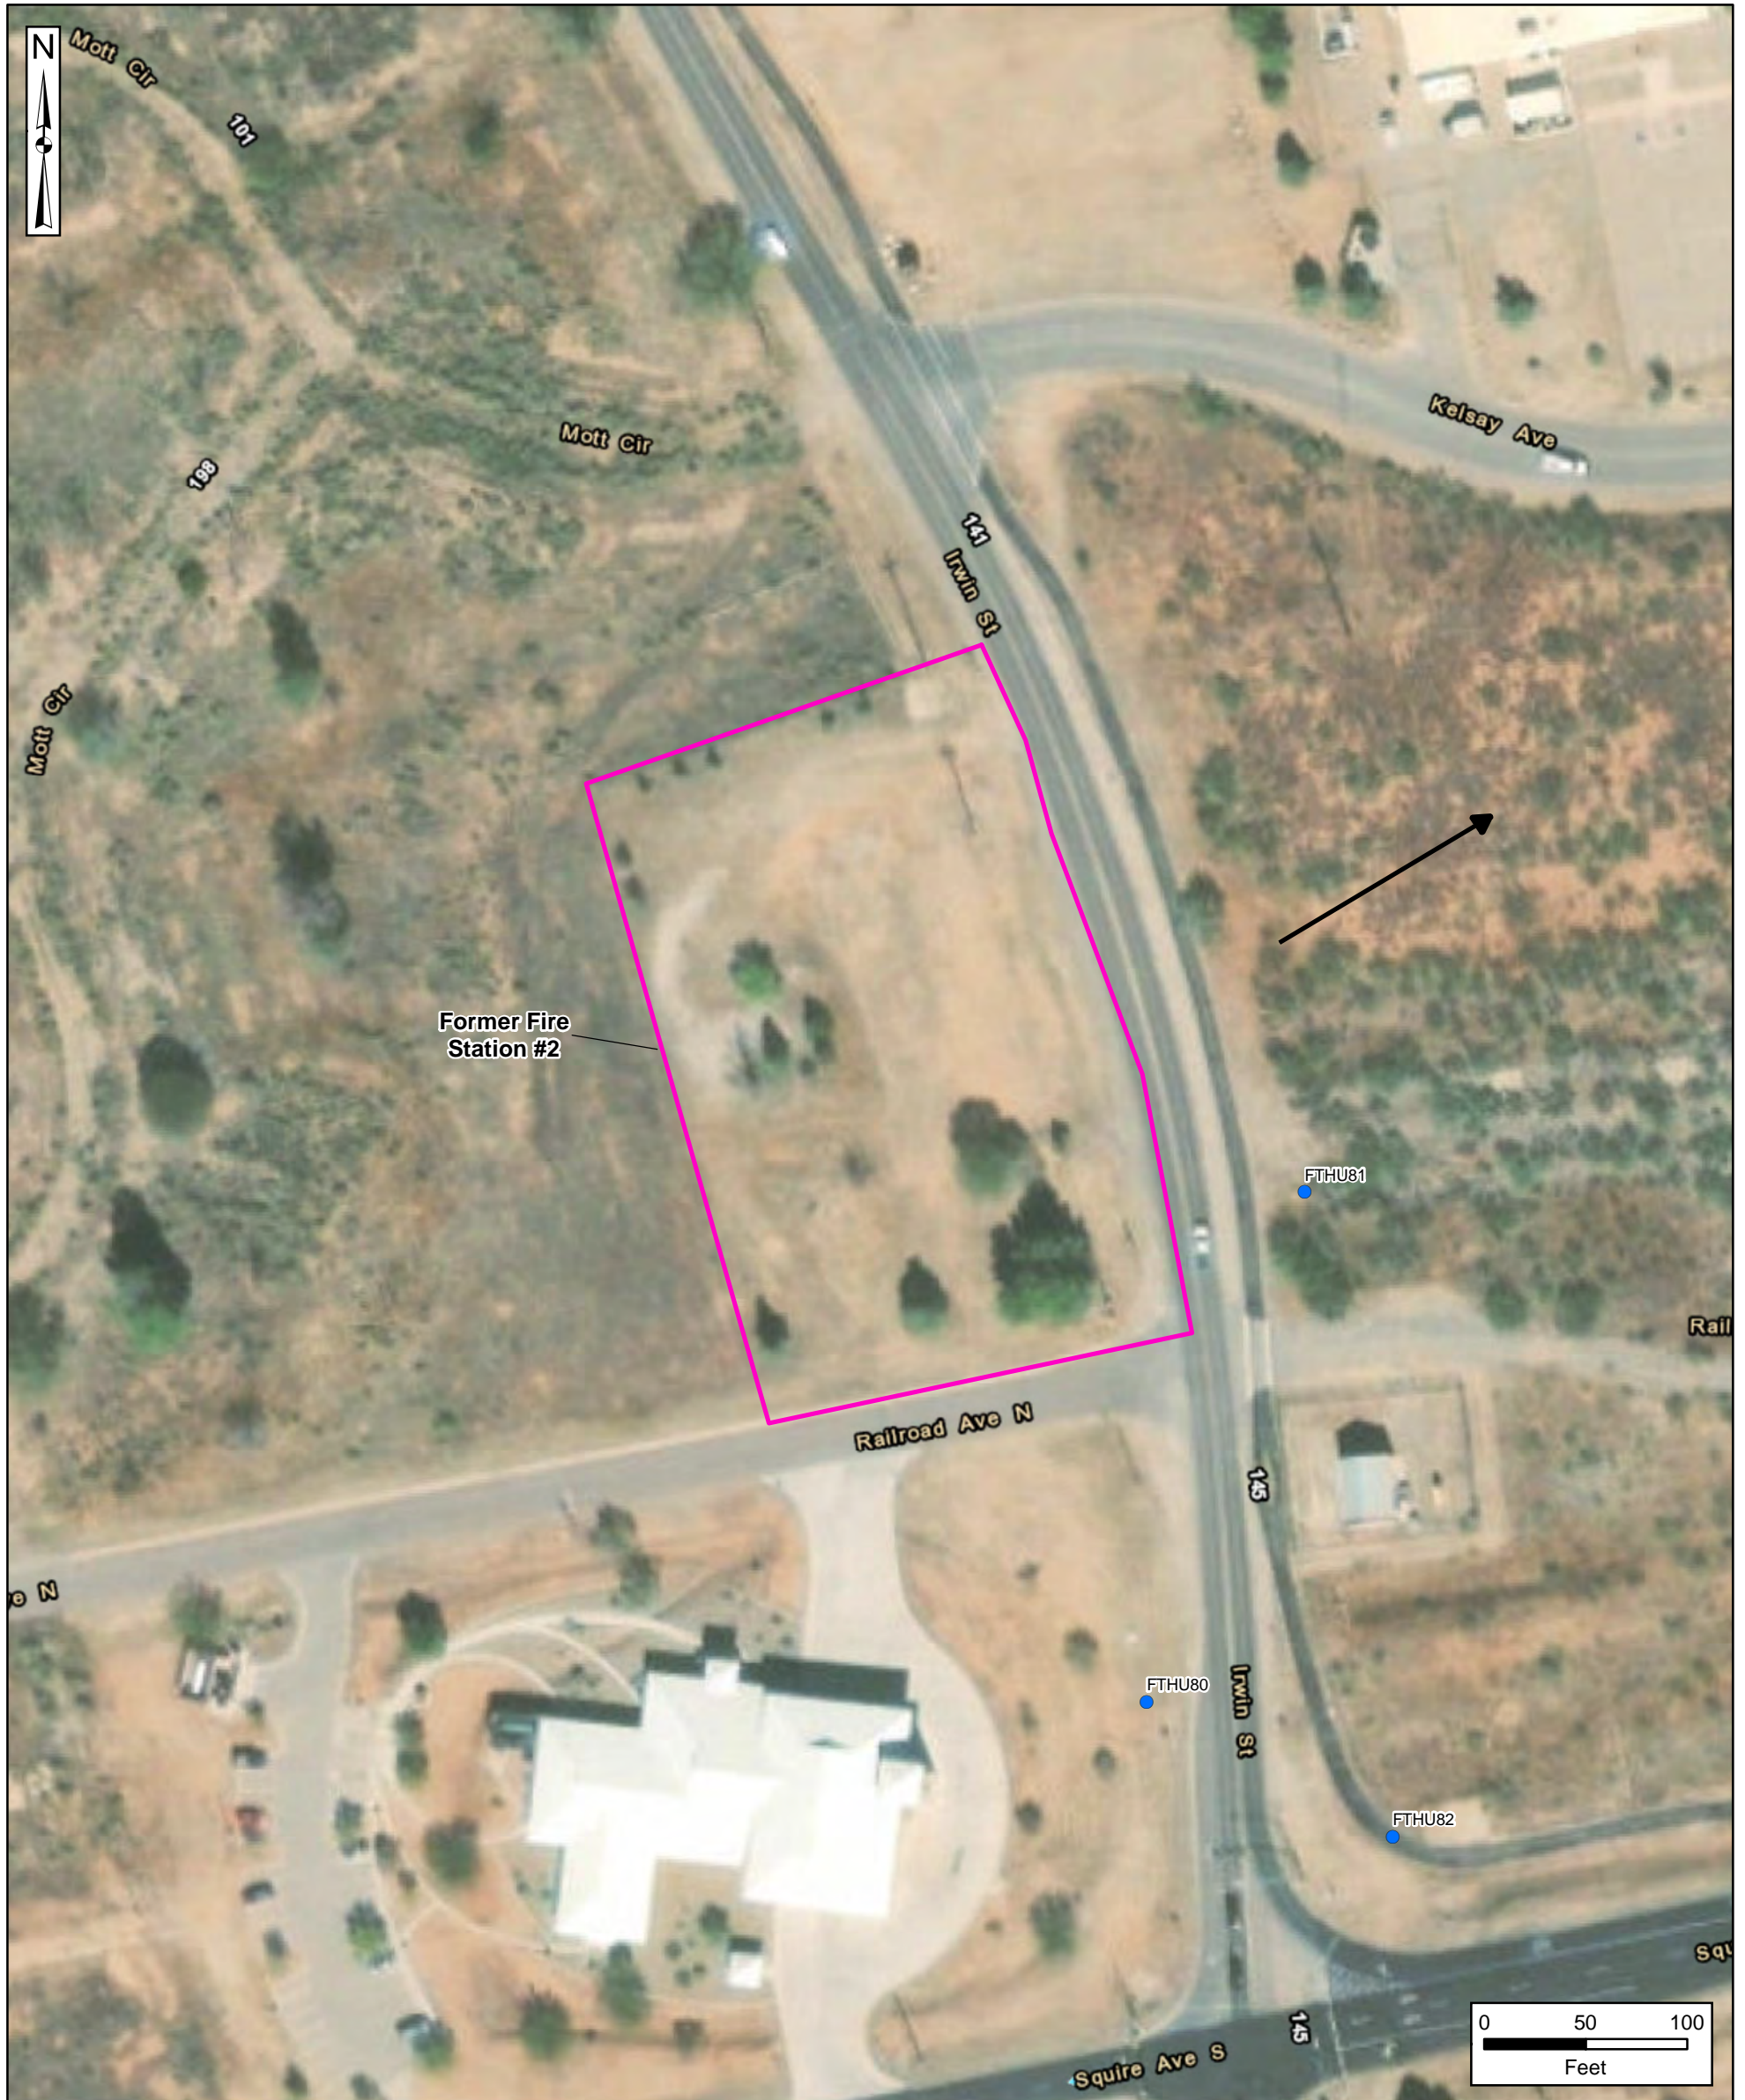
Figure 5-5
Aerial Photo of
Former Fire Station #2 AOPI

The Former Fire Station #2 AOPI does not overlap with IRP sites and consists of the entire footprint of the former station, including its bays, aprons, wash rack, and the oil water separator. **Figure 5-5** shows the aerial extent of this AOPI.

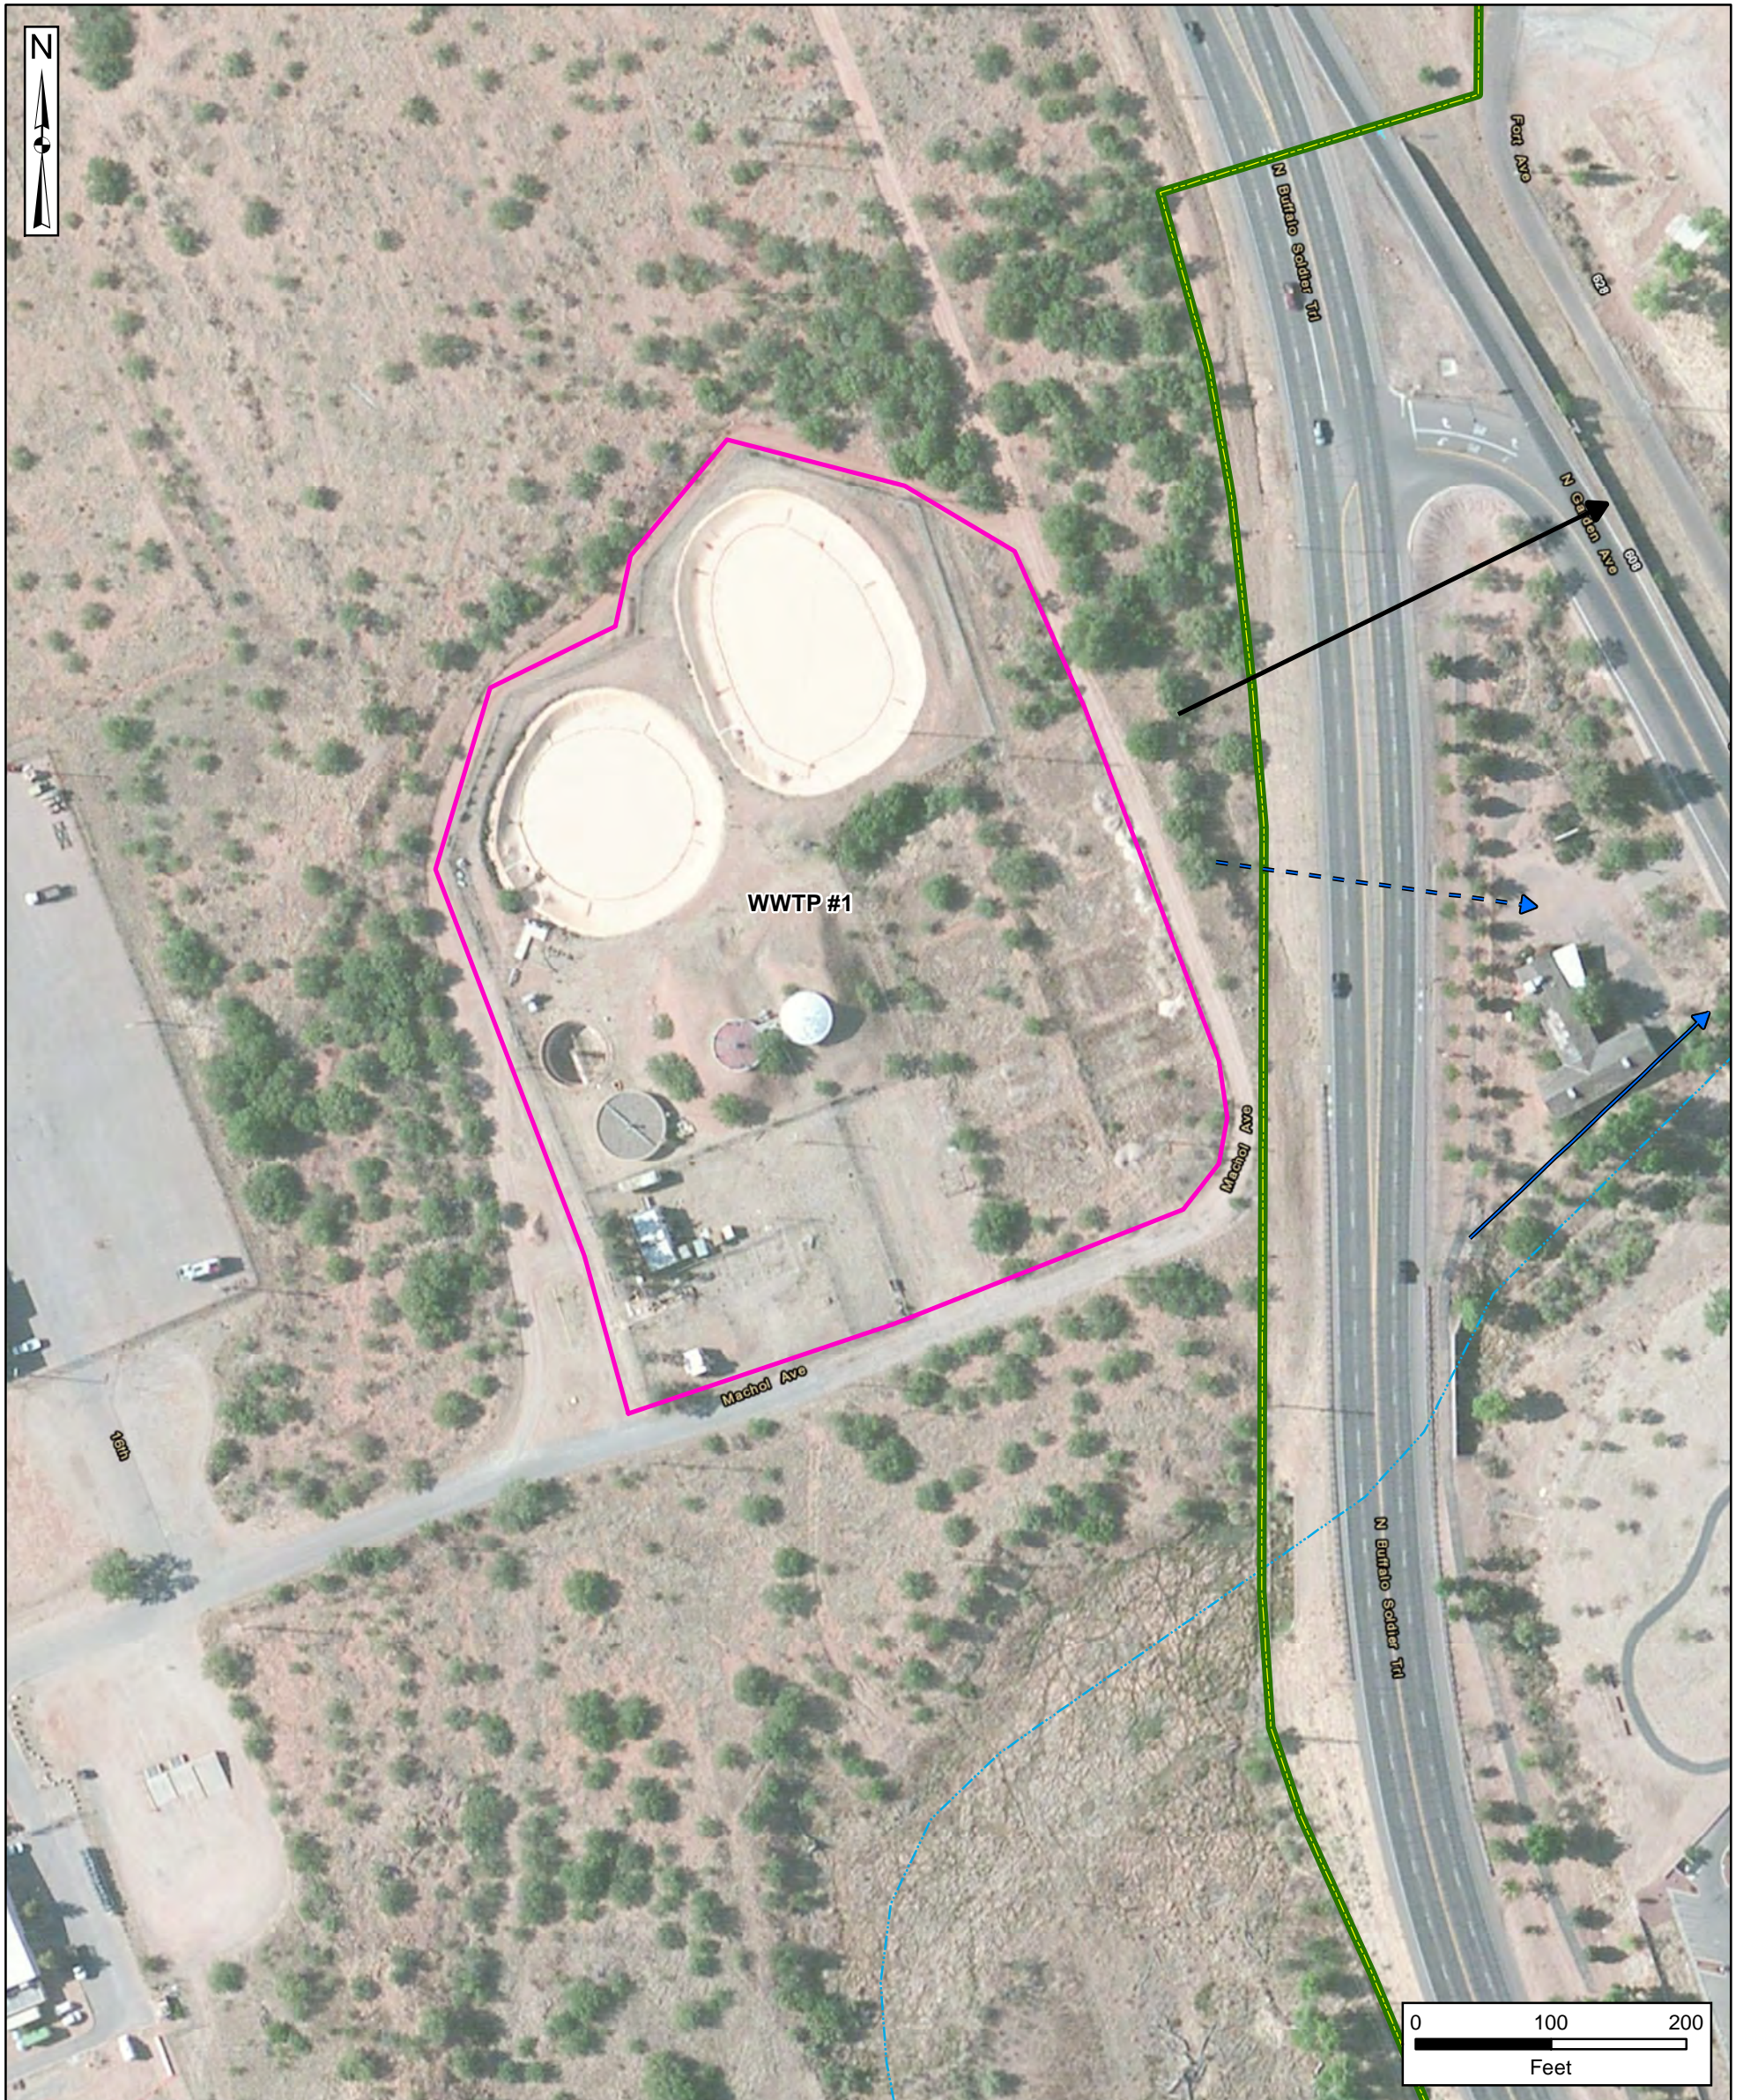
Figure 5-7
Aerial Photo of
WWTP #1 AOPI

The WWTP #1 AOPI does not overlap with IRP sites and consists of a barscreen, a pre-aeration chamber, primary clarifiers, a trickling filter, a final clarifier, two lined effluent holding ponds (which hold treated effluent from WWTP #2), a two-stage anaerobic digestion system, and 12 unlined sludge drying beds. All features are currently inactive except for the effluent holding ponds. **Figure 5-7** shows the aerial extent of this AOPI.

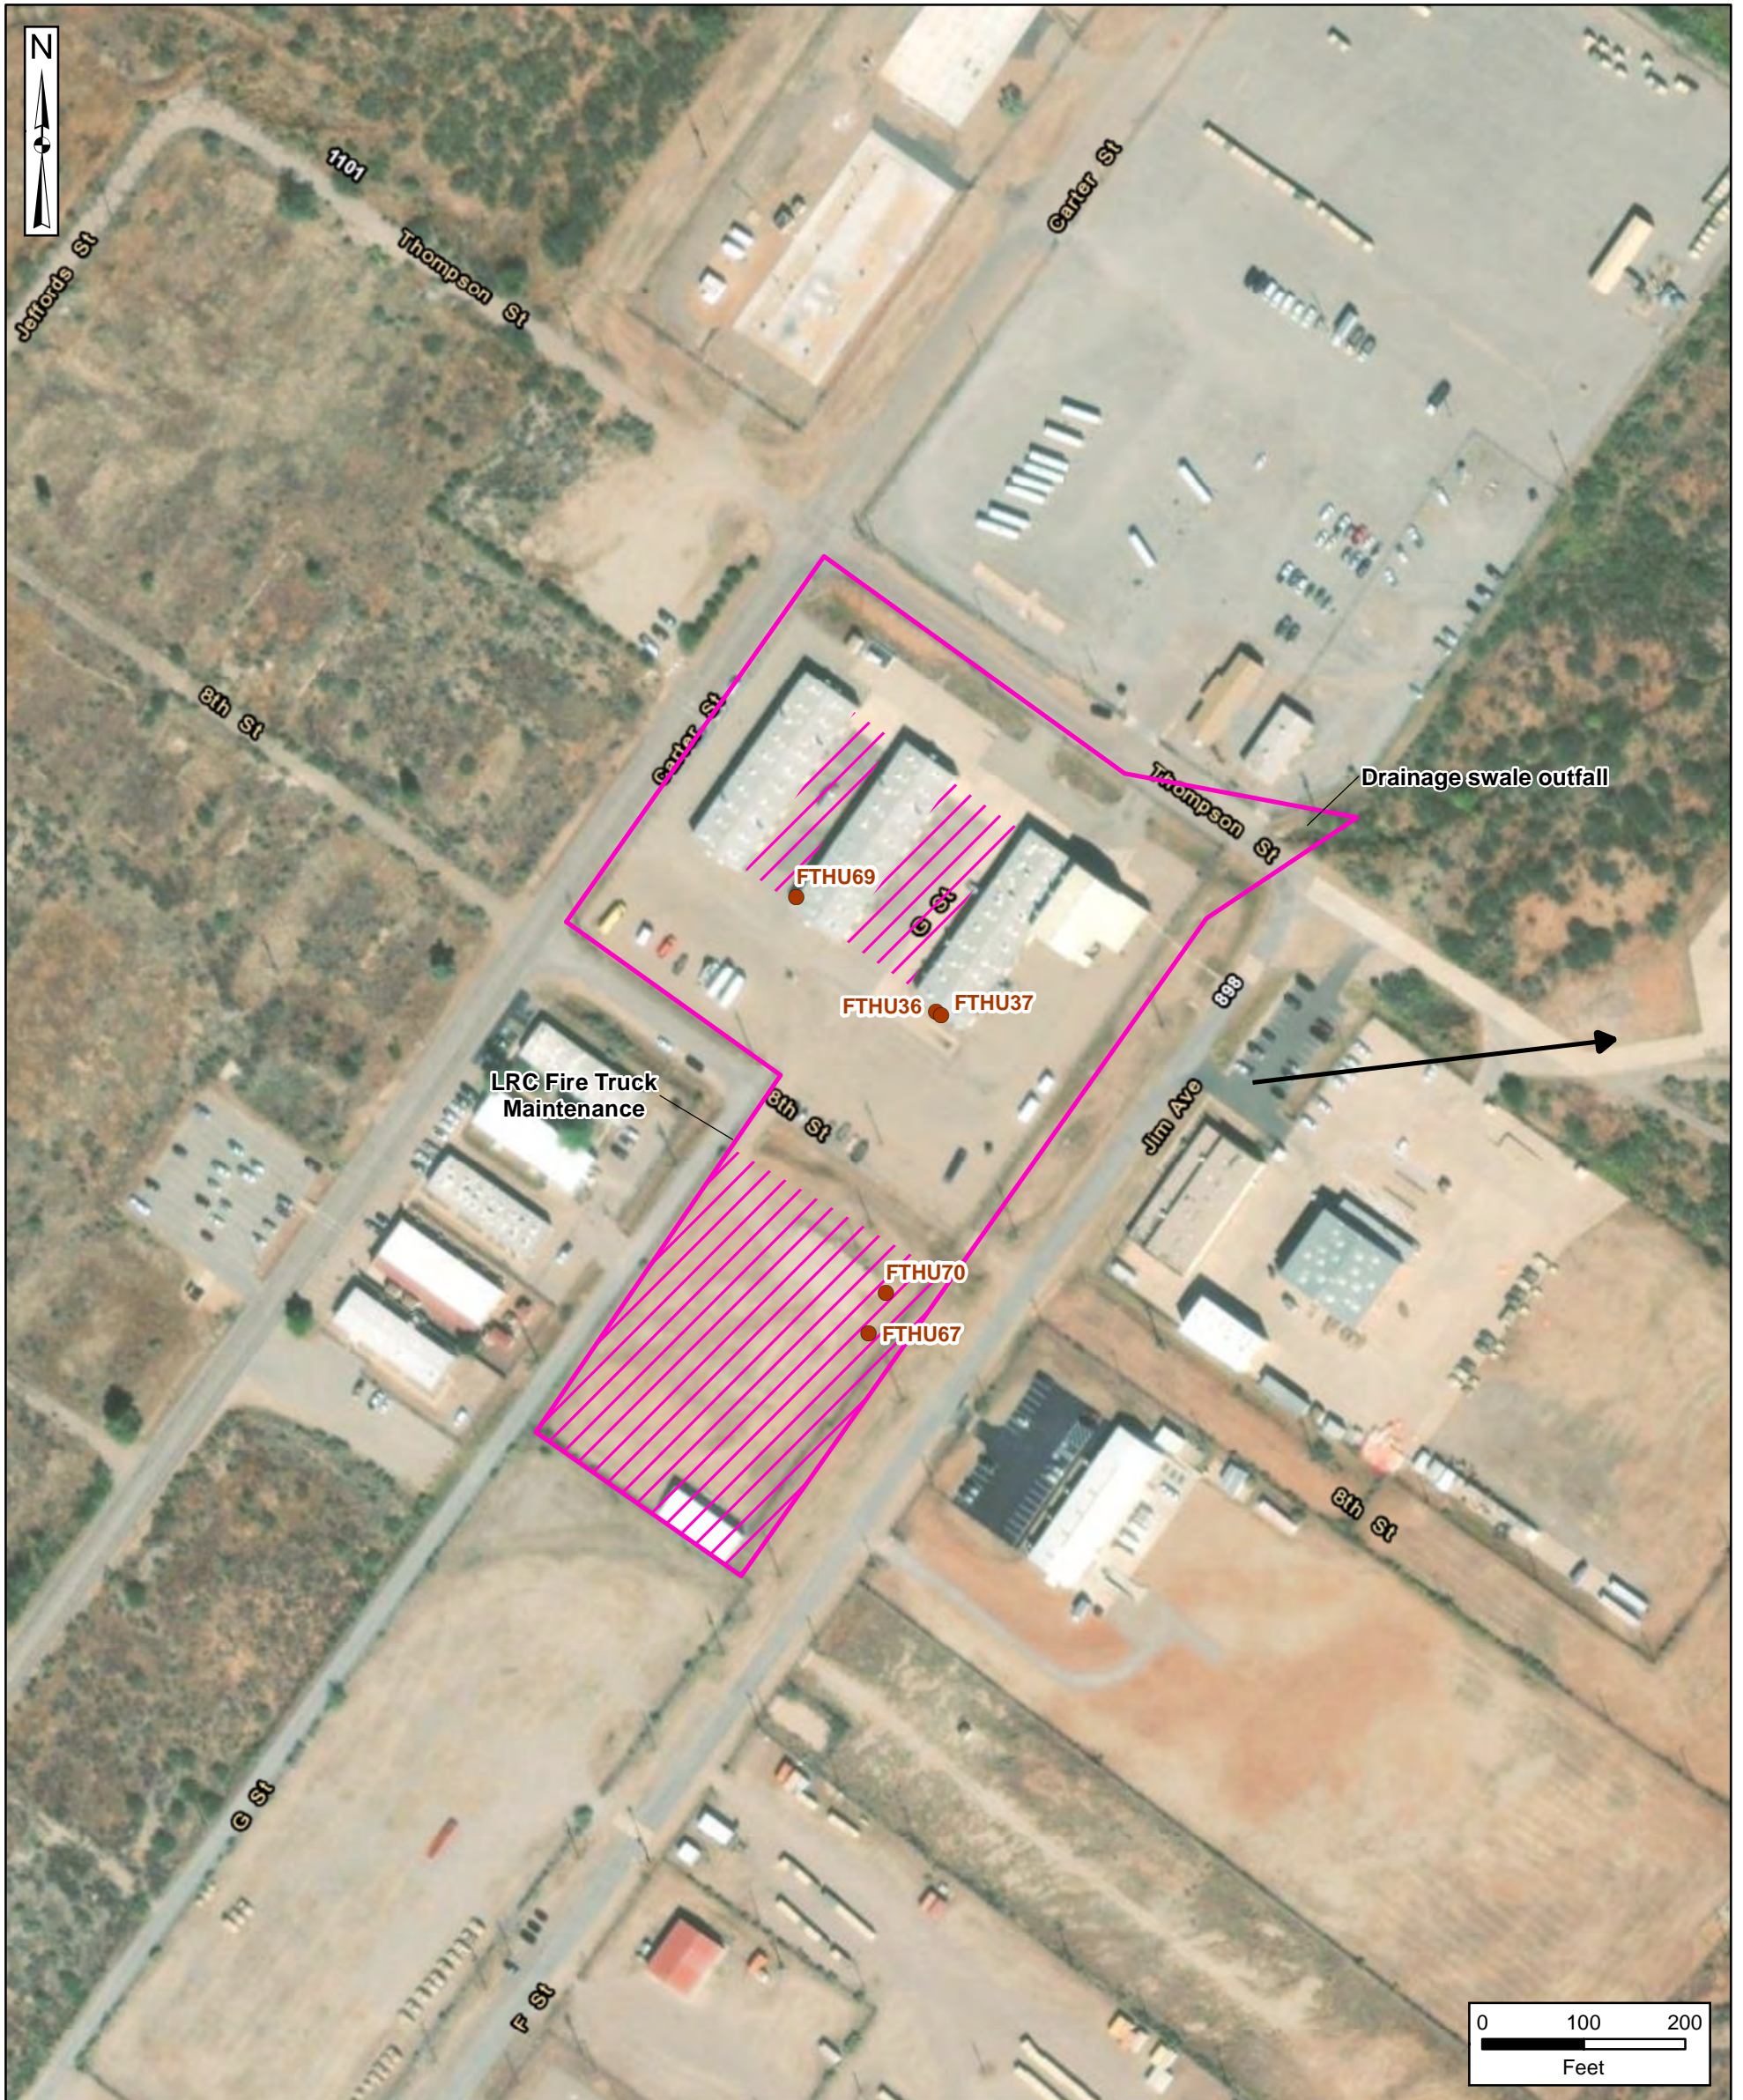
Figure 5-9
Aerial Photo of
LRC Fire Truck Maintenance AOP

The LRC Fire Truck Maintenance AOPI overlaps with FTHU-69, FTHU-36, FTHU-37, FTHU-70, and FTHU-67 identified by USAEC and consists of Buildings 75901, 75902, and 75903, the defunct wash rack, and the current wash rack. FTHU-69 and FTHU-70 received a no further action declaration in 2000 and FTHU-67 received a no further action declaration in 2002. FTHU-36 and FTHU-37 had no evidence of contamination, and no further investigation was recommended in 1980 (USAEC 2017). **Figure 5-9** shows the aerial extent of this AOPI.

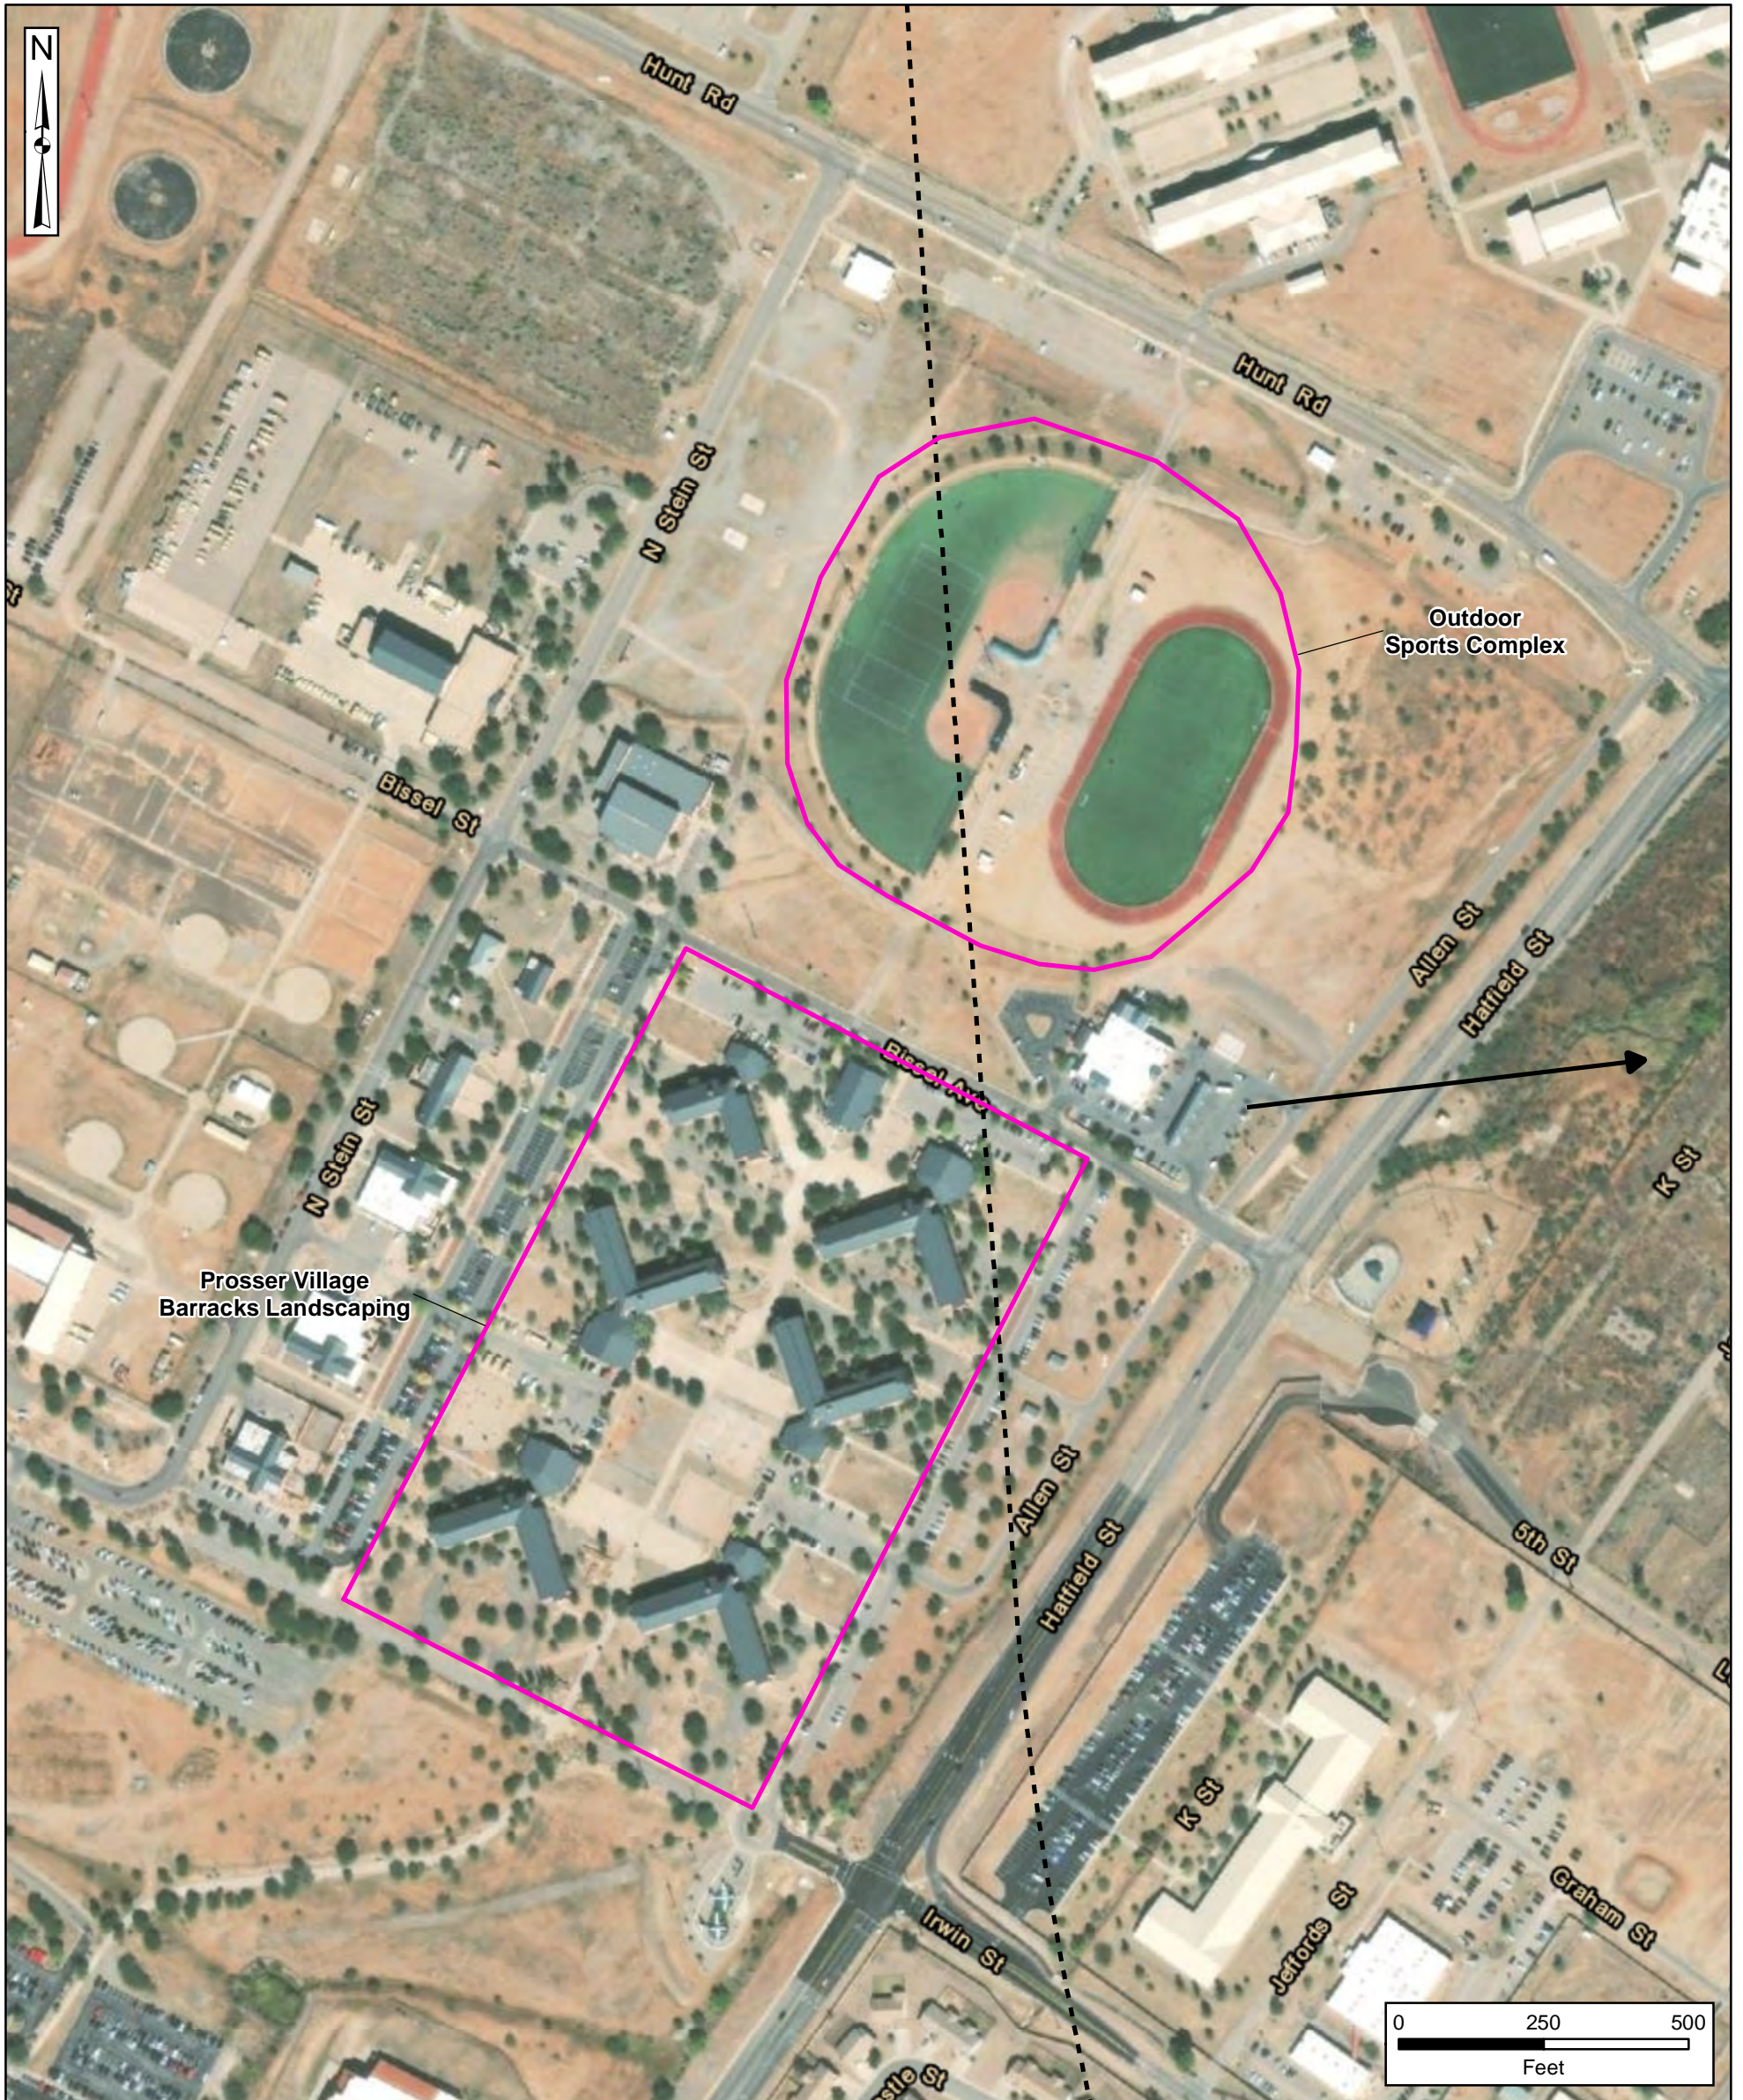
Figure 5-10
Aerial Photo of
Outdoor Sports Complex and
Prosser Village Barracks Landscaping AOPIs

The Outdoor Sports Complex AOPI does not overlap with IRP sites and consists of the entire sports complex, including Krueger Track, Warrior-Sentinel Fields, the roads, bleachers, and dining areas dividing and surrounding them. **Figure 5-10** shows the aerial extent of this AOPI.

The Prosser Village Barracks Landscaping AOPI does not overlap with IRP sites and consists of the entire footprint of the Prosser Village Barracks. **Figure 5-10** shows the aerial extent of this AOPI.
