FINAL PRELIMINARY ASSESSMENT AND SITE INSPECTION OF PER- AND POLYFLUOROALKYL SUBSTANCES

Fort Huachuca, Arizona

Prepared For:
U.S. Army Corps of Engineers, Baltimore District
2 Hopkins Plaza
Baltimore, Maryland 21201

February 2023

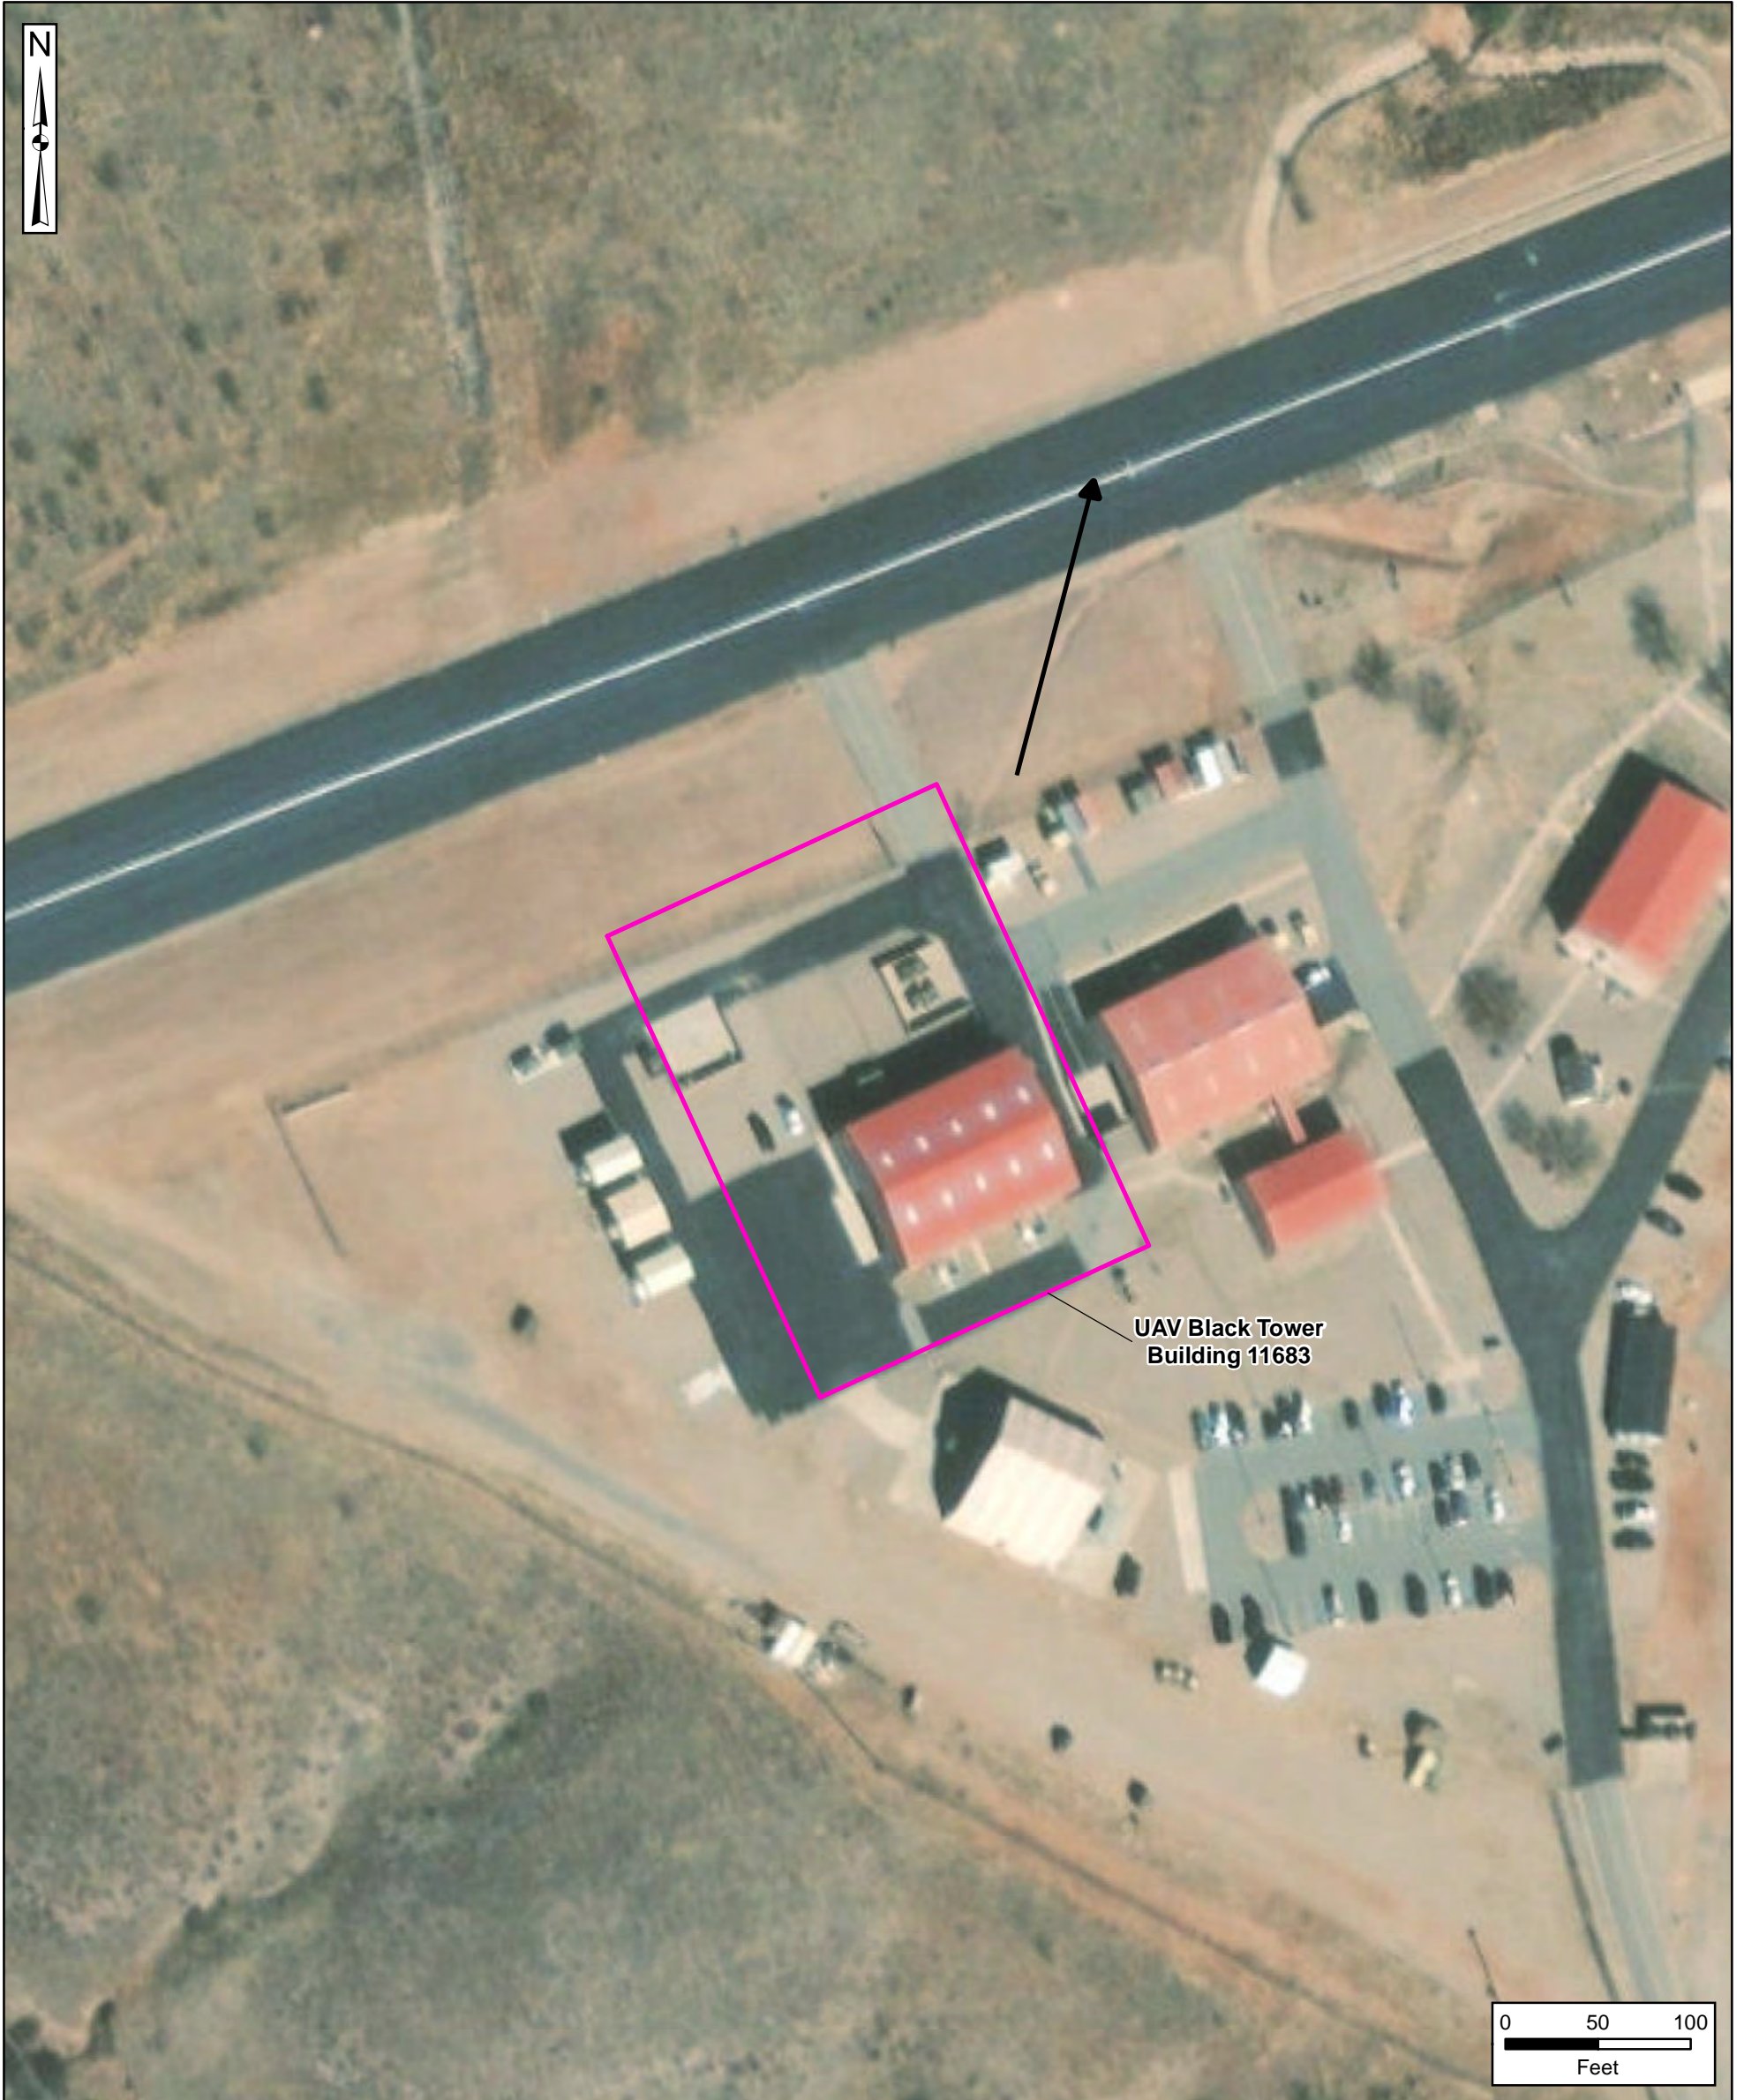
Figure 5-14
Aerial Photo of
UAV Black Tower Building 11683 AOPI

The UAV Black Tower Building 11683 AOPI does not overlap with IRP sites and consists of the building footprint, the gravel area to the north, and a portion of the paved and unpaved areas surrounding the building to the south, east, and west. **Figure 5-14** shows the aerial extent of this AOPI.

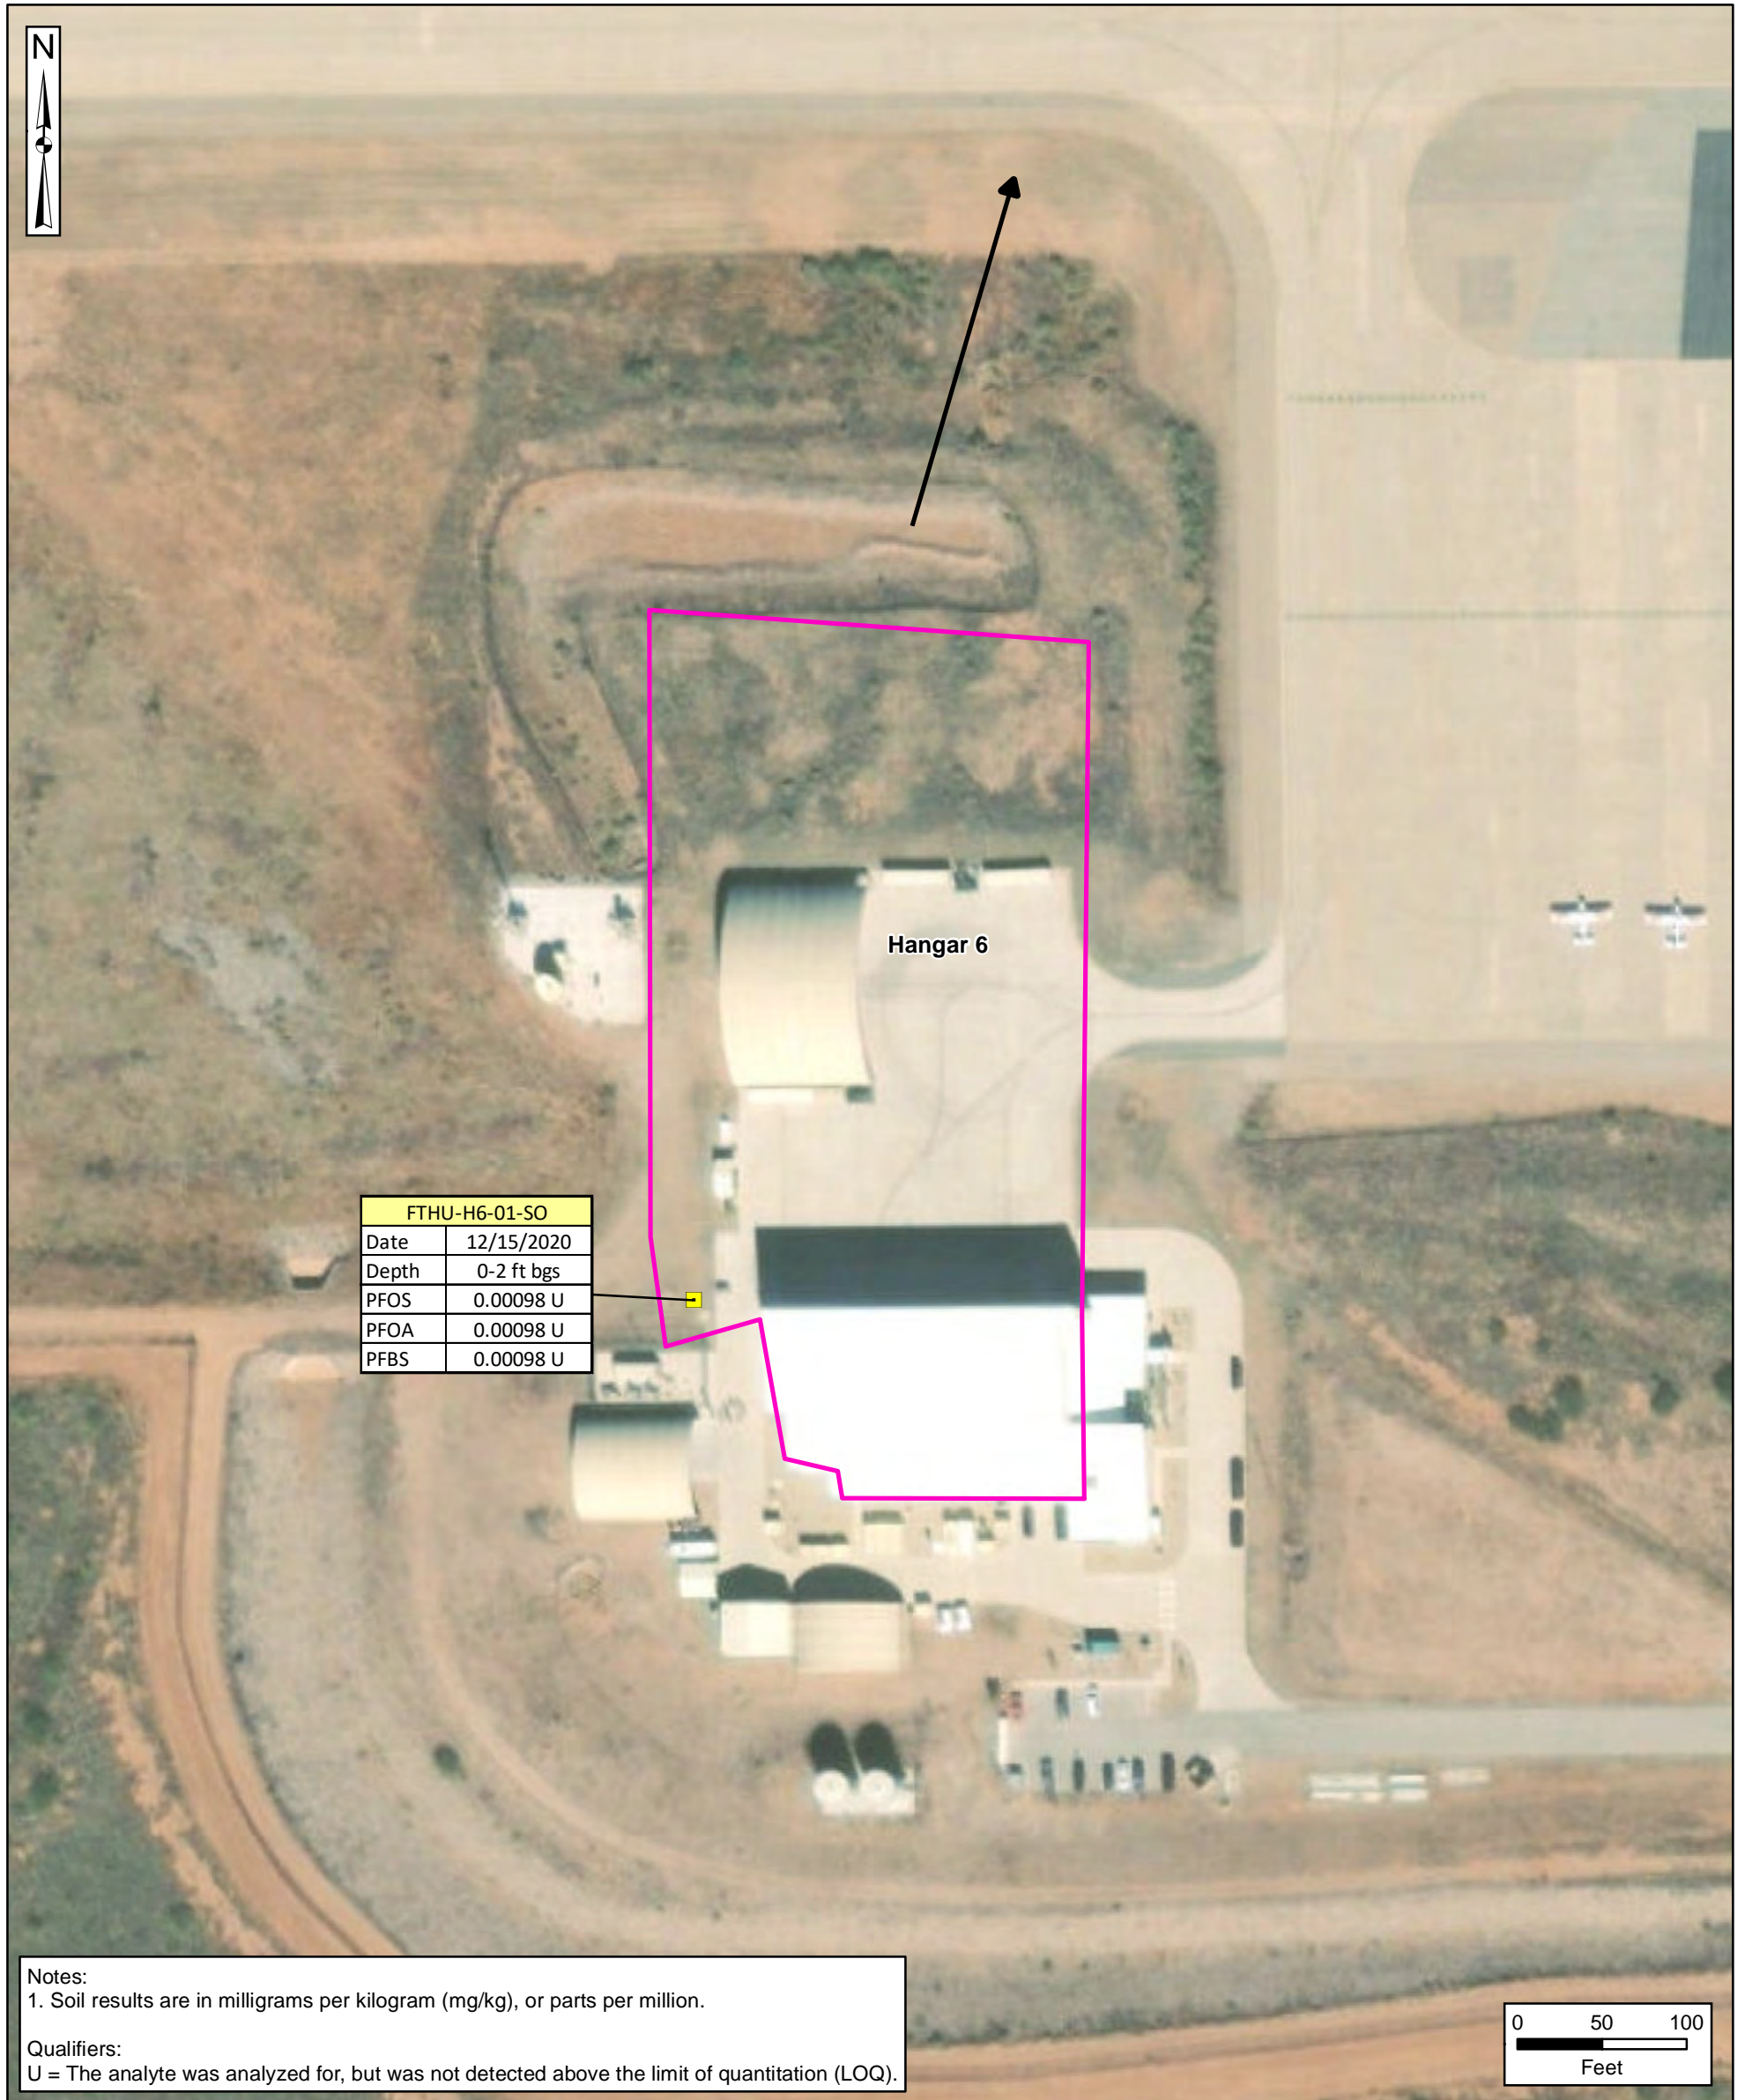
Figure 7-10
Hangar 6 AOPI
PFOS, PFOA, and PFBS Analytical Results

Notes:
1. Soil results are in milligrams per kilogram (mg/kg), or parts per million.

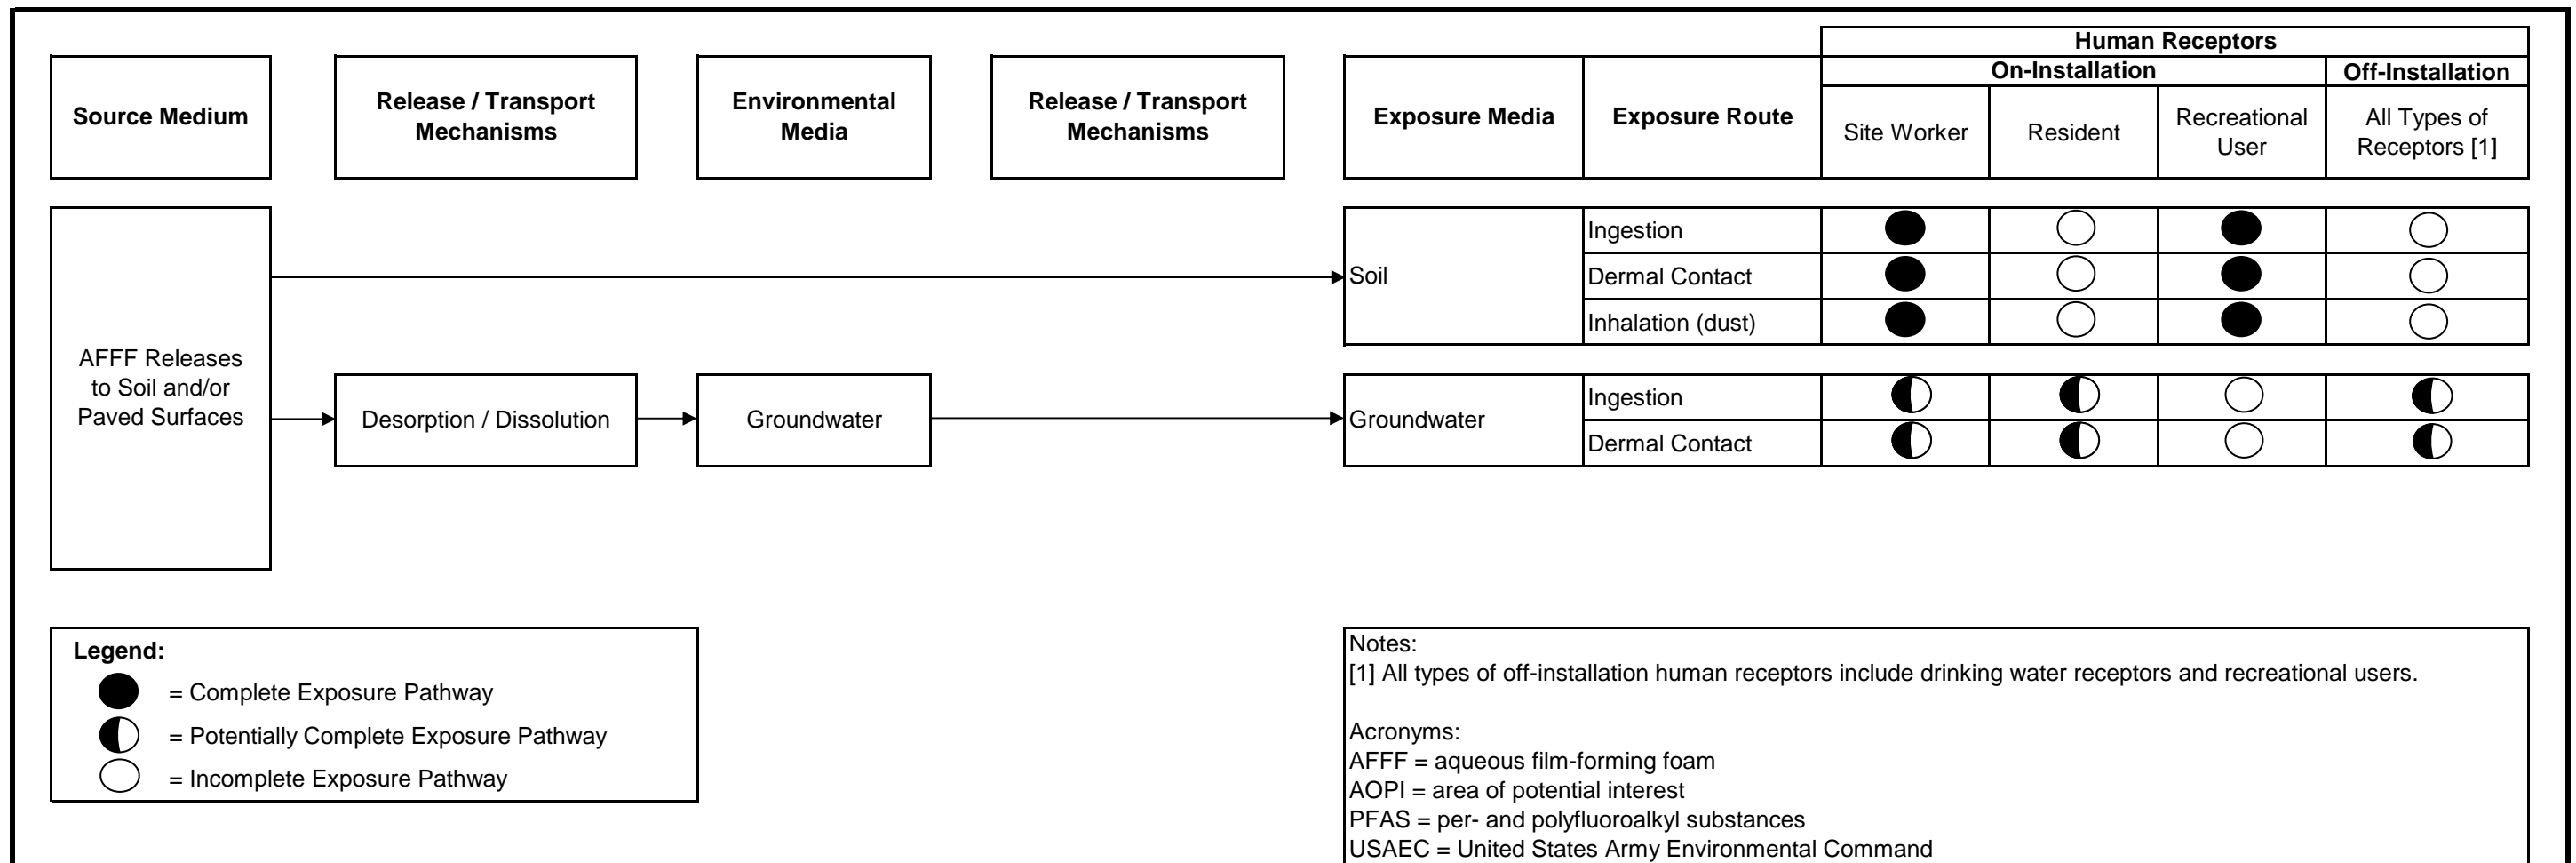
Figure 7-15

Conceptual Site Model for Beehive on School Fence and Outdoor Sports Complex AOPIs
 USAEC PFAS Preliminary Assessment / Site Inspection
 Fort Huachuca, Arizona

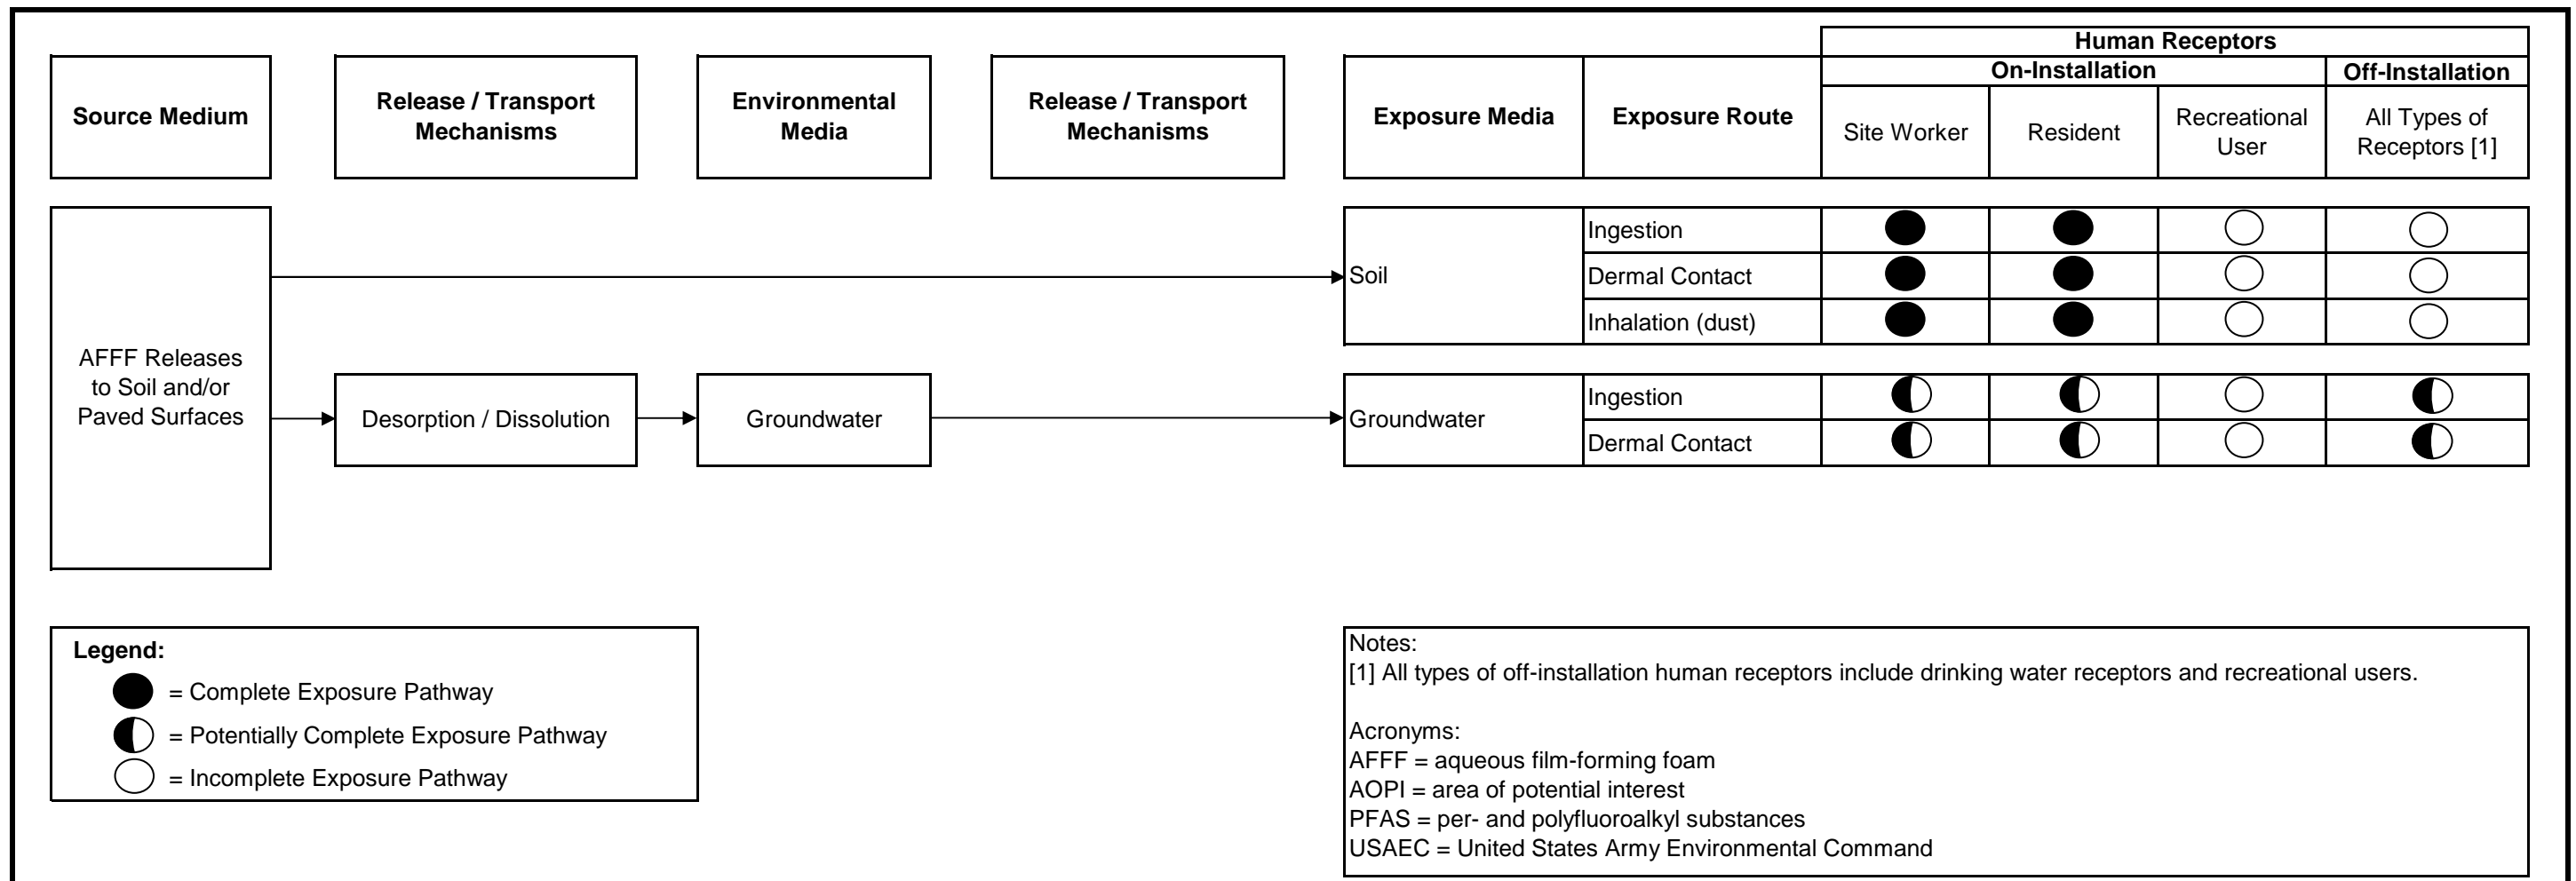
Figure 7-18

Conceptual Site Model for Prosser Village Barracks Landscaping AOPI
 USAEC PFAS Preliminary Assessment / Site Inspection
 Fort Huachuca, Arizona

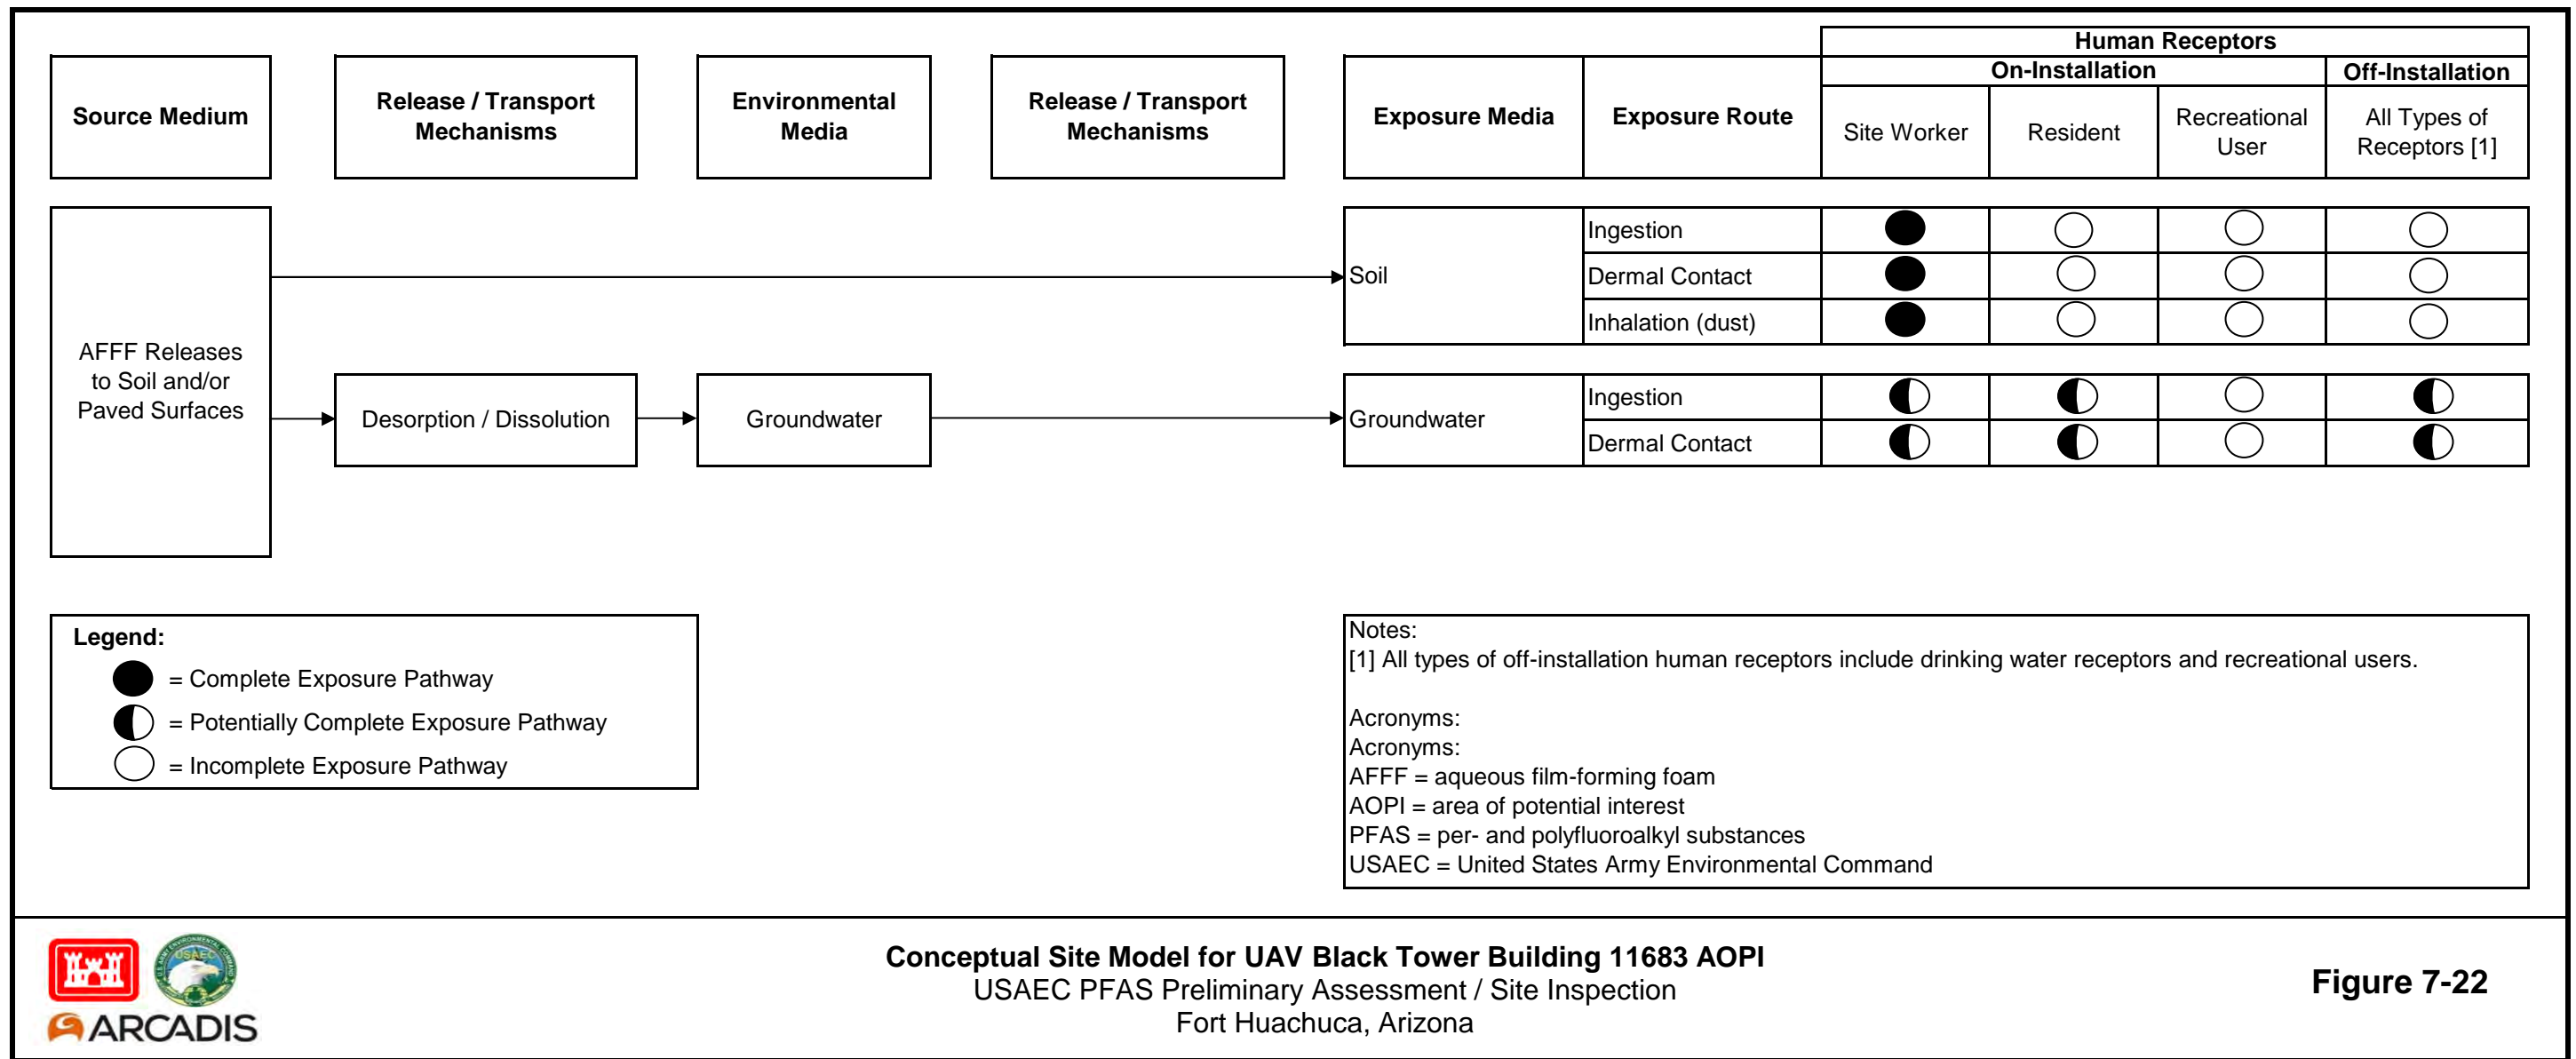
Figure 7-22

Conceptual Site Model for UAV Black Tower Building 11683 AOPI
 USAEC PFAS Preliminary Assessment / Site Inspection
 Fort Huachuca, Arizona
