FINAL PRELIMINARY ASSESSMENT AND SITE INSPECTION OF PER- AND POLYFLUOROALKYL SUBSTANCES

**The National Training Center and
Fort Irwin, California**

Prepared For:
U.S. Army Corps of Engineers, Baltimore District
2 Hopkins Plaza
Baltimore, Maryland 21201

December 2022

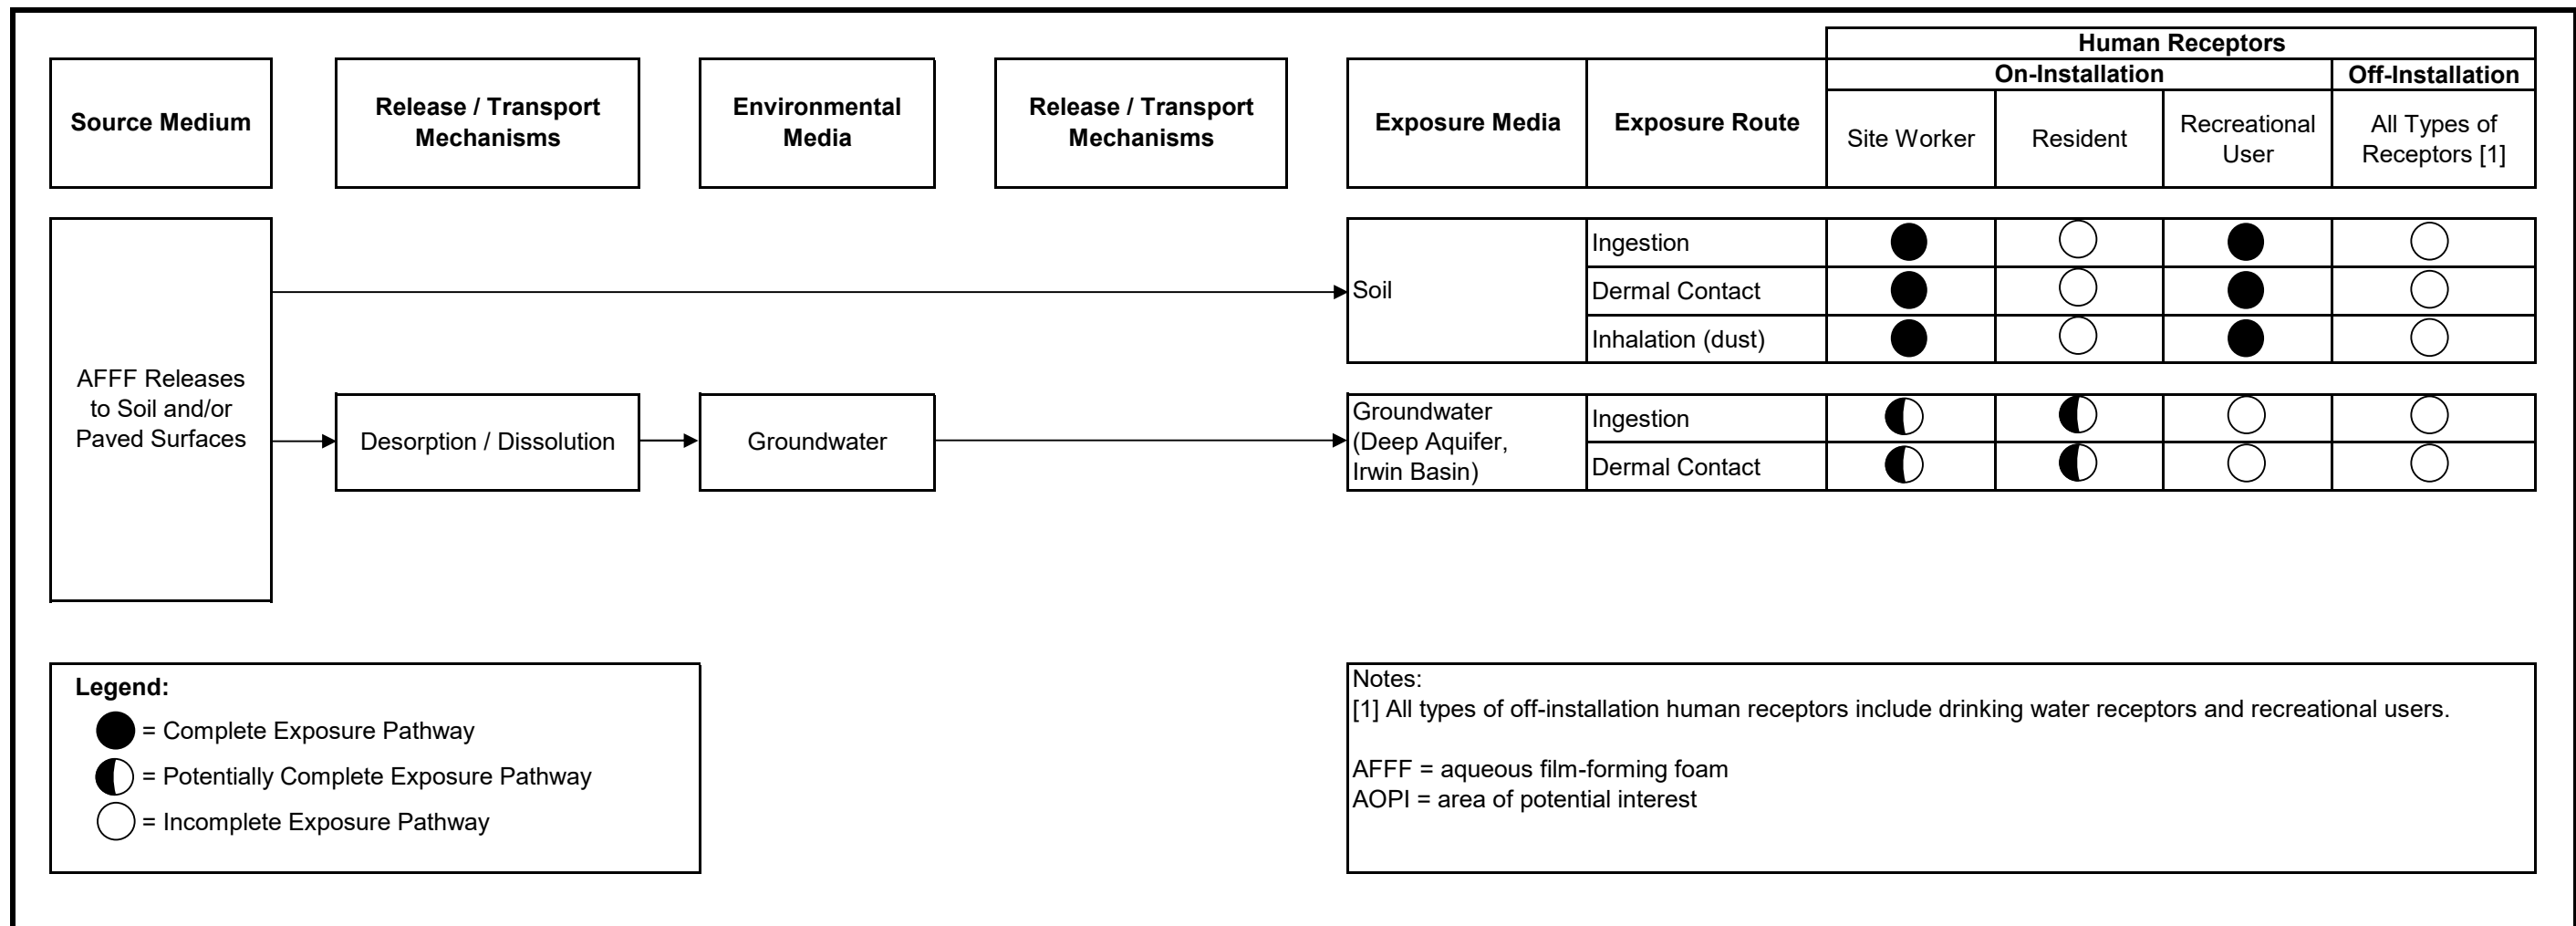
Figure 7-18

Conceptual Site Model for Active Recreational Ball Fields AOP
 USAEC PFAS Preliminary Assessment / Site Inspection
 Fort Irwin, California

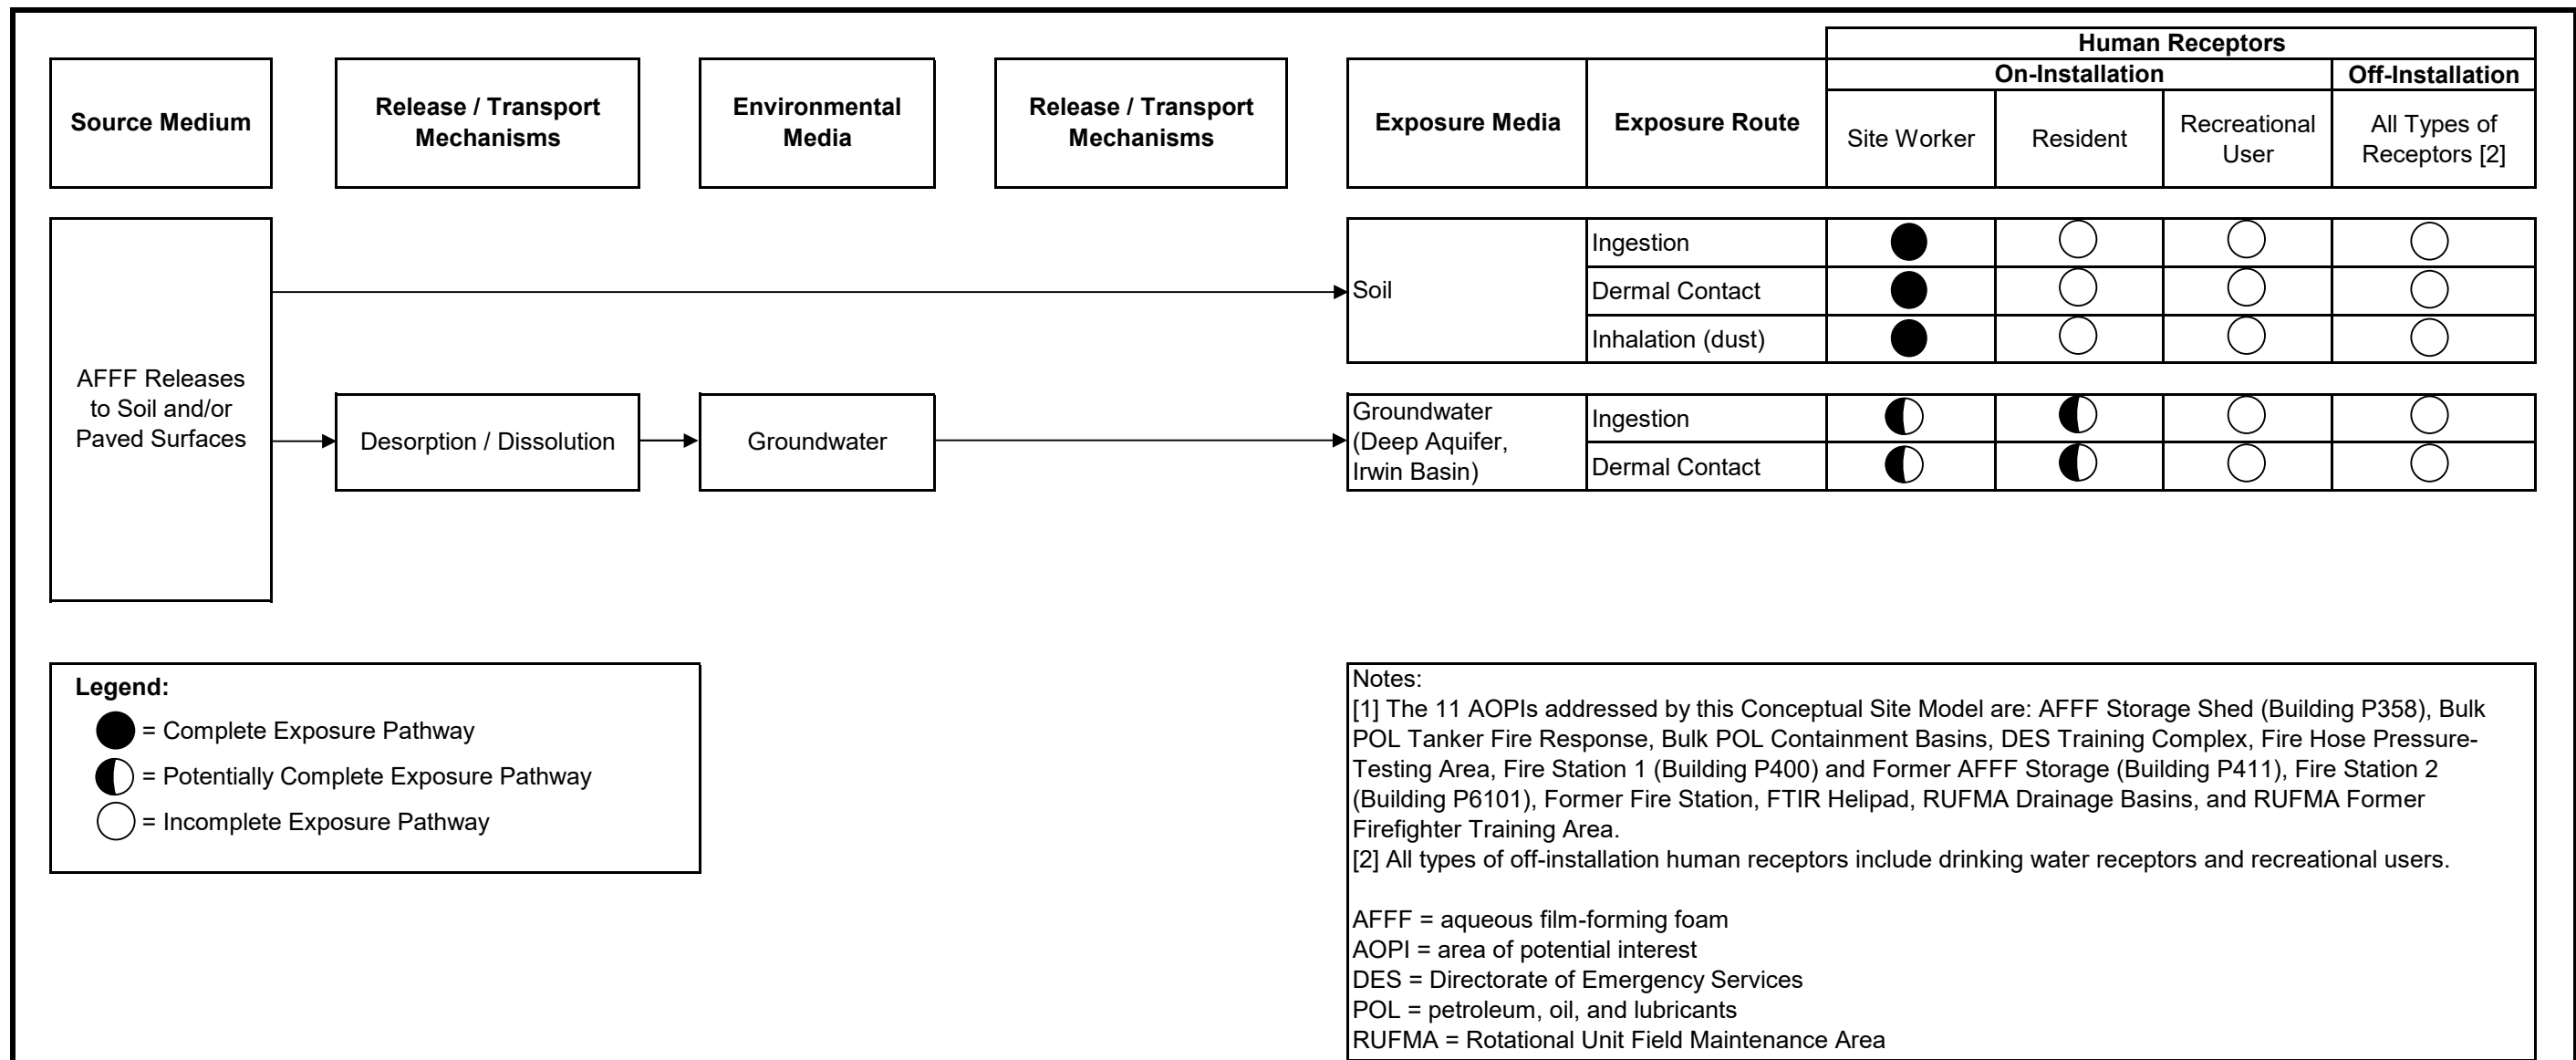
Figure 7-19

Conceptual Site Model for 11 AOPIs Located within the Irwin Groundwater Basin
 USAEC PFAS Preliminary Assessment / Site Inspection
 Fort Irwin, California

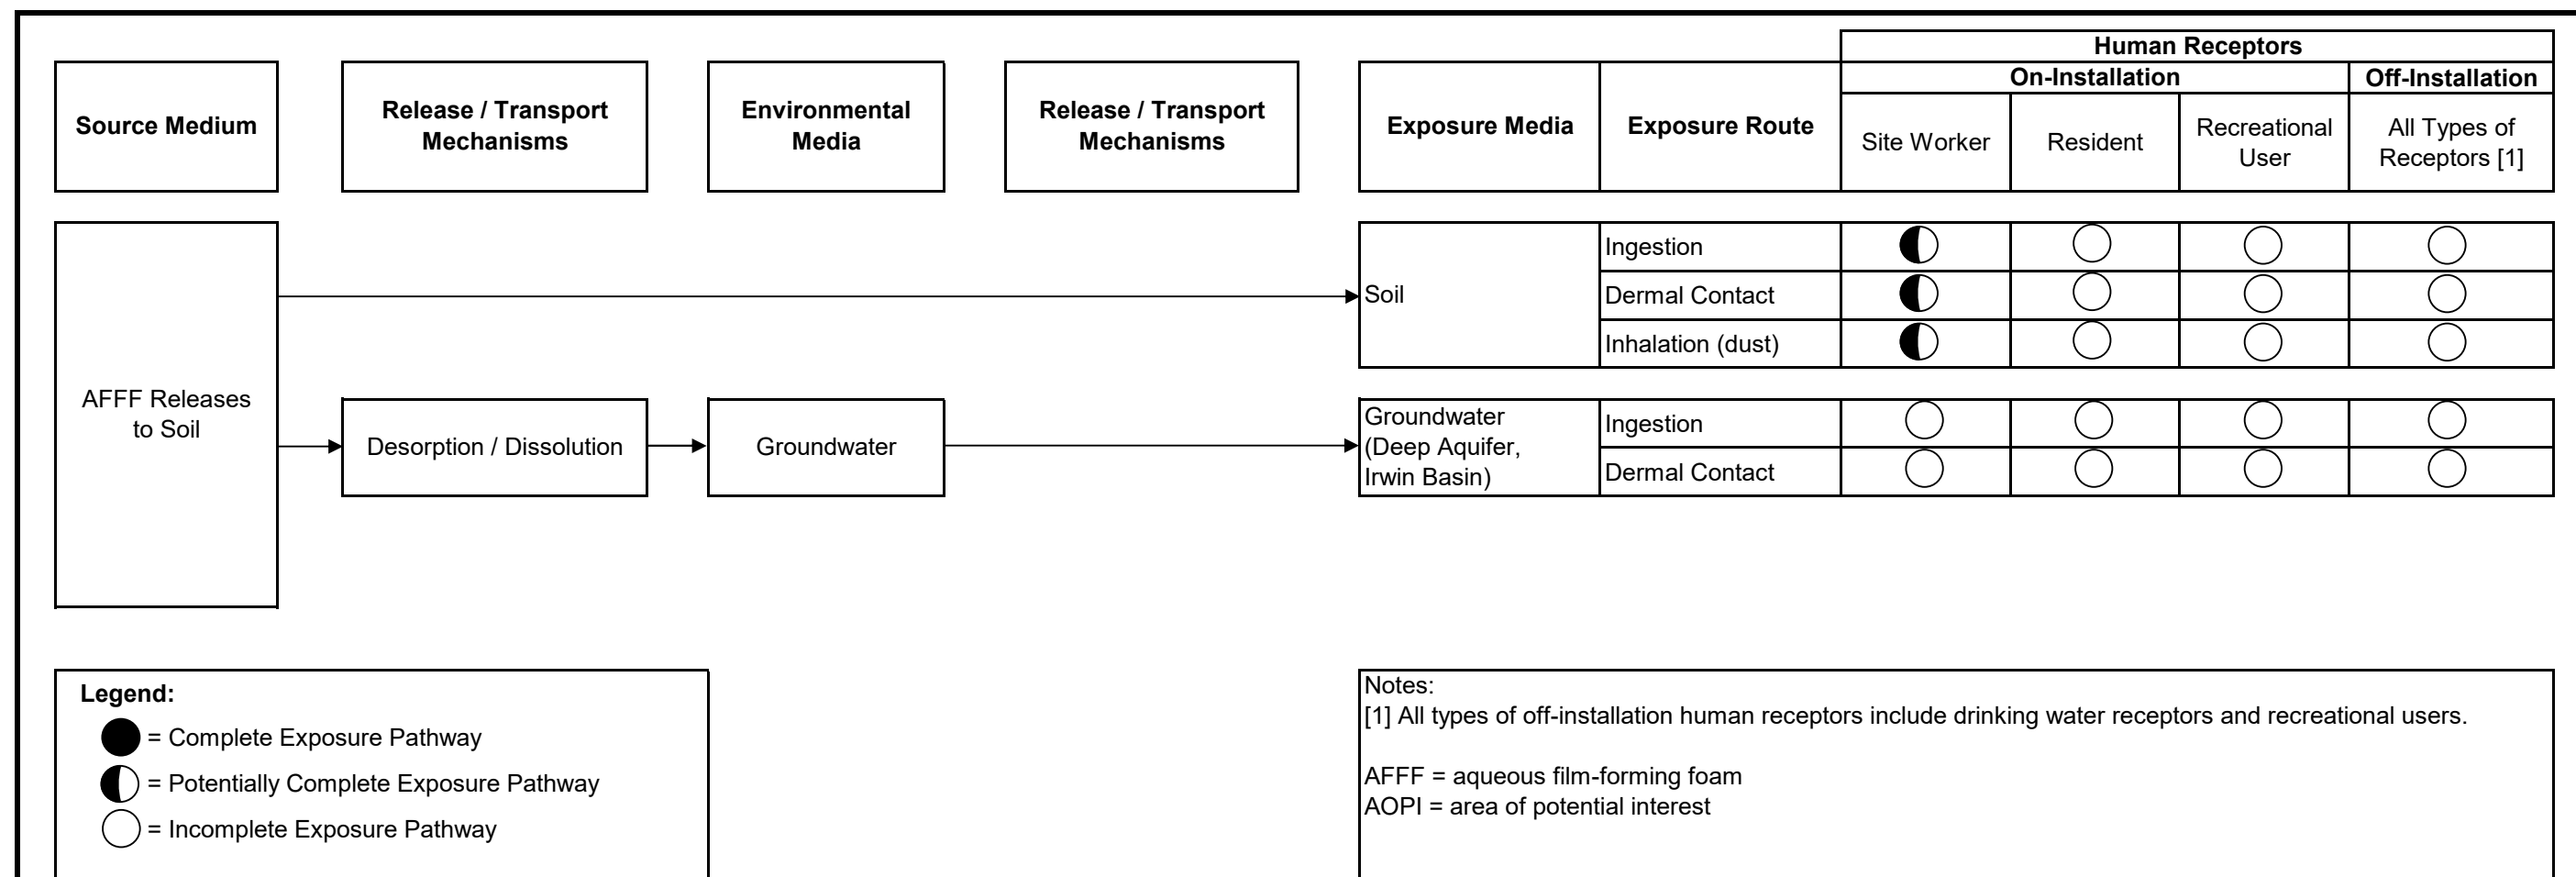
Figure 7-21

Conceptual Site Model for Land Farm Drying Pits AOPI
 USAEC PFAS Preliminary Assessment / Site Inspection
 Fort Irwin, California

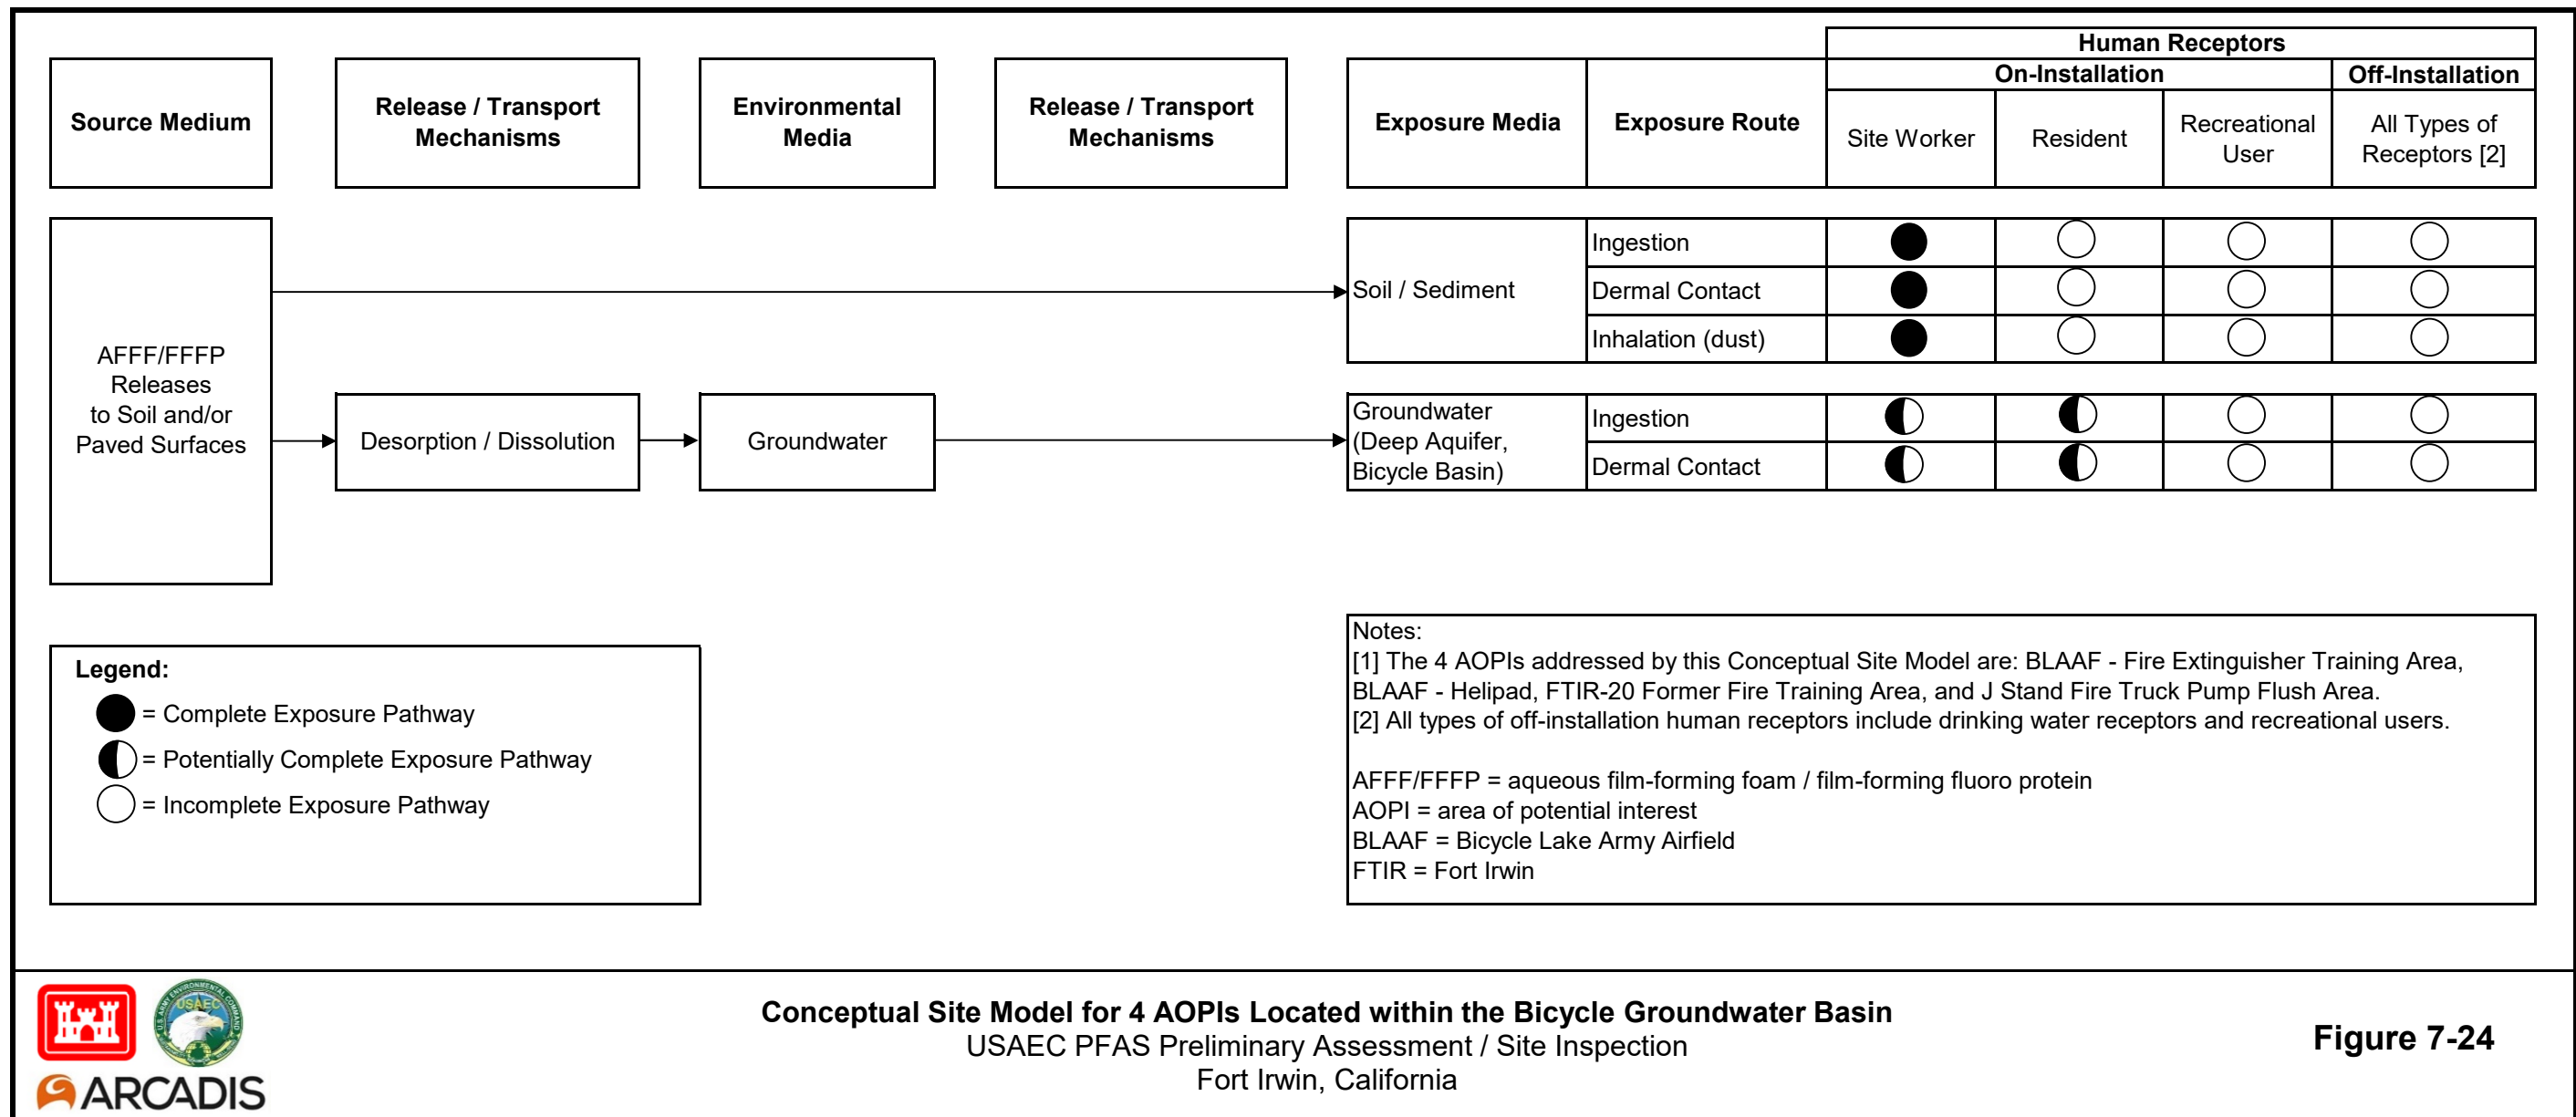
Figure 7-24

Conceptual Site Model for 4 AOPs Located within the Bicycle Groundwater Basin
 USAEC PFAS Preliminary Assessment / Site Inspection
 Fort Irwin, California

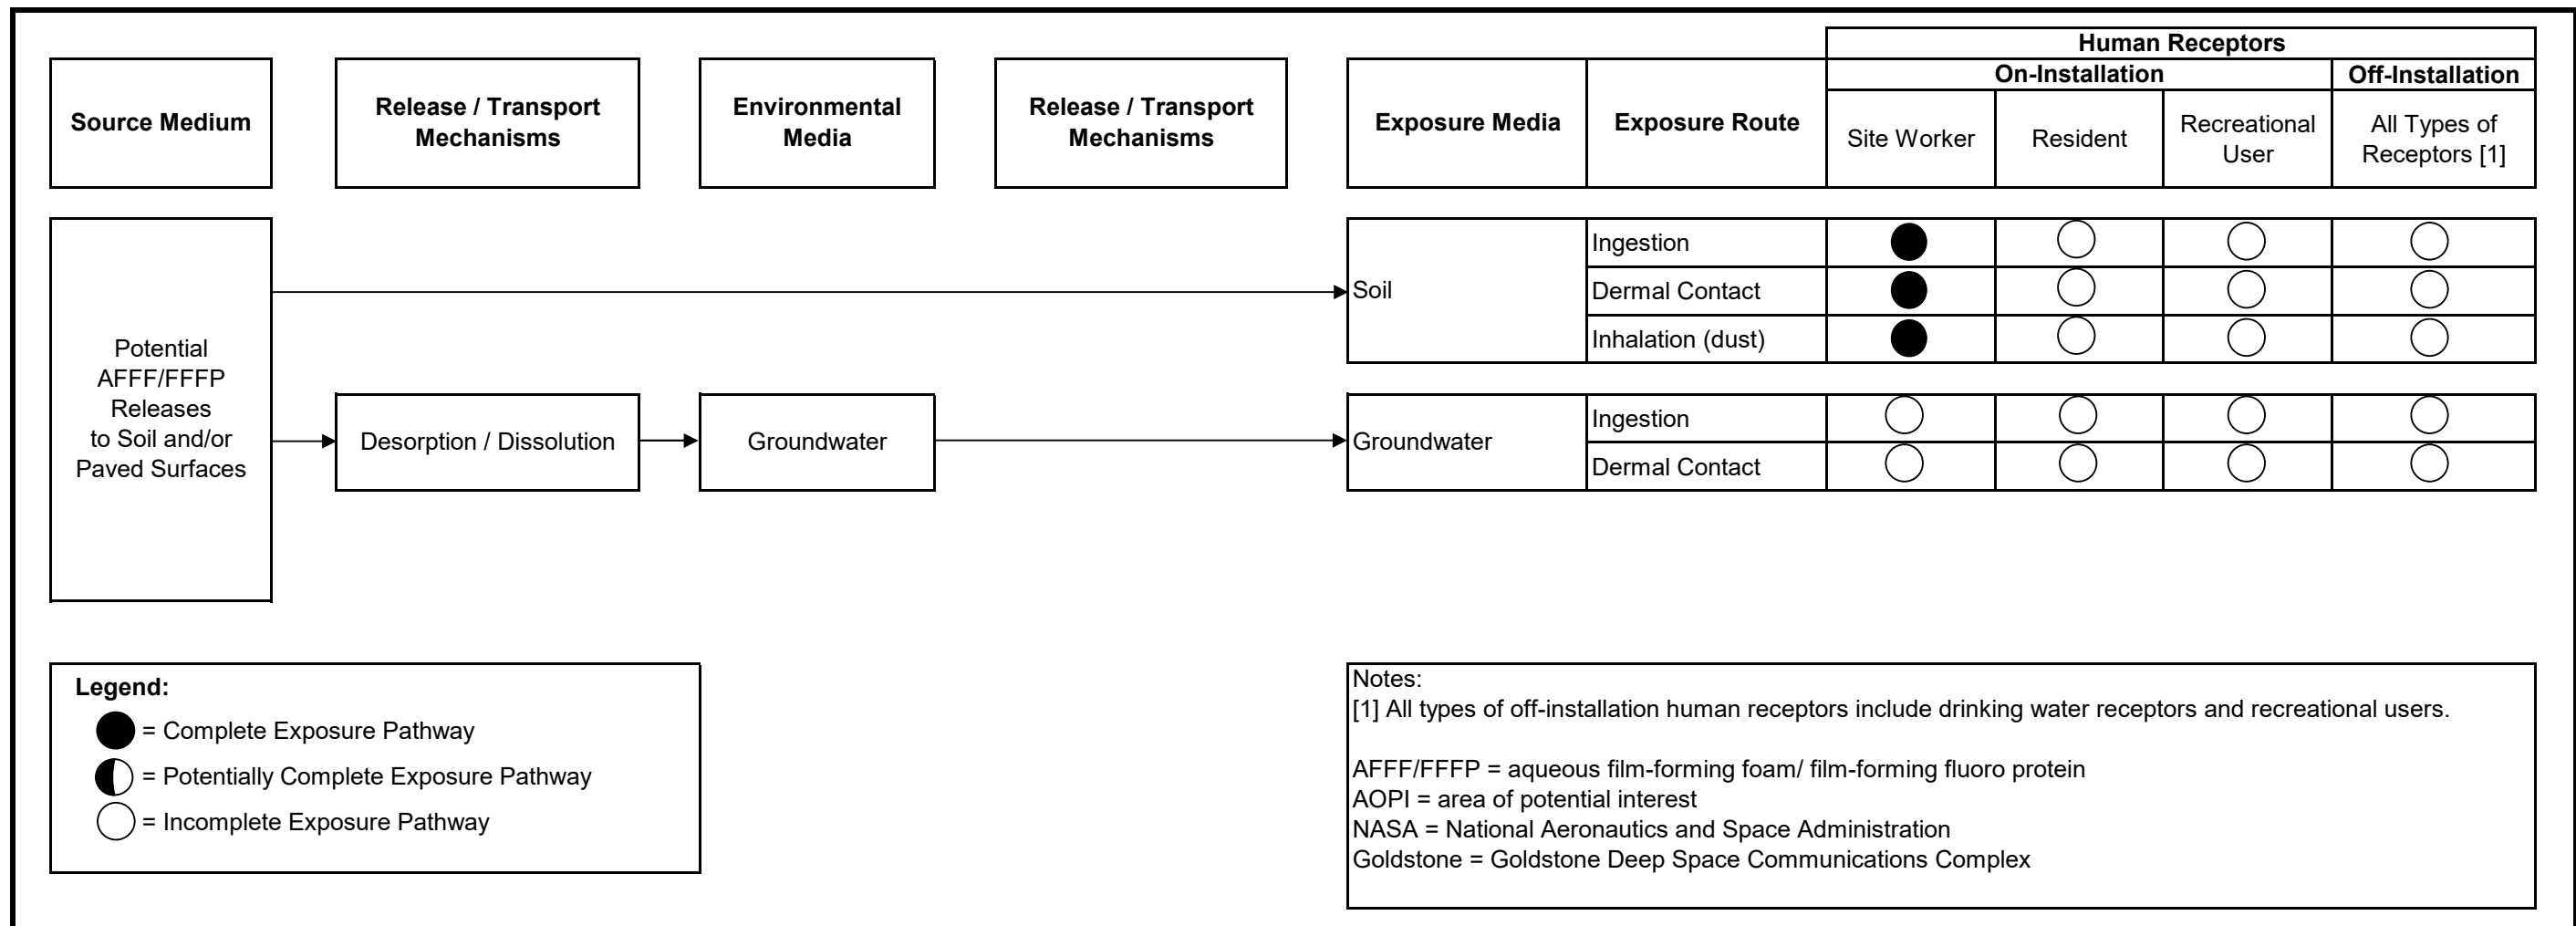
Figure 7-26

Conceptual Site Model for NASA Goldstone Former Microwave Test Facility AOPI
 USAEC PFAS Preliminary Assessment / Site Inspection
 Fort Irwin, California
