# FINAL PRELIMINARY ASSESSMENT AND SITE INSPECTION OF PER- AND POLYFLUOROALKYL SUBSTANCES

## Former Jefferson Proving Ground, Indiana

August 2023

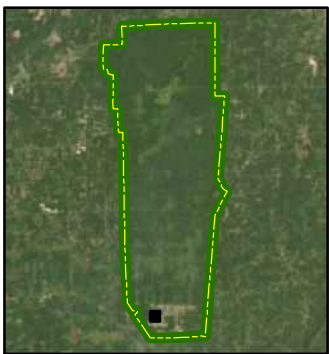
Figure 5-3  
Aerial Photo of  
Old Fire Training Pit AOPI

- Installation Boundary
- AOPI
- Groundwater Flow Direction

The AOPI locations are shown on **Figure 5-2**. Aerial photographs of each AOPI that also show the approximate extent of AFFF use (if applicable) are presented on **Figures 5-3 through 5-6**.

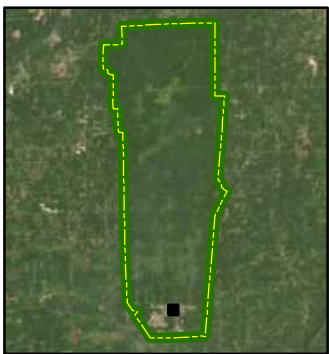
Figure 5-4  
Aerial Photo of Building 125 -  
Former Fire Station and Fire Training Area AOP

- Installation Boundary
- AOPI
- Inferred Groundwater Flow Direction

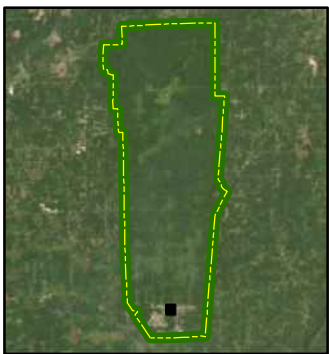
Figure 5-5  
Aerial Photo of  
Building 127 - Former Fire Station AOP

- Installation Boundary
- AOP
- Inferred Groundwater Flow Direction

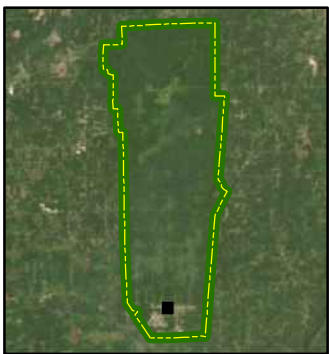
Figure 5-6  
Aerial Photo of  
Building 186 Roof Fire AOPI

- Installation Boundary
- AOPI
- Inferred Groundwater Flow Direction

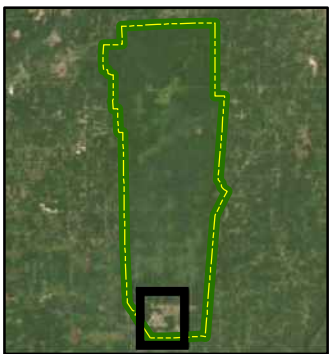
Figure 7-1  
AOPI Locations and OSD  
Risk Screening Level Exceedances

- Installation Boundary
- River/Stream (Perennial)
- Stream (Intermittent)
- Water Body
- Surface Water Flow Direction
- Regional Groundwater Flow Direction
- Closed - No Access
- AOPI
- AOPI with OSD Risk Screening Level Exceedance

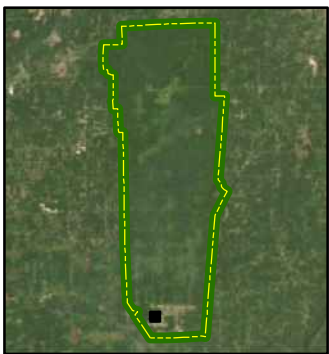
Figure 7-2  
Old Fire Training Pit AOPI  
PFOS, PFOA, PFBS, PFNA, and PFHxS Analytical Results

Installation Boundary  
AOPI

The subsections below summarize the groundwater and soil PFOS, PFOA, PFBS, PFNA, and PFHxS analytical results associated with the Old Fire Training Pit AOPI (**Figure 7-2**).

GW-032923 was collected at JPG-OFTP-GW-1)). The groundwater analytical results for PFOS, PFOA, PFBS, PFNA, and PFHxS are shown on **Figure 7-2** and **Table 7-1**, and are summarized below:

Three soil samples were collected via hand auger at the Old Fire Training Pit AOPI (JPG-OFTP-SO-1, JPG-OFTP-SO-2, JPG-OFTP-SO-3 [FD sample JPG-FD-1-SO-032923 was collected at JPG-OFTP-SO-1]). The soil analytical results for PFOS, PFOA, PFBS, PFNA, and PFHxS are shown on **Figure 7-2** and **Table 7-2**, and are summarized below:
