**FINAL  
PRELIMINARY ASSESSMENT REPORT  
FORMER KANSAS ARMY AMMUNITION PLANT**

**September 2023**

**U.S. ARMY**

United States Army Corps of Engineers – Kansas City District

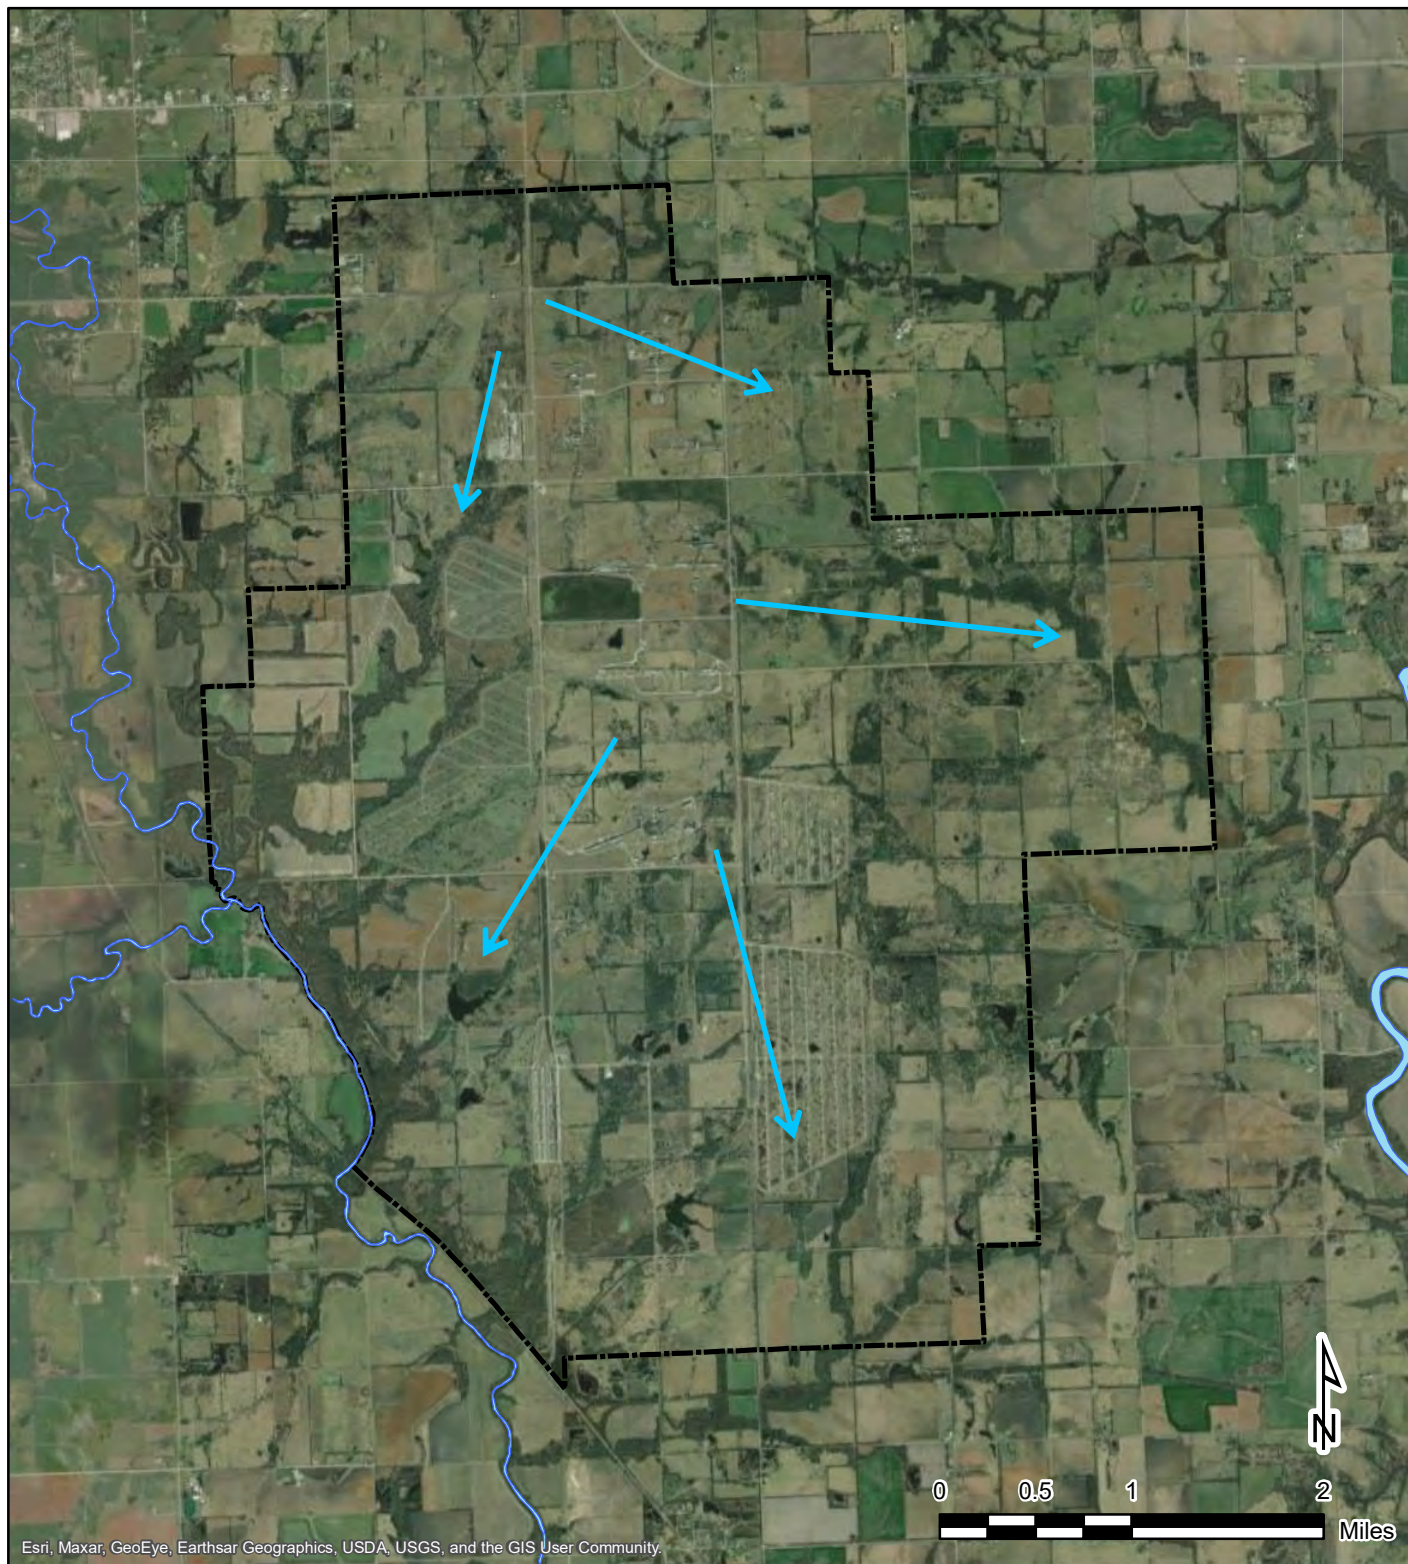
- Installation Boundary
- River/Creek
- ➔ Groundwater Flow Direction

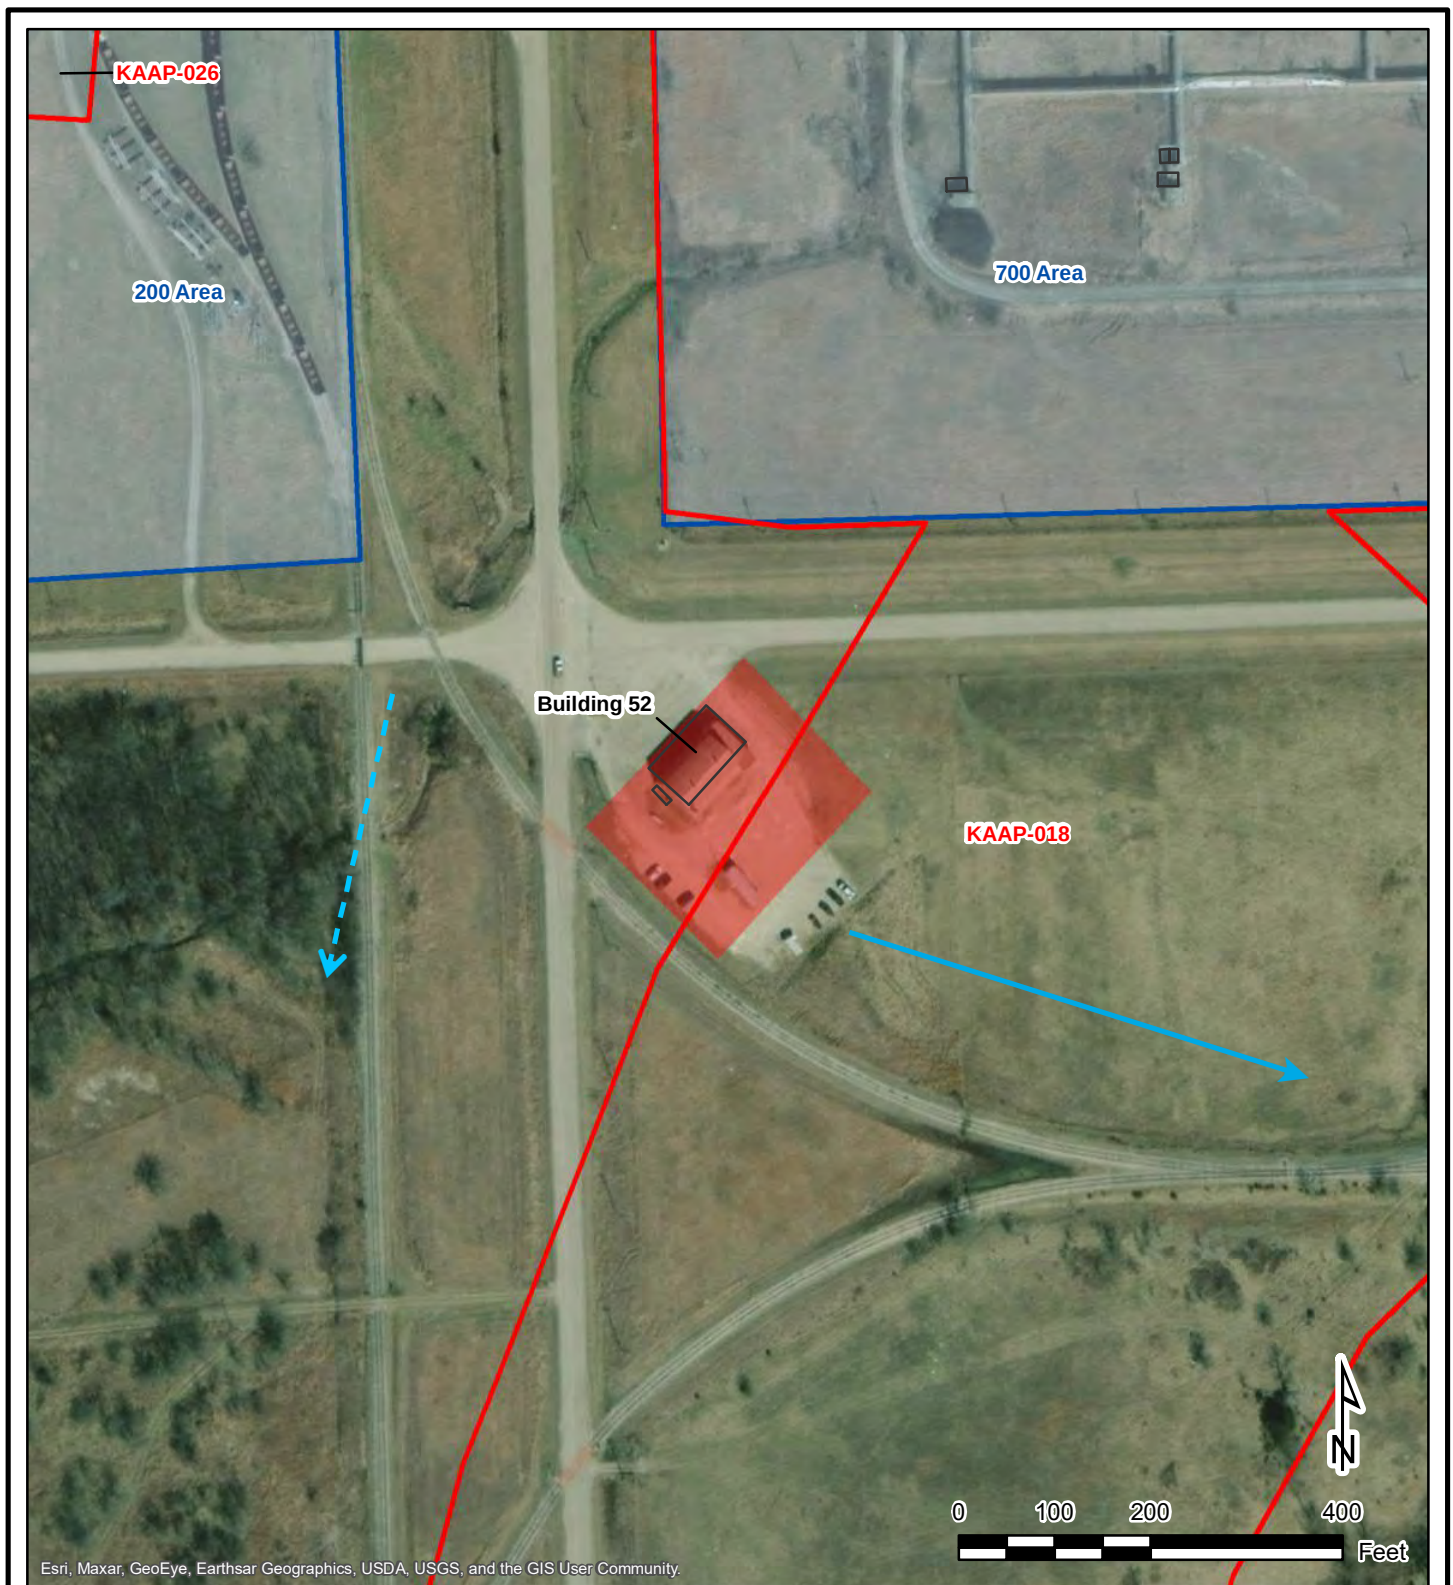
- Installation Boundary
- KAAP Site
- Production Area
- AOI 1
- Surface Water Flow Direction
- - -> Groundwater Flow Direction
