**FINAL  
SITE INSPECTION REPORT  
PFAS AOI, BUILDING 52 – FORMER FIRE STATION  
FORMER KANSAS ARMY AMMUNITION PLANT**

**December 2023**

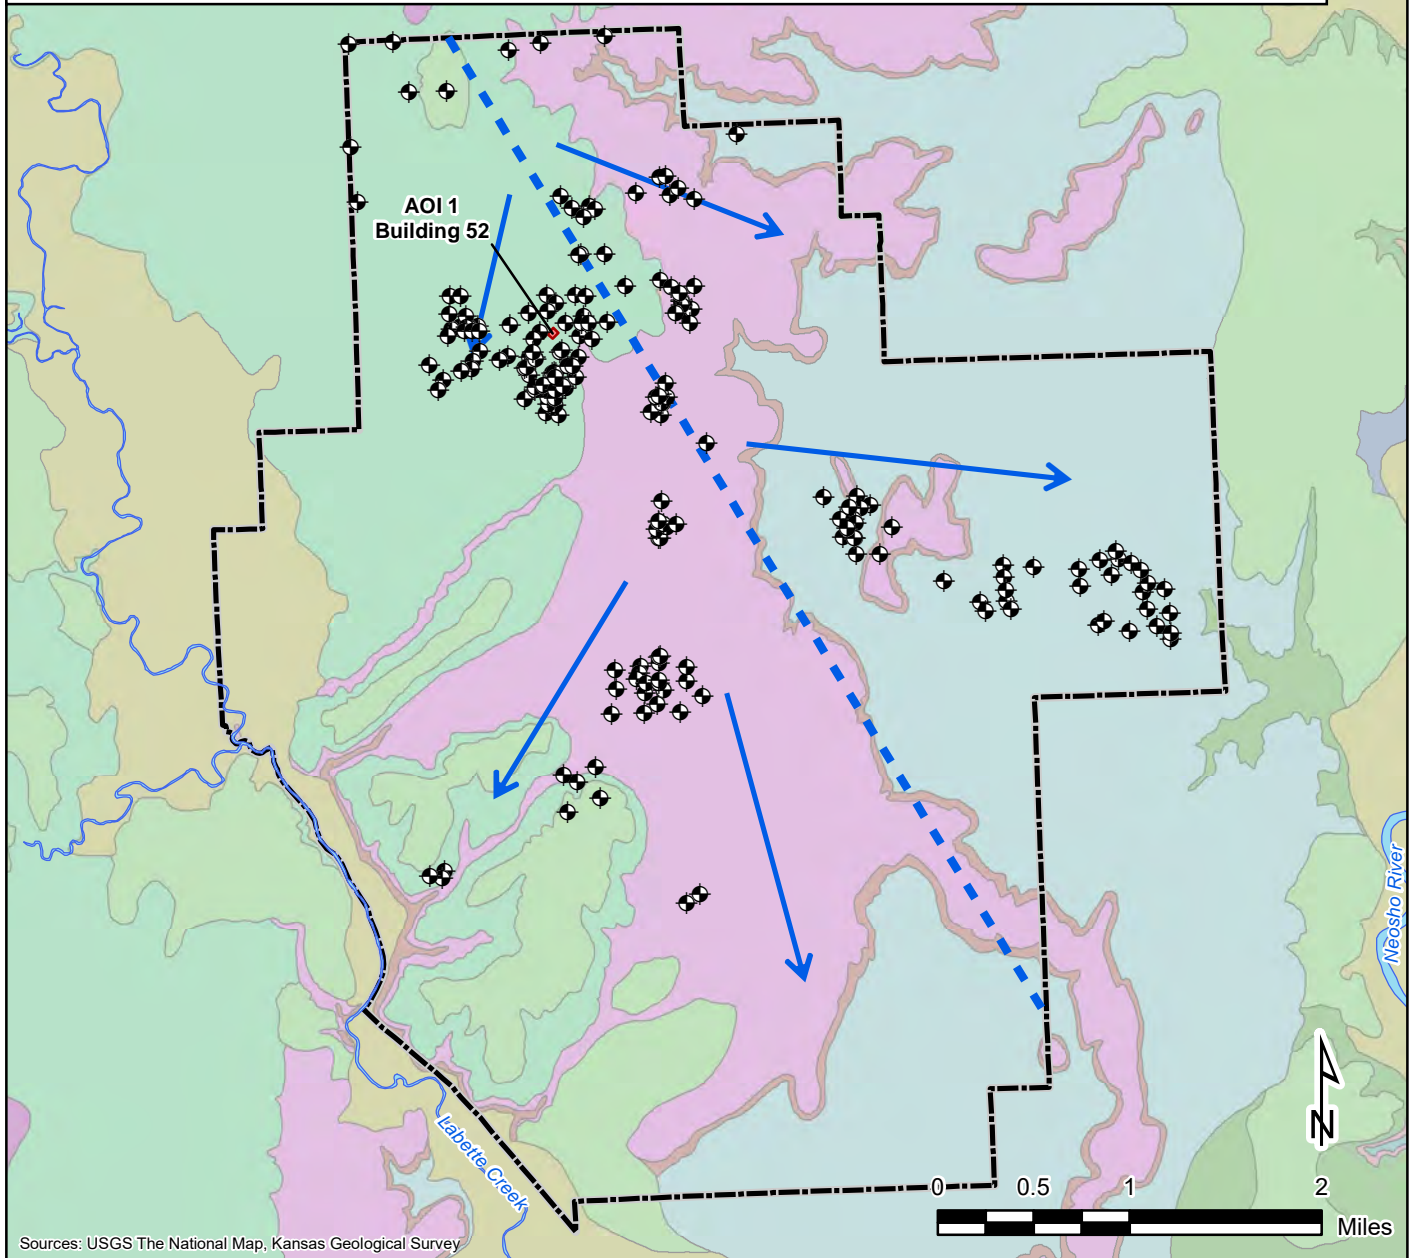
- Installation Boundary
- AOI 1
- River/Creek
- Approximate Groundwater Divide
- ➔ Groundwater Flow Direction
- KSAAP Monitoring Well (includes wells from 2006 and 2018 data sources)

The Cherokee Group underlies the Marmaton Group and ranges in thickness from about 395 to 560 feet. The Cabaniss Formation is the first unit underlying the Marmaton Group. The shale and interbedded sandstone lenses of the Cherokee thicken toward the southwest in Labette County. Geology features for the regional area are depicted on **Figure 2-1**.

- A north-south trending groundwater divide subdivides the facility into two groundwater flow systems (**Figure 2-1**). In the north part of KSAAP, this groundwater divide roughly coincides with the surface water divide that separates the Labette Creek and Neosho Creek watersheds.
- West of the divide, groundwater flows west-southwest toward discharge areas along Labette Creek.
- East of the divide, groundwater flows generally east toward discharge areas along Neosho Creek.
