FINAL PRELIMINARY ASSESSMENT AND SITE INSPECTION OF PER- AND POLYFLUOROALKYL SUBSTANCES

Fort Knox, Kentucky

May 2022

PRELIMINARY ASSESSMENT/SITE INSPECTION OF PFAS AT FORT KNOX, KENTUCKY

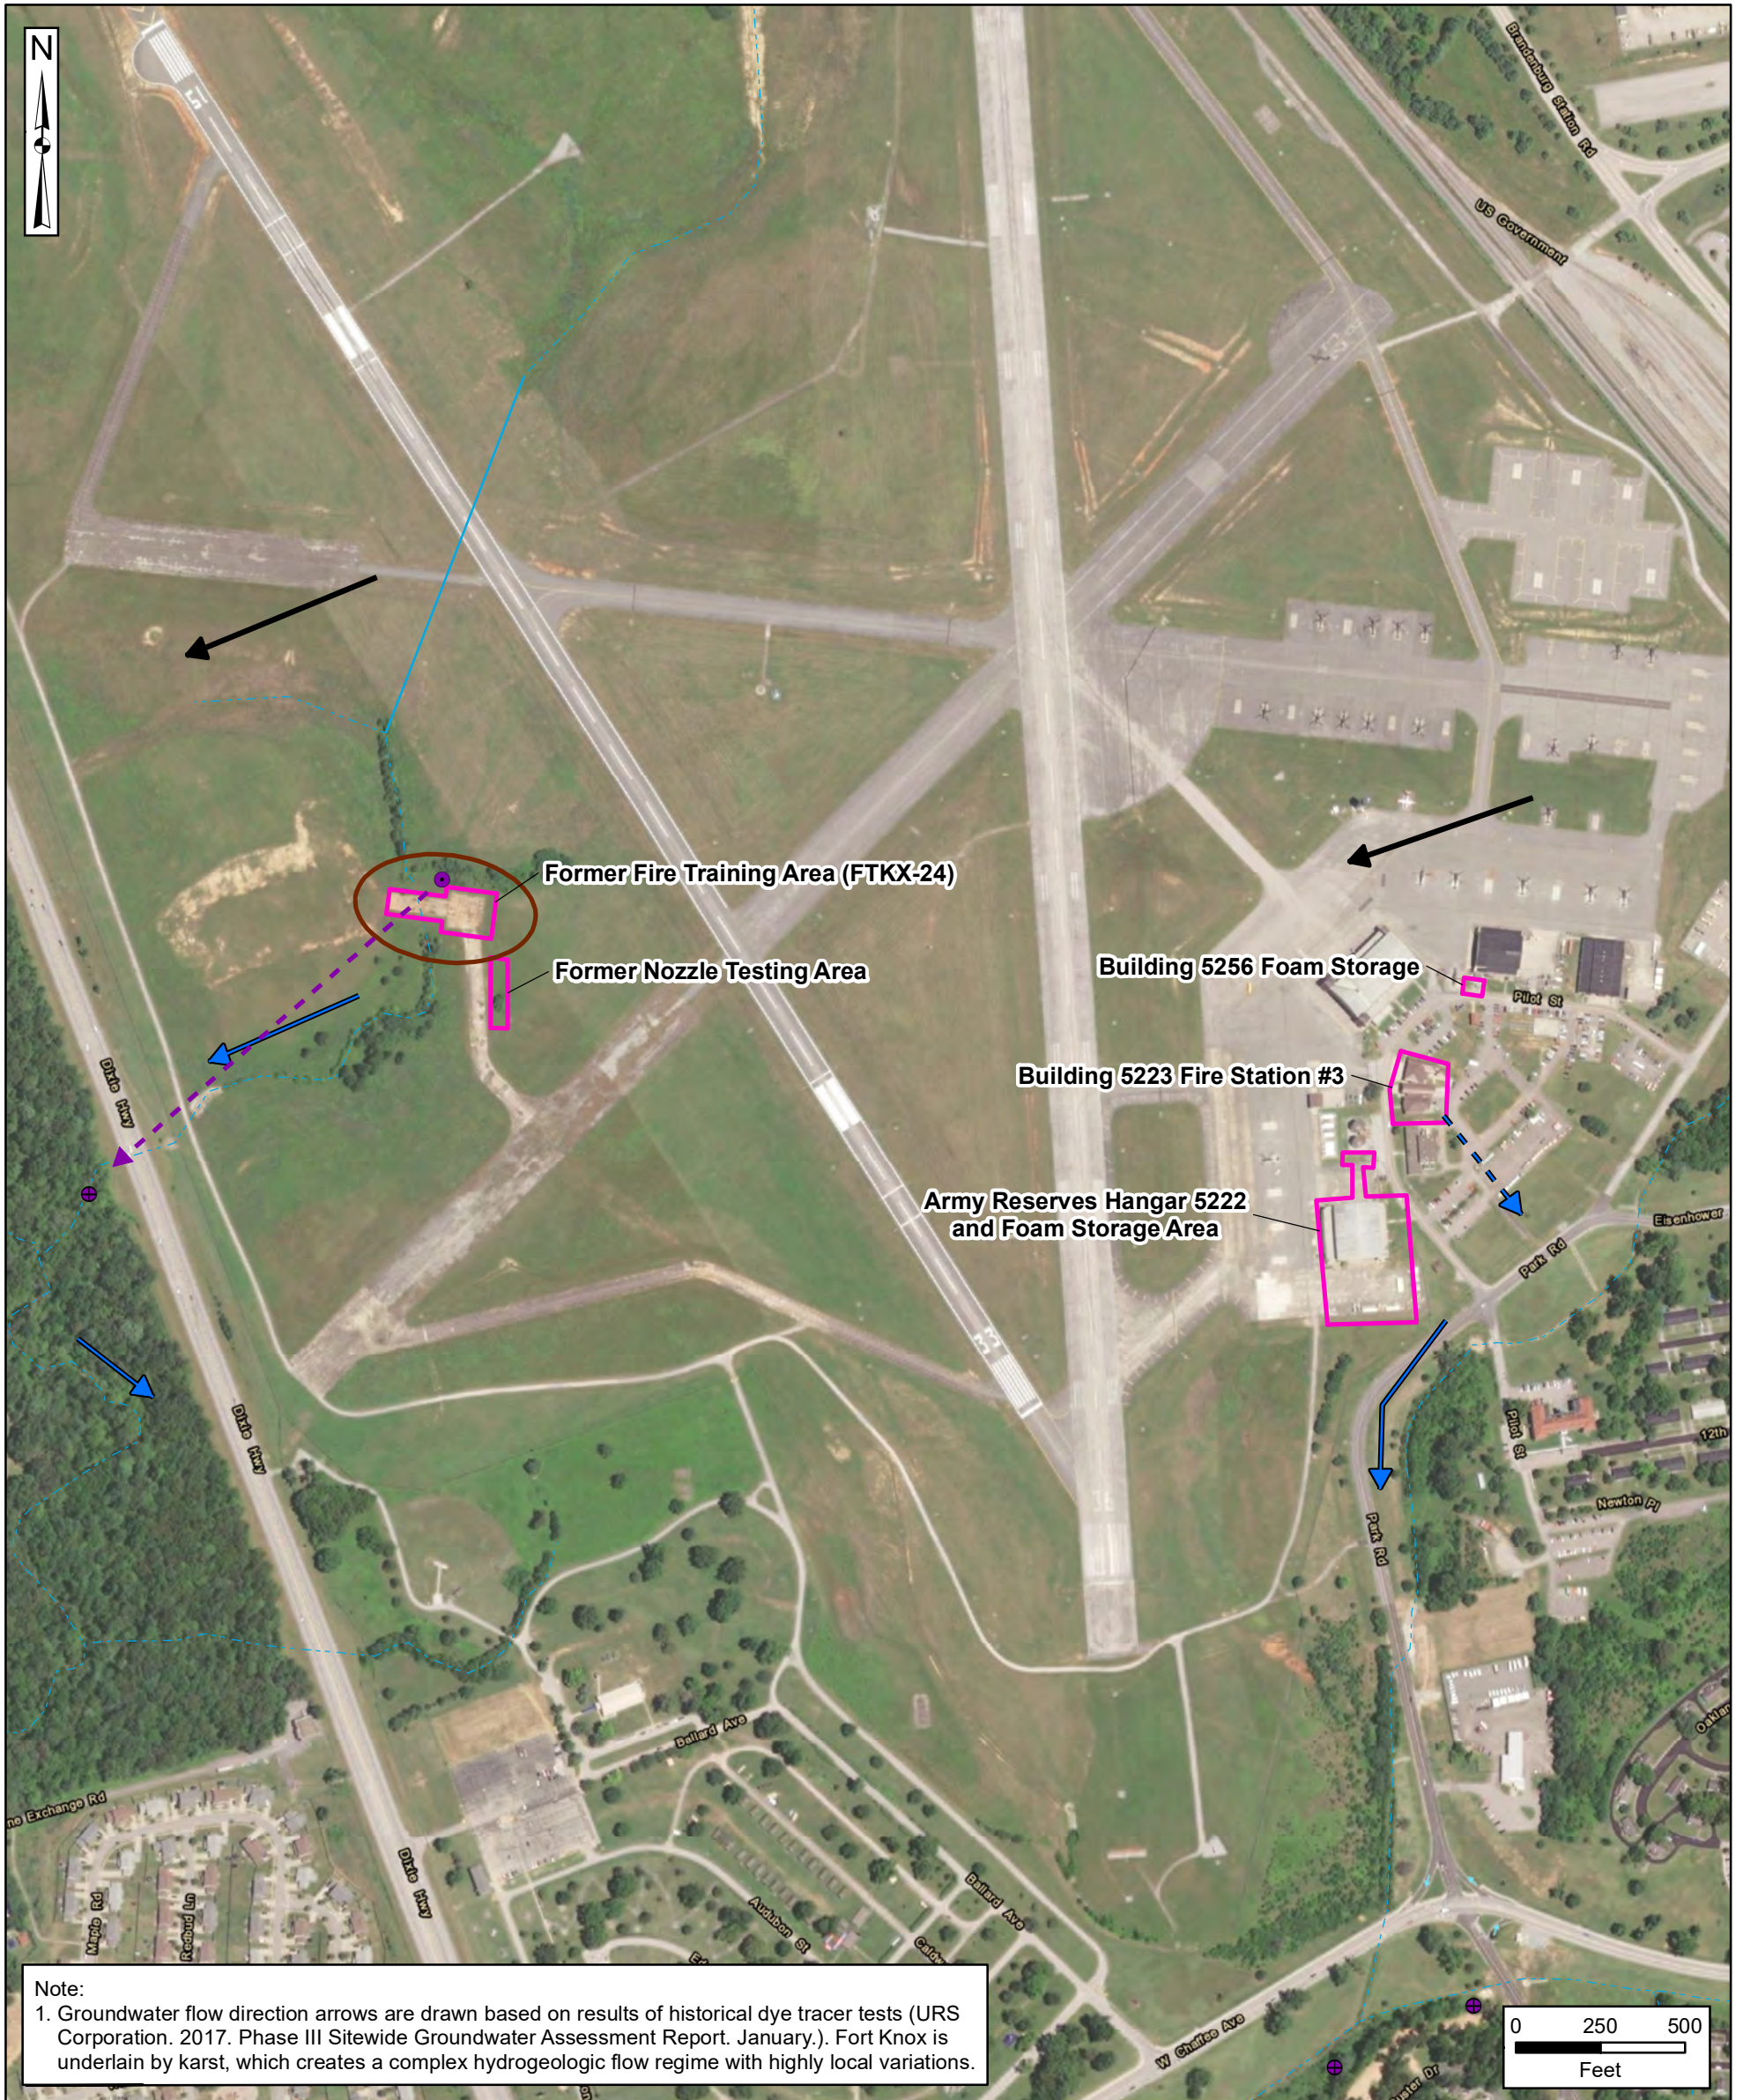
Figure 5-3
Aerial Photo of
Godman Army Airfield AOPI

utilized for fire training activities at this location (**Figure 5-3**). During the training exercises, jet fuel was used to ignite fires that were subsequently extinguished using AFFF. Water and foam collected by the berms drained to an OWS, and liquid from the OWS drained to ground surface, which then flowed into a drainage ditch that feeds tributaries of the Ohio River.

The Building 5223 Fire Station #3 is identified as an AOPI following records research, personnel interviews, and site reconnaissance due to historical fire department activities at the station. Fire Station #3 has been active since the 1960s and is the storage location of hundreds of gallons of AFFF; located on a tile and grout floor of a heat-regulated building with no secondary containment (**Figure 5-3**).

Note:
1. Groundwater flow direction arrows are drawn based on results of historical dye tracer tests (URS Corporation, 2017, Phase III Sitewide Groundwater Assessment Report, January.). Fort Knox is underlain by karst, which creates a complex hydrogeologic flow regime with highly local variations.
