# FINAL PRELIMINARY ASSESSMENT OF PER- AND POLYFLUOROALKYL SUBSTANCES

## USAG Kwajalein Atoll

Prepared For:  
U.S. Army Corps of Engineers, Baltimore District  
2 Hopkins Plaza  
Baltimore, Maryland 21201

February 2023

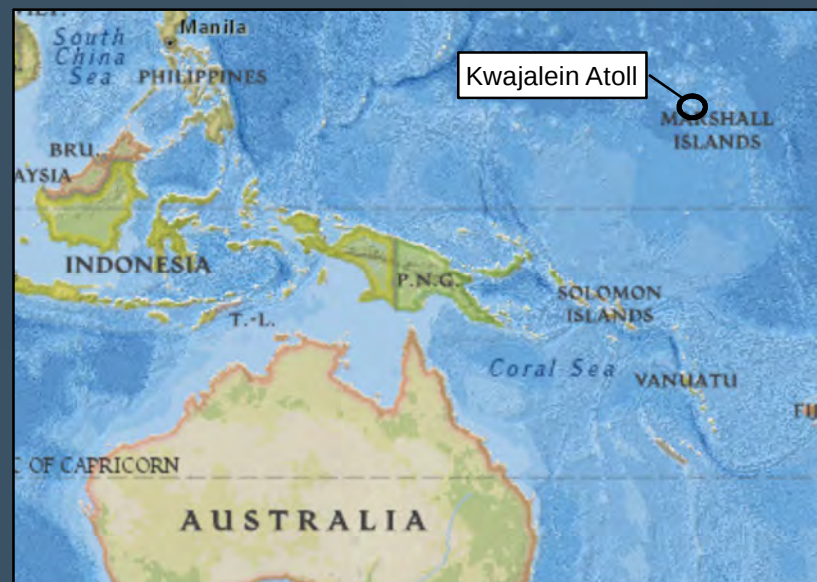
Figure 2-1  
Site Location

Kwajalein Atoll is in the northern equatorial Pacific Ocean, approximately 700 nautical miles north of the equator and 2,100 nautical miles southwest of Honolulu, Hawaii (**Figure 2-1**). The atoll is approximately 75 nautical miles long, averages 15 nautical miles in width, and encompasses approximately 100 islands. The islands, which total 10.2 square miles of landmass, surround one of the largest lagoons in the world, covering over 900 square miles. All Kwajalein Atoll islands are low coral islands averaging 6 feet above mean sea level (amsl), with a few natural or manmade points rising above 15 feet amsl (DynCorp International, LLC [DynCorp] 2019). USAG-KA encompasses all or a portion of 11 islands within the Kwajalein Atoll of the Republic of the Marshall Islands; however, this PA focuses on the Kwajalein (**Figure 2-2a**) and Roi-Namur (**Figure 2-2b**) Islands. Kwajalein Island and Roi-Namur Island are located at the atoll's southern and northern extremity, respectively, with approximately 43.4 nautical miles spanning between them (WHPacific 2012).
