**SITE INSPECTION REPORT FOR PER- AND  
POLYFLUOROALKYL SUBSTANCES AT  
LEXINGTON-BLUEGRASS ARMY DEPOT,  
LEXINGTON, KENTUCKY**

**Final  
October 2023**

**Leidos  
1750 Presidents Street  
Reston, Virginia 20190**

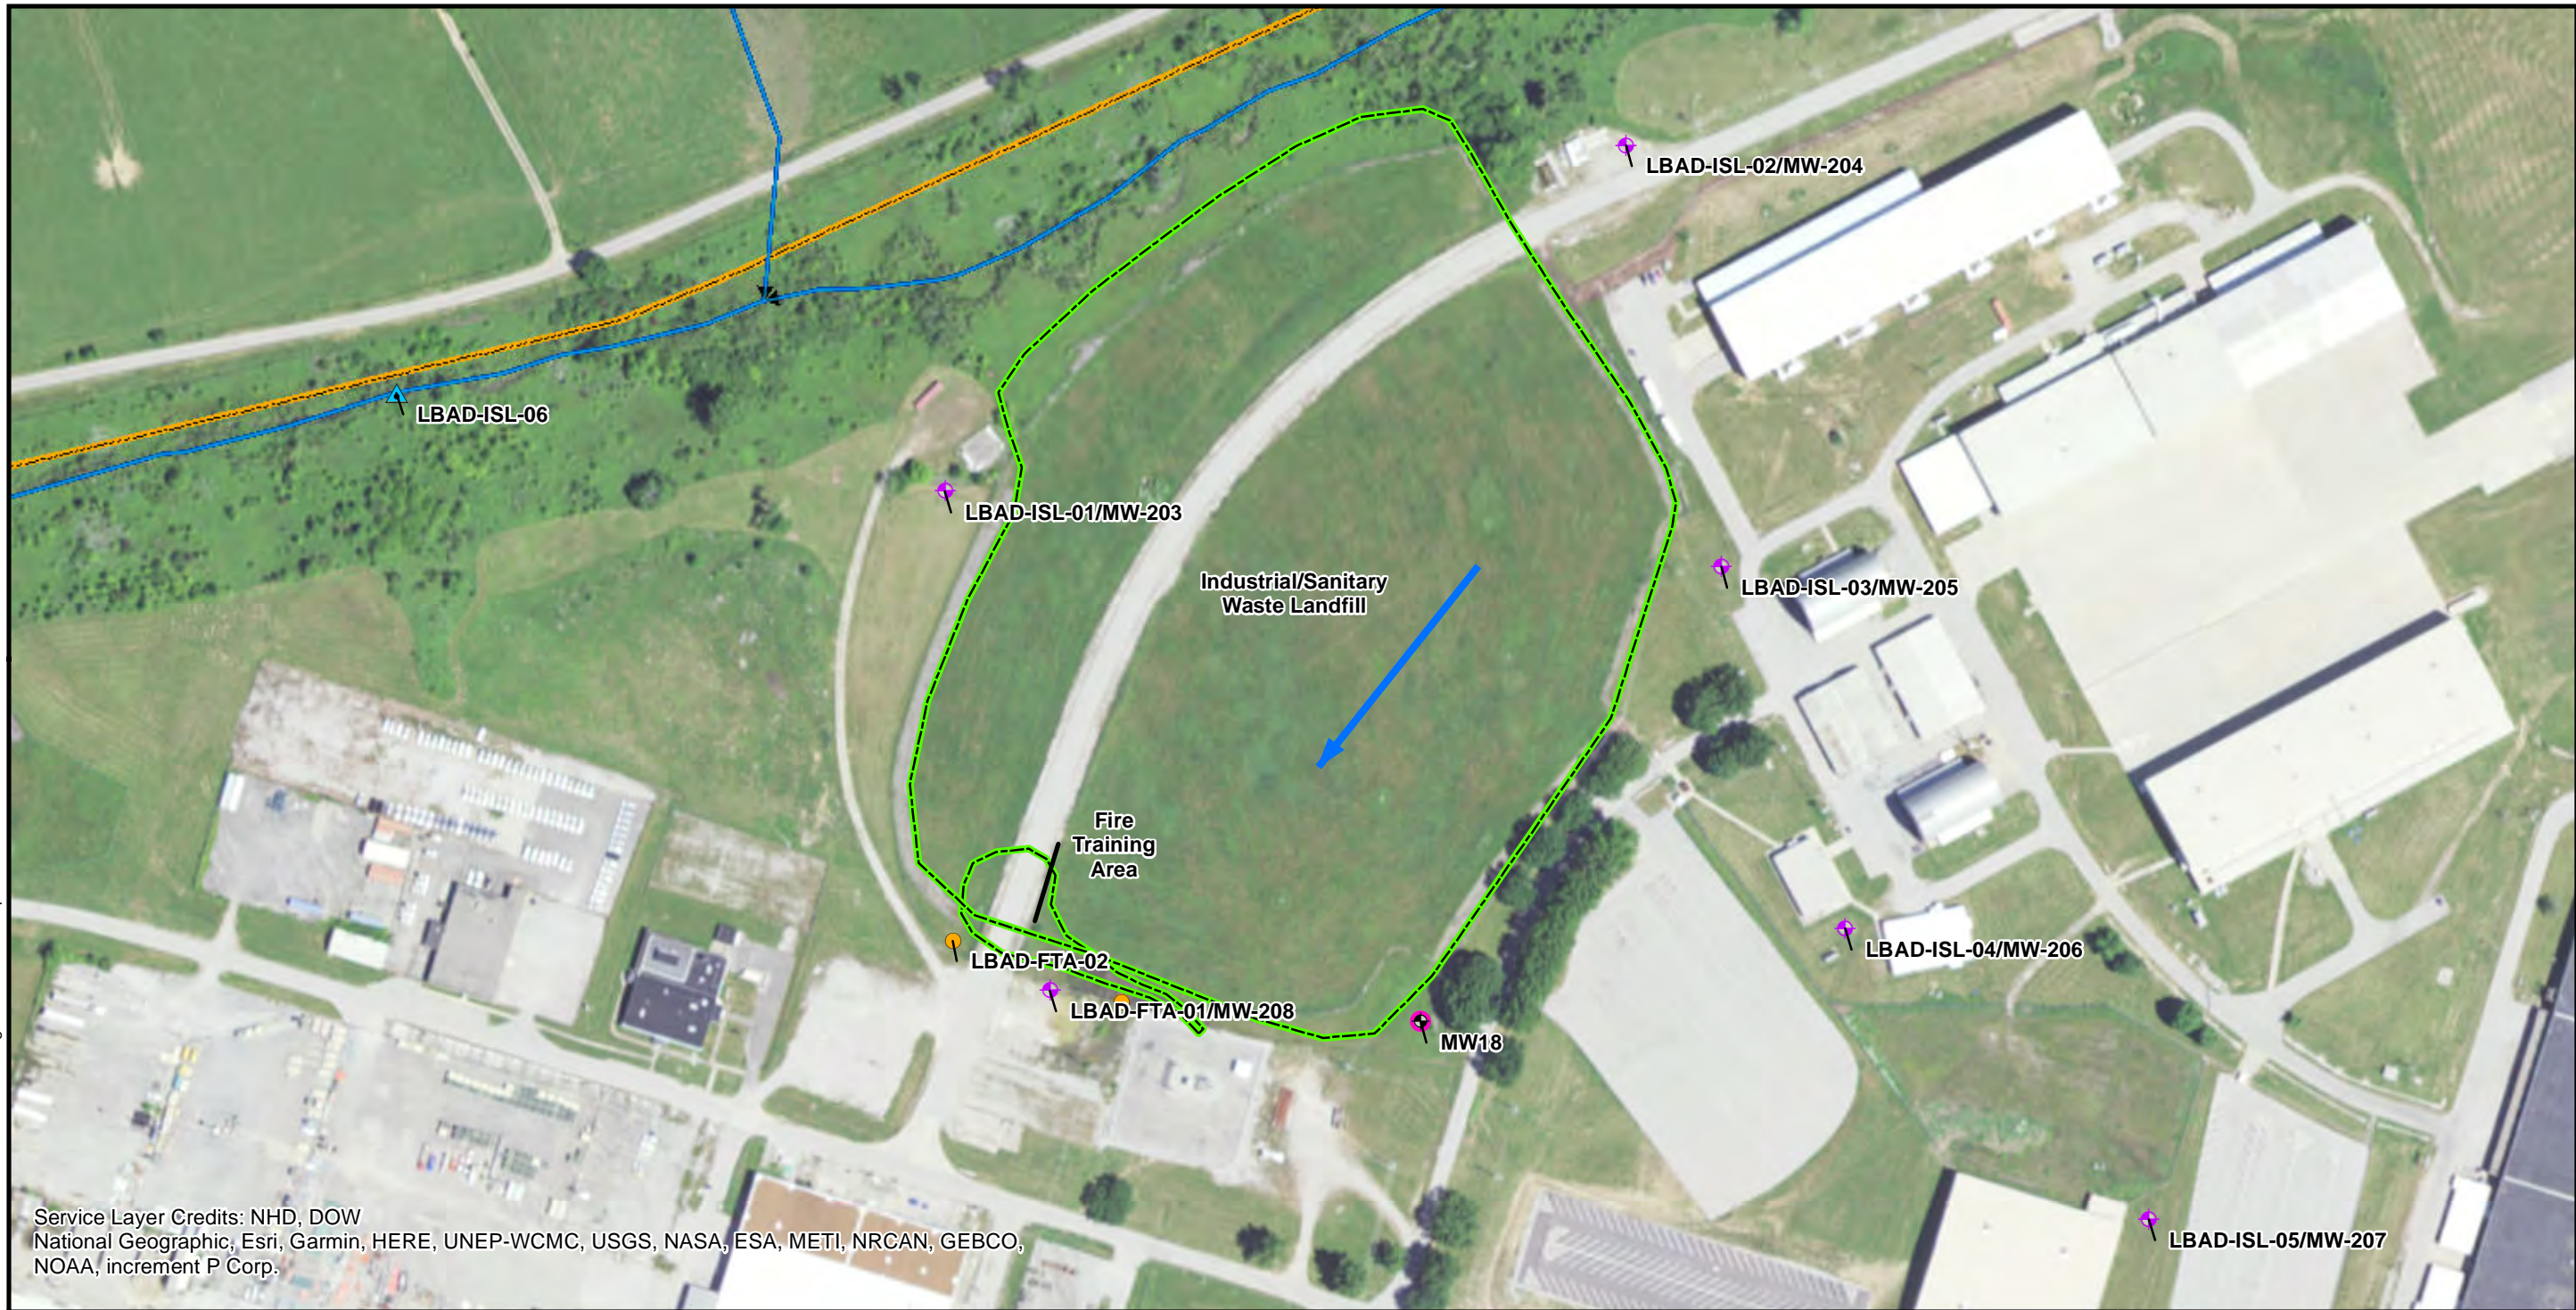
**Figure 6-3. Human Health CSM for New Landfill AOPI**

LUCs restricting landfill cap and soil disturbance and groundwater use are currently in place at the New Landfill. However, as the LUCs are based on non-PFAS specific contaminants, the onsite soil and groundwater exposure pathways are considered potentially complete for the duration of the current restrictions because Target PFAS were detected in groundwater at concentrations less than the SLs. A potentially complete groundwater exposure pathway exists for offsite residents because Target PFAS were detected in groundwater below the SLs, and groundwater wells are present within 1 mile of LBAD (including six downgradient wells). Because Target PFAS were detected in surface water and sediment below the SLs at the New Landfill AOPI, the surface water and sediment exposure pathways for onsite workers are potentially complete. Surface water that leaves LBAD enters an unnamed tributary of Elkhorn Creek, which flows to the Kentucky River several miles downstream and is used as a drinking water source by KAW; therefore, the surface water and sediment exposure pathways are potentially complete for offsite residents and recreators. Figure 6-3 presents the CSM for the New Landfill AOPI.

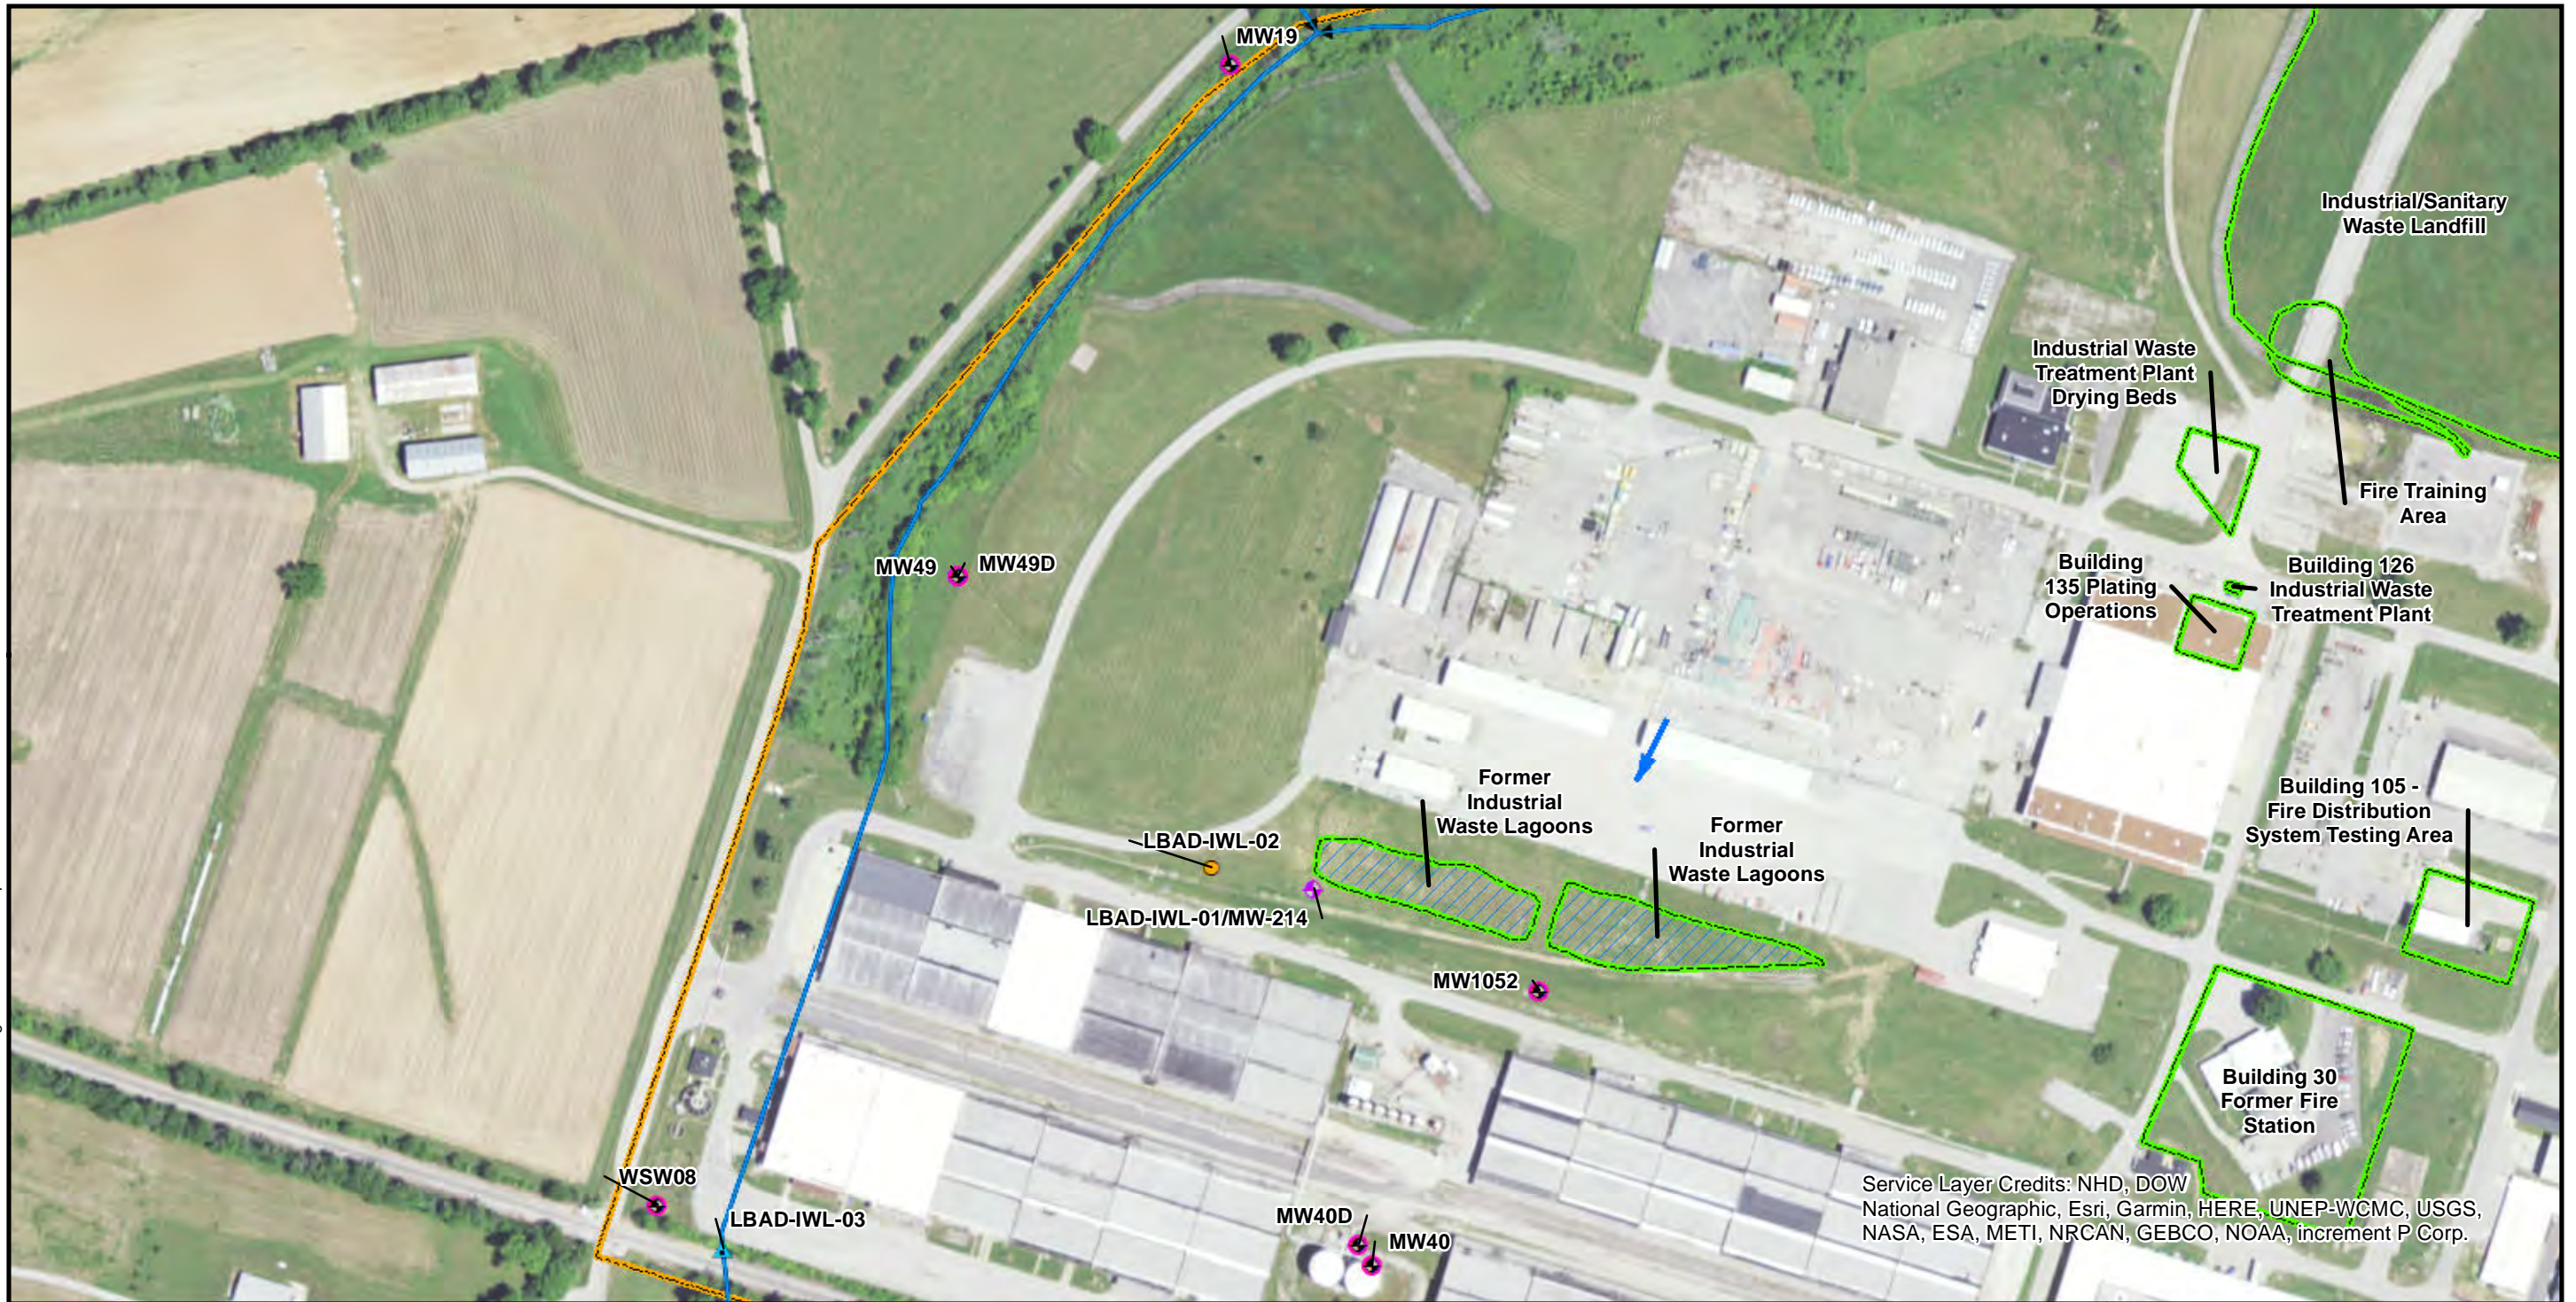
FIGURE 6-17	DATE: 10/19/2023
-------------	------------------

Soil, groundwater, surface water, and sediment samples were collected from the Industrial Waste Lagoons AOPI at the following locations (Figure 6-17):

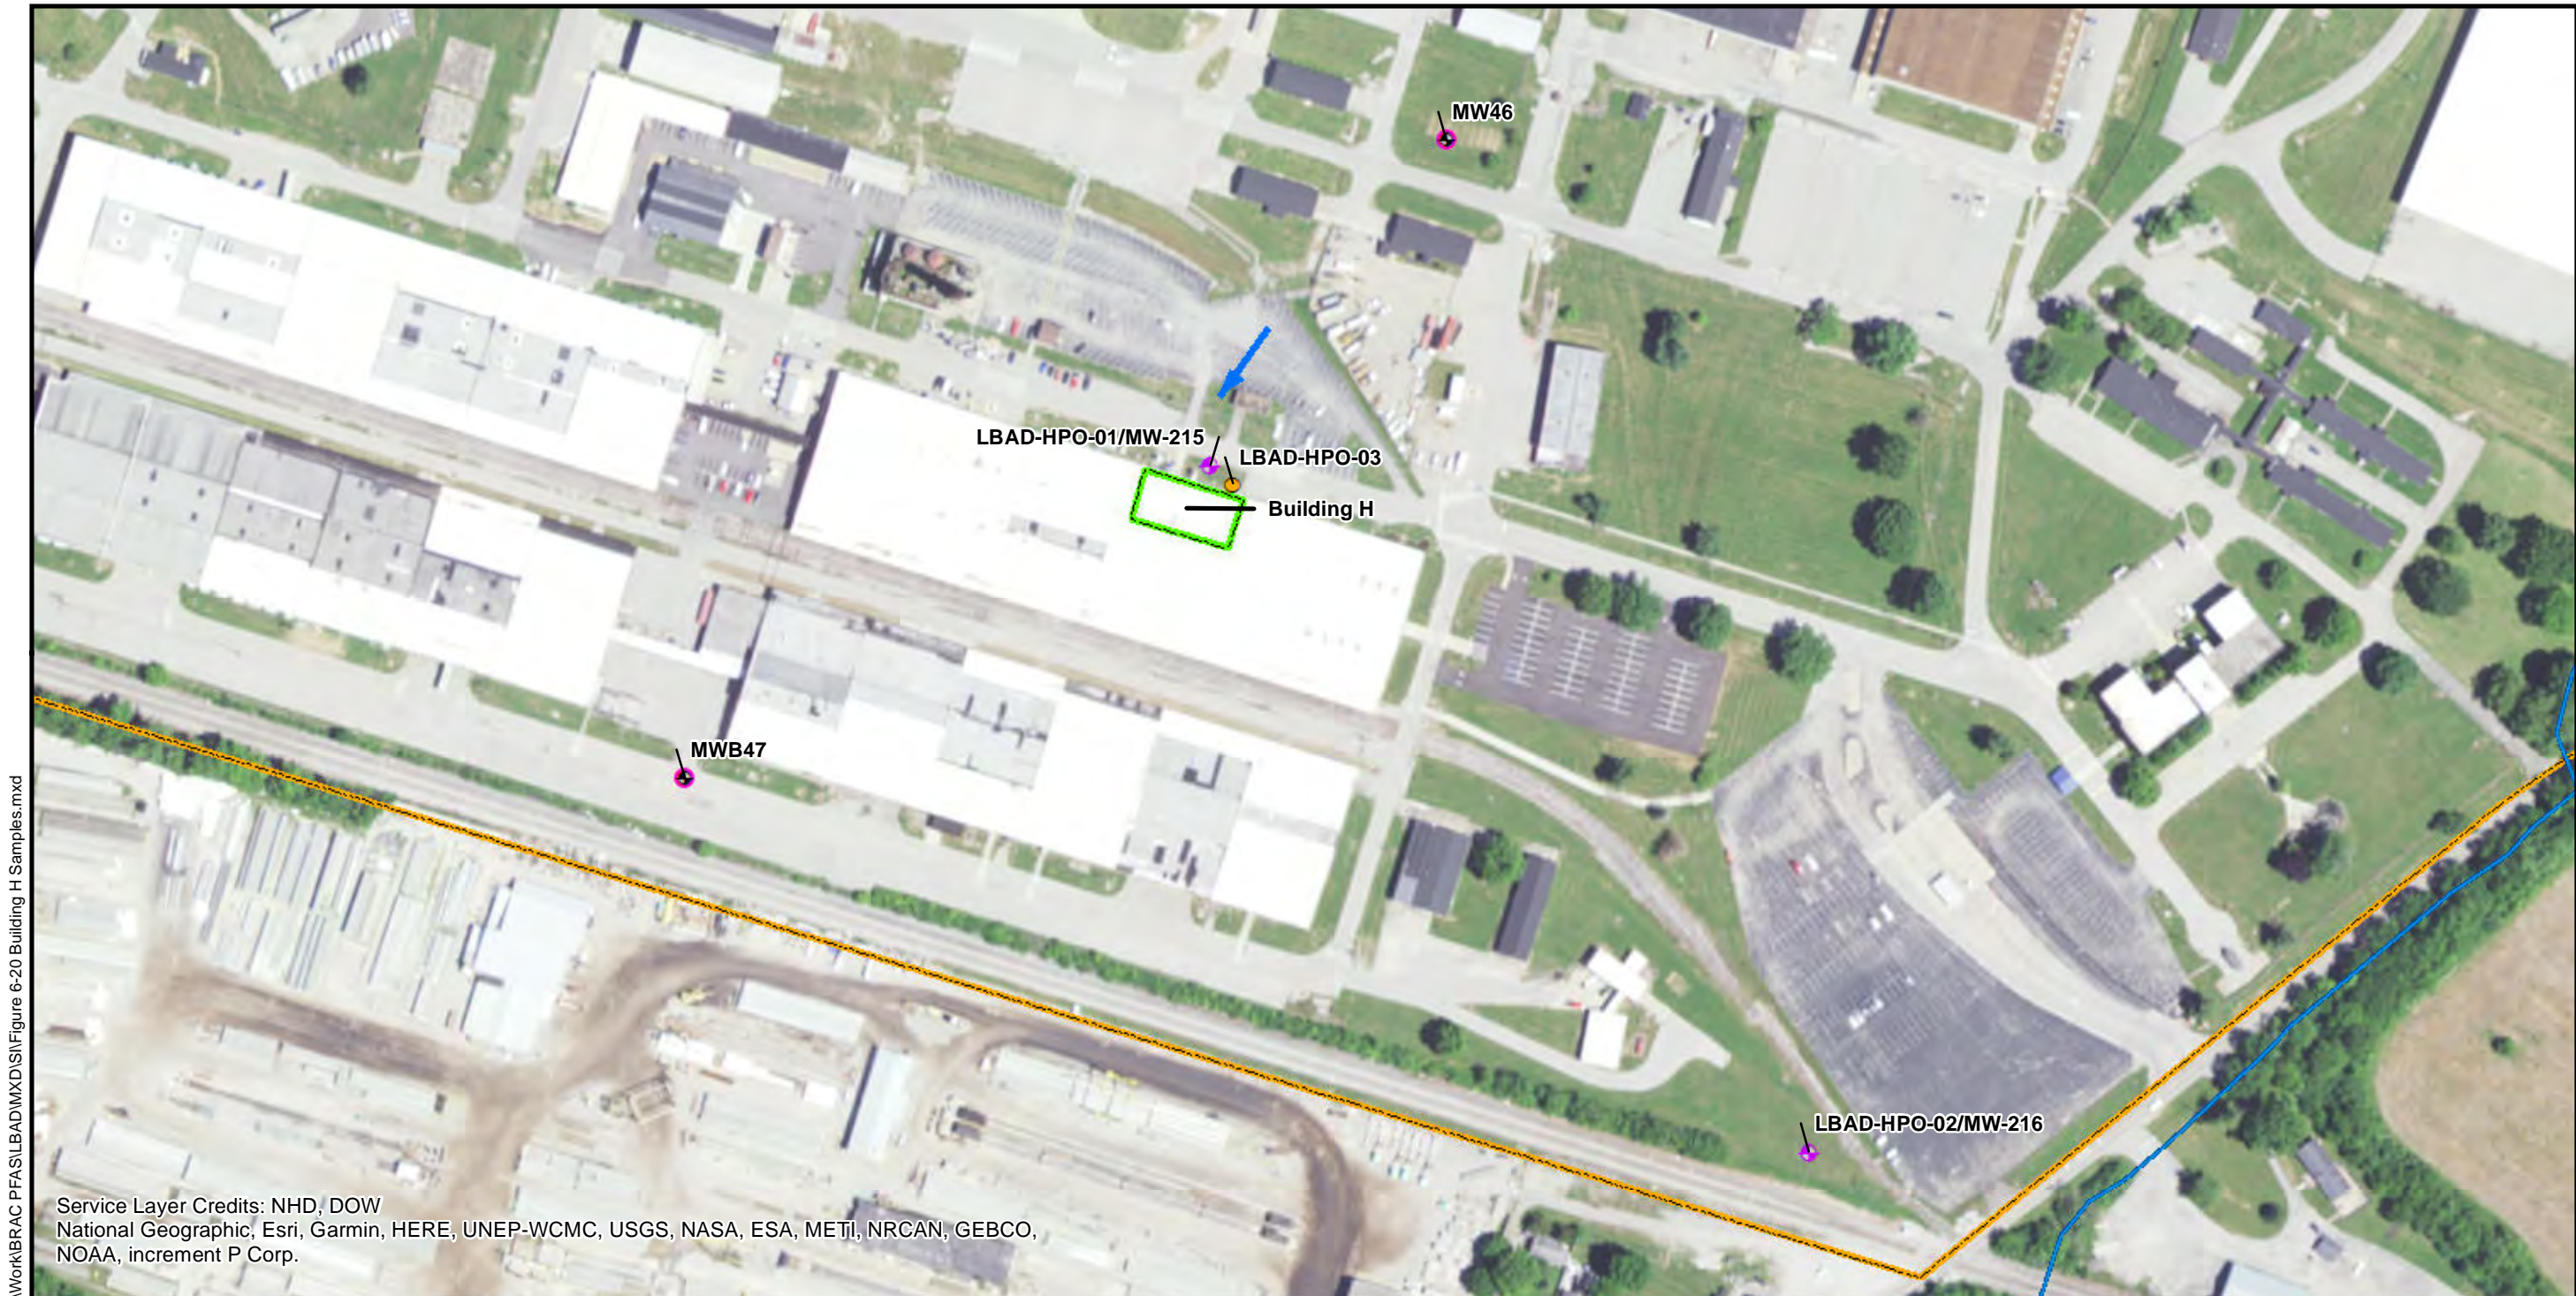
**Figure 6-19. Human Health CSM for Industrial Waste Lagoons AOPI**

Concentrations of PFOS and PFOA exceeded SLs at the LBAD boundary downstream from surface water runoff from the Industrial Waste Lagoons AOPI (LBAD-IWL-03). However, several factors support the conclusion that the concentrations of PFOA and PFOS in this surface water sample are not a result of a release at the Industrial Waste Lagoons. No concentrations of Target PFAS exceeded the SLs in soil or groundwater within or immediately adjacent to the Industrial Waste Lagoons AOPI. Sample location LBAD-IWL-03 is located at the point of discharge of most of the surface drainage from LBAD, including upstream areas, currently existing post-BRAC facilities, and potentially areas outside LBAD. Therefore, this location is considered representative of facility-wide surface water and not the Industrial Waste Lagoons AOPI. Further discussion is presented in Section 6.11. Figure 6-19 presents the CSM for the Industrial Waste Lagoons AOPI.

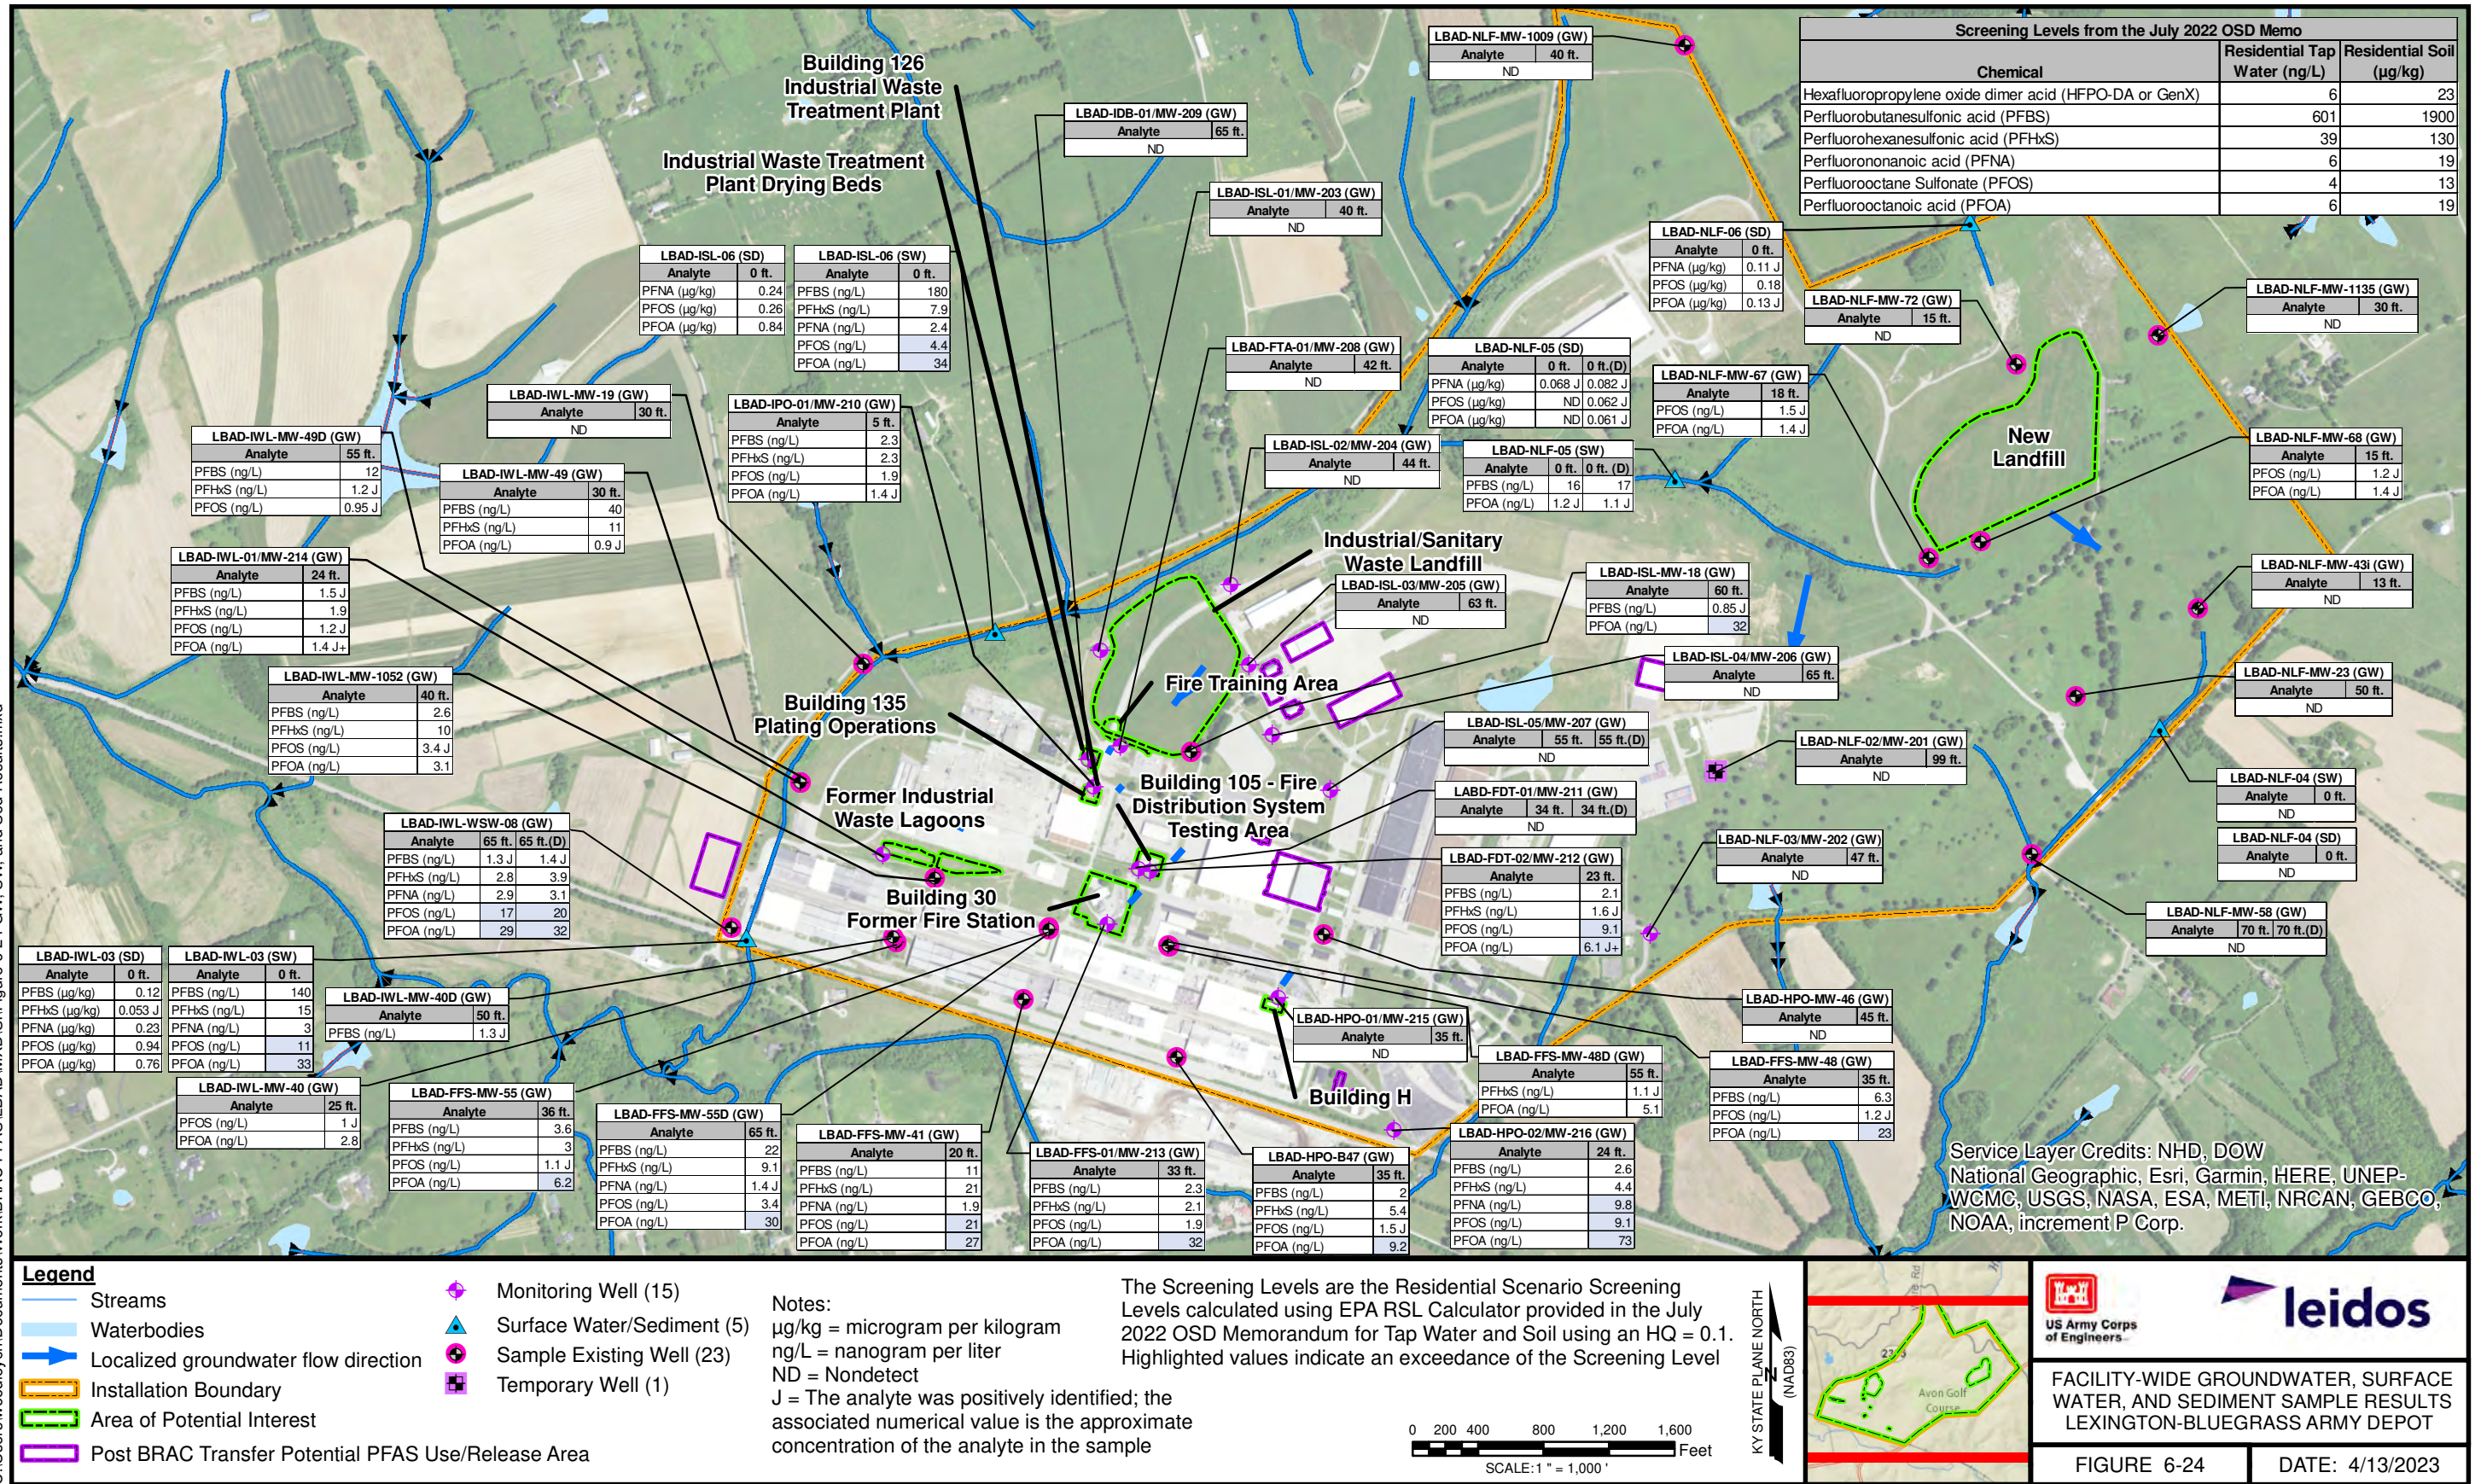
C:\Users\woodleych\Documents\Work\BRAC PFAS\LBAD\MXD\SI\Figure 6-24 GW, SW, and Sed Results.mxd

The Target PFAS analytical results for the supplementary groundwater, surface water, and sediment samples are summarized below and presented with all of the SI groundwater sample results in Table 6-10 and Figure 6-24.
