FINAL PRELIMINARY ASSESSMENT AND SITE INSPECTION OF PER- AND POLYFLUOROALKYL SUBSTANCES

Letterkenny Army Depot, Pennsylvania

August 2022

PRELIMINARY ASSESSMENT/SITE INSPECTION OF PFAS AT LETTERKENNY ARMY DEPOT,
PENNSYLVANIA

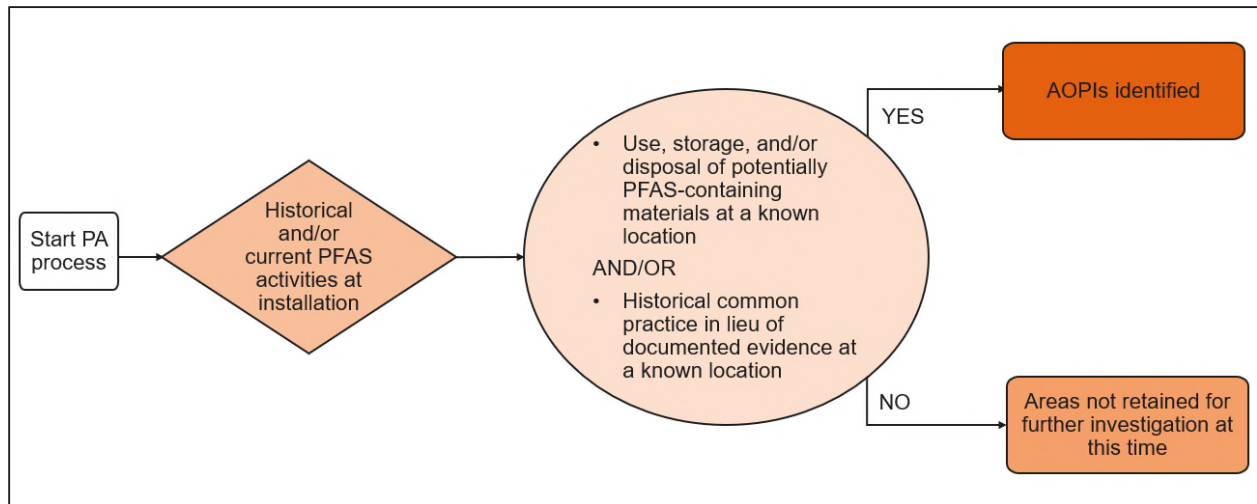
Figure 5-1: AOPI Decision Flowchart

The preliminary locations evaluated for potential use, storage, and/or disposal of PFAS-containing materials at LEAD were further refined during the PA process and identified either as an area not retained for further investigation or as an AOPI. In accordance with the established process for the PA/SI, 12 areas have been identified as AOPIs. The process used for refining these areas is presented on **Figure 5-1**, below.

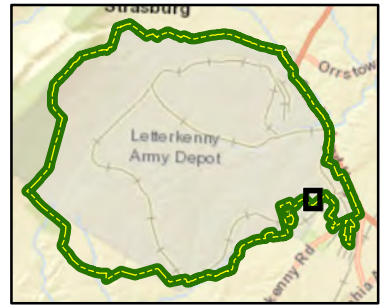
Figure 5-11
Sludge Application Area – Vehicle Test Track (VTT)
Southern Lobe (LEAD-016) AOPi

The Sludge Application Area – VTT Southern Lobe (LEAD-016) is identified as an AOPI following personnel interviews, and site reconnaissance due to the historical application of possible PFAS-containing sludges generated at the IWTP between the years of 1978 and 1983 (**Figure 5-11**). The AOPI resides within the southern lobe of the VTT, located in the Southeast Area of LEAD and Southeast OU 3B. The area surrounding the AOPI consists of grassed and paved areas used for depot storage. Review of aerial photography, topographic contours, and stormwater maps shows a series of storm water pipes that direct stormwater runoff away from the AOPI. Surface water and groundwater from this area flow northeast and discharge off post to Rowe Run, located approximately 2.0 miles northeast of the AOPI and into the Susquehanna River watershed.

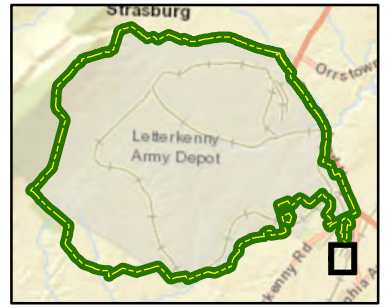
Figure 5-12
BRAC Area –
Government Vehicle Storage Area

The BRAC Area – Government Vehicle Storage Area is identified as a BRAC AOPI following records research and personnel interviews due to the use of the area as a fire station support building and parking area for government vehicles (**Figure 5-12**). The building is located at the intersection of Indiana Avenue and Opportunity Avenue in the industrial Southeast Area of LEAD and resides within a BRAC excessed portion of LEAD. A fire chief stated in an interview conducted during the PA that three government vehicles are regularly parked at this location, including one government vehicle stocked with AFFF.

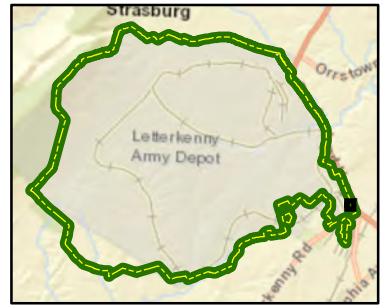
Figure 5-13
Past AFFF Storage Area AOPI

The Past AFFF Storage Area is identified as an AOPI following personnel interviews due to the use of the area as a staging ground for empty AFFF drums scheduled for off-site disposal (**Figure 5-13**). The AOPI resides within an industrial portion of the Southeast Area of LEAD, within Southeast OU 11. The area surrounding the AOPI is highly developed and consists of industrial buildings and grass lawns. The AOPI is located directly southeast of the Former Buildings 361 and 362 – IWTP and Former Sludge Holding

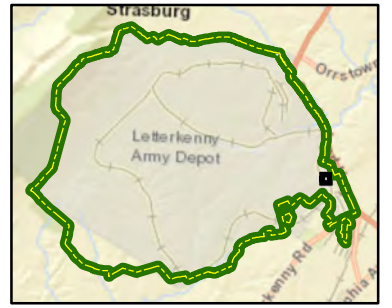
Figure 5-14
Low Temperature Thermal Volatilization
(LTTV) Site AOPI

The Low Temperature Thermal Volatilization (LTTV) Site is identified as an AOPI following records research and personnel interviews due to use of the area for LTTV treatment on soil excavated from the Former Lagoons 361 and 362 suspected to have PFAS-containing materials (**Figure 5-14**). The AOPI is located at the intersection of East Patrol Road and North Patrol Road in the Southeast Area of LEAD, due west of the Former Area B Fire Training Area (LEAD-009). The site is comprised of pavement and loose gravel. The northern portion of the site is currently being used for depot storage. Mounds of dirt and other stock-piled material are visible in aerial photography in the southeastern portion of the site. The surrounding environment consists of weathered roads, grassed and treed areas over rolling karst terrain. Based on review of aerial photography, topographic contours, and existing stormwater maps, there are no surface water bodies or stormwater management systems within the vicinity of this AOPI. Surface water and groundwater flow northeast and off post through the northeastern boundary of LEAD before discharging to Rowe Spring, located approximately 1.43 miles northeast of this AOPI.

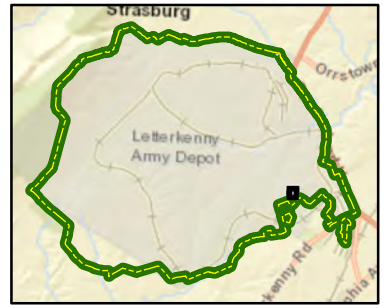
Figure 7-4
Former Concrete Lined
Fire Training Area (LEAD-063) AOPI
PFOS, PFOA, and PFBS Analytical Results

One groundwater sample was collected from existing monitoring well 17-PDO-3, which is located down gradient (in relation to groundwater flow) of the area where AFFF was suspected to be used at the Former Concrete Lined Fire Training Area (LEAD-063) (LEAD-17-PDO-3; **Figure 7-4**). The groundwater sample was collected from the middle of the open hole at approximately 45 feet bgs. A summary of PFOS, PFOA, and PFBS groundwater analytical results is provided in **Table 7-1**.

Soil samples were collected via hand auger from two locations where AFFF was suspected to flow off the concrete pad at the Former Concrete Lined Fire Training Area (LEAD-063) [LEAD-Concrete-FTA-1-SO-(0-2) and LEAD-Concrete-FTA-2-SO-(0-2); **Figure 7-4**]. The soil locations were collected from the native soil directly outside the boundaries of the excavated FTA. Each boring included one surface soil sample from 0 to 2 feet bgs. A summary of PFOS, PFOA, and PFBS soil analytical results is provided in **Table 7-2**.

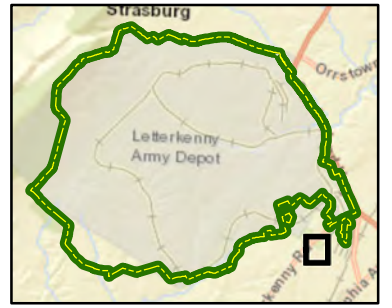
Figure 7-6
Current Fire Department Station AOP
PFOS, PFOA, and PFBS Analytical Results

Two groundwater samples were collected from temporary wells via sonic drilling (**Figure 7-6**). LEAD-B521-GW-01 was installed on the downgradient (eastern) side of the Current Fire Department Station, associated with a release of PFAS-containing materials (AFFF) to the ground surface at the station. LEAD-B521-GW-02 was installed at the Current Fire Department Station's stormwater outlet pond downgradient of the station (south-southeast). The temporary well samples were collected mid-screen, which was approximately 23 feet bgs and 18 feet bgs, respectively. One existing monitoring well was sampled, which was cross-gradient to the inferred groundwater flow direction (LEAD-93-SE-04; **Figure 7-6**). The groundwater sample was collected from the middle of the inferred screen interval, which was

Soil samples were collected via hand auger from four locations along the fire station driveway and stormwater inlet locations along the driveway, due to surface gradient and flow direction, at the Current Fire Department Station [LEAD-B521-1-SO-(0-2), LEAD-B521-2-SO-(0-2), LEAD-B521-3-SO-(0-2), and LEAD-B521-4-SO-(0-2); **Figure 7-6**]. Each boring included one surface soil sample from 0 to 2 feet bgs. A summary of PFOS, PFOA, and PFBS soil analytical results is provided in **Table 7-2**.

One surface water sample, co-located with a sediment sample, was collected at the stormwater outfall southeast of the Current Fire Department Station, where AFFF was suspected to drain (LEAD-B521-1-SW; **Figure 7-6**). This sample was collected from the storm water outfall southeast of the building. A summary of PFOS, PFOA, and PFBS surface water analytical results is provided in **Table 7-3**.

One sediment sample, co-located with a surface water sample, was collected at the stormwater outfall southeast of the Current Fire Department Station, where AFFF was suspected to drain (LEAD-B521-1-SE; **Figure 7-6**). This sample was collected from the storm water outfall southeast of the building. A summary of PFOS, PFOA, and PFBS sediment analytical results is provided in **Table 7-4**.
