PRELIMINARY ASSESSMENT REPORT

OF PFAS

LONE STAR ARMY AMMUNITION

PLANT, TEXAS

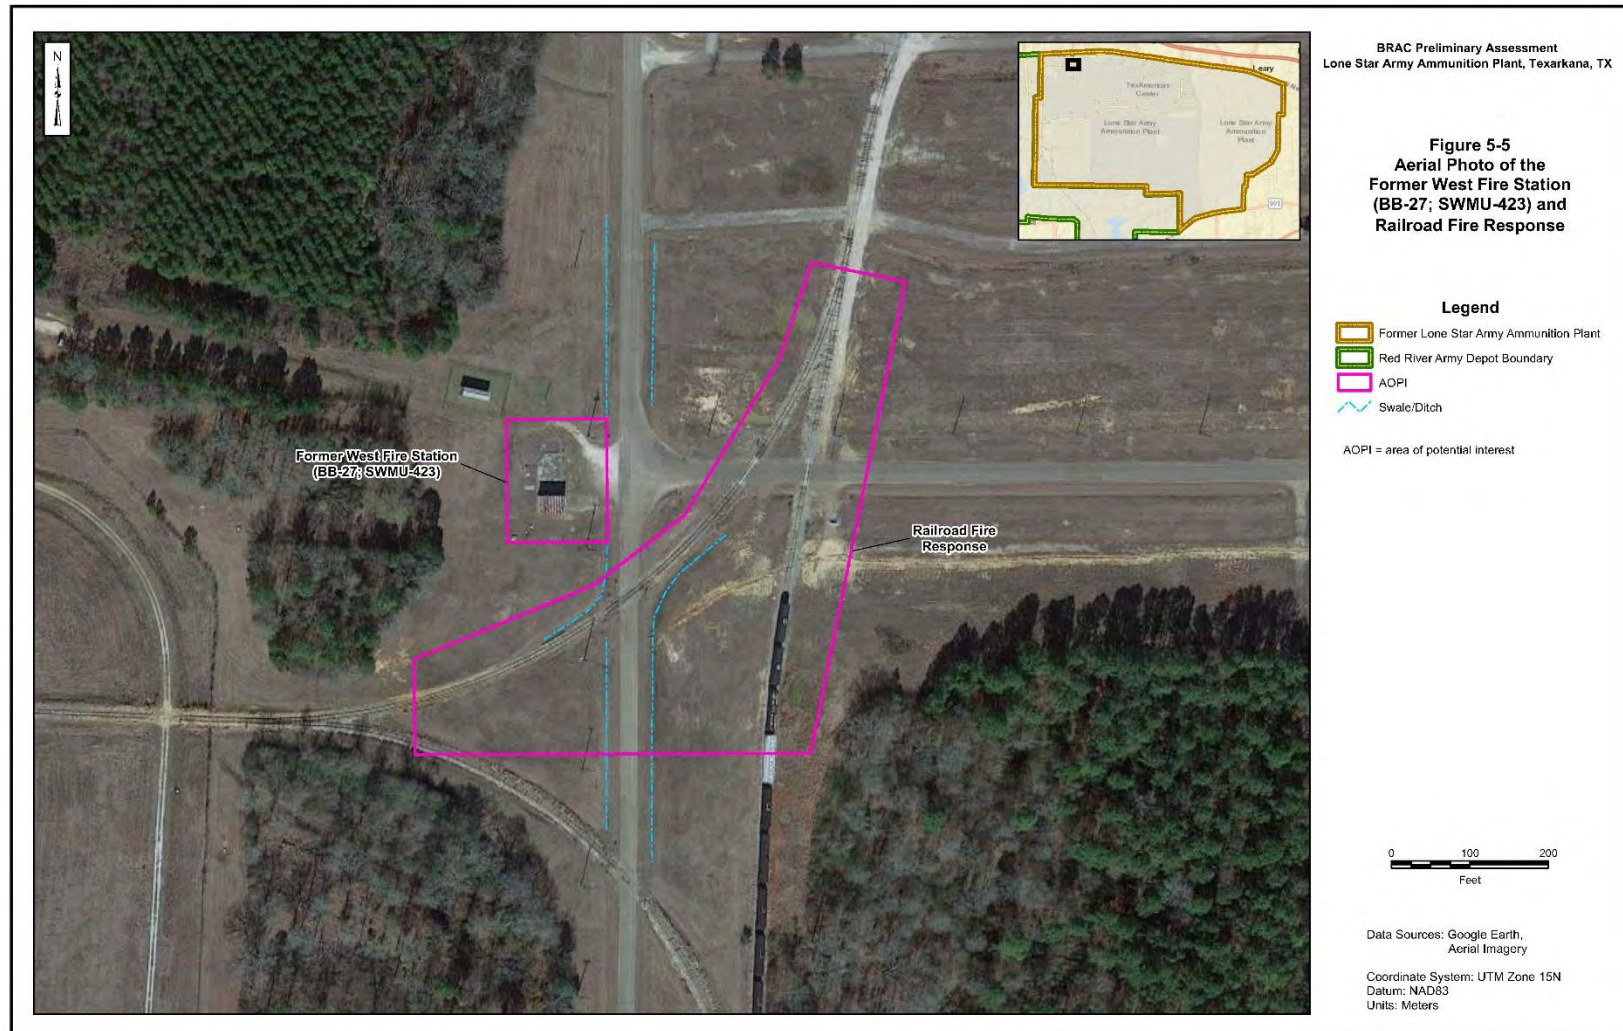
Figure 5-5: Aerial Photo of the Former West Fire Station (Building BB-27; SWMU-423) & Railroad Fire Response

An aerial photograph of the Former West Fire Station is provided on **Figure 5-5**. The Former West Fire Station is located in Area BB with grassy areas to the north, west, and south. Runoff would likely flow east toward a swale running parallel to the street. The street runs from north to south.

An aerial photograph of the Railroad Fire Response is provided on **Figure 5-5**. The area is vegetated and has gravel dispersed through the area. Runoff would flow north towards a swale that is parallel to the street, running west and east.

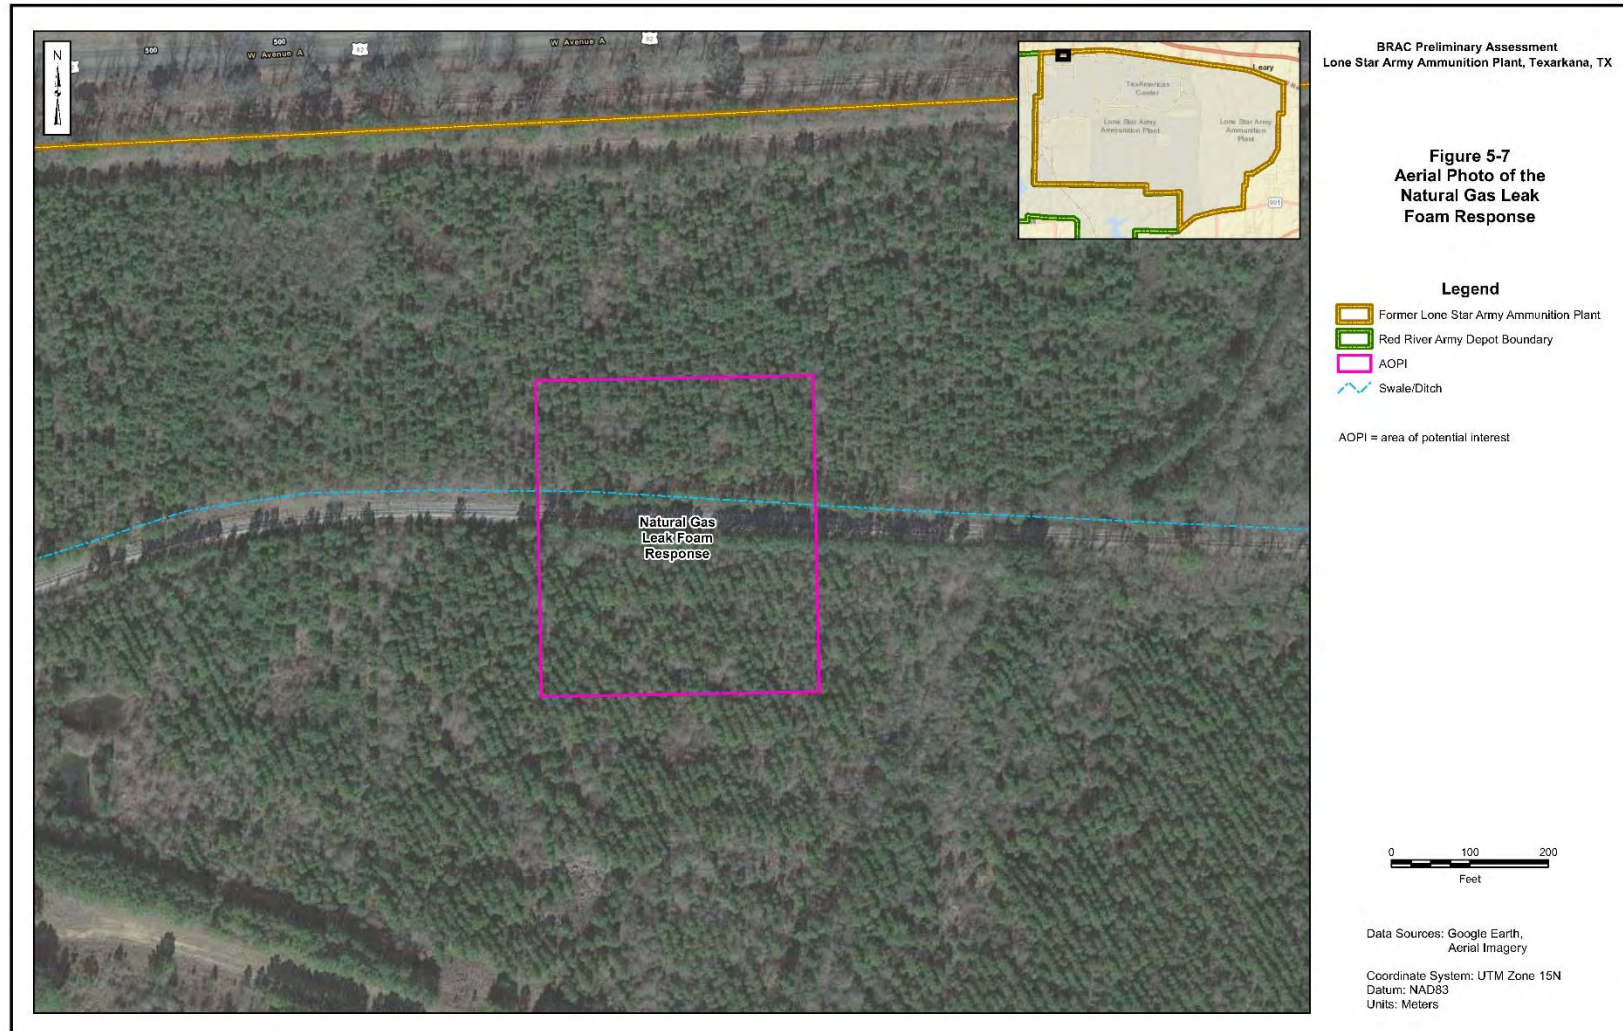
Figure 5-7: Aerial Photo of the Natural Gas Leak Foam Response

The Natural Gas Leak Foam Response Area (located north of Area A) is identified as an AOPI following interviews because it was reported that AFFF was deployed here in response to a natural gas leak within the 2008/2009 timeframe. The exact location of this response and the volume of AFFF deployed was not known, but it is believed to have been near the roadway, where the utilities lines are located.

have been near the roadway, where utilities run. The general location of the natural gas leak is shown in *Figure 5-7*.
