FINAL PRELIMINARY ASSESSMENT AND SITE INSPECTION OF PER- AND POLYFLUOROALKYL SUBSTANCES

Camp Frank D. Merrill, Georgia

June 2022

Catherine Coffey
Site Inspection Project Manager, Arcadis U.S., Inc.

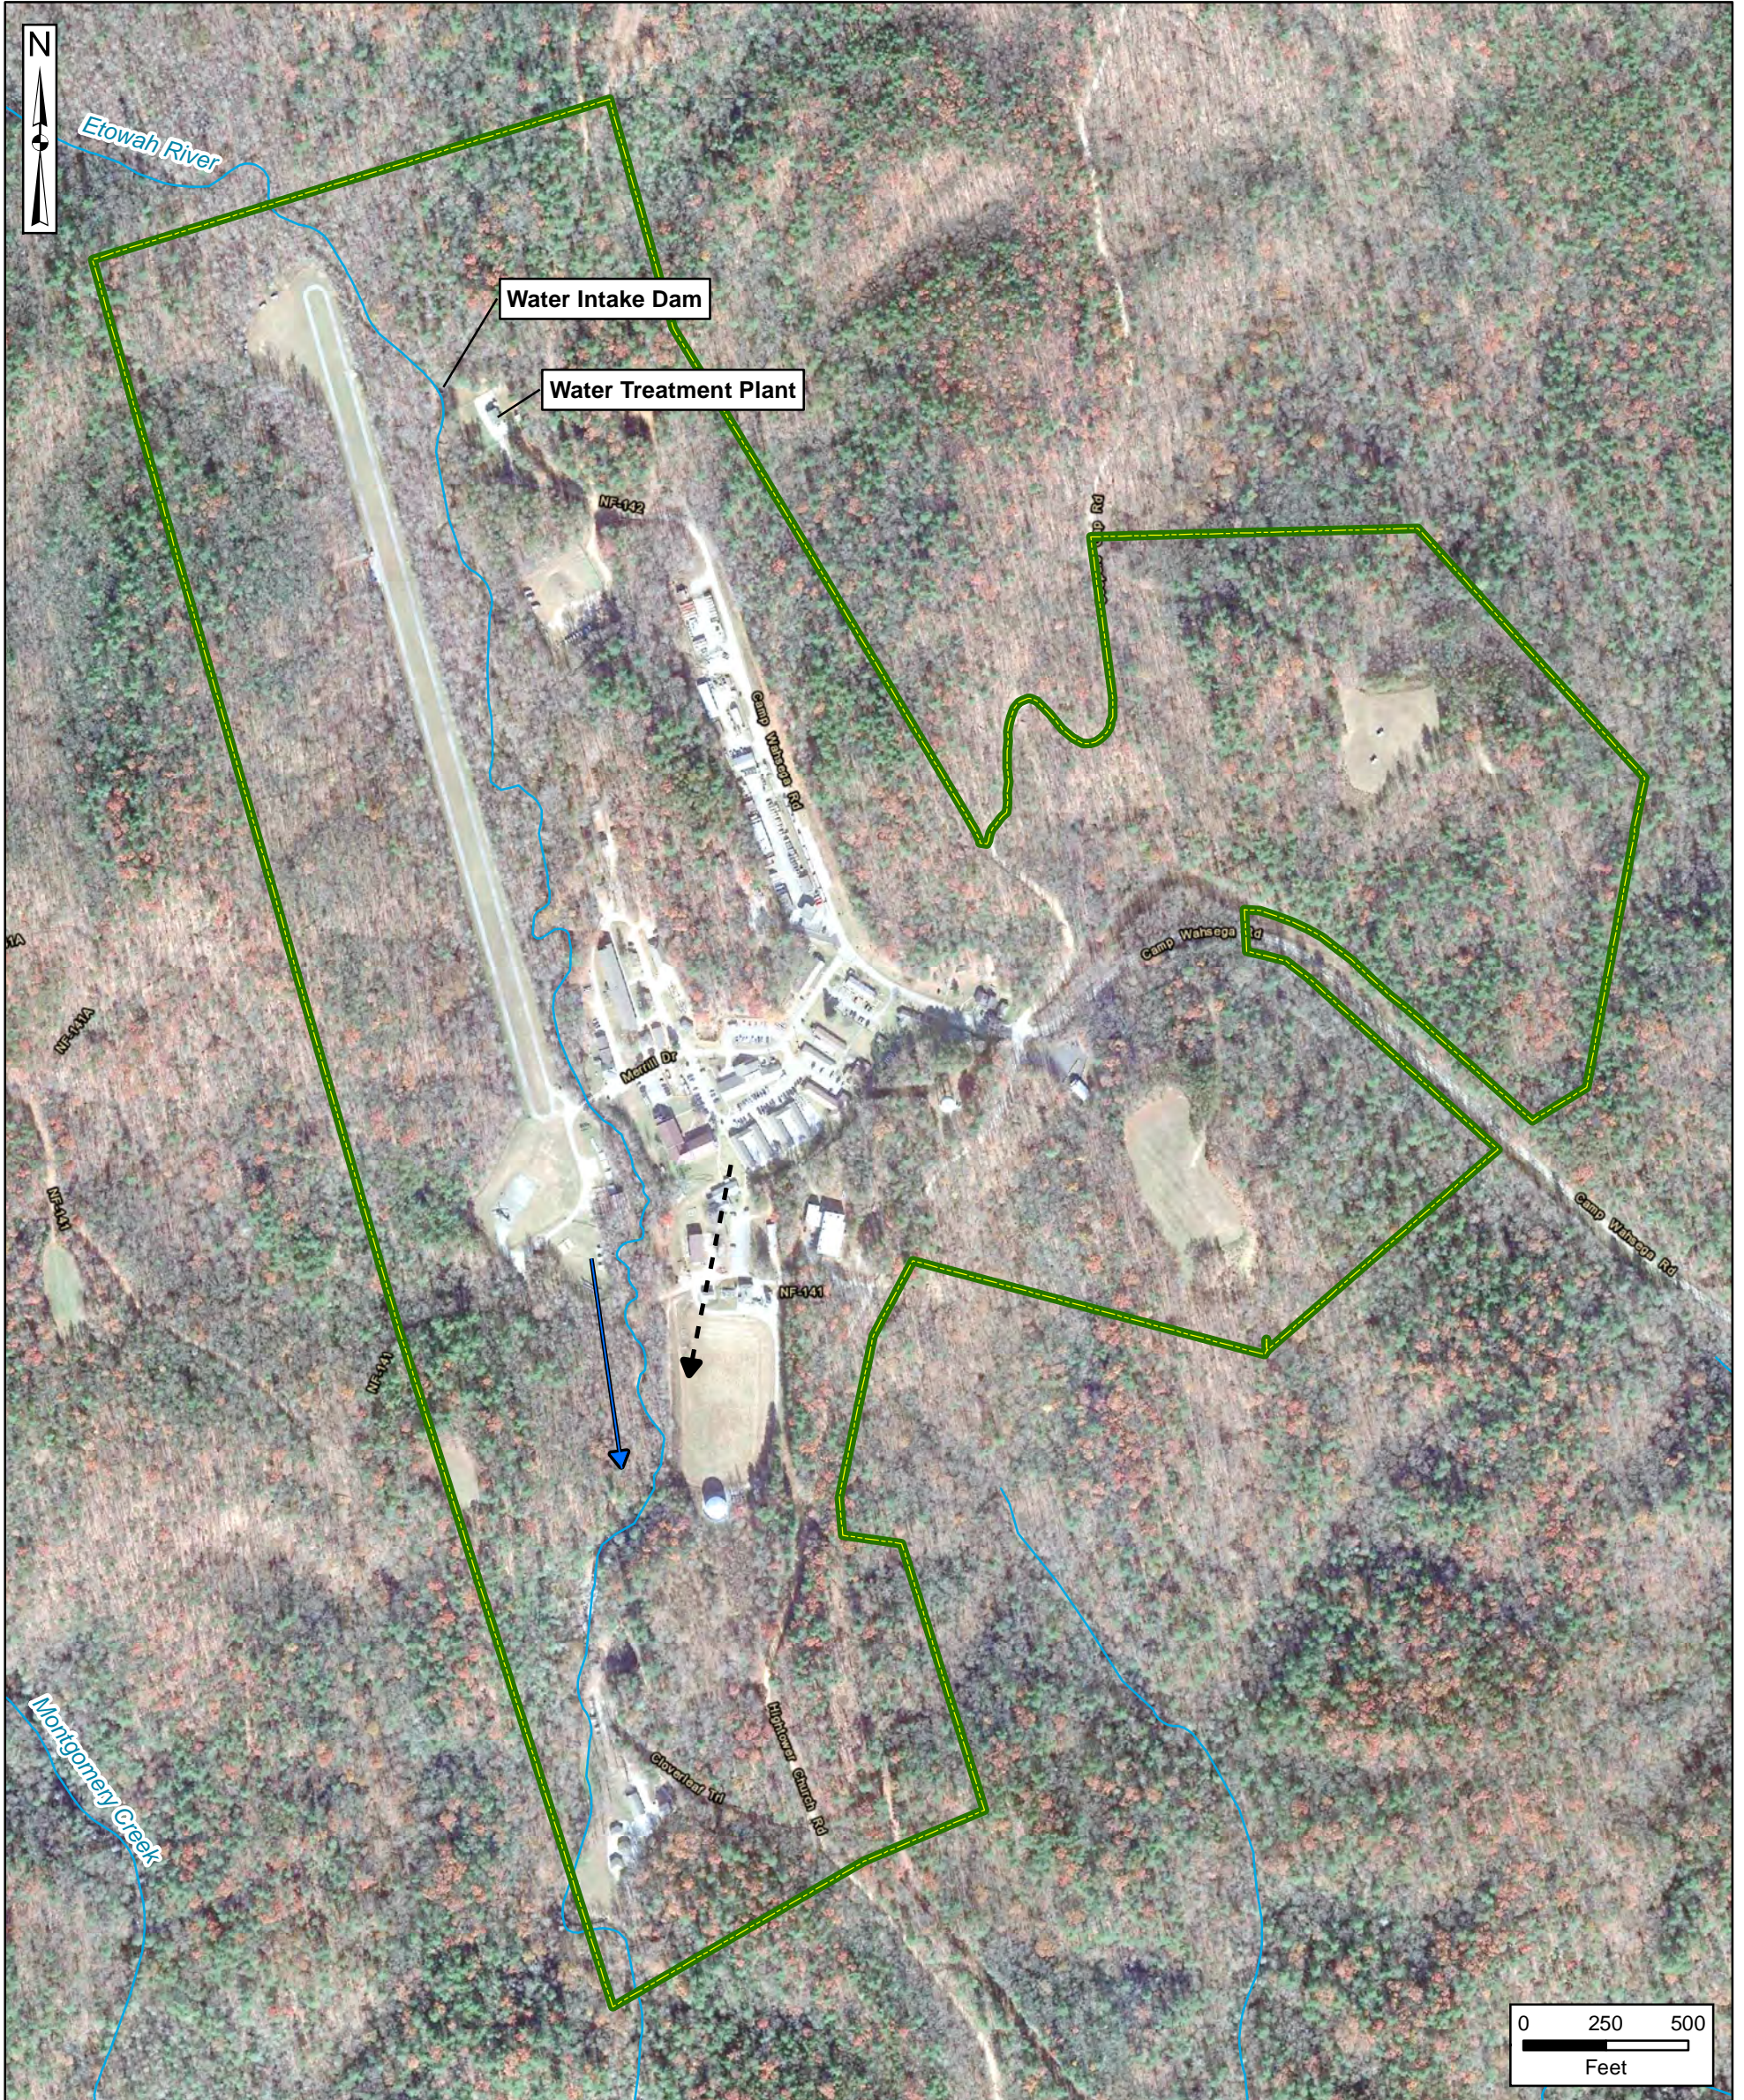
**Figure 2-3
Topographic Map**

* Based on analysis of topographic and elevation/contour maps, general groundwater and surface water flow appears to be directed south, although the area in close proximity to the Etowah River likely drains into this river before moving southward.

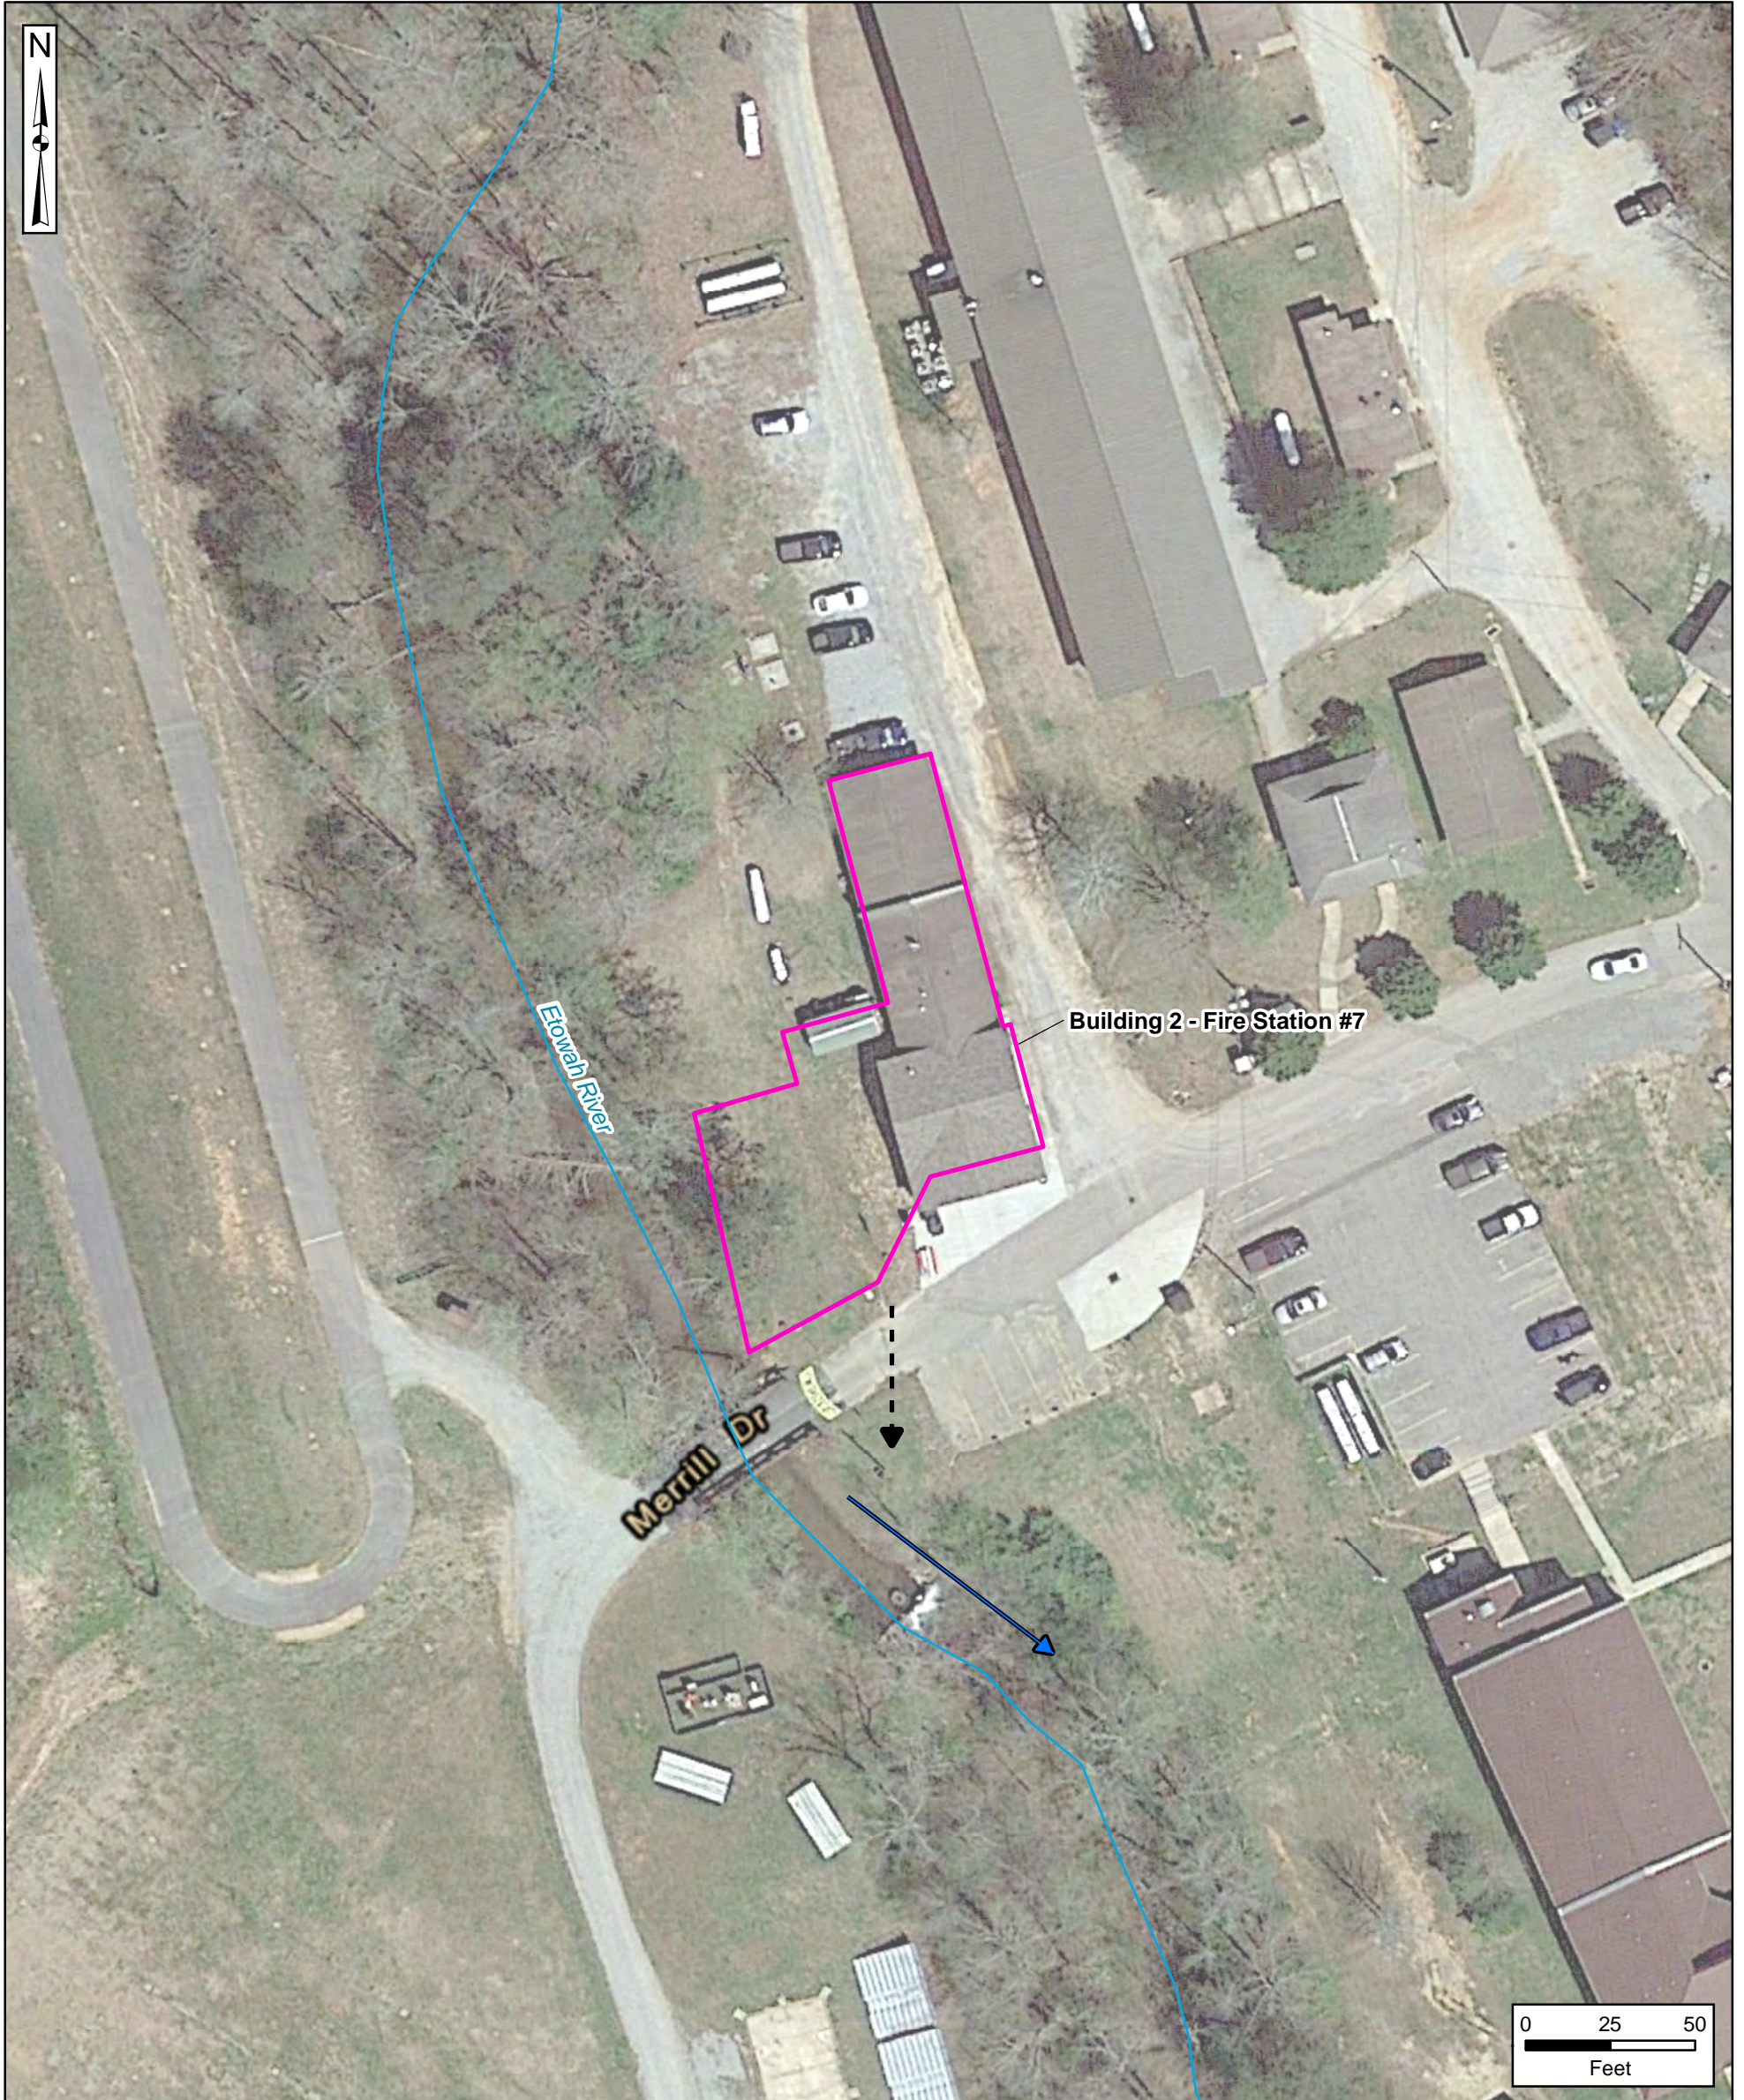
Figure 5-3
Aerial Photo of Building 2 - Fire Station #7 AOPI

* Based on analysis of topographic and elevation/contour maps, general groundwater flow appears to be directed south, although the area in close proximity to the Etowah River probably drains into this river before moving southward.

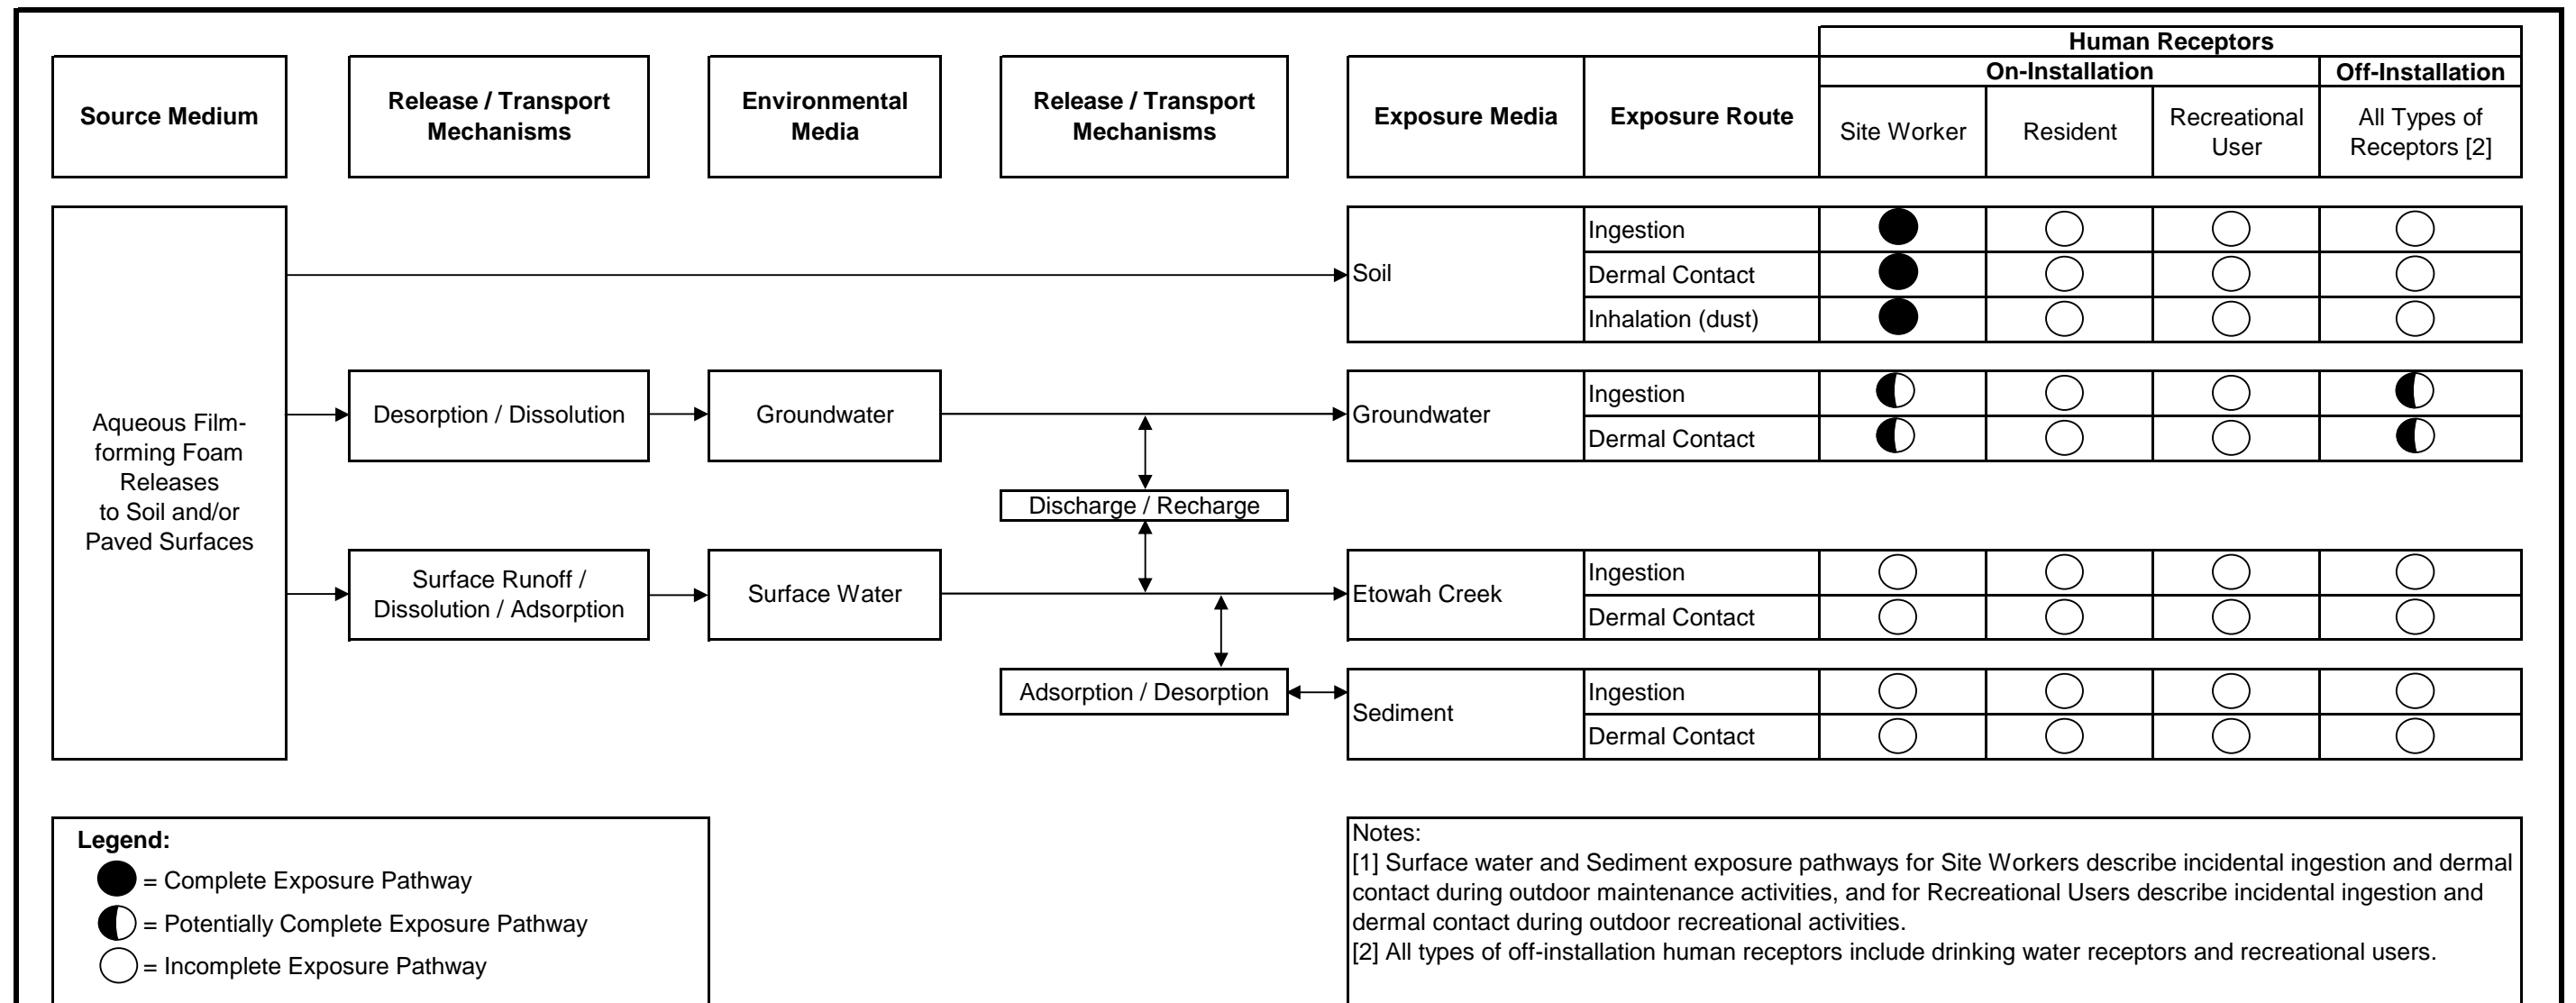
Figure 7-4

Conceptual Site Model for Building 2 - Fire Station #7 AOPI
 USAEC PFAS Preliminary Assessment / Site Inspection
 Camp Merrill, Georgia

Human exposure pathways are shown as “complete”, “potentially complete”, or “incomplete” on the CSM figures. A complete exposure pathway consists of a constituent source and release mechanism, a transport or retention medium, an exposure point where human contact with the contaminated medium could occur, and an exposure route at the exposure point. If any of these elements is missing, the exposure pathway is incomplete. Pathways are “potentially complete” where data are insufficient to conclude the pathway is either “complete” or “incomplete”. Additionally, the CSMs do not include ecological receptors and exposure pathways. The potential for ecological exposures to PFOS, PFOA, and PFBS may be evaluated at a future date if those pathways warrant further consideration.
