FINAL PRELIMINARY ASSESSMENT AND SITE INSPECTION OF PER- AND POLYFLUOROALKYL SUBSTANCES

Milan Army Ammunition Plant, Tennessee

December 2021

Arcadis U.S., Inc.

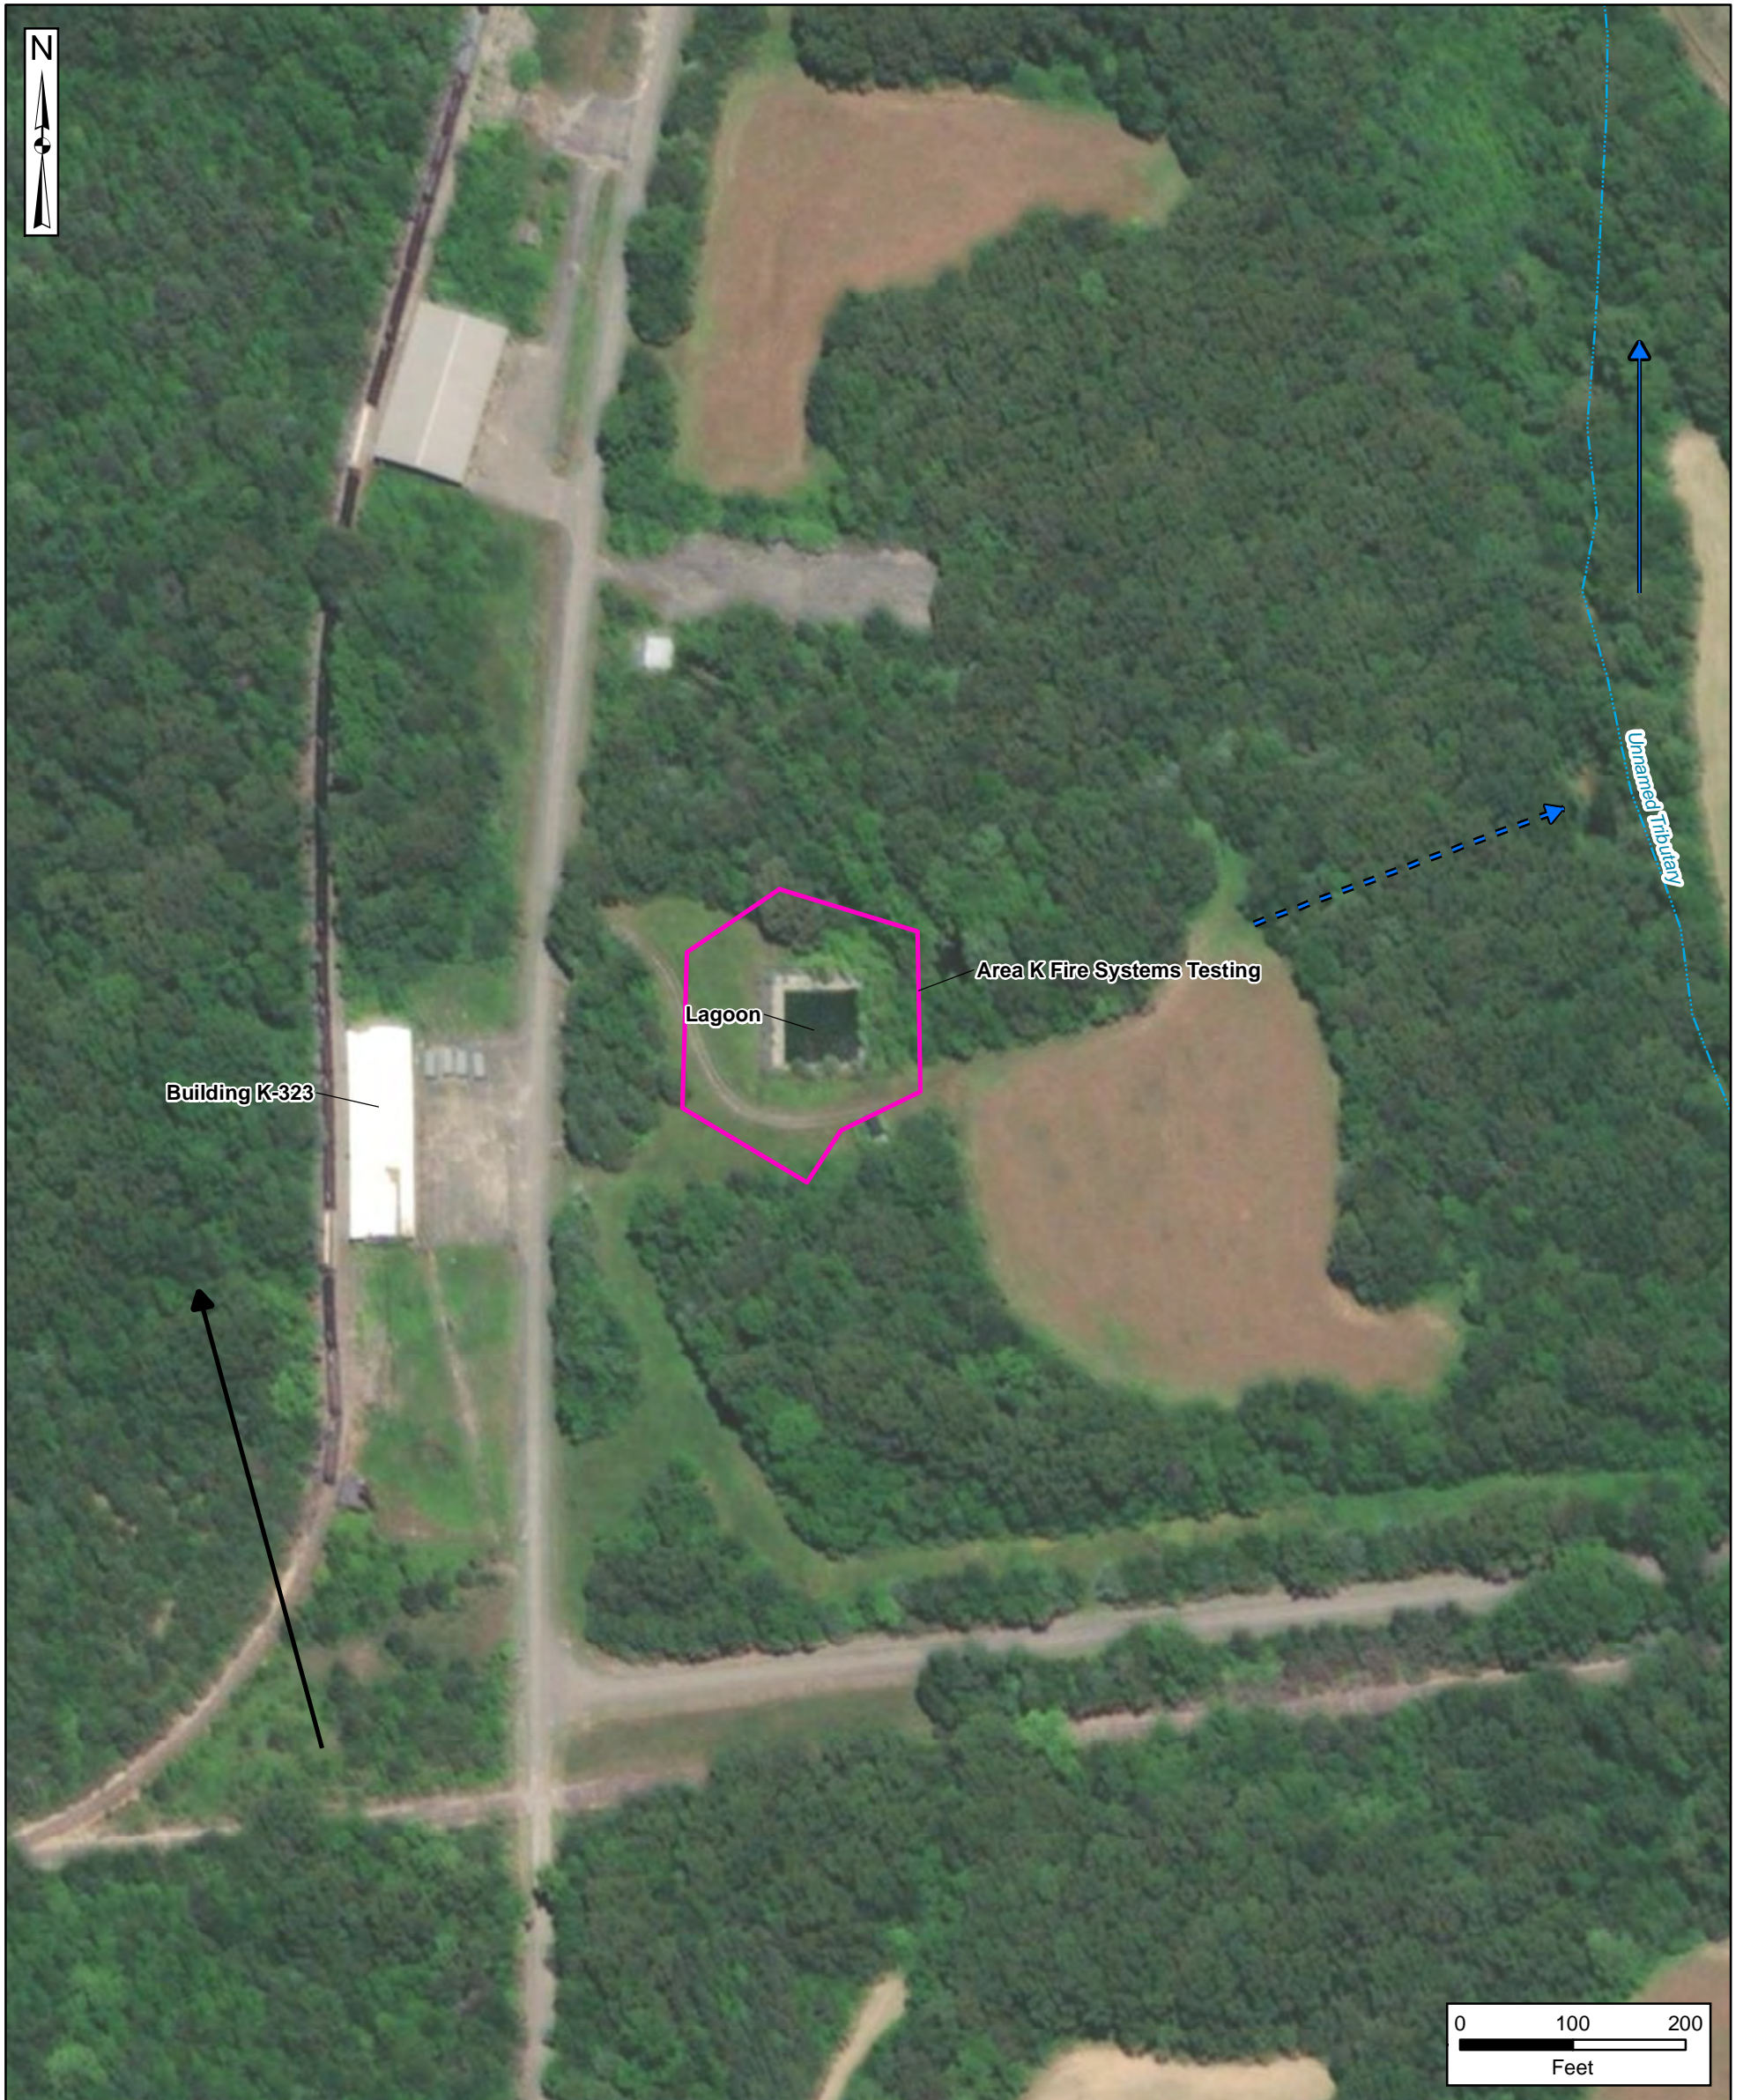
Figure 5-4
Aerial Photo of
Area K Fire Systems Testing

The Area K Fire Systems Testing (**Figure 5-4**) is identified as an AOPI following records research, personnel interviews, and site reconnaissance due to AFFF use. At least one reported AFFF training exercise occurred around 1980, when a first-hand witness reported that the fire truck pulled onto a road north of the lagoon east of Building K-323 and used water pumped from the lagoon to spray AFFF onto the adjacent ground surface.

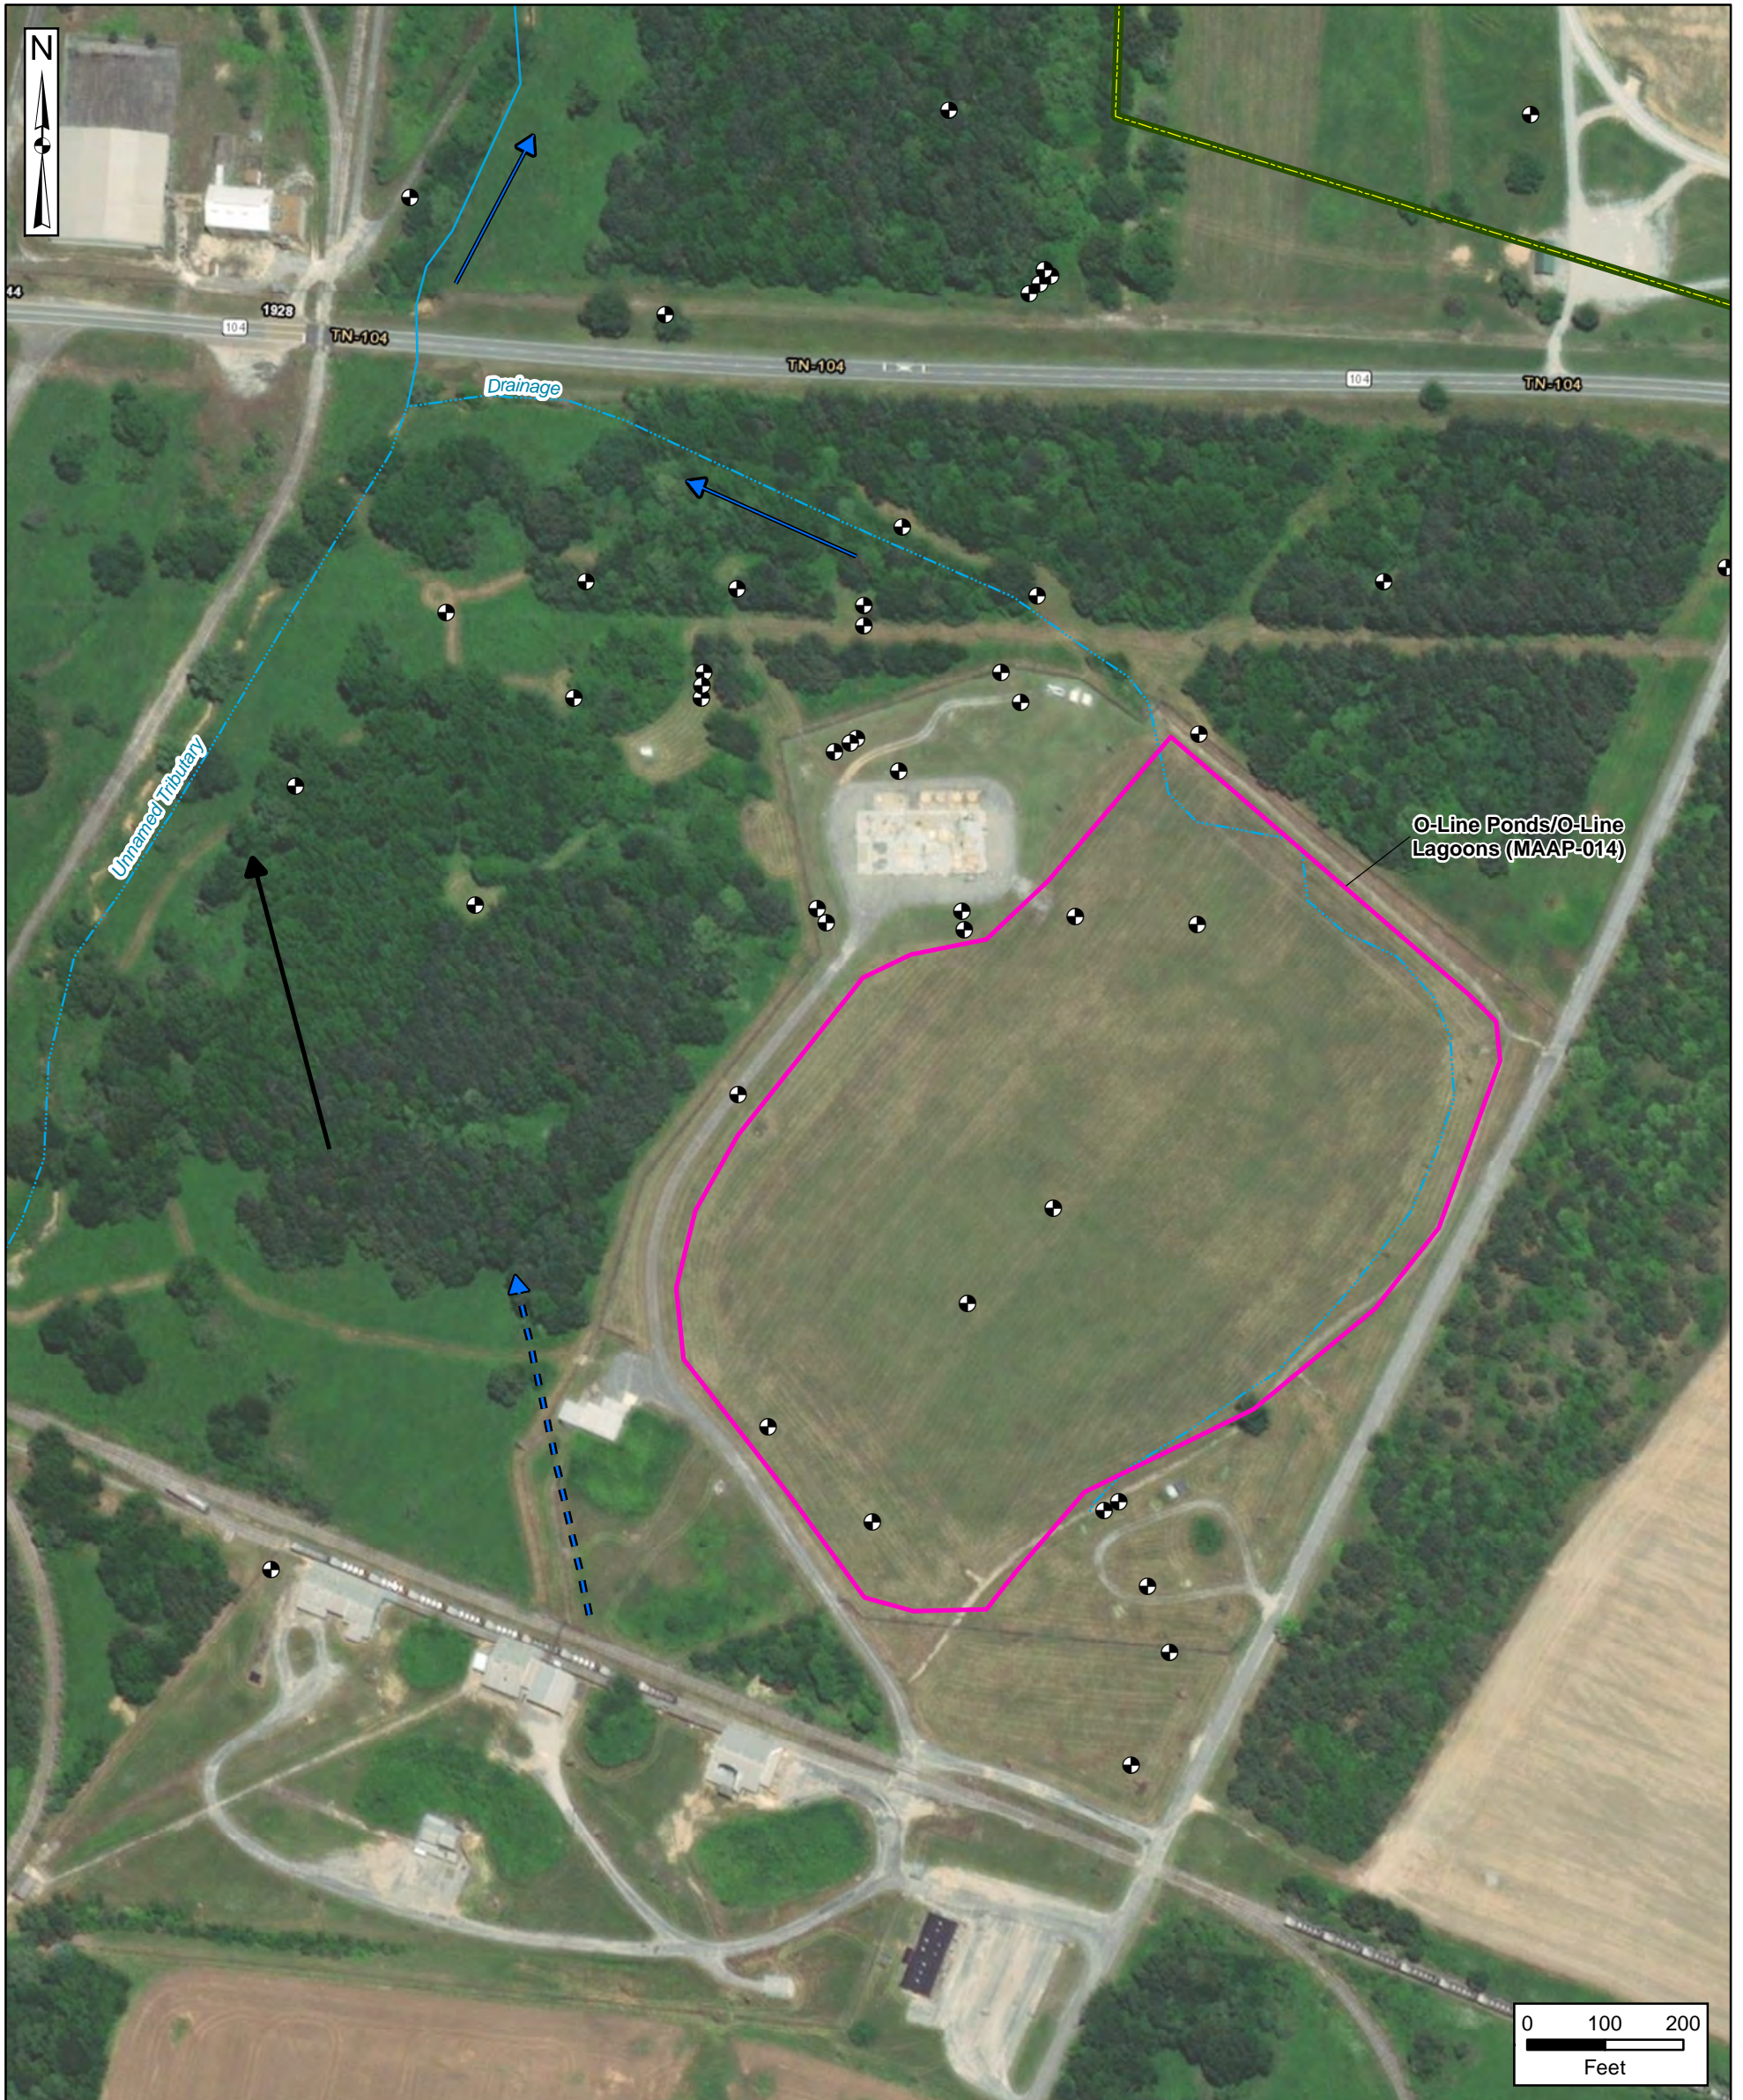
Figure 5-6
Aerial Photo of
O-Line Ponds/O-Line Lagoons

The O-Line Ponds/O-Line Lagoons (**Figure 5-6**) is identified as an AOPI following records research, personnel interviews, and site reconnaissance due to contact of wastewater with potentially Teflon®-containing process machinery. This former wastewater treatment area of unlined ponds received water from the O-Line washout facility from 1941 to 1984. It is likely that machinery in the washout operation contained Teflon® parts. Effluent from the last pond flowed through sawdust-filled tanks then discharged to the surrounding ditch. The sawdust and collected solids were burned at the Open Burning Ground (**Section 5.2.6**). In 1984, the facility was closed and capped.

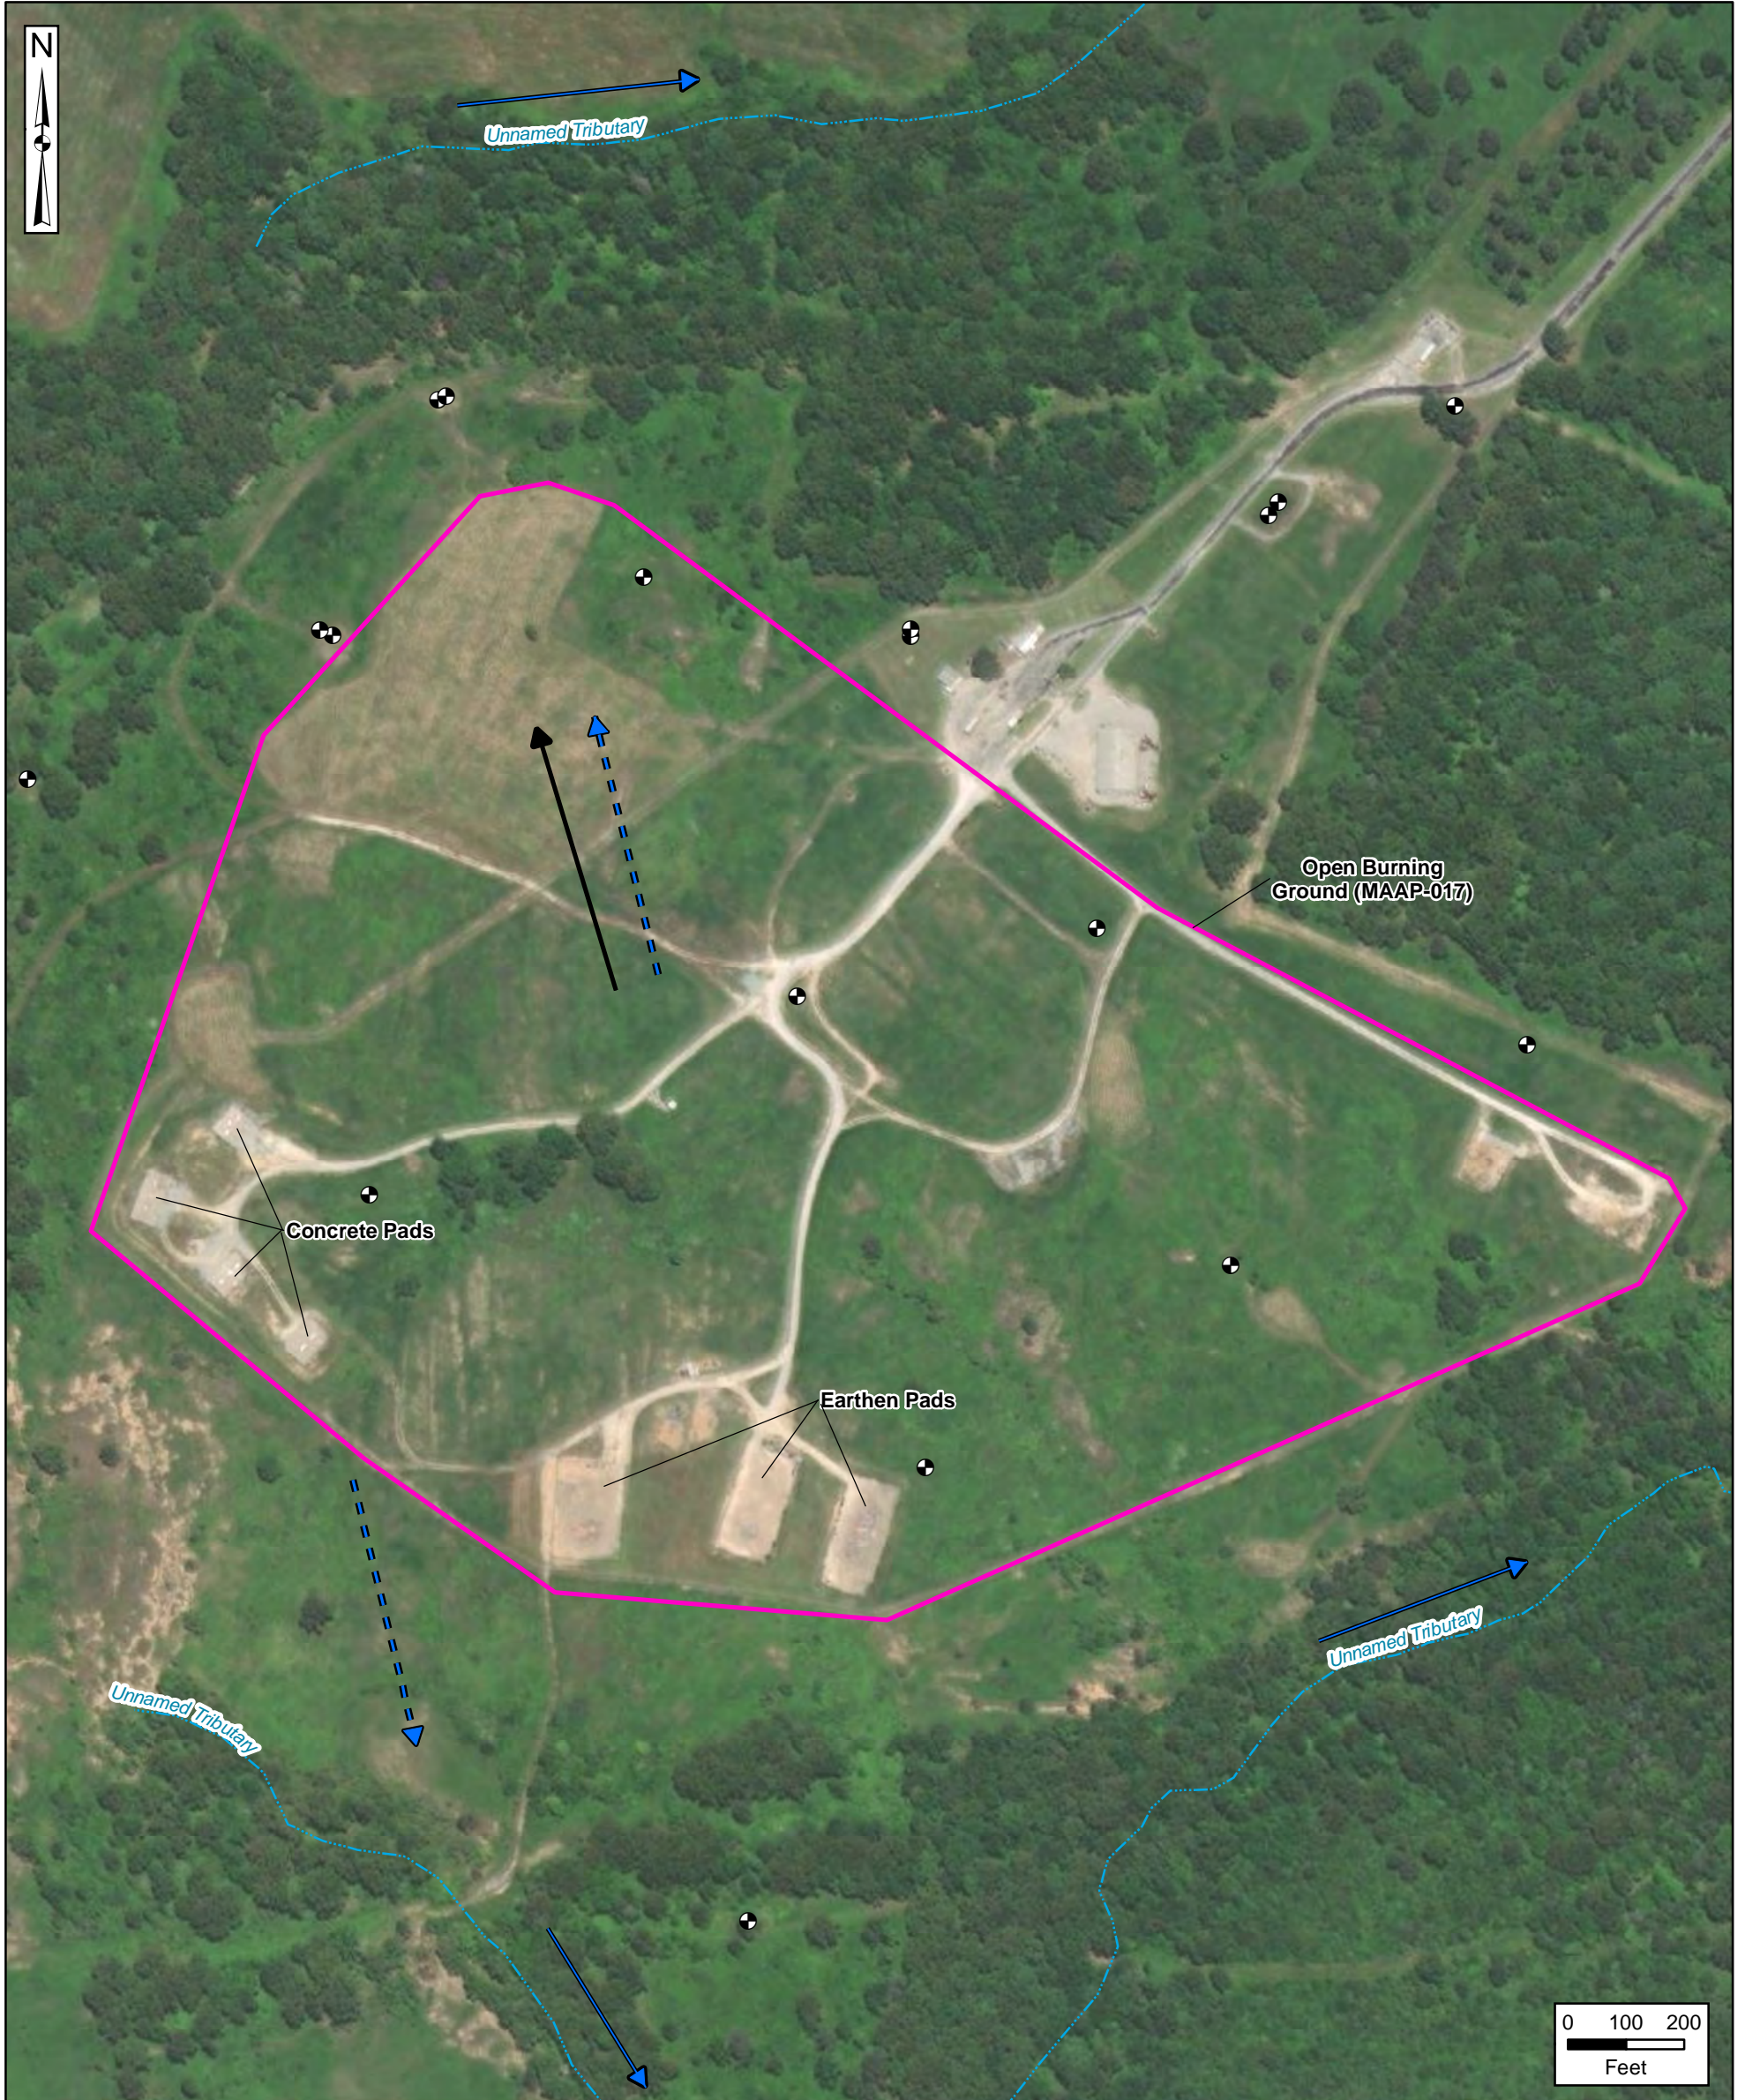
Figure 5-7
Aerial Photo of
Open Burning Ground

The Open Burning Ground (**Figure 5-7**) is identified as an AOPI following records research, personnel interviews, and site reconnaissance due to burning of potential PFOA-containing waste (Teflon®-containing flares and O-Line Ponds/O-Line Lagoons waste as described in **Section 5.2.4**). From 2004 to 2014, a total of 253,352 pounds of flares containing Teflon® powder were burned at the Open Burning Ground in flash pans on concrete pads. Ash was swept into 35-gallon drums and disposed of at the

Active Industrial Landfill (**Section 5.2.7**). Additionally, parts containing Teflon®, such as gaskets and spacers, may have been burned on the ground surface prior to the construction of the concrete pads. The specific quantities of parts burned, burn locations, and dates the parts may have been burned are unknown. These concrete and earthen pads are located less than 0.5 mile downgradient away from unnamed tributaries. PFOA from these areas may have been carried via stormwater runoff to an unnamed tributary approximately 700 feet to the northeast.

From 1941 to 1984, solid waste from the O-Line Ponds/O-Line Lagoons washout facility effluent treatment system, which consisted of sawdust-filled tanks, was also burned at the Open Burning Ground. O-Line wastewater is suspected to have contained Teflon® due to contact with Teflon®-containing machinery. The soil from the O-Line Ponds/O-Line Lagoons was also treated at the Building A-50 Soil Bioremediation Facility and then spread at the Open Burning Ground area. The Building A-50 Soil Bioremediation Facility is not considered an AOPI because there is no evidence of PFOS, PFOA, or PFBS-containing materials at this facility. SI soil and groundwater samples from the O-Line Ponds/O-Line Lagoons AOPI (from which the soil treated at Building A-50 was excavated) were non-detect for PFOS, PFOA, or PFBS. Quantities and exact locations of the soil spread within the Open Burning Ground is unknown.

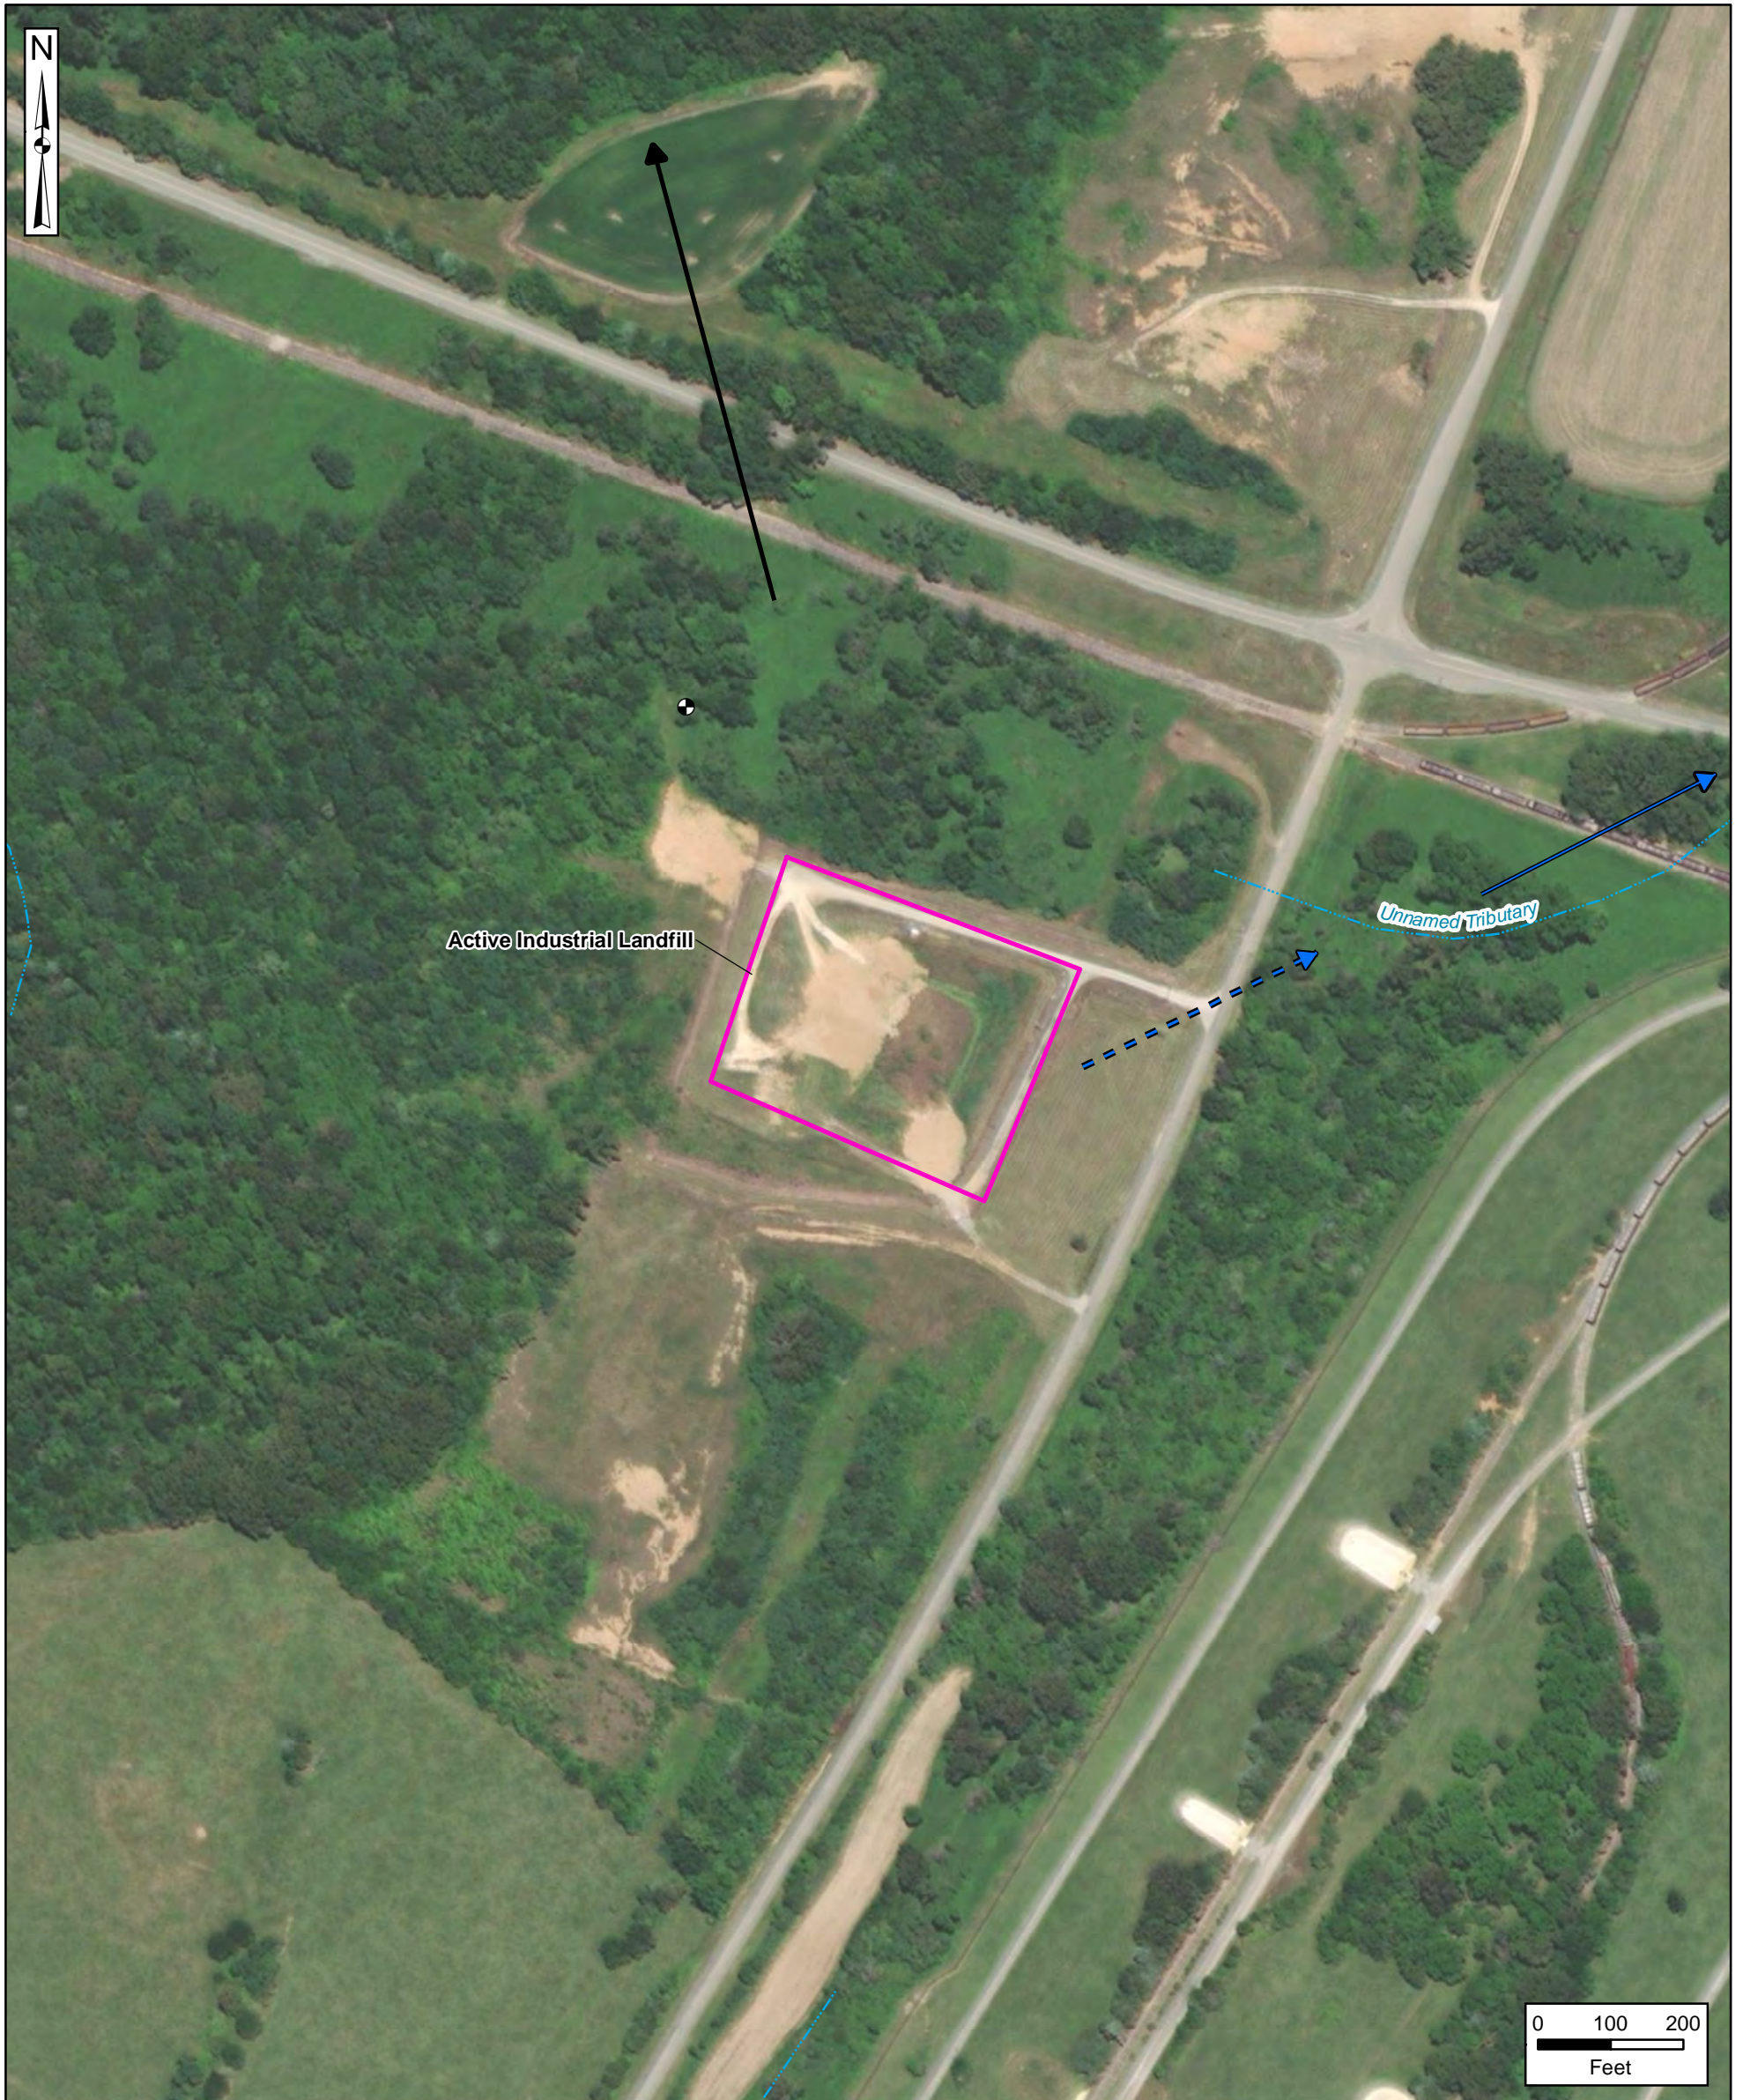
Figure 5-8
Aerial Photo of
Active Industrial Landfill

The Active Industrial Landfill (**Figure 5-8**) is identified as an AOPI following records research, personnel interviews, and site reconnaissance due to disposal of potential PFOA-containing waste (Teflon®-containing flares). This landfill has been active since 1993. It received ash disposal from flares known to contain Teflon® that were burned at the Open Burning Ground from 2004 to 2014. The Active Industrial Landfill is lined and contains a leachate collection system. Areas that are filled have been capped. The Active Industrial Landfill is a currently active Resource Conservation and Recovery Act-permitted landfill.

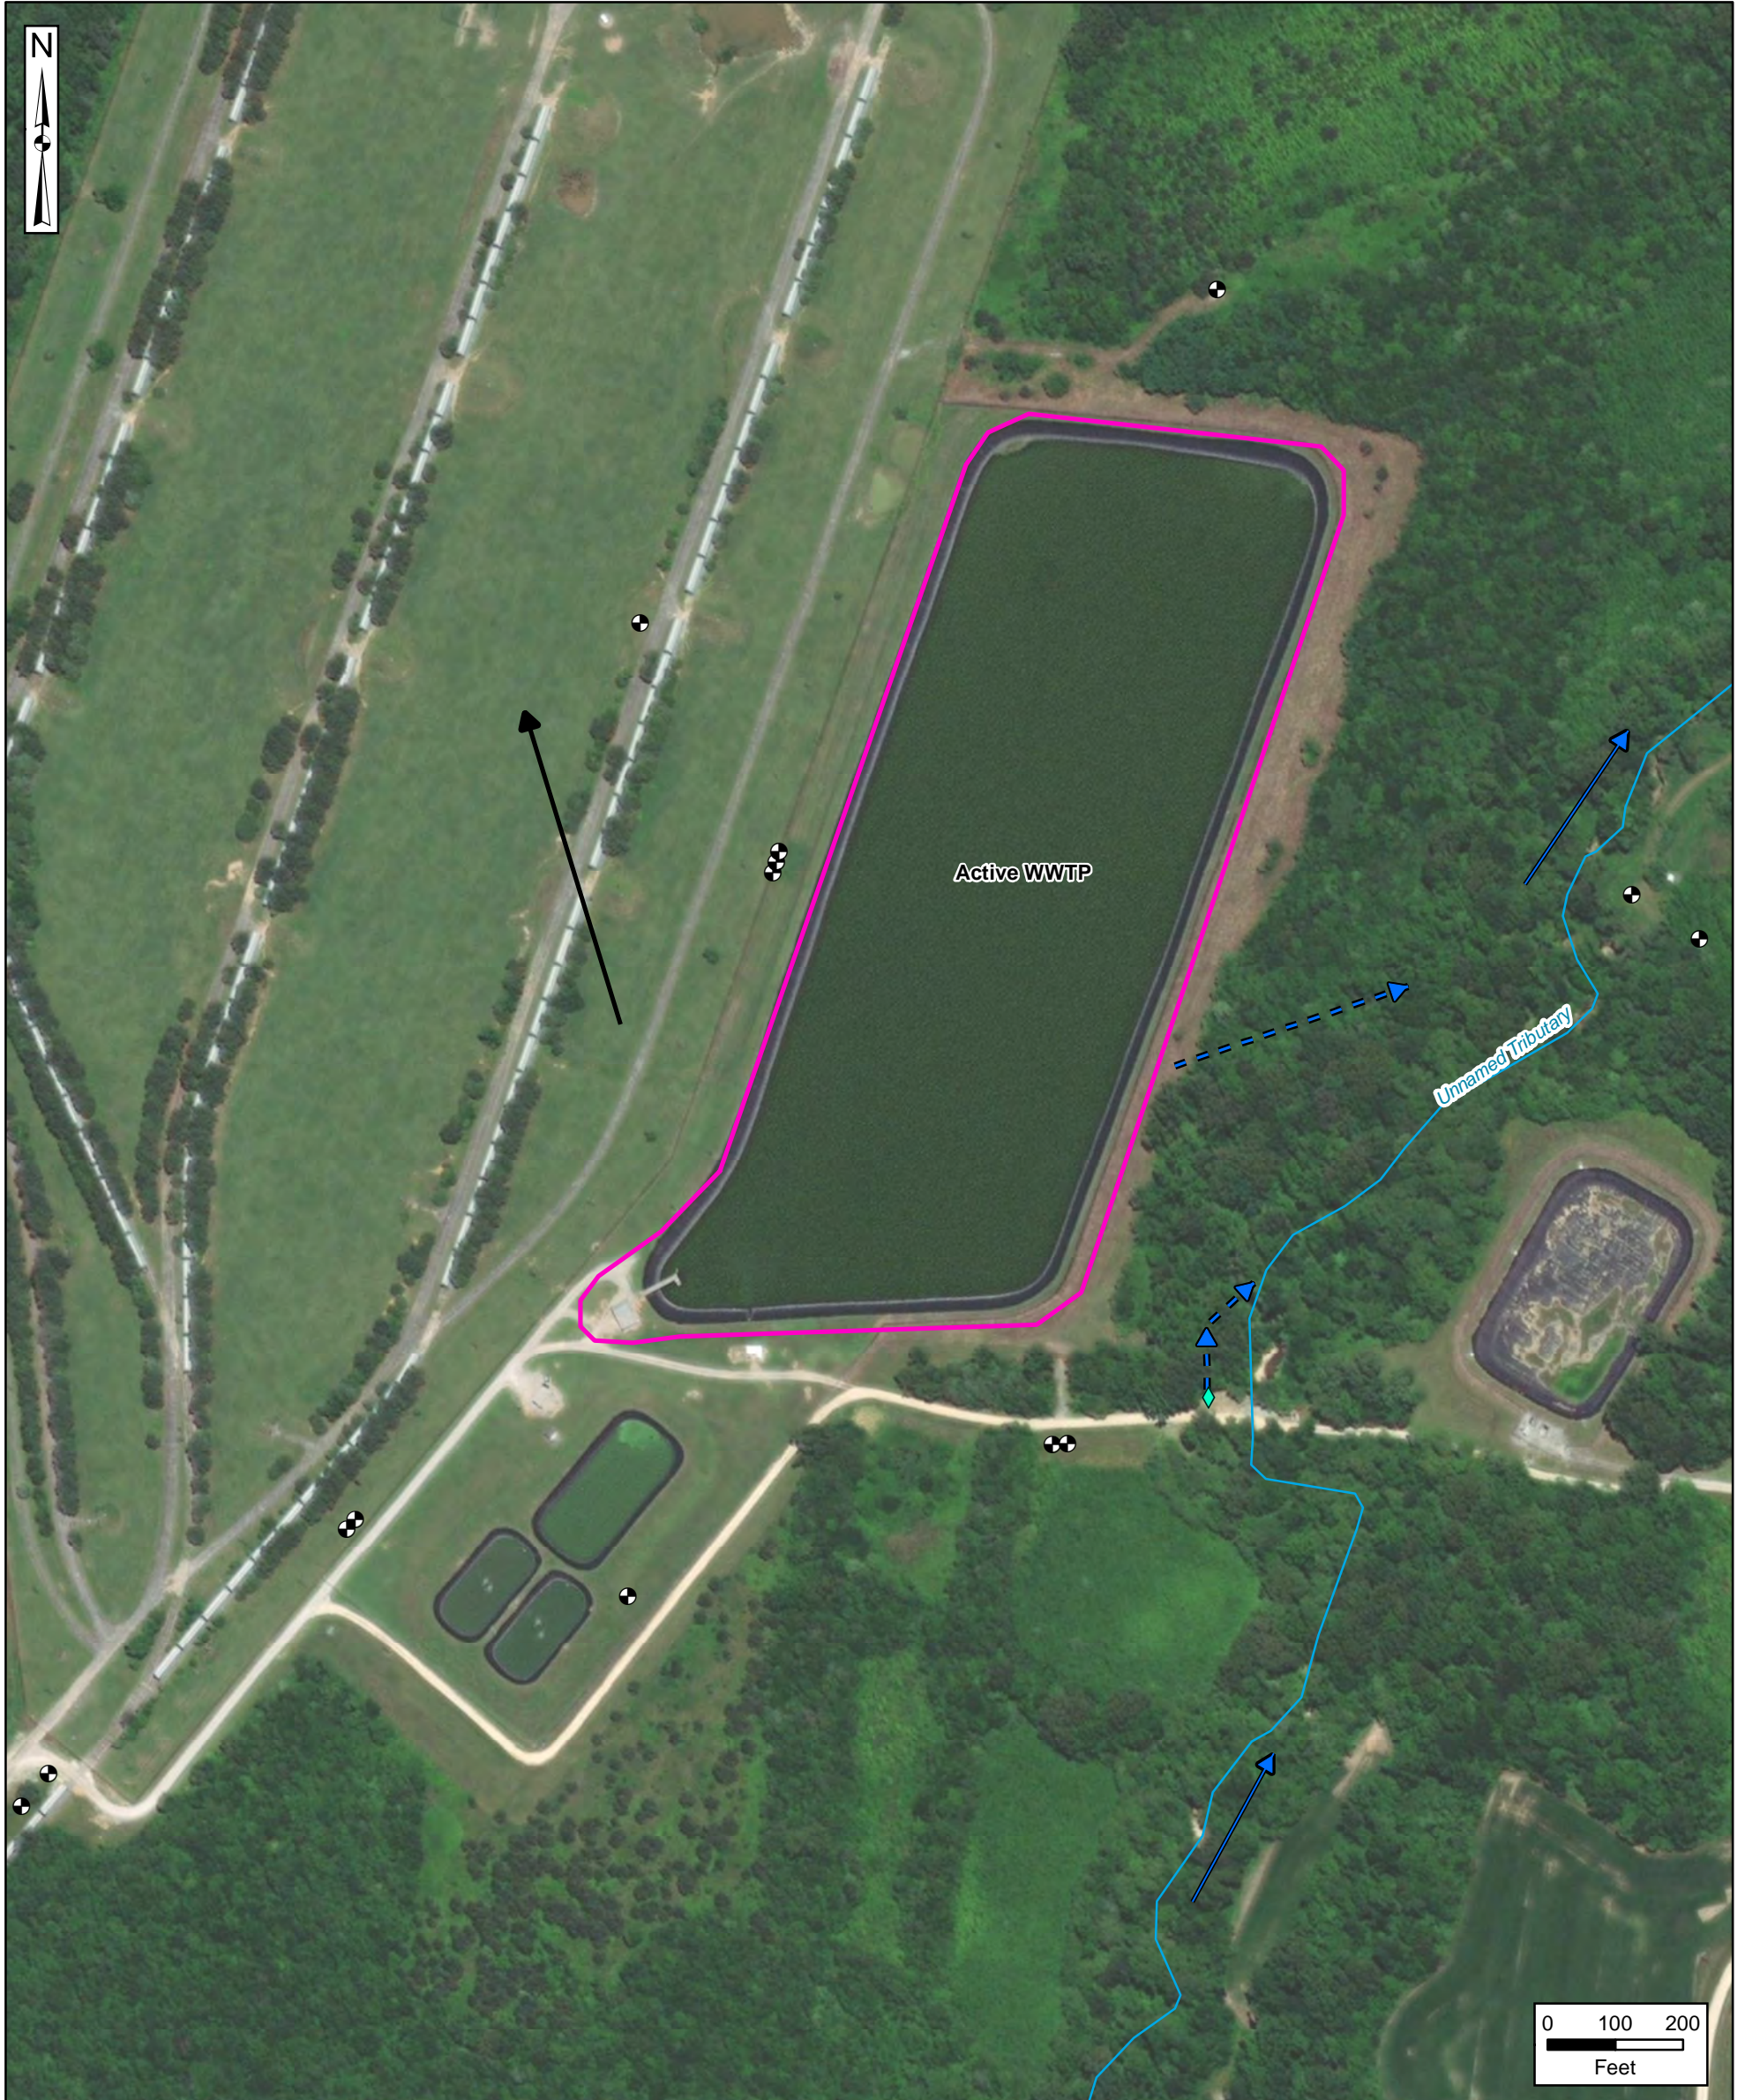
Figure 5-11
Aerial Photo of
Active WWTP

The Active WWTP (**Figure 5-11**) is identified as an AOPI following records research, personnel interviews, and site reconnaissance due to processing of potential PFOA-containing wastewater. The Active WWTP has been in use from 2002 to the present. Wastewater from all LAP lines, including the Line Z (**Section 5.2.3**) flare operation containing Teflon®, is discharged to the lined WWTP lagoon. During warmer months, treated water is pumped to the Spray Fields (**Section 5.2.11**). Secondary outfall from the lagoon is to an unnamed tributary of the RFOR.
