**PRELIMINARY ASSESSMENT OF PER- AND
POLYFLUOROALKYL SUBSTANCES AT
FORT MONROE, HAMPTON, VIRGINIA**

**Final
August 2023**

Leidos
1750 Presidents Street
Reston, Virginia 20190

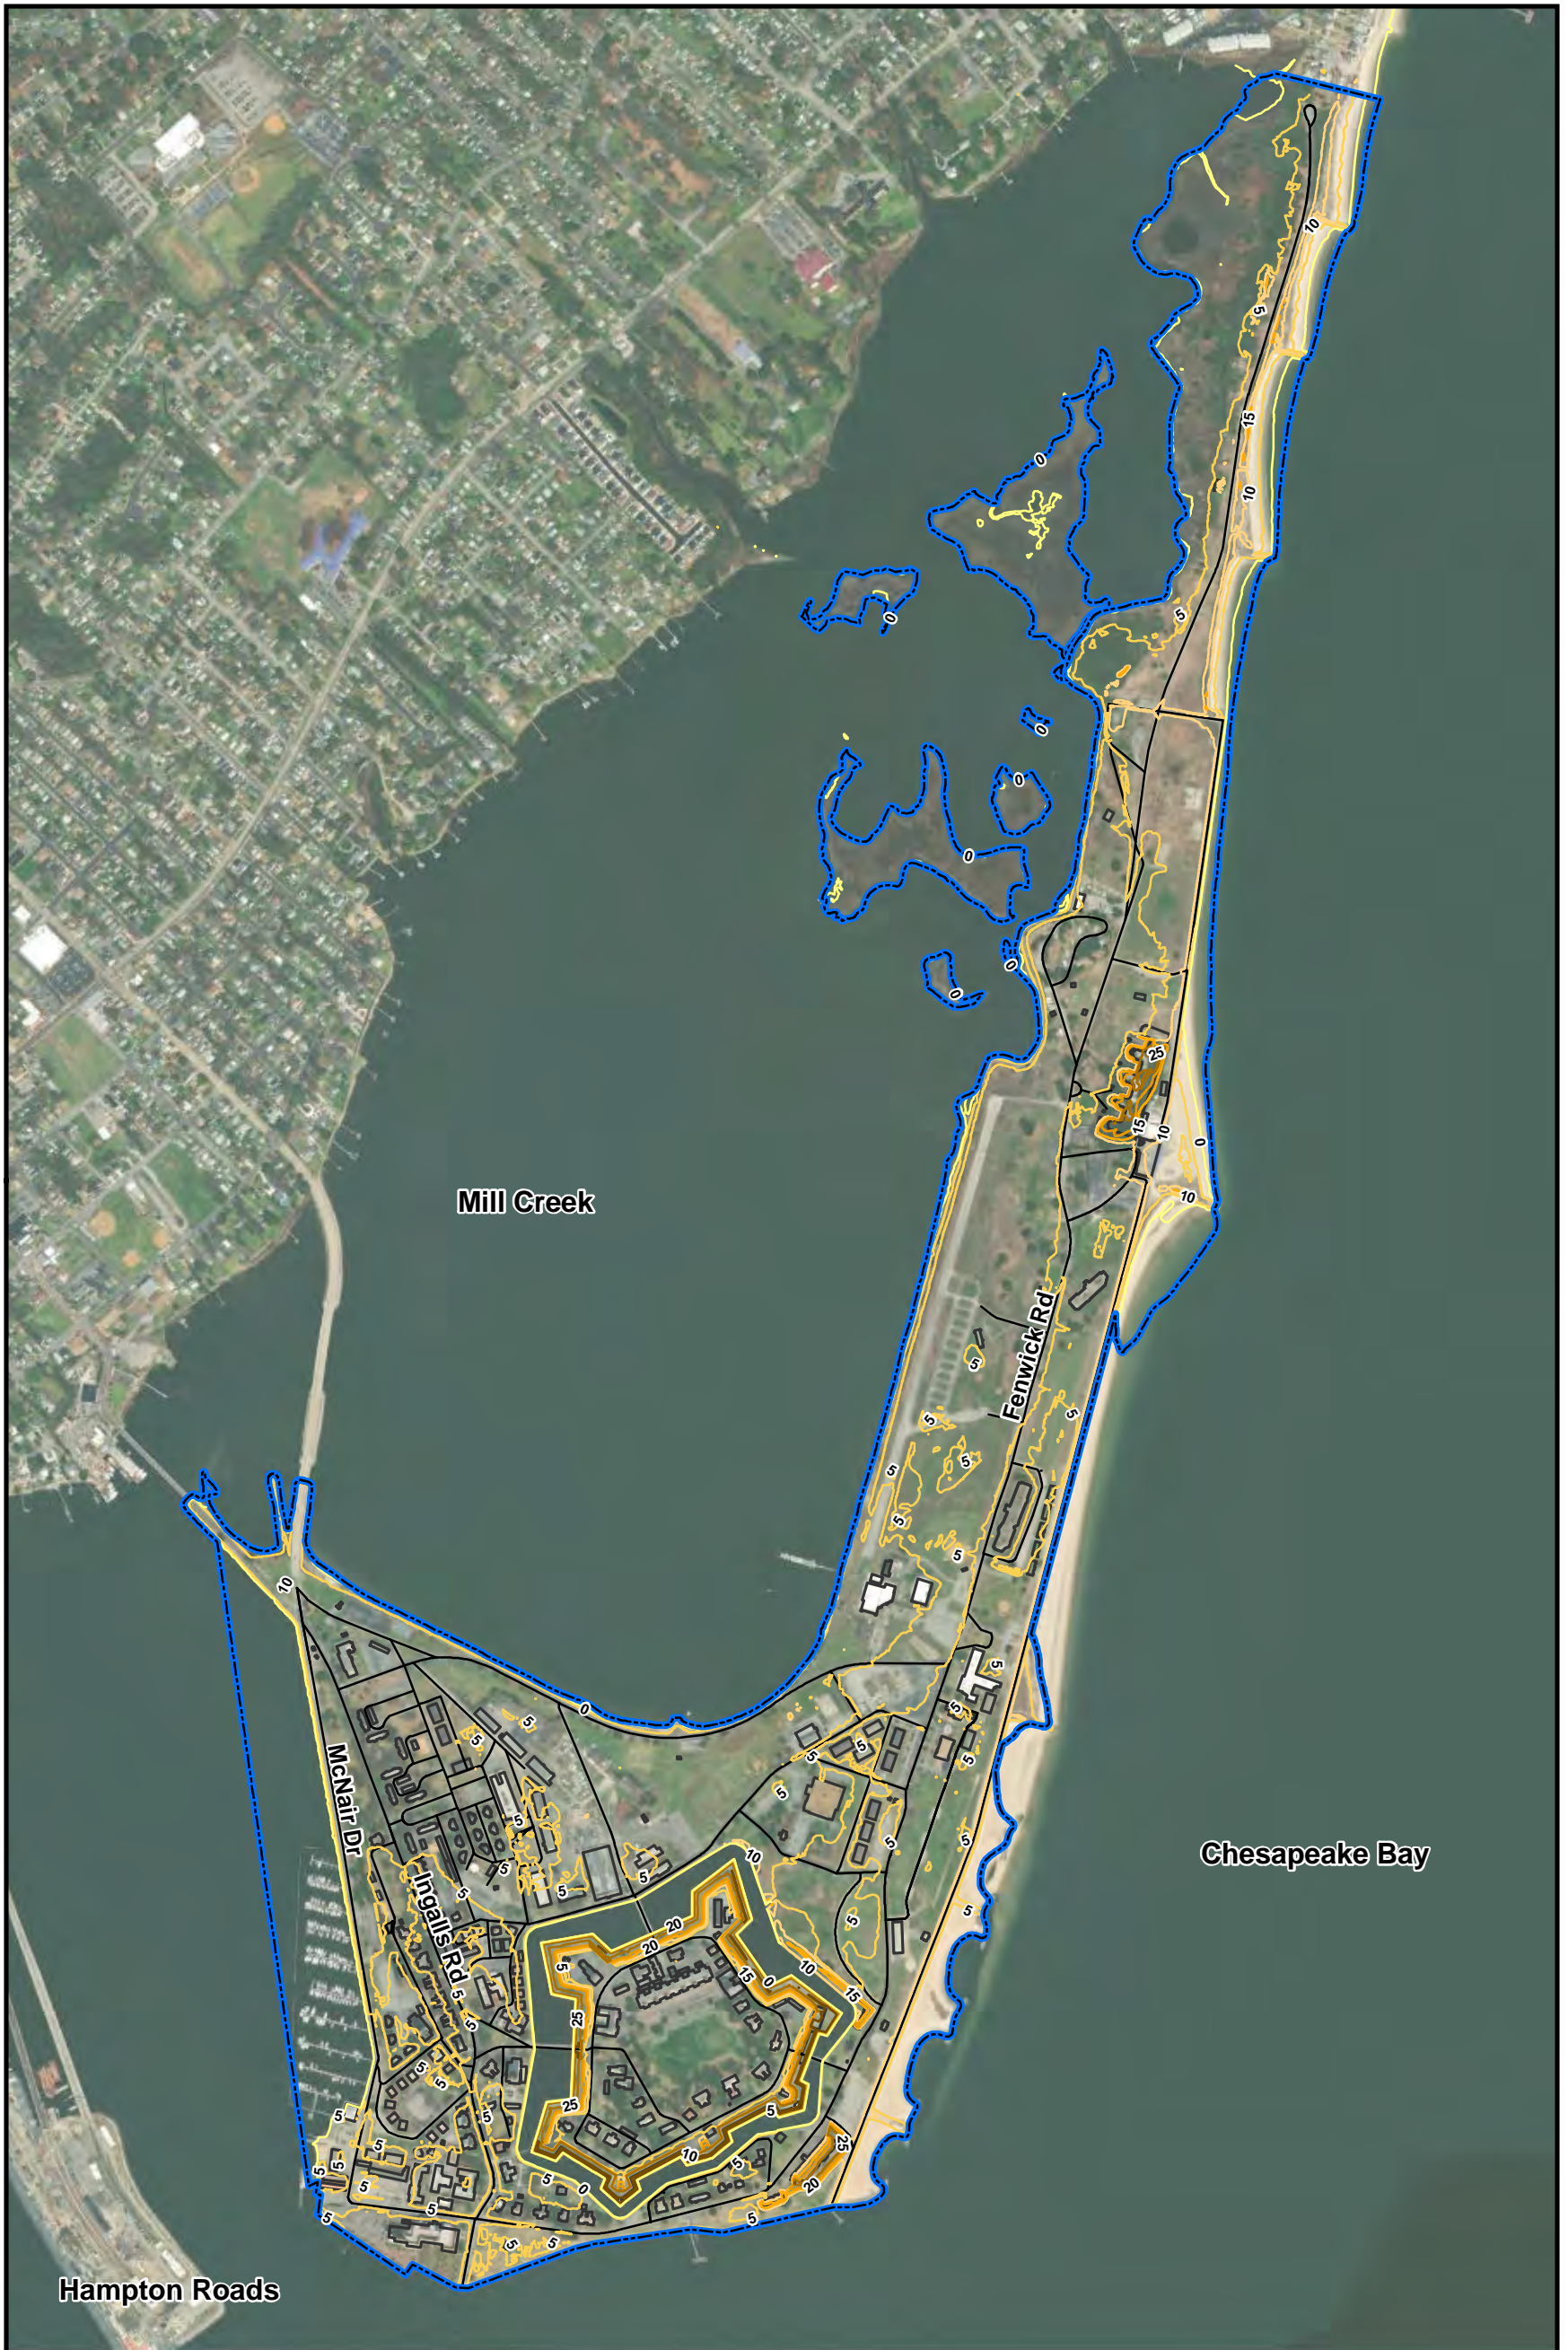
C:\Users\woodley\Documents\Work\IBRAC PFAS\Fort Monroe\PA\Figure 2-1 Fort Monroe_Site.mxd

Fort Monroe is located at the southeastern tip of Virginia's lower peninsula, between Hampton Roads harbor to the southwest, the Chesapeake Bay to the east, and Mill Creek to the west (Figure 1-1). Fort Monroe lies within the Hampton, Virginia, corporate limits, south of the community of Phoebus, and is accessible only by two bridges (Highways 143 and 258) that lead to a single main entrance. Fort Monroe's land connection, adjacent to the community of Chesapeake Heights, is fenced with no ready access. Fort Monroe spans 565.5 acres, which include accreted lands. Approximately 108 acres of the Fort Monroe property are submerged (R&K Engineering and GRW Engineers 1996, as cited in SAIC 2000) and 85 acres of property are wetlands (Tiner et al. 1998). The remaining acres of Fort Monroe are classified as improved or semi-improved. The improved area has been modified for the military mission or heavily landscaped. Figure 2-1 depicts the Fort Monroe site features.

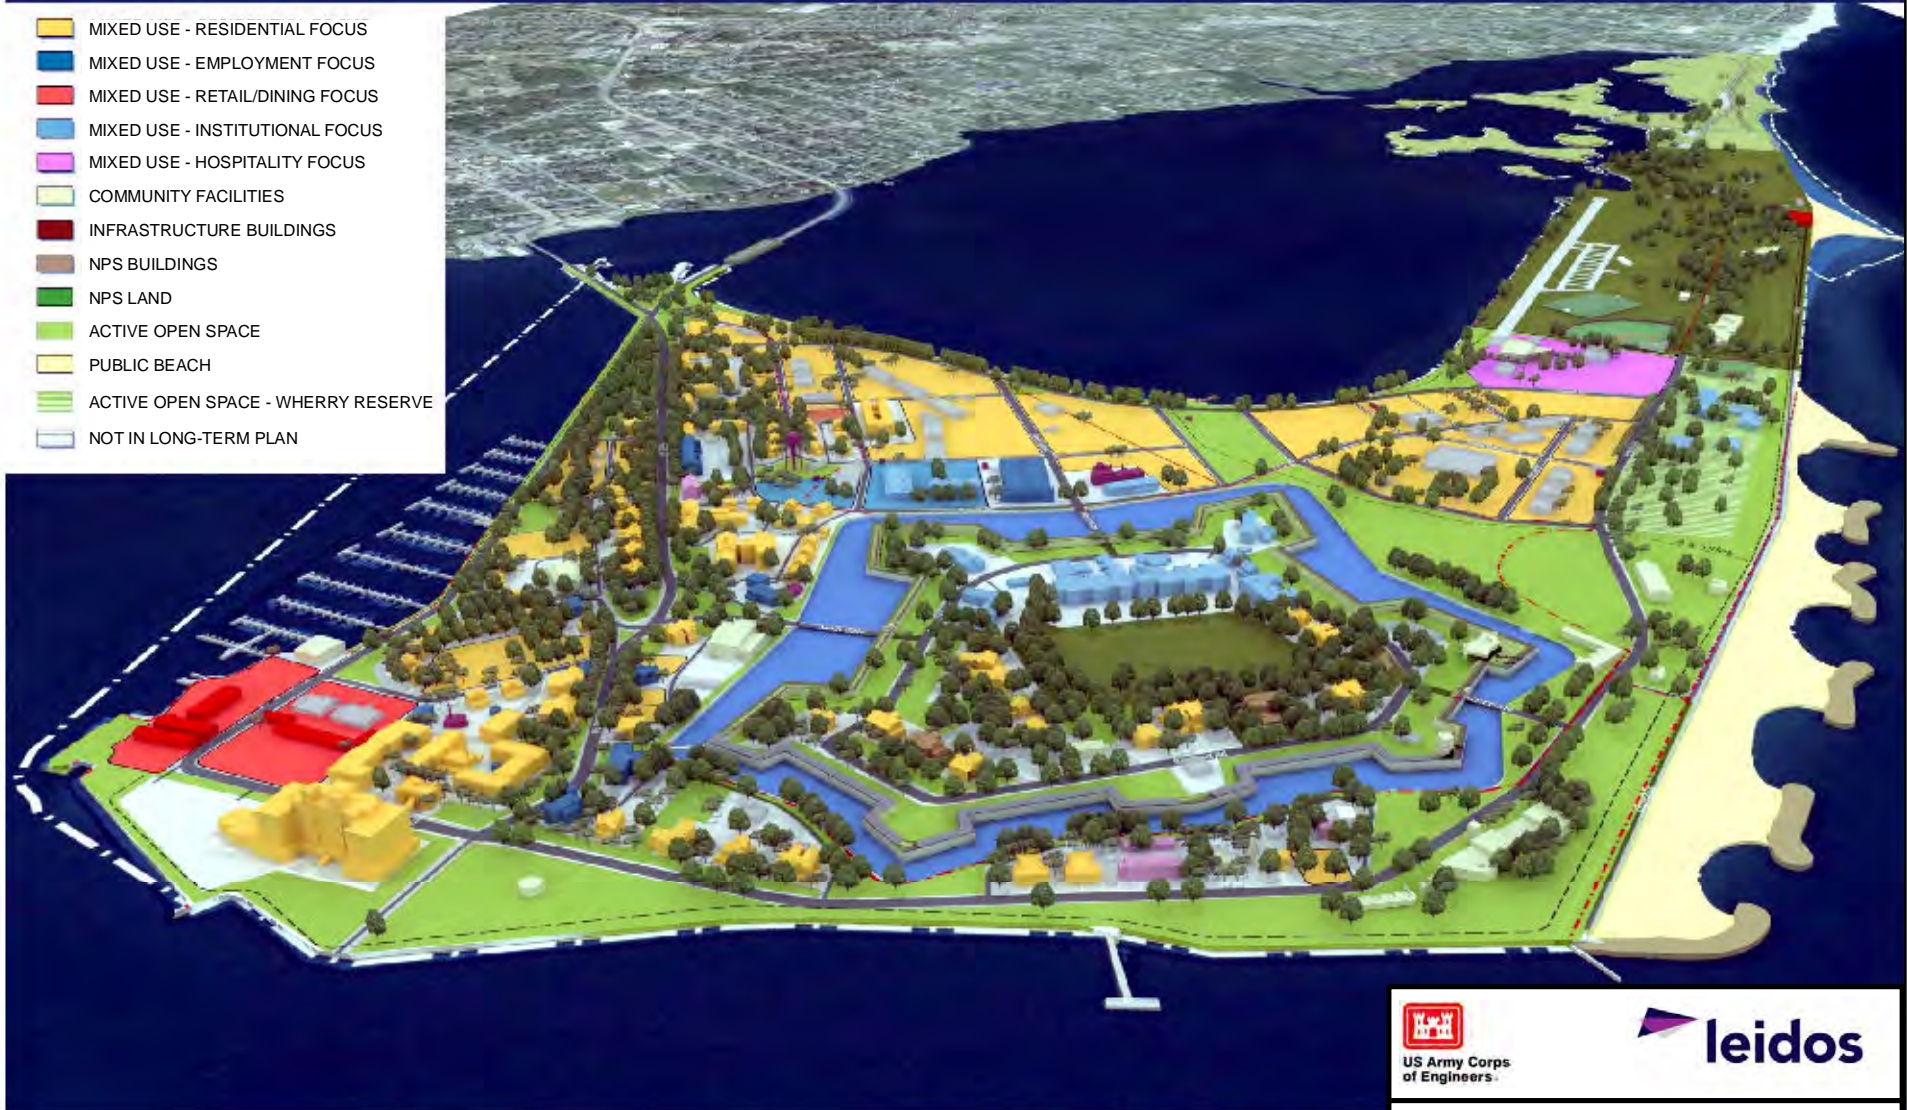
US Army Corps of Engineers	 
LAND USE MAP FORT MONROE, VA	
FIGURE 2-2	DATE: 4/18/2023

Note: The Fort Monroe Land Use Master Plan was reproduced from the Fort Monroe Master Plan Final Presentation (Sasaki 2013).

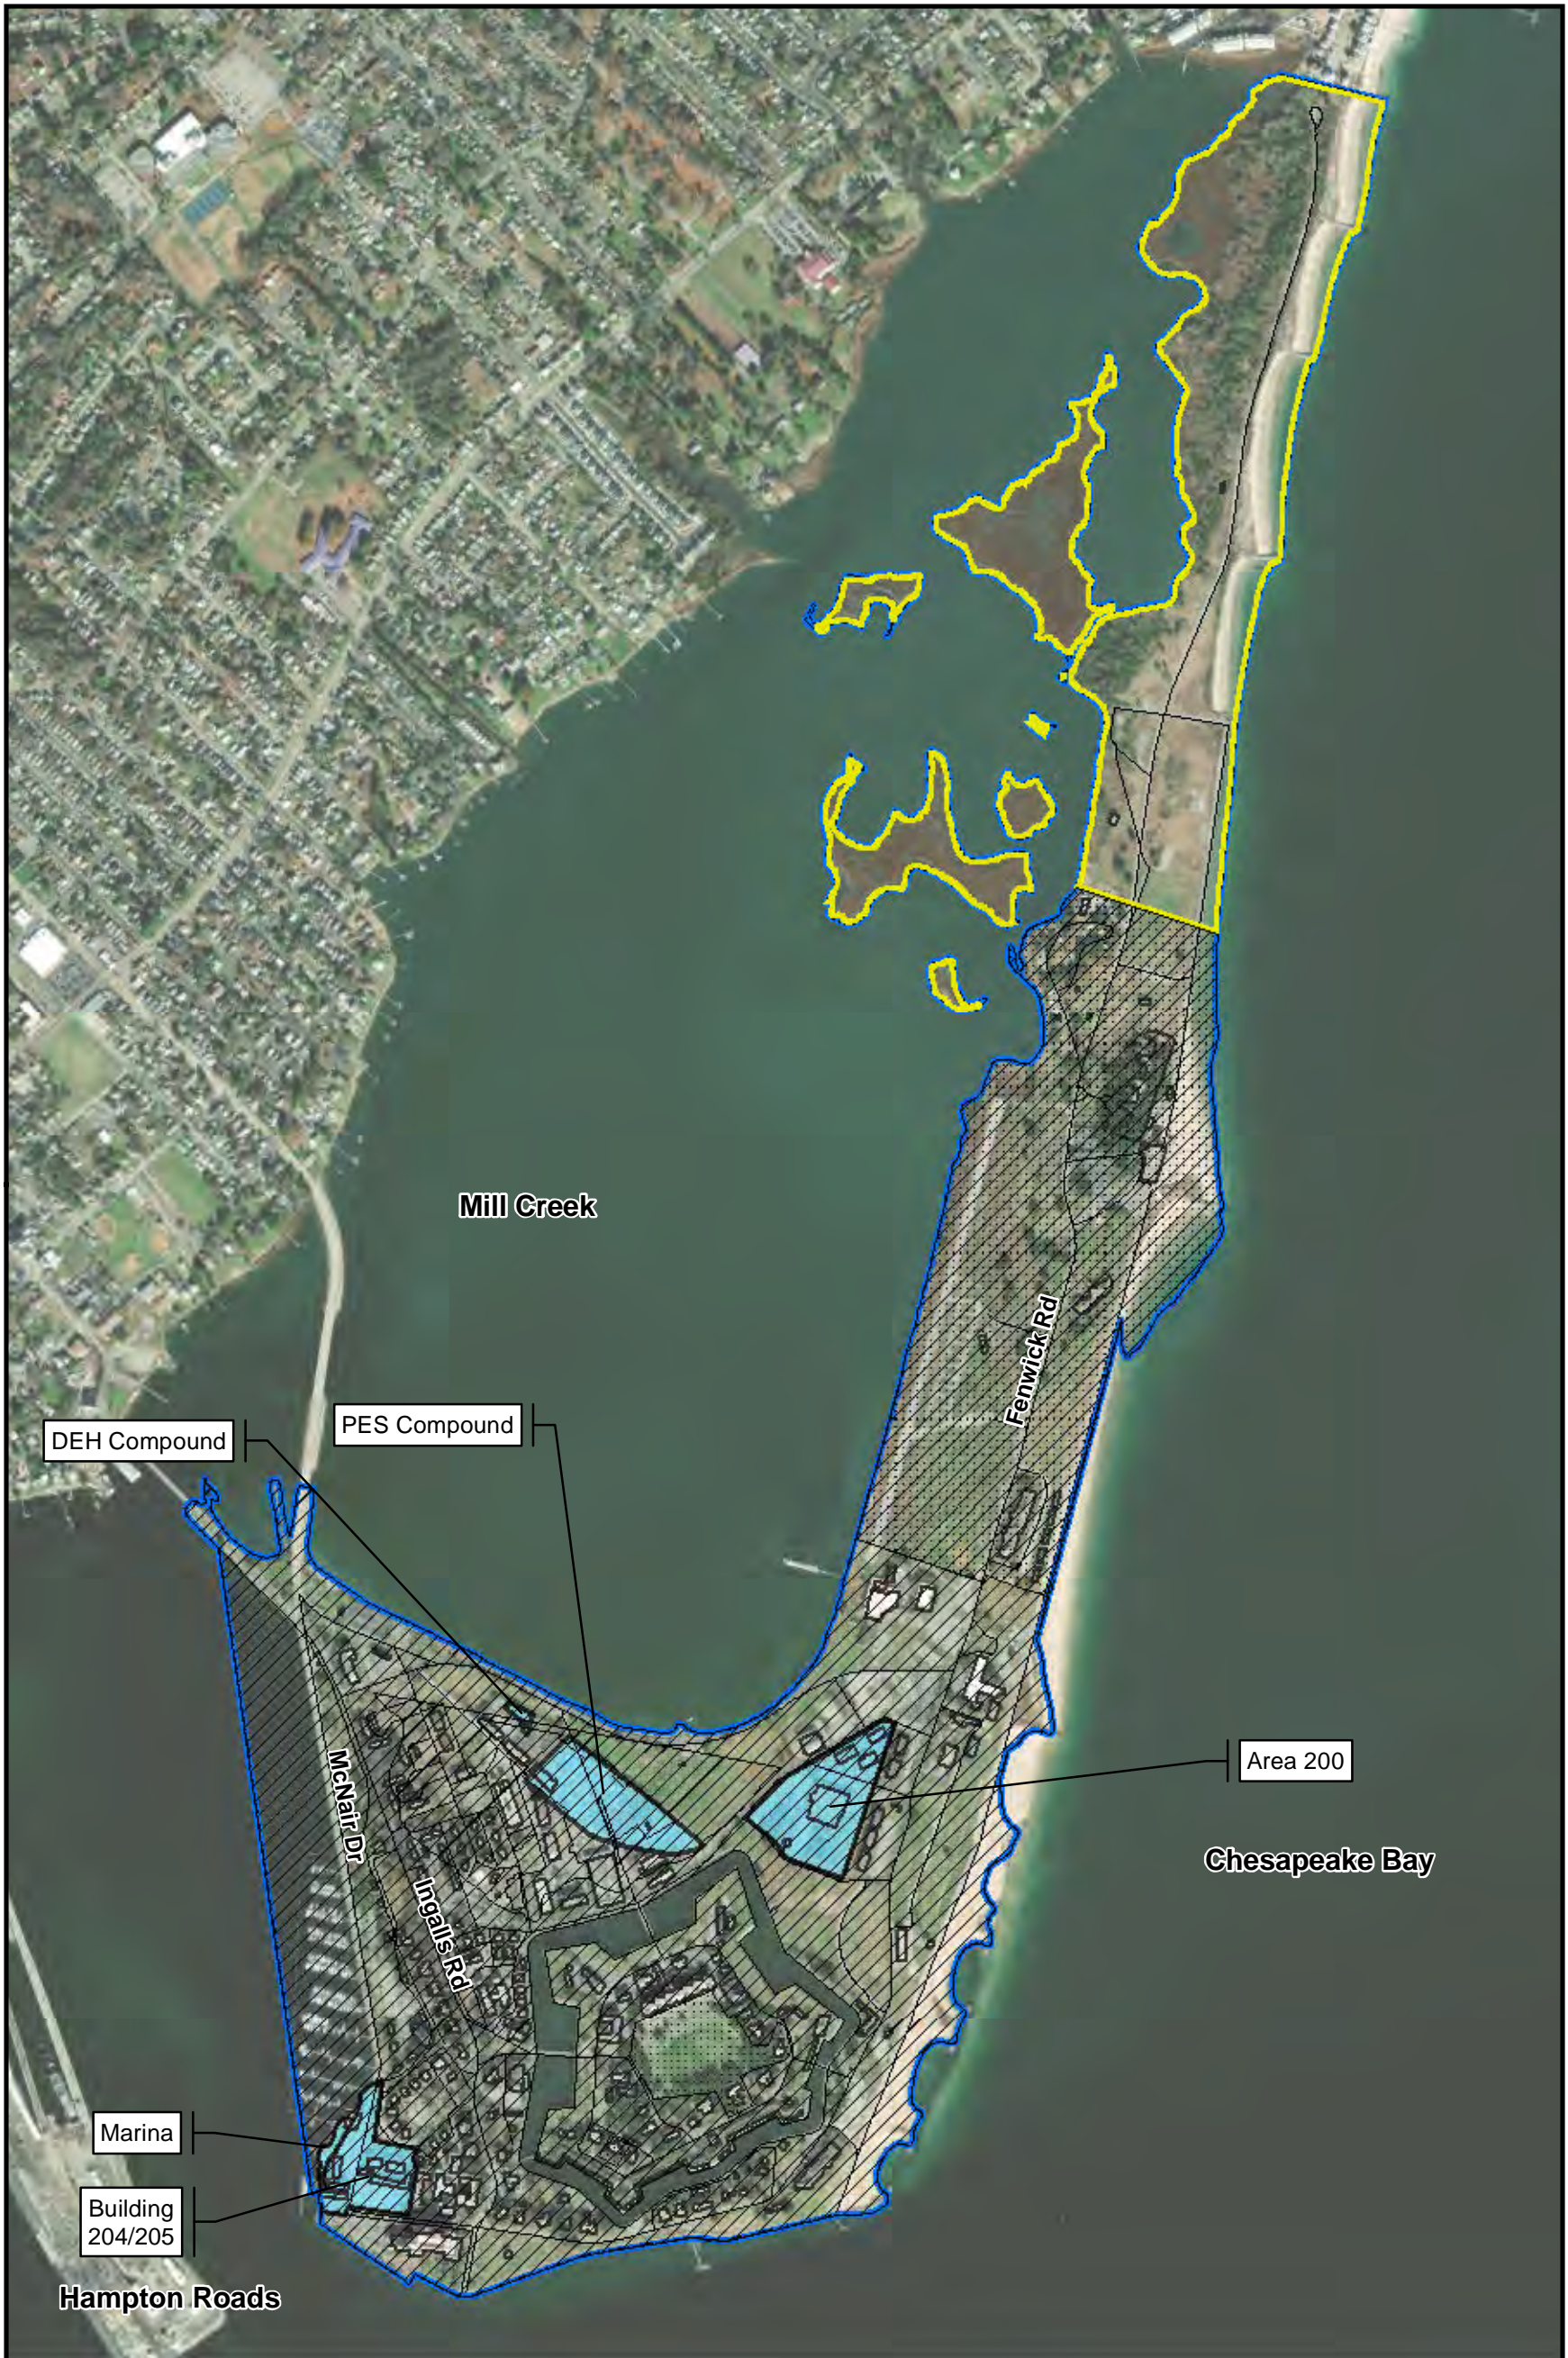
C:\Users\woodley\Documents\Work\IBRAC PFAS\Fort Monroe\PA\Figure 2-3 FortMonroe_Transferred_Property.mxd

- Installation Boundary
- Buildings
- Property Transferred to the Commonwealth of Virginia/FMA
- Property FMA Transferred to NPS
- Property not yet transferred
- MOU prohibits groundwater use and consumption
- Roads

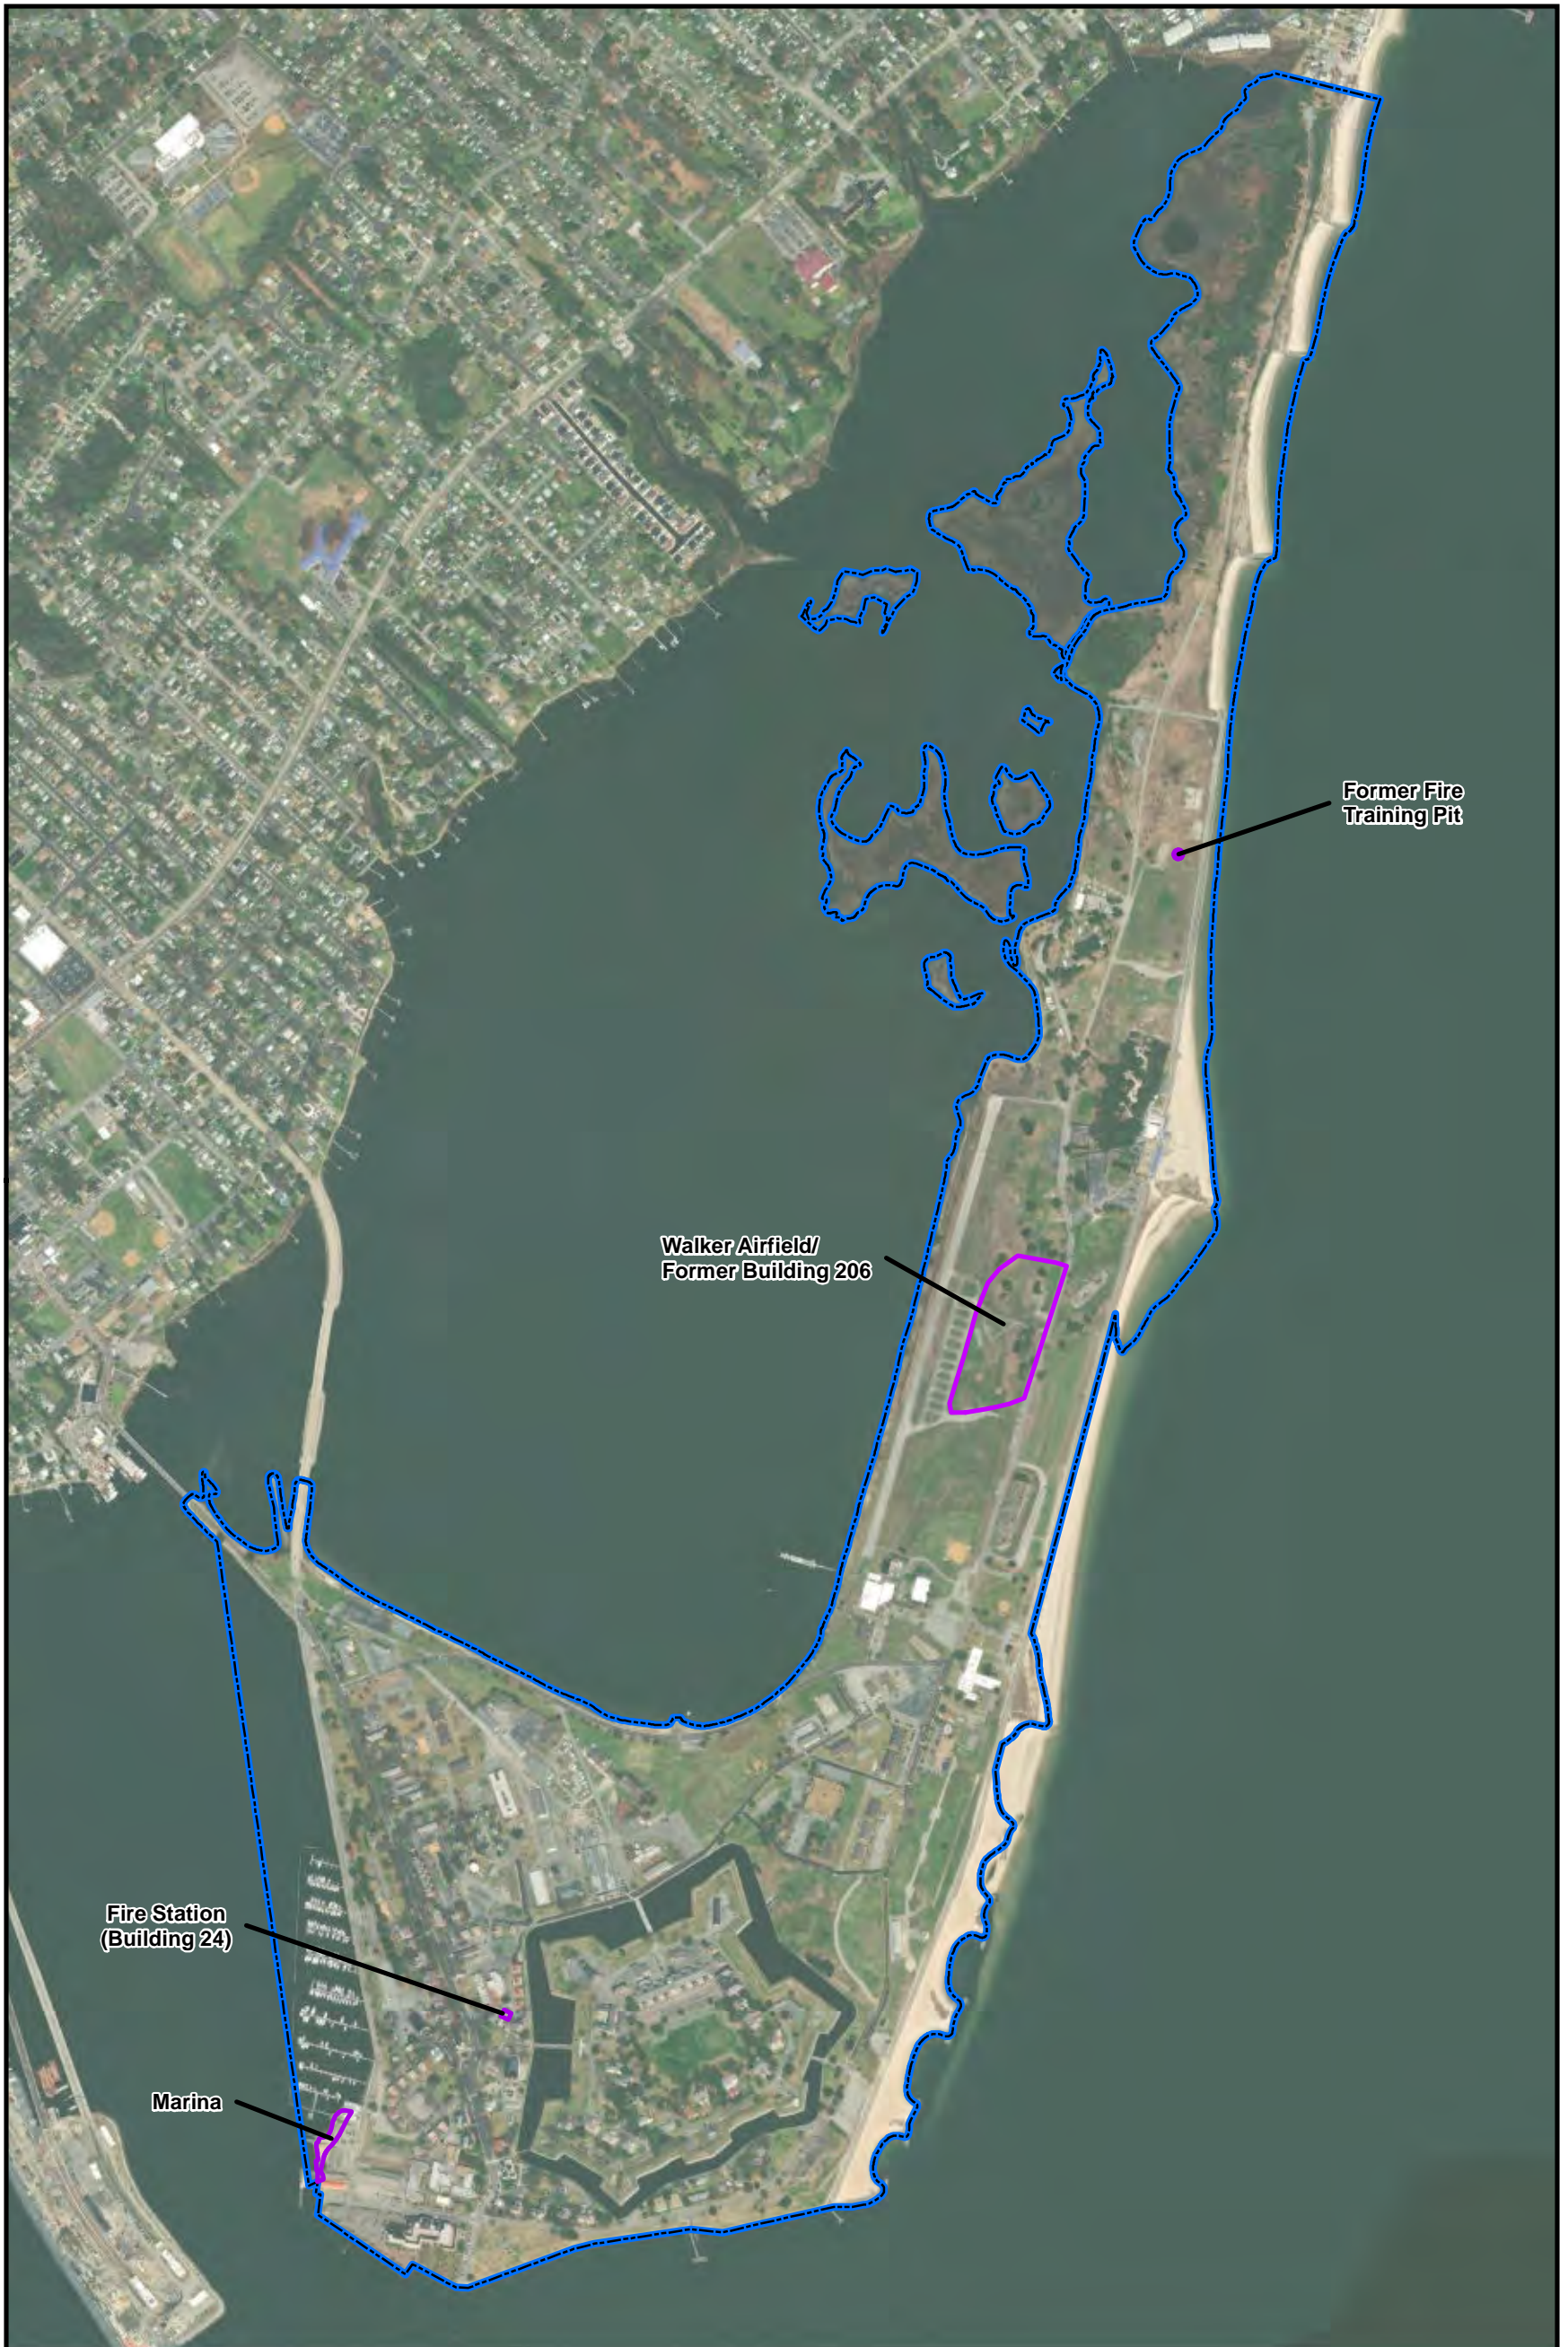
C:\Users\woodley\Documents\Work\BRAC PFAS\Fort Monroe\PA\Figure 5-1 FortMonroe_AOPIs.mxd

In conducting the PA of the BRAC property at the former Fort Monroe, four AOPIs were identified where a potential for release of PFAS exists resulting from site operational history. AOPIs were identified at potential PFAS-release locations on the BRAC property only.
