**SITE INSPECTION REPORT FOR PER- AND  
POLYFLUOROALKYL SUBSTANCES AT  
FORT MONROE, VIRGINIA**

**U.S. ARMY**

**Final  
October 2023**

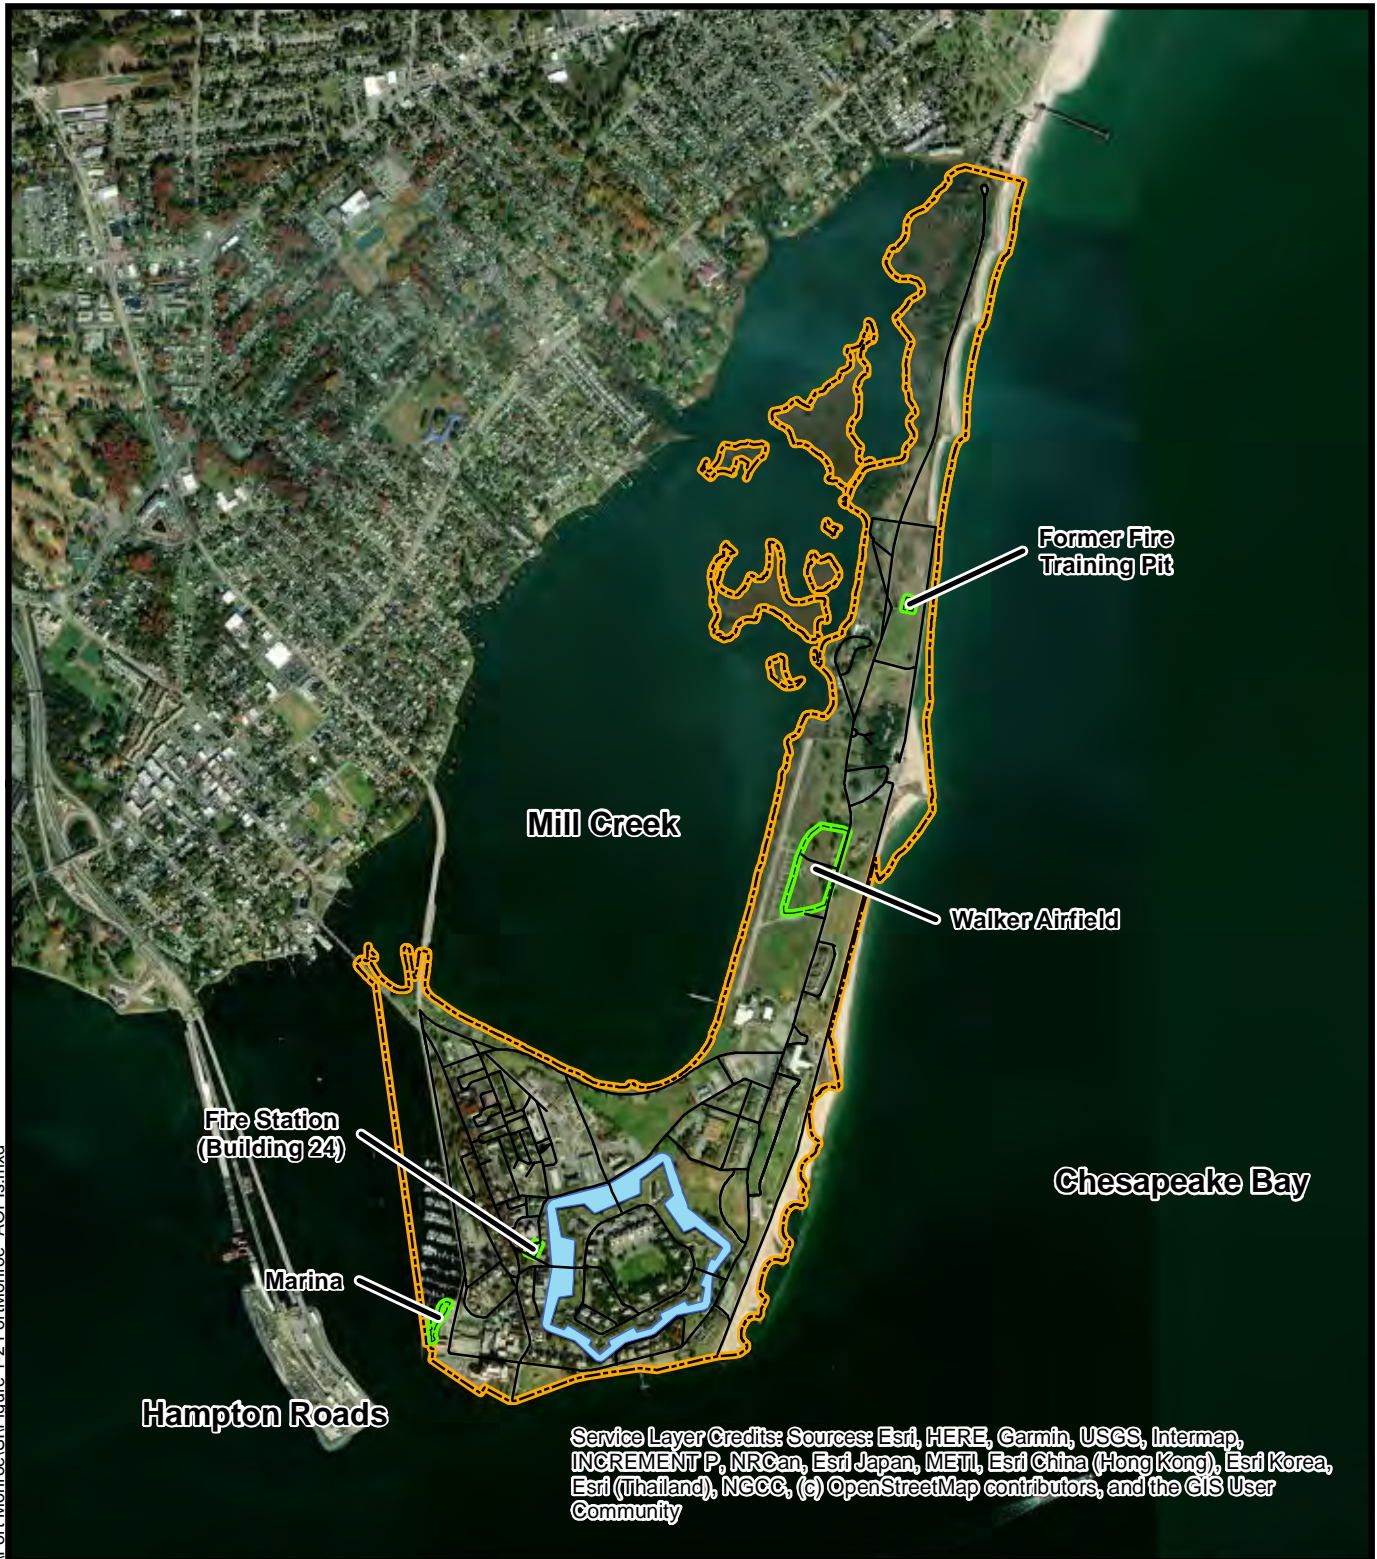
FIGURE: 1-2

due to known or potential historical PFAS-containing material use, storage, or disposal. The AOPIs, as well as the dates of operation and sizes of each area, are presented in Table 1-1 and illustrated in Figure 1-2.

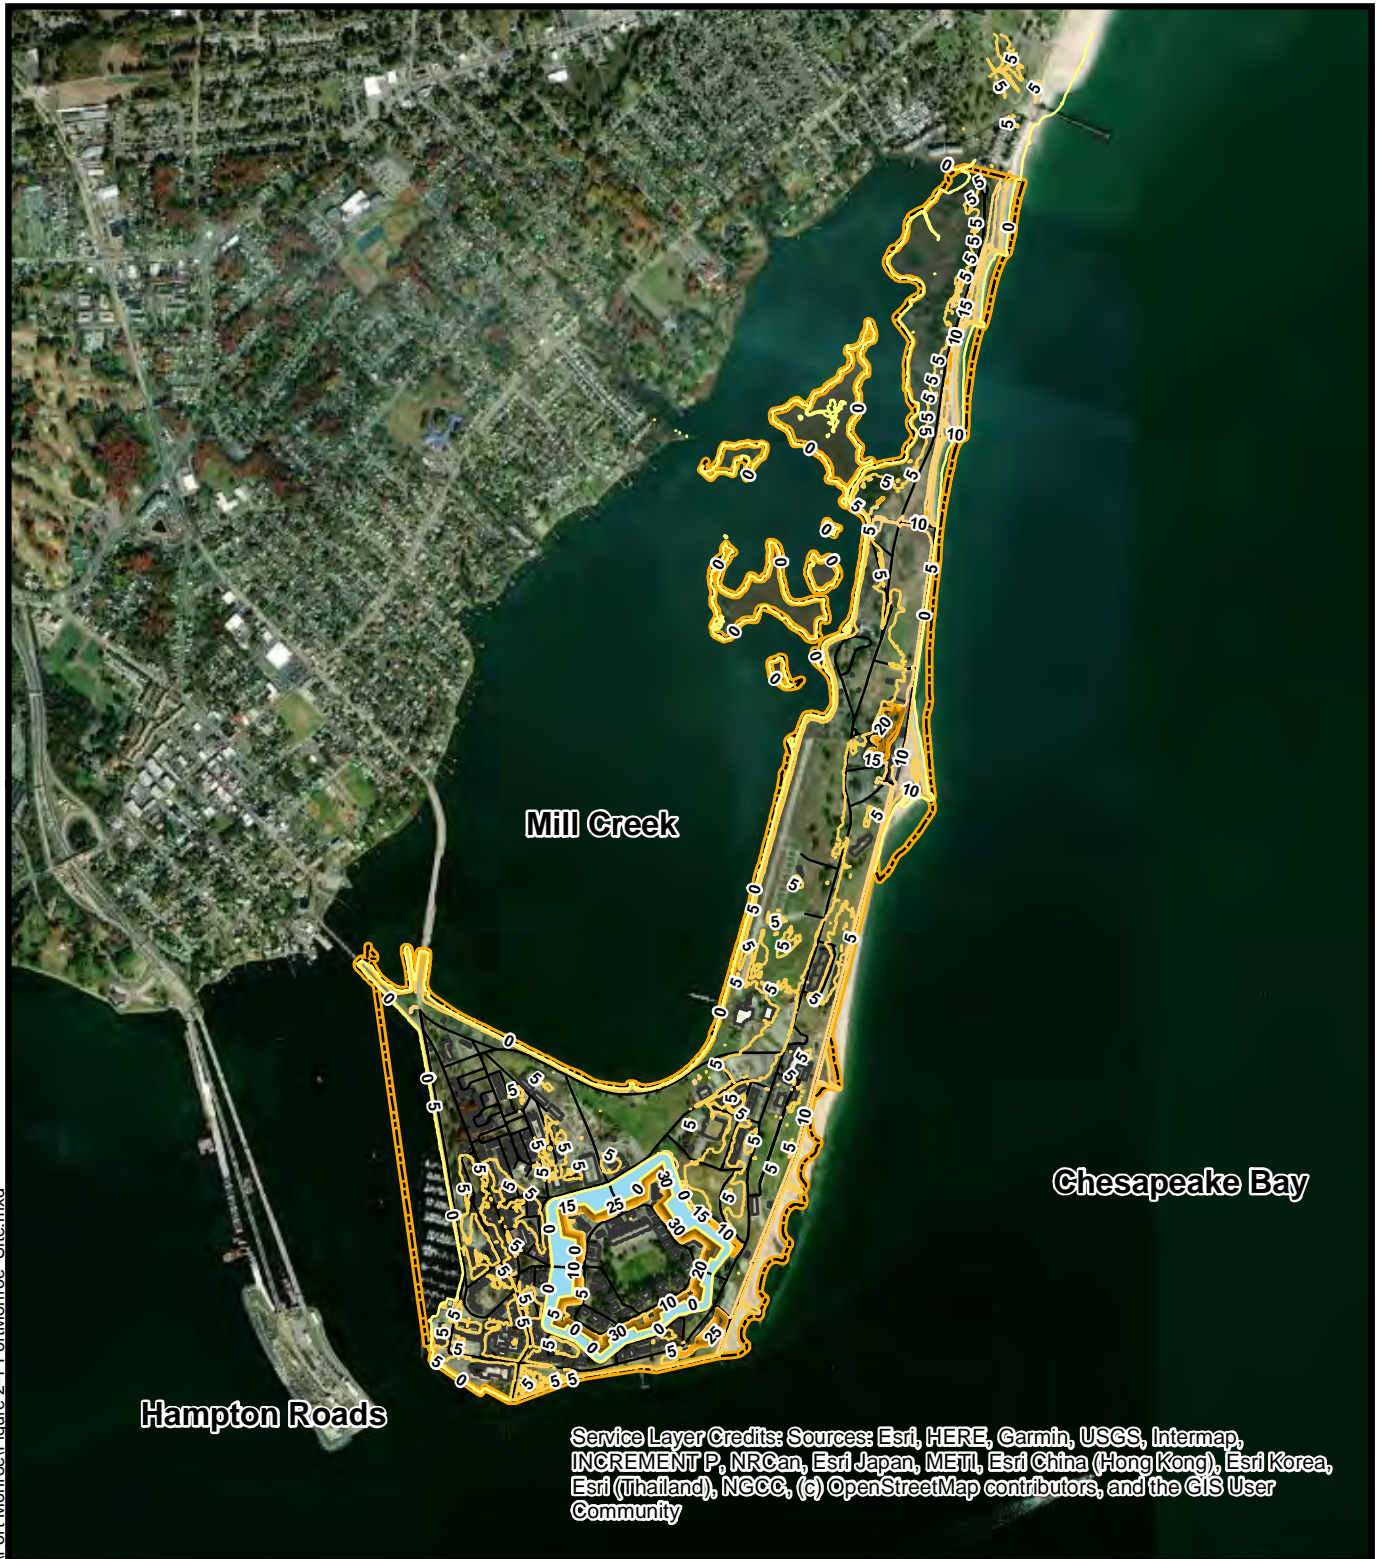
FIGURE: 2-1

Fort Monroe is located at the southeastern tip of Virginia's lower peninsula, between Hampton Roads harbor to the southwest, the Chesapeake Bay to the east, and Mill Creek to the west (Figure 1-1). Fort Monroe lies within the Hampton, Virginia, corporate limits, south of the community of Phoebus, and is accessible only by two bridges (Highways 143 and 258) that lead to a single main entrance. Fort Monroe spans 565.5 acres, which include accreted lands. Approximately 108 acres of the Fort Monroe property are submerged (R&K Engineering and GRW Engineers 1996, as cited in SAIC 2000) and 85 acres of property are wetlands (Tiner et al. 1998). The remaining acres of Fort Monroe are classified as improved or semi-improved. The improved area has been modified for the military mission or heavily landscaped. Figure 2-1 depicts the Fort Monroe site features.

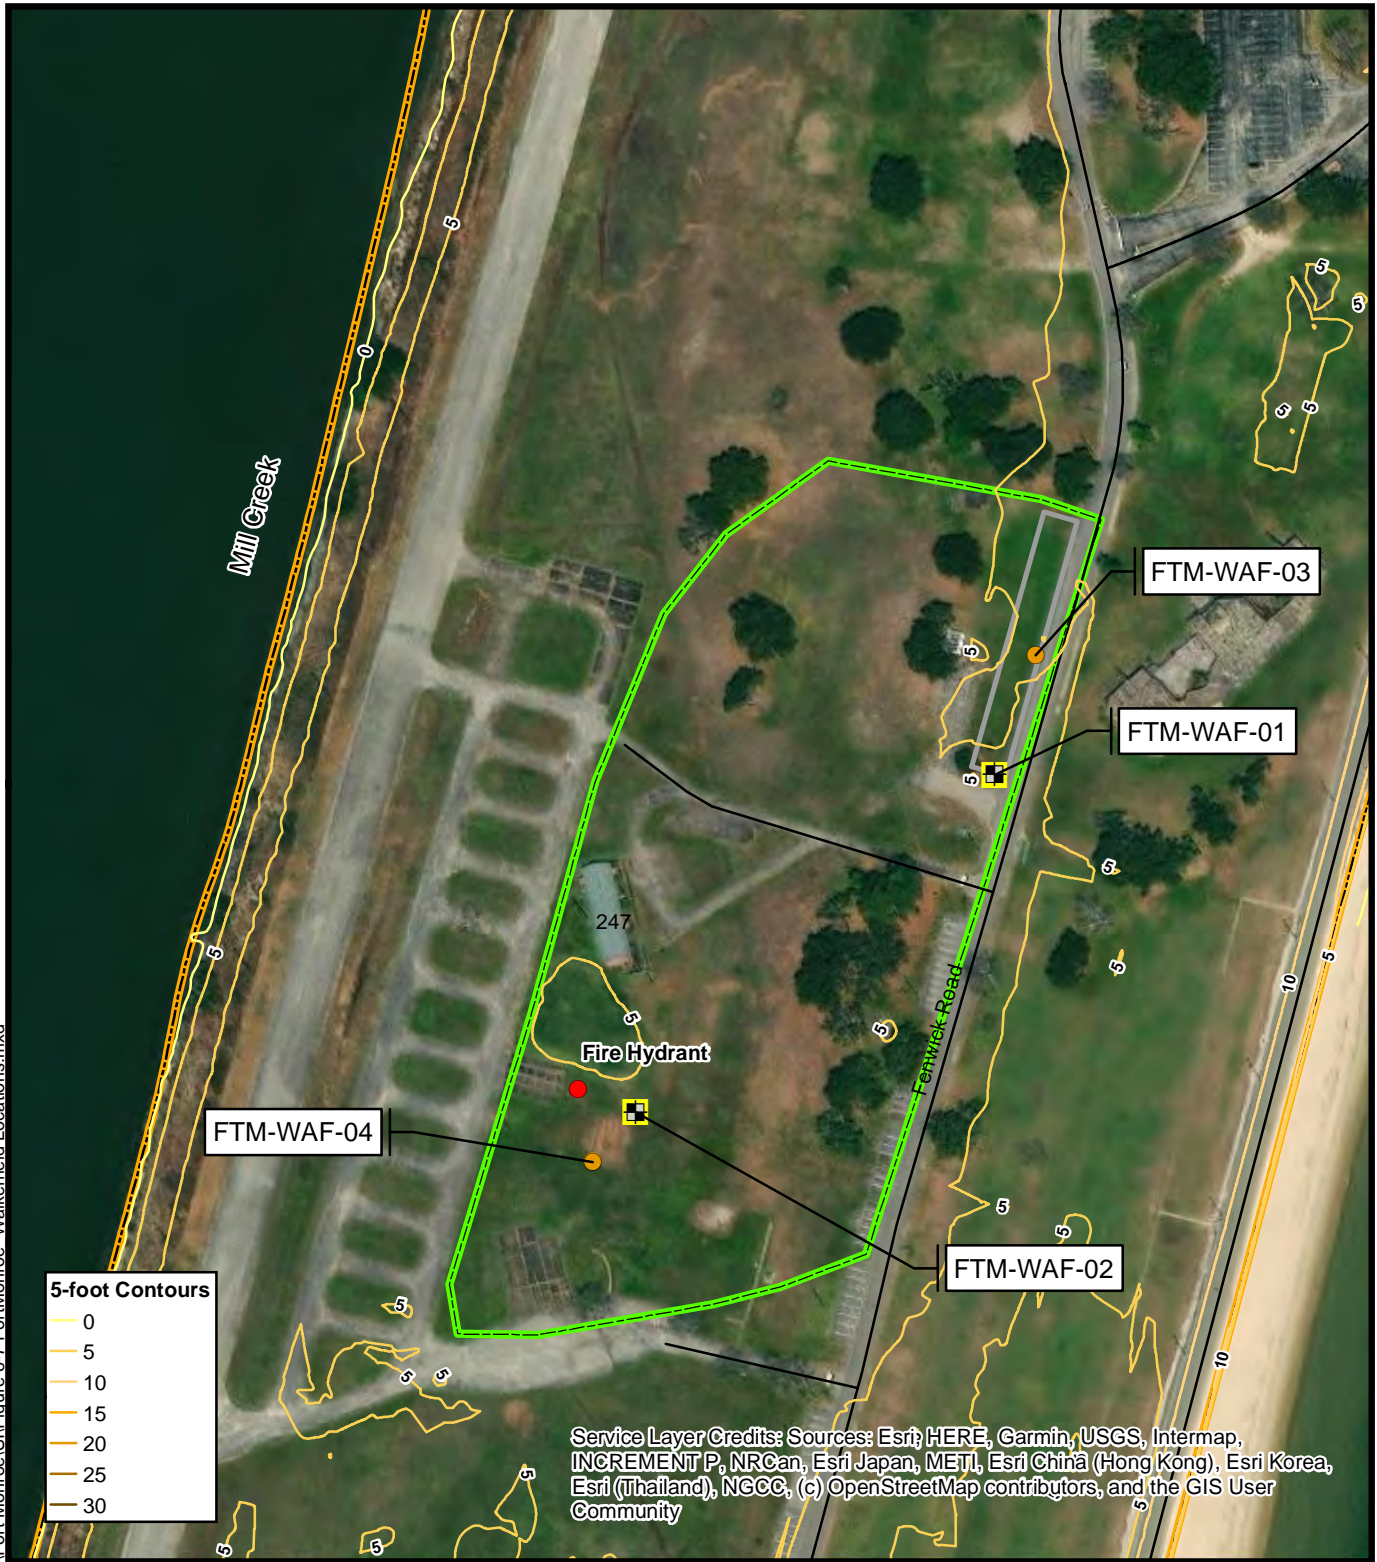
FIGURE: 6-7 | DATE: 5/18/2023

Soil and groundwater samples were collected from the Walker Airfield AOPI at the following locations (Figure 6-7):
