FINAL PRELIMINARY ASSESSMENT OF PER- AND POLYFLUOROALKYL SUBSTANCES

Natick Soldier Systems Center, Massachusetts

October 2020

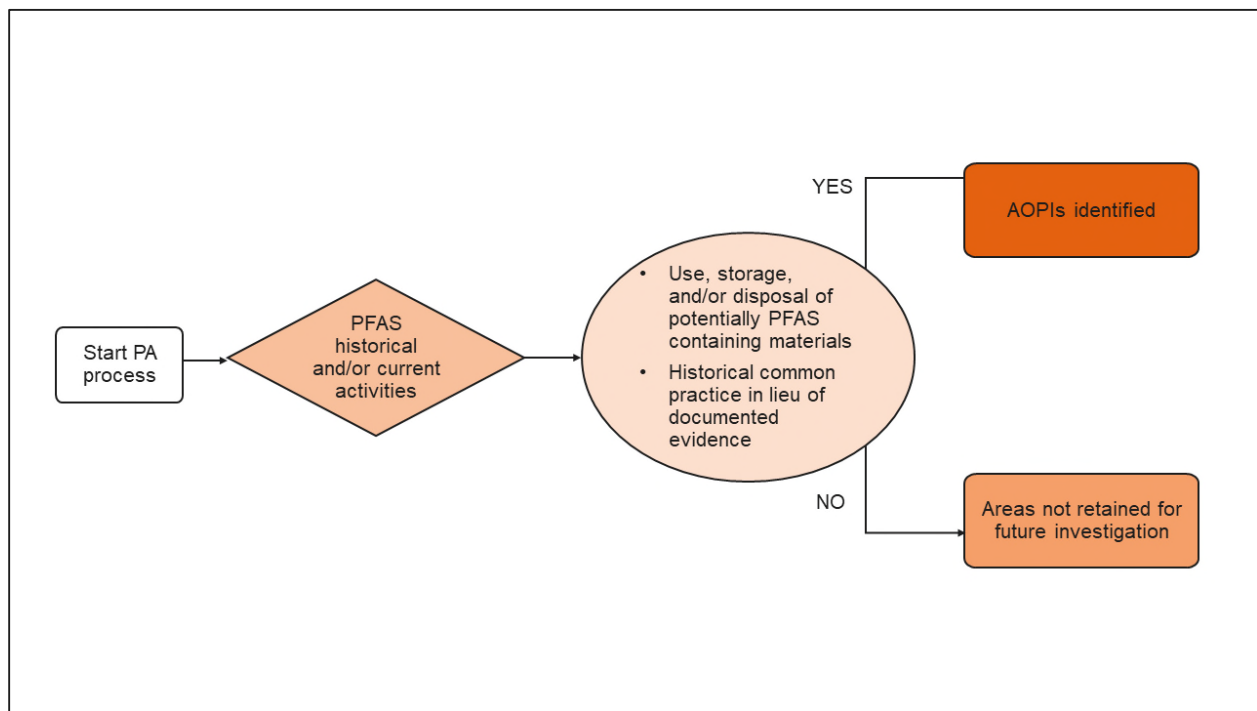
Figure 5-1: AOPI Decision Flowchart

The areas evaluated for potential PFAS use or storage and/or disposal at NSSC were refined during the PA process and identified either as an area not retained for further investigation or as an AOPI. In accordance with the established process for the PA, fifteen have been identified as areas not retained for further investigation and none have been identified as AOPIs. The process used for refining these areas is presented on **Figure 5-1**, below.

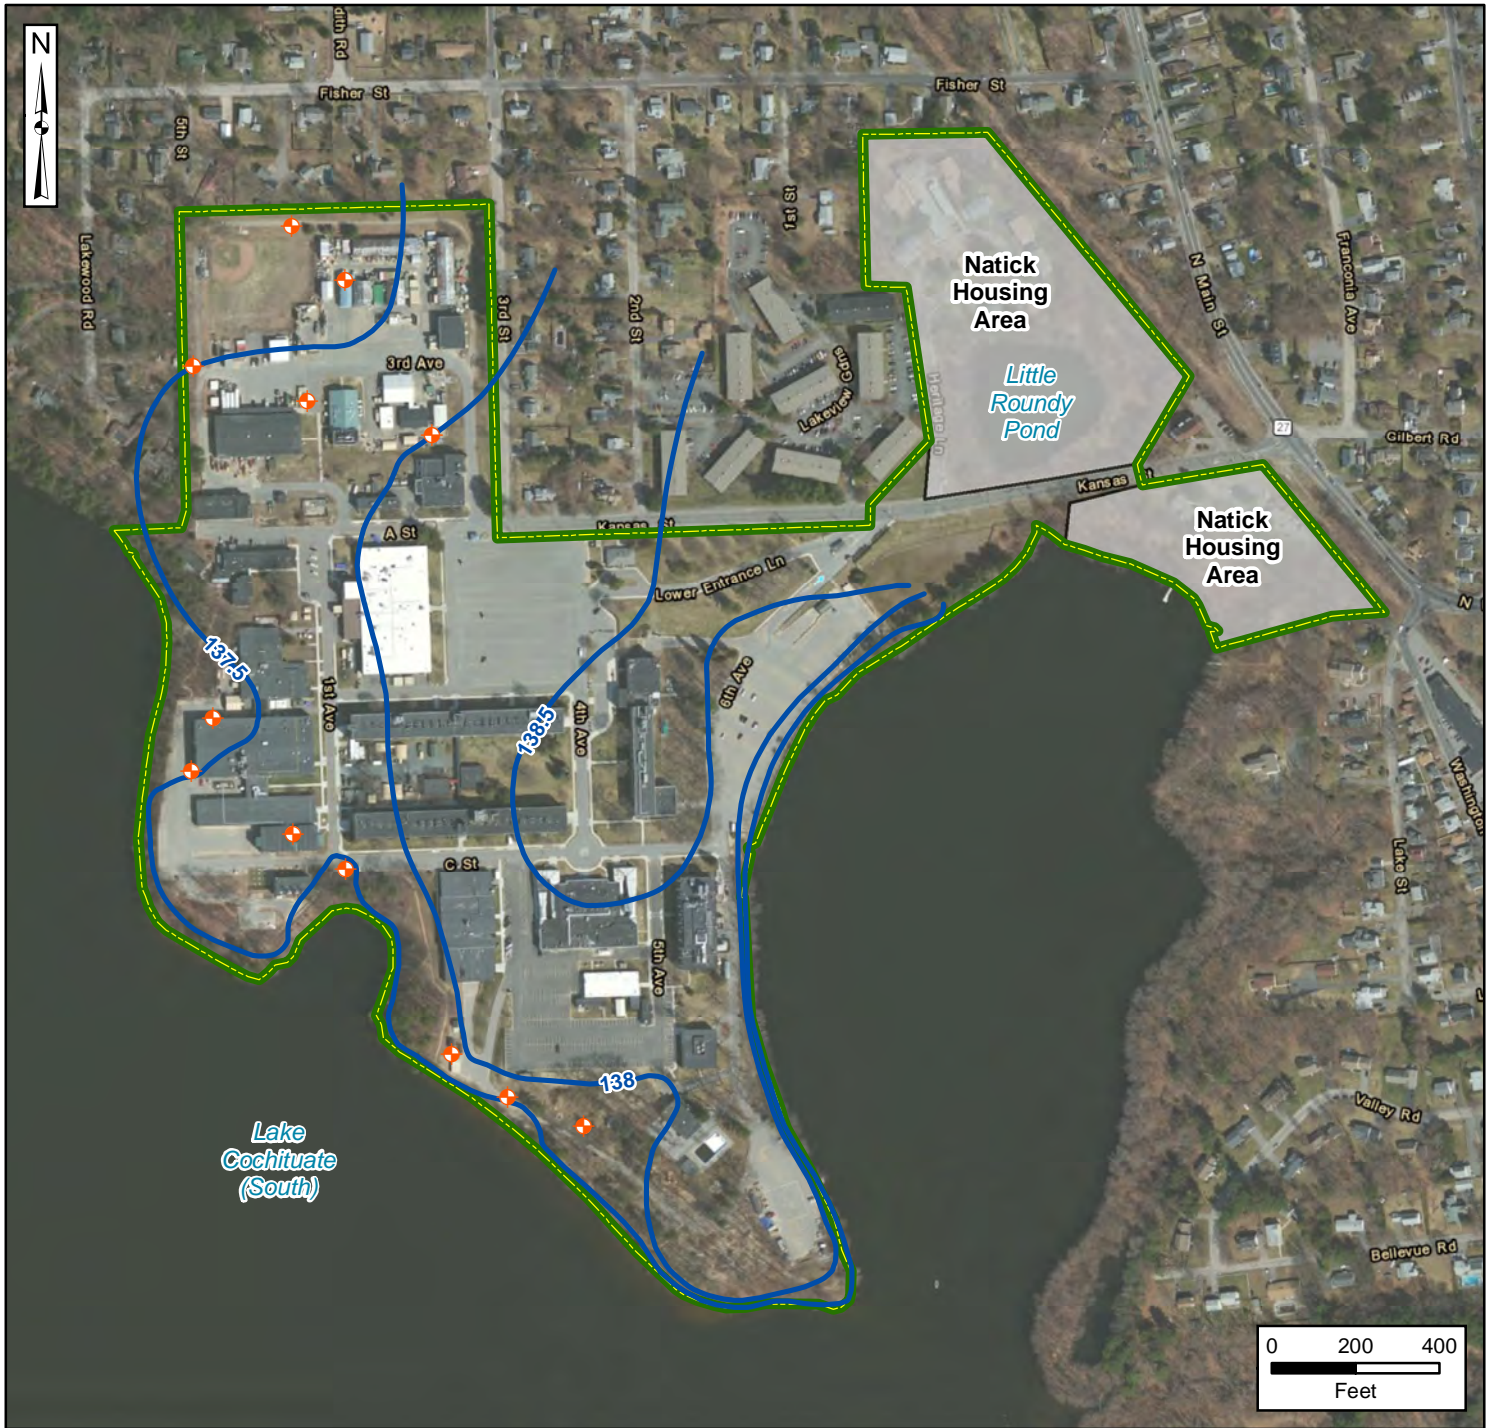
Figure 2-4a
Shallow Table Aquifer Groundwater Flow Map

- Installation Boundary
- Natick Housing Area
- Groundwater Elevation Contour (ft) (Nov. 27, 2017)
- Extraction Well

Note: Potentiometric contours and wells were obtained from the following report:
Plexus, 2018. Draft Groundwater Monitoring Event 75 and 2017 Groundwater Extraction and Treatment System Annual Report, U.S. Army Soldier Systems Center, Natick, Massachusetts. May.

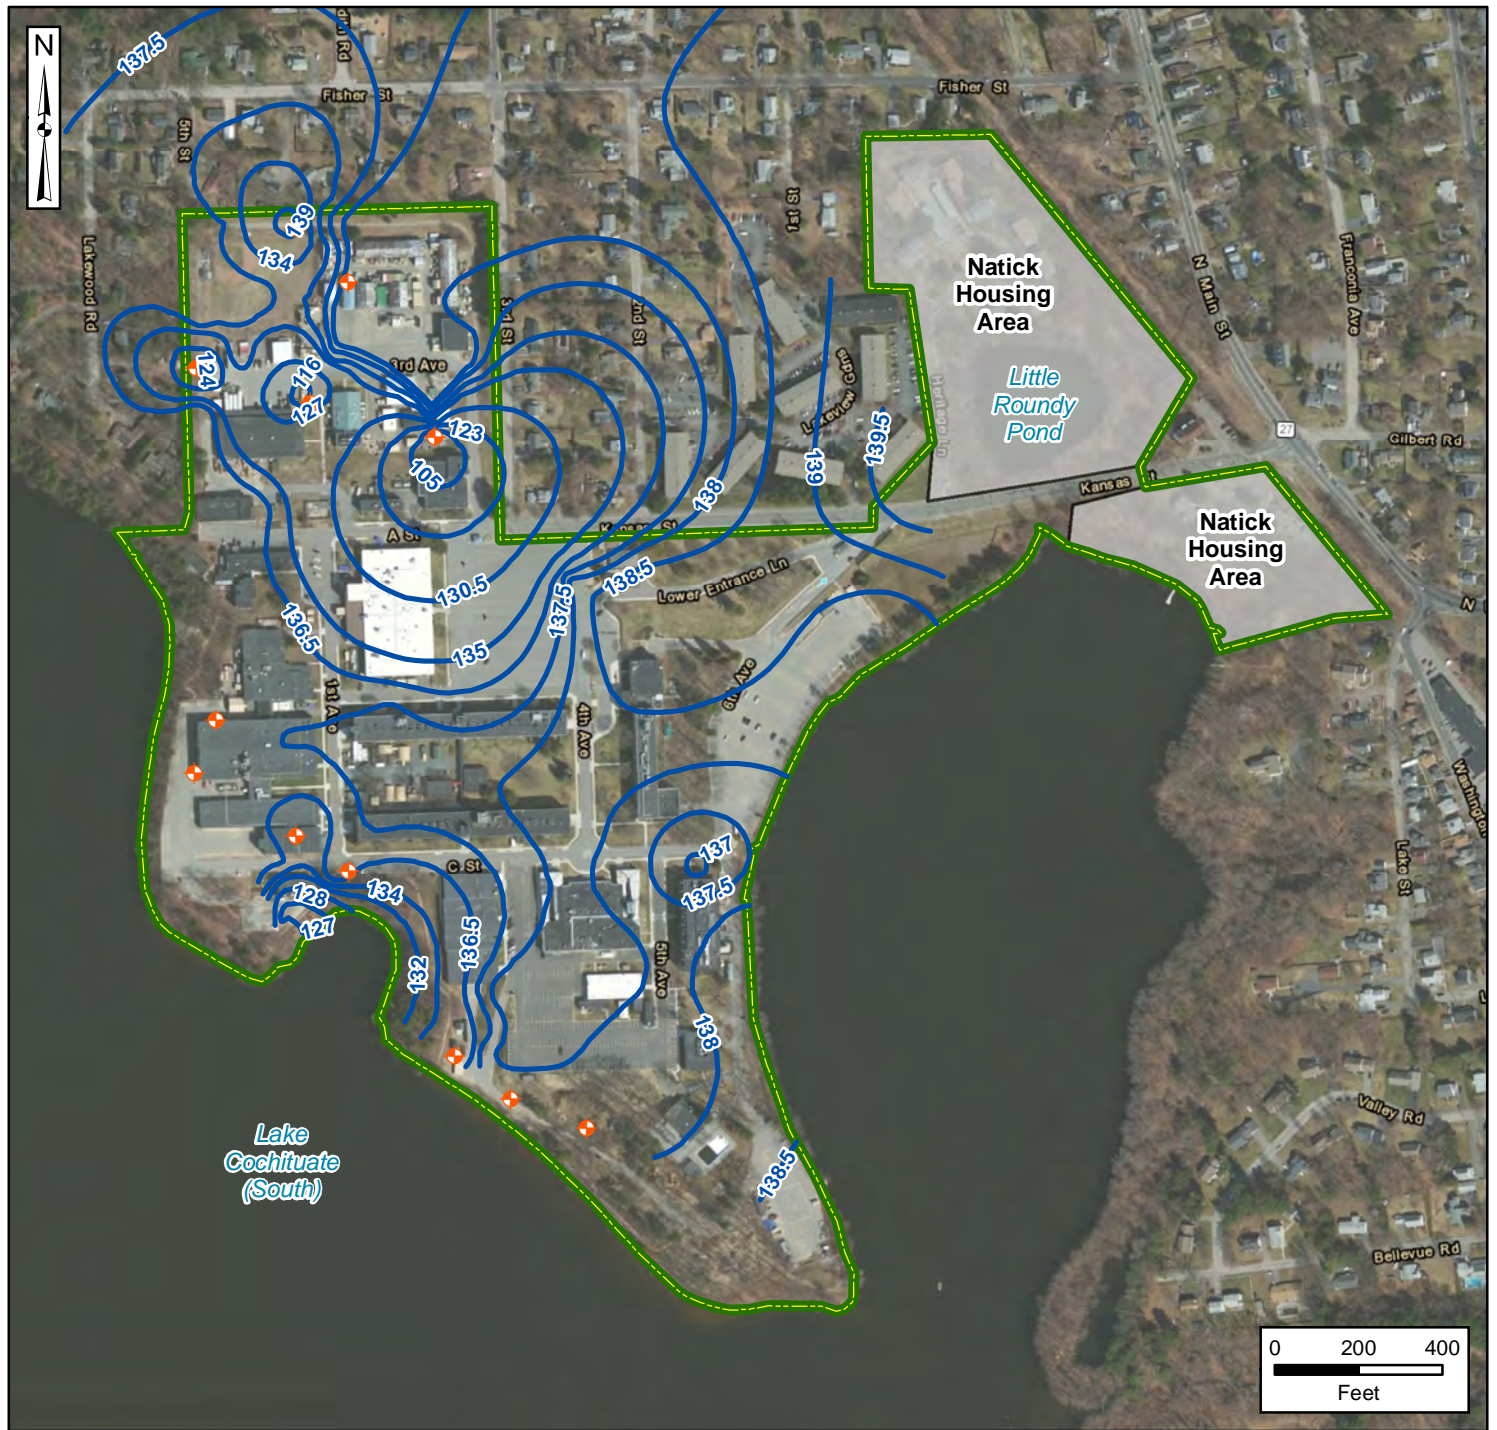
Figure 2-4b
Deep Overburden Aquifer Groundwater Flow Map

- Installation Boundary
- Natick Housing Area
- Groundwater Elevation Contour (ft) (Nov. 27, 2017)
- Extraction Well

Note: Potentiometric contours and wells were obtained from the following report:
Plexus, 2018. Draft Groundwater Monitoring Event 75 and 2017 Groundwater Extraction and Treatment System Annual Report, U.S. Army Soldier Systems Center, Natick, Massachusetts. May.

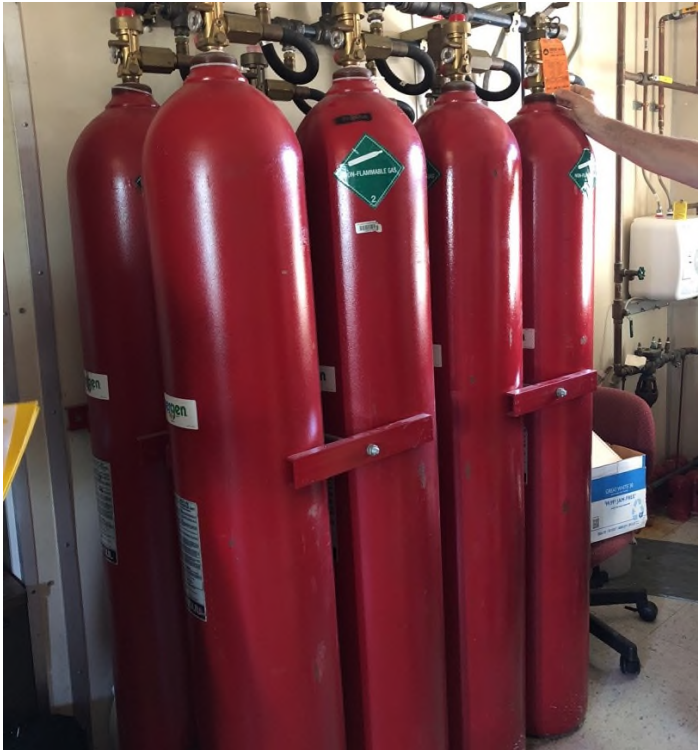
Photograph: 1

Fire Suppression System located outside of Small Hazardous Waste Storage Area.

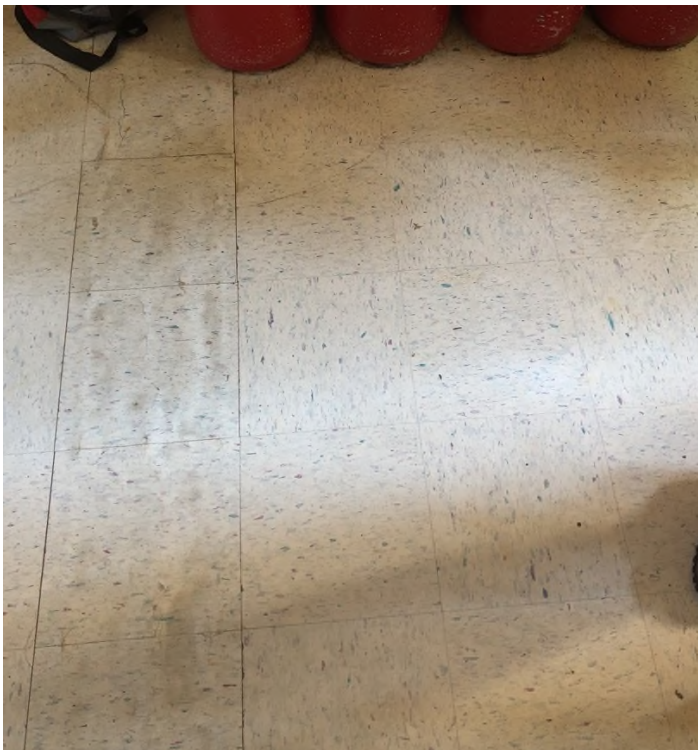
Photograph: 2

Condition of floor near fire suppression system located outside of Small Hazardous Waste Storage Area.

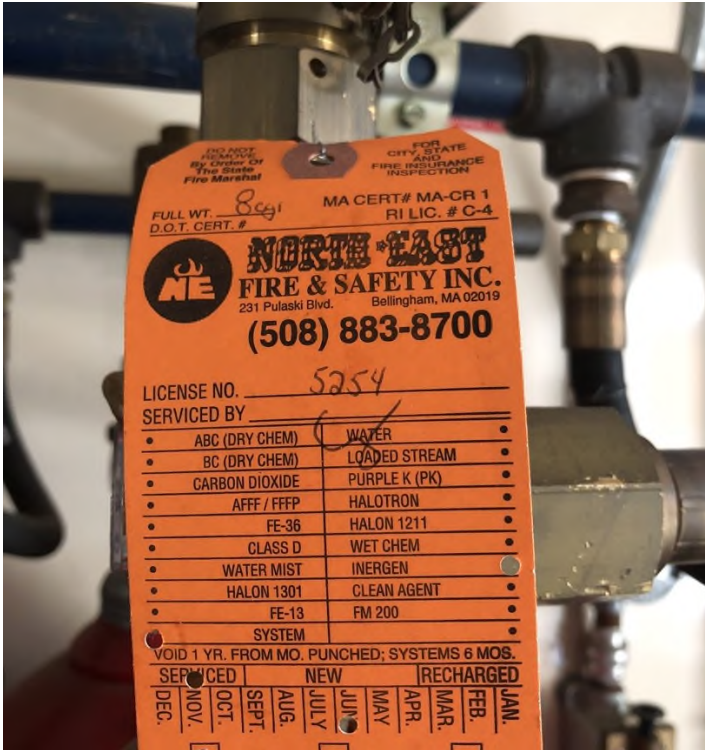
Photograph: 3

Fire Suppression System descriptor tag on fire suppression system located outside of Small Hazardous Waste Storage Area.

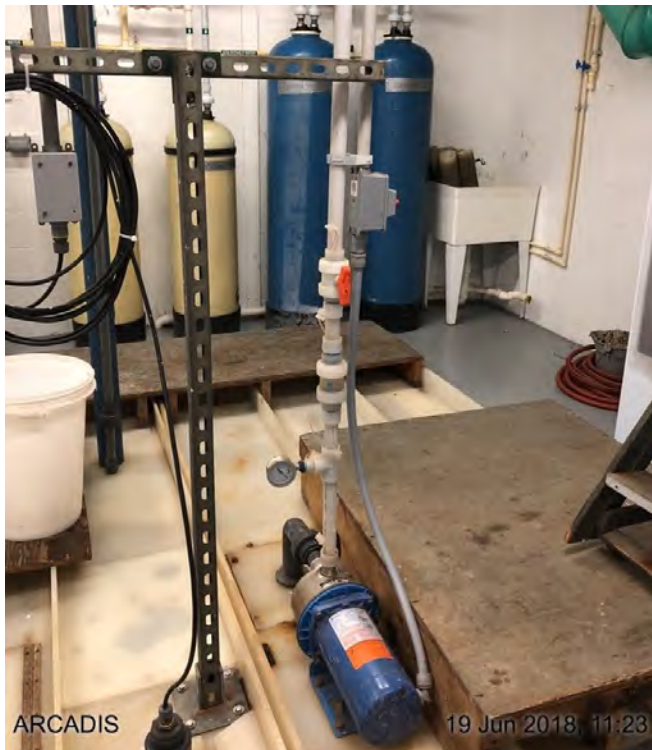
Photograph: 6

Description:
Mercury reduction treatment system with carbon filtration and ion exchange resin.

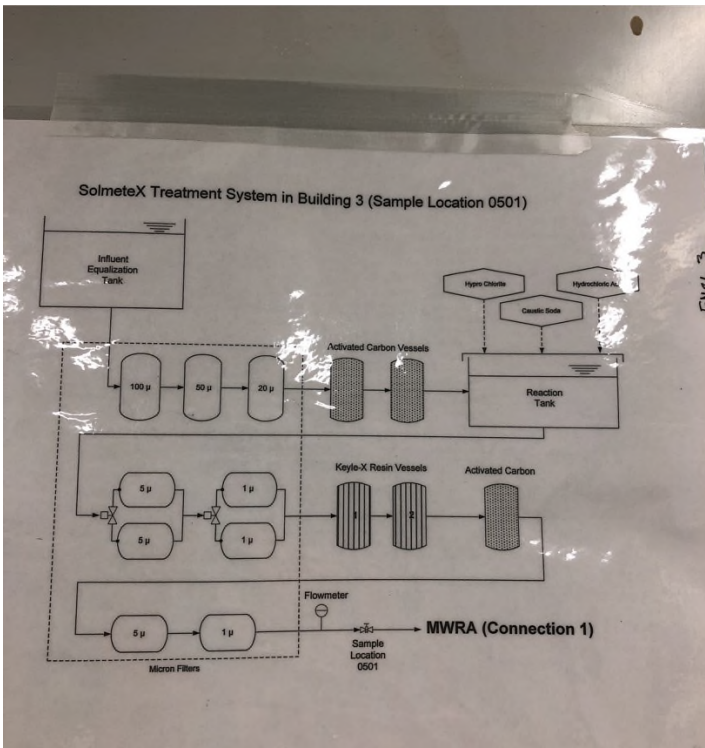
Photograph: 8

Description:
Mercury reduction treatment system with carbon filtration and ion exchange resin. System layout.

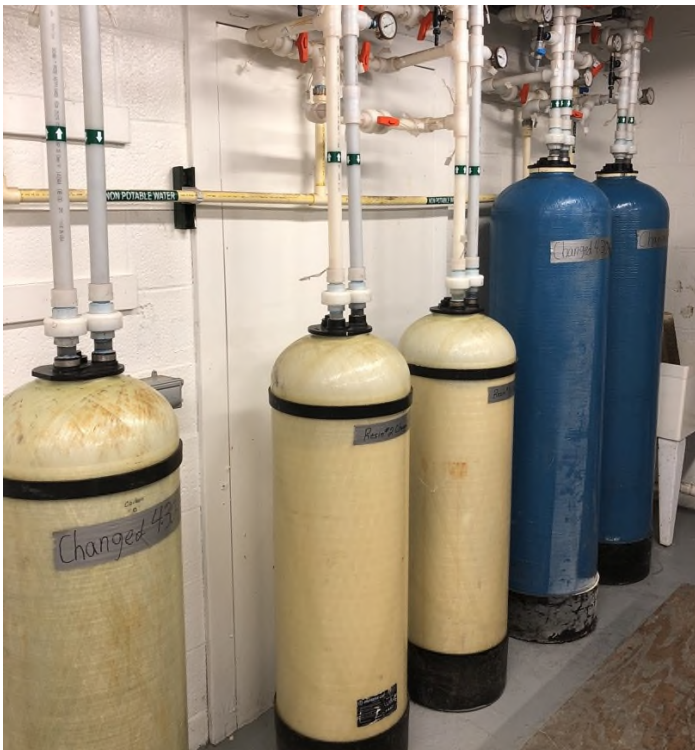
Photograph: 10

Description:
Mercury reduction
treatment system with
carbon filtration and ion
exchange resin.
Carbon filters.

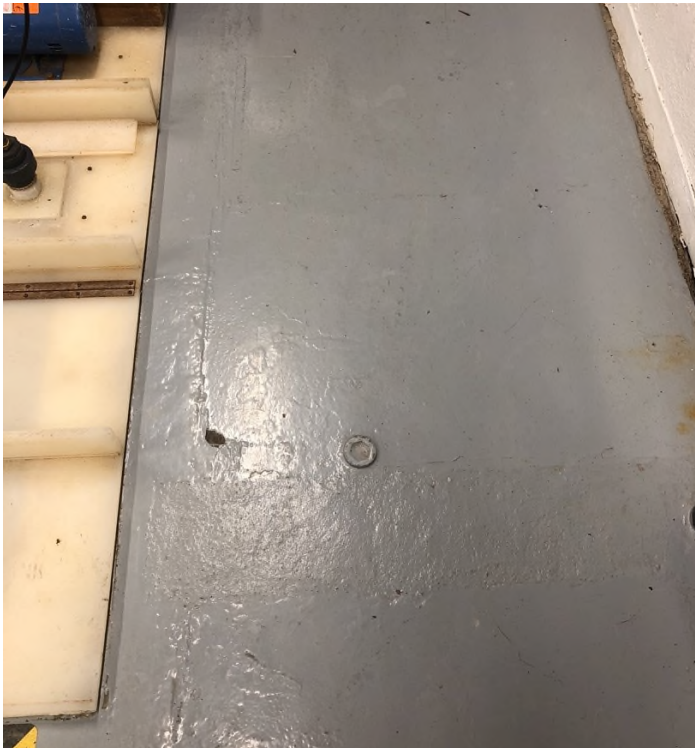
Photograph: 12

Description:
Mercury reduction treatment system with carbon filtration and ion exchange resin. Floor condition.

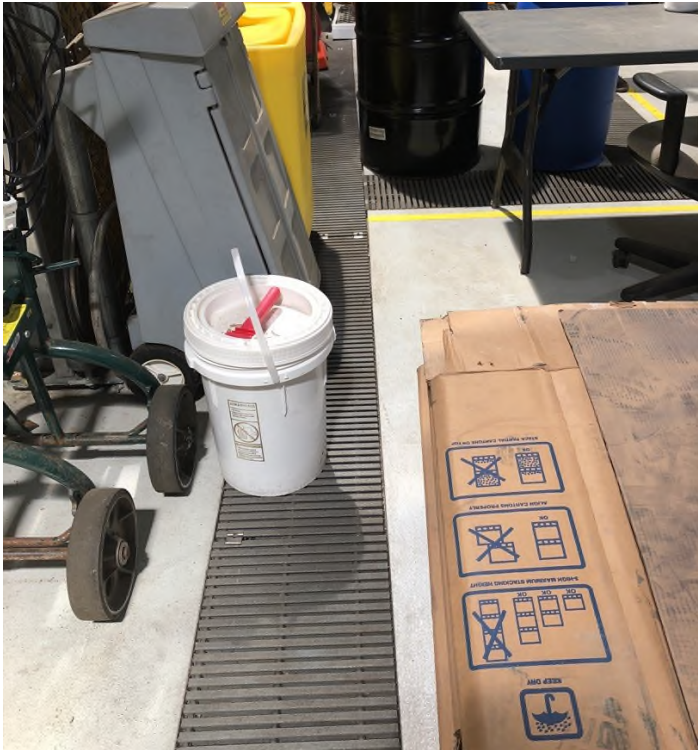
Photograph: 15

Description:
Bulk Hazardous Waste
Storage Facility.
Floor sumps.

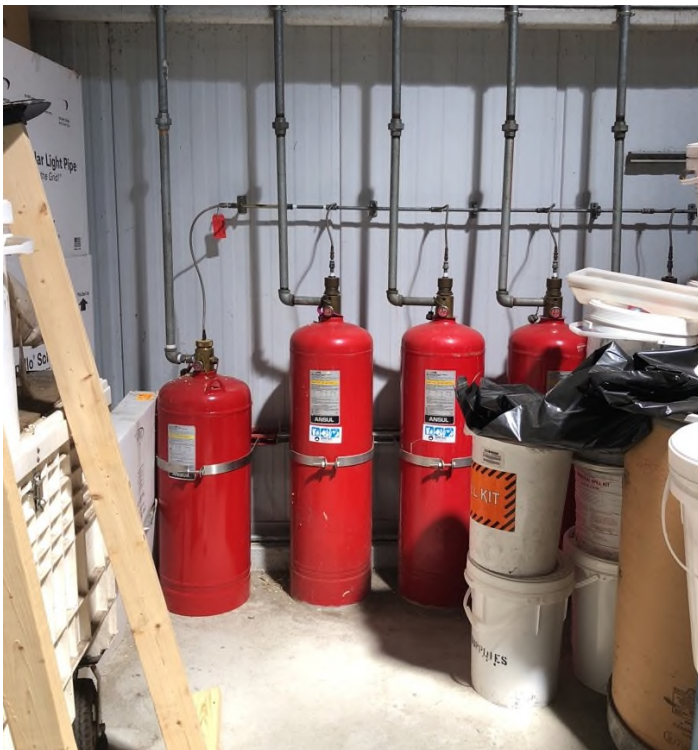
Photograph: 16

Description:
Bulk Hazardous Waste
Storage Facility. Fire
Suppression System.

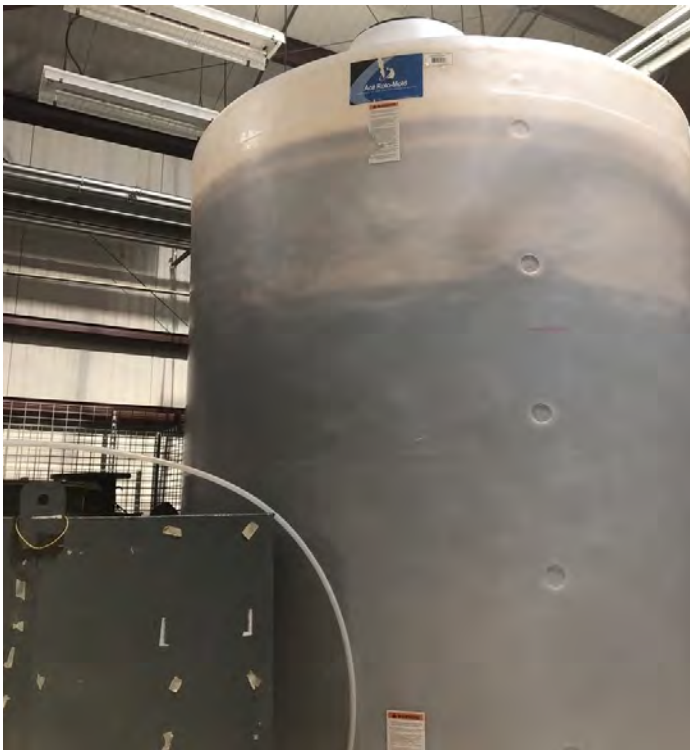
Photograph: 20

Description:
Tank in CERCLA Site
Groundwater Extraction
and Treatment System
(GWETS) Building.

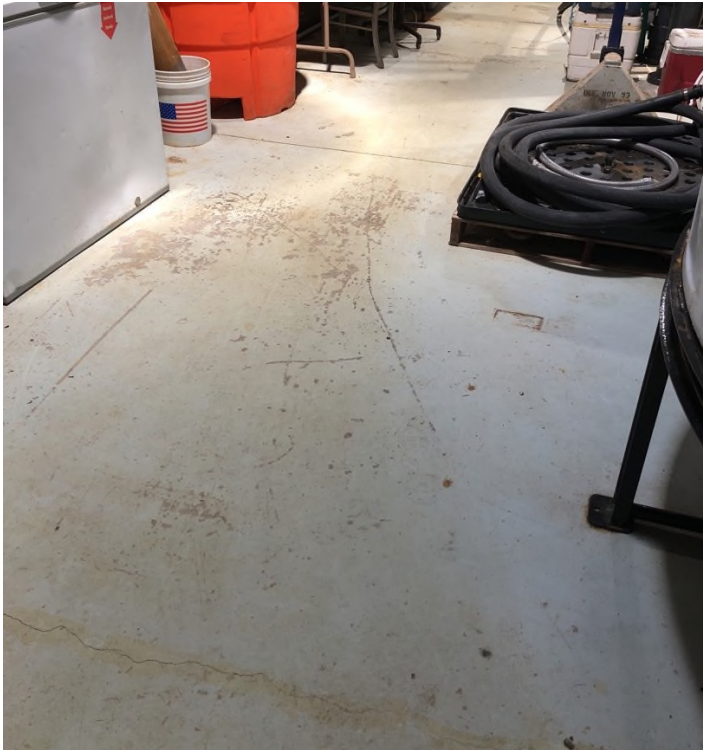
Photograph: 23

Description:
CERCLA Site
Groundwater Extraction
and Treatment System
(GWETS) Building.
Floor condition.

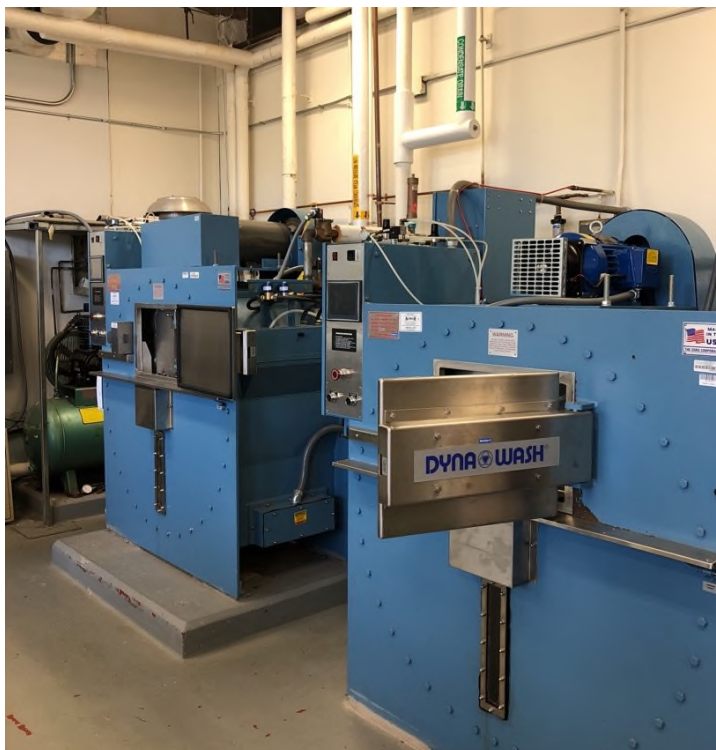
Photograph: 28

Description:
Laundry machines in
Navy Clothing and
Textile Research
Facility Laboratory.
