FINAL PRELIMINARY ASSESSMENT AND SITE INSPECTION OF PER- AND POLYFLUOROALKYL SUBSTANCES

Pohakuloa Training Area and Kilauea Military Reservation, Hawaii

July 2023

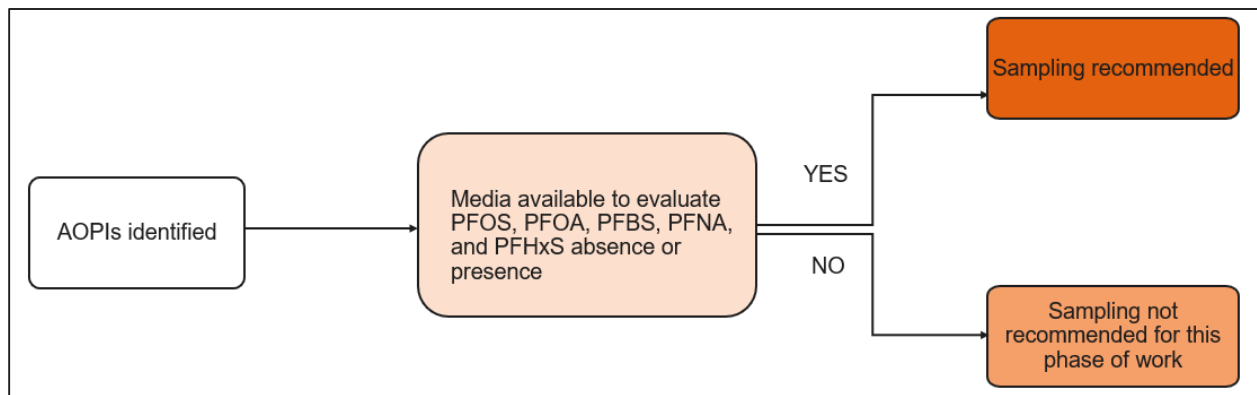
Figure 6-1: AOPi Sampling Decision Tree

The rationale for sampling at each AOPI is illustrated on **Figure 6-1** below.

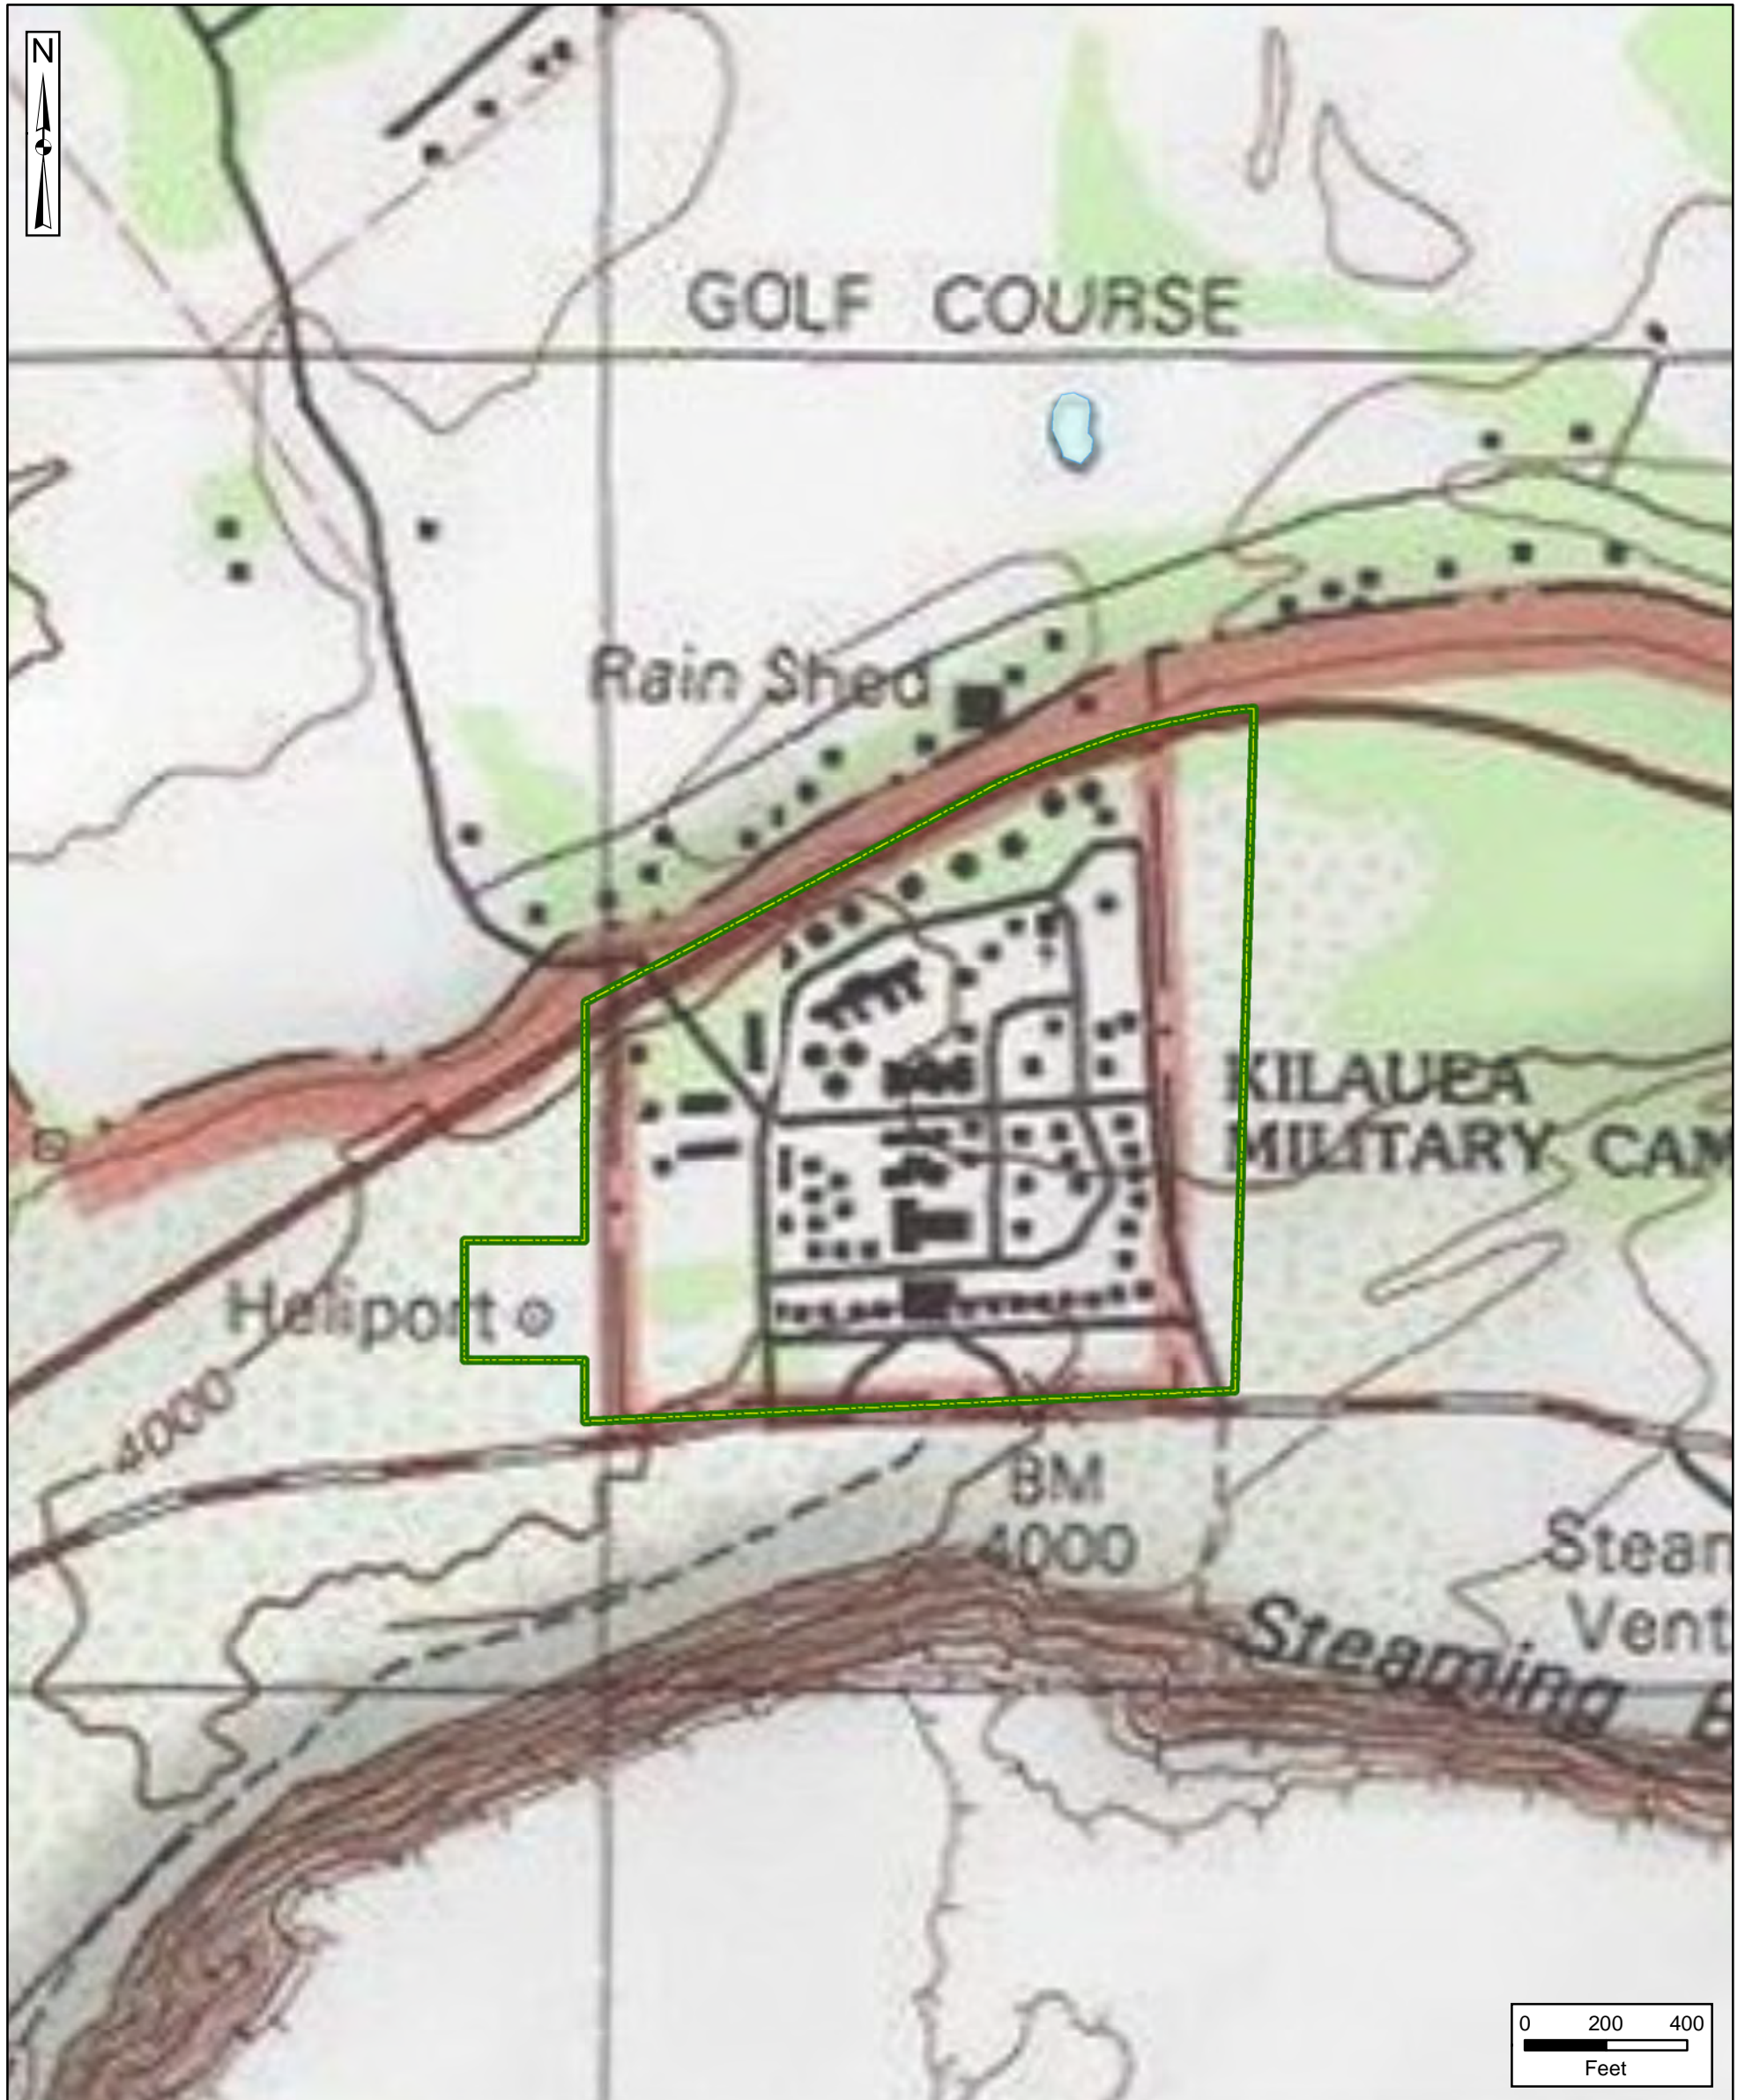
Figure 2-7
 KMR Topographic Map

At an elevation of 4,000 feet amsl, KMR is surrounded by the gentle southeast slope of Mauna Loa and the steep bluffs at the northern rim of Kilauea Caldera (**Figure 2-7**) (TLI 2007).

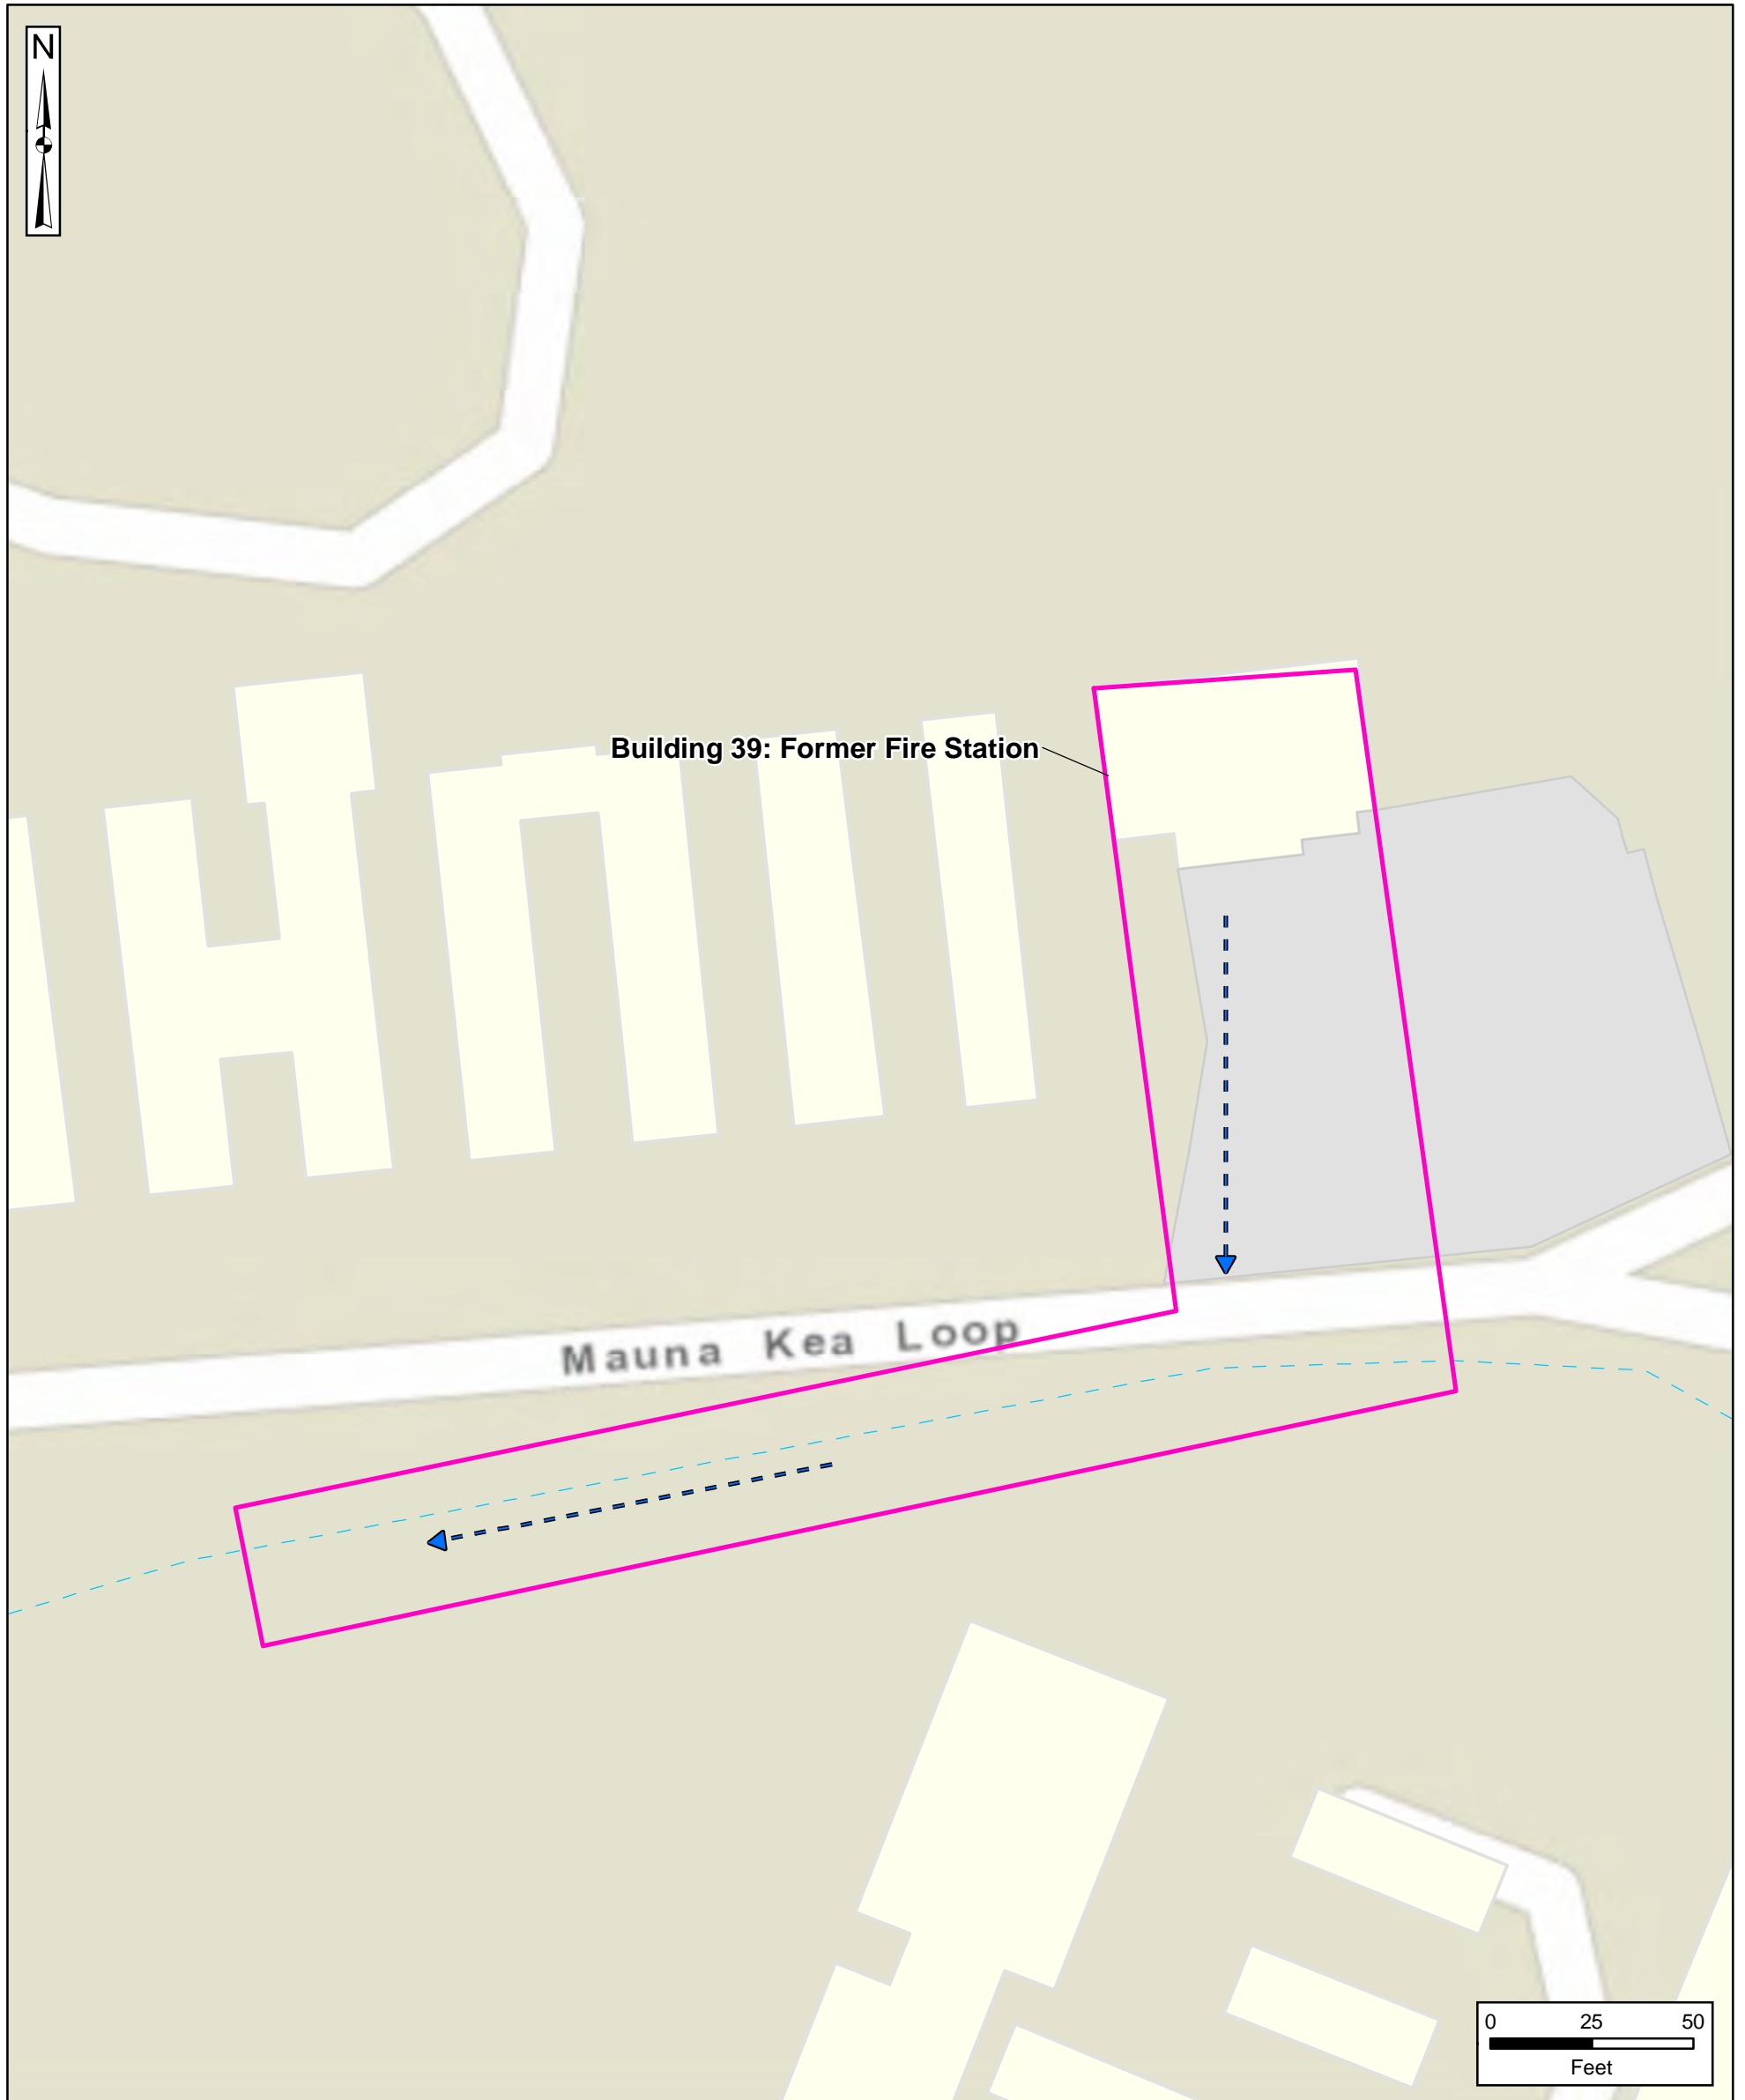
Figure 5-3
Building 39: Former Fire Station

The Building 39: Former Fire Station is identified as an AOPI following records research, personnel interviews, and site reconnaissance due to historical use of PFAS-containing materials and/or AFFF (**Figure 5-3**). Building 39 was operated as a fire station from 1969 through approximately 1996. AFFF was stored throughout the interior and exterior of the building, in various types of containers including, but not limited to, buckets and CONEX boxes. The buckets of AFFF were stacked vertically, which frequently resulted in the bottom buckets becoming cracked due to the weight of the buckets above. Fire trucks were filled with AFFF on the fire station apron. Truck maintenance activities were also conducted at the station.

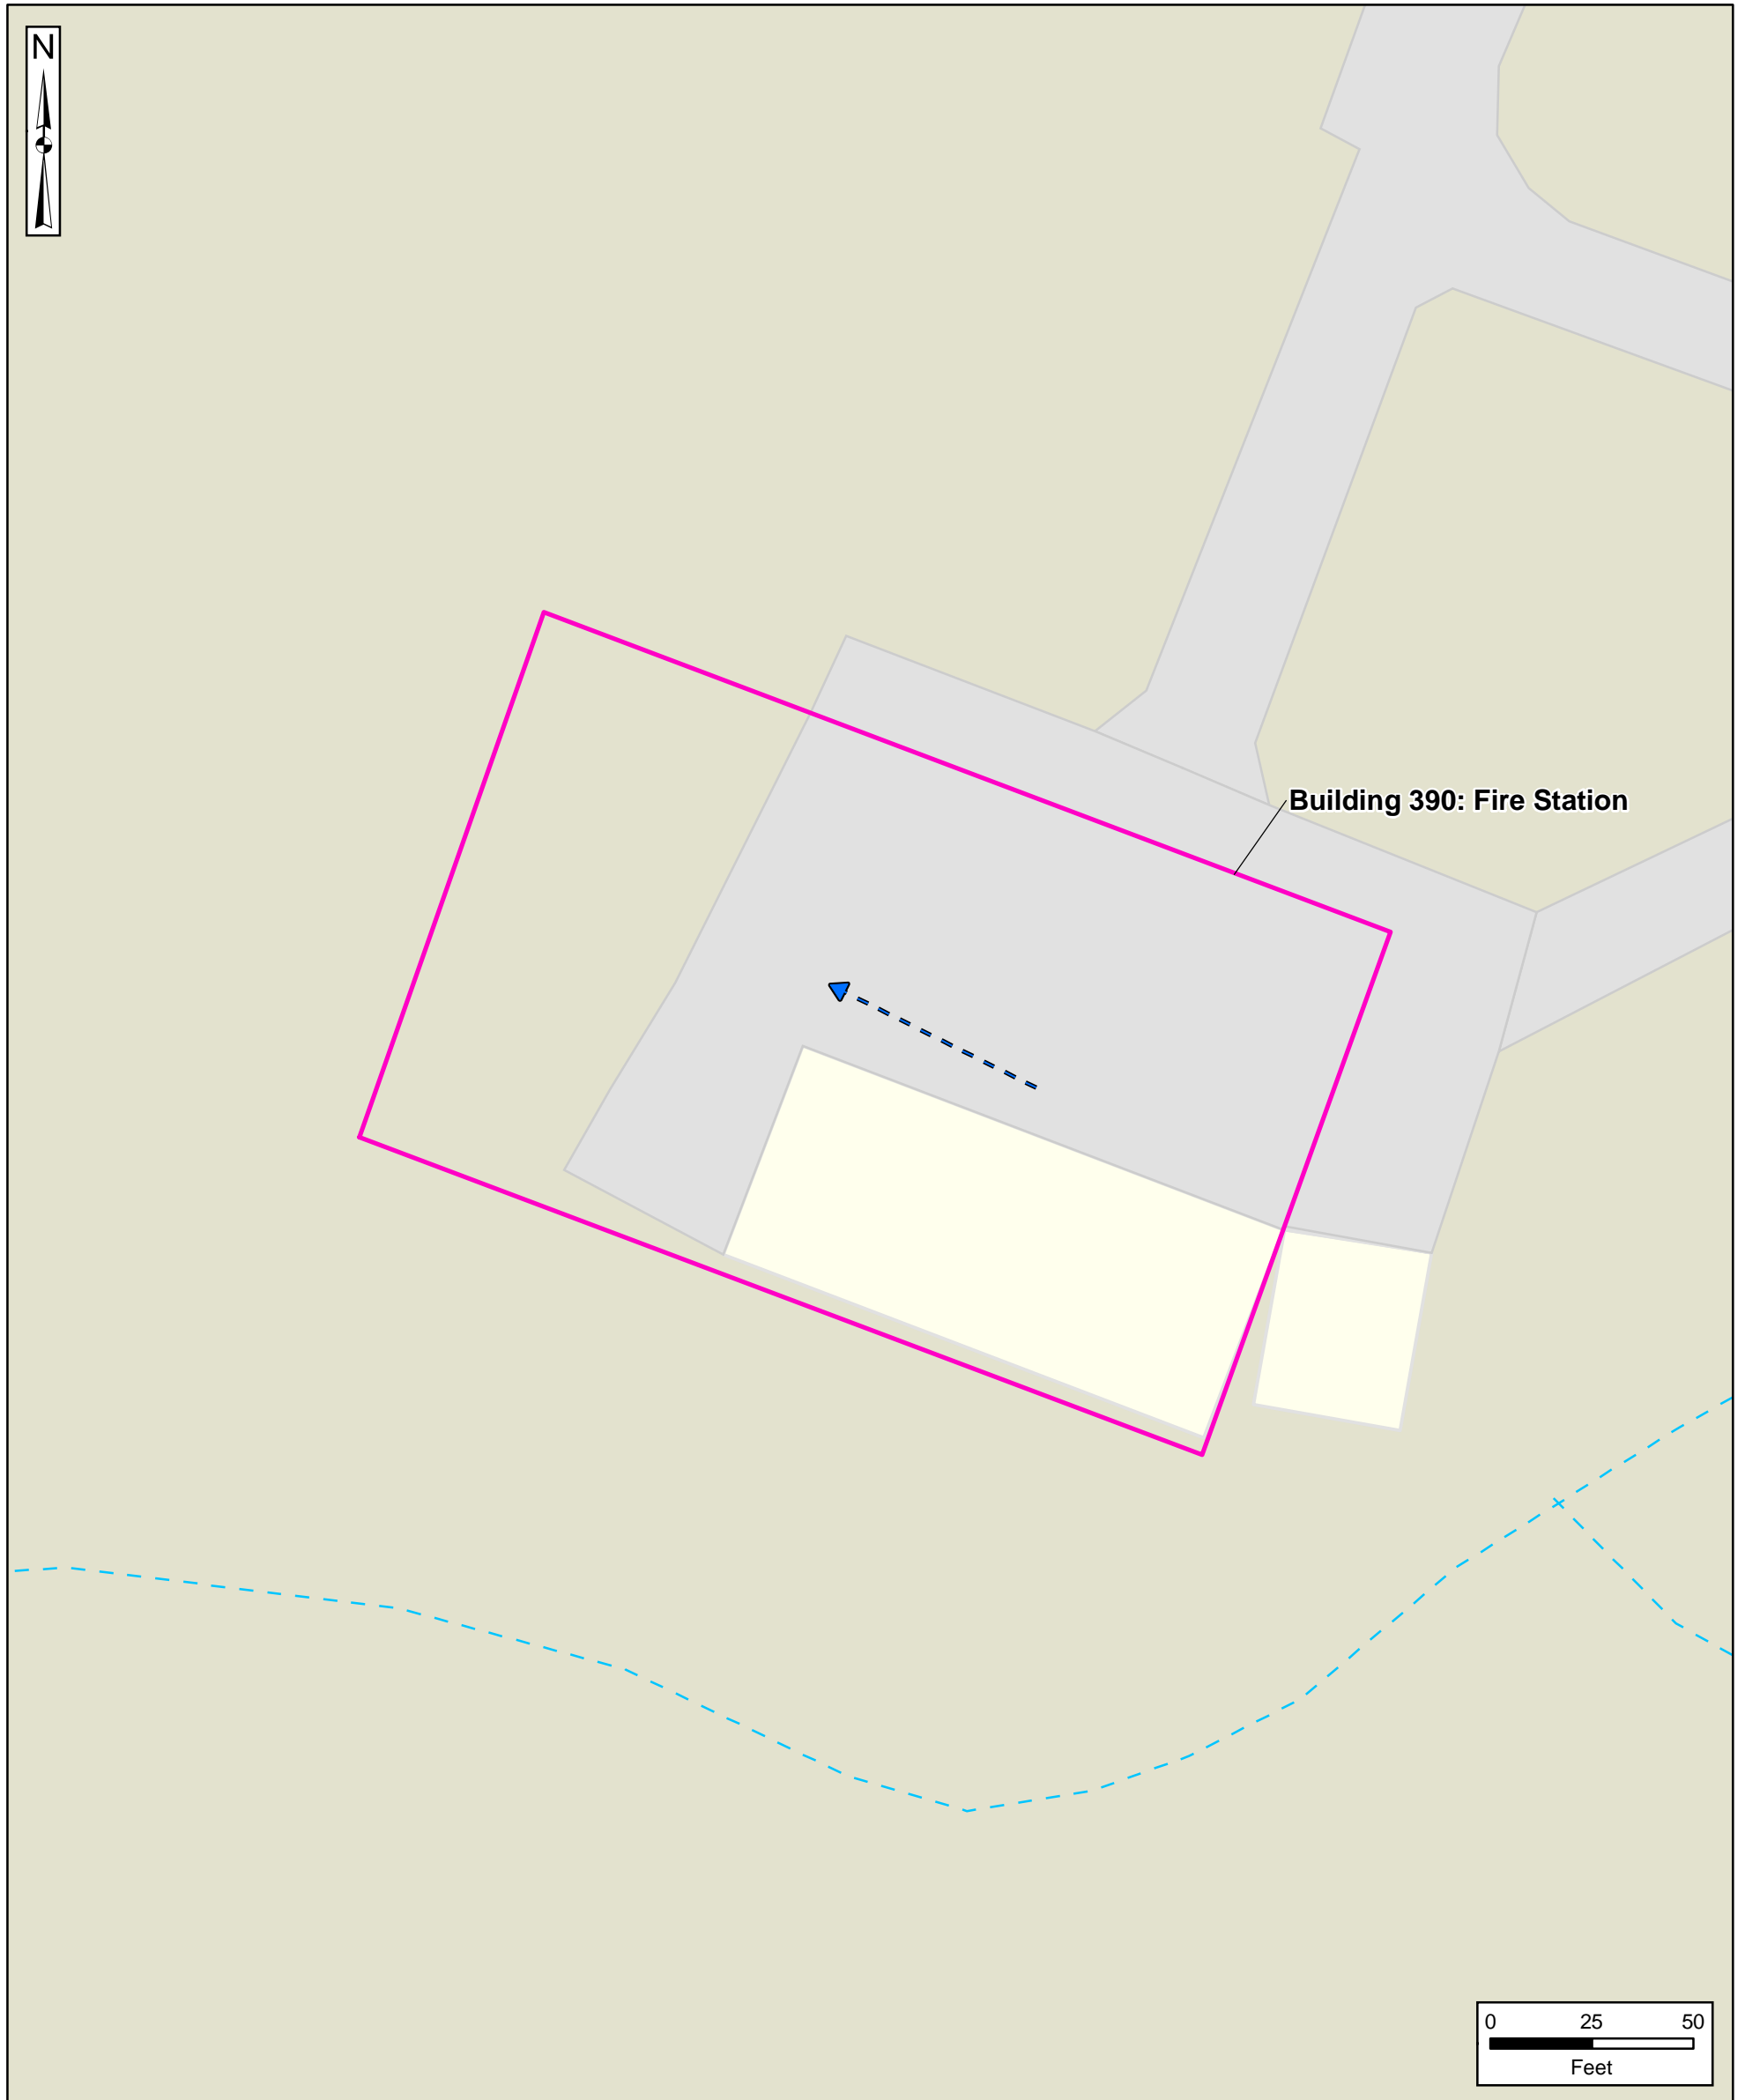
Figure 5-4
Building 390: Fire Station

The Building 390: Fire Station is identified as an AOPI following records research, personnel interviews, and site reconnaissance due to historical use of PFAS-containing materials and/or AFFF (**Figure 5-4**). The current fire station was constructed circa 1983 to 1985. AFFF has been stored throughout the interior and exterior of the building in various types of containers including, but not limited to, buckets and CONEX boxes. From approximately 1992 to 1999, spills were known to have occurred from buckets stacked on the exterior of the building. In 2019, there were approximately 310 gallons (sixty-two 5-gallon buckets) of AFFF stored in a shed west of the station building. The AFFF had been purchased approximately 8 years prior. Historically, truck maintenance activities were conducted at the station (until approximately 1999), and fire trucks were filled with AFFF on the fire station apron.

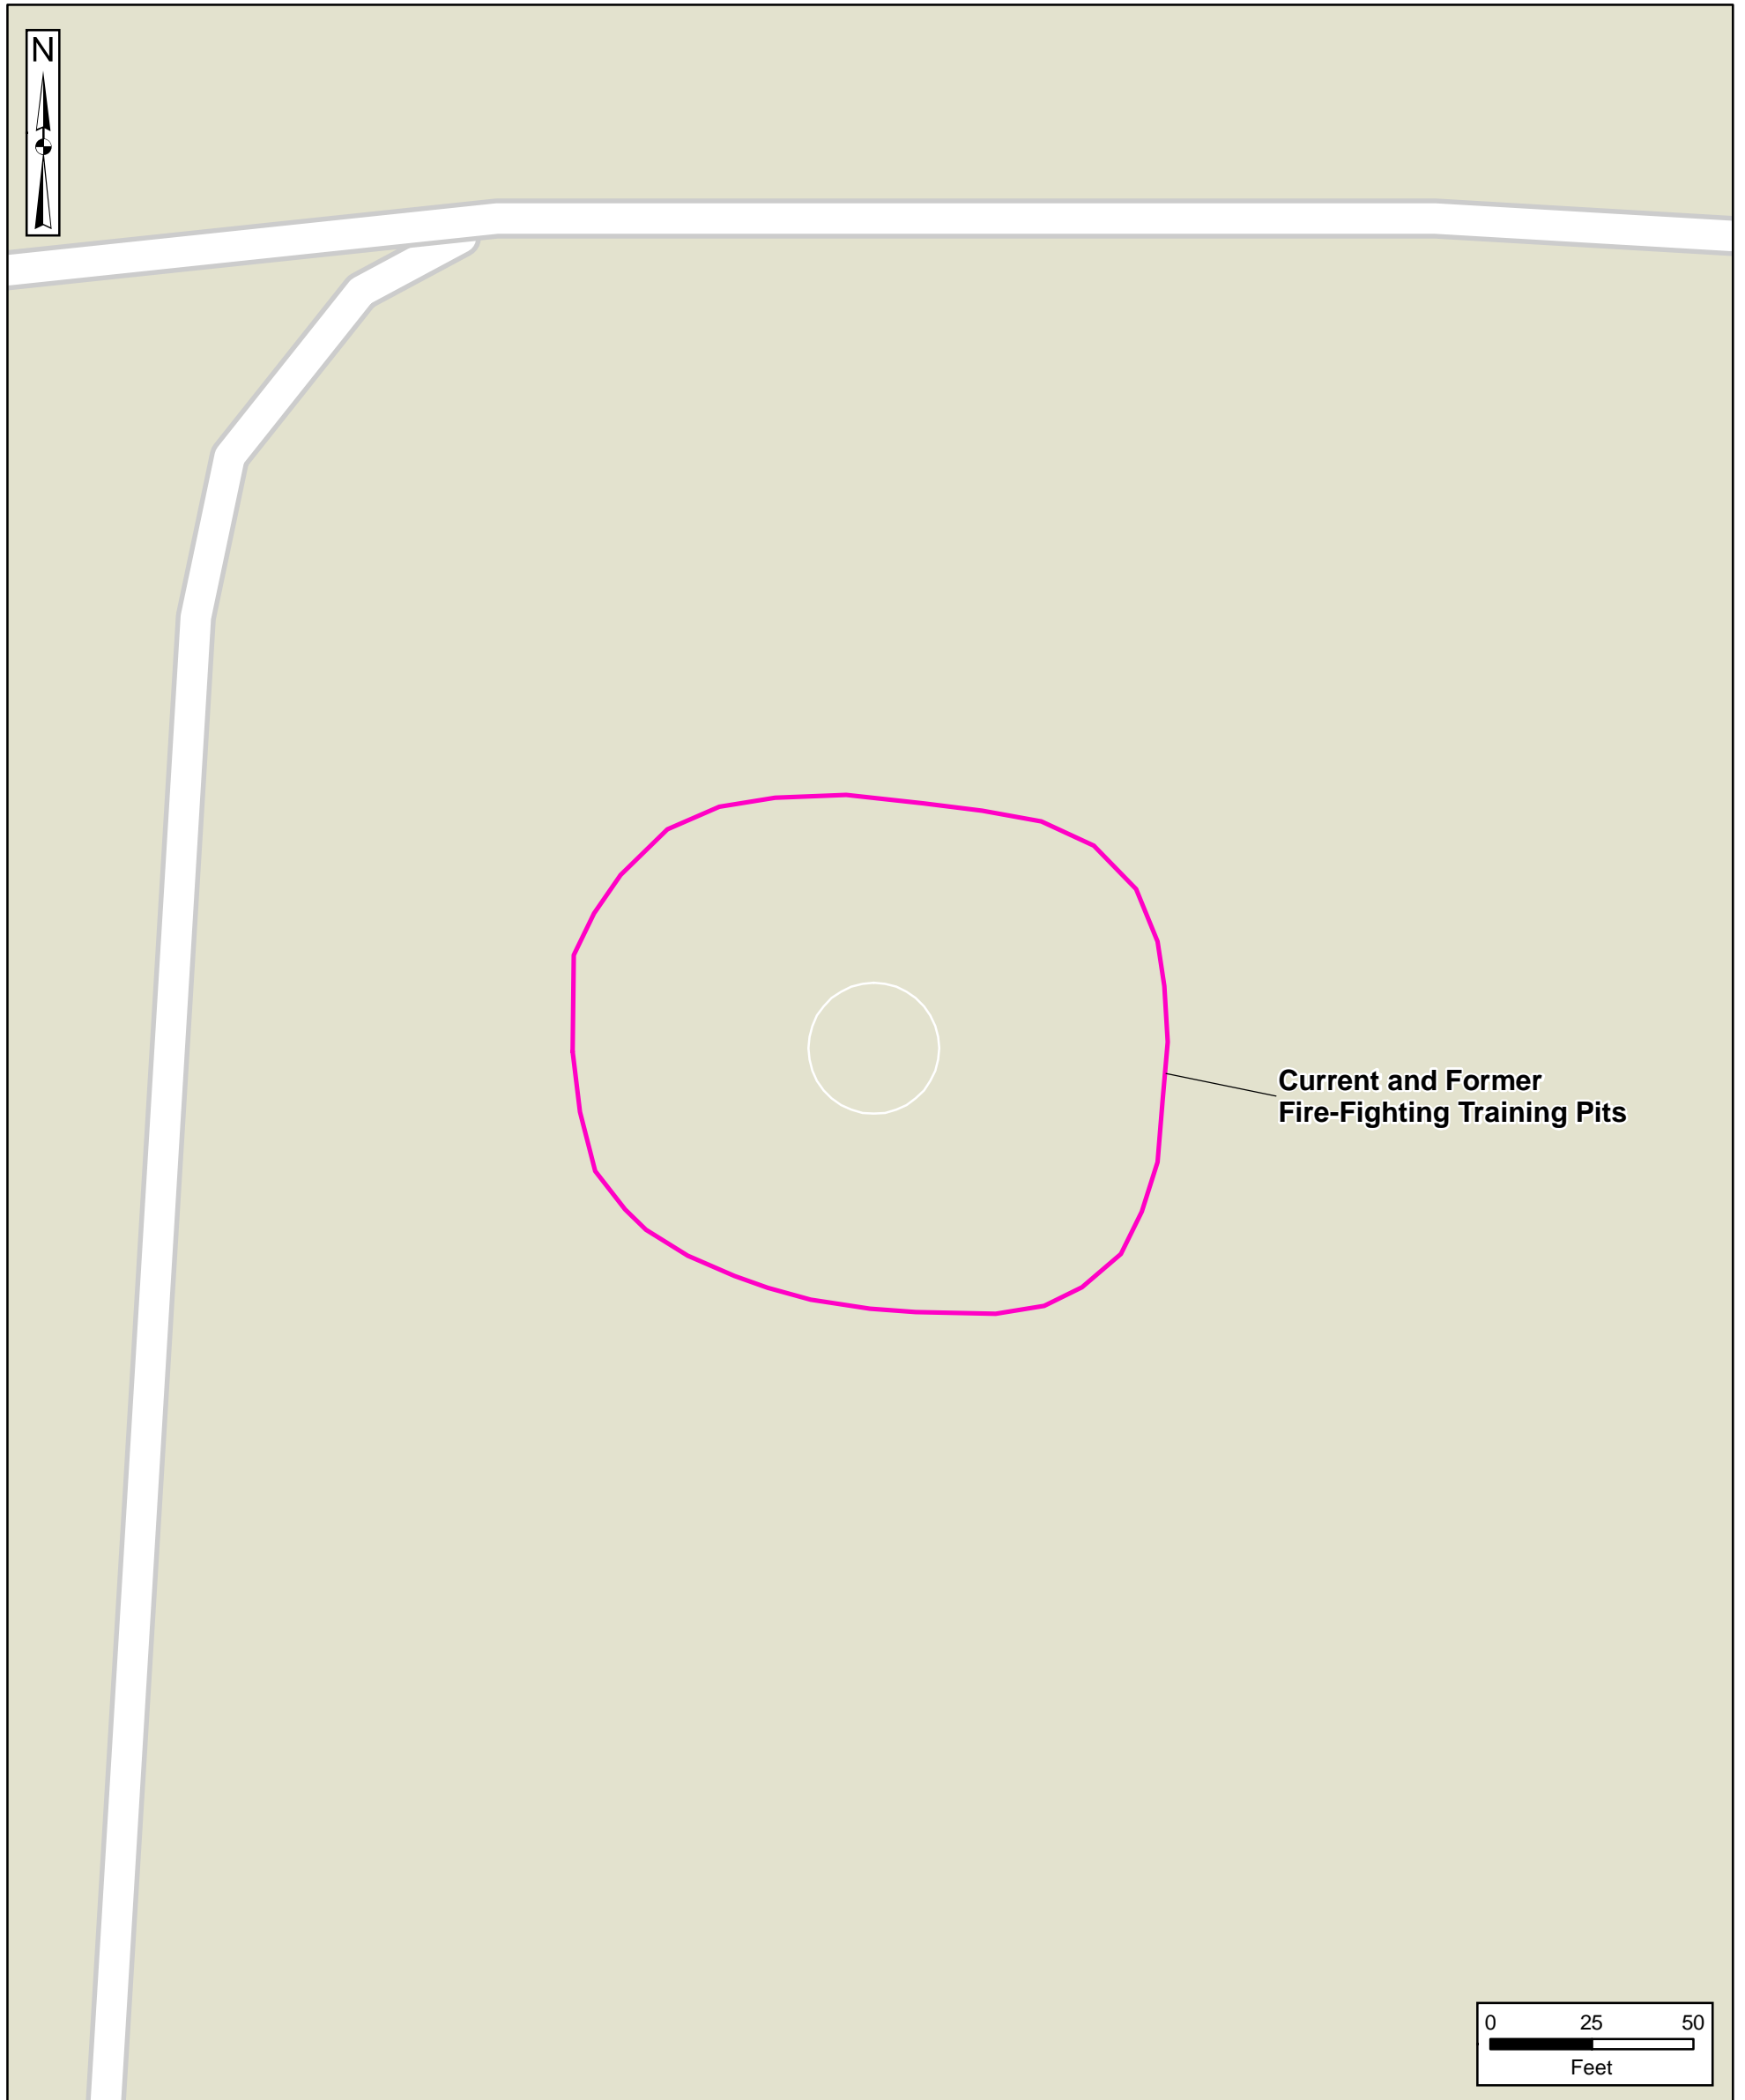
Figure 5-5
Current and Former Fire-Fighting Training Pits

The Current and Former Fire-Fighting Training Pits (HQAES:2216A.1001) is identified as an AOPI following records research, personnel interviews, and site reconnaissance due to historical firefighting training activities (**Figure 5-5**). Two iterations of fire-fighting training pits were used at PTA: a former pit that was used from an unknown date until 1984 and a newer pit that was constructed in 1984 and operated until 2003. The former pit was constructed with loose rubber plates covered with dirt, surrounded by an earthen berm. Flammable liquids that were poured into the burn pit during fire training exercises may have seeped into the underlying soil and bedrock along the unsealed plate seams. The former pit was decommissioned due to an unsuitable design for flammable liquids and access problems. In 1984, the pit was renovated by installing a concrete pit and covering the surrounding fire break with red

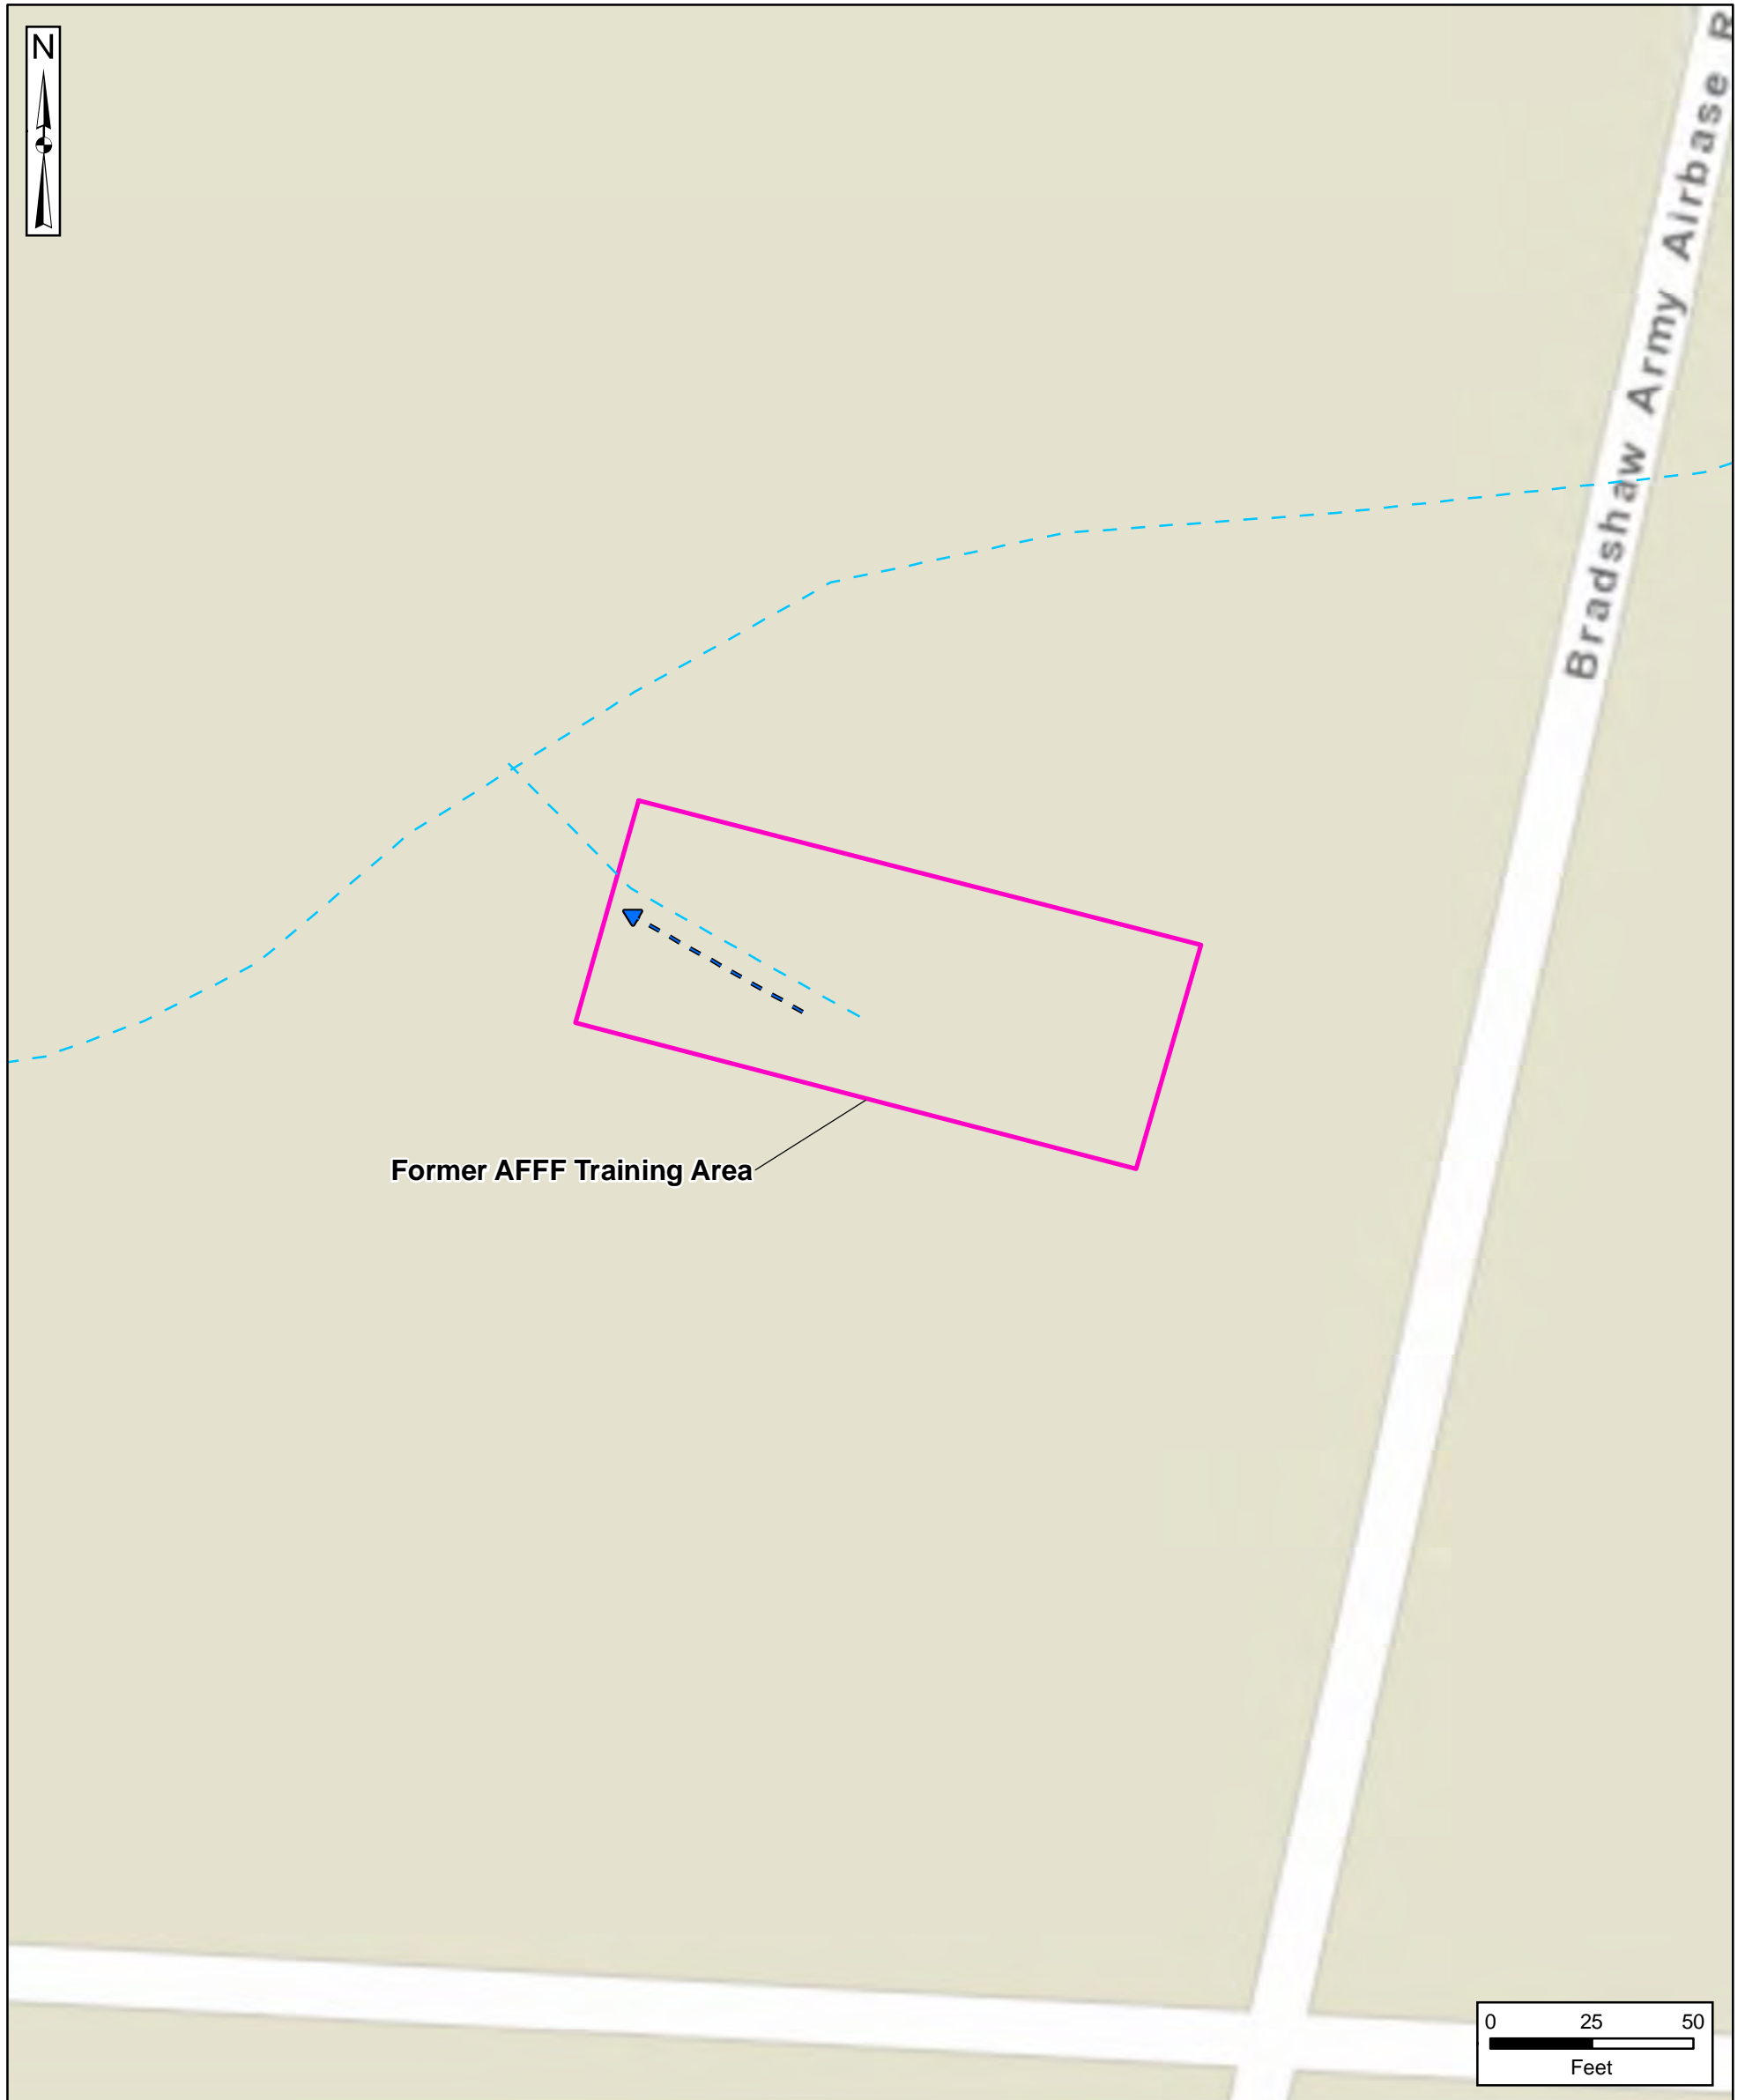
Figure 5-6
 Former AFFF Training Area

The Former AFFF Training Area is identified as an AOPI following records research, personnel interviews, and site reconnaissance due to historical firefighting training activities (**Figure 5-6**). The Former AFFF Training Area, located near the Bradshaw Army Airfield control tower, was used for firefighting training one to two times per year from approximately 1999 to 2009. Foam was sprayed towards and into a brush-filled drainage ditch.
