FINAL PRELIMINARY ASSESSMENT AND SITE INSPECTION OF PER- AND POLYFLUOROALKYL SUBSTANCES

Pohakuloa Training Area and Kilauea Military Reservation, Hawaii

July 2023

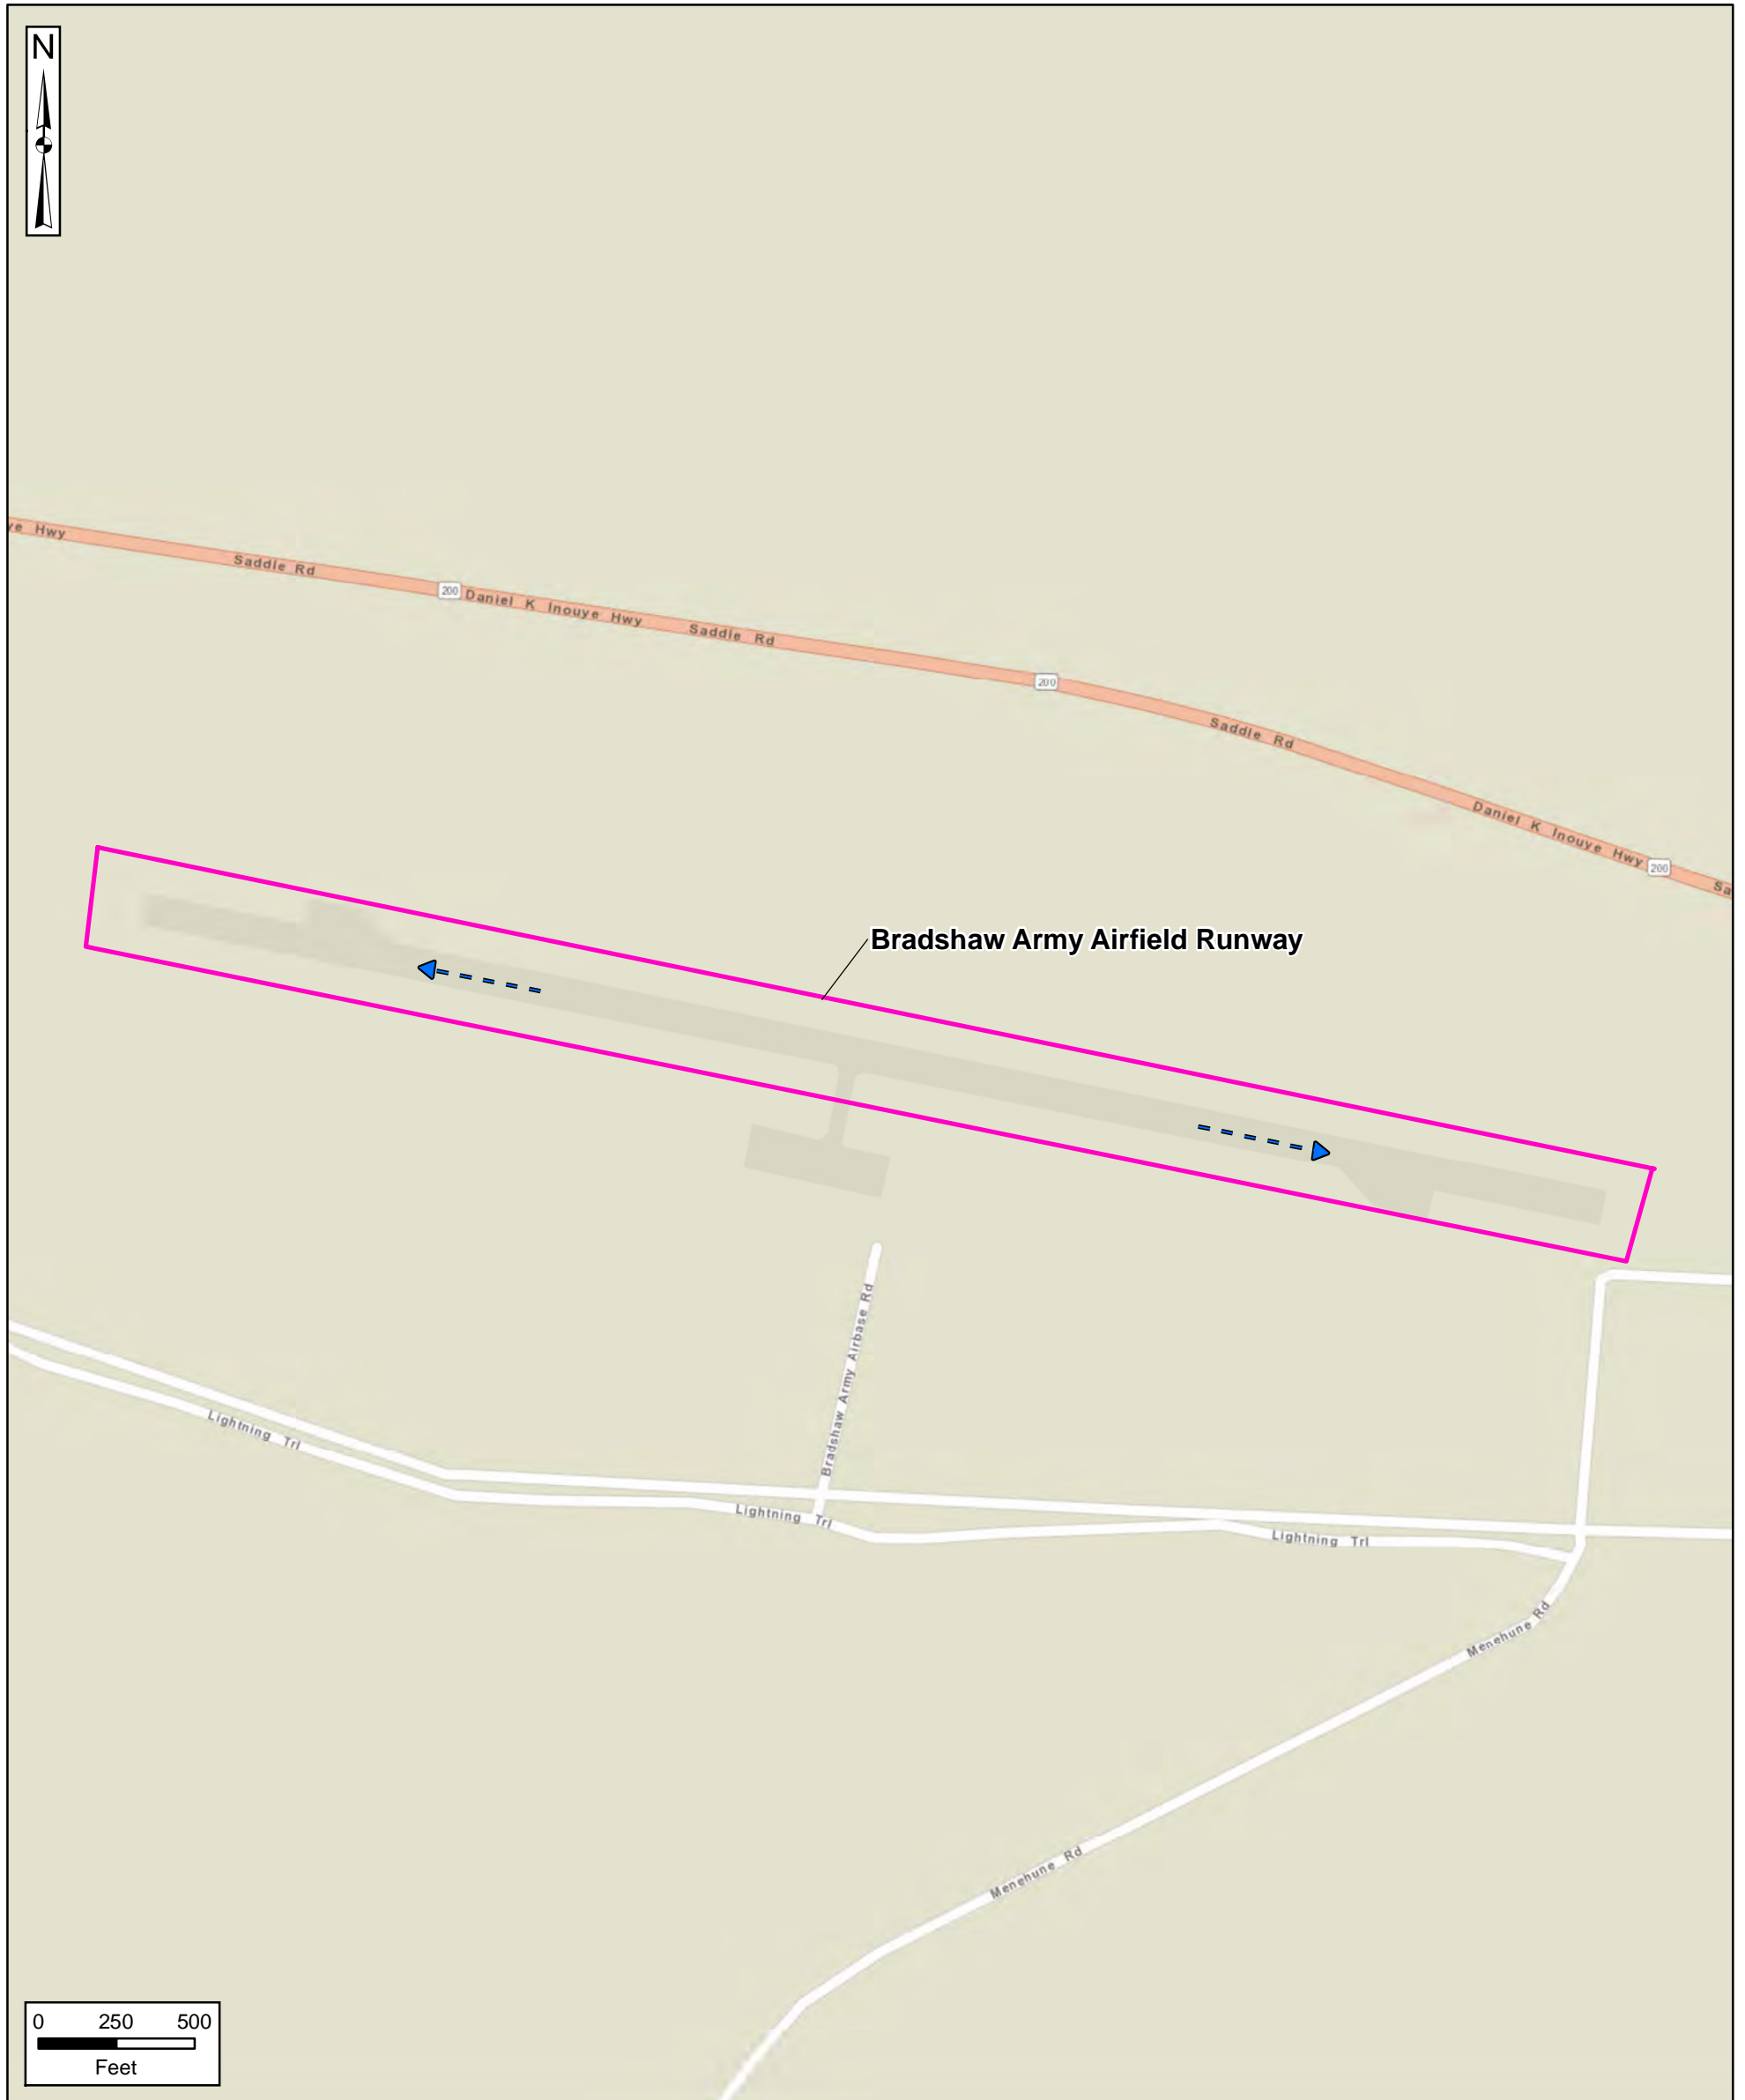
Figure 5-8
Bradshaw Army Airfield Runway

The Bradshaw Army Airfield Runway is identified as an AOPI following records research, personnel interviews, and site reconnaissance due to historical use and disposal of PFAS-containing materials (**Figure 5-8**). From 1992 to 1997, training exercises were performed on the Bradshaw Army Airfield Runway to empty PFAS-containing materials from fire truck reservoirs prior to performing truck plumbing maintenance. Training was performed throughout the runway; however, most of the training was likely conducted on the ends of the runway. The specific location of each training exercise depended on the wind direction.

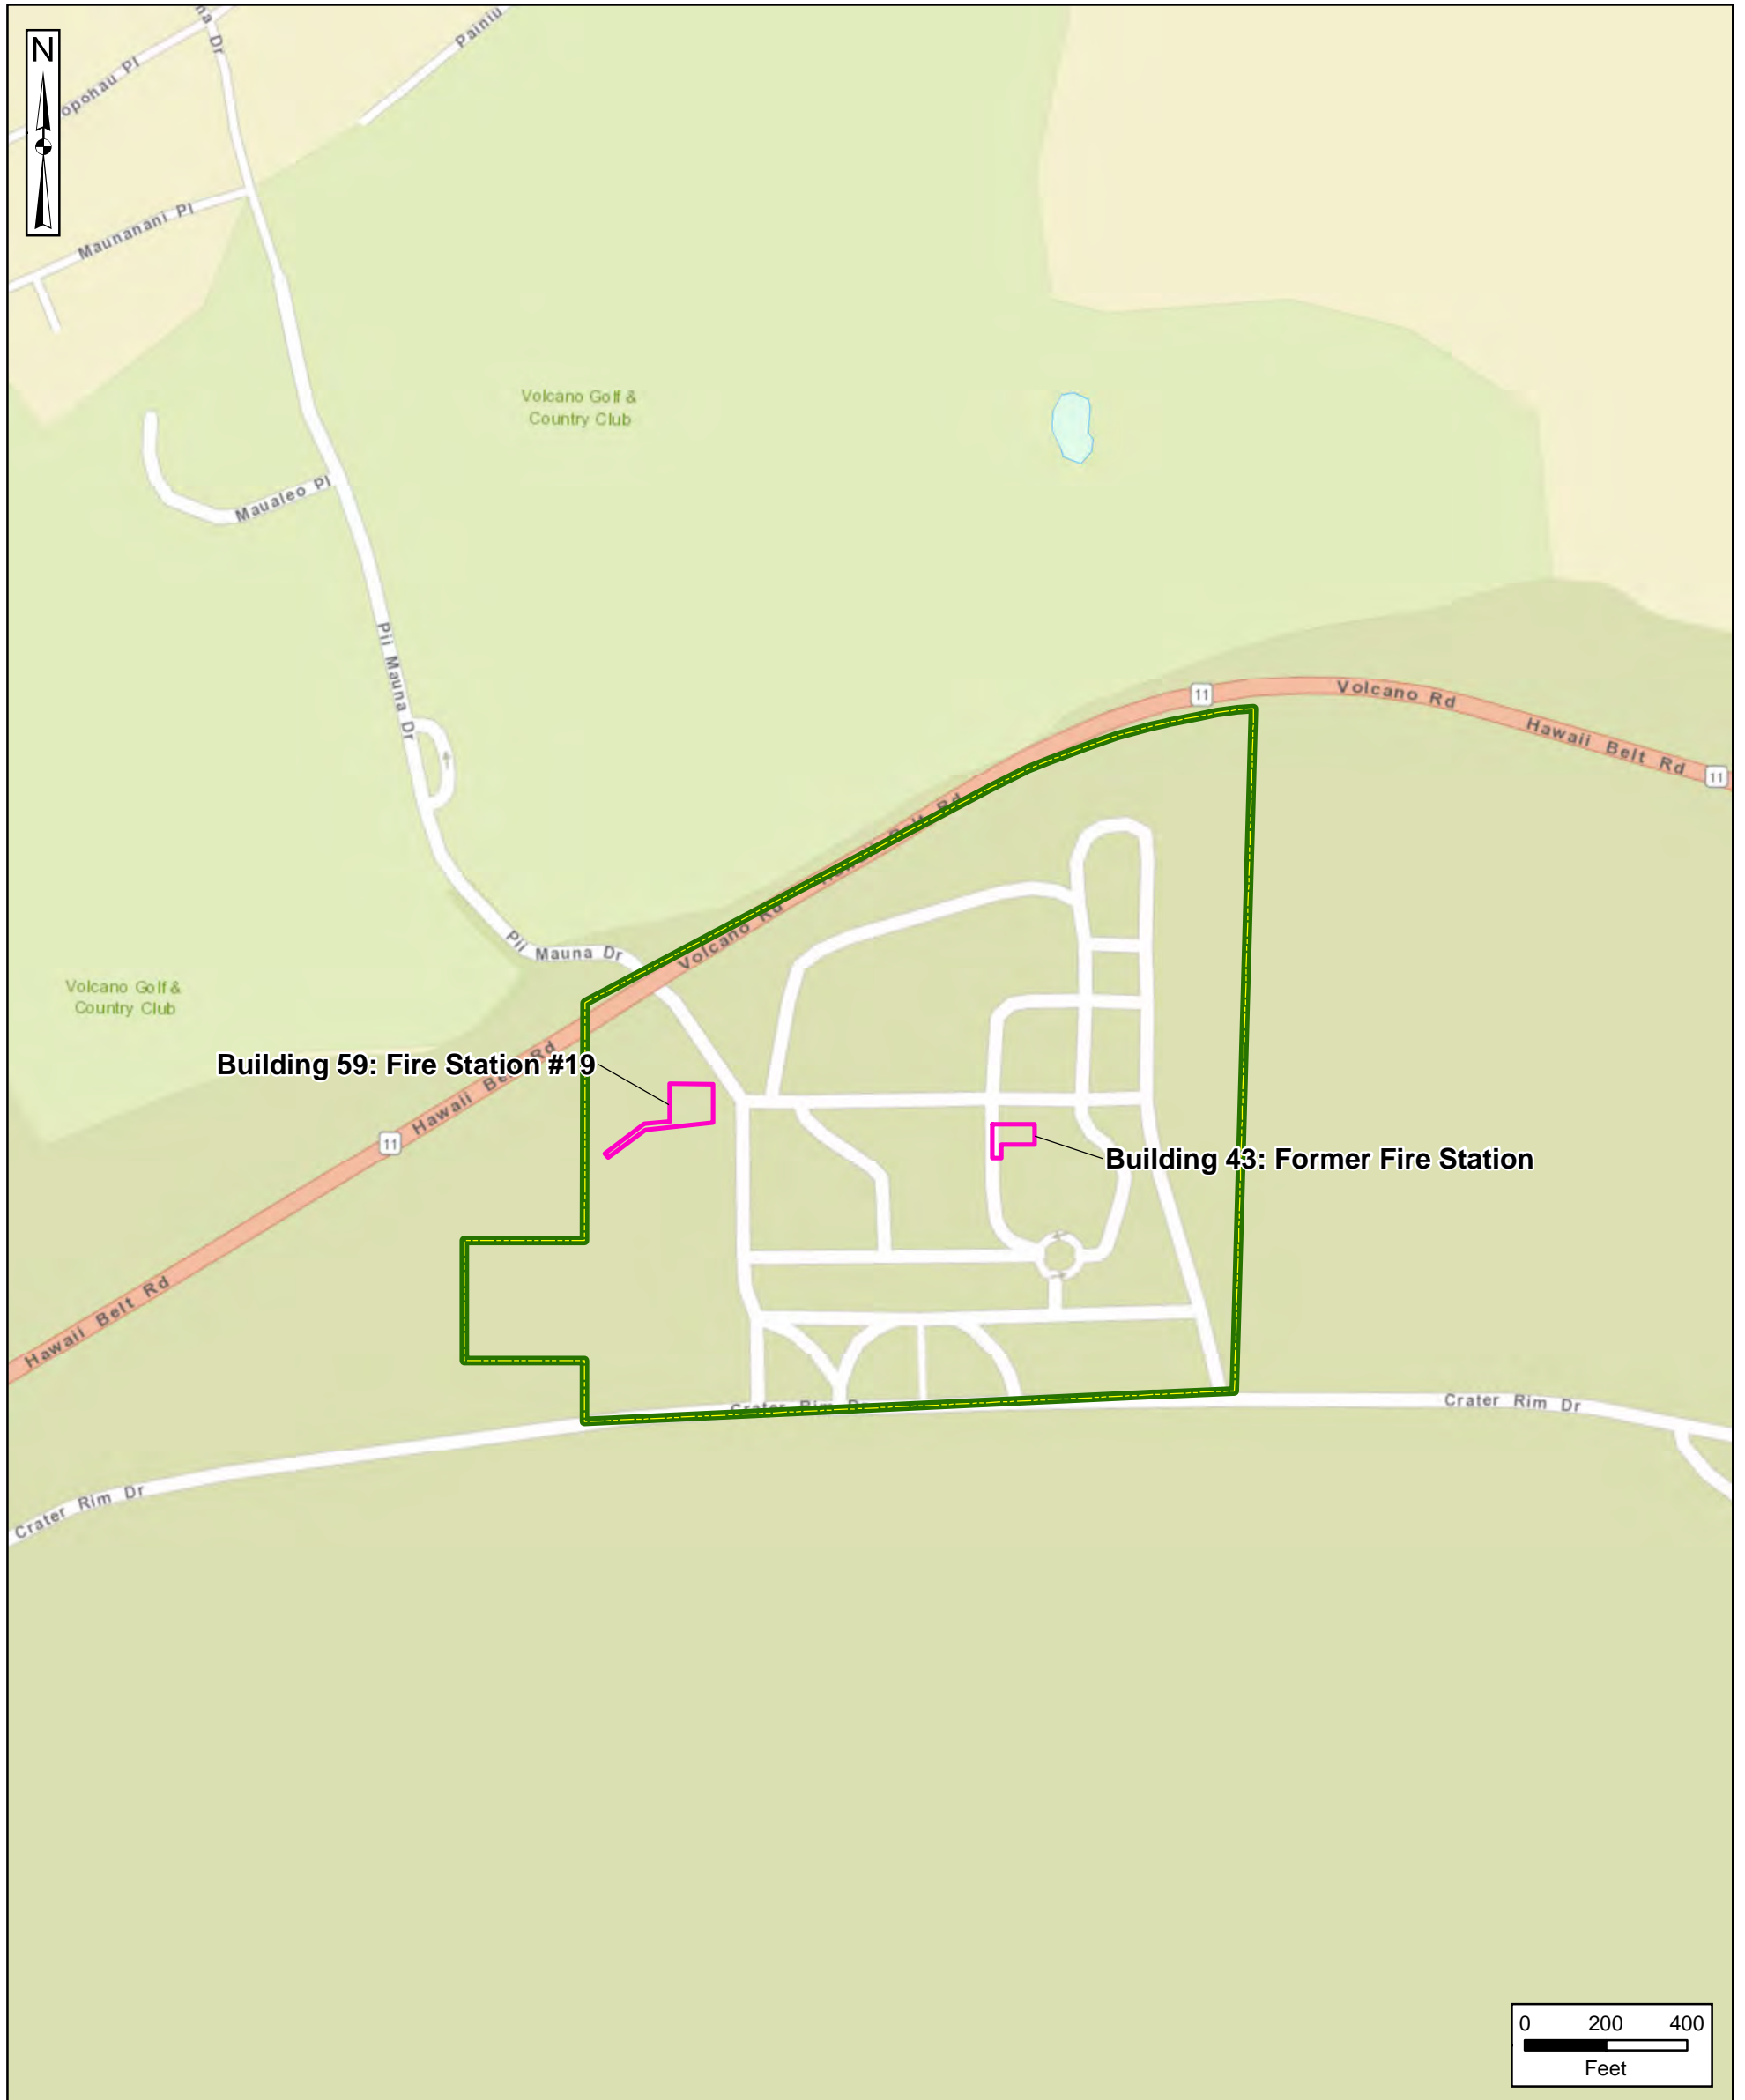
Figure 5-9
KMR AOPI Locations

Overviews for each AOPI identified during the PA process are presented in this section. One of the AOPIs overlap with KMR IRP sites and/or Headquarters Army Environmental System (HQAES) sites (**Figure 5-9**). The AOPI, overlapping IRP site identifier, HQAES number, and current site status are discussed within each AOPI subsection presented below. At the time of this PA, none of the KMR IRP sites have historically been investigated or are currently being investigated for the possible presence of PFAS.

The AOPI locations are shown on **Figure 5-9** and details of each AOPI that also show the approximate extent of AFFF use (if applicable) are presented on **Figures 5-10** through **5-11**.

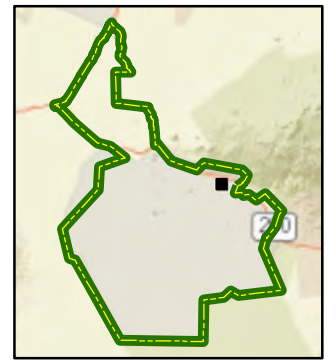
Figure 7-7
Bradshaw Army Airfield Runway
PFOS, PFOA, PFBS, PFNA, and PFHxS Analytical Results

PTA-BAAFR-5-SO	
Date	8/31/2021
Depth	0-2 ft
PFOS	0.00095
PFOA	0.00061
PFBS	0.0020 U
PFNA	0.00060 U
PFHxS	0.00060 U

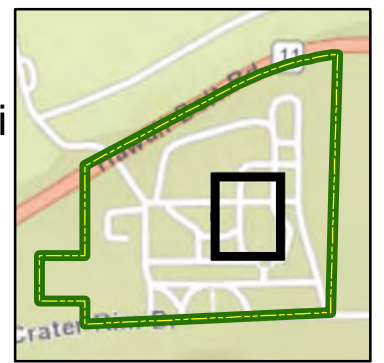
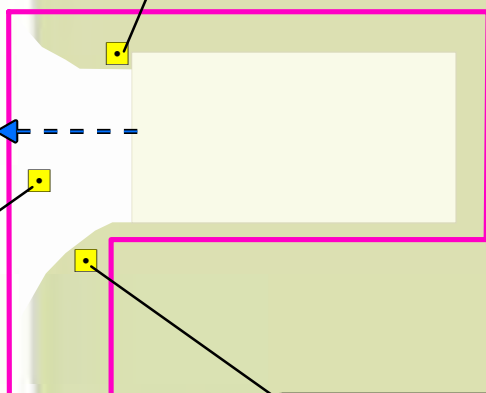
Figure 7-9
Building 43: Former Fire Station
PFOS, PFOA, PFBS, PFNA, and PFHxS Analytical Results

KMC-BLD43-1-SO	
Date	12/12/2022
Depth	0-2 ft
PFOS	0.0020
PFOA	0.00011 J
PFBS	0.00024 U
PFNA	0.00027
PFHxS	0.00014 J

KMC-BLD43-2-SO	
Date	12/13/2022
Depth	0.2-2 ft
PFOS	0.0052
PFOA	0.00025 J
PFBS	0.00026 U
PFNA	0.00012 J
PFHxS	0.00046

KMC-BLD43-3-SO	
Date	12/12/2022
Depth	0-2 ft
PFOS	0.012
PFOA	0.00054
PFBS	0.00021 U
PFNA	0.00011 J
PFHxS	0.00094

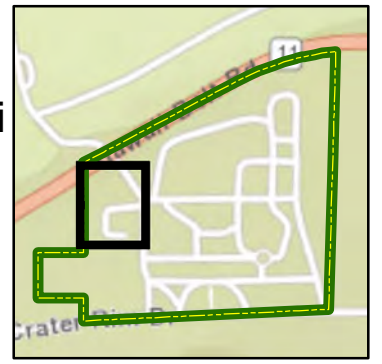
Figure 7-10
Building 59: Fire Station #19
PFOS, PFOA, PFBS, PFNA, and PFHxS Analytical Results

Three soil samples were collected via hand auger at the Building 59: Fire Station #19 AOPI on 12 and 13 December 2022. Soil samples KMC-BLD59-1-SO-121322 (0.2 to 2 feet bgs) and KMC-BLD59-2-SO-121322 (0.2 to 2 feet bgs) were located within the apron south of the fire station shown on **Figure 7-10**. Soil sample KMC-BLD59-3-SO-121222 (0 to 2 feet bgs) was located southwest of the fire station (downgradient from stormwater flow) adjacent to the covered drain in a grassy area shown on **Figure 7-10**. A field duplicate (KMC-FD-1-SO-121222) was collected and corresponds to parent sample KMC-BLD59-2-SO-121322. The field duplicate sample results are shown in brackets below following the parent sample results.

One sediment sample was collected from the upper 5 centimeters via stainless-steel trowel at the Building 59: Fire Station #19 AOPI on 12 December 2022. Sediment sample KMC-BLD59-4-SE-121322 was located southwest of the fire station, at the mouth of the covered drain shown on **Figure 7-10**. A field

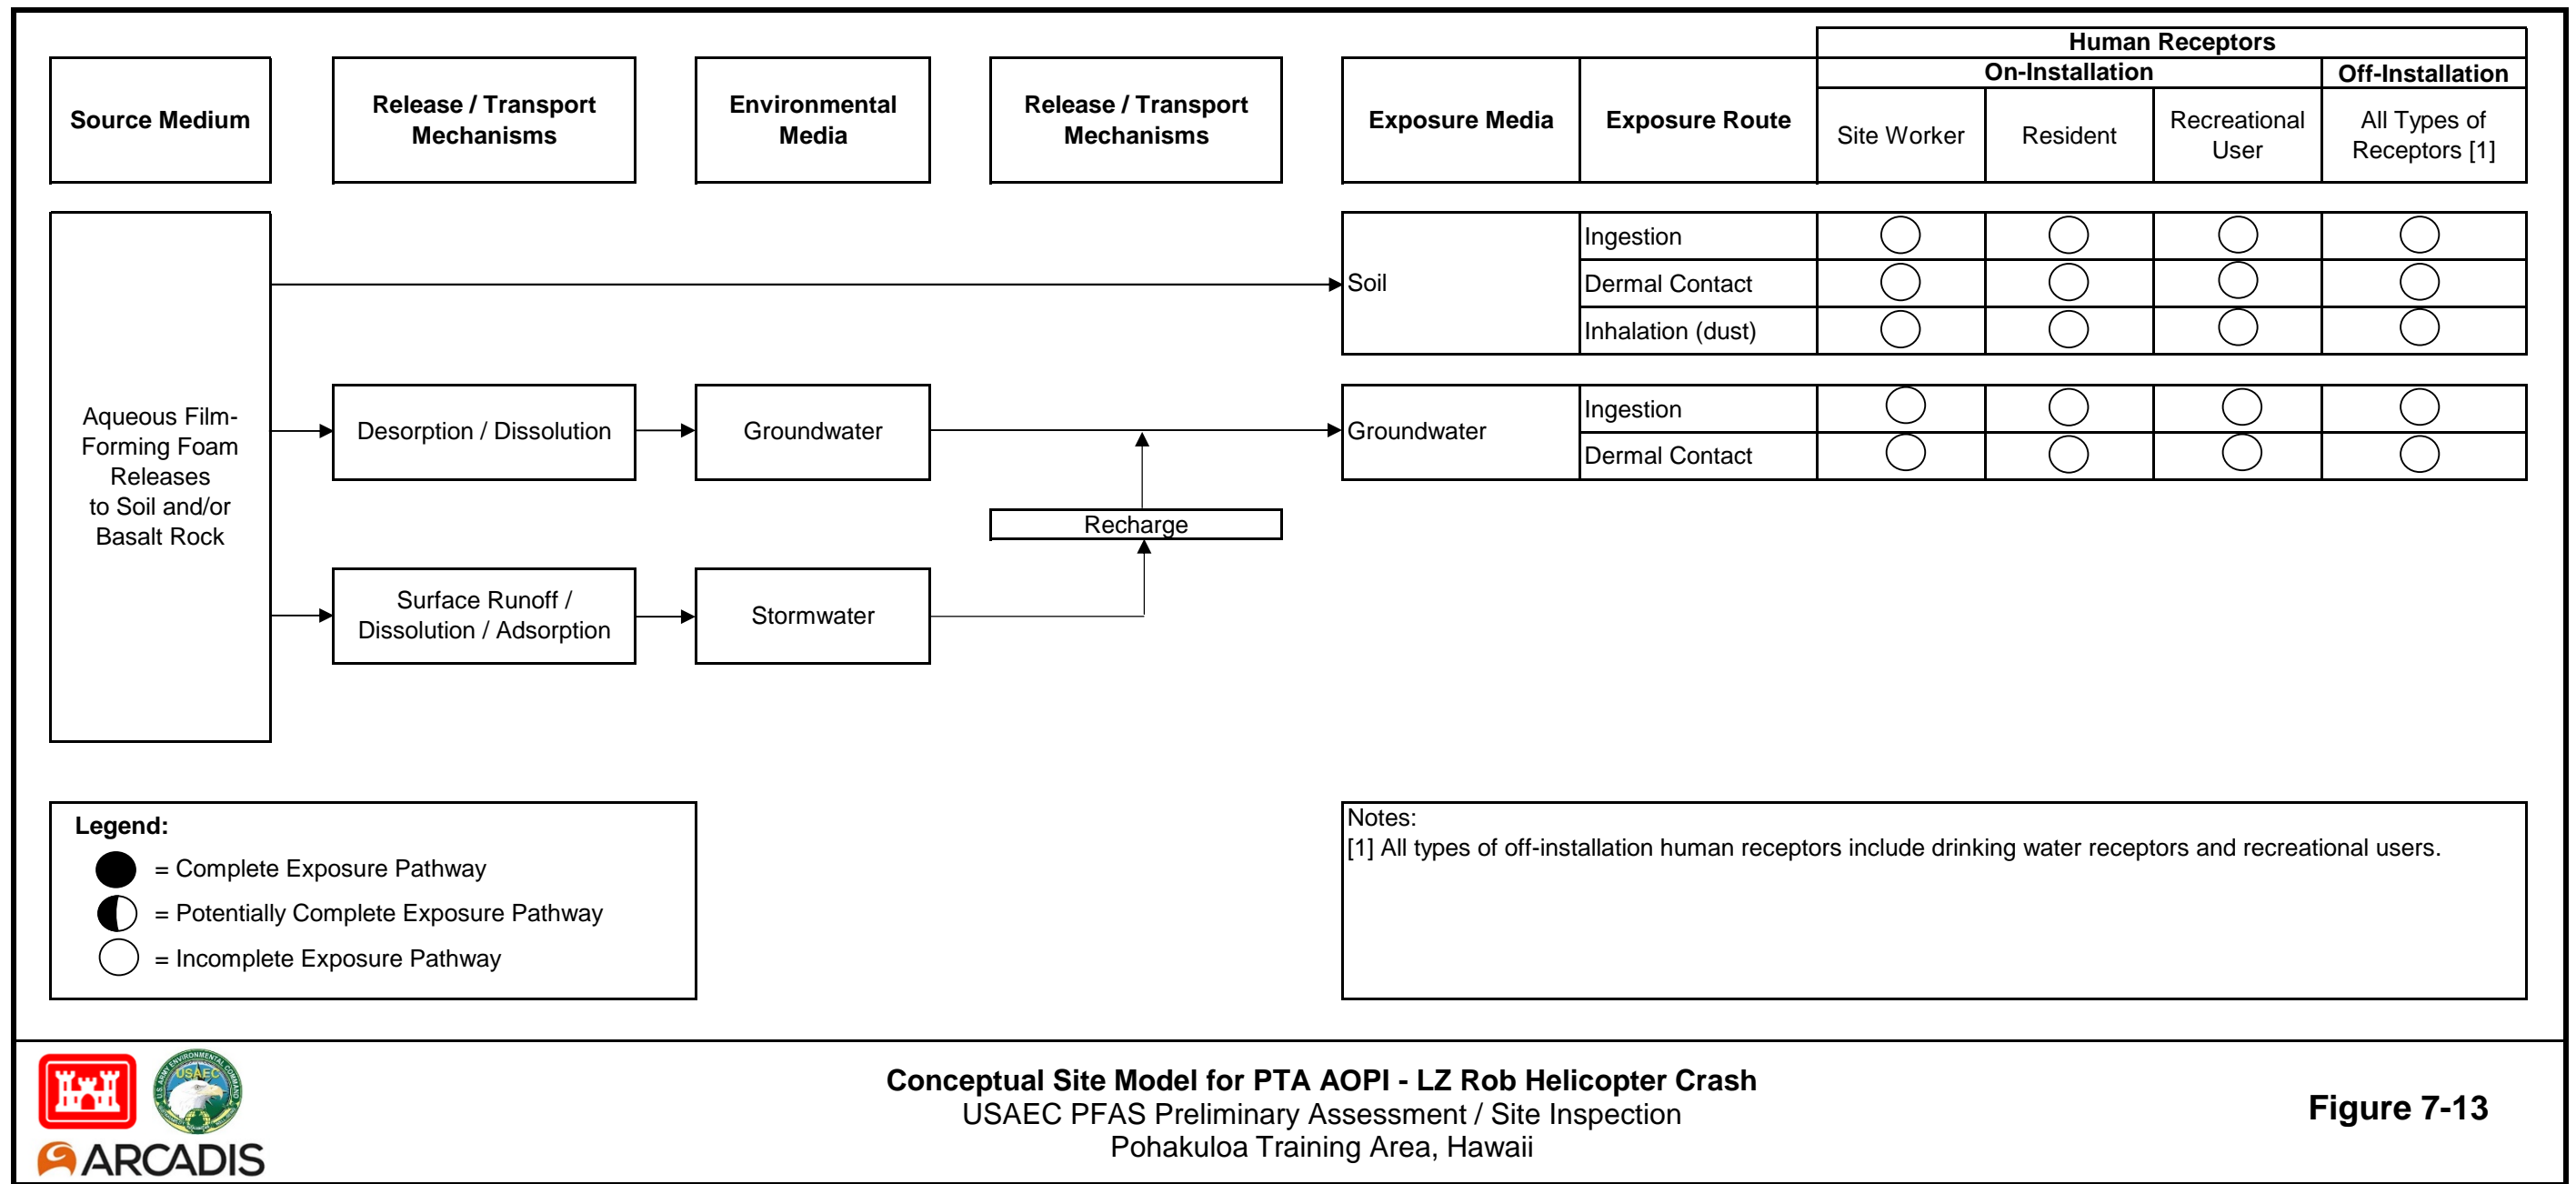
Figure 7-13

Conceptual Site Model for PTA AOPI - LZ Rob Helicopter Crash
 USAEC PFAS Preliminary Assessment / Site Inspection
 Pohakuloa Training Area, Hawaii

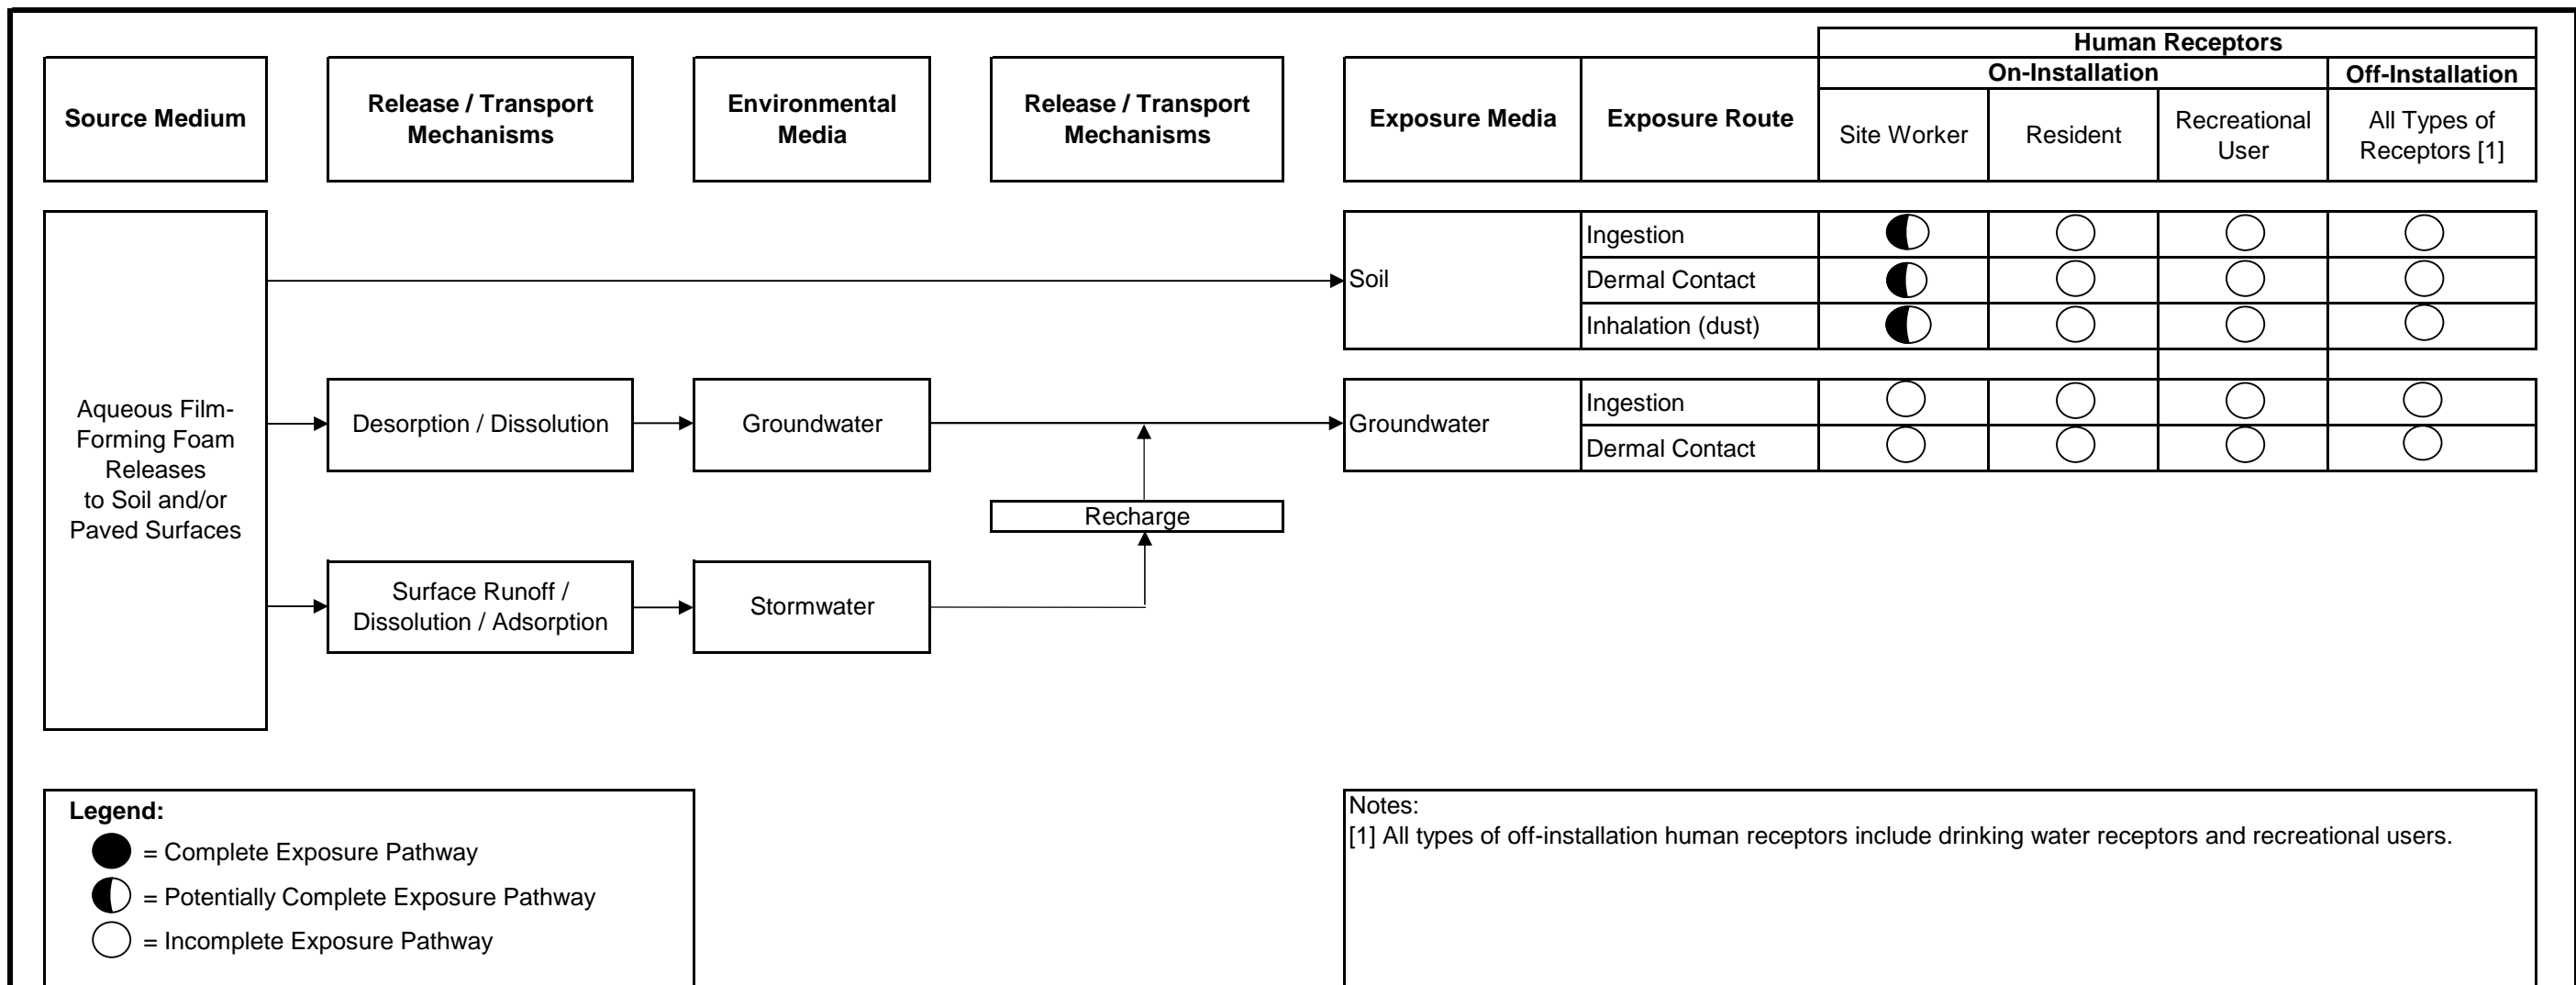
Figure 7-14

Conceptual Site Model for KMR AOPI - Building 43: Former Fire Station
 USAEC PFAS Preliminary Assessment / Site Inspection
 Kilauea Military Reservation, Hawaii
