**FINAL
PRELIMINARY ASSESSMENT OF
AQUEOUS FILM FORMING FOAM AREAS**

PUEBLO CHEMICAL DEPOT

**Contract No. W9128F-18-D-0027
Delivery Order No. W9128F18F0158**

September 2020

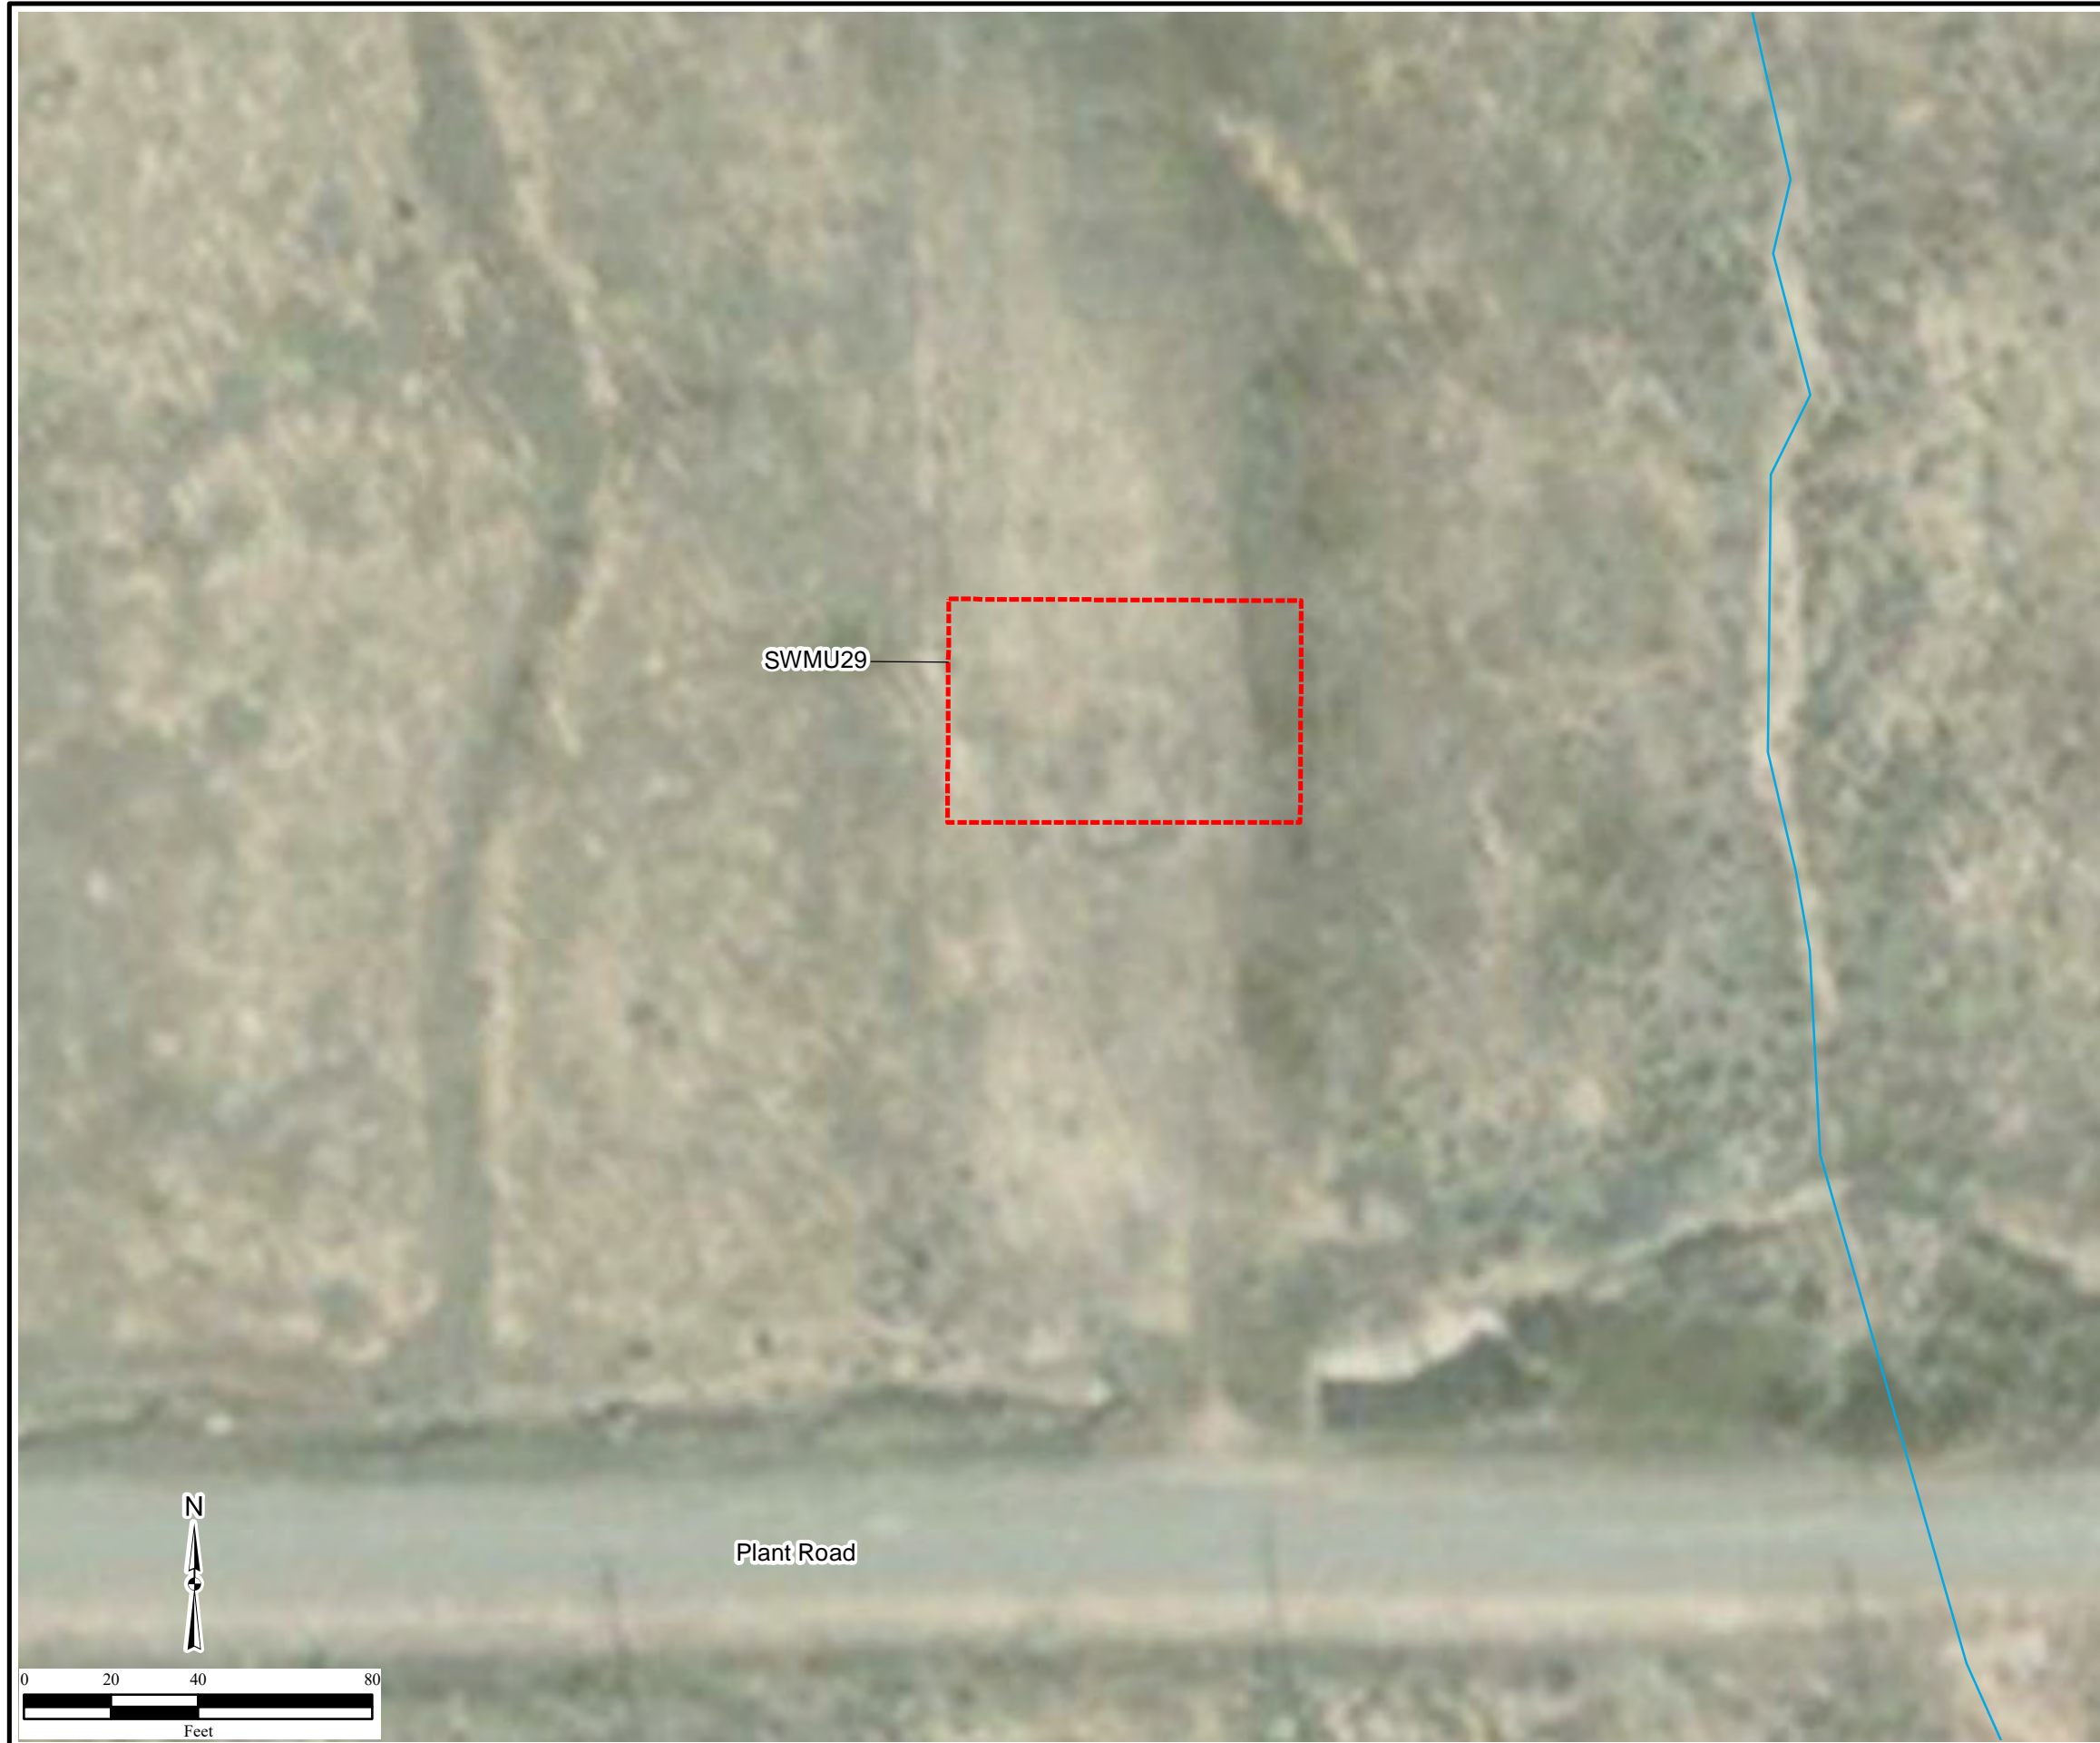
The Fire Protection Training Area (SWMU 29) is in the southern part of PCD north of SWMU 14 near the intersection of Third Street and Burma Road (see Figure 3.1). SWMU 29 consisted of a shallow depression approximately 24 feet wide by 25 feet long and 1.5 feet deep. The area surrounding SWMU 29 is mostly flat and grassy and slopes slightly to the east. A small, unnamed north-south trending drainage channel is 350 feet east of the site. Groundwater at SWMU 29 is found at a depth of 25 feet with a flow direction to the southeast (PCD, 2006; TLI, 2016).

According to historical documentation, this area was used for fire training exercises twice in the 1980s. These exercises consisted of burning off-specification oil and diesel in a lined pit and extinguishing the fire. The depression was lined with a synthetic liner, covered with soil and gravel, and surrounded by an earthen berm. After completion of fire exercises, the soil from the lined pit was removed, and the old liner was replaced. Components of firefighting fluids/extinguishers included, but were not limited to, magnesium silicate, mono-ammonium phosphate, and ammonium sulfate (PCD, 2006). The historical document review found no records of AFFF usage during these training activities.

The Fire Protection Training Area (SWMU 29) in the southern part of PCD was reportedly used for fire training exercises twice in the 1980s. These exercises consisted of burning off-specification oil and diesel in a lined pit and extinguishing the fire. Available documentation does not indicate that AFFF was used during these training exercises. The depression was lined with a synthetic liner, covered with soil and gravel, and surrounded by an earthen berm.

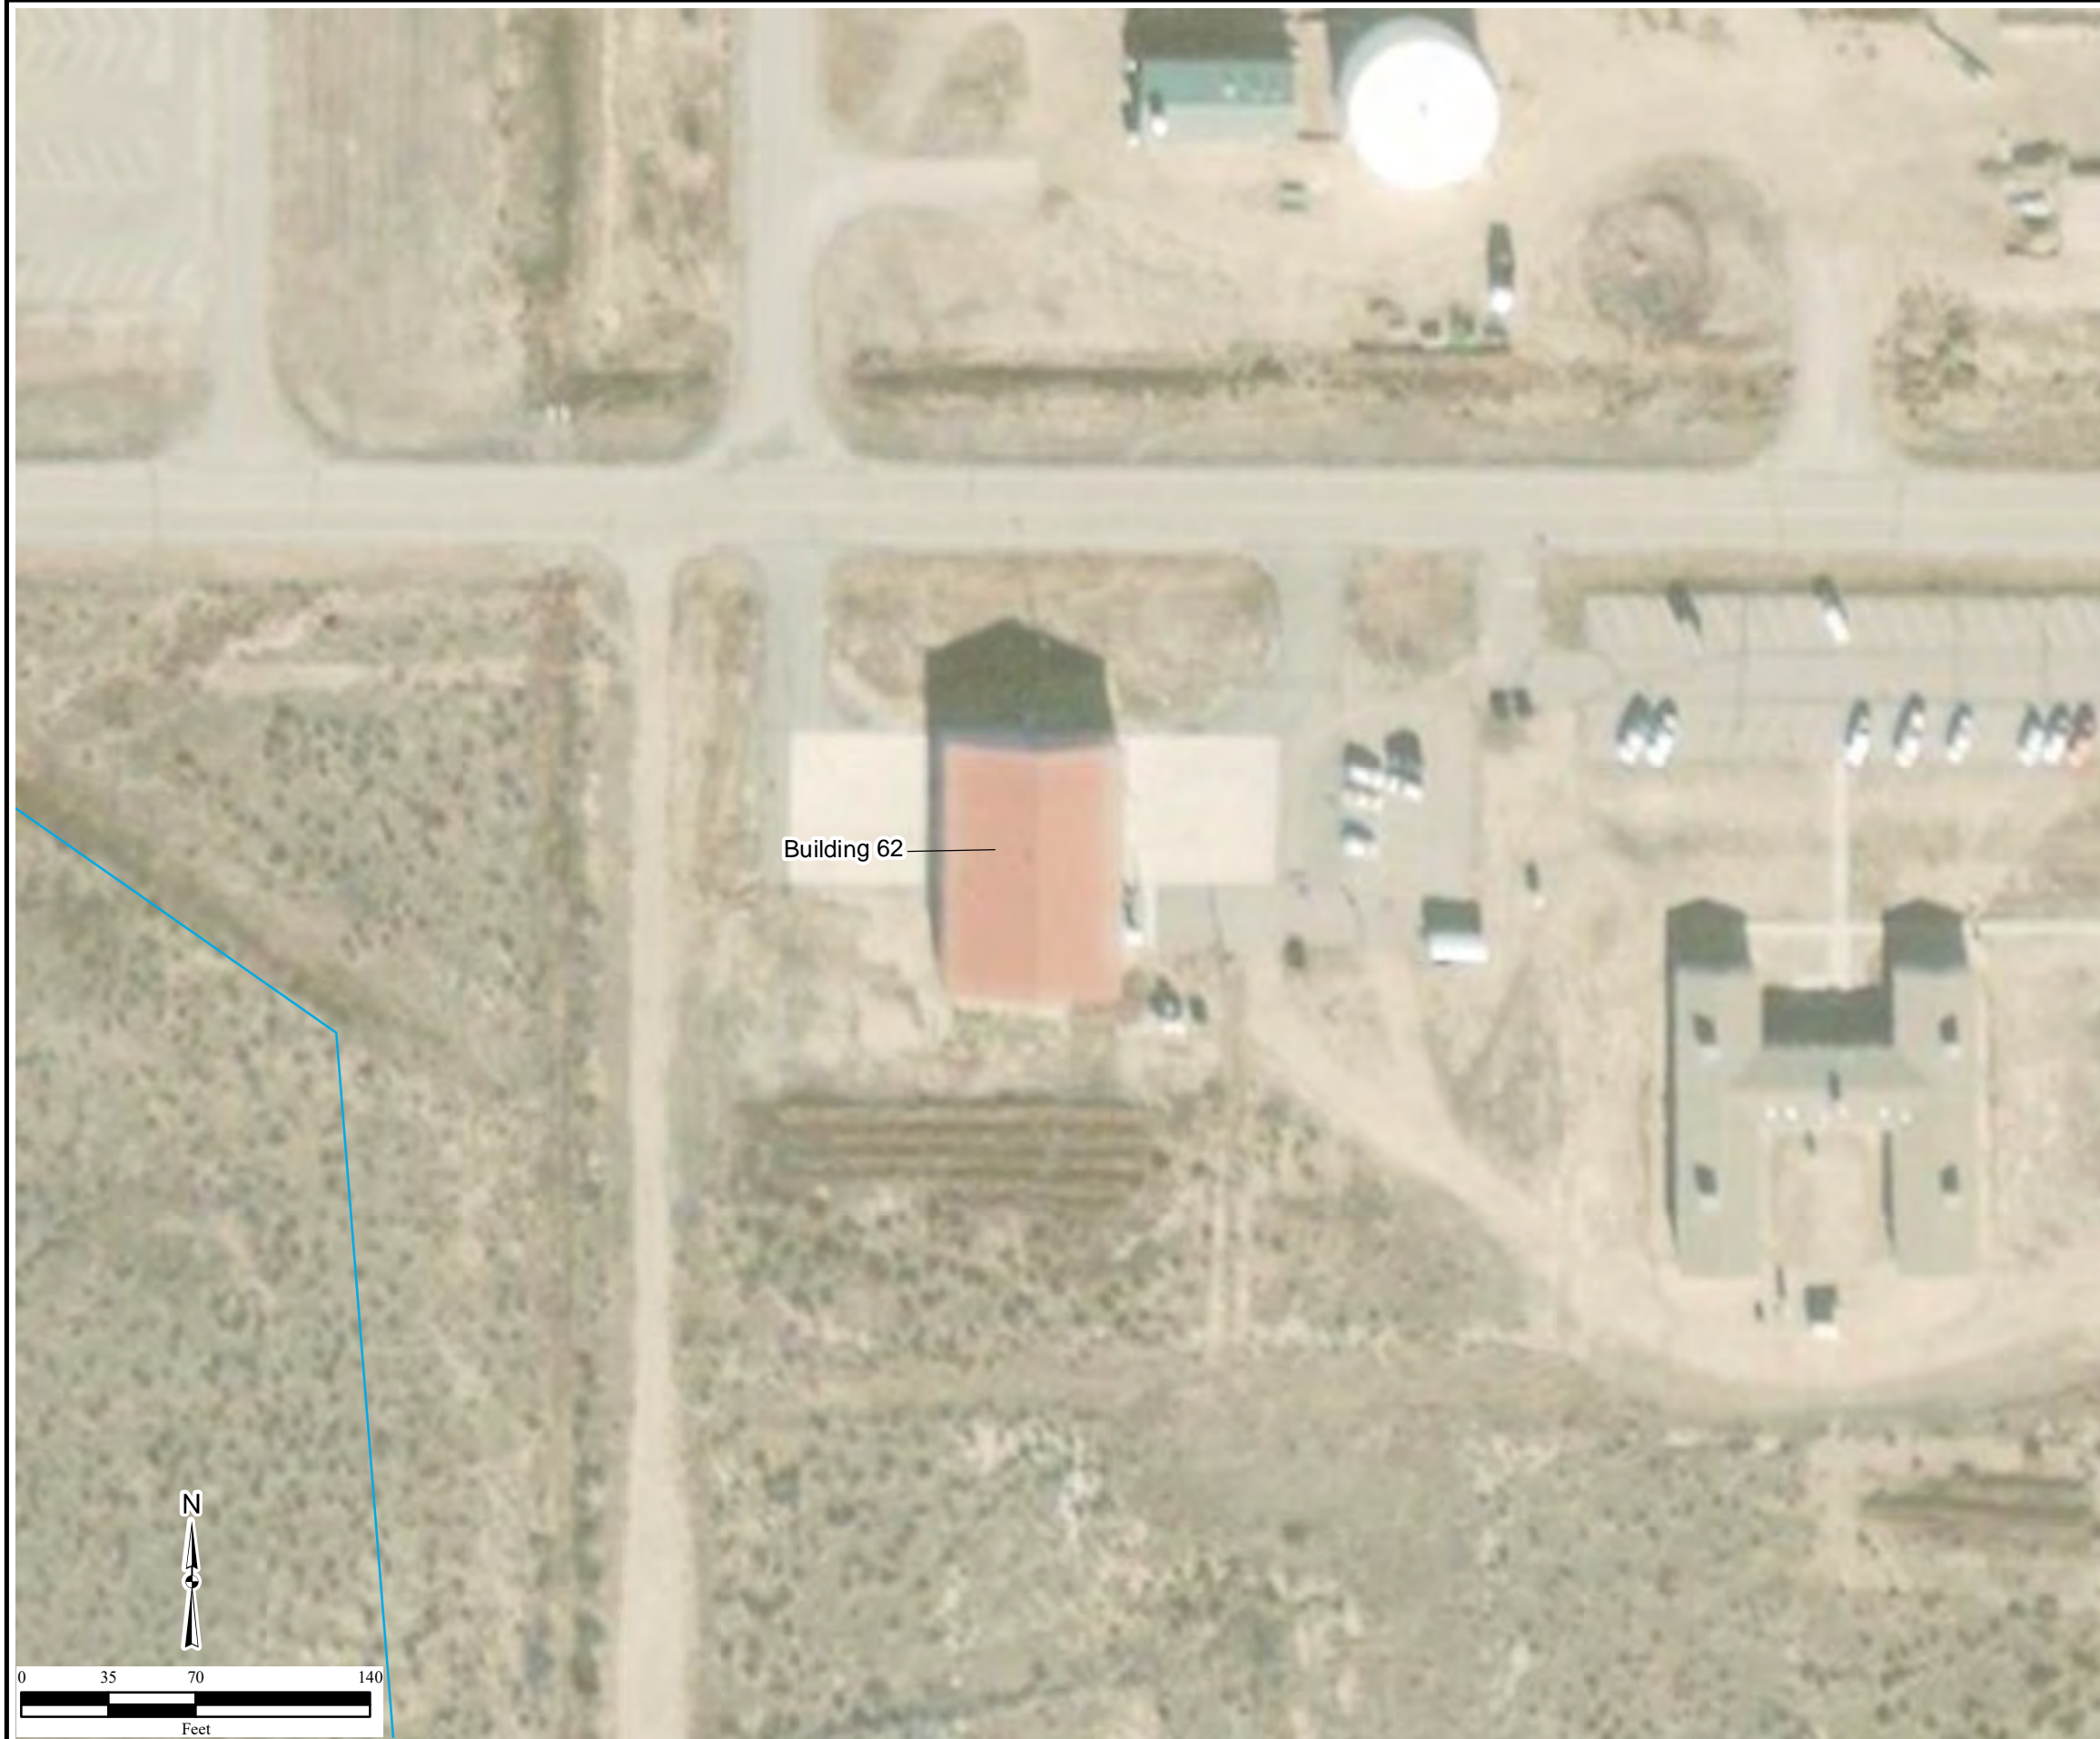
Figure 4.4
SWMU 28
Plating Waste
Drainage Ditch and
Former Building 539

The Plating Waste Drainage Ditch (SWMU 28), north of Plant Road, runs east to west along the southern boundary of the warehouse area and dissipates to the east (Figure 4.4). The ditch received operation wastes from the former Metal Plating Shop, Building 539, and the Metal Surface Treatment Shop. Metal plating operations were conducted in Building 539 until 1973 when the building was demolished. Operations in these shops required the use of chromic, sulfuric, hydrochloric, nitric, and phosphoric acids; sodium hydroxide; copper and cadmium cyanides; and nickel and zinc solutions (USACE, 2017).

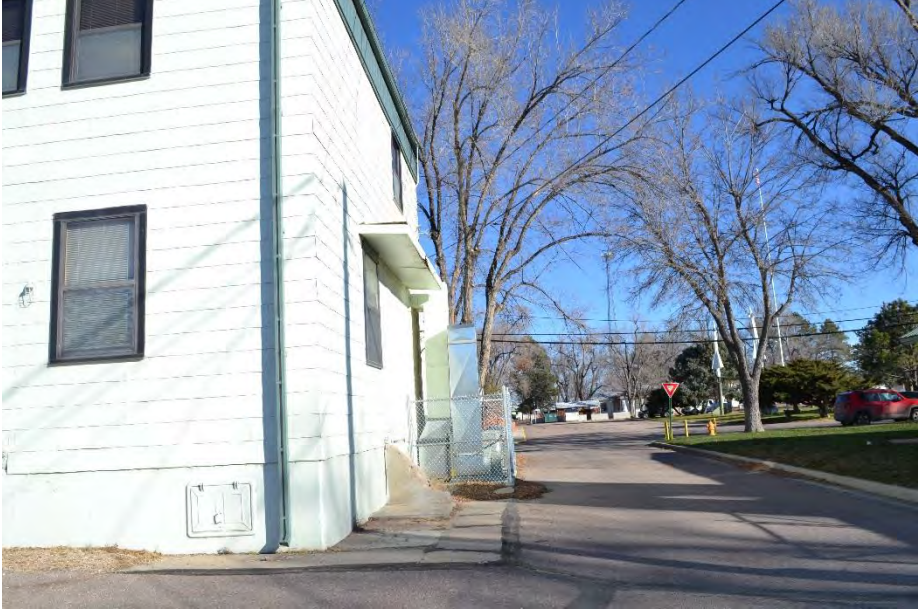
Photograph 1

Location: PCD	
Date: 11/29/2018	
Building 3, Facing East	
Photograph 2

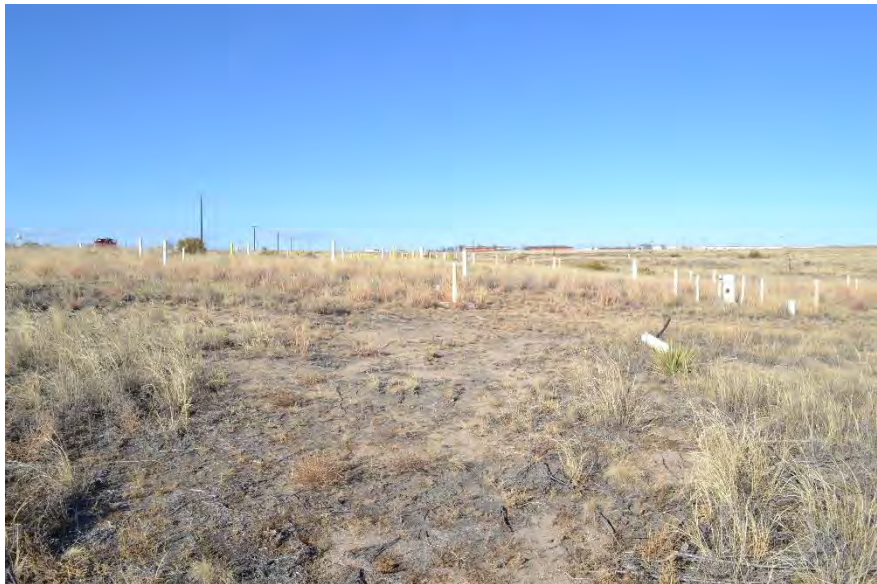
Photograph 17

Location: PCD	
Date: 11/29/2018	
SWMU 14 (Landfill), Wells, Facing North	
Photograph 18

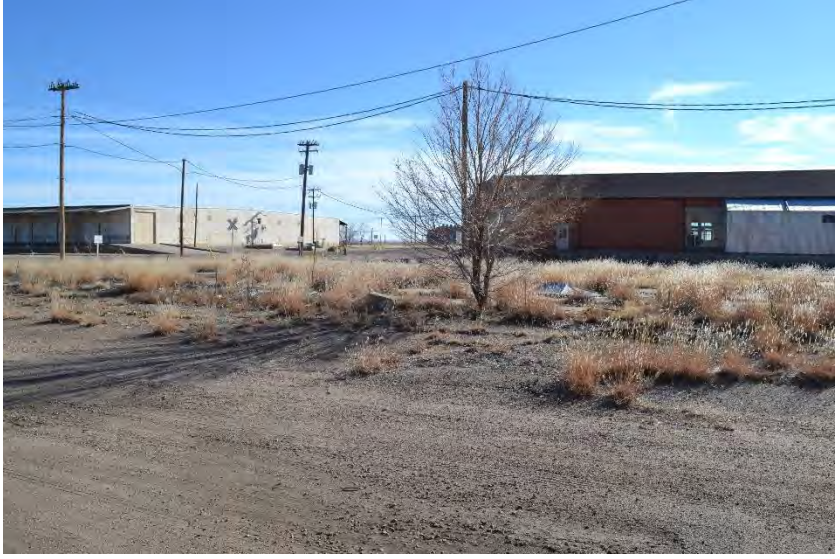
Photograph 21	
Location: PCD	
Date: 11/29/2018	
SWMU 28 (Plating Waste Drainage Ditch and Former Building 539), Drainage Ditch, Facing East

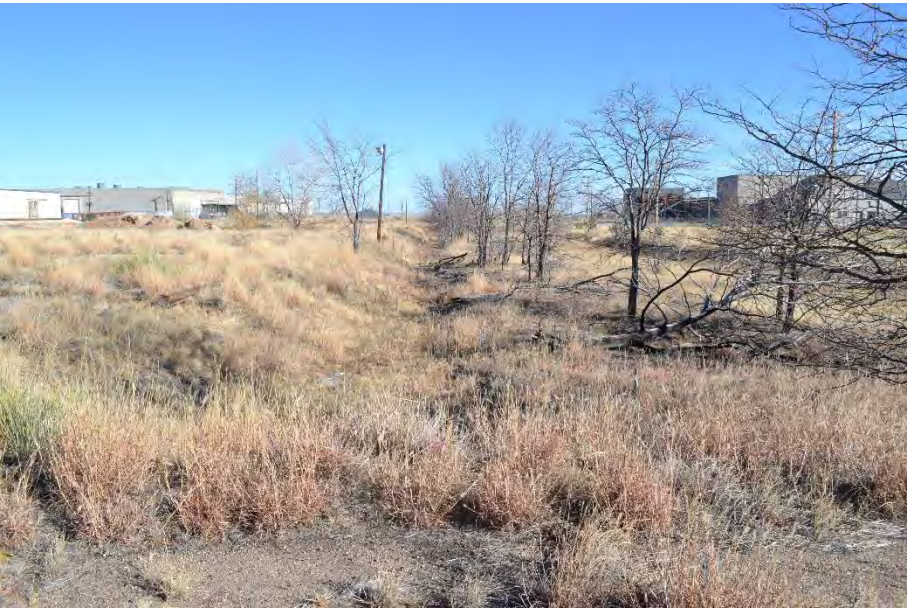
Photograph 25

Location: PCD	
Date: 11/29/2018	
SWMU 28 (Plating Waste Drainage Ditch and Former Building 539), Facing East	
Photograph 26

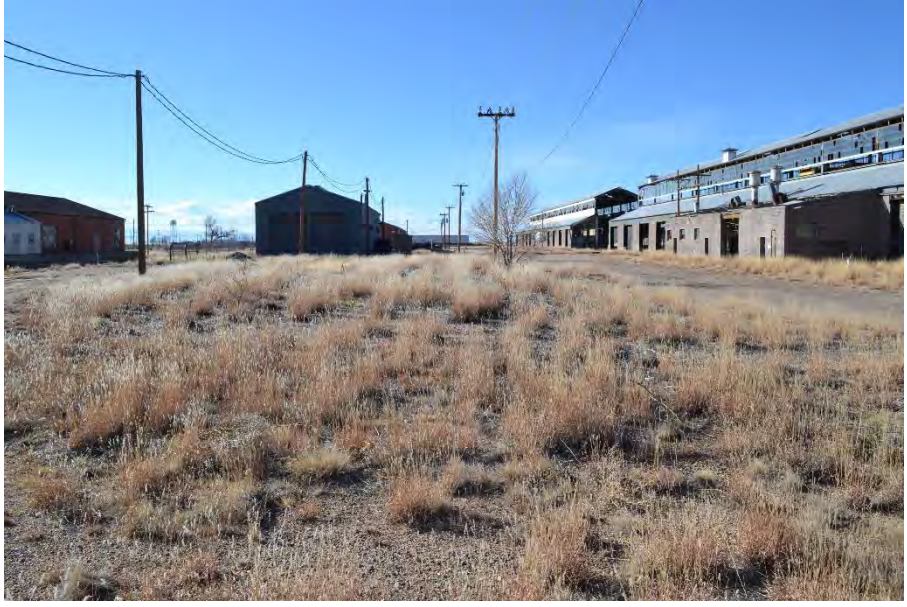
Location: PCD	
Date: 11/29/2018	
SWMU 28 (Plating Waste Drainage Ditch and Former Building 539), Former Building, Facing West

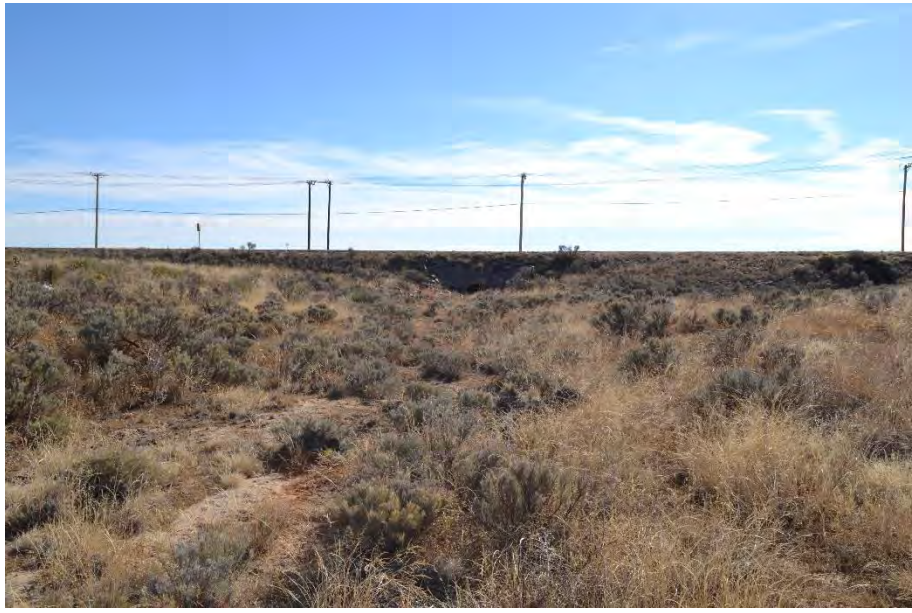
Photograph 31

Location: PCD	
Date: 11/29/2018	
SWMU 29 (Fire Protection Training Area), Ditch Facing Southeast	
Photograph 32	 
Location: PCD	
Date: 11/29/2018	
SWMU 29 (Fire Protection Training Area), Facing North-Northeast

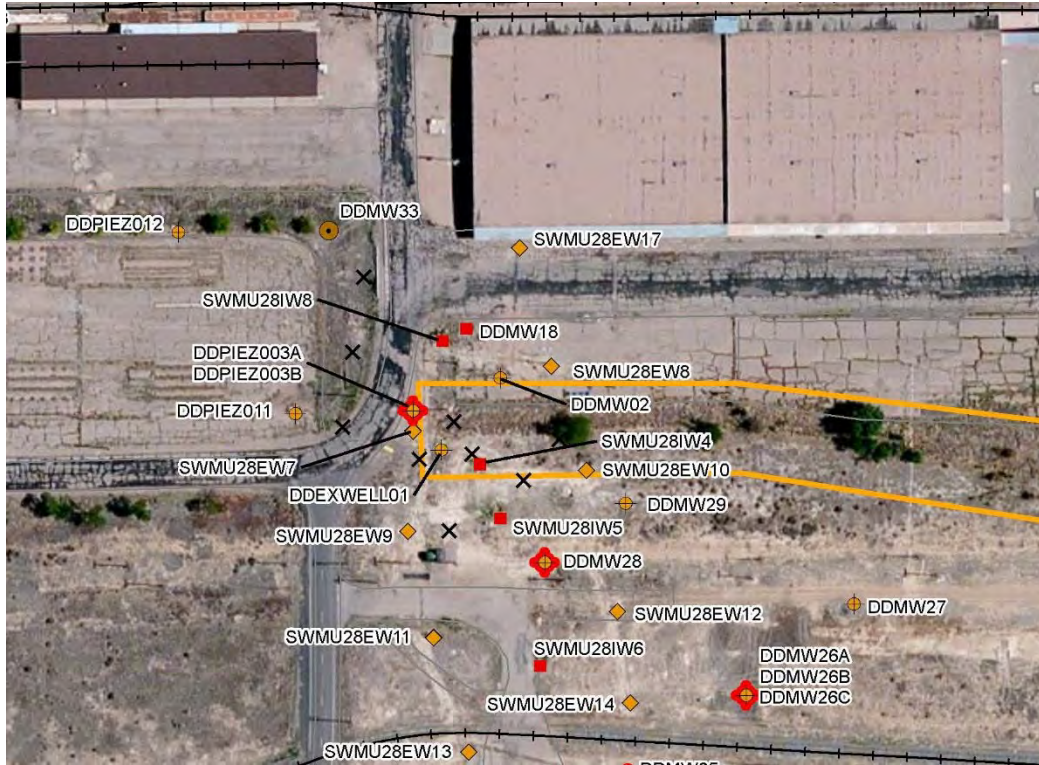
Figure 2: SWMU 28 PFAS Sampling Locations.

The presence of PFAS in groundwater at SWMU 28 will influence selection of remedial technologies for treatment of SWMU 28 groundwater and thus will affect proposed pilot studies. Two wells (Figure 2) were selected (DDPIEZ003A and DDPIEZ003B) for PFAS sampling as they are located at the head of the SWMU 28 ditch and contain higher concentrations of TCE. Groundwater samples were collected in January and analyzed for 18 PFAS analytes (Table 2). Groundwater in DDPIEZ003A and DDPIEZ003B was non- detect for all 18 analytes. PFAS will not be considered during the selection of remedial technologies due to no PFAS detections at SWMU 28.

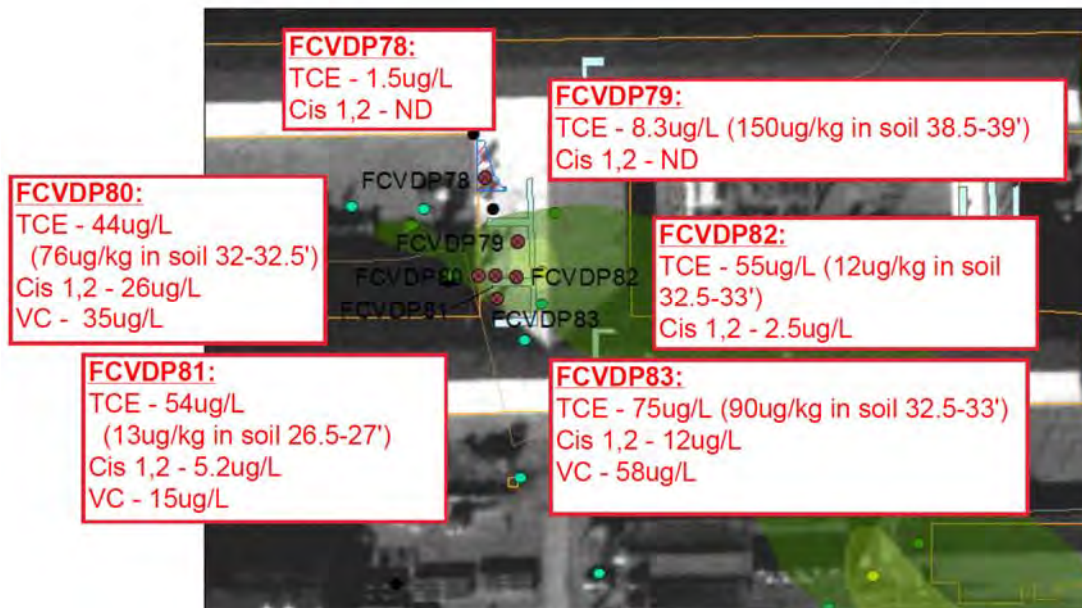
Figure 3: SWMU 36 Source

A total of twelve boreholes with temporary wells were installed using Direct Push Technology (DPT) in December 2017 (Figure 3). Six boreholes (FCVDP78 through FCVDP83) were drilled in order to better characterize the soil under the concrete slab that was removed in June 2017 where an underlying tank containing TCE was also removed. Lithology logs and soil samples were collected in December 2017 from the borings, and soil was analyzed for VOCs using EPA method SW8260B (Figure 3). TCE concentrations in the soil samples were non-detect or less than 15 ug/kg with only three samples having concentrations greater than 50 ug/kg (FCVDP79, 80, and 83). The highest TCE concentration was 150 ug/kg at location FCVDP79 at a depth of 38.5 – 39 feet below ground surface (bgs). A groundwater sample was collected from each temporary well in January 2018 and analyzed for VOCs using EPA method SW8260B. TCE concentrations in the groundwater ranged from 1.5 ug/L at FCVDP78 to 75 ug/L at FCVDP83 (Figure 3).
