**FINAL
SOLID WASTE MANAGEMENT UNIT 29
SITE INSPECTION REPORT FOR PER- AND
POLYFLUOROALKYL SUBSTANCES
PUEBLO CHEMICAL DEPOT, PUEBLO,
COLORADO**

November 2023

**Swift River TLI Joint Venture
1726 Cole Boulevard, Suite 115
Lakewood, Colorado 80401**

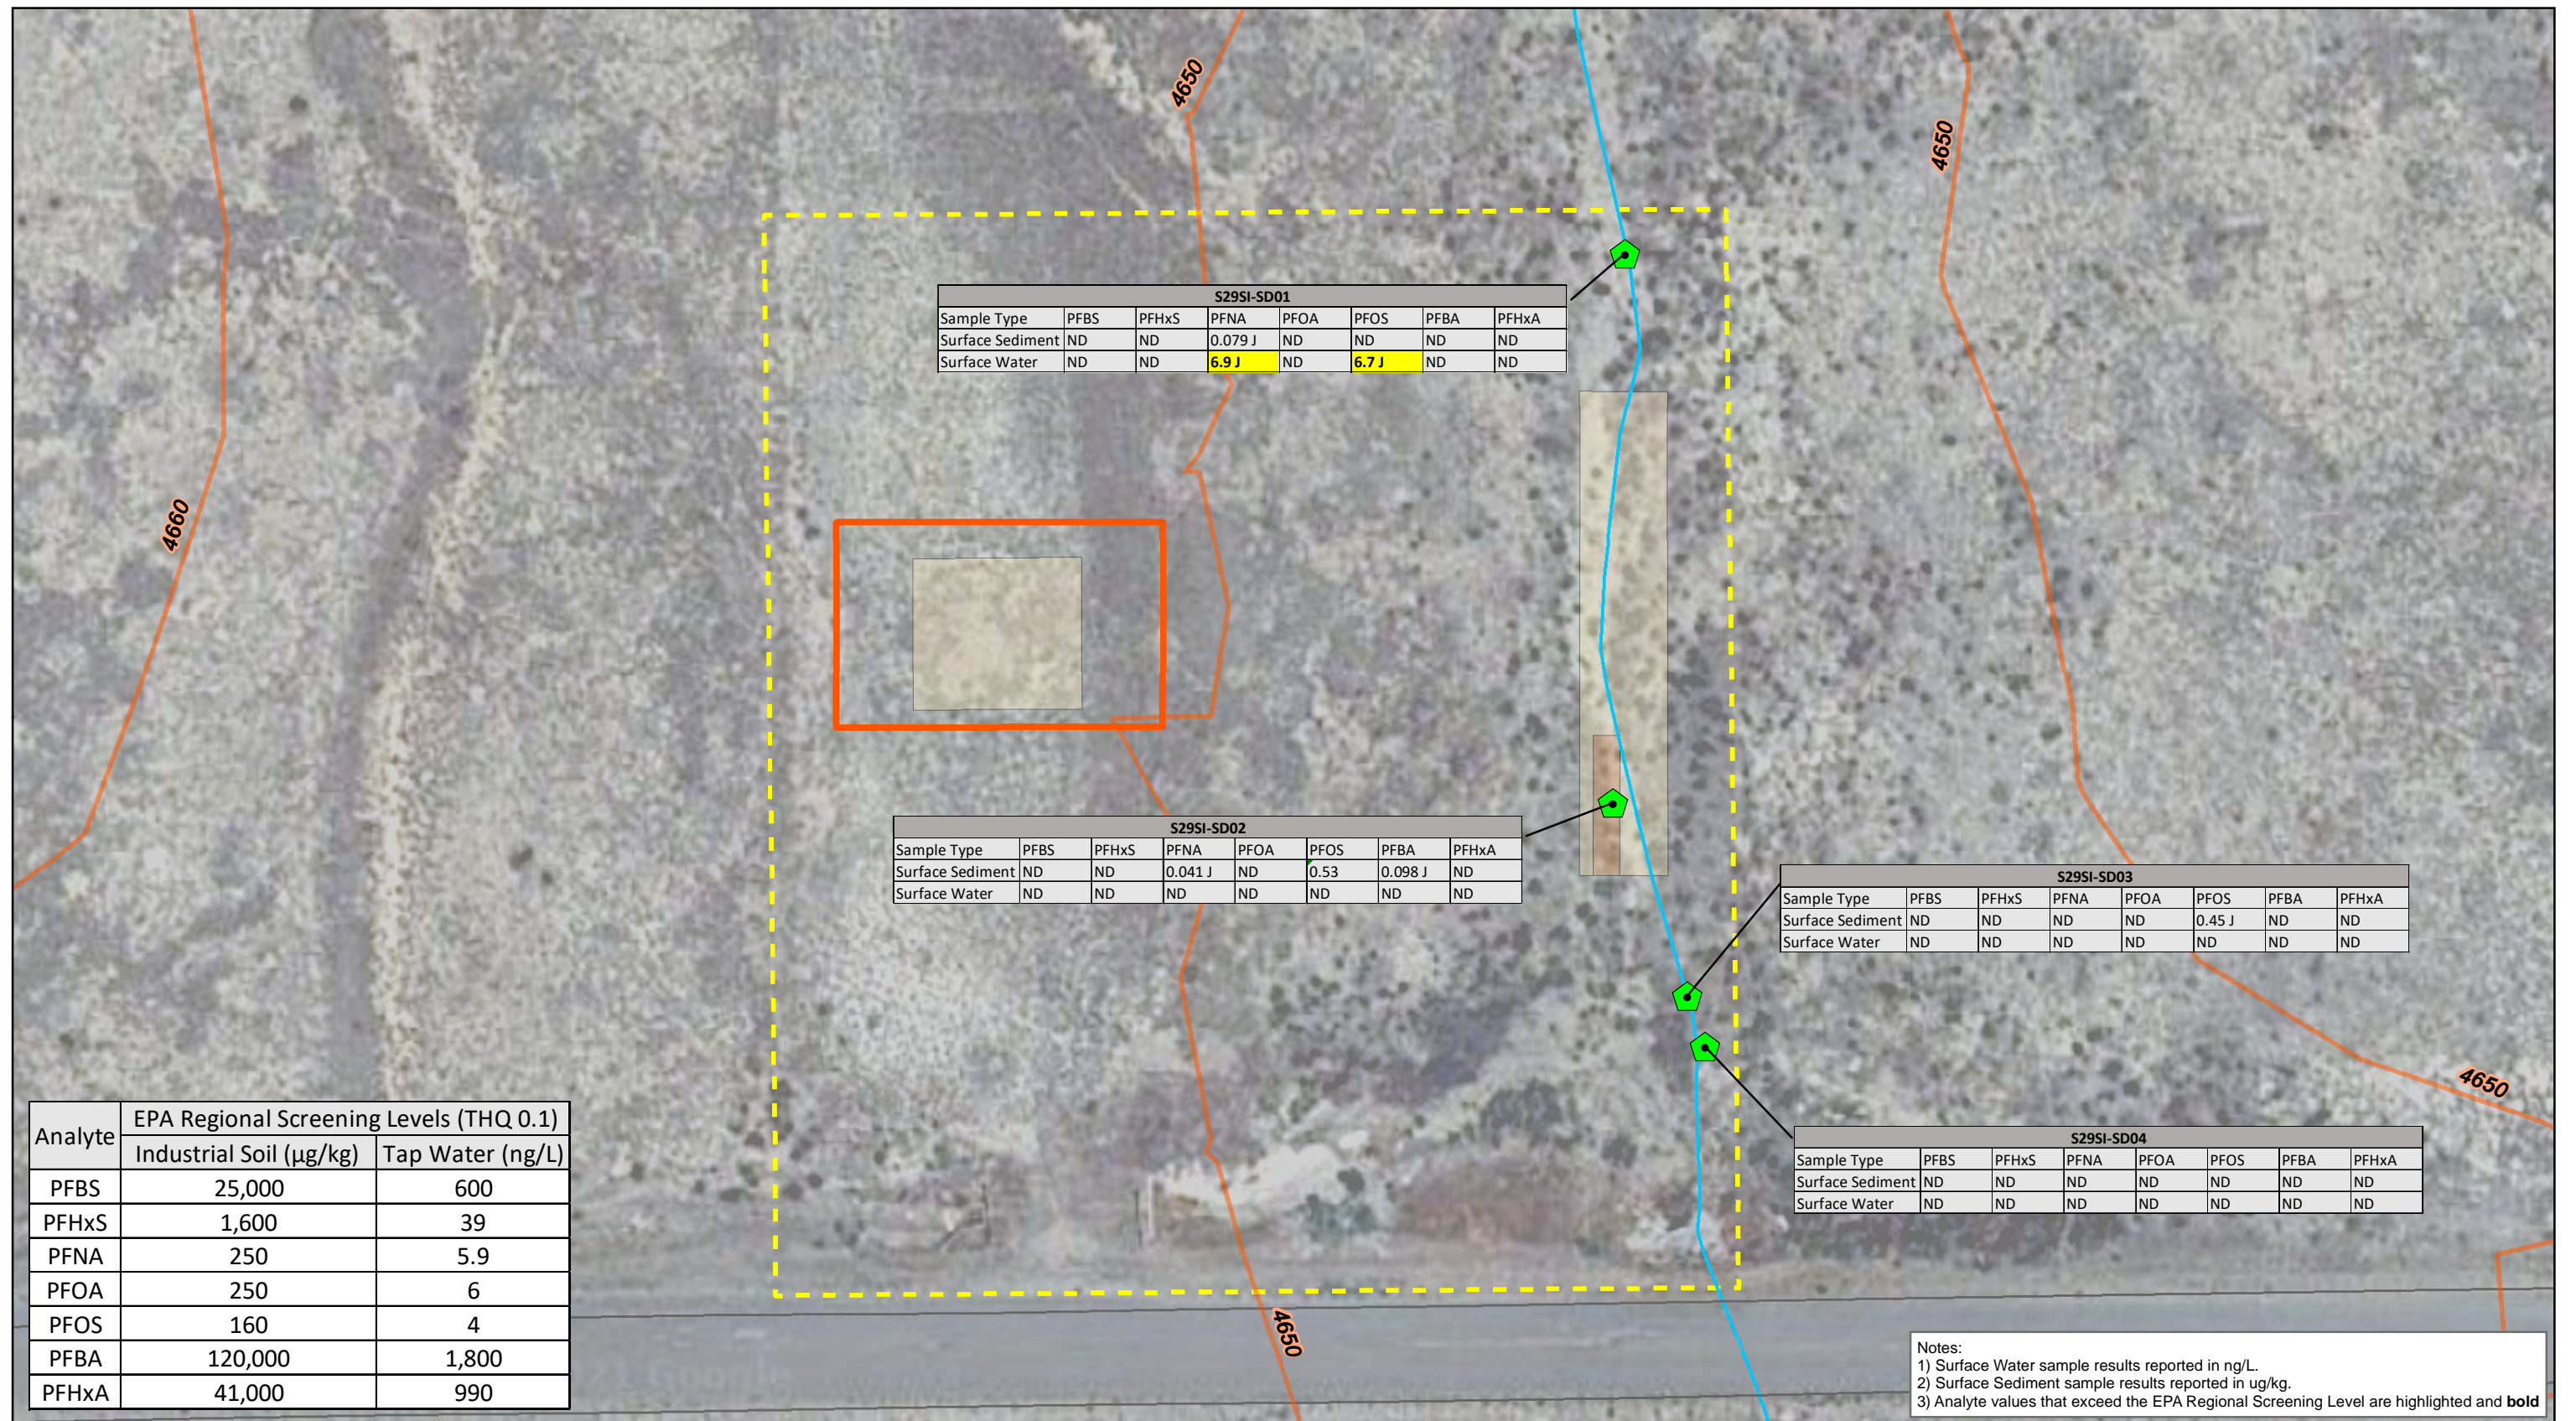
Figure 6-3. SWMU 29 SI Surface Water / Surface Sediment Sample Results

During analysis, the PFAS aliquots for the four surface waters and one field duplicate sample were prepared using a reduced volume of 25 milliliters rather than the regular, 250 milliliters of sample volume which represents a 10X preparation factor. The laboratory noted that the sample matrix contained a large amount of particulates and sediment. The associated non-detected results are at elevated LODs and LOQs due to the reduced sample size. Due to the reduced sample aliquot volume, non-detected results (LOD) for PFNA, PFOS, and PFOA are reported at concentrations greater than the Regional Screening Levels.

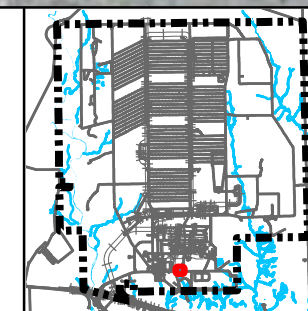
Figure 6-3
SWMU 29 SI
Surface Water/Surface Sediment
Sample Results

PFBS, PFHxS, PFHxA, and PFOA were not detected above the LODs in any of the sediment samples collected at SWMU 29. PFNA was detected in three of the five sediment samples while PFOS was detected in two of five sediment samples and PFBA was detected in one of the five sediment samples (Table 6-2, Figure 6-3). PFNA was detected in samples S29SI-SD01 and S29SI-SD02 while PFOS was detected in samples S29SI-SD02 and S29SI-SD023 and PFBA was detected in sample S29SI-SD02. The two PFNA detections are J-flagged, and the approximate concentrations are four orders of magnitude below SLs. There were two PFOS detections, the result at S29SI-SD03 is J-flagged, and the result at S29SI-SD02 has no QC flags. While PFOS at S29SI-SD01 was reported as detection by the laboratory, the result was determined to be associated with laboratory blank contamination and is not considered to be legitimate detection so a final not-detected, U, qualifier was applied to this result during data validation. All the approximate concentrations are three to four orders of magnitude below their respective SLs. The August 2023 ASD Memorandum does not provide guidance for PFAS in sediment, and PFAS concentrations are compared to the SLs for surface soils.

PFBS, PFHxS, PFHxA, PFOA, and PFBA were not detected above the LODs in any of the surface water samples collected at SWMU 29. PFNA and PFOS were detected in one of the five surface water samples (Table 6-2, Figure 6-3). PFNA and PFOS were detected in sample S29SI-SW01. The PFNA and PFOS detections are J-flagged, however; both approximate concentrations are above their respective SLs. This location is the northernmost sample location at the upgradient portion of the drainage channel. There were no detections above the LODs in any of downstream sample locations, thus Target PFAS is not migrating downgradient via surface water. The August 2023 ASD Memorandum does not provide guidance for PFAS in surface water, and PFAS concentrations are compared to the SLs for tap water.

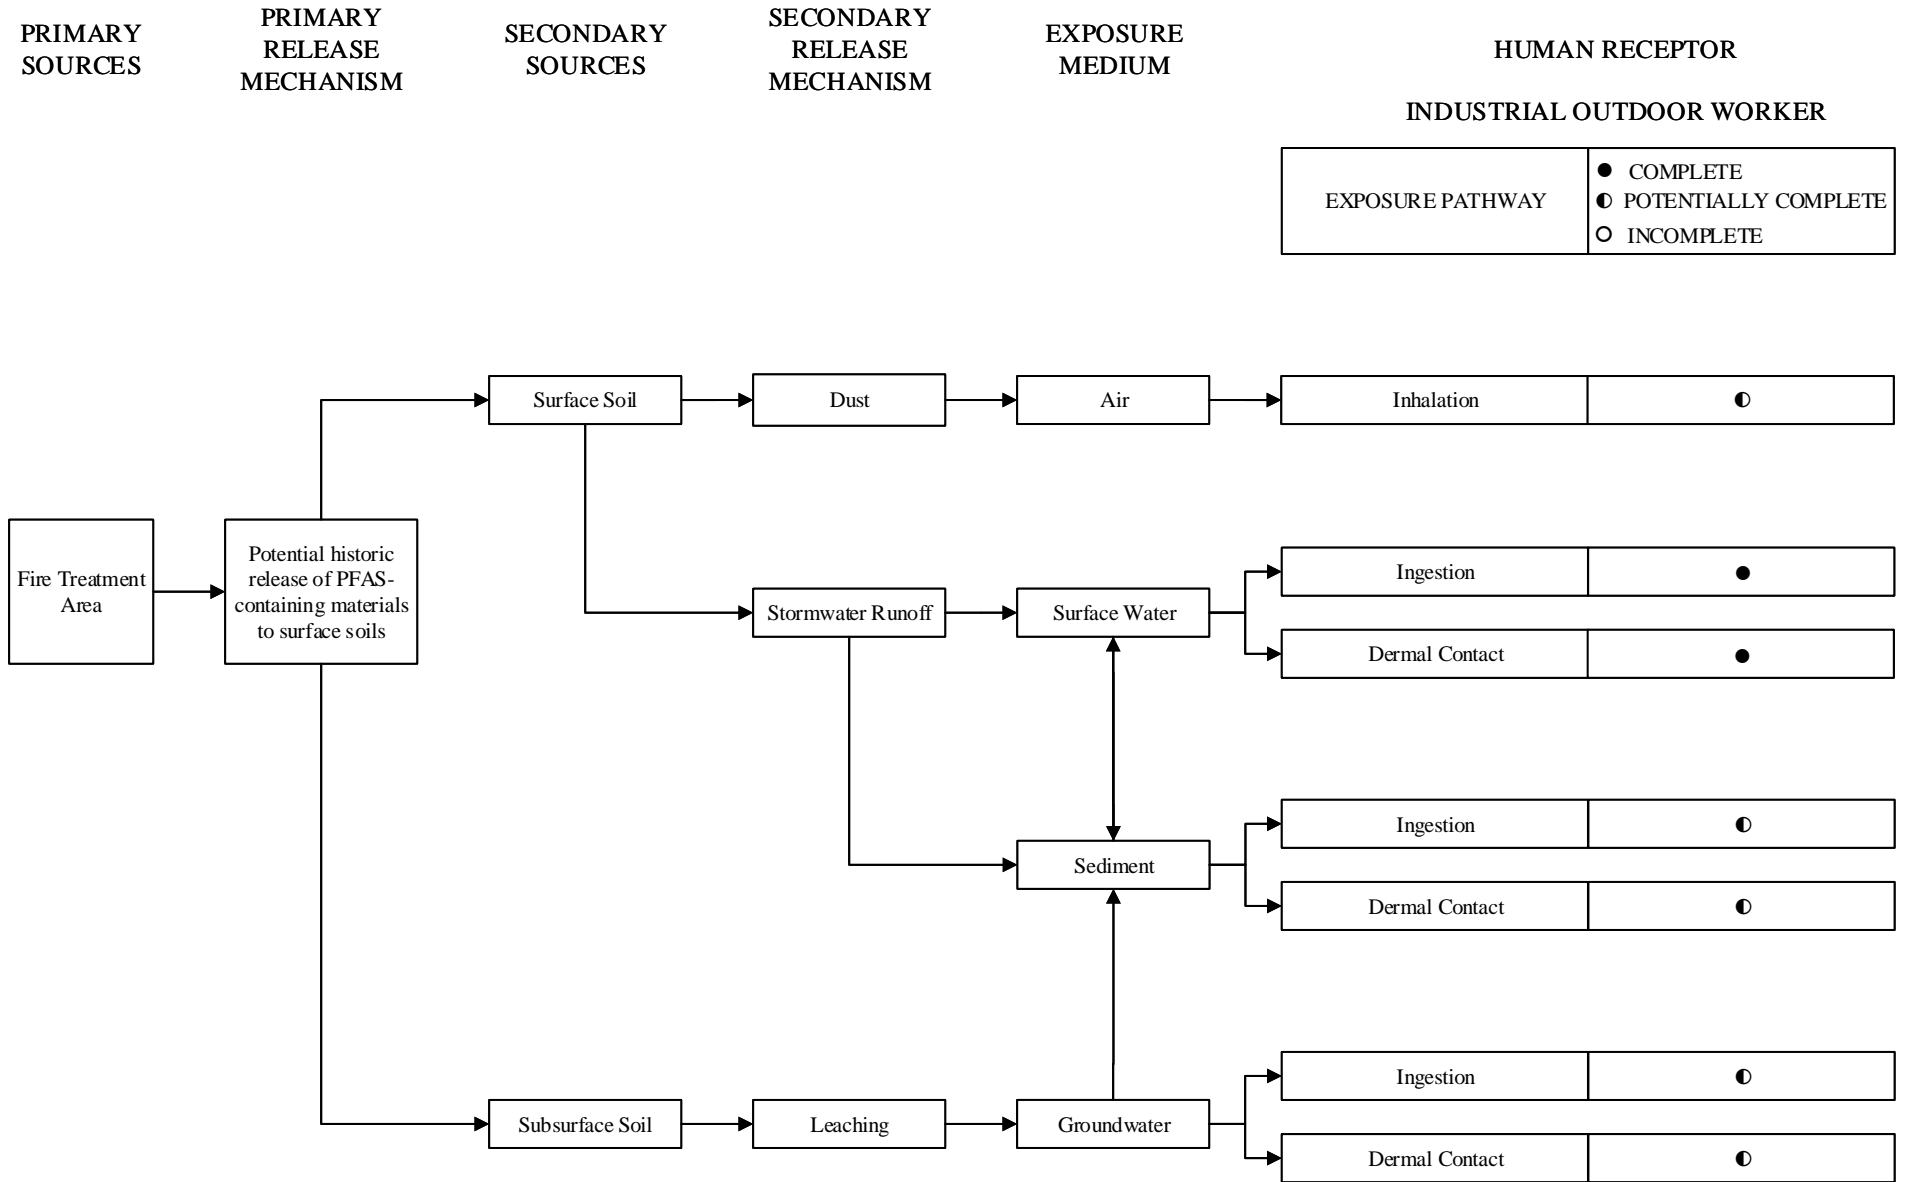
Figure 6-5. Human Health Conceptual Site Model for SWMU 29

The preliminary CSM developed for SWMU 29 during the PA was further refined where Target PFAS were detected above the LOD in soil, groundwater, surface water, or sediment. Based on the SI sample results, the CSM presented represents the current understanding of site conditions with respect to known or suspected sources of PFAS-containing materials, potential transport mechanisms and migration pathways, and potentially exposed human receptors.

Based on the CSM provided in the UFP-QAPP (Swift River TLI JV 2023), vertical and horizontal migration of PFAS is driven by wind dispersion resulting from human activities or fugitive dust, surface runoff from precipitation events, precipitation infiltration, and the downgradient groundwater migration. In consideration of current and planned industrial use, human receptors potentially exposed to surface and/or subsurface media are Industrial Outdoor Workers (IOW). Human exposure pathways to be evaluated for the future IOW are ingestion of or dermal contact with surface or subsurface soils, sediment, surface water, or groundwater. Human exposure pathways to be evaluated for the future Resident include ingestion of or dermal contact with surface or subsurface soils, sediment, surface water, or groundwater, and ingestion of biota. The exposure pathways are evaluated as complete, potentially complete, or incomplete in the CSM presented in Figure 6-5. In the absence of toxicity information for the inhalation route, the inhalation exposure pathway of PFAS (via dust) is considered potentially complete in soil where Target PFAS are detected. The remaining exposure pathway designations were determined as follows:

The primary release mechanism is the potential release of PFAS-containing materials to surface soils related to historical operations at the FTA. The secondary contaminant migration and fate and transport considerations include downward contaminant migration from surface soil to deeper subsurface soil and groundwater through infiltration, leaching, and percolation.
