FINAL SITE INSPECTION OF PER- AND POLYFLUOROALKYL SUBSTANCES

Picatinny Arsenal, New Jersey

Prepared For:
U.S. Army Corps of Engineers, Baltimore District
2 Hopkins Plaza
Baltimore, Maryland 21201

April 2022

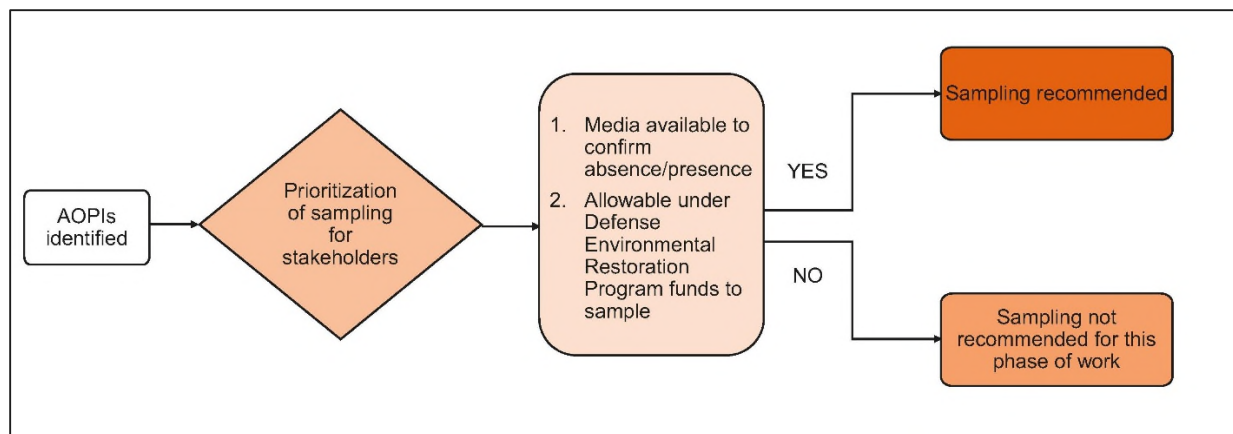
Figure 4-1: AOPI Sampling Decision Tree

The rationale for sampling at each AOPI is illustrated on **Figure 4-1** below.

The sampling design for pre-SI and SI sampling activities at PICA are detailed in Worksheets #17 of the QAPP Addenda (Arcadis 2018b; Arcadis 2019d). Briefly, the areas of focus for this SI were selected based on a review of historical documents and data and information obtained by conducting personal interviews during the PA (Arcadis 2019c). Approximate sampling depths, and constituents analyzed for each sampling location and medium are included in **Table 4-1**. Sampling depths noted for existing monitoring wells represent approximately the center of the saturated screened interval. The sampling design rationale for the pre-SI and SI include the following.

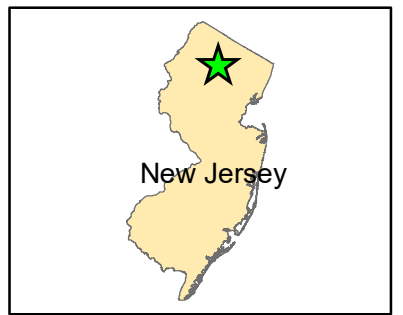
Figure 2-1 Site Location

PICA, which covers approximately 5,900 acres, contains both improved and unimproved lands and is located in Rockaway Township, Morris County, New Jersey (NJ) approximately 45 miles west of New York City and four miles northeast of Dover, NJ (**Figure 2-1**). The installation is bordered by numerous major highways including State Route 15, Interstate 80, and U.S. Route 46 (**Figure 2-1**).

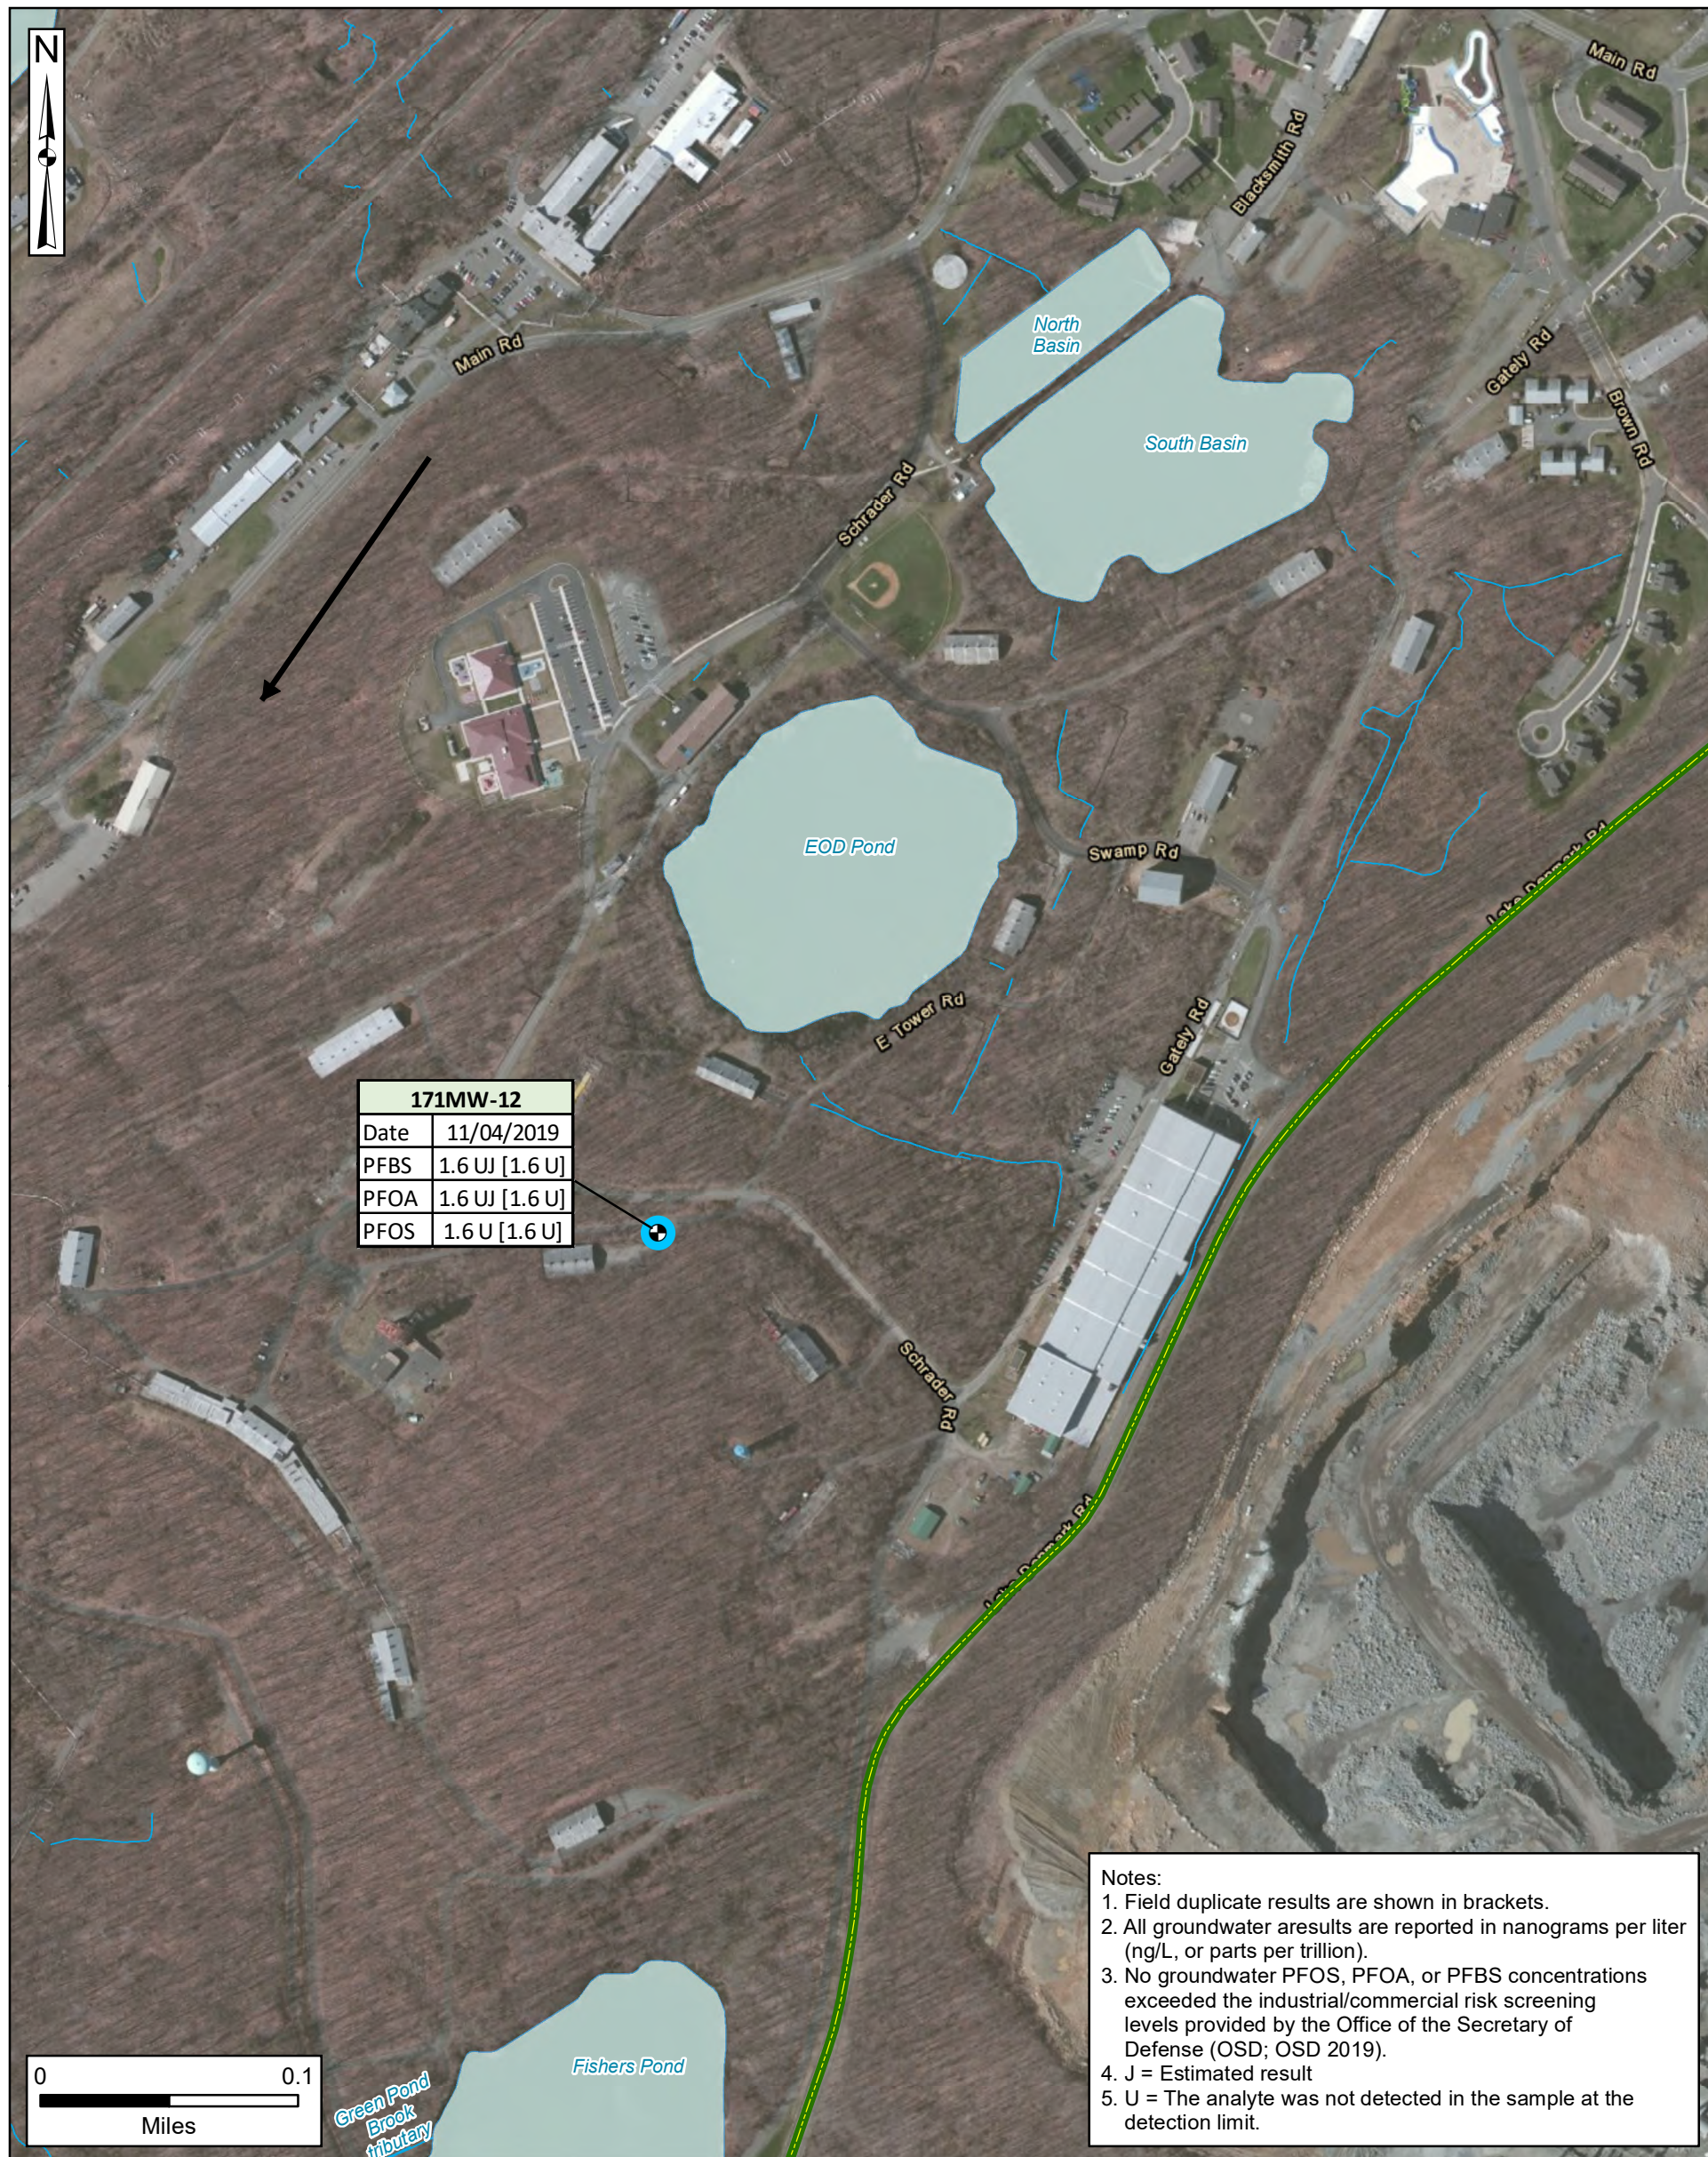
Figure 5-4
Mid-Valley Upgradient On-Site
Sampling Results

While not directly associated with any particular AOPI, Mid-Valley Upgradient On-Site is centrally located within PICA, upgradient of the southern AOPIs. One groundwater sample was collected from existing monitoring well, 171MW-12. PFOS, PFOA, and PFBS were not detected in the groundwater sample. Refer to **Table 5-1** and **Figure 5-4**.
