FINAL PRELIMINARY ASSESSMENT AND SITE INSPECTION OF PER- AND POLYFLUOROALKYL SUBSTANCES

Rock Island Arsenal, Illinois

October 2022

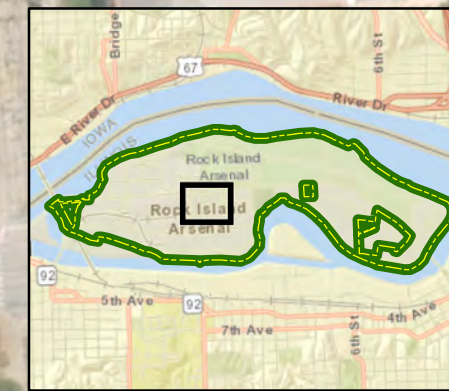
Figure 7-5
Building 225 and Building 107 AOPIs
PFOS, PFOA, and PFBS
Analytical Results

Soil samples were collected from two locations at Building 107 (**Figure 7-5**). Each boring included a surface soil sample collected from 0 to 1-foot bgs. A summary of PFOS, PFOA, and PFBS soil analytical results is provided in **Table 7-2**. PFOS, PFOA, and PFBS, were not detected in either sample.

One groundwater sample was collected via DPT drilling and temporary well sampling downgradient of Building 107 (**Figure 7-5**). The groundwater sample was collected at the first-encountered groundwater, which was at approximately 12.5 feet bgs. Two groundwater samples were planned at AOPI Building 107; however, as discussed in **Section 6.3.4**, a groundwater sample could not be collected from RIA-107-1 due to refusal from shallow bedrock and a lack of water in the overburden soil. A summary of PFOS, PFOA, and PFBS groundwater analytical results is provided in **Table 7-1**.

Soil samples were collected from three locations at Building 225 (**Figure 7-5**). Soil samples RIA-225-1 and RIA-225-2 were collected at 0 to 2 feet bgs and sample RIA-225-3 was collected at 1 to 3 feet bgs, beneath the overlying asphalt. A summary of PFOS, PFOA, and PFBS soil analytical results is provided in **Table 7-2**.

Groundwater samples were collected from two borings via rotosonic drilling and temporary well sampling at Building 225 (RIA-225-1-GW and RIA-225-2-GW; **Figure 7-5**). Grab groundwater samples were collected at first-encountered groundwater, which was at approximately 24 to 30 feet bgs. A summary of PFOS, PFOA, and PFBS groundwater analytical results is provided in **Table 7-1**.
