FINAL PRELIMINARY ASSESSMENT AND SITE INSPECTION OF PER- AND POLYFLUOROALKYL SUBSTANCES

Redstone Arsenal, Alabama

Prepared For:
U.S. Army Corps of Engineers, Baltimore District
2 Hopkins Plaza
Baltimore, Maryland 21201

June 2022

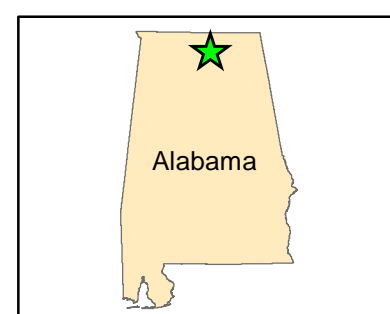
Figure 2-2 Site Layout

RSA receives drinking water from the Tennessee River, while the surrounding communities source water from both the Tennessee River and groundwater sources. Three WTP intakes are identified on the Tennessee River and within a 5-mile radius of RSA (**Figure 2-2**). The RSA WTP has a surface water intake in the southwestern portion of the installation. Two municipal WTPs owned by Huntsville Utilities are located on the Tennessee River, one upstream (South Parkway WTP) and one downstream (Southwest WTP) of RSA. Groundwater resources at RSA are under an installation-wide LUC precluding the use of groundwater for drinking water or irrigation per the conditions of a 2007 IROD (Shaw 2007). While no groundwater drinking water systems are active within the boundary of RSA, several potable groundwater systems are proximal to RSA and operated by Huntsville Utilities and the City of Madison. The closest groundwater supply wells are the Williams and Drake Wells, located within 1 mile of the RSA installation boundary (**Figure 2-2**). Communications with Huntsville Utilities indicate that the Williams Well has not been used for regular water supply since approximately 2012 and is currently designated as an emergency water source (EA and Arcadis 2015). The City of Madison operates the Drake Well, a 5-million-gallon-per-day supplemental groundwater supply well located approximately 2.3 miles north of the Williams Well (**Figure 2-2**). The water systems associated with Huntsville Utilities and Madison County Waterworks were sampled in 2014/2015 as part of the UCMR3 efforts and yielded no detections of PFAS constituents. These water systems were again sampled for PFAS constituents in 2020 and yielded very low-level detections of PFAS constituents. Huntsville Utilities detected a maximum concentration of 10 ng/L of combined PFAS constituents. The City of Madison identified PFOS, PFOA, and PFBS detections of 2 ng/L, 1 ng/L, and 3 ng/L, respectively.

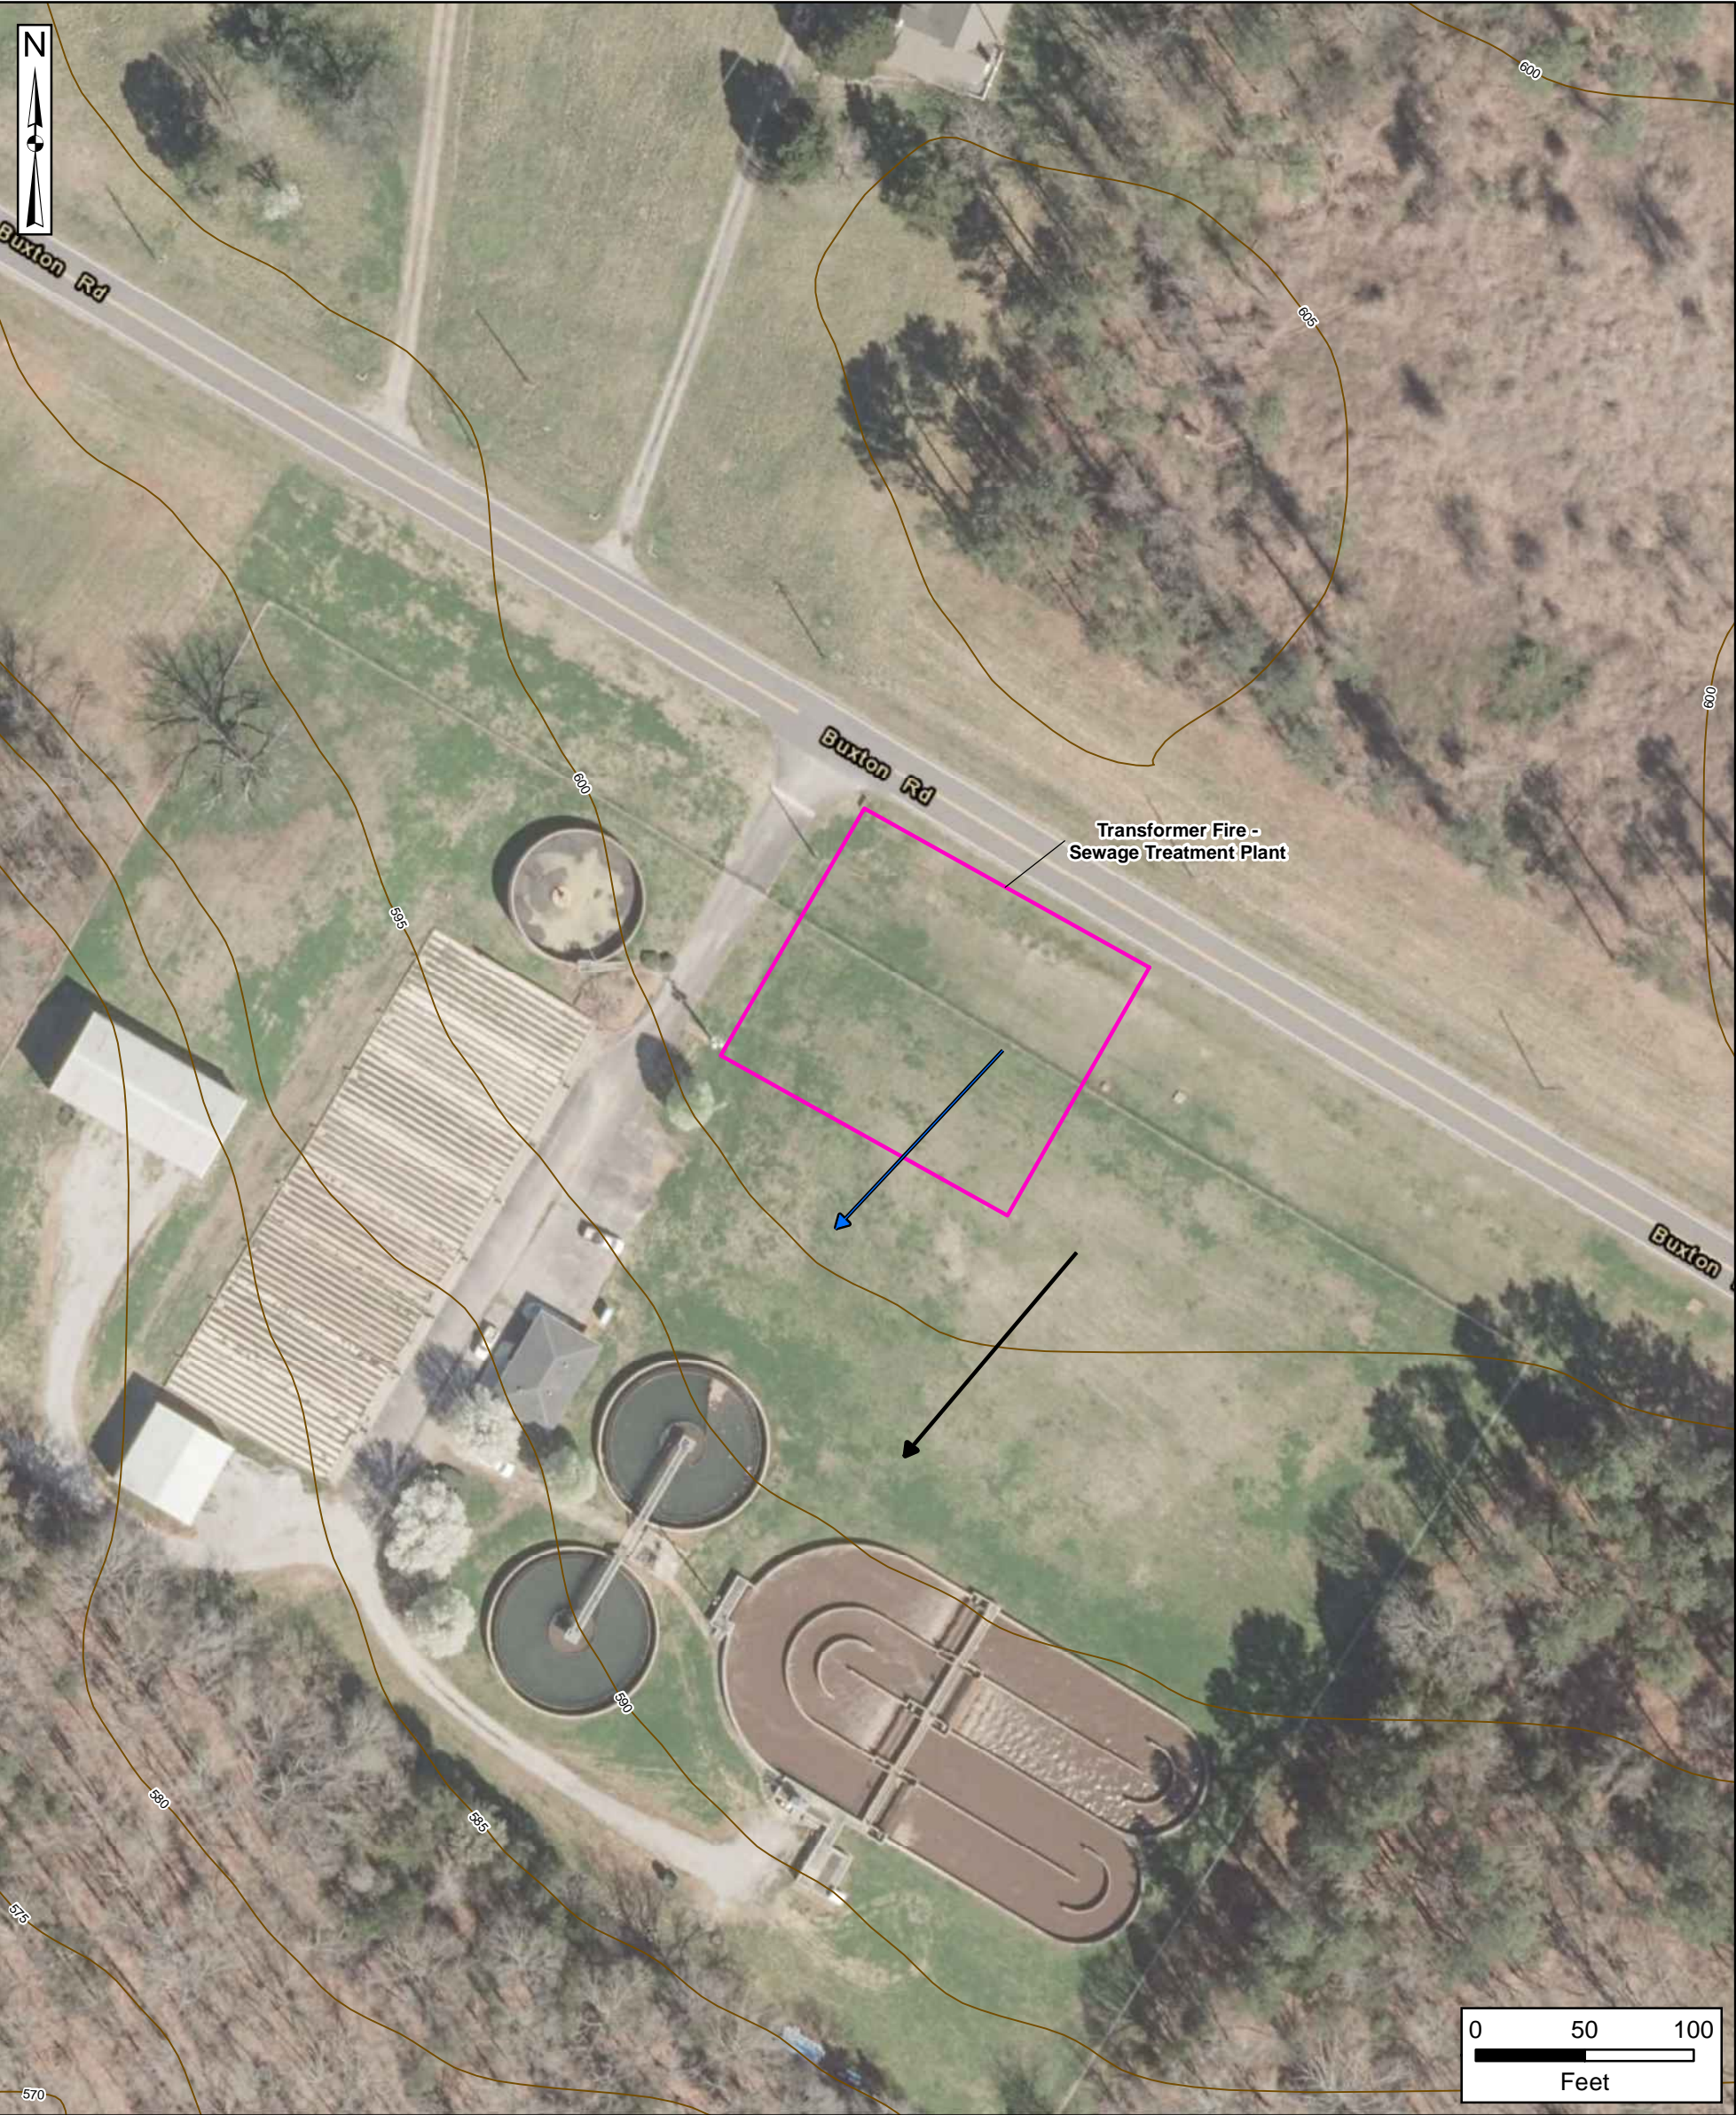
Figure 5-7
Aerial Photo of Transformer Fire

the Transformer Fire AOPI is provided on **Figure 5-7**. The current and planned future land use of the treatment plant area is industrial. The Transformer Fire AOPI does not overlap with any IRP sites.

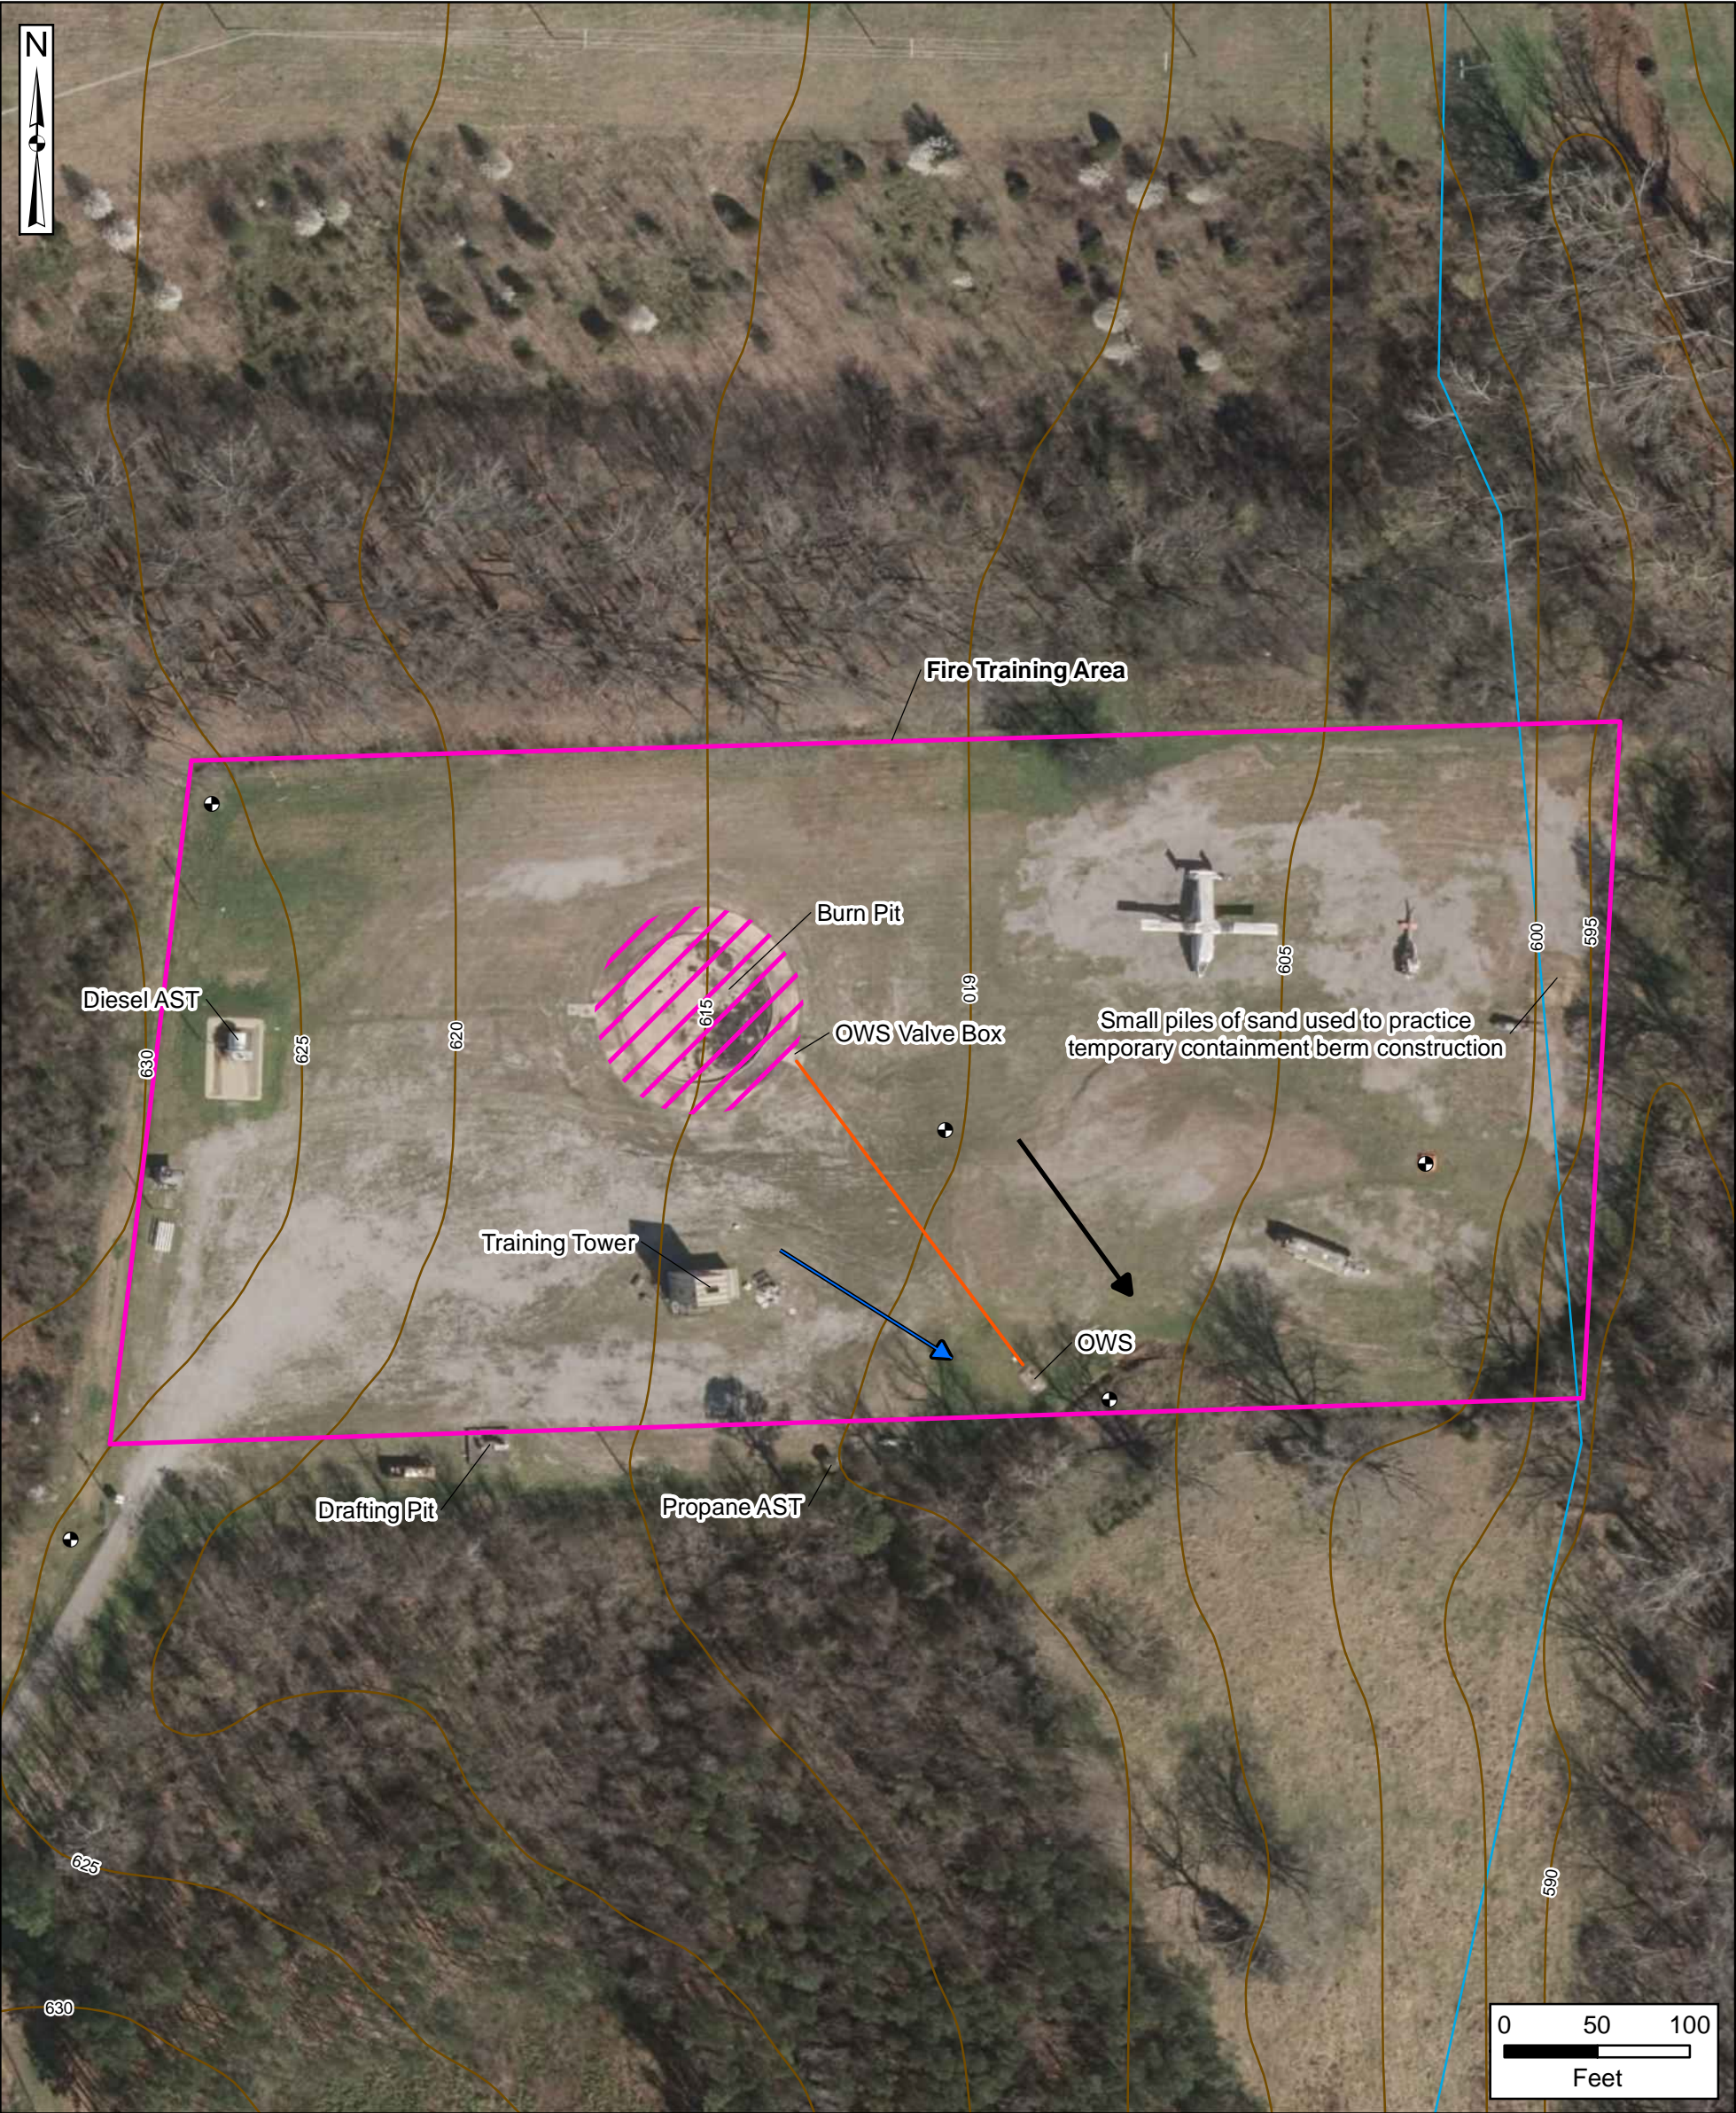
Figure 5-12
Aerial Photo of Fire Training Area

Based on historical imagery, the FTA was initially constructed between 1984 and 1992. The original construction of the FTA burn pit reportedly consisted of a curbed firebrick base lined with high-density polyethylene. The initial construction of the burn pit did not include a method to remove the fuel and water from the pit after completion of training exercises. During heavy rains, the burn pit filled with rainwater,

resulting in overflows that contained training residues. In the 1990s, the burn pit was rebuilt using concrete. Deficiencies in the selected concrete were noted in the form of cracks that occurred due to the high heat of fire training exercises. The burn pit was rebuilt again in the late 1990s using refractory concrete and a 14-foot-wide catch apron with drains. In its current form, the burn pit consists of an 80-foot-diameter concrete circle 16 inches deep constructed of 1-foot-thick refractory concrete, underlain by a 30-millimeter high-density polyethylene liner approximately 2 feet below the bottom of the pit. The catch apron drains are routed to an OWS that discharges to a drainage ditch located in the southeastern portion of the site. A 2012 interview with RSA Fire and Emergency Services personnel indicated that the burn pit was being used two to three times per year for local training exercises and a few other times per year by an Air National Guard unit from a base located in Birmingham, Alabama (CB&I 2017b).

An aerial photograph of the FTA is provided on **Figure 5-12**. The AOPI is located within an undeveloped area in the northwestern portion of RSA, northeast of the airfield. The AOPI area is generally clear of vegetation and surrounded by a fence with a locked security gate across a gravel entrance in the southwest corner of the site. The major site features include the following structures, which are used to support fire training activities: a fire burn pit, a diesel fuel aboveground storage tank (AST), a training tower, a drafting pit, a propane AST, and an OWS. Additionally, decommissioned hulls of an airplane and a helicopter are located in the northeastern portion of the FTA AOPI; these hulls are used to practice emergency personnel extraction techniques. The AOPI is flat with a gentle downward slope toward the southeast. The current and planned future land use of the FTA is industrial.

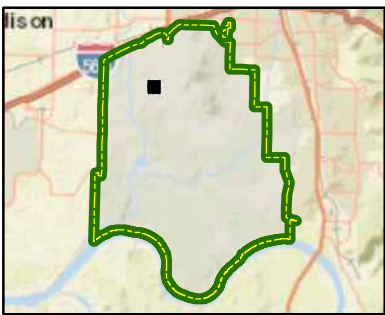
Figure 7-13
PFOS, PFOA, and PFBS Analytical Results for
Fire Station #4 (Building 4810),
Fire Station #5 (Building 4813), and Hangar 4815

Two surface soil samples were collected via hand auger near FS #5 on October 1, 2020. Samples RSA-FS5-SO-01 (0-2 ft bgs) and RSA-FS5-SO-02 (0-2 ft bgs) were collected from locations along the south side of the FS driveway in the likely direction of surface water runoff (**Figure 7-13**).

Four groundwater samples associated with Hangar 4815 were collected, two from nearby existing monitoring wells and two from temporary monitoring wells. Temporary well RSA-4815-GW-02 is associated with the historical septic drainage field for both FS #5 and Hangar 4815, as discussed in **Section 7.12.1 (Figure 7-13)**. Temporary well RSA-FS4-GW-01 is associated with FS #4 as well as with FS#5 and Hangar 4815 (see **Section 7.11.1**). Existing monitoring wells MW08 and RS1604 were sampled on November 11 and November 20, 2020, respectively. Groundwater samples were collected from approximately the center of each monitoring well's saturated screened interval of 57 to 67 ft bgs for MW08 and 115 to 130 ft bgs for RS1604. MW08 is located downgradient of the inferred groundwater flow direction from Hangar 4815 and monitoring well RS1604 is located upgradient of the hangar and within the airfield. Both monitoring wells were sampled because of drilling difficulties encountered during rotosonic drilling in the vicinity of Hangar 4815.

Three surface soil samples were collected via hand auger near Hangar 4815 on October 1, 2020. Sample RSA-4815-SO-01 (0-2 ft bgs) was collected from the grassy area west of (behind) the hangar, near the presumed AFFF storage tank location. Sample RSA-4815-SO-02 (0-2 ft bgs) was co-located with groundwater sample RSA-4815-GW-02 in the area of the historical septic tank drain field. Sample RSA-1815-SO-03 was collected from the northwest corner of Hangar 4815 (**Figure 7-13**).

1. PFOS was detected in sample RSA-4815-GW-02, collected from the septic tank drain field that historically served both Fire Station #5 and Hangar 4815. During data validation, it was noted that the extracted internal standard recovery for PFOS was outside control limits. PFOS is considered present; however, the reported value has unknown bias, is unreliable, and cannot be compared to screening criteria. Another groundwater sample collected directly downgradient of both Fire Station #5 and Hangar 4815 (RSA-FS4-GW-01) had a detection of PFOS at 46 ng/L, exceeding the OSD risk screening level of 40 ng/L. Therefore, Fire Station #5 and Hangar 4815 are recommended for further study in a remedial investigation.

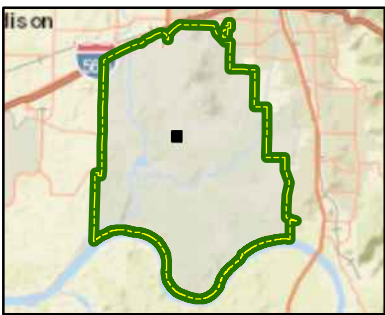
Figure 7-17
PFOS, PFOA, and PFBS Analytical Results for
Vehicle Fire

RSA-VF-SO-02	
Date	9/28/2020
Depth	0-2 ft bgs
PFOS	0.0013 U [0.0011 U]
PFOA	0.0013 U [0.0011 U]
PFBS	0.0013 U [0.0011 U]

RSA-VF-GW-01	
Date	11/3/2020
PFOS	23 BJ+
PFOA	7 J-
PFBS	3.5 J-
RSA-VF-SO-01	
Date	9/28/2020
Depth	0-2 ft bgs
PFOS	0.001
PFOA	0.00055 J
PFBS	0.0010 U

A grab groundwater sample (RSA-VF-GW-01) was collected from one boring advanced via DPT near the presumed location of the vehicle fire. The groundwater sample was collected at first-encountered groundwater obtained from a temporary well screen installed at a depth interval of 1 to 16 ft bgs. The boring was located in the grassy area to the east of the Building 4650 parking lot near a stormwater drainage swale (**Figure 7-17**). Groundwater sampling was completed on November 3, 2020.

Two surface soil samples were collected via hand auger near the Vehicle Fire AOPI on September 28, 2020. Surface soil sample RSA-VF-SO-01 was co-located with groundwater sample RSA-VF-GW-01 near a drainage swale in the direction of surface runoff flow from the presumed vehicle fire location. Surface soil sample RSA-VF-SO-02 was collected from the grassy area directly east of the reported vehicle fire location (**Figure 7-17**).

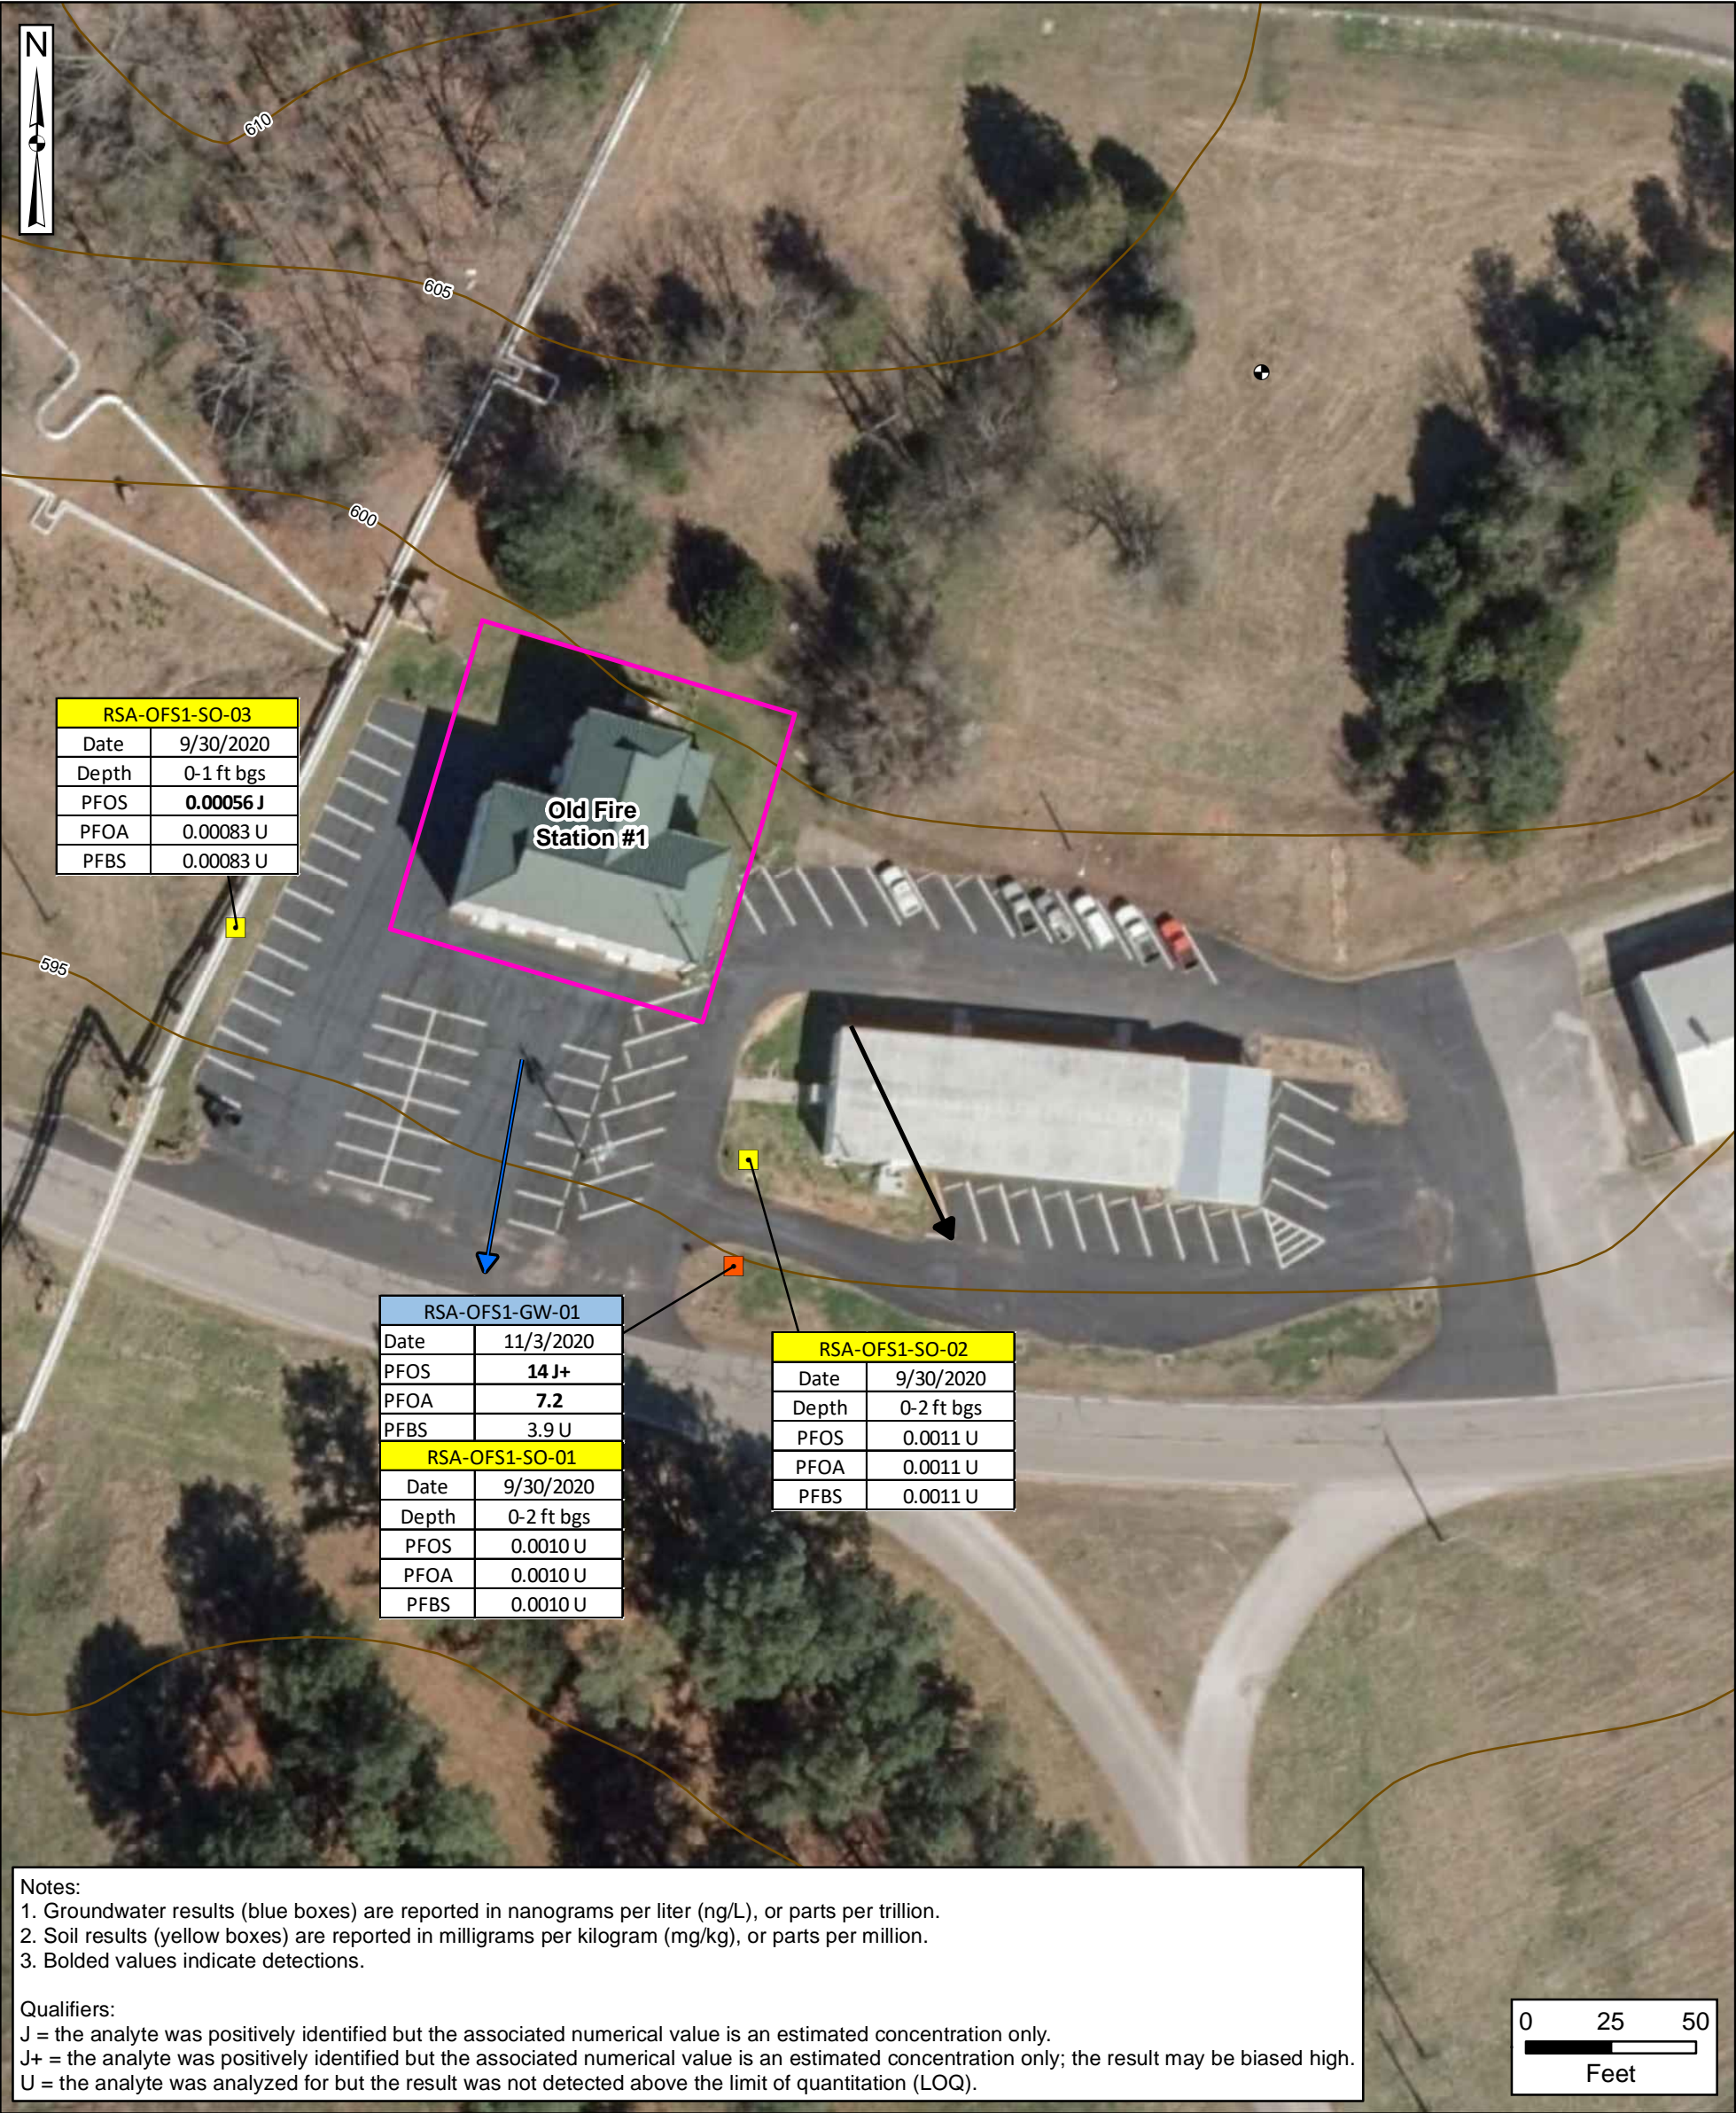
Figure 7-20
PFOS, PFOA, and PFBS Analytical Results for
Old Fire Station #1

A grab groundwater sample (RSA-OFS1-GW-01) was collected from one boring advanced via DPT at Old FS #1. The groundwater sample was collected at first-encountered groundwater obtained from a temporary well screen installed at a depth interval of 0 to 19 ft bgs. The boring was located in the grassy area to the southeast of the building in the direction of surface water runoff from the parking lot (**Figure 7-20**). Groundwater sampling was completed on November 3, 2020.

Three surface soil samples were collected via hand auger near Old FS #1 on September 30, 2020. Surface soil sample RSA-OSF1-SO-01 (0-2 ft bgs) was co-located with groundwater sample RSA-OSF1-GW-01; sample RSA-OSF1-SO-02 (0-2 ft bgs) was collected directly southeast of the building; and sample RSA-OFS1-SO-03 (0-1 ft bgs) was collected from the west of the building, in a grassy area where released AFFF may have been conveyed (**Figure 7-20**).
