# FINAL PRELIMINARY ASSESSMENT AND SITE INSPECTION OF PER- AND POLYFLUOROALKYL SUBSTANCES

## Fort Rucker, Alabama

November 2022

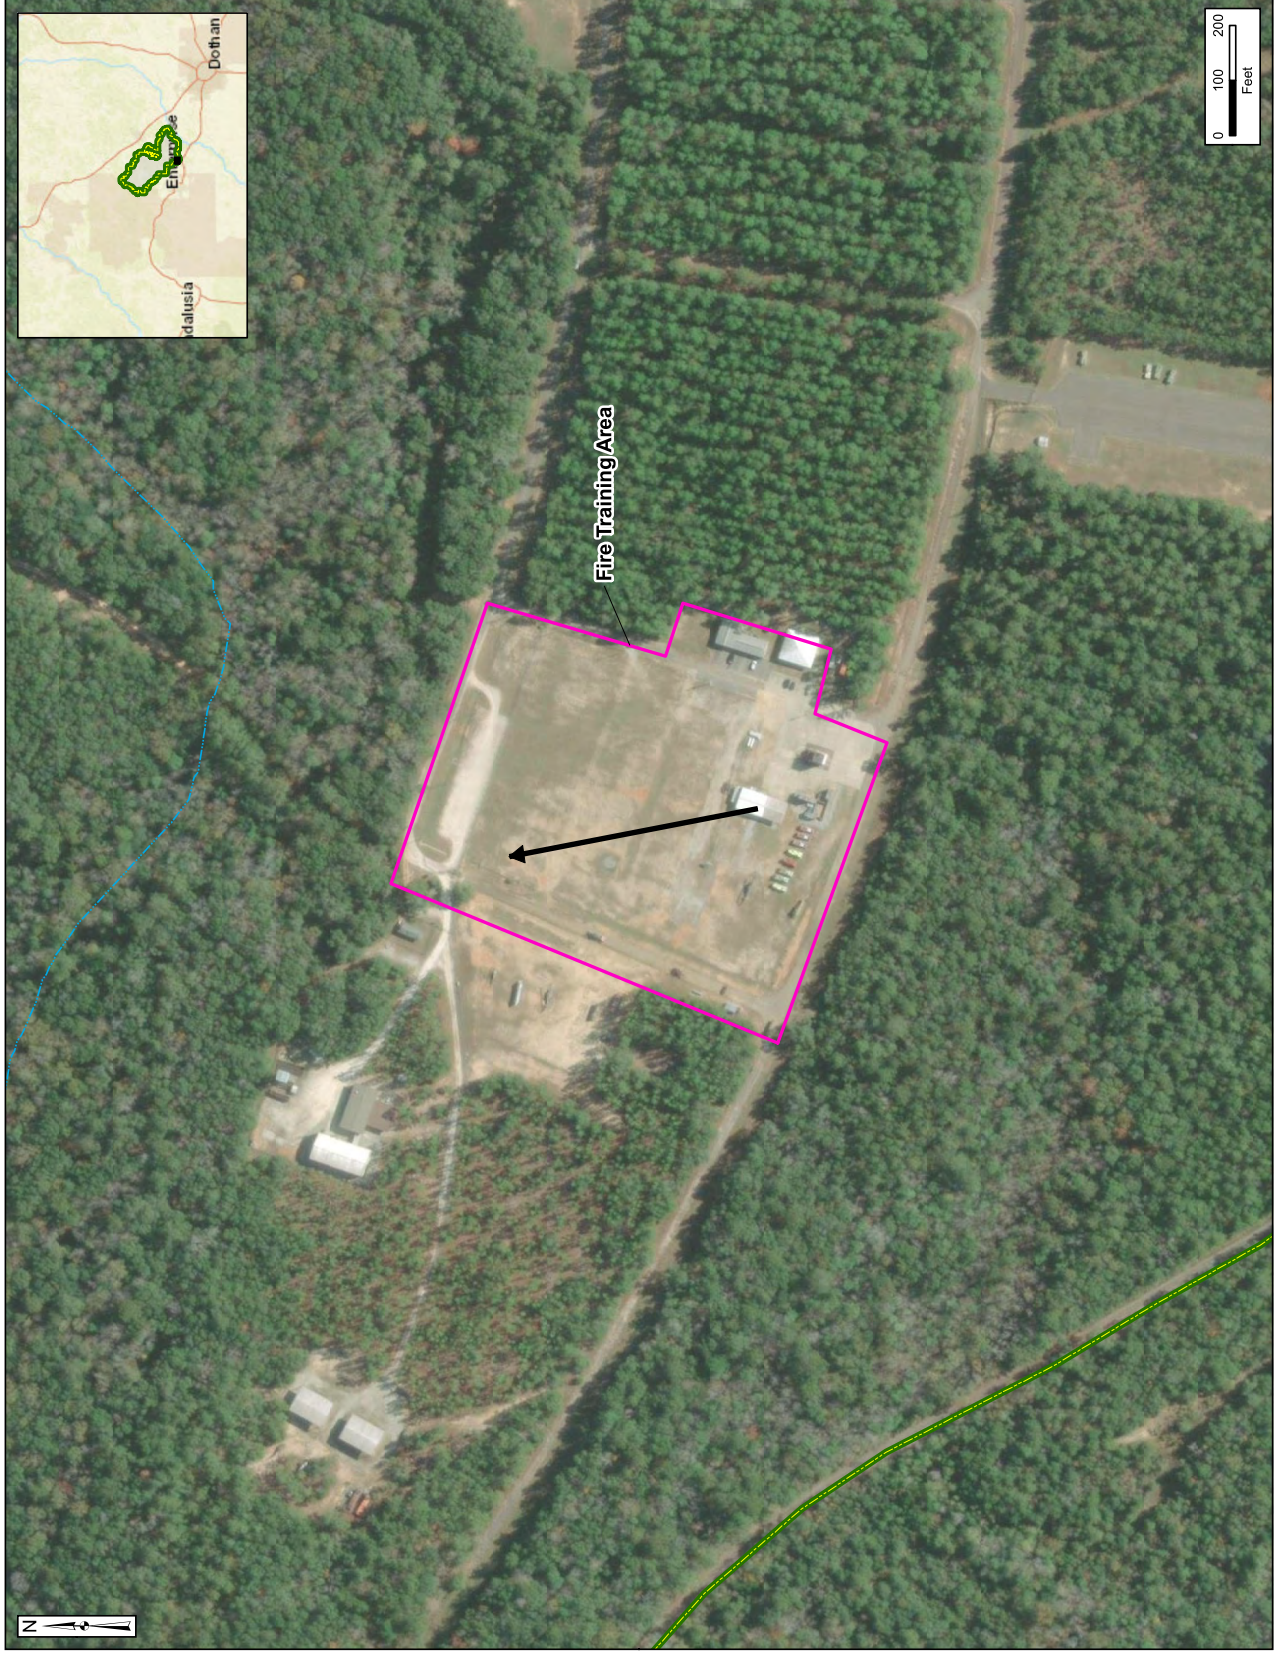
Figure 5-11  
 Aerial Photo of  
 Goldberg Stage Field

Goldberg SF is identified as an AOPI following records research and personnel interviews due to presence of an RIV equipped with between 70 and 120 gallons of AFFF. The Goldberg SF is located east of the main cantonment, is approximately 110 acres, and houses two permanent structures: an air traffic control tower and an operation building where emergency service equipment is stored (**Figure 5-11**). The current and future land use is classified as industrial. While there is no indication of emergency use of AFFF at the SF, it was noted that AFFF concentrate was changed out and/or nozzle testing may have

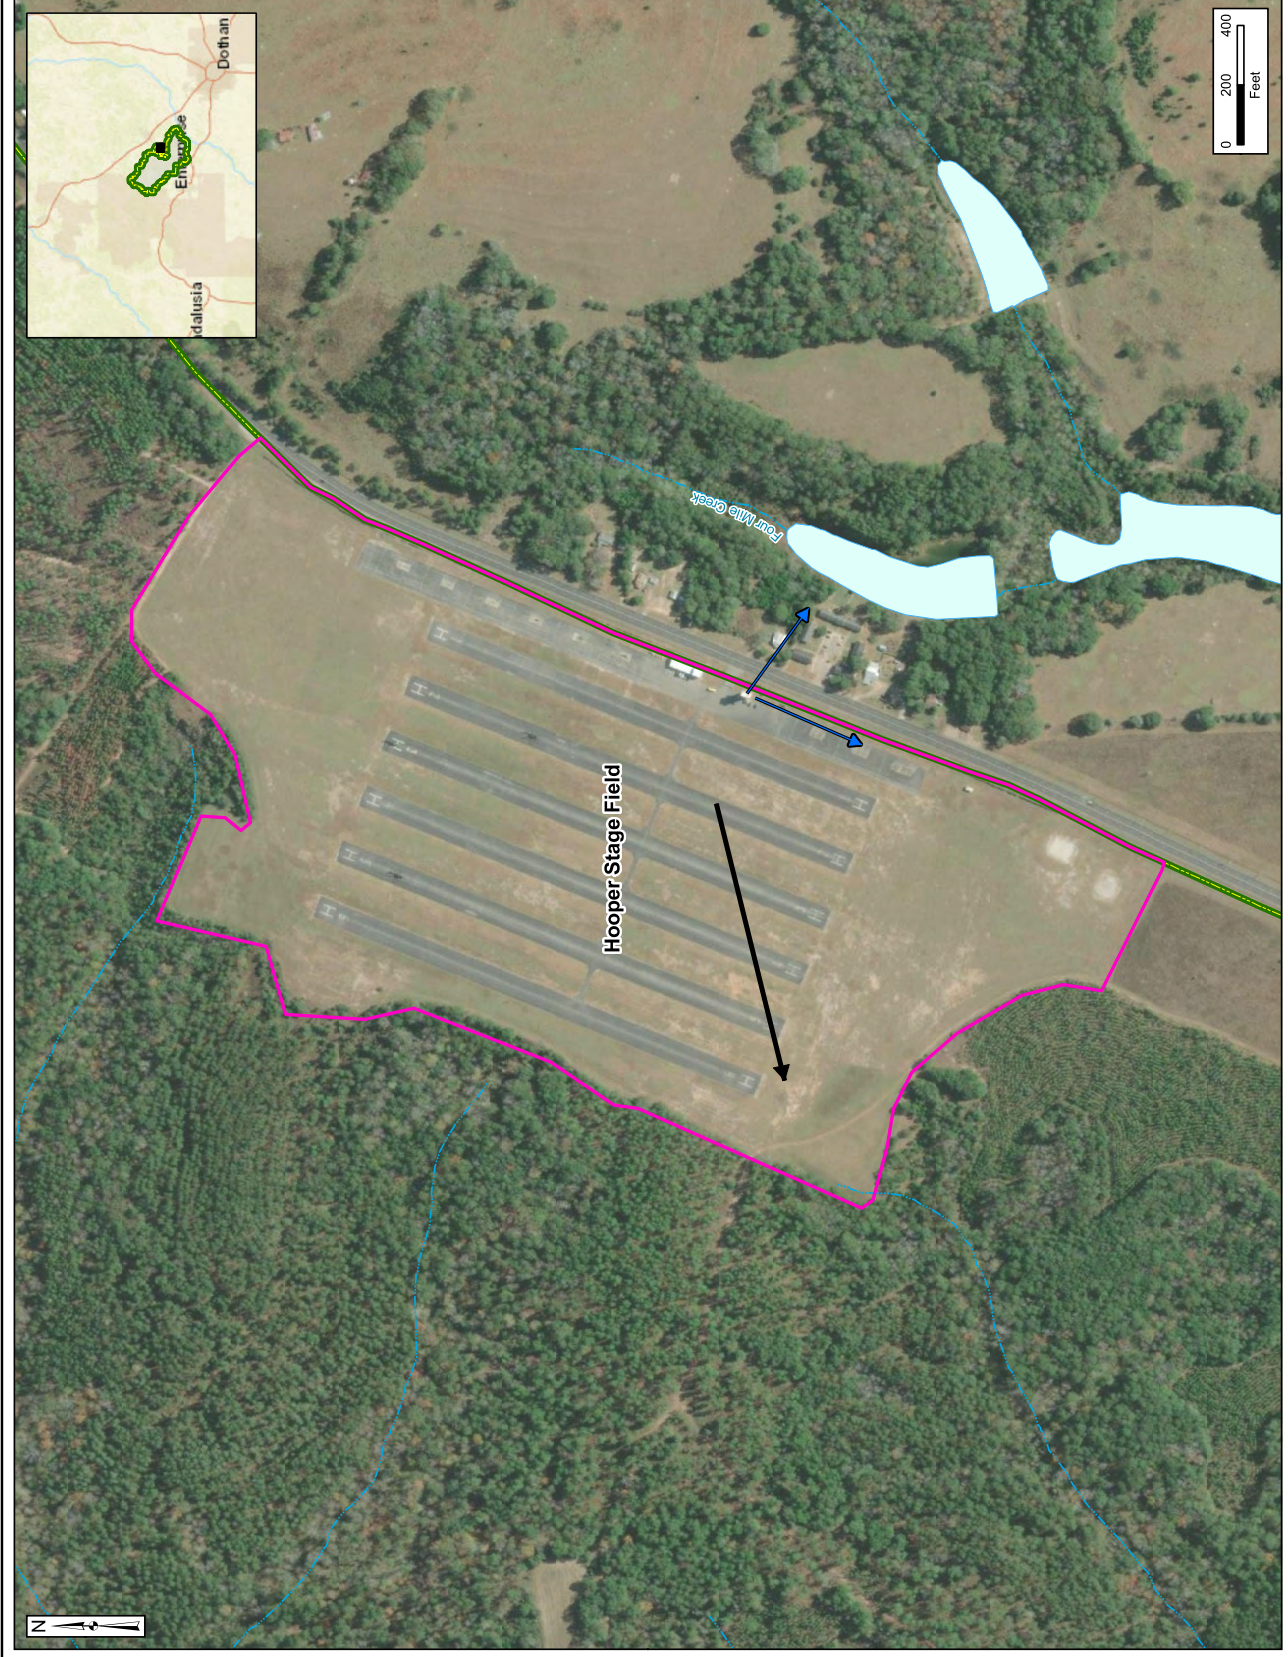
Figure 5-16  
 Aerial Photo of  
 Hunt Stage Field

Hunt SF is identified as an AOPI following records research and personnel interviews due to presence of an RIV equipped with between 70 and 120 gallons of AFFF. The Hunt SF is located east of the main cantonment, consists of approximately 125 acres and houses three permanent structures: an air traffic control tower, an operation building where emergency service equipment is stored, and what appears to be a well pump house (**Figure 5-16**). The current and future land use is classified as industrial. While there is no indication of emergency use of AFFF at the SF, it was noted that AFFF concentrate was changed out and/or nozzle testing likely occurred annually and that the AFFF may have been released to the environment via paved surfaces and/or soil at the SF.
