FINAL **PRELIMINARY ASSESSMENT** **AND SITE INSPECTION OF** **PER- AND** **POLYFLUOROALKYL** **SUBSTANCES**

Fort Riley, Kansas

January 2022

**Preliminary
Assessment and Site
Inspection of Per- and
Polyfluoroalkyl
Substances**

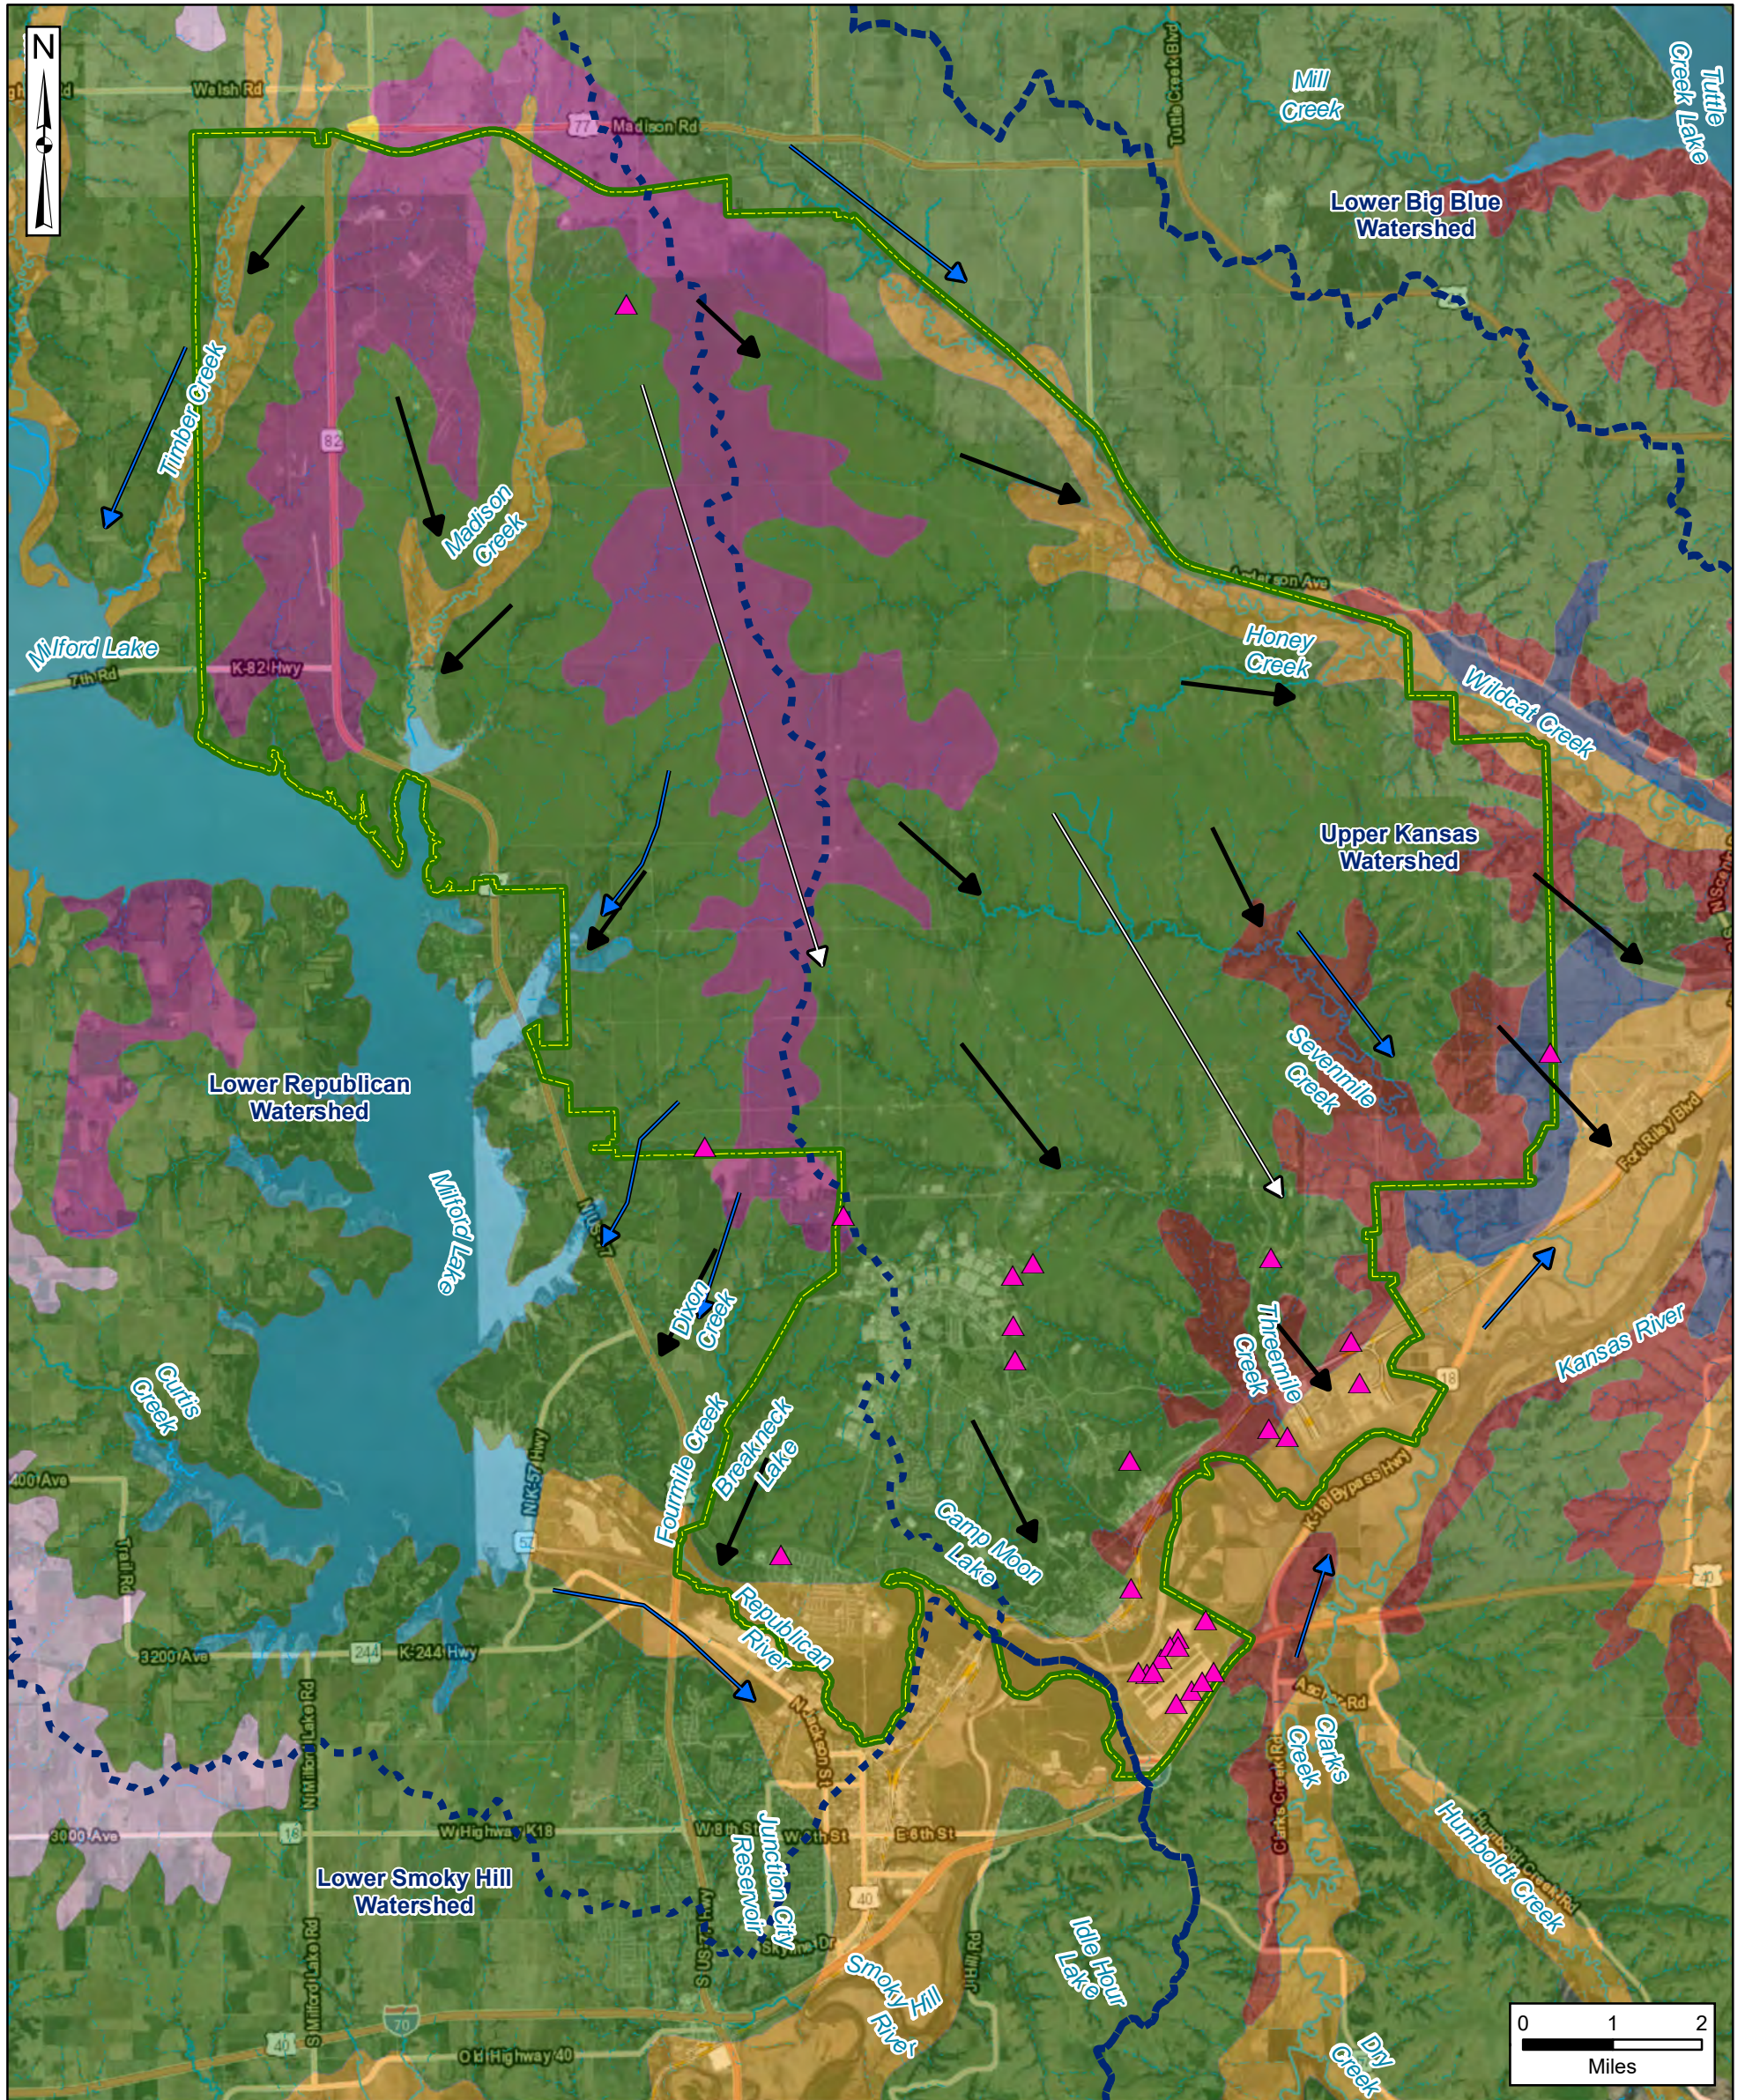
Figure 2-4
Geology and Hydrogeology

The hydrogeology at FTRI is summarized on **Figure 2-4**. Groundwater at FTRI occurs in alluvial deposits of Quaternary age (approximately 1.8 million years ago to present) along the major streams and rivers and in the fissured, near-surface limestone of the upland areas (Fort Riley 2001b). The alluvial aquifer is unconfined and bounded on the sides and bottom by Permian age shale and limestone bedrock (USGS 2000). Where the saturated thickness of the alluvial aquifer ranges from 20 to 40 feet, well yields of 300 to 1,000 gallons per minute (gpm) are obtainable and yields in excess of 1,000 gpm can be obtained where the saturated thickness of the aquifer exceeds 40 feet (Fort Riley 2001b). Moderate quantities of groundwater occur in bedrock formations underlying the alluvial deposits, particularly the Fort Riley and Florence formations (Chase Group) and the Cottonwood Formation (Council Grove Group). Well yields of 100 gpm or more can be obtained in this bedrock aquifer (Fort Riley 2001a and 2001b; Malcolm Pirnie 2009). Groundwater is available in other bedrock units underlying the Chase and Council Grove groups; these regional groundwater sources are utilized as aquifers in other parts of Kansas. Near Fort Riley, these systems are isolated from the alluvial deposits and from most of the other bedrock aquifer systems by several shale units that act as low effective-porosity barriers (USACHPPM 2004; Malcolm Pirnie 2009).

The depth to groundwater in the alluvial aquifer is between 10 and 30 feet below ground surface (bgs); the depth to groundwater in the bedrock is approximately 60 to 100 feet bgs (Fort Riley 2001b; United States Department of Health and Human Services [USDHHS] 1999). Groundwater elevations in the alluvial aquifers are affected primarily by the stage of the Kansas River and to a lesser extent by the stages of tributaries, ponds, and lakes and by infiltration from precipitation (USGS 2000; Malcolm Pirnie 2009).

For the majority of the installation, groundwater flows south and southeast toward the river (USDHH 1999). Topography, in conjunction with the interconnectedness of bedrock joints, fractures, and bedding planes, exerts strong influence over groundwater flow systems in the upper water-bearing bedrock formations (i.e., Fort Riley and Florence formations) (USACHPPM 2004). The deeper regional groundwater aquifer flow system underlying the Fort Riley and Florence formations may be less influenced by topography and may be primarily under the influence of the shallow regional dip to the west-northwest; thus, groundwater present in the regional groundwater aquifer is flowing to the west (USACHPPM 2004; Malcolm Pirnie 2009).

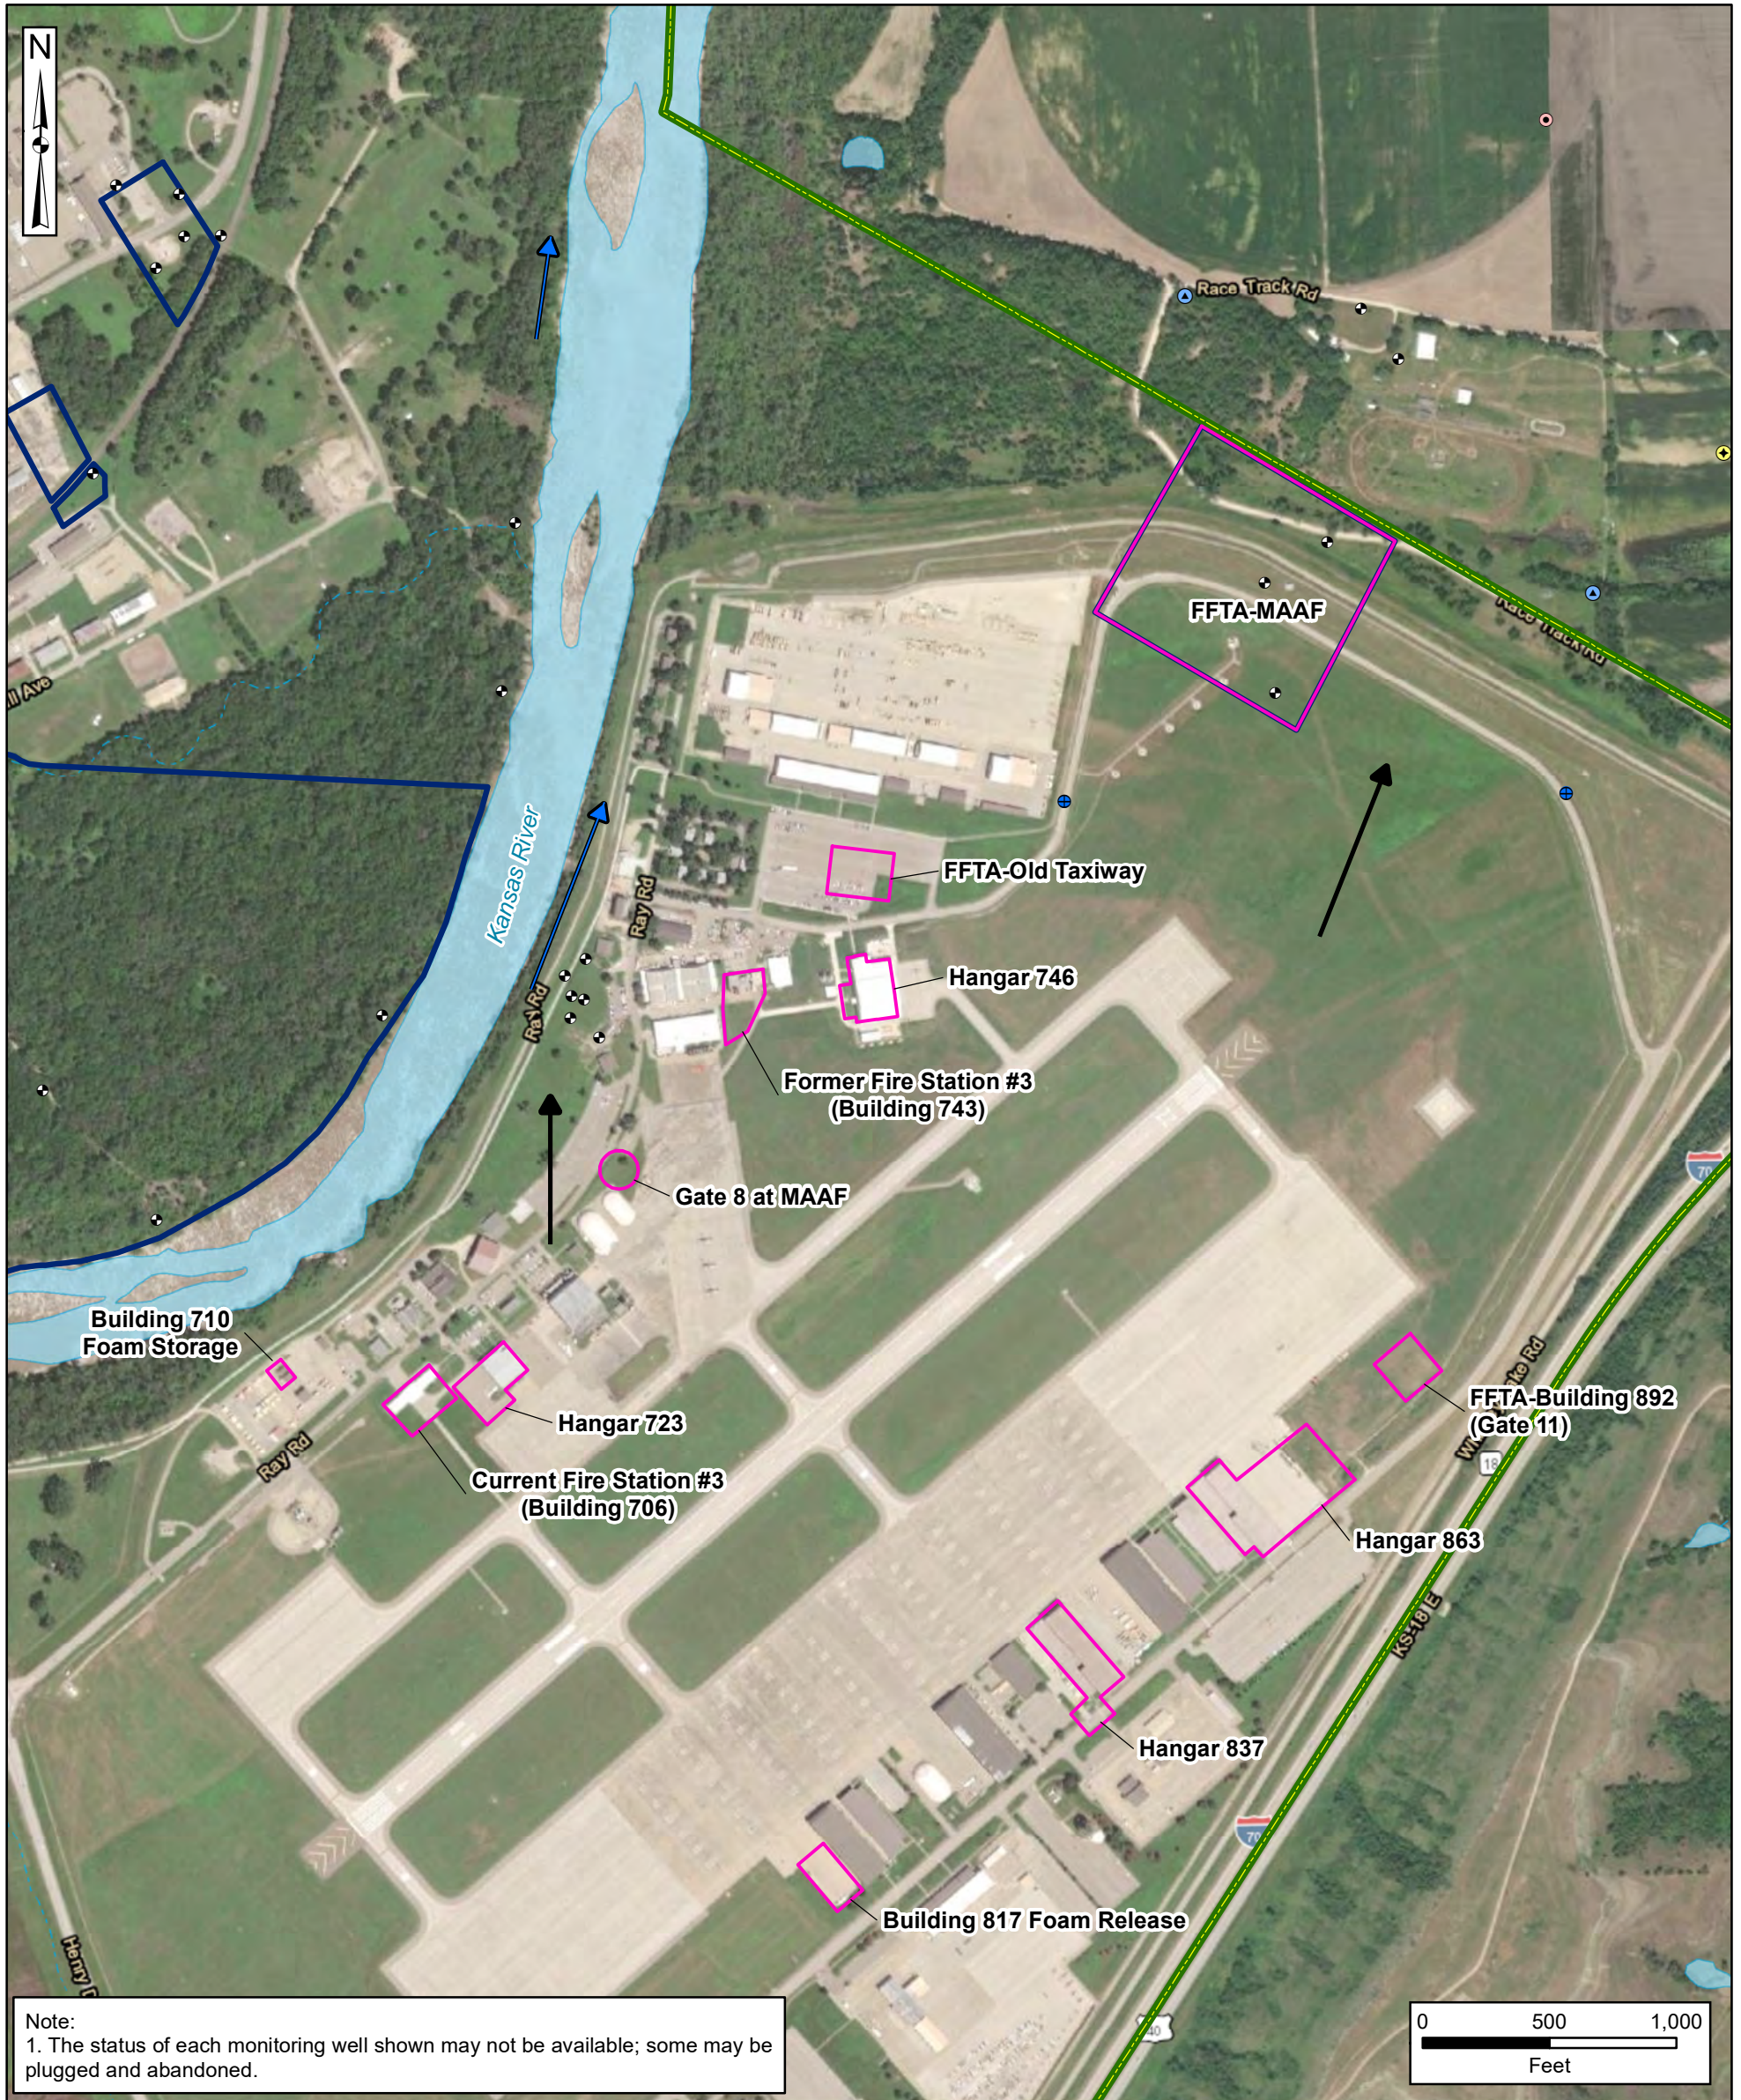
Figure 5-3
Aerial Photo of the
Marshall Army Airfield AOPIs

The FFTA-Building 892 (Gate 11) (FTRI-018, 20605.1018) at the MAAF was identified as an AOPI due to historical fire training activities (**Figure 5-3**). A former fire department burn pit, designated Building 892,

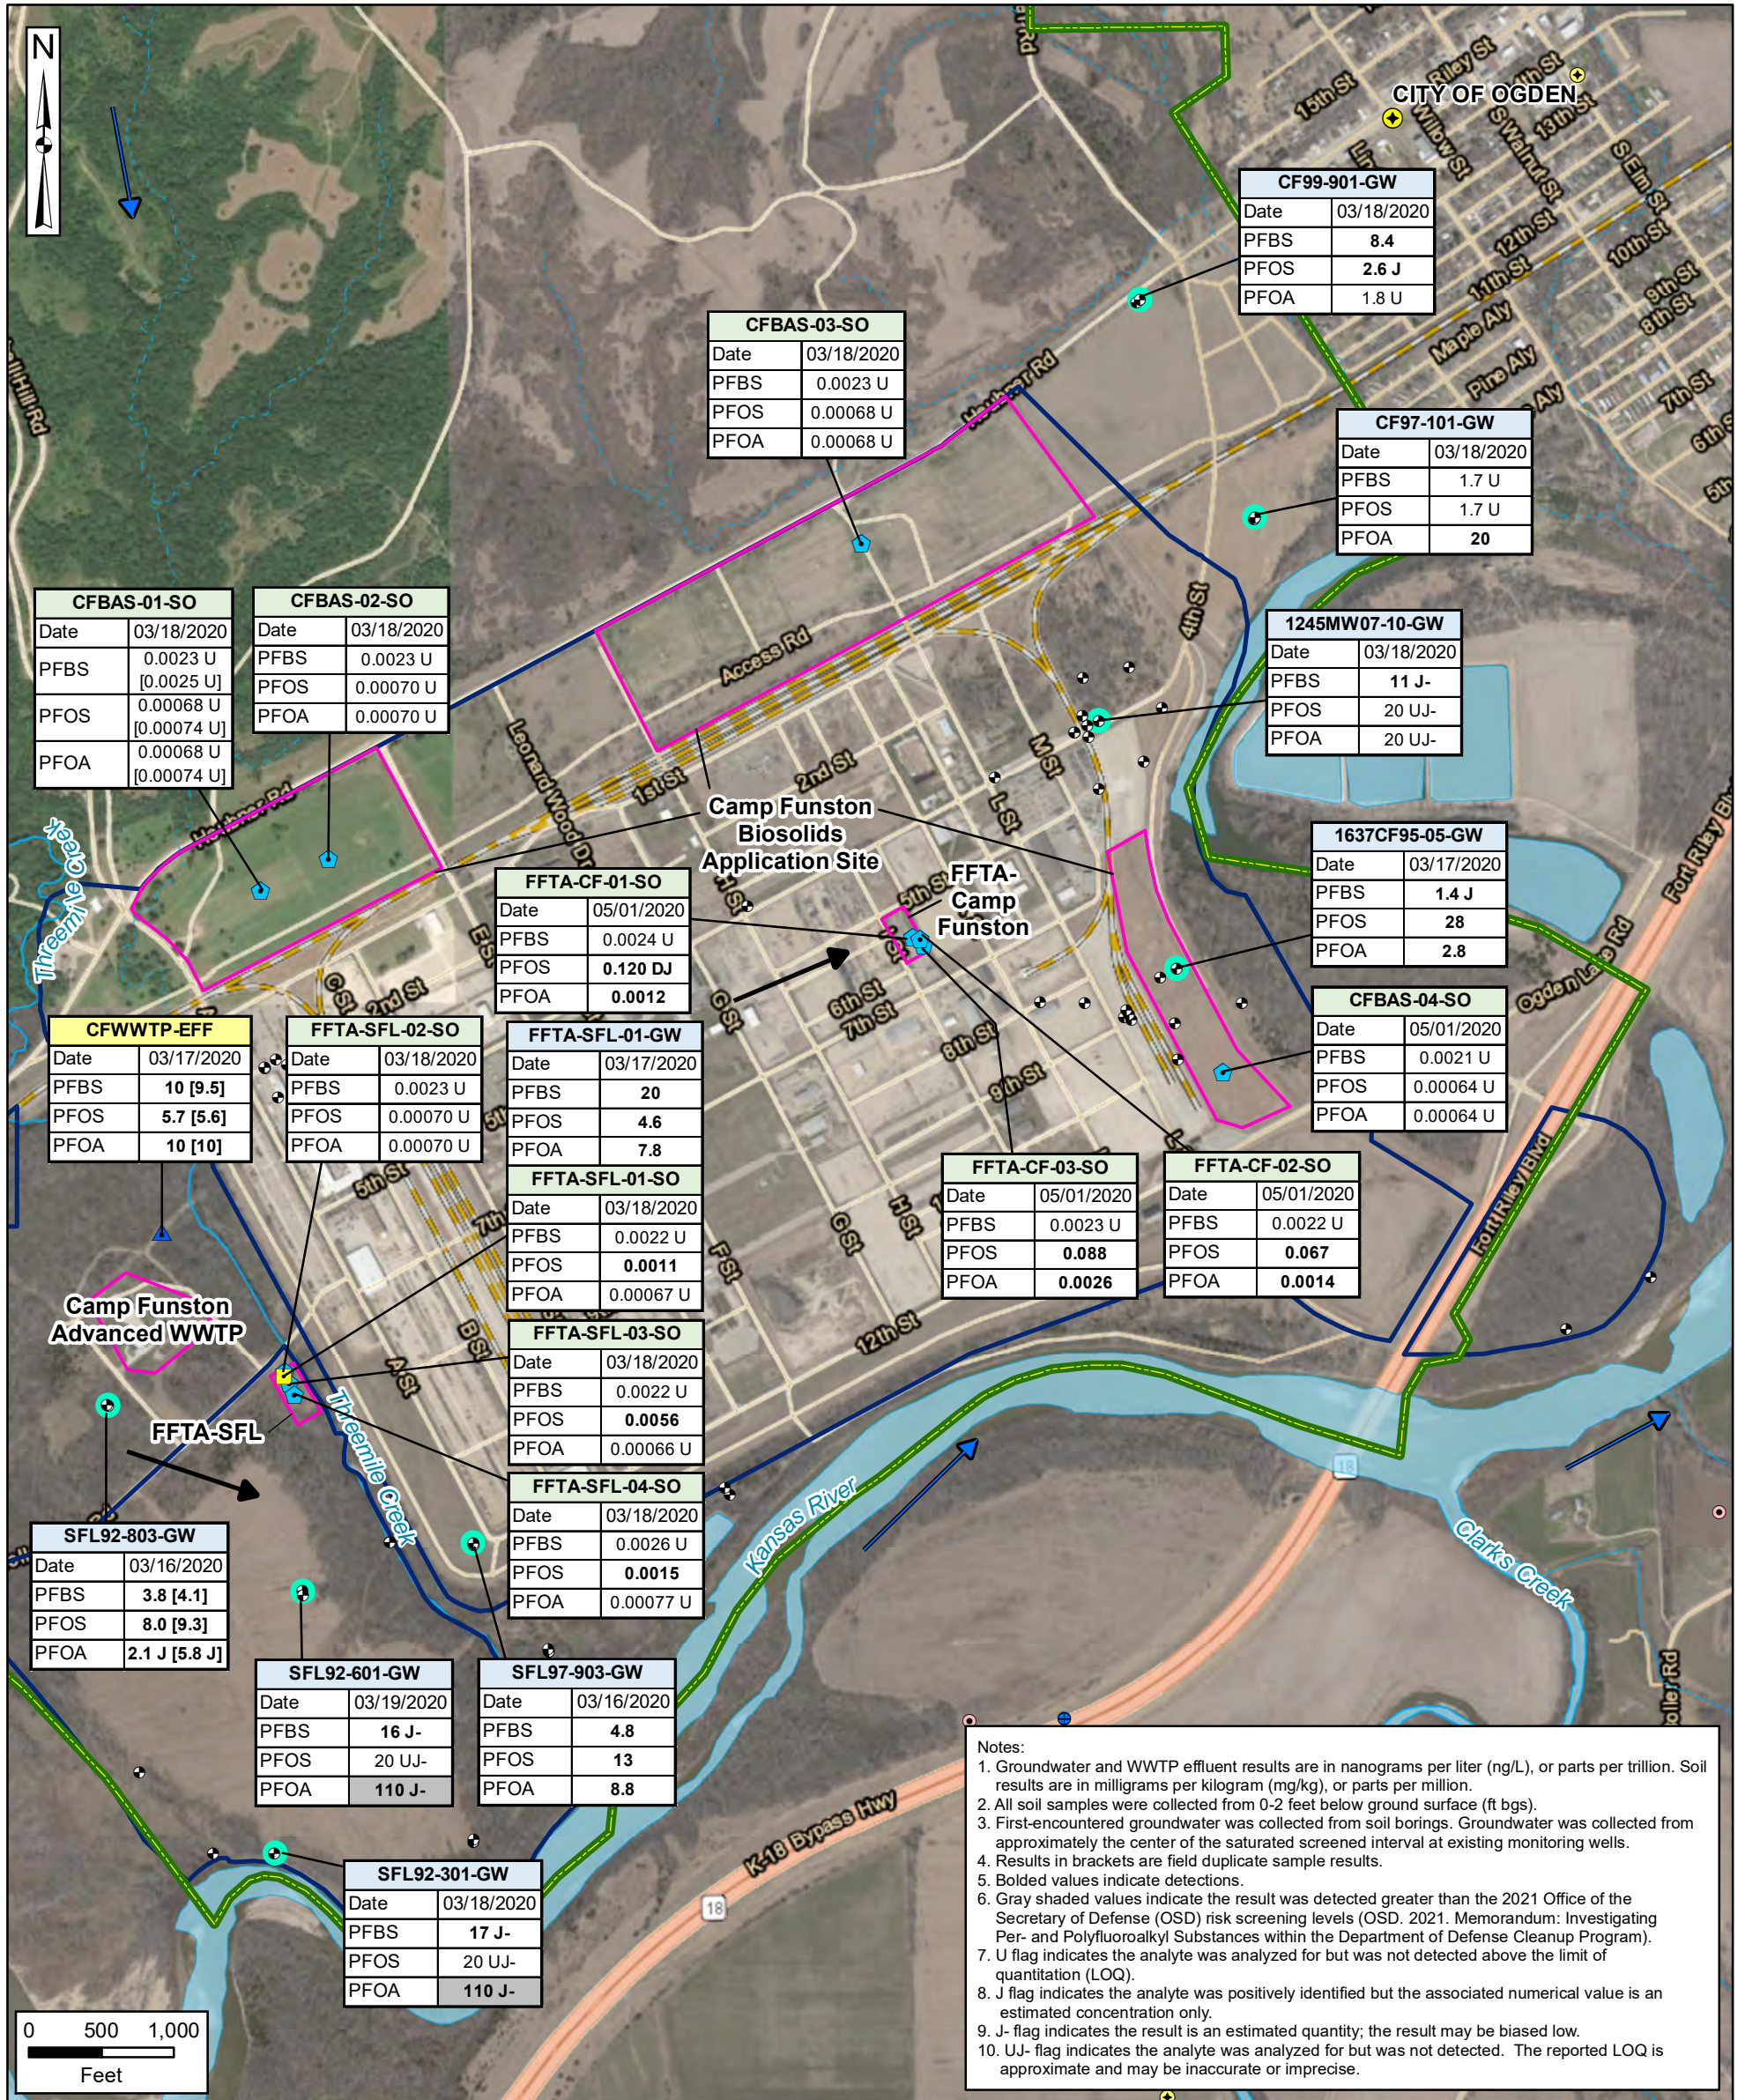
Figure 7-3
Camp Funston AOPIs
PFOS, PFOA, and PFBS Analytical Results

- Notes:
1. Groundwater and WWTP effluent results are in nanograms per liter (ng/L), or parts per trillion. Soil results are in milligrams per kilogram (mg/kg), or parts per million.

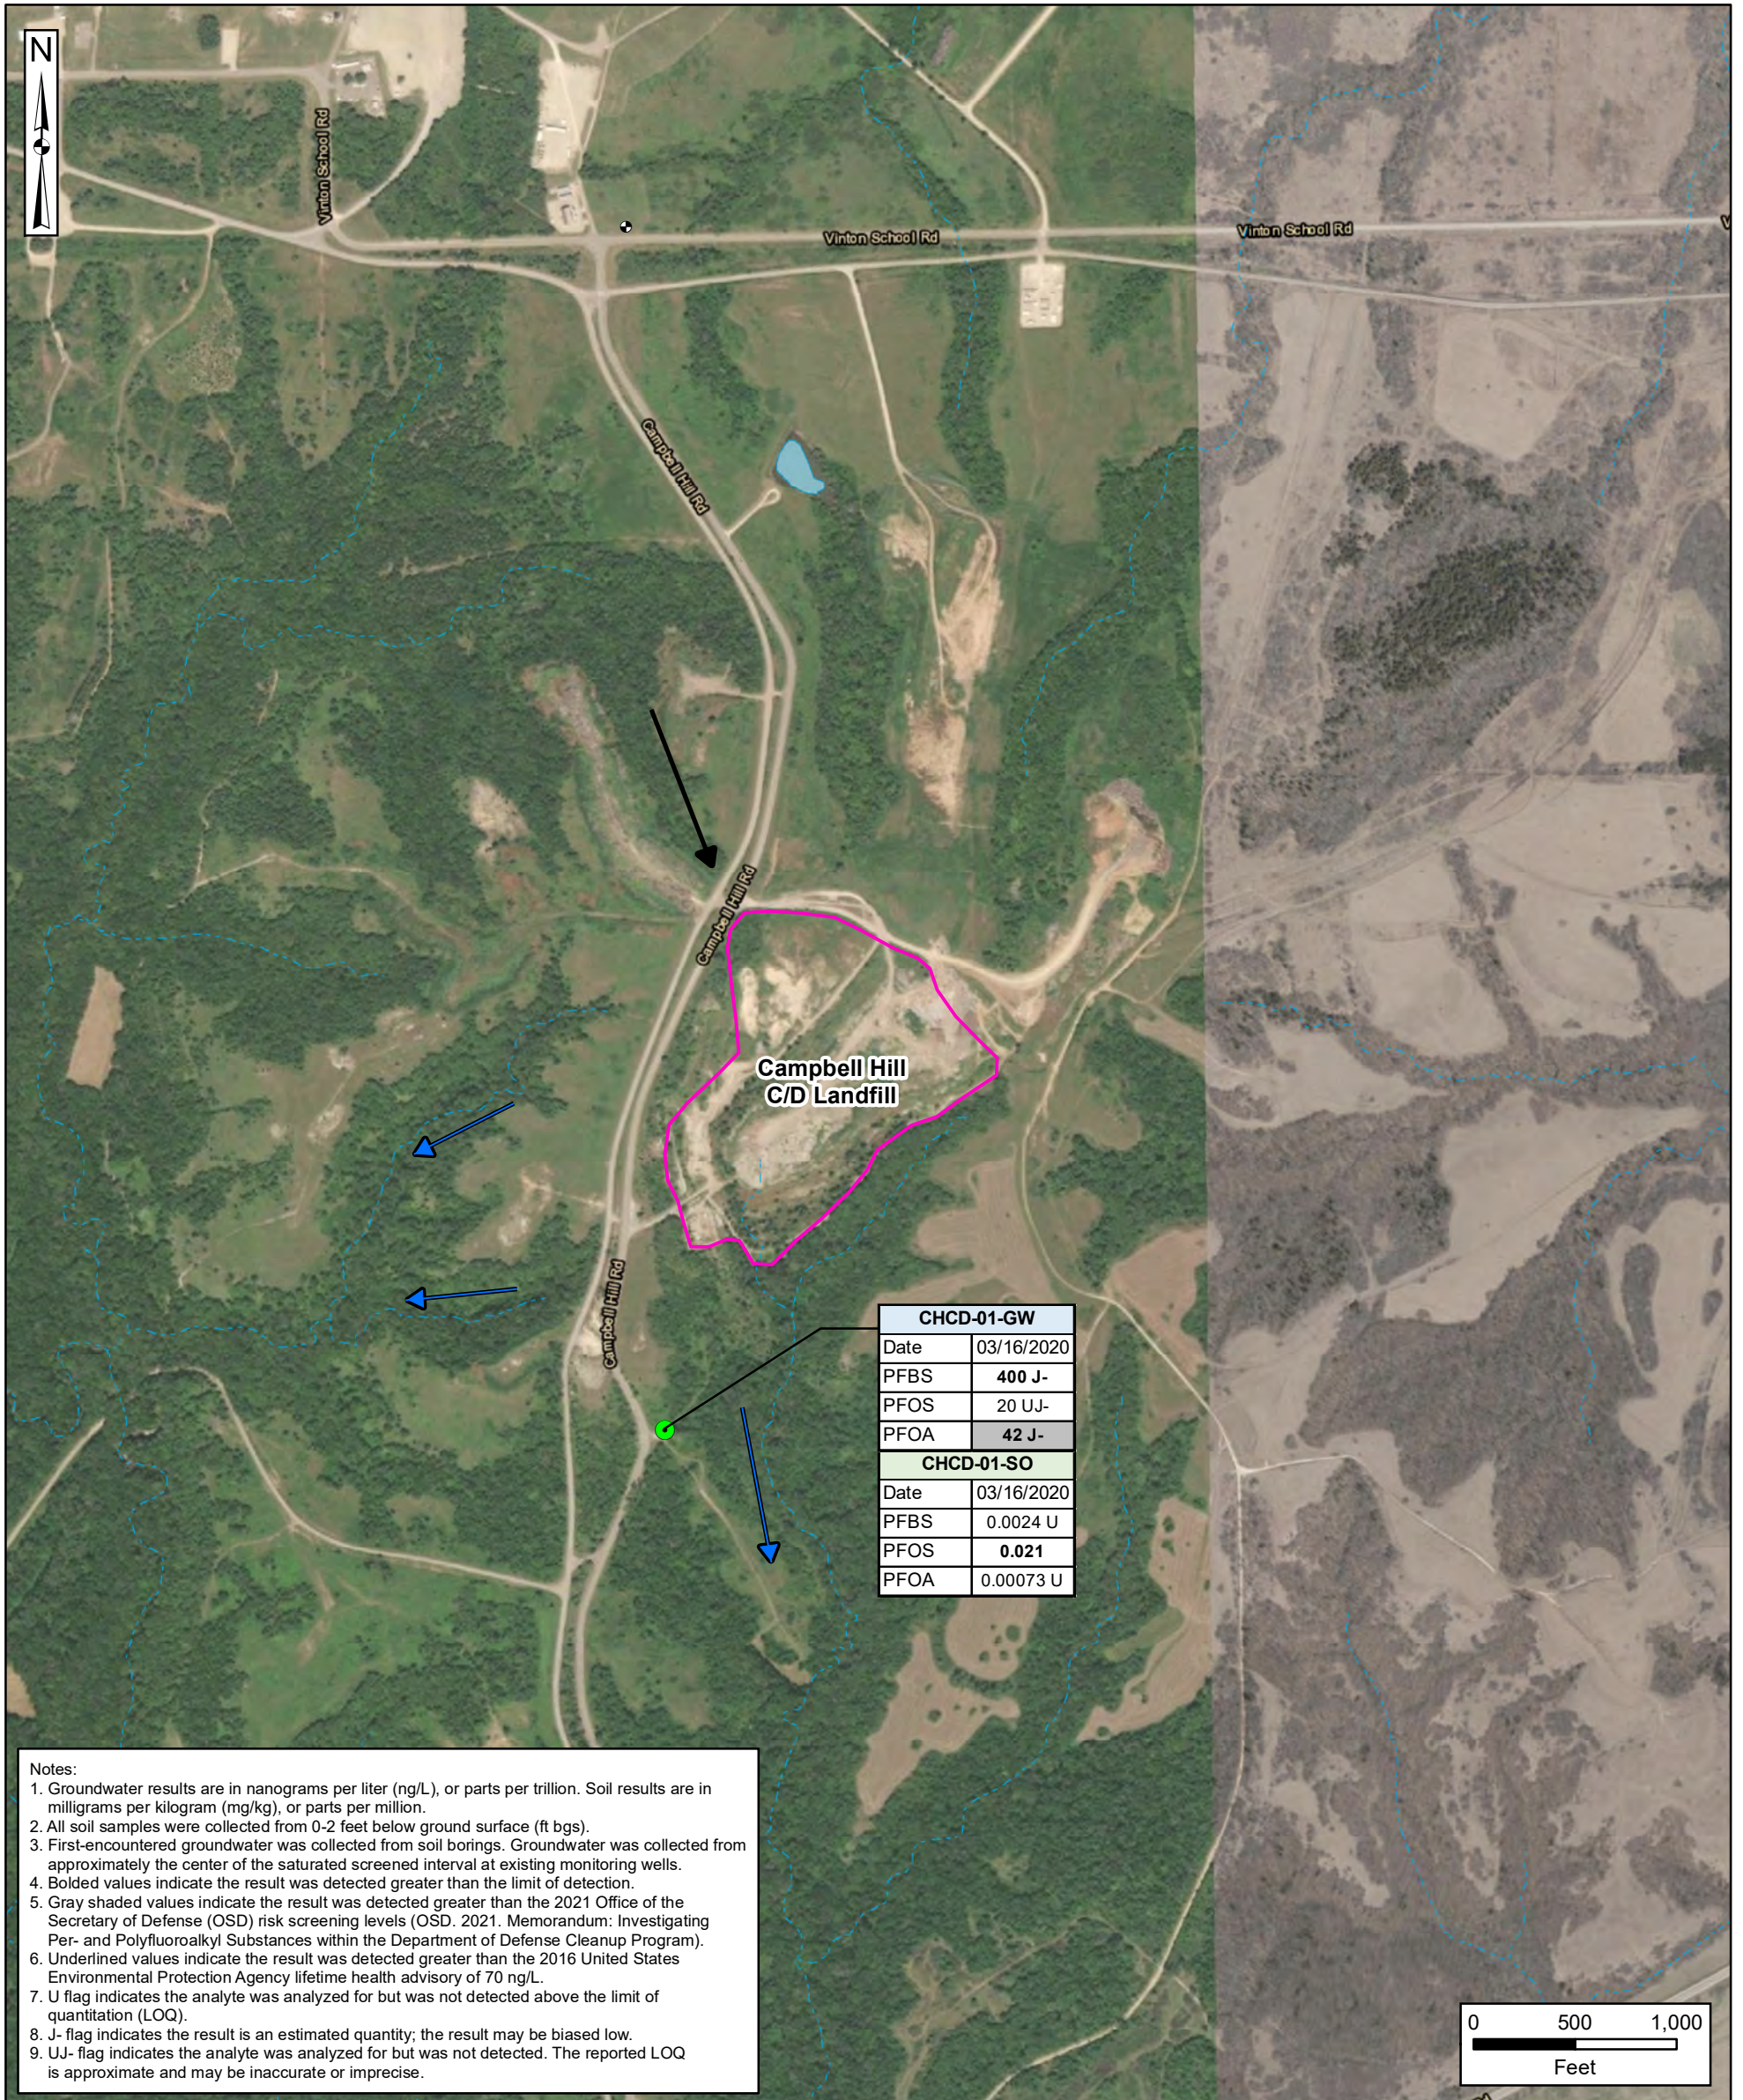
Figure 7-5
Campbell Hill C/D Landfill
PFOS, PFOA, and PFBS Analytical Results

- Notes:
1. Groundwater results are in nanograms per liter (ng/L), or parts per trillion. Soil results are in milligrams per kilogram (mg/kg), or parts per million.

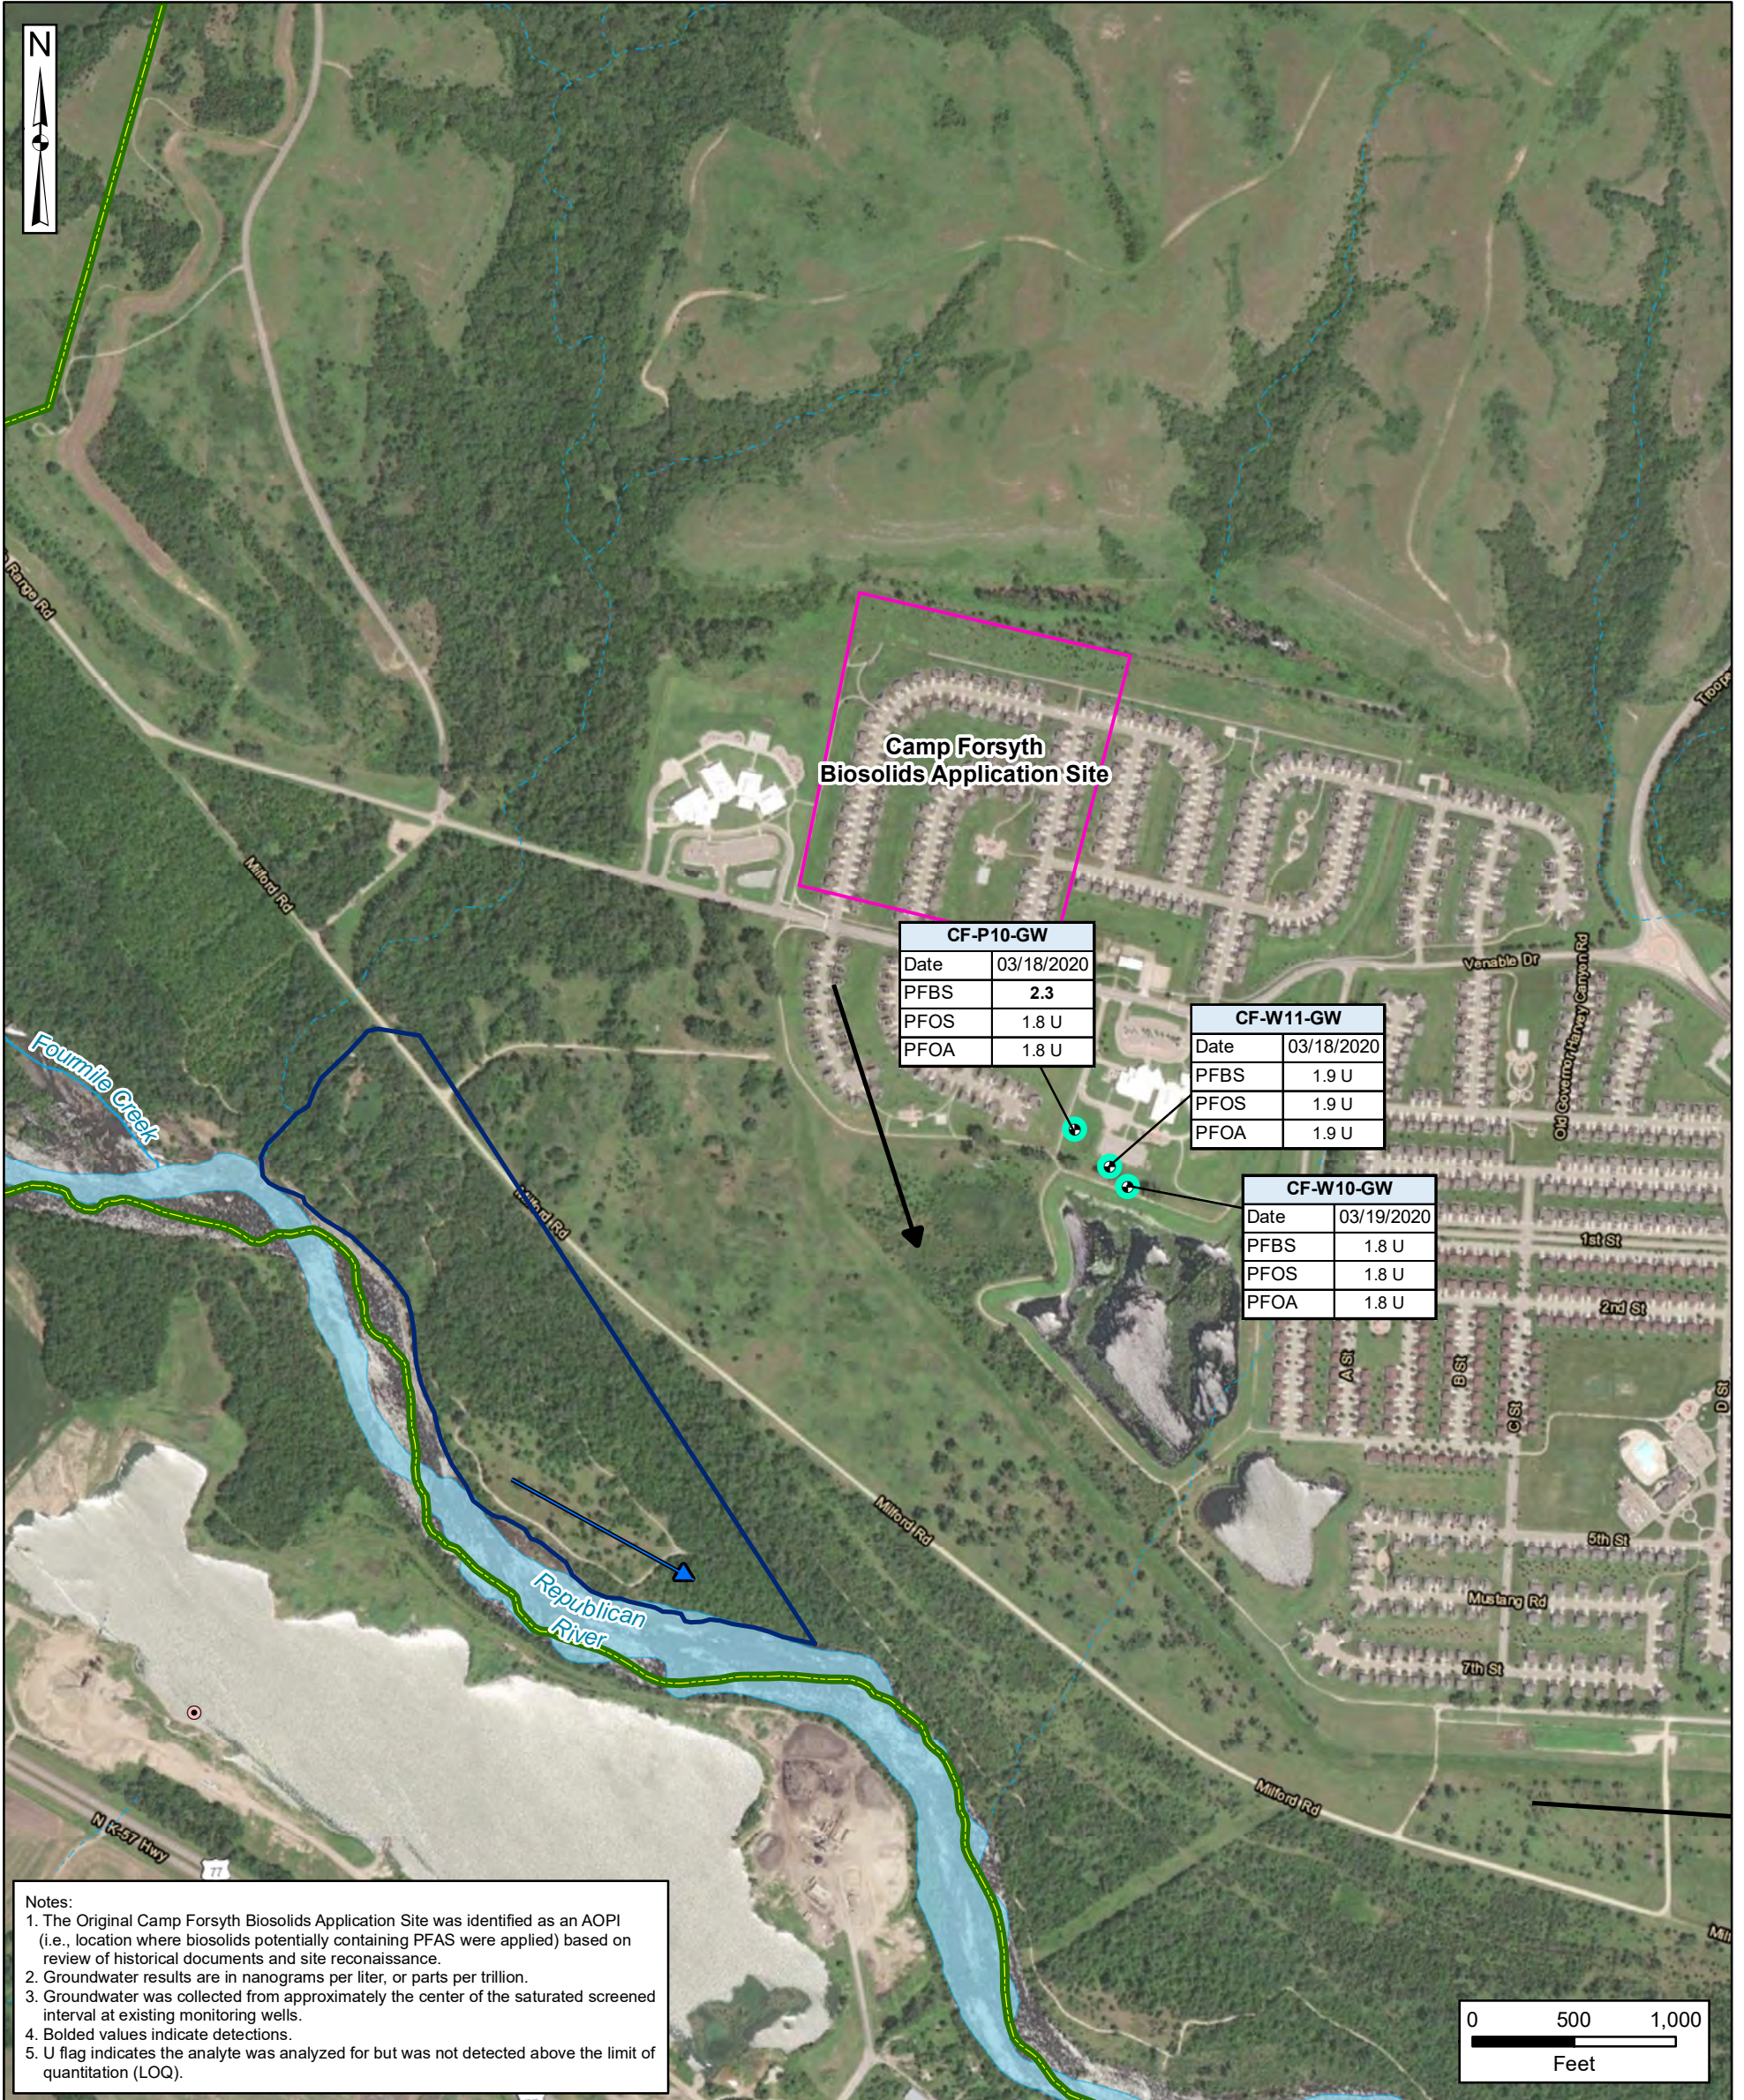
Figure 7-12
Camp Forsyth Biosolids Application Site
PFOS, PFOA, and PFBS Analytical Results

Notes:
 1. The Original Camp Forsyth Biosolids Application Site was identified as an AOPi (i.e., location where biosolids potentially containing PFAS were applied) based on review of historical documents and site reconnaissance.
 2. Groundwater results are in nanograms per liter, or parts per trillion.
 3. Groundwater was collected from approximately the center of the saturated screened interval at existing monitoring wells.
 4. Bolded values indicate detections.
 5. U flag indicates the analyte was analyzed for but was not detected above the limit of quantitation (LOQ).
