FINAL **PRELIMINARY ASSESSMENT** **AND SITE INSPECTION OF** **PER- AND** **POLYFLUOROALKYL** **SUBSTANCES**

Fort Riley, Kansas

January 2022

**Preliminary
Assessment and Site
Inspection of Per- and
Polyfluoroalkyl
Substances**

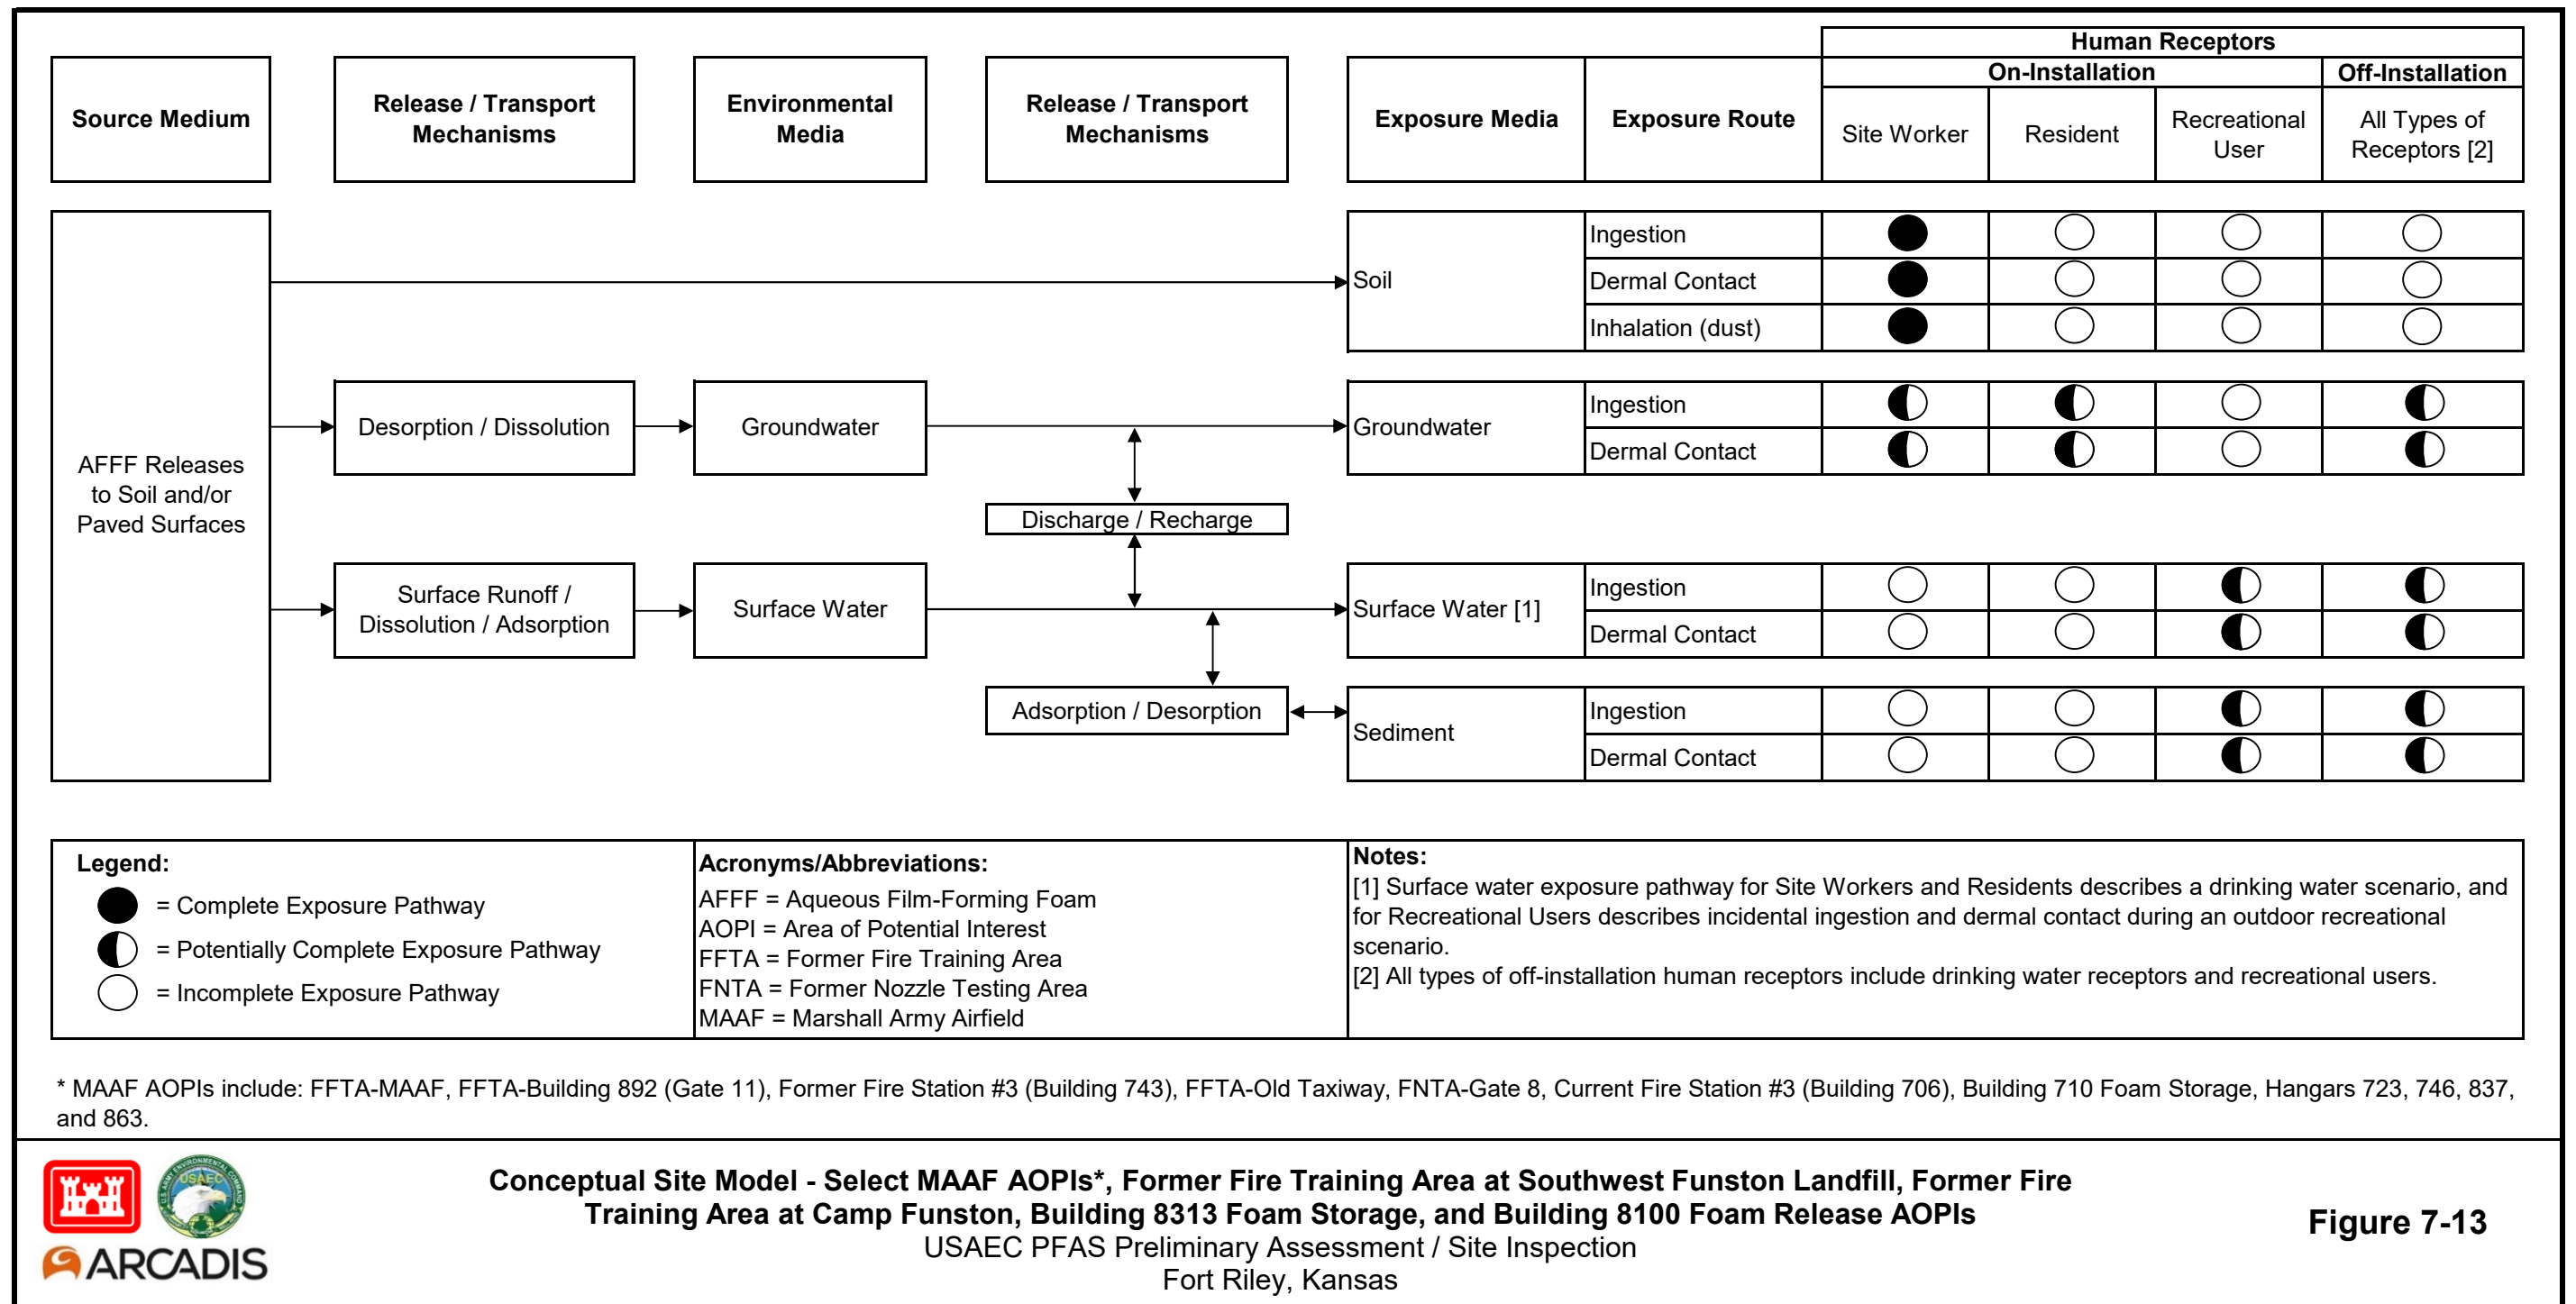
Figure 7-13

Conceptual Site Model - Select MAAF AOPIs*, Former Fire Training Area at Southwest Funston Landfill, Former Fire Training Area at Camp Funston, Building 8313 Foam Storage, and Building 8100 Foam Release AOPIs
 USAEC PFAS Preliminary Assessment / Site Inspection
 Fort Riley, Kansas

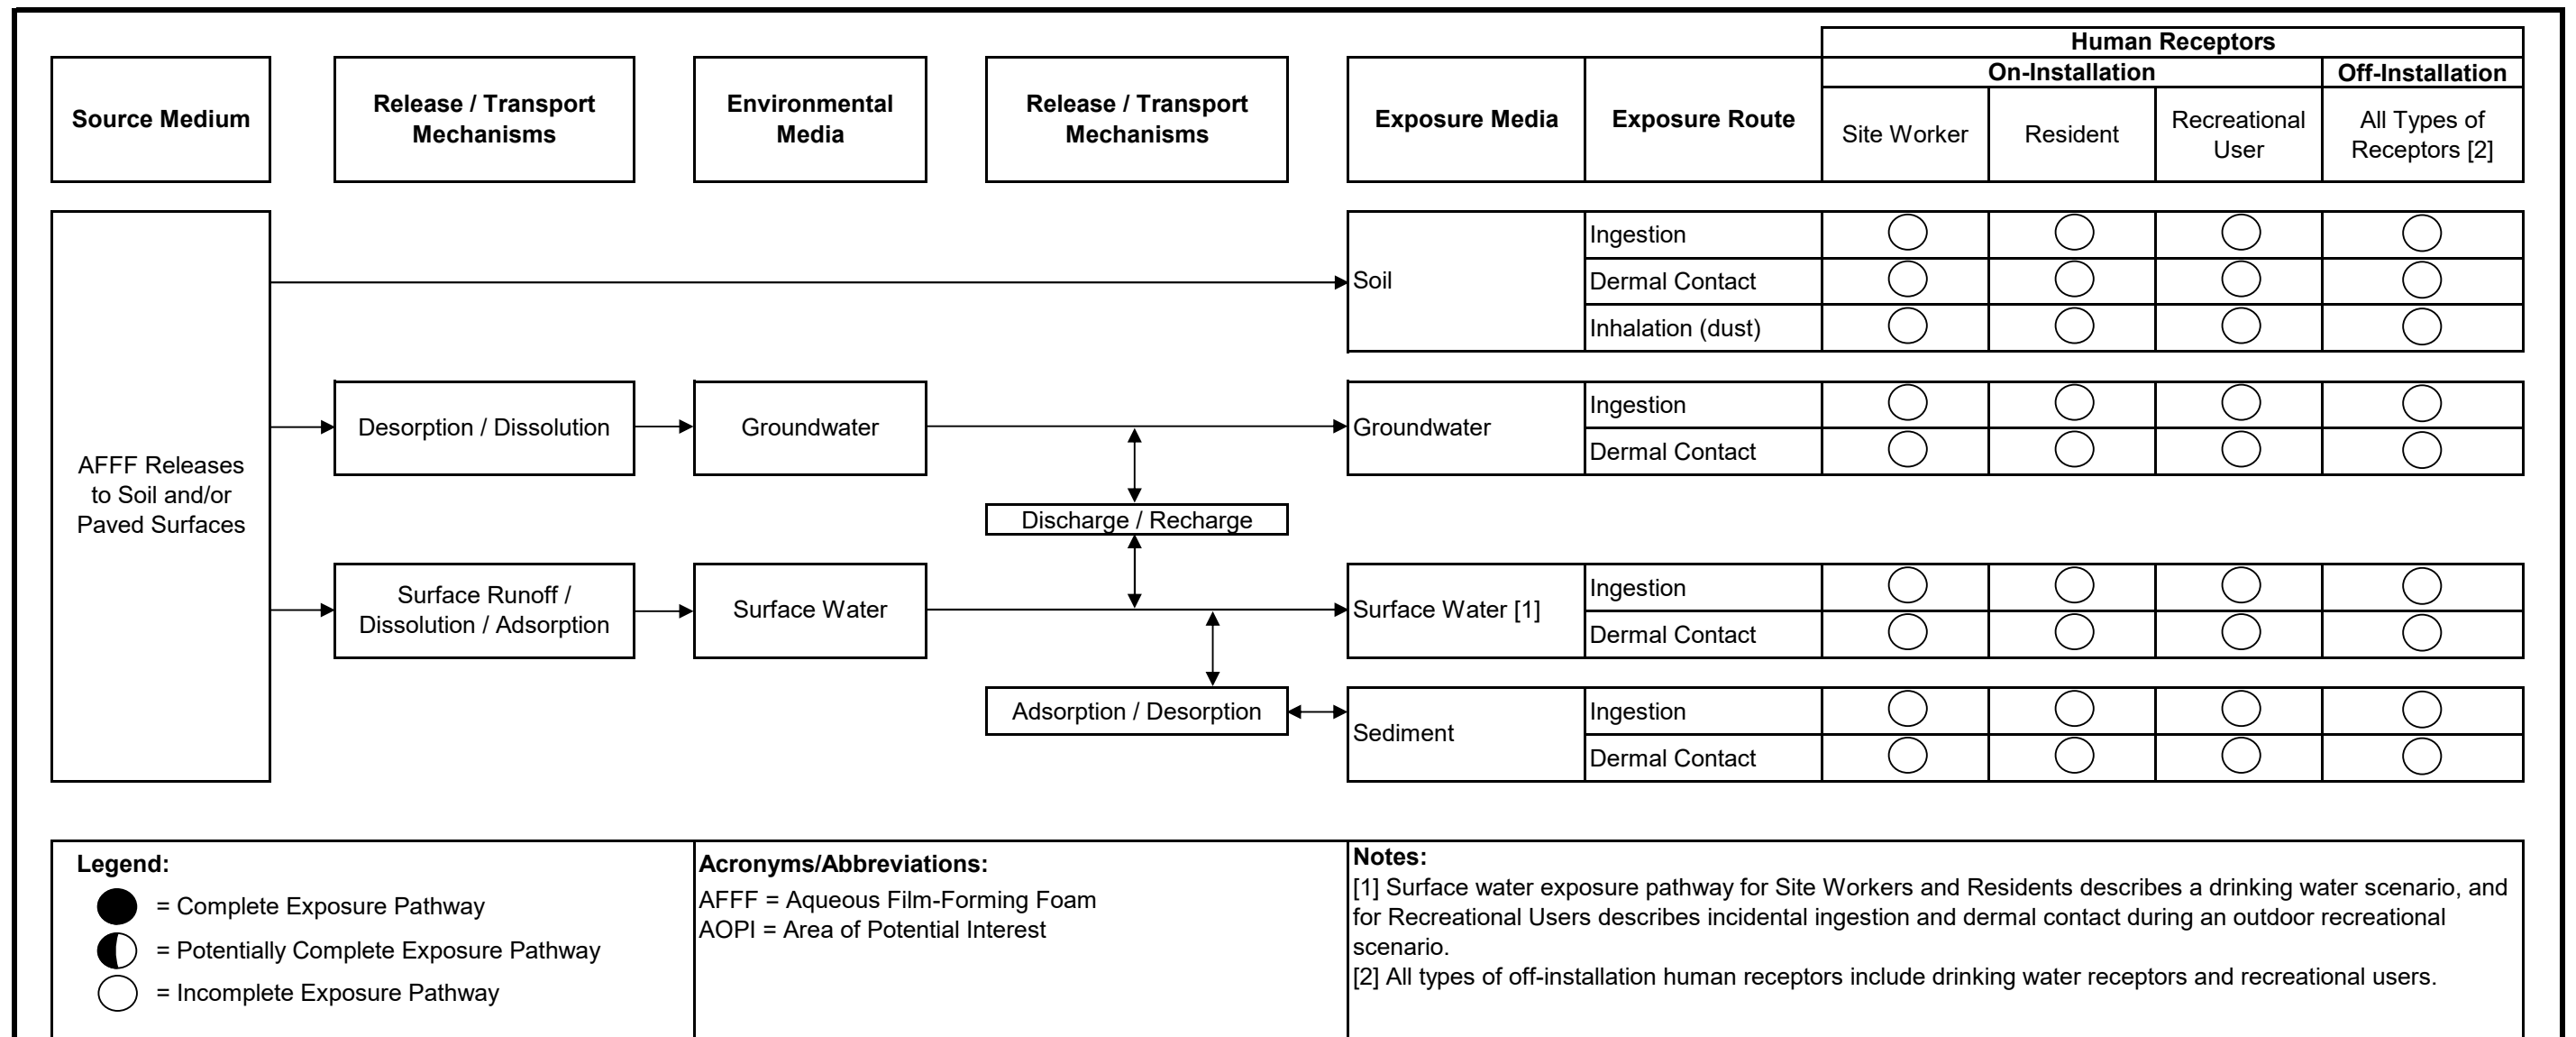
Figure 7-14

Conceptual Site Model - Building 817 Foam Release AOPI
 USAEC PFAS Preliminary Assessment / Site Inspection
 Fort Riley, Kansas

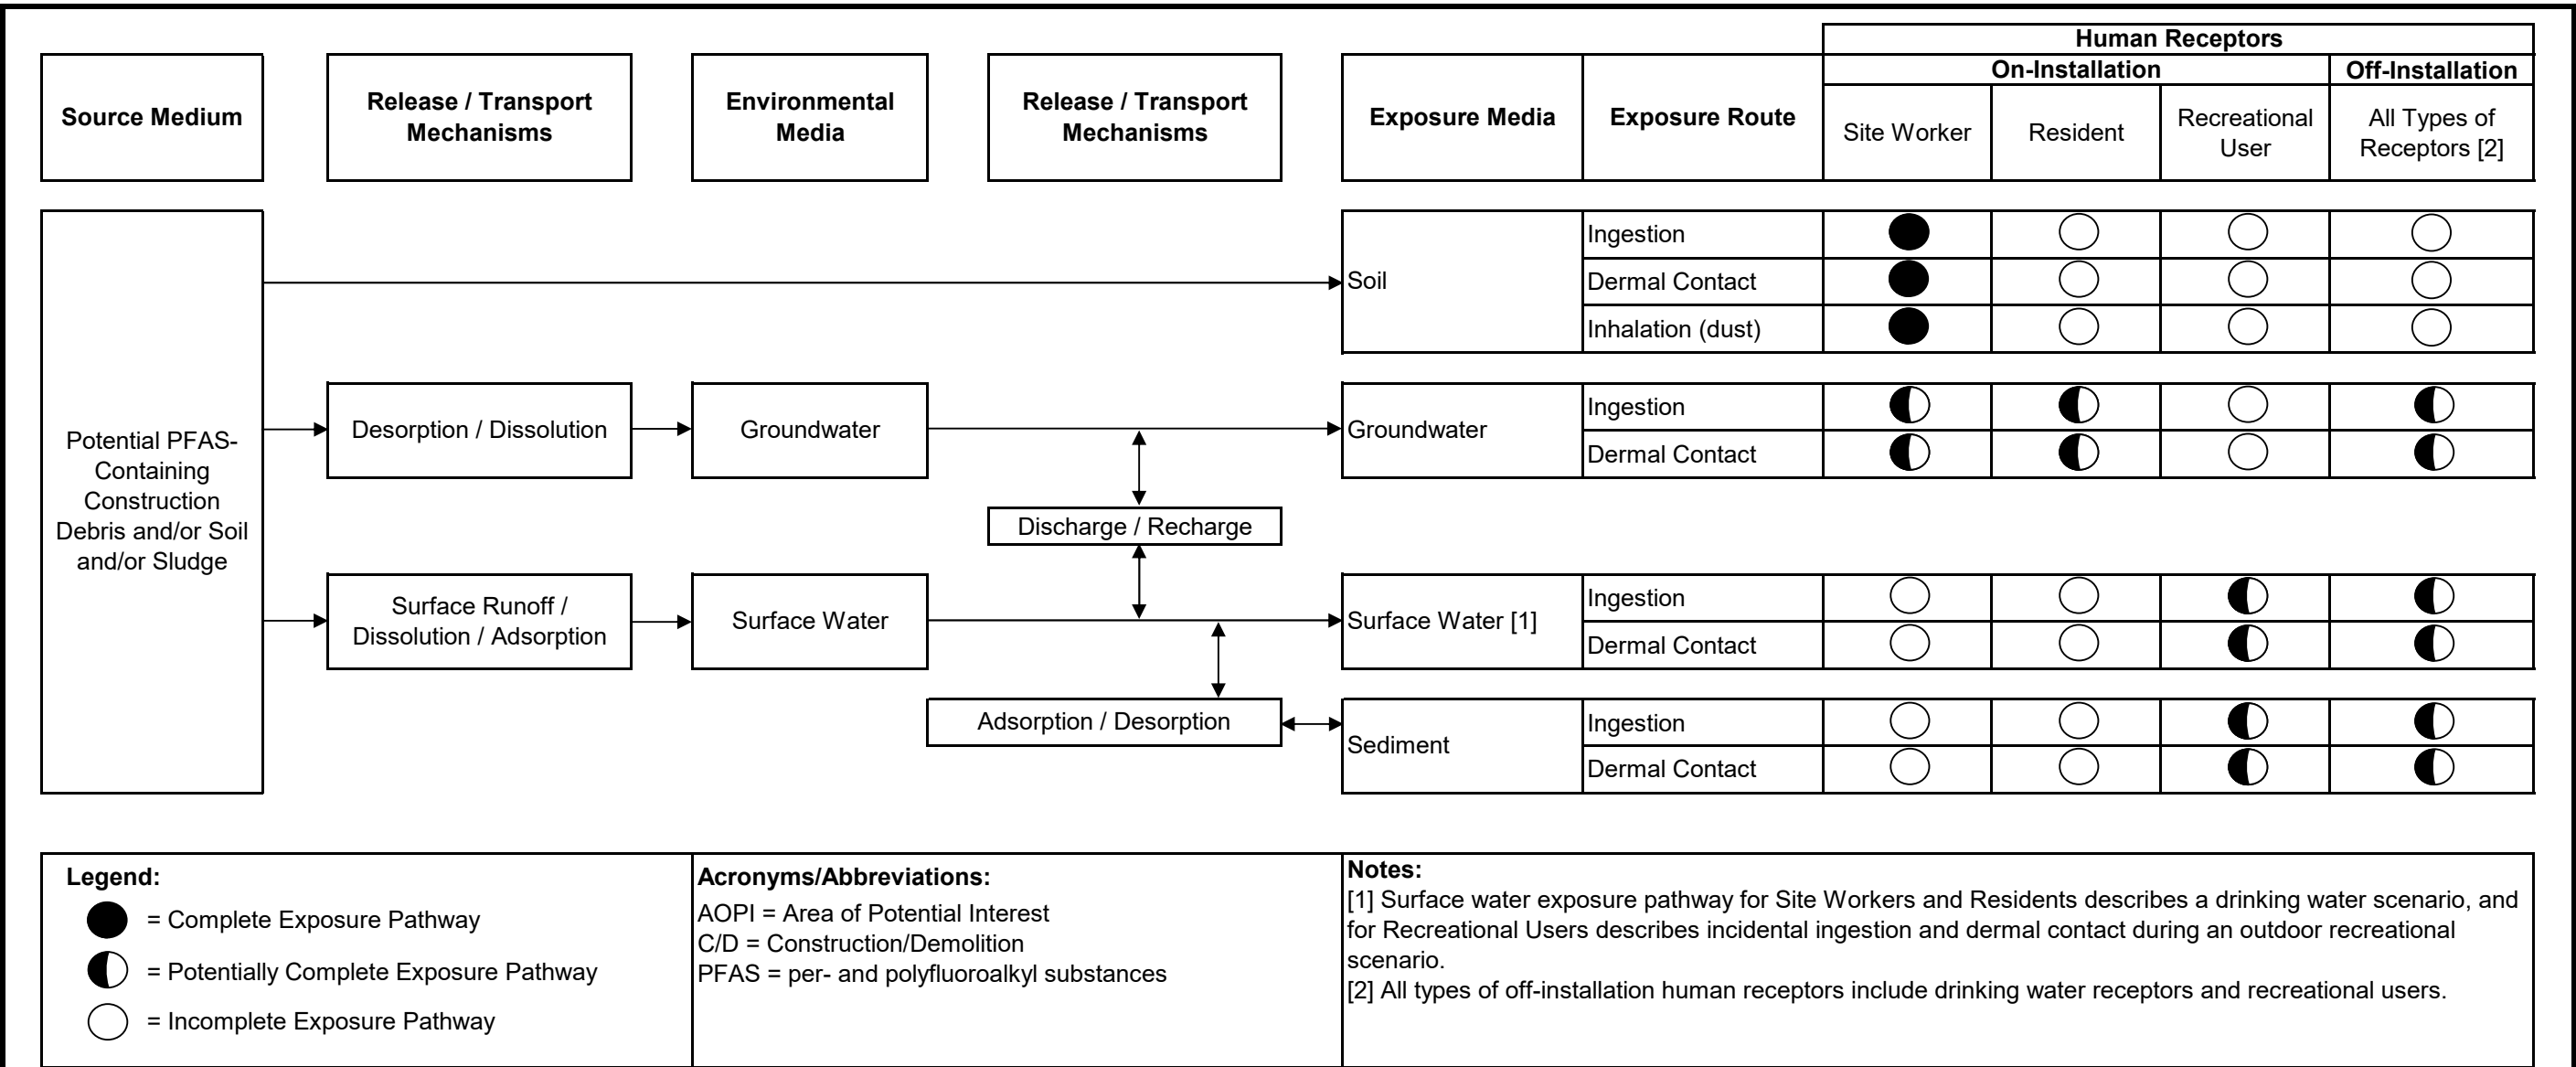
Figure 7-15

Conceptual Site Model - Whitside C/D Landfill and Campbell Hill C/D Landfill AOPIs
USAEC PFAS Preliminary Assessment / Site Inspection
Fort Riley, Kansas

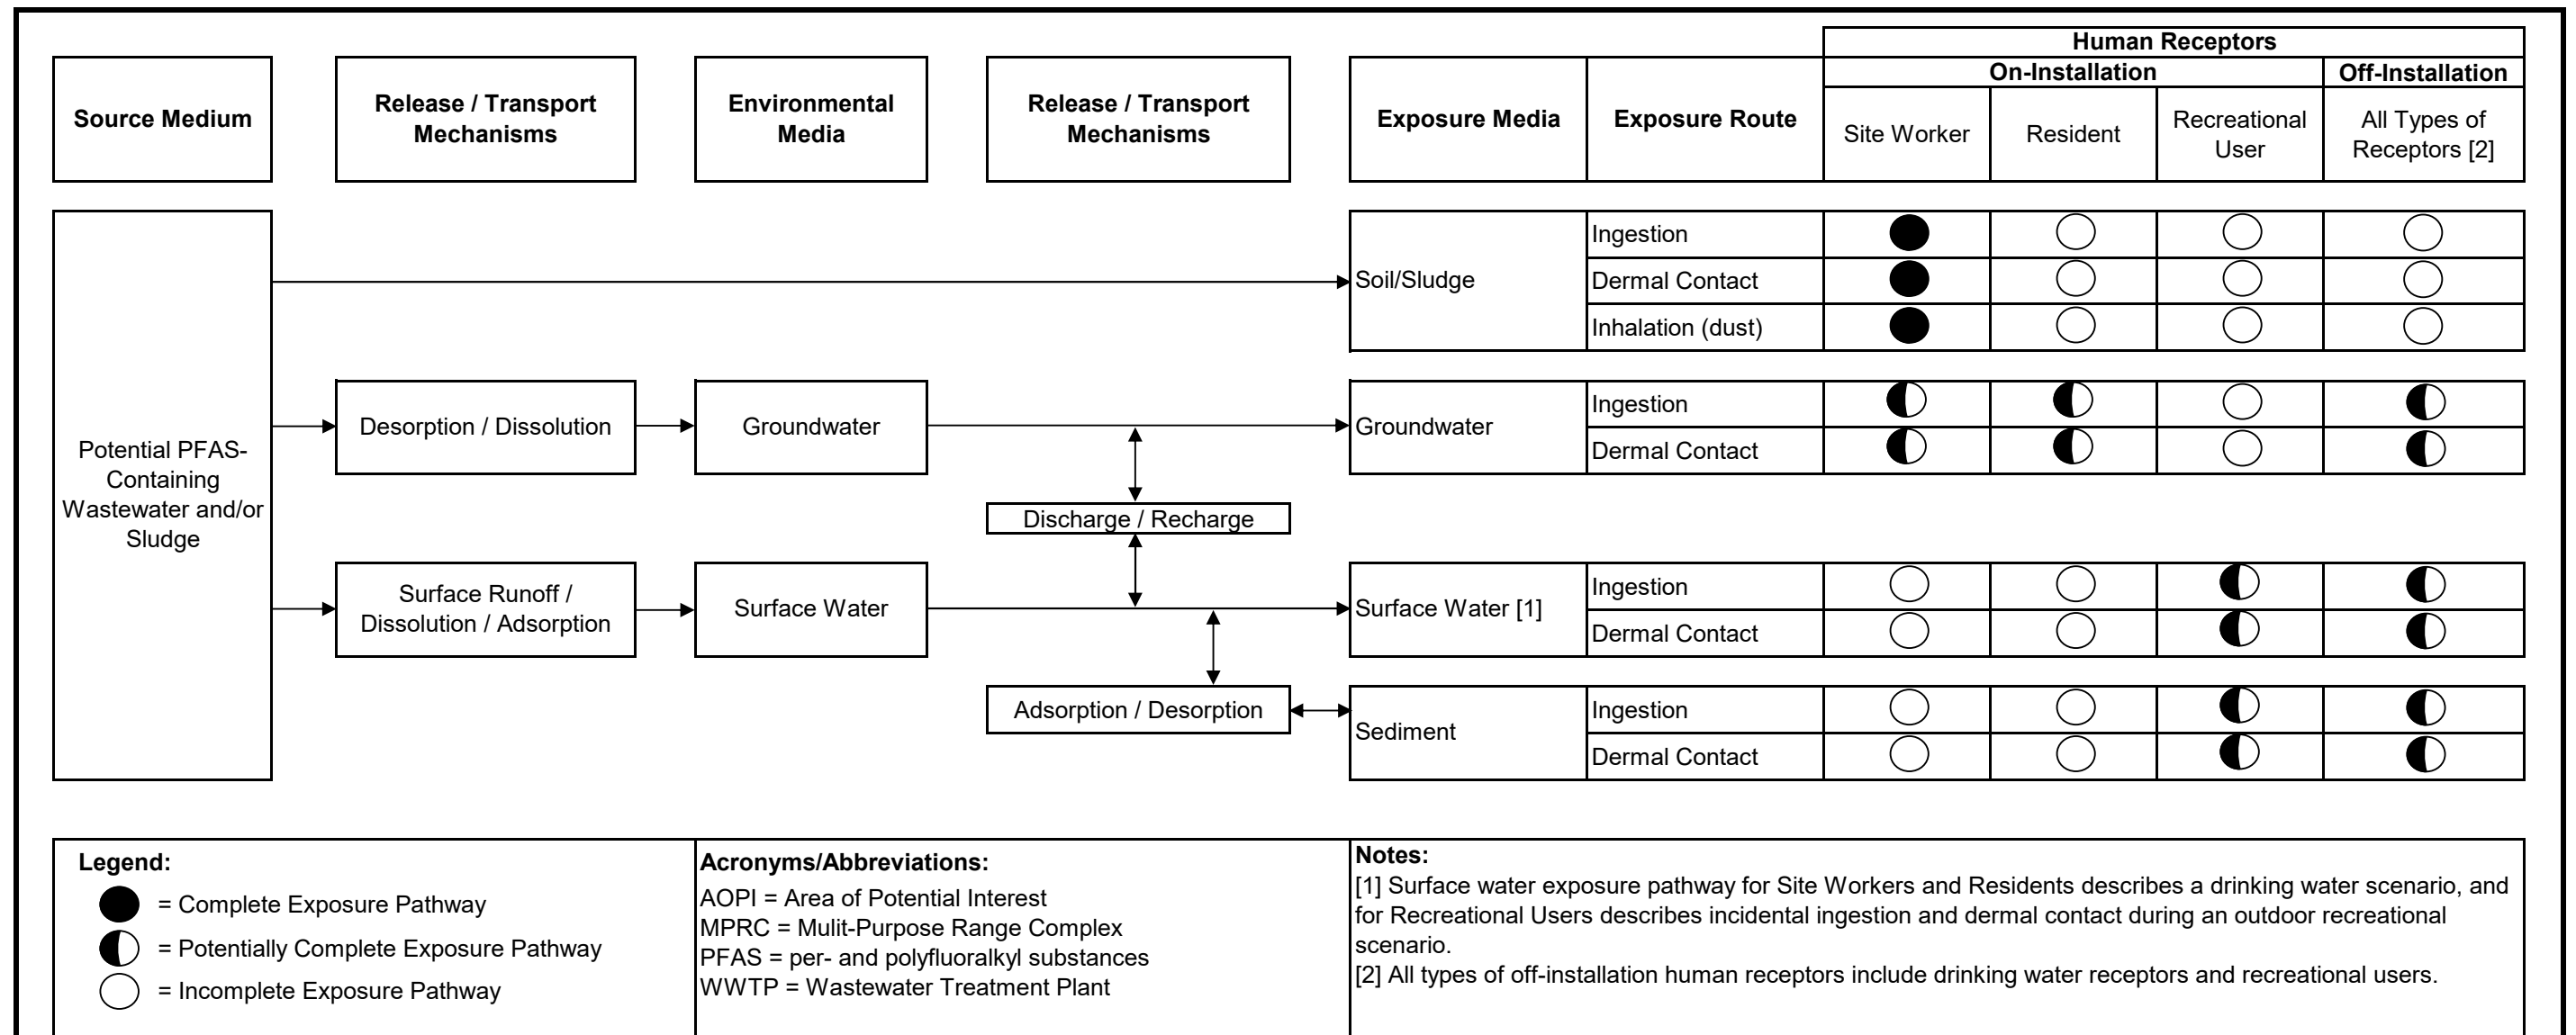
Figure 7-16

Conceptual Site Model - Main Post WWTP and Sludge Beds, Firebreak 1 Biosolids Application Site, Firebreak 10 Biosolids Application Site, MPRC Biosolids Application Site, Custer Hill Sanitary Landfill, and Custer Hill WWTP and Sludge Beds AOPIs
 USAEC PFAS Preliminary Assessment / Site Inspection
 Fort Riley, Kansas

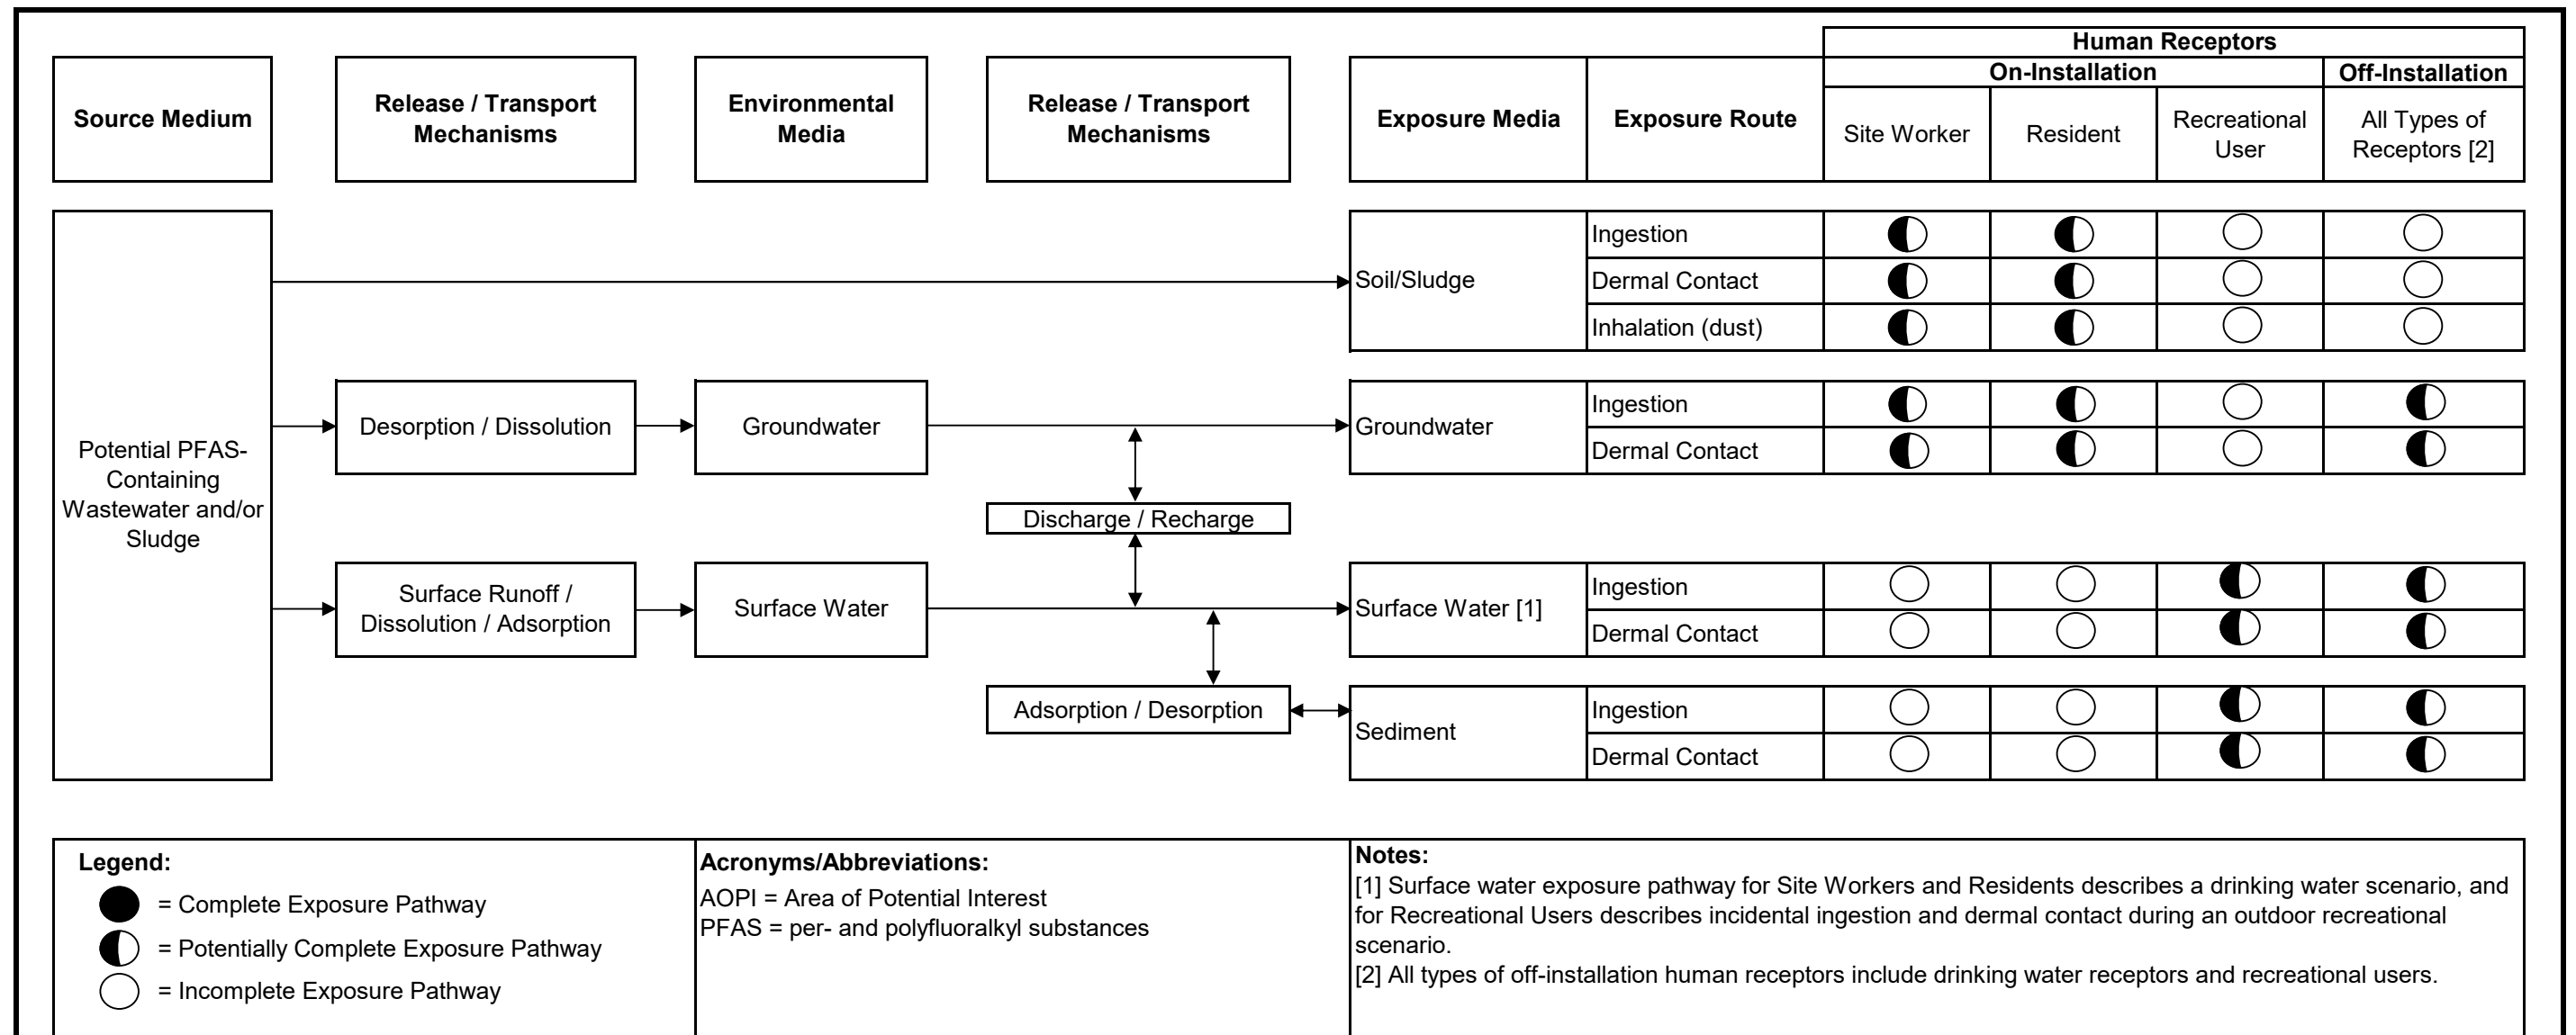
Figure 7-17

Conceptual Site Model - Camp Forsyth Biosolids Application Site AOPI
 USAEC PFAS Preliminary Assessment / Site Inspection
 Fort Riley, Kansas

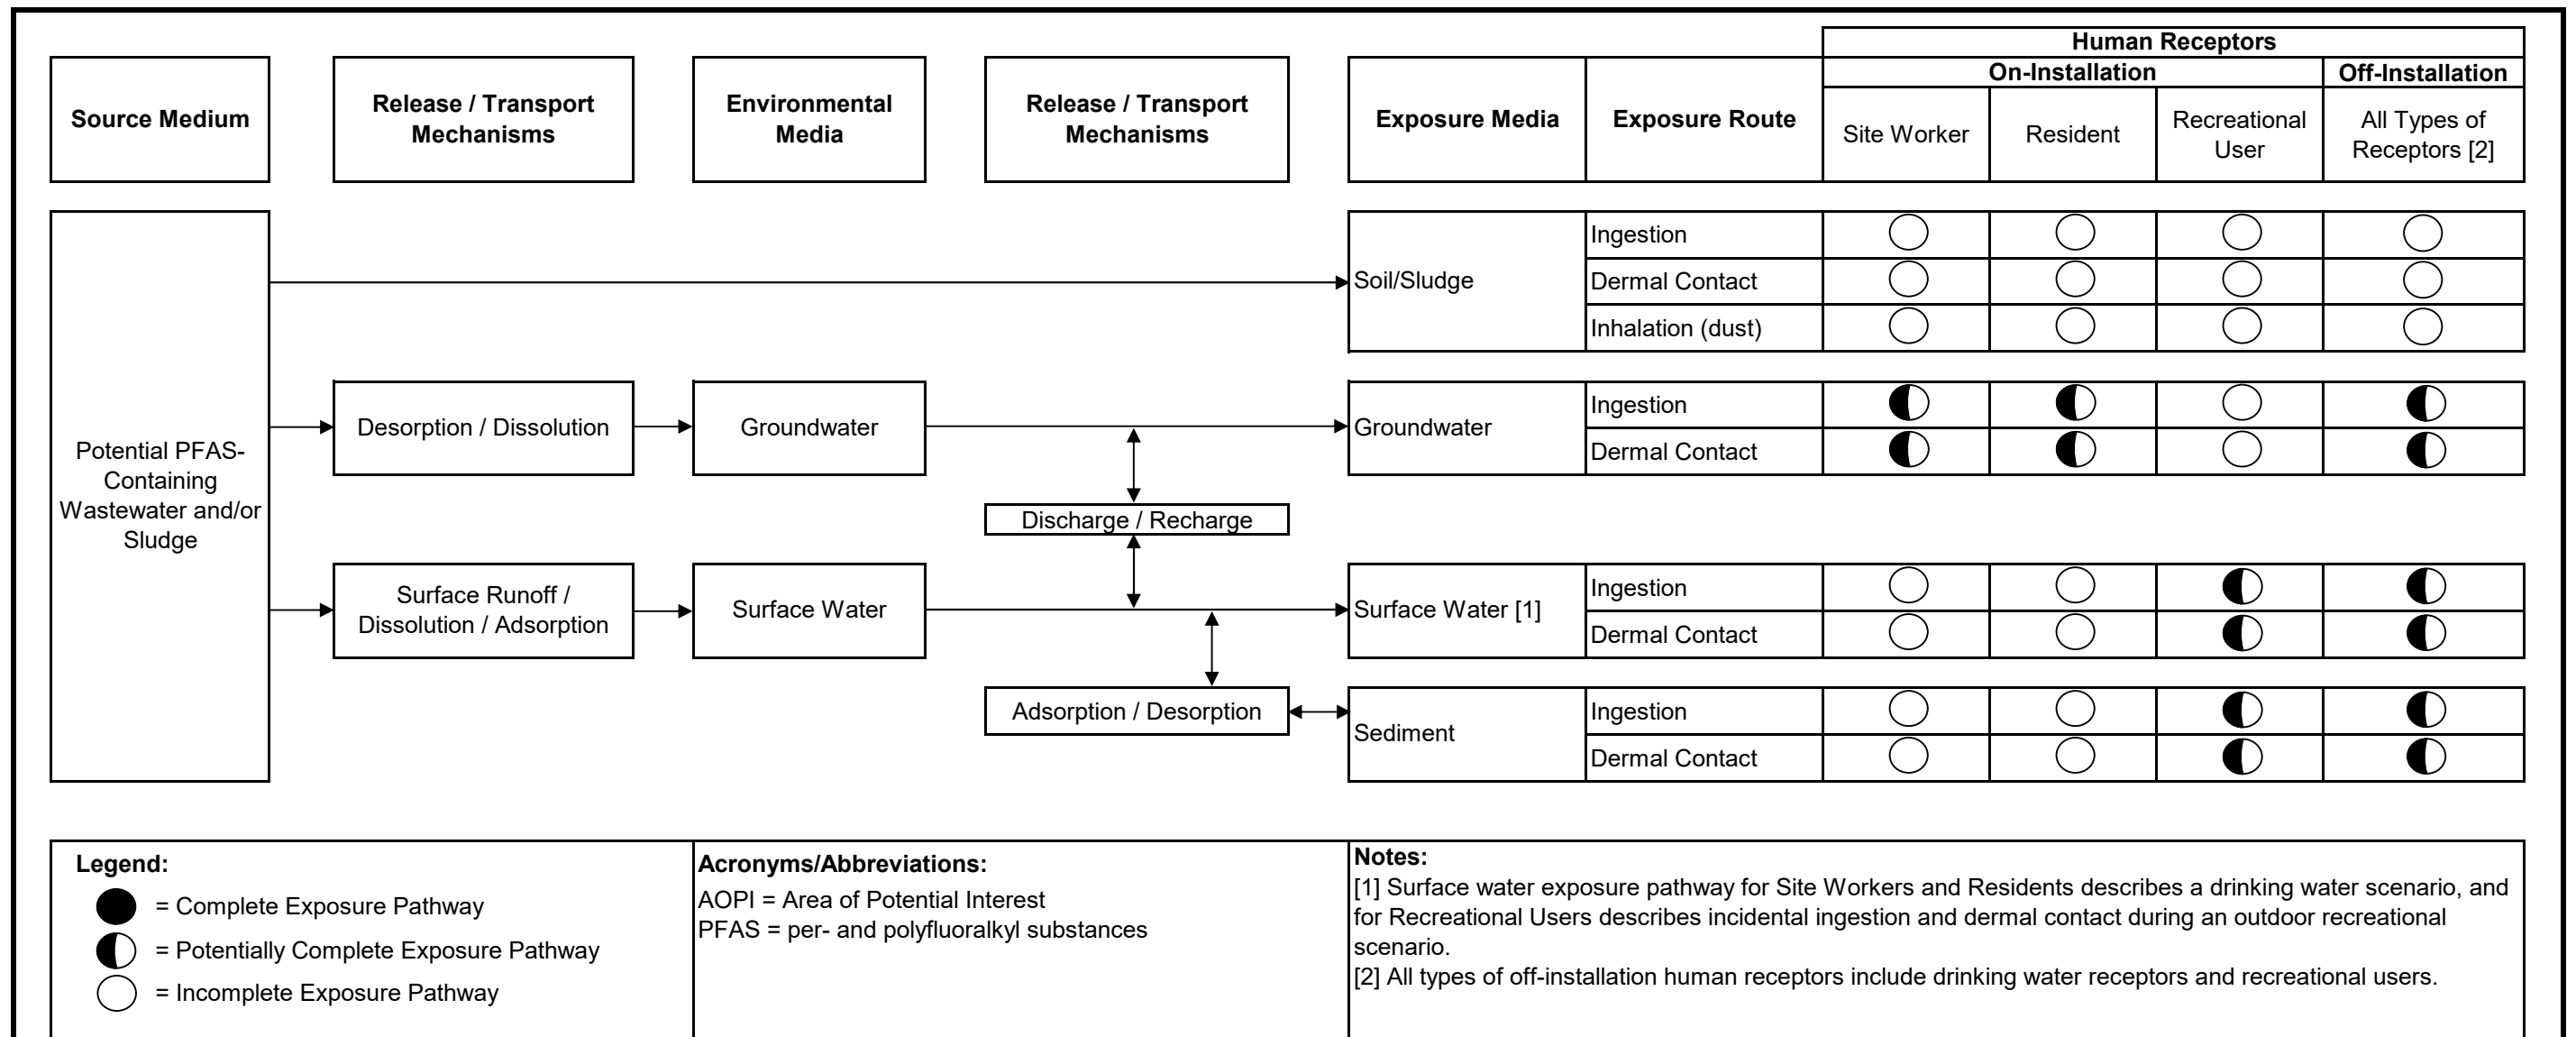
Figure 7-18

Conceptual Site Model - Camp Funston Biosolids Application Site AOPI
 USAEC PFAS Preliminary Assessment / Site Inspection
 Fort Riley, Kansas

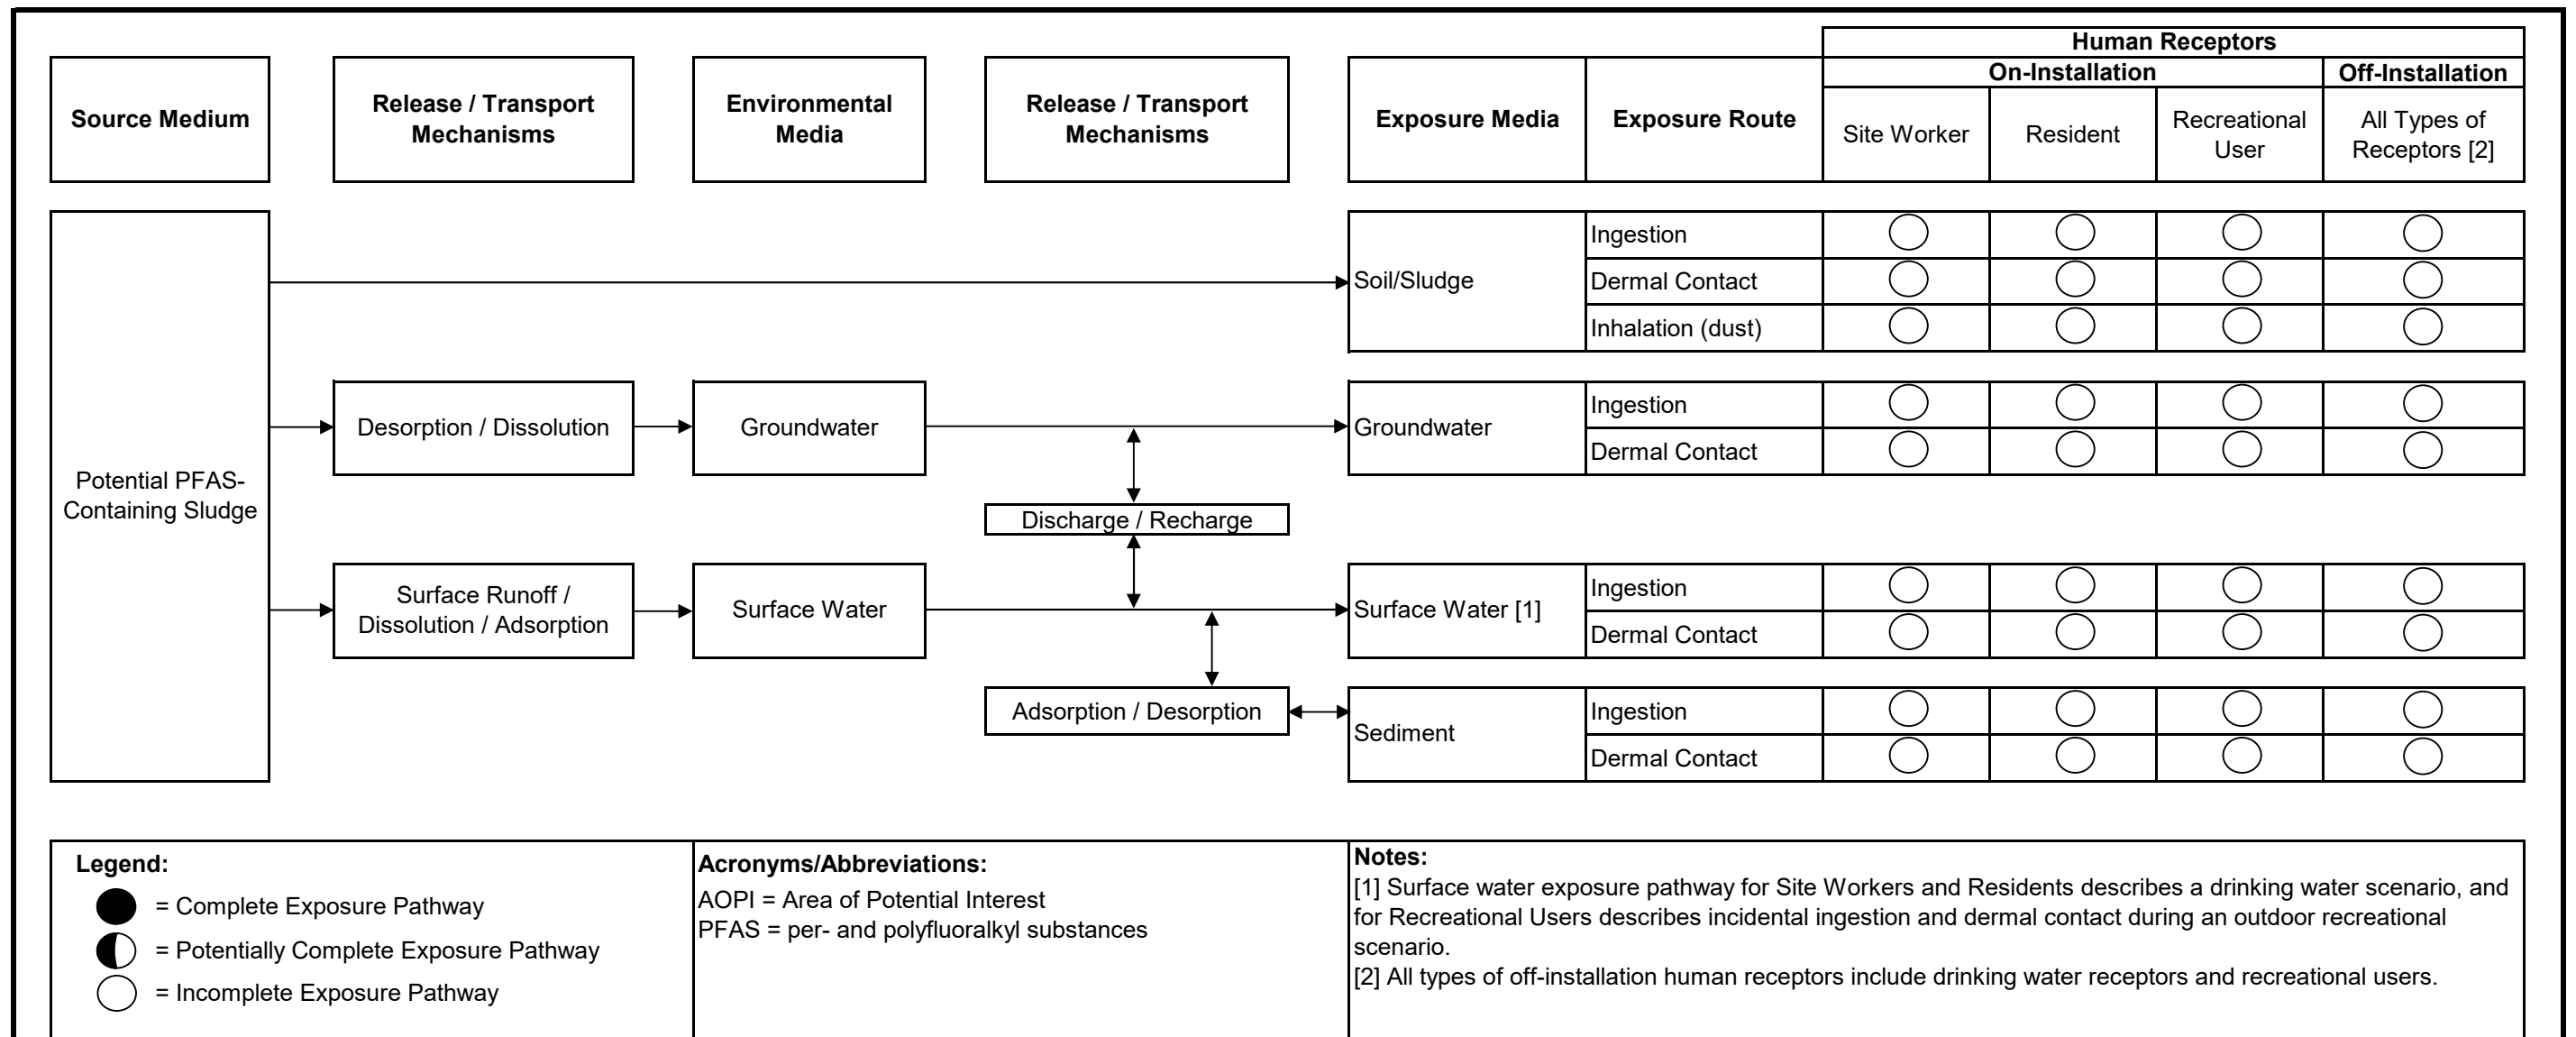
Figure 7-19

Conceptual Site Model - Firebreak 9 Biosolids Application Site AOPI
USAEC PFAS Preliminary Assessment / Site Inspection
Fort Riley, Kansas
